# Weir Farm

## Weir Farm Projects:

### Rustic Fence Restoration Spring 2003

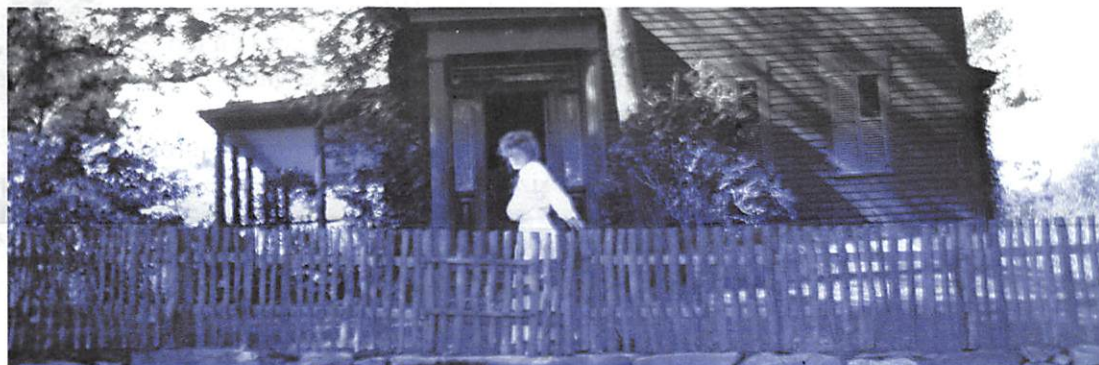
A young woman runs her hand along the rustic fence, c. 1905. National Park Service photograph.

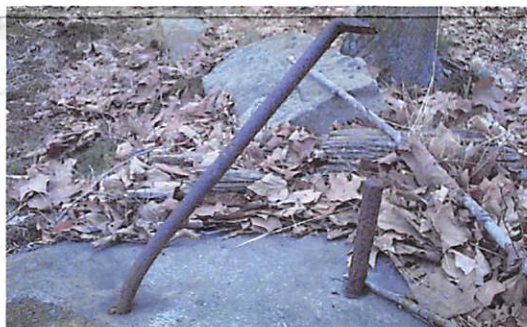
The fence that surrounded the domestic grounds of the Weir Farmhouse was built before 1890. It was constructed in segments roughly four to six feet long, using log posts and two horizontal rails to support the wood palings. In most areas, bedrock was close to the soil surface. The builders set the posts on iron shafts with iron angle braces embedded directly into the rock.

In certain areas the iron brace supports were all that was left of the original fence material.

The fence posts were made of unmilled cedar logs from a local sawmill. In the section of fence in front of the Weir House, the original iron hardware that supports the fence posts was reused for the restoration. A local blacksmith made hardware to replace the pins and brackets that had broken over time.

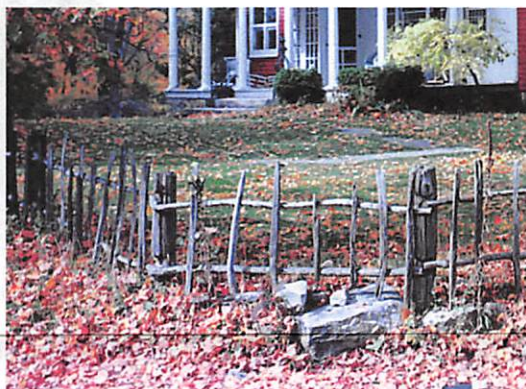
The existing fence was dilapidated and no longer looked the way it did when it was first built.

By the time of the restoration project, most of original pickets had been replaced with pickets that were semi-circular (not triangular) in shape. In fact, some of the pickets seemed to be no more than tree branches opportunely placed. Also, when placed, they were spaced farther apart than the pickets had originally been from one another. The fence had greatly deteriorated.

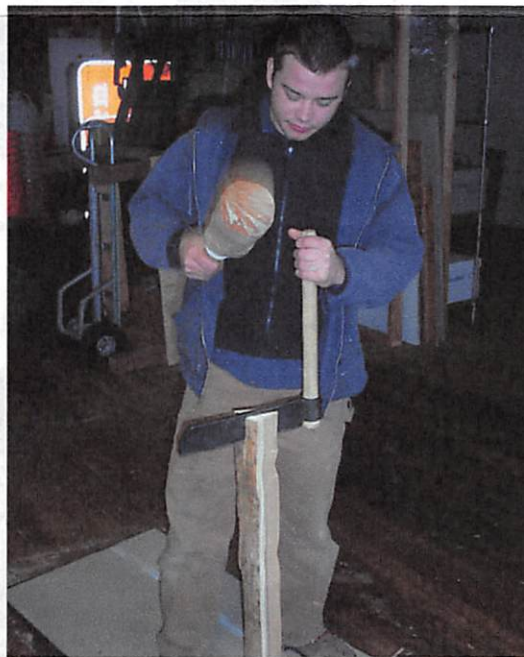
Hand-splitting each picket using a froe and mallet creates a rustic yet controlled cut. PTEI photo.

The fence was reconstructed using techniques as similar as possible to those originally used to build it. Since cedar native or indigenous to Connecticut is no longer readily available as a building material, the pickets are actually made of a western species of cedar. However, they were split by hand using traditional hand tools - hatchets and froes. A froe is a long metal blade fastened at a right angle to a wooden handle. The blade is placed on top of the log to be split and struck with a mallet. The froe enables workers to split pickets quickly and to exercise great control over their size.
