Cultural Landscape Inventory

## M'Clintock House

Women's Rights National Historical Park

# **M'Clintock House**

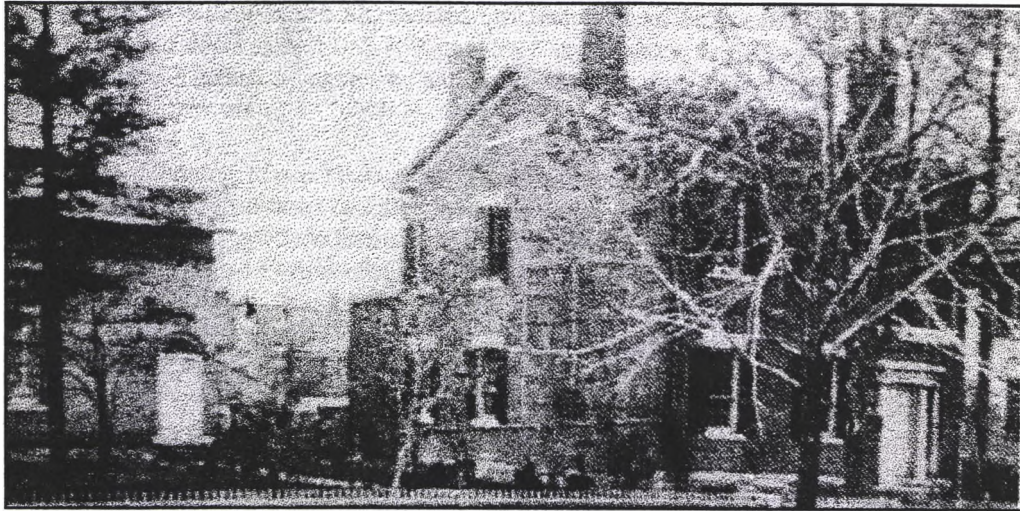
Fig #5: M'Clintock House and 1875 Church, c. 1879

Between 1875 and 1876 the parish constructed a church on the property east of the M'Clintock house. It was a plain, rectangular brick structure, built well back from Williams Street and used as a Sunday-school and lecture room. Two photographs of the 1876 church are known. One of these photos, dated 1879 (see Fig #5), is also the earliest known photo of the M'Clintock house. It depicts the main structure of the house looking much like it does today but with a two-story rear wing. A large trellis was attached to the brick on the east side of the house. The type of vines grown on the trellis are undocumented. A white picket fence in good repair appears to stretch the length of the north property line along the street. One large street tree stood near the center line of the lot. Minor vegetation appears at various locations on the property.

Construction of the 1875 church building would have caused any existing driveway on site to be rerouted. Evidenced by the 1879 photo and the existing drive, the new drive probably ran along the west side of the property and behind the M'Clintock house and the church.

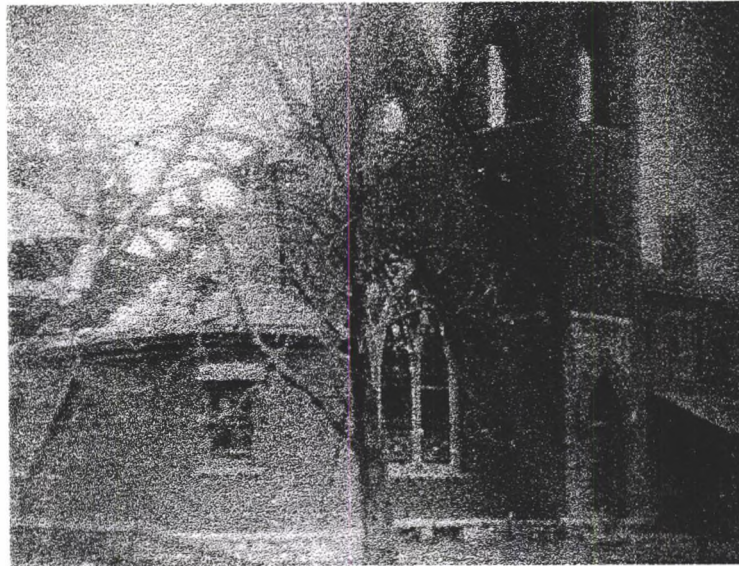
In 1906 a fire nearly destroyed the Waterloo Baptist Church (see Fig #7). The pastor, Rev. Bain, was arrested for having set the fire in the southwest corner of the cellar. The church rebuilt true to the original design and rededicated in November 1906. No record of any damage to the M'Clintock House, as a result of the fire, has been found.

*Fig #7: Fire Damaged Waterloo Baptist Church and Adjacent M'Clintock House, 1906*

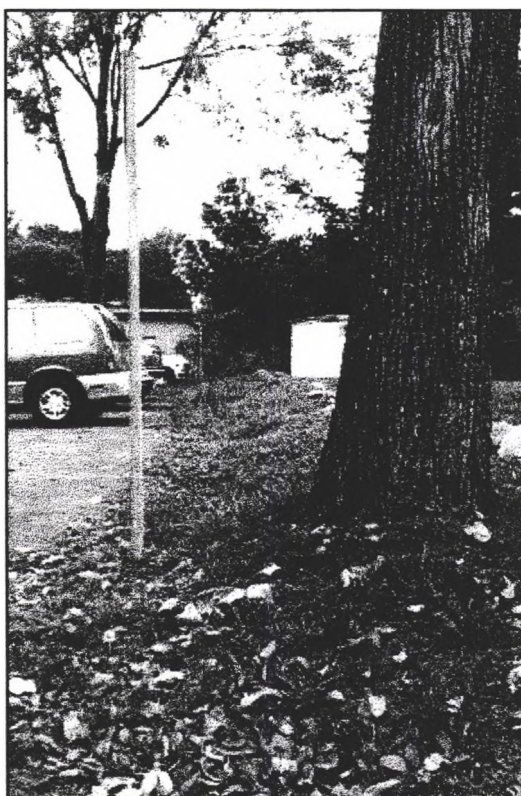
The majority of the landscape surface at the M'Clintock House has been significantly disturbed since the historic period, either through the construction and demolition processes themselves or through the piling and spreading of excess fill. The existing topography does not reflect the topography of the historic period.

*Fig #8 : Topographic Change At Southern Property Line, 1996*

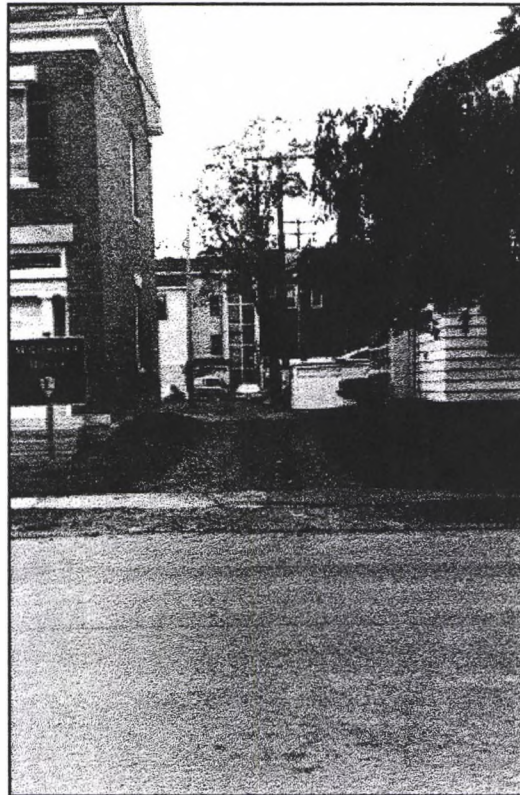
Due to the combination of landscape changes, such as the construction of the church buildings, the resulting grade changes, and the lack of circulation features existing today, it is clear that the existing circulation does not reflect what existed during the historic period. No character-defining features of the historic circulation remain, and the existing features were not present during the historic period.

*Fig #9 : Gravel Driveway at Western Property Line, 1996*

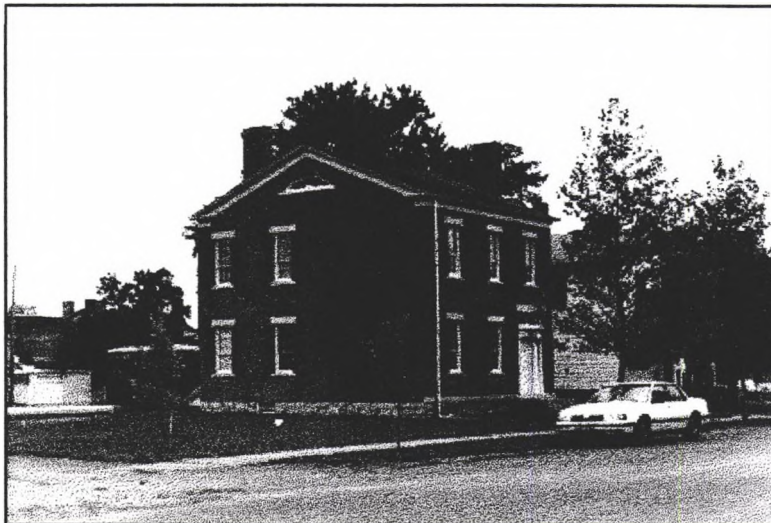
Although the vegetation of the historic period is undocumented, the current vegetation was planted without any reference to historic conditions. The existing vegetation does not reflect what would have existed during the historic period.

*Fig #10 : Young Sycamores Along Williams Street, 1996*

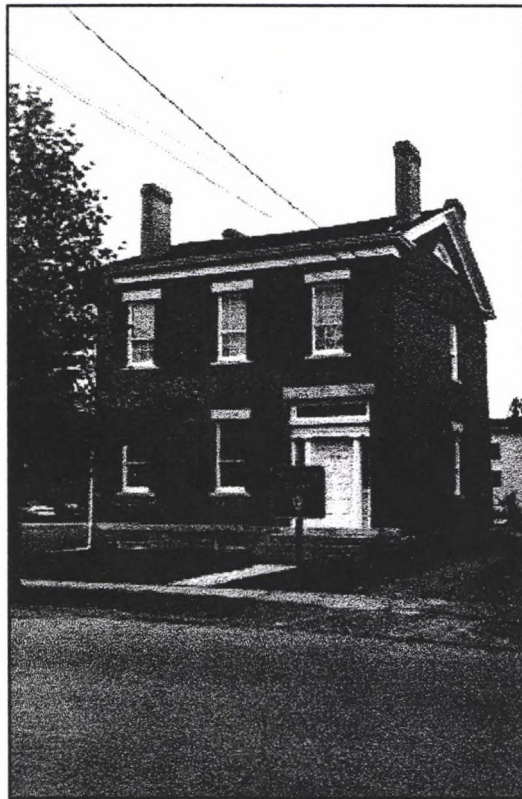
During the Baptist Church's ownership, there were various structures constructed and demolished on the site. A simple church building was built to the back of the eastern portion of the lot in 1875-1876. A new stable/barn was built to the south of the parsonage in 1893, and was later replaced by a garage around 1910. From 1897-1899 a large addition was built onto the front side of the existing church. In 1955 a fire destroyed the rear kitchen wing of the M'Clintock house. The site's outbuildings were all removed by 1981. The entire church building was demolished by the NPS in 1988. Currently, the house is the only structure remaining on the site (see Fig #11).

As a resource itself, the M'Clintock house retains high integrity. It's exterior has been restored to its appearance during the period of significance and its interior is currently undergoing the restoration process. Other than the house, no other character-defining structures remain.

*Fig #11 : M'Clintock House, 1996*

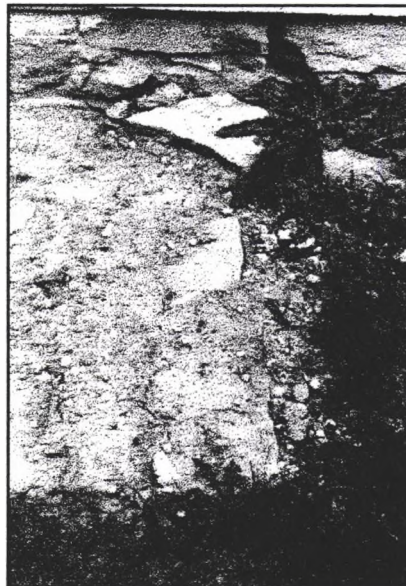
Immediately to the rear of the house, the remains of the kitchen wing foundation are visible (see Fig #12).

While several archeological issues are apparent, including the existing kitchen foundation, grade changes, and the potential of a curb located in front of the house, the majority of the site has been severely disturbed by the construction and demolition of the Waterloo Baptist Church. As a result, the archeological potential of the site is minimal.

*Fig #12: Kitchen Wing Foundation Remains, 1996*
