CLASSIFIED STRUCTURE FIELD INVENTORY REPORT  
(Attach 4" x 5" Black and White Photograph)

REGION RMR PARK/AREA NAME Zion National Park PARK NUMBER 1590

STRUCTURE NAME Comfort Station STRUCTURE NUMBER 130

LOCATION OF STRUCTURE Grotto Picnic Area PARK LOCATION CODE LG

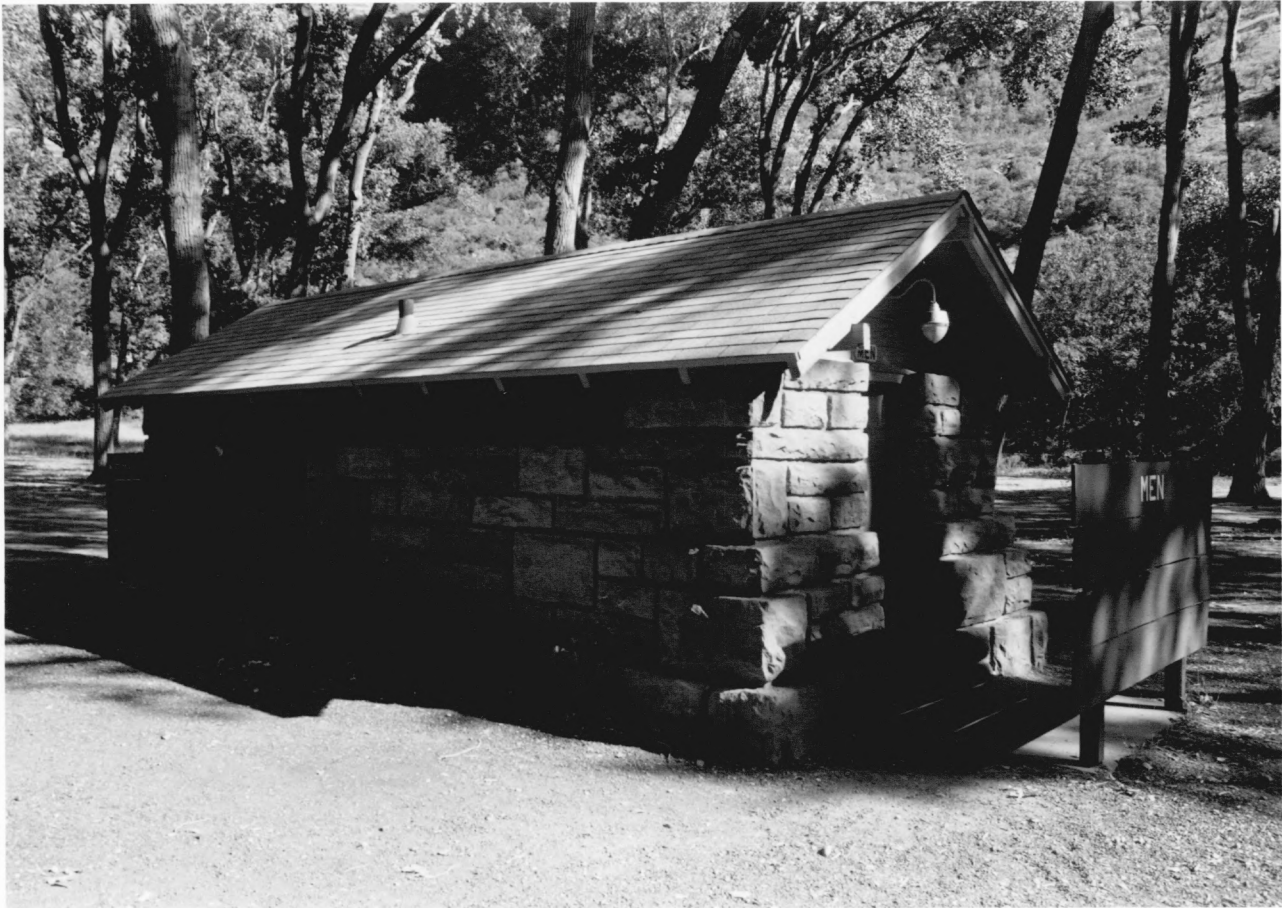
LCS No. 45-130  
Photo No. Roll # 15, view 8  
Subject concert station

Built of red sandstone, the building retains its original character and fabric typical of the NPS-Rustic style at Zion.

**OVERALL BUILDING PLAN (FOOTPRINT):** Rectangle **WINDOWS:** 5 wood casement windows attached in a row on each long elevation close to eaves.  
**OVERALL DIMENSIONS:** 13' x 26'

**COMPOSITION (NPS 28 CODE):** ST **DOORS:** Doors are panelled wood. Projecting wood screens are built to extend from 2 entrances to restrooms.  
**STORIES:** One-story **ADDITIONS:** None

**FOUNDATION:** Red sandstone  
**WALLS:** Large red sandstone blocks with stepped lower courses **INTERIOR PLAN:** Two-room (men's and women's restrooms)

**ROOF:** Asphalt gable roof with 2" x 6" rafter tails and exposed purlins; gable faces are wood flushboard; Roof eaves extend 2'. **INTERIOR FINISHES:** Modernized - drywall plus tile

Retains original wall fabric and fenestration.

Descrip. of View west  
Location of Subject Crofts Picnic Area  
Zion National Park  
Location of Negative RMRD - Denver
