REGION RMR PARK/AREA NAME Zion National Park PARK NUMBER 1590

STRUCTURE NAME Pine Creek Irrigation Canal STRUCTURE NUMBER IR 15

STATEMENT OF SIGNIFICANCE: Inoperable Park owned irrigation canal of historical and architectural significance.

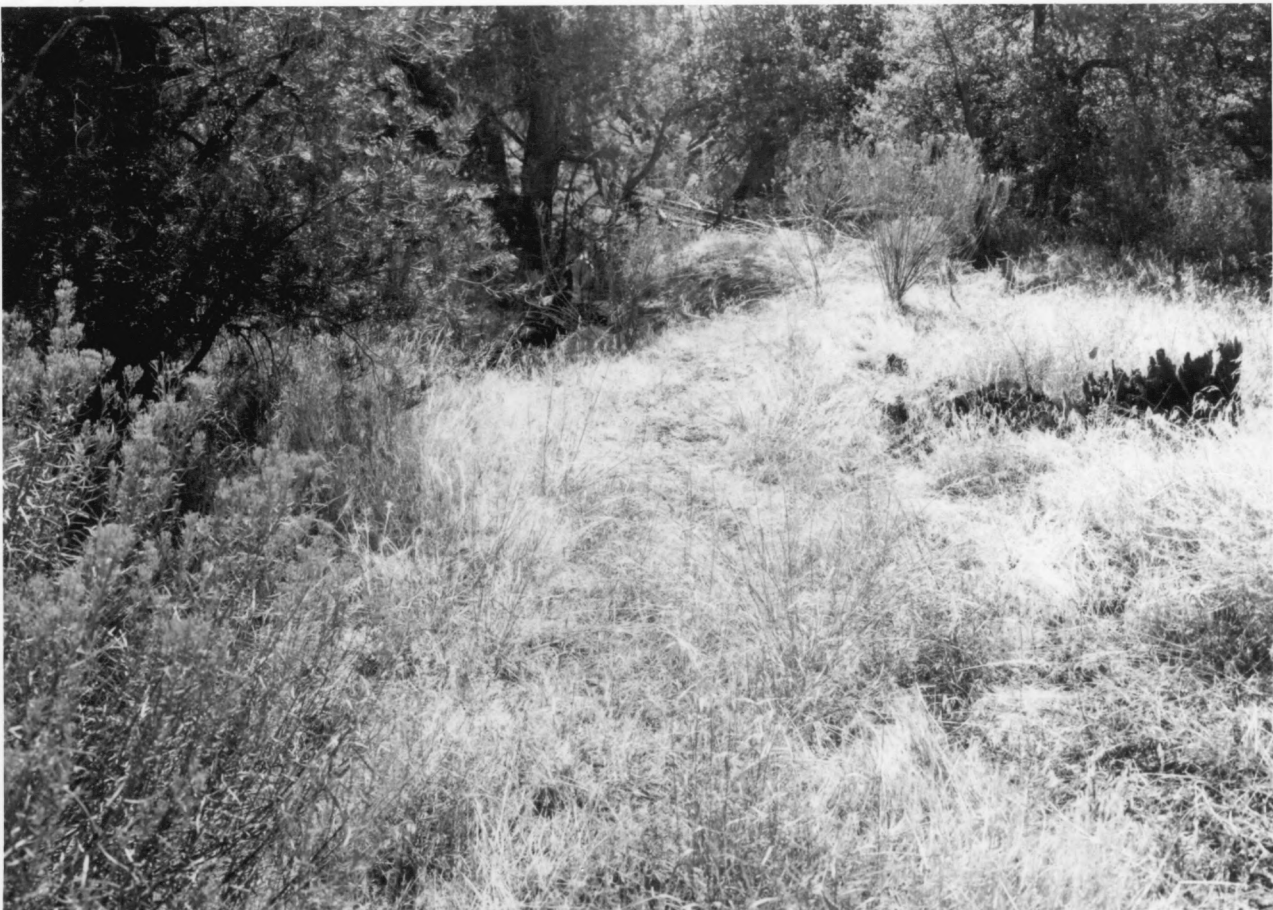
HAER UT-38-C-1

Pine Creek Irrigation Canal
Pine Creek Canal

South

Sections of "dry" random rubble, pioneer-built, rock retaining walls which supported the canal bed are apparent, as well as water delivery system artifacts, such as the well preserved remains of a 15'-long stave pipe flume constructed of oak slats, and wire rings with a 18" diameter, which conveyed water over a gulch located approx. 1/8 mile to the south of Pine Creek. The sketchy remains of an associated irrigation system, the Flanigan Ditch, which reportedly took off from a boulder dam on the west side of the Virgin River opposite the Supts. House and was flumed to the east bank, are also found in the area.
