**CLASSIFIED STRUCTURE FIELD INVENTORY REPORT**  
(Attach 4" x 5" Black and White Photograph)

REGION RMR PARK/AREA NAME Zion National Park PARK NUMBER 1590  
STRUCTURE NAME Zion Nature Center/Zion Inn STRUCTURE NUMBER 90  
LOCATION OF STRUCTURE South Campground H.D. PARK LOCATION CODE SI  
NATIONAL REGISTER \_\_\_\_\_ DATE: / / MANAGEMENT CATEGORY: (A) (B) (C) (D)  
NPS LEGAL INTEREST FEE MANAGEMENT AGREEMENT: \_\_\_\_\_

Zion Nature Center--South Campground

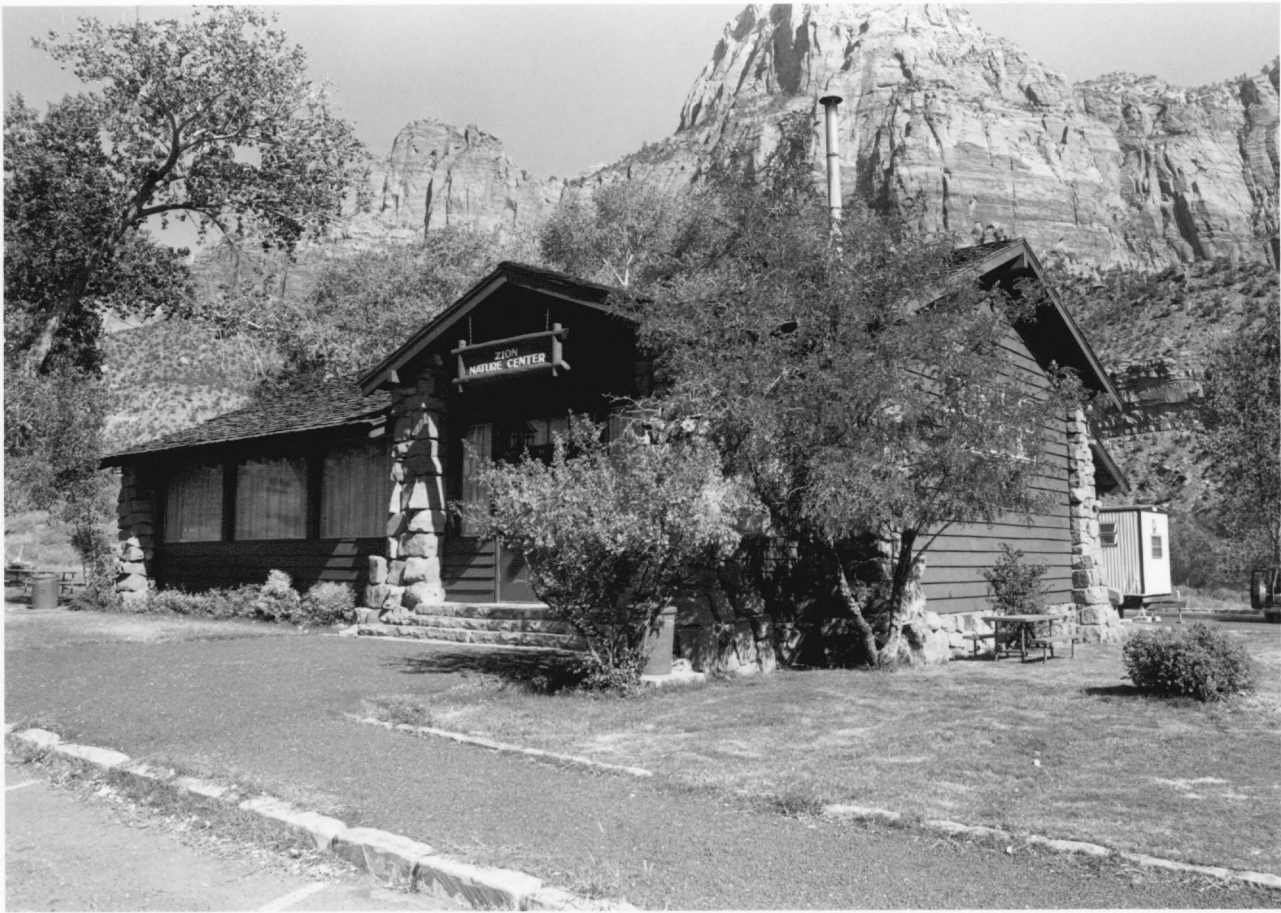
Photo No. Roll # 15, View CA

Subject Zion Nature Center / Zion Inn

Descrip. of View Southwest

Location of Subject South campground H.D.
