Preliminary Report

THE CHAMBERLAIN HOUSE AND DEPENDENCIES

THE MOUND PLANTATION DEVELOPMENT

Jefferson County, Mississippi

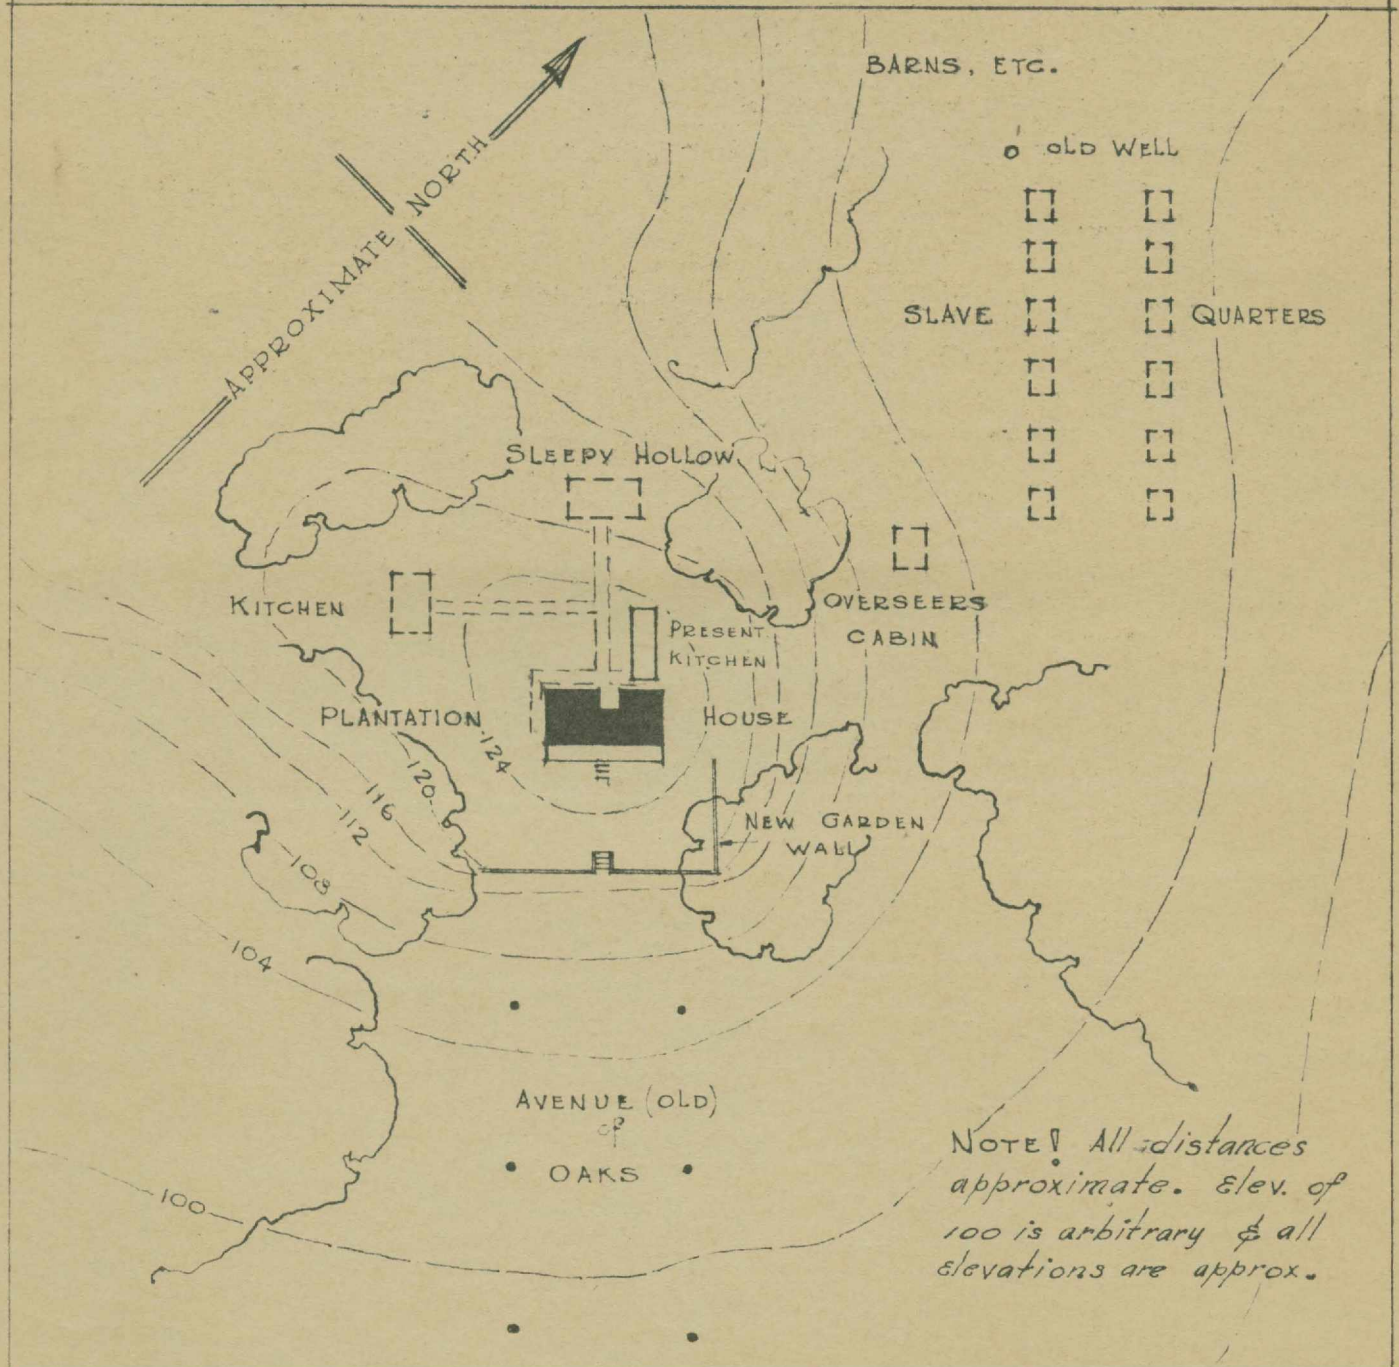
DIAGRAMMATIC ARRANGEMENT OF MOUND PLANTATION GROUP.

FROM VERBAL DESCRIPTION BY MRS CHAMBERLAIN.

For purpose of illustration only
