List of Classified Structures

Thomas Stone
National Historic Site

List of Classified Structures
Thomas Stone National Historic Site
Park Index

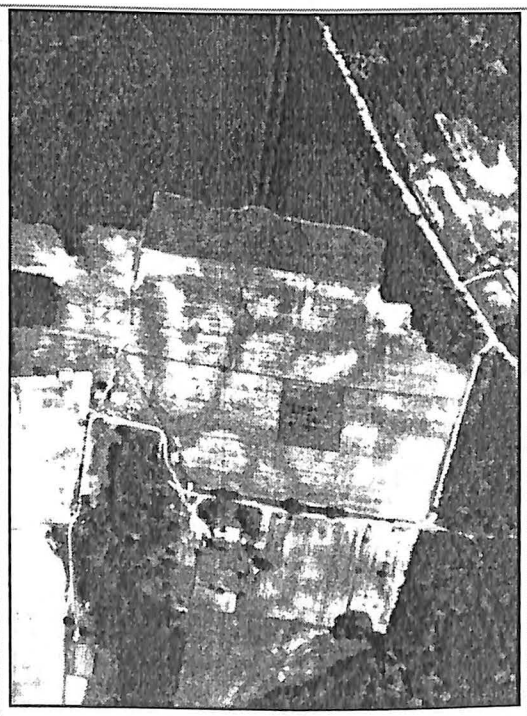
Structure Condition:	Fair
Year Condition Assessed:	2002
Impact Level:	Moderate
Primary Impact:	Neglect

Graphic	Caption	Graphic Date/Year	Sequence
1.		Map taken from CLR, 2/1/96	August 2002	1
2.		Formal Entrance Trace, view from South	August 2002	2

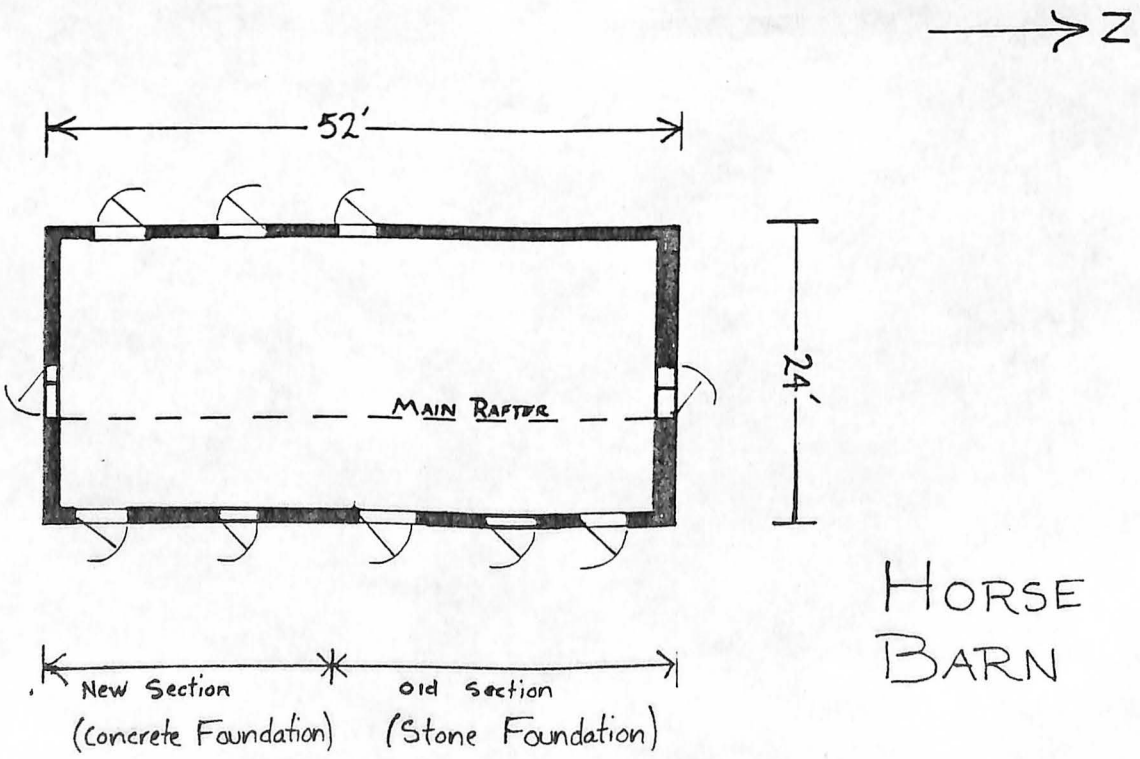
THE HORSE BARN IS SEVERELY DAMAGED BY ROT TO THE SILLS AROUND THE OLD AND NEW PORTIONS OF THE BARN. WITHOUT SIGNIFICANT REBUILDING, SCABBING OF DAMAGED POSTS AND REPAIR, THE STRUCTURE IS IN JEOPARDY.

13. PARTS NEEDING SPECIAL ATTENTION: SILLS AND POSTS NEED TO BE REPAIRED AND REPLACED.

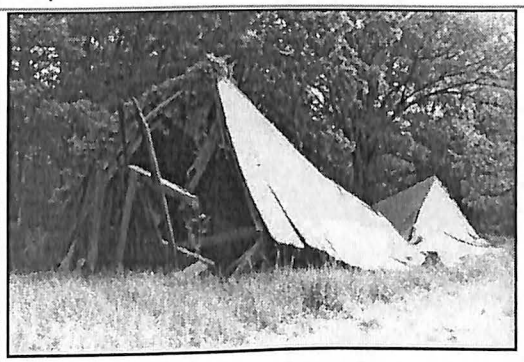
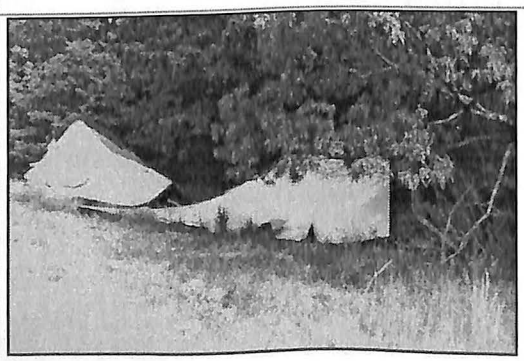
Text: further deterioration and restored as an integral part of the agricultural landscape." Currenlty Sheep Barn has fallen further than 1992 photos dictate. Barn should be recorded, intact elements salvaged and barn restored.

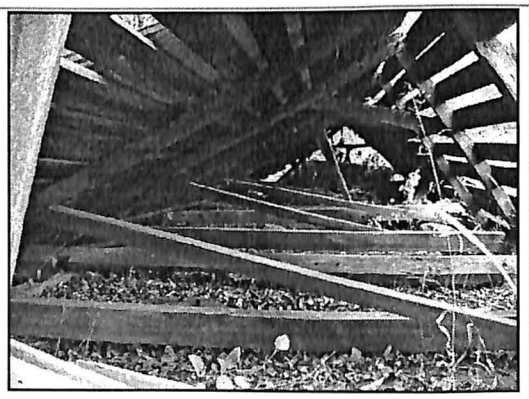
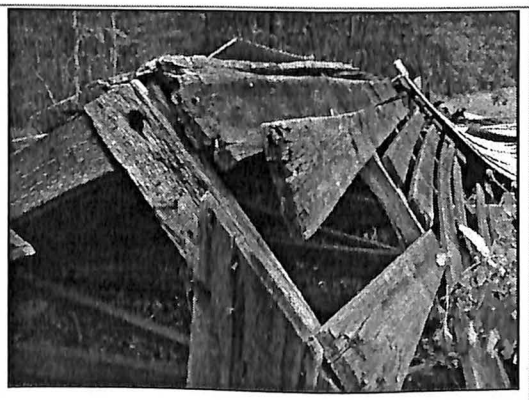
Barn Ruin , view from SE	2002	
4.		Sheep Barn Ruin, det. intact roof struc, vw fr S	August 2002	4
5.		Sheep Barn Ruin, view from S	August 2002	5

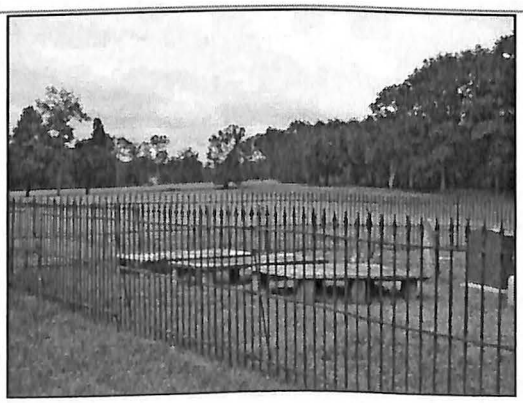
Short Management Text: Structure in need of rust defoliation, primed and painted with rust inhibitor paint.

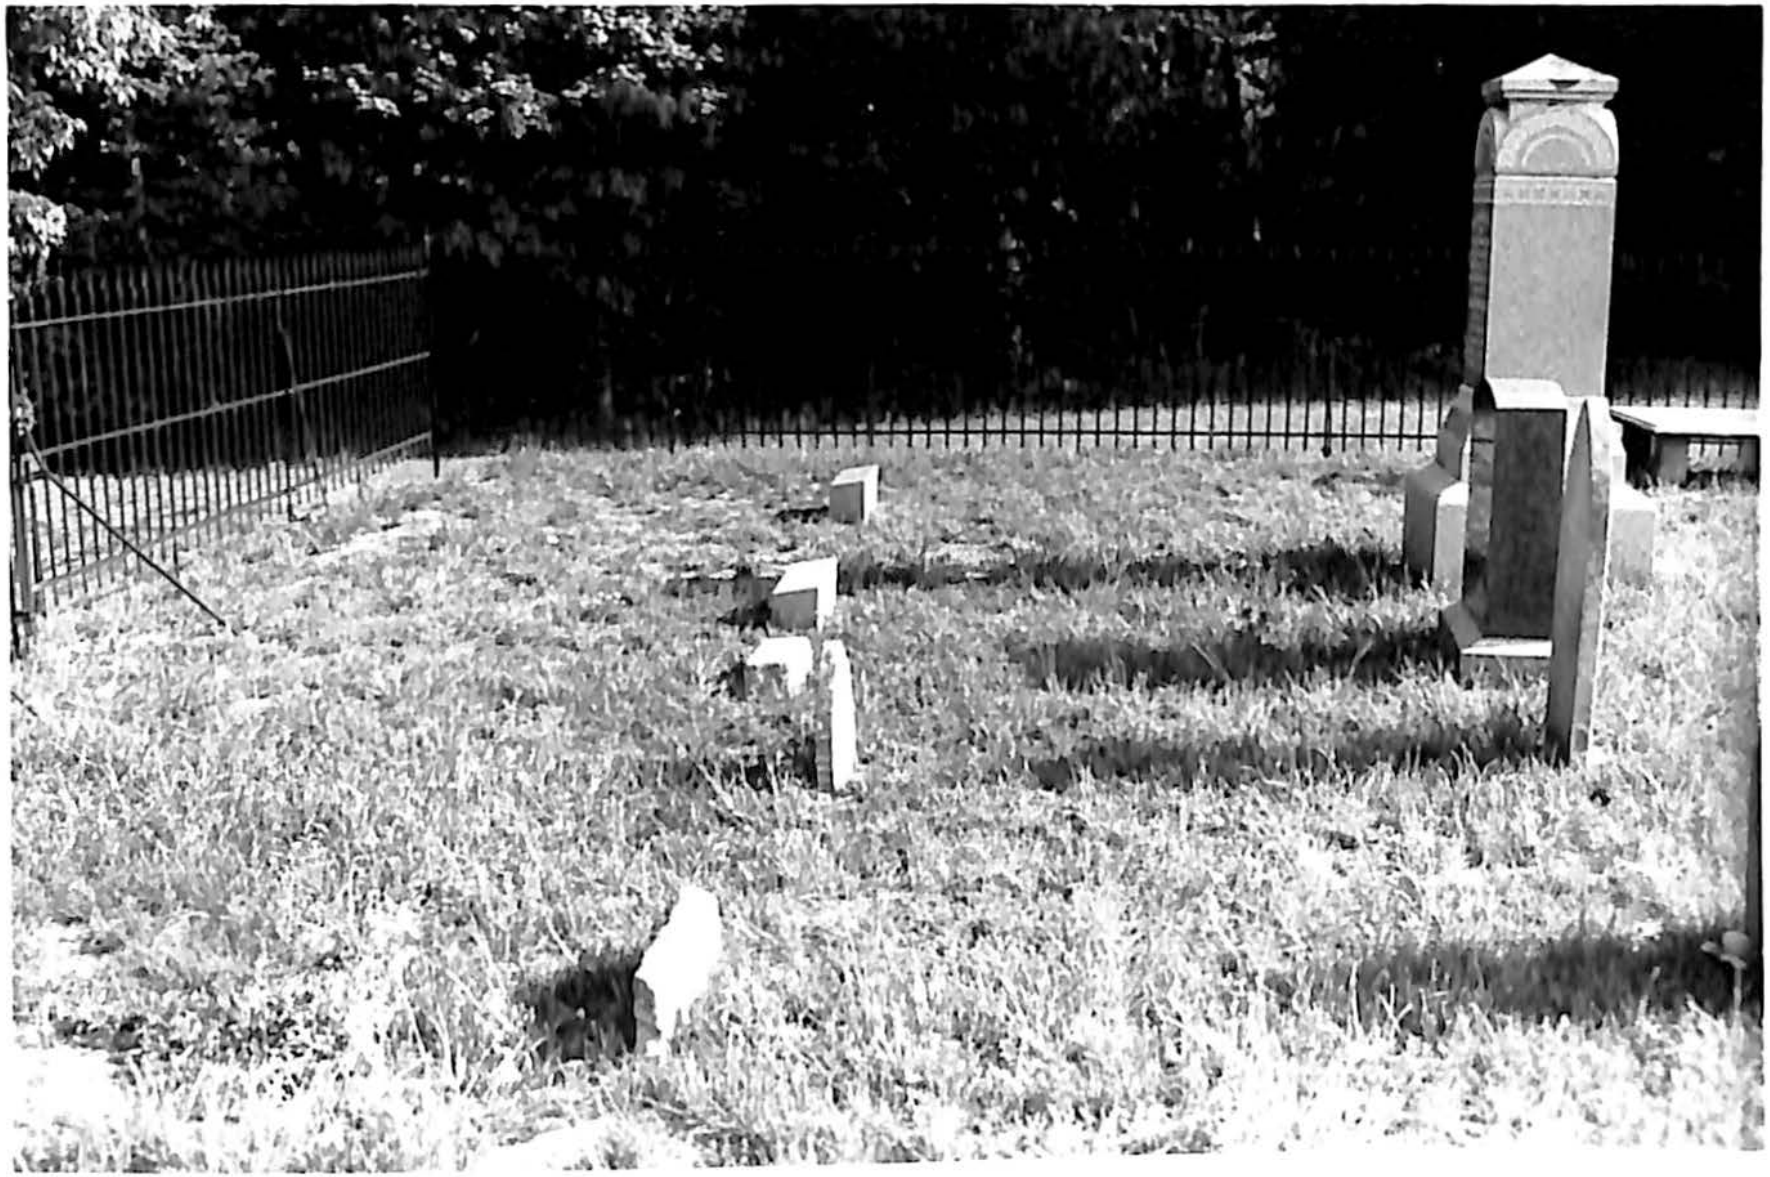
THST
80071

Burial Ground
Gravestone Detail, View from West
May 1992

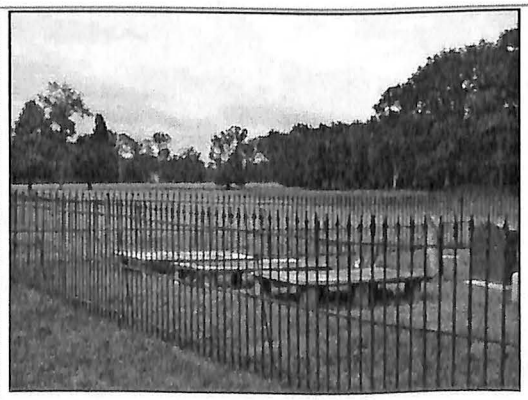
Short Management Text:	The Maryland Garden Club donated $9,000 to the 1990-1991 restoration of the Burial Ground. No changes to condition noted in FY01 update. Stones are in need of minor cleaning and waxing but are in good shape.

2.		Burial Markers, view from SW	July 2002	1
3.		Markers with footstones, view from South	July 2002	3
4.		Slab markers set on concrete piers, vw frm NE	July 2002	4

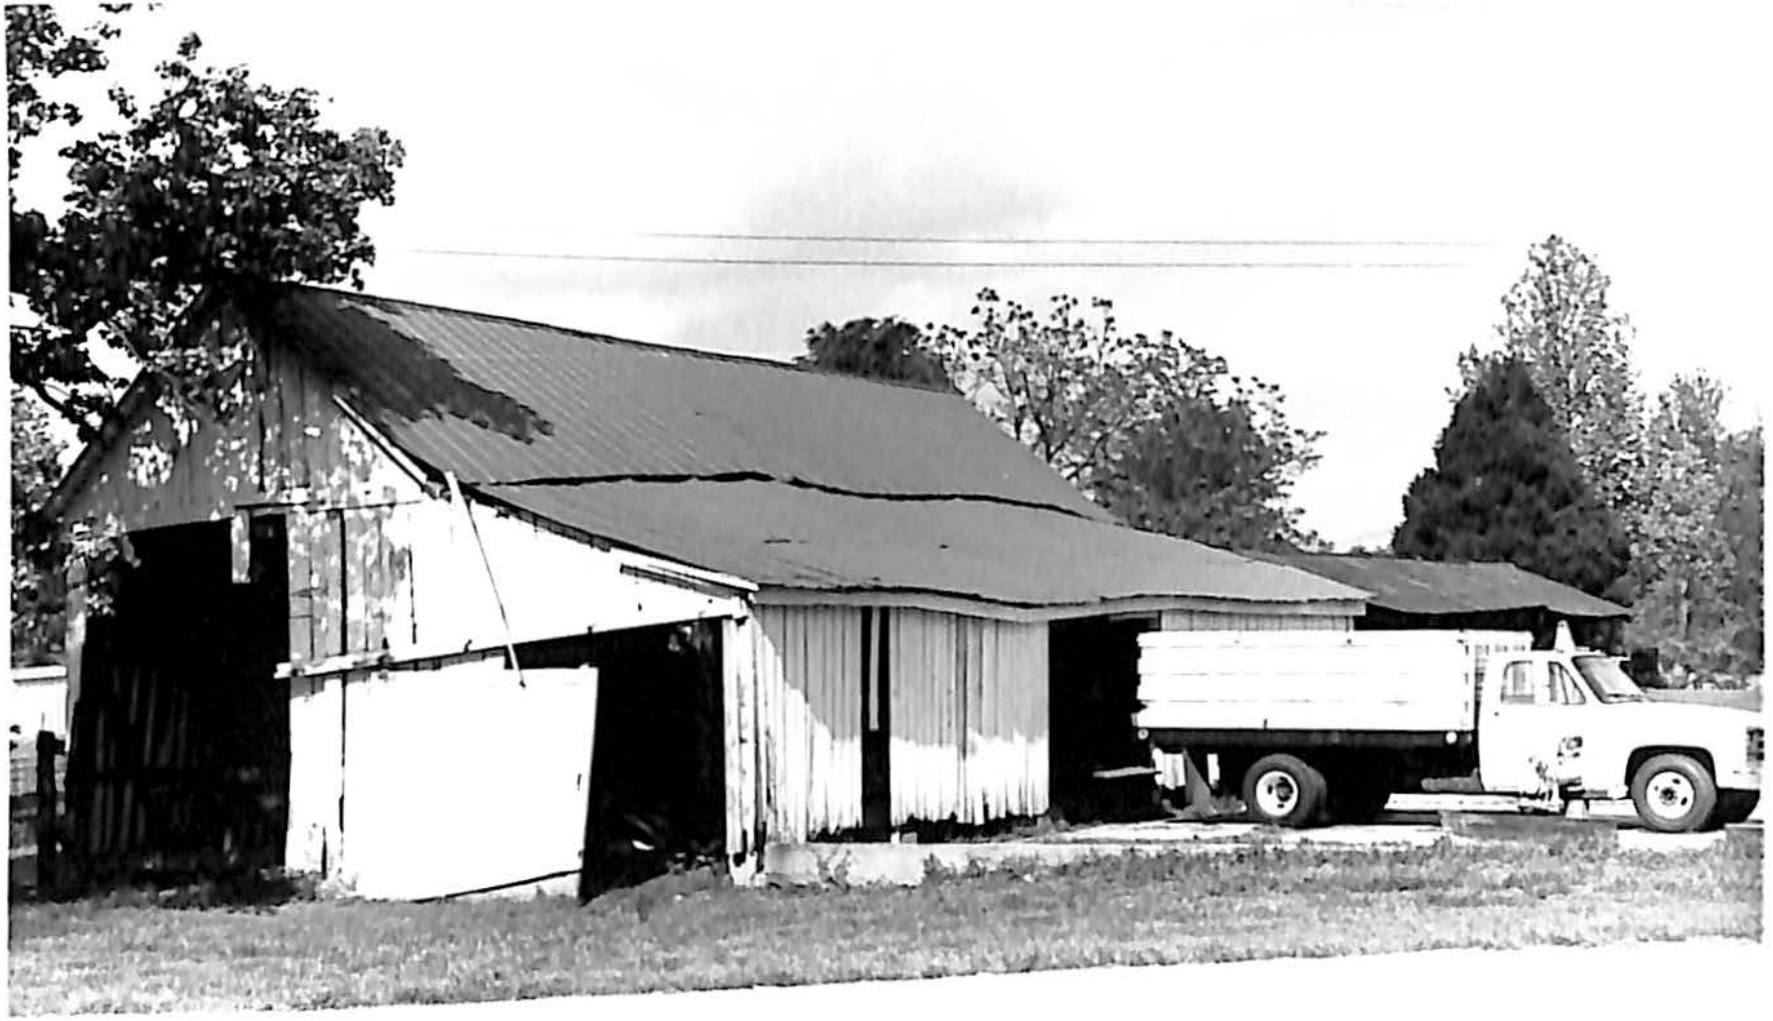
THST
80069

Cattle Barn
View from northwest
May 1992

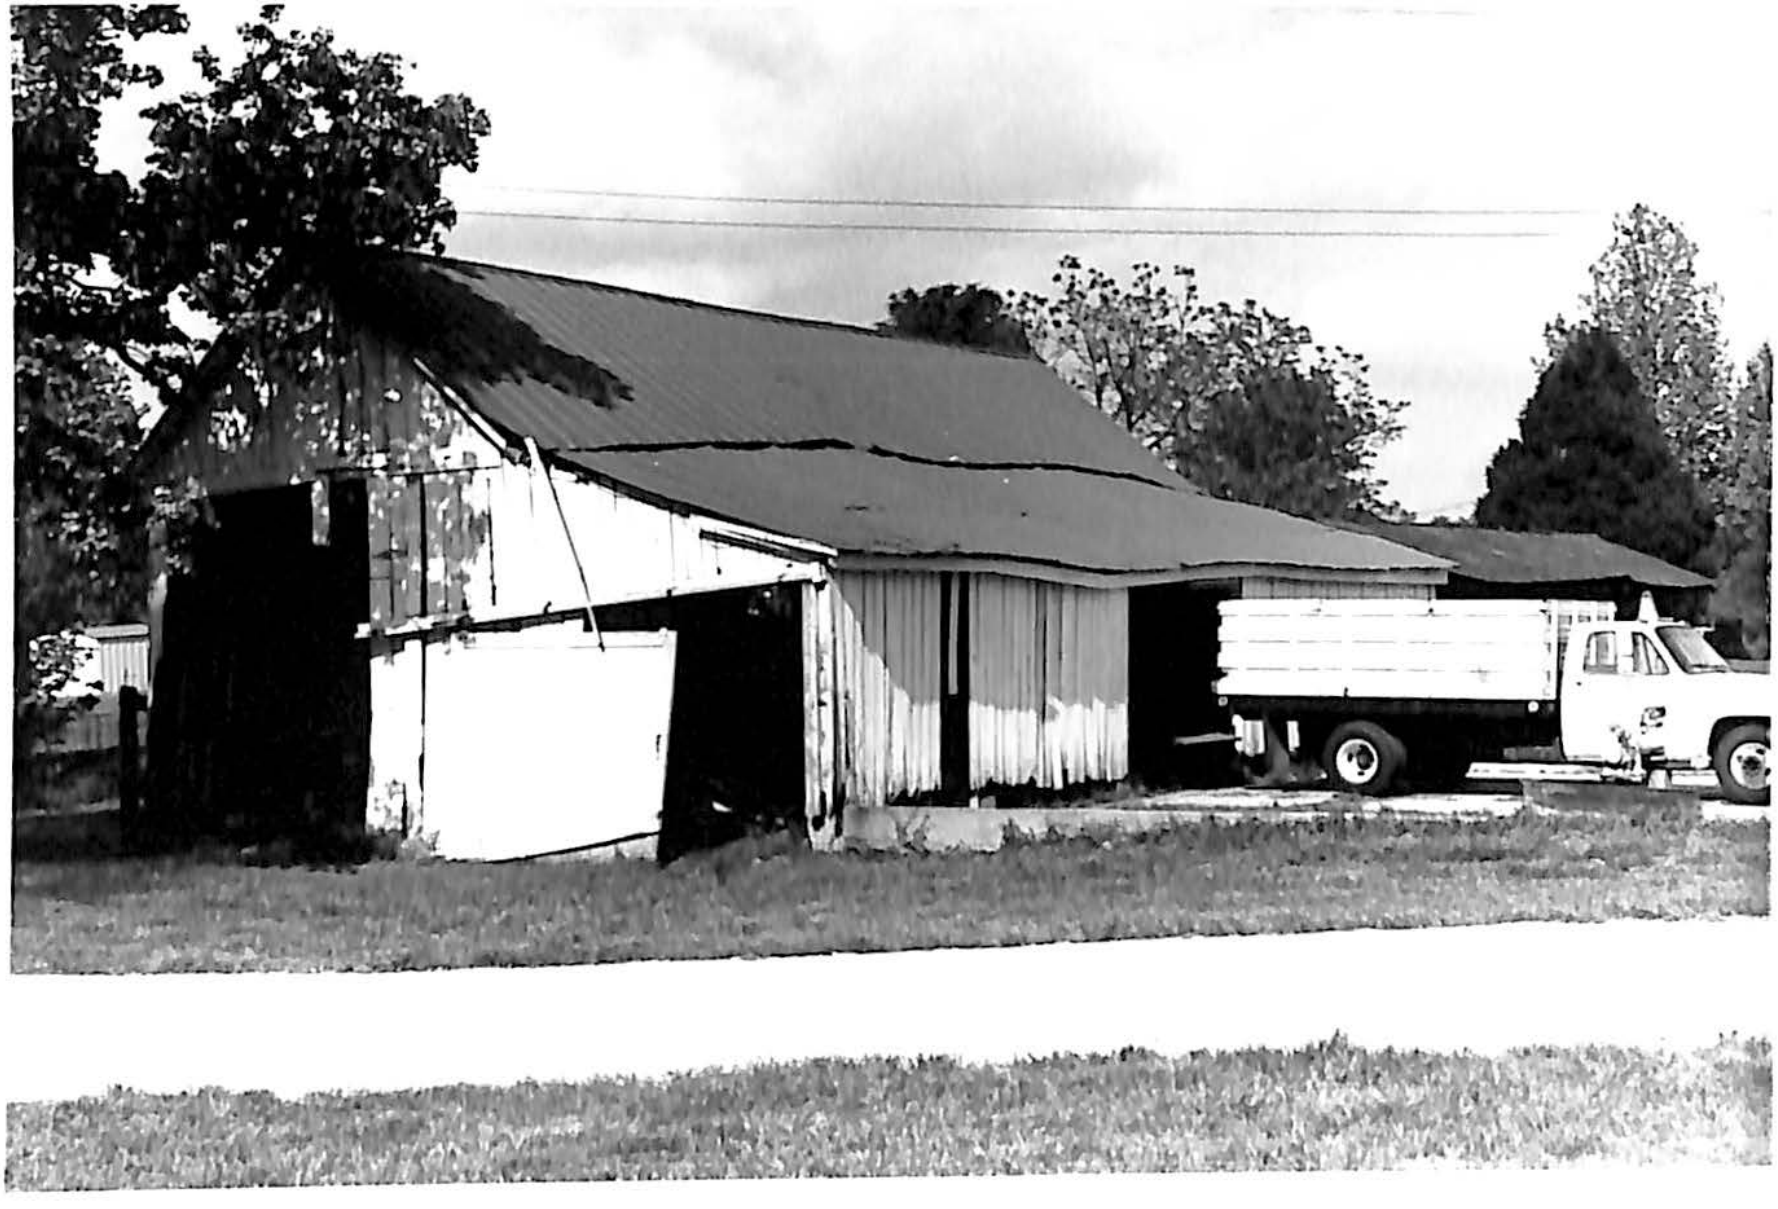
THST
80069

Cattle Barn
View from southwest
May 1992

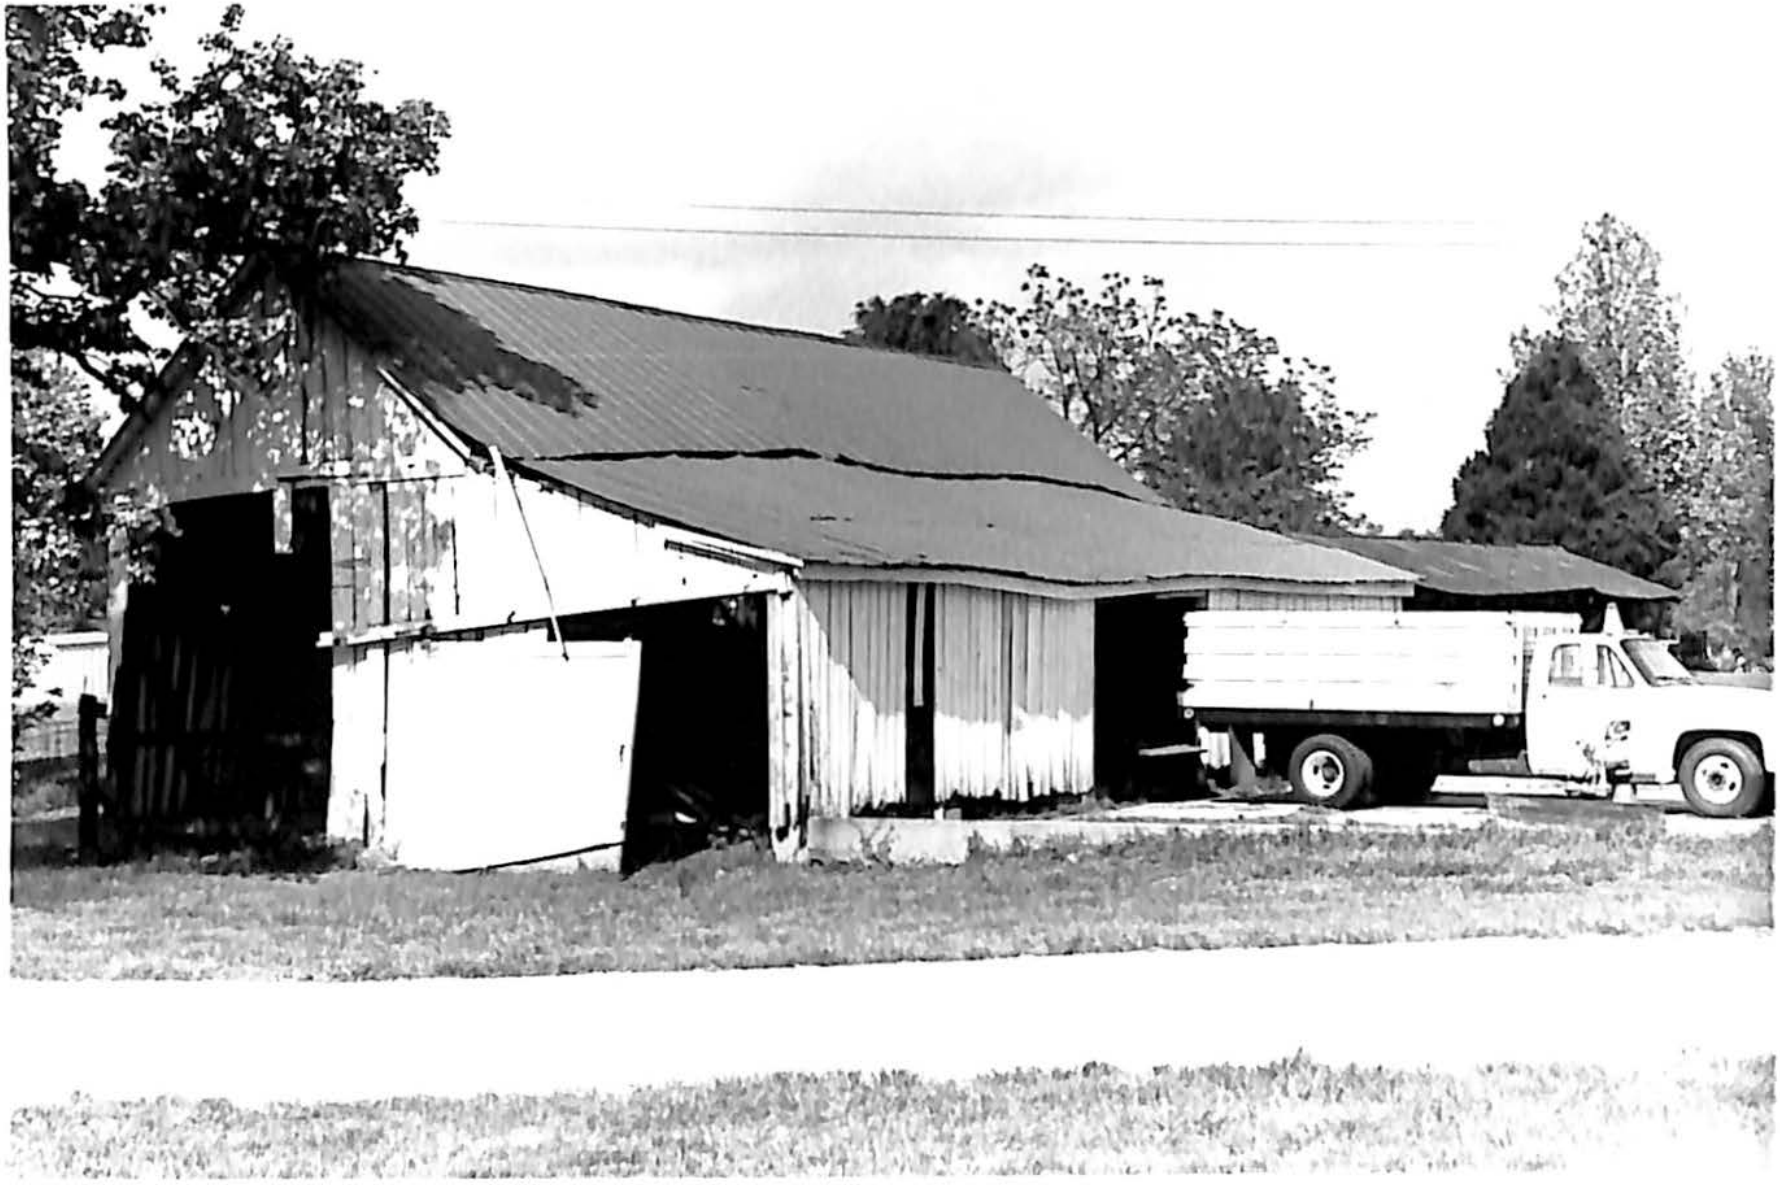
THST
80069

Cattle Barn
View from southwest
May 1992

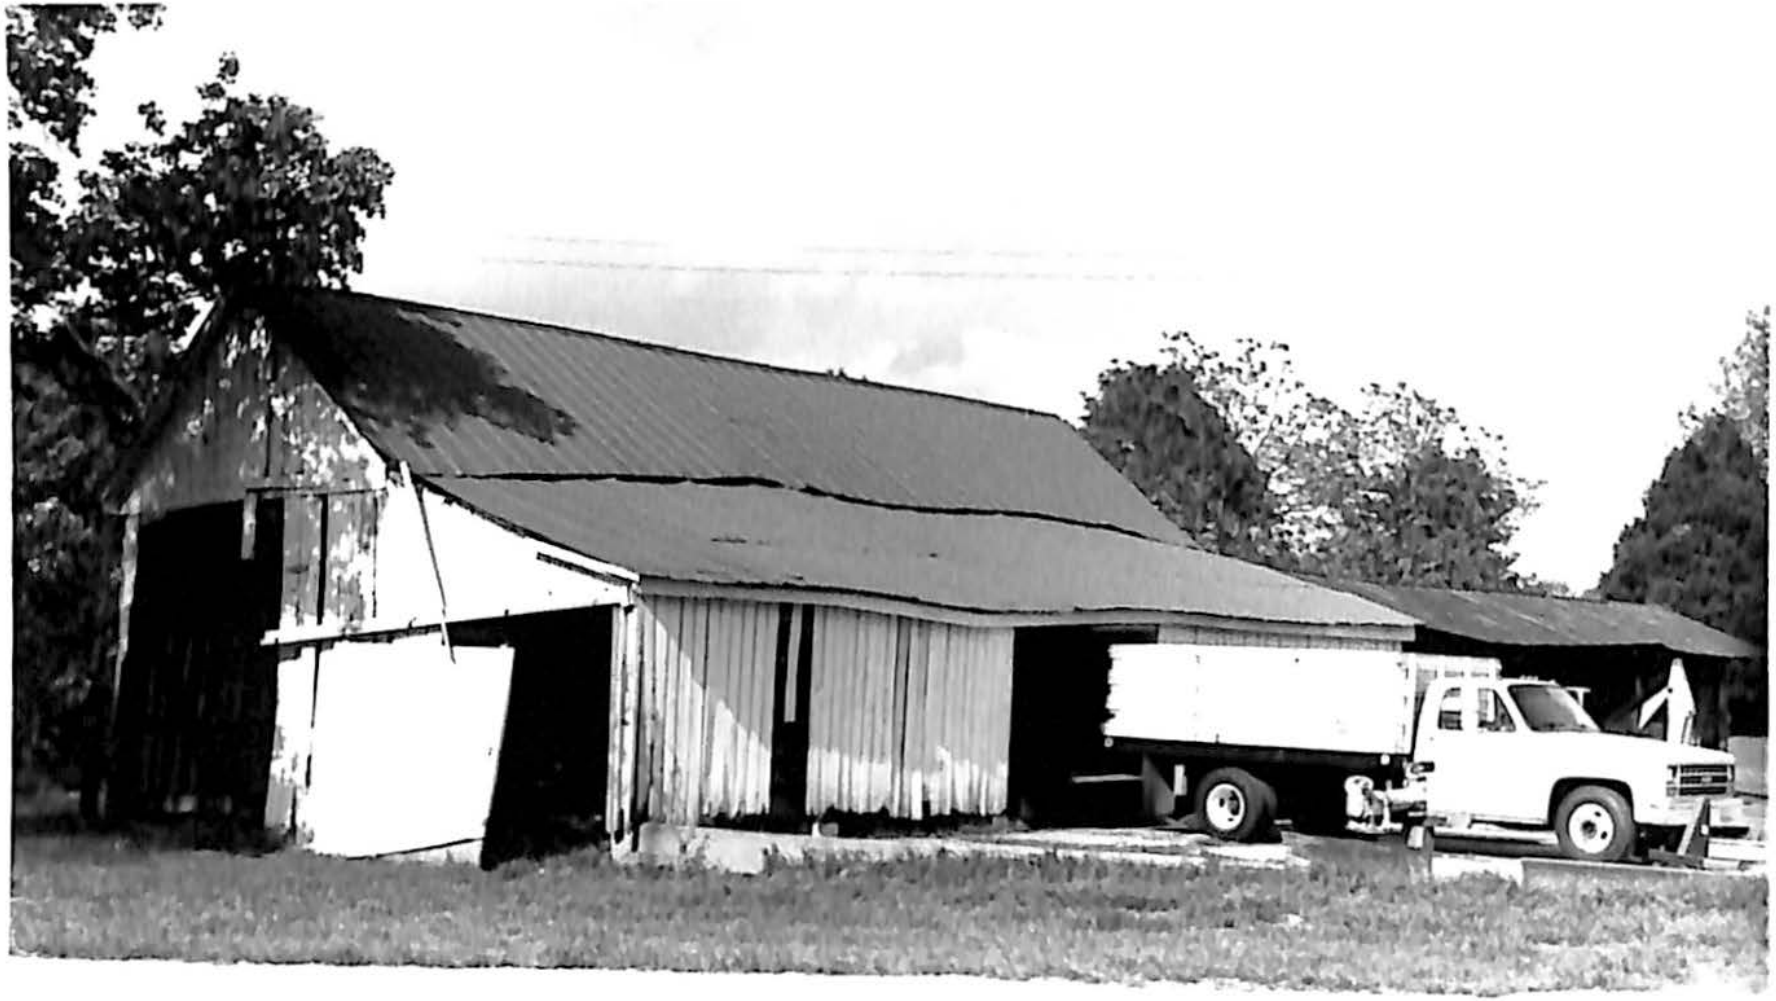
THST
80069

Cattle Barn
View from southwest
May 1992
