SOUTHWESTERN MONUMENTS
SPECIAL REPORT

NO. 10

REPAIR AND RESTORATION
OF TUMACACORI-1921

FRANK PINKLEY

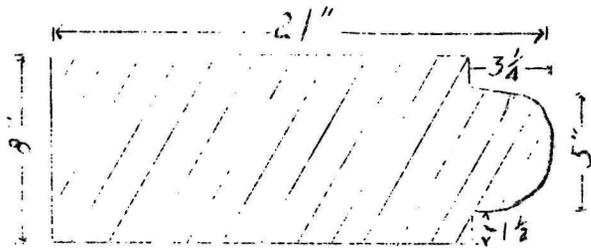
FIG. 3 - The 8x16
3" Thick

We arrived at this solution of the problem of the wedge shaped brack too late to keep us from burning a supply of them, so while it was not really necessary, we restored the wedge shaped brick where we found it had been used with the exception of the pediment at the top of the front wall where we considered the 8 by 16 size stronger for the purpose.
