Historic Structure Report

Baker Island Light Station

Acadia National Park, Maine

2013

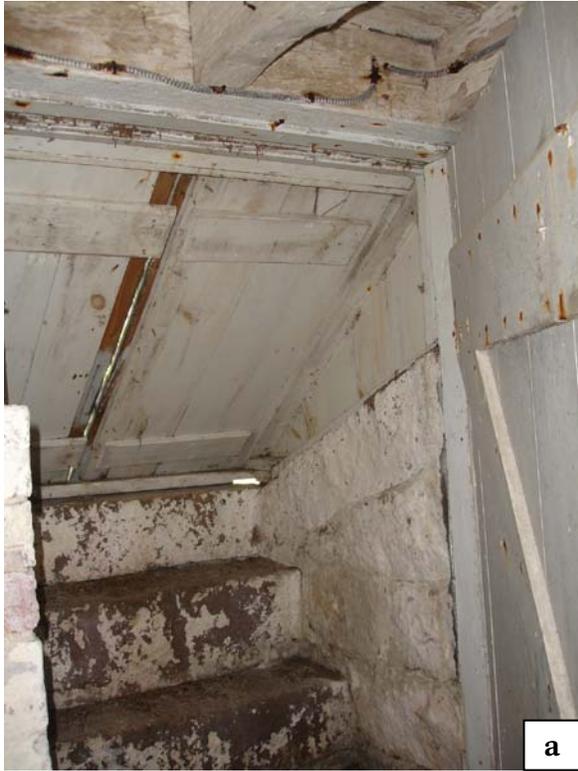
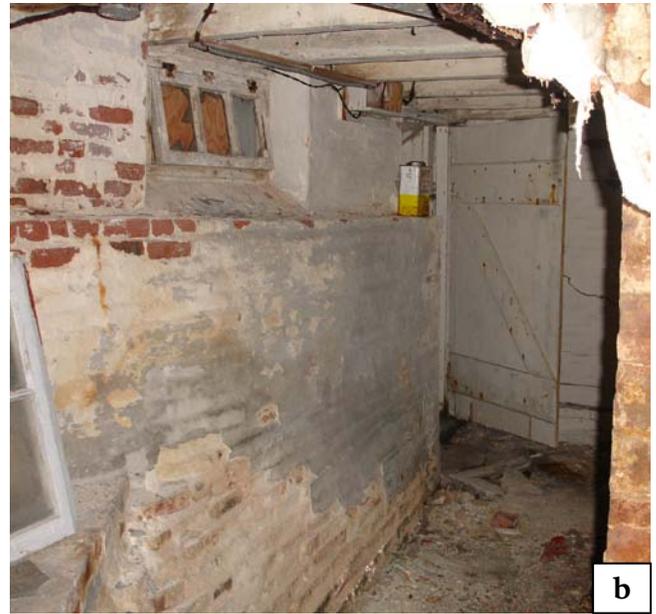
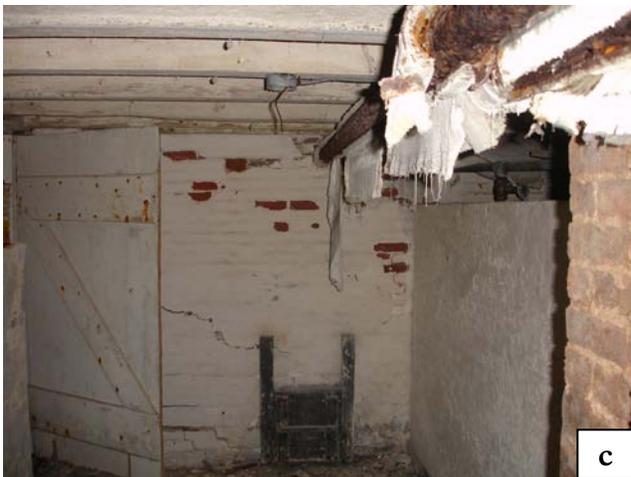
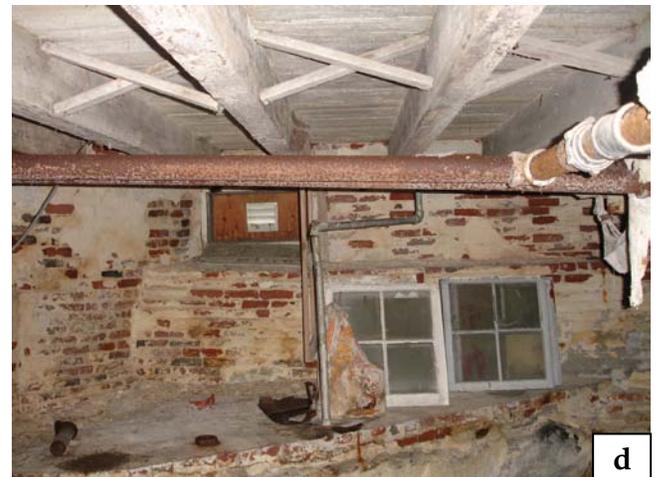
Baker Island Keeper's Dwelling Main Cellar

Three original window openings dating to 1855 survive in the shaft of the light tower (fig. 42). The windows retain their granite sills and lintels. All other historic elements of the windows (sashes and casings) were removed sometime between 1974 and 1976, when the existing glass blocks were installed by the U.S. Coast Guard. The sashes are stored in the main cellar of the keeper's dwelling today (fig. 54d).

Figure 54. Main cellar of the keeper's dwelling, 2012: (a) bulkhead entrance in the southeast corner, (b) east wall looking south, (c) coal chute and cistern at the south wall (c); and east wall at the northeast corner.

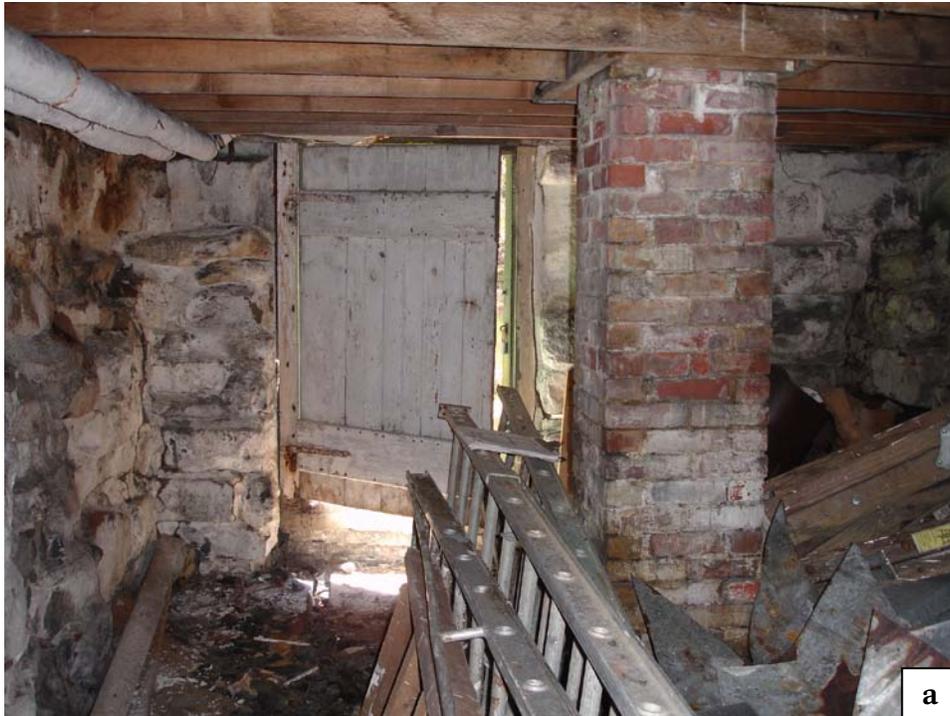
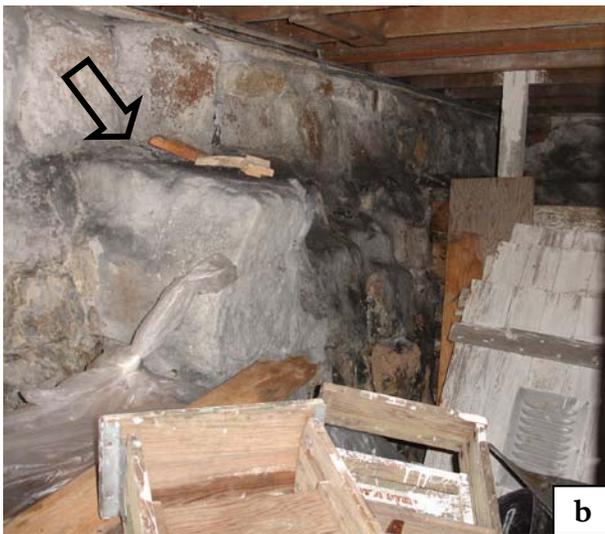
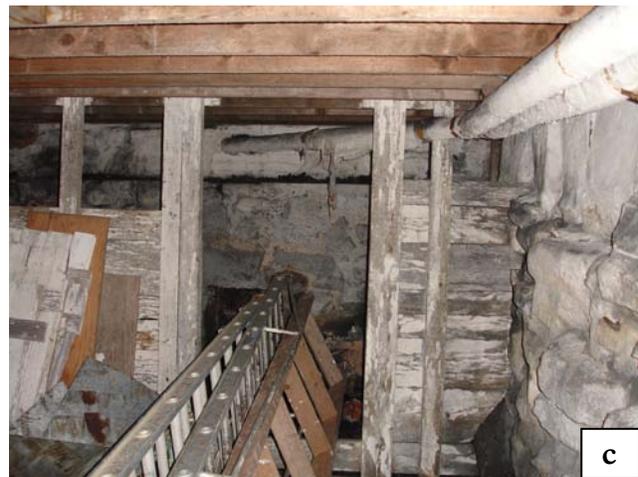
Baker Island Keeper's Dwelling Kitchen-Wing Cellar

Figure 55. Unfinished cellar of the keeper's dwelling beneath the kitchen wing, 2012: (a) entrance doorway at the south wall, (b) remnant of former end wall (at arrow) at the east wall, and (c) coal storage bin at the north wall.

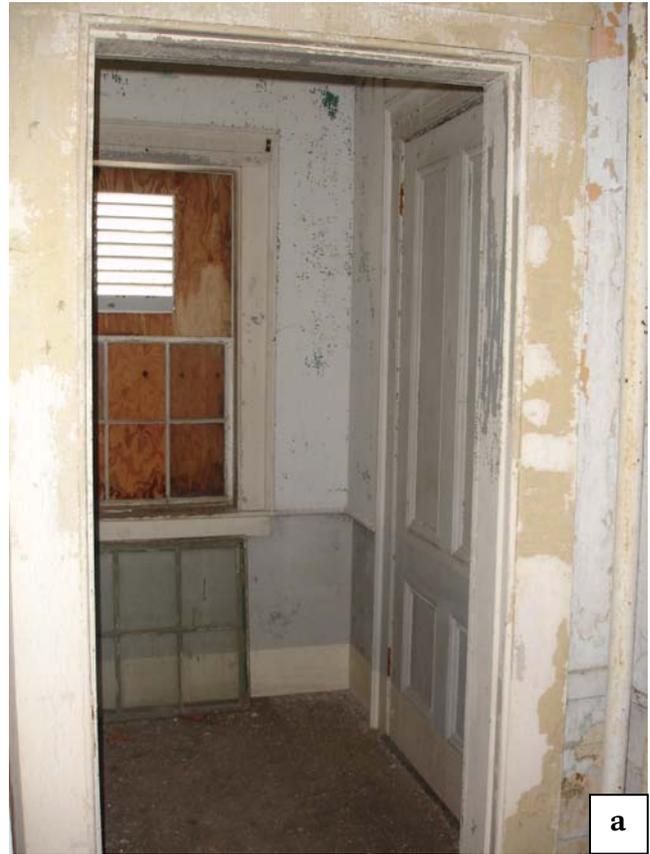
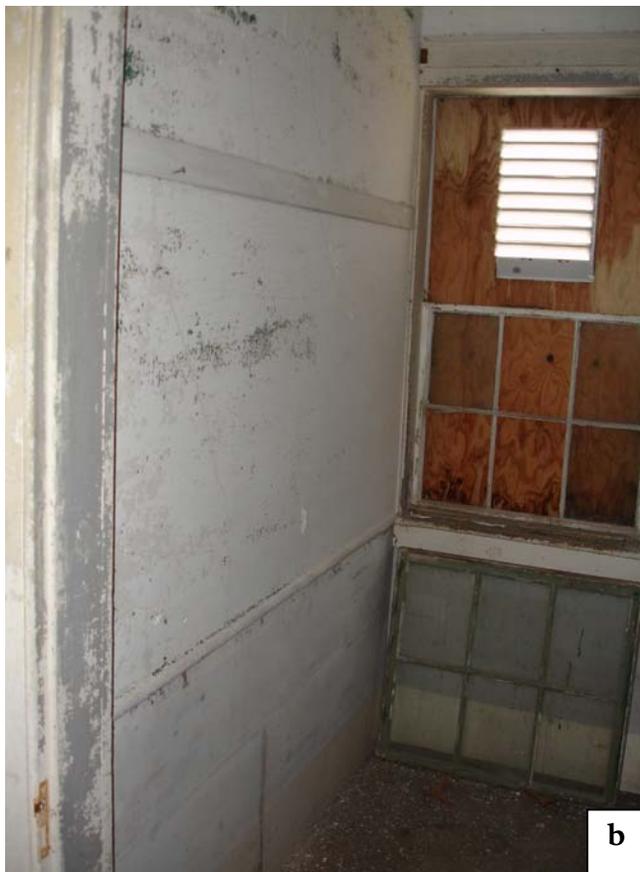
Figure 56. Room 101 (vestibule) of the keeper's dwelling, 2012: (a) front doorway at the north wall, and (b) circa-1903 partition at the south wall.

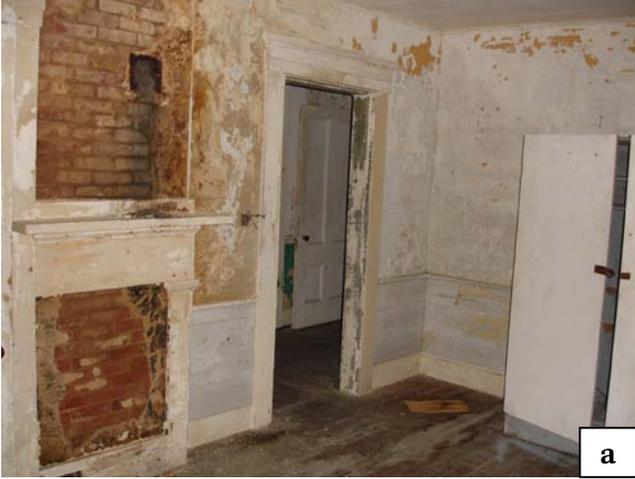
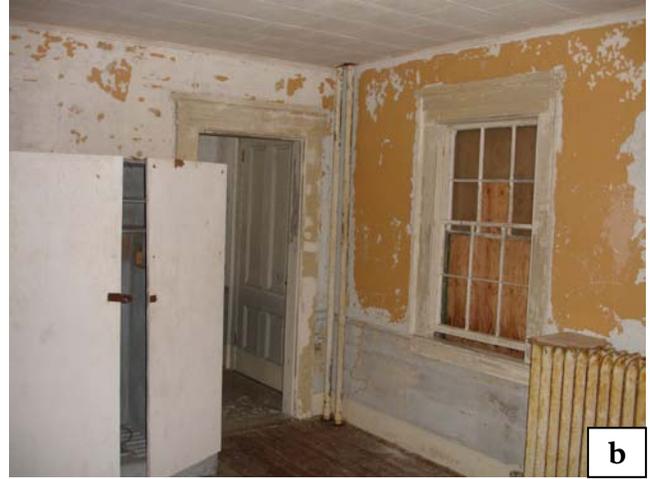
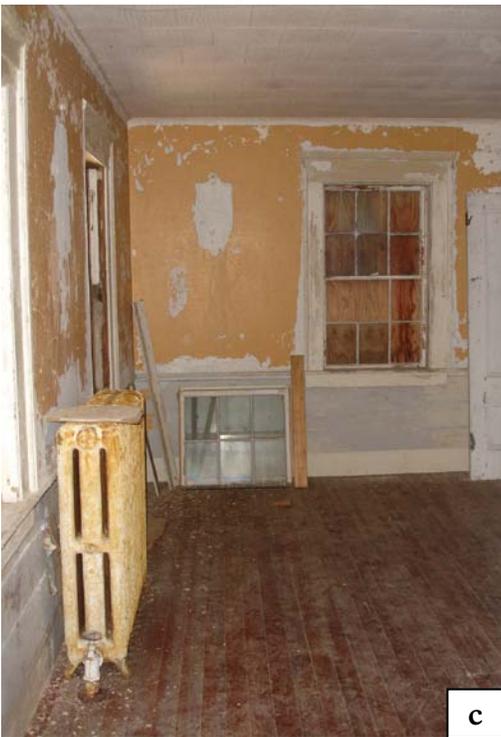
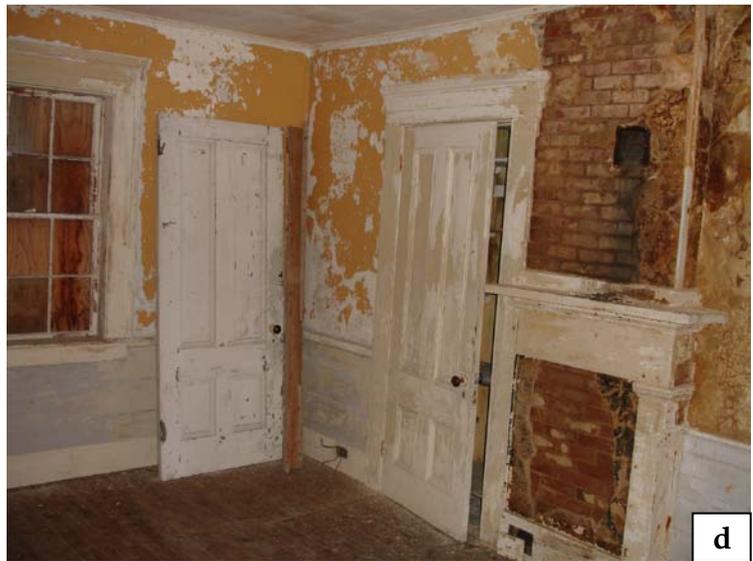
Figure 57. Room 102 (parlor) of the keeper's dwelling, 2012:
(a) southwest corner, (b) northwest corner, (c) northeast corner, and
(d) southeast corner.

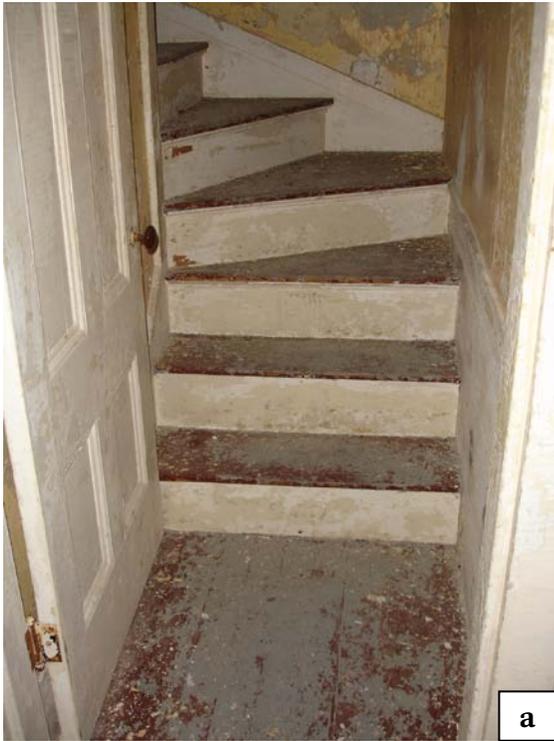
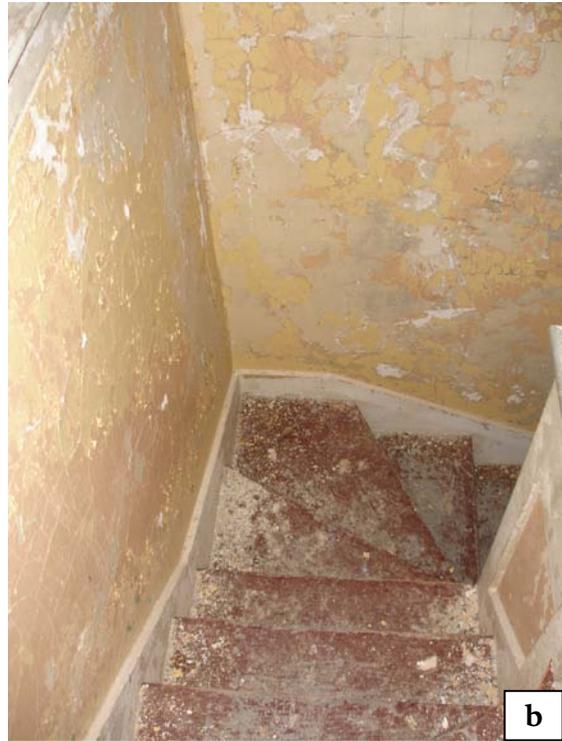
simple baseboard, and no railing. The opening in the second story has a railing with jigsaw balusters supported by a newel with hipped cap. (Figs. 58a-b and 66b-c).

Figure 58. Room 103 (circa- 1903 stairway) of the keeper's dwelling, 2012: (a) lower run of the stair, and (b) upper run of the stair, both looking north.

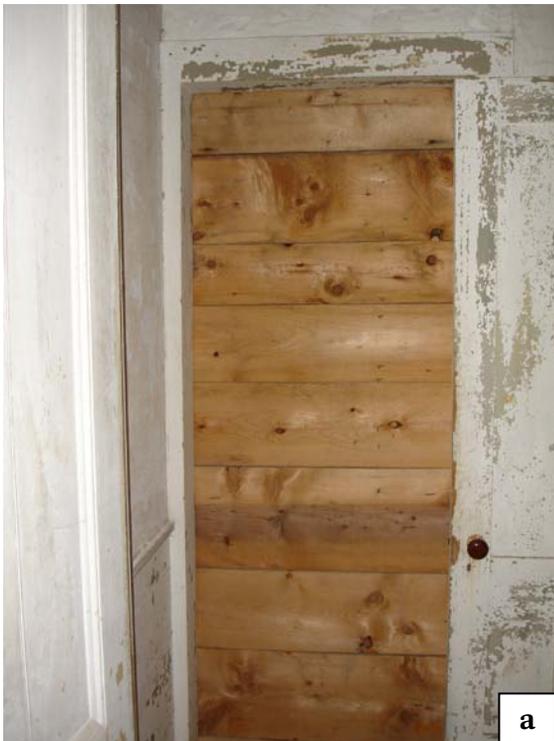
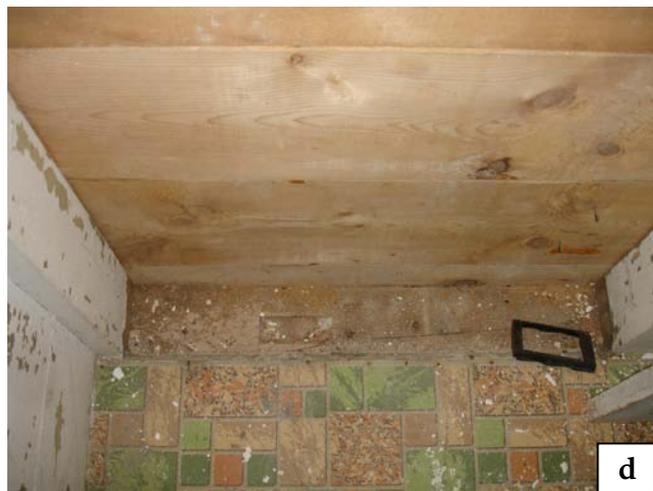
Rooms 103 & 104

An interior doorway that is missing today formerly connected with a work room on the west side of the house. This provided an interior connection with the nearby light tower prior to demolition of the work room around 1958. All that remains today is the framed opening and casing at the west wall of the cellar hall (Room 104).

Figure 59. Room 104 (side entry) of the keeper's dwelling, 2012: (a) blocked doorway in the west wall, and (b) flooring and threshold at the blocked doorway.

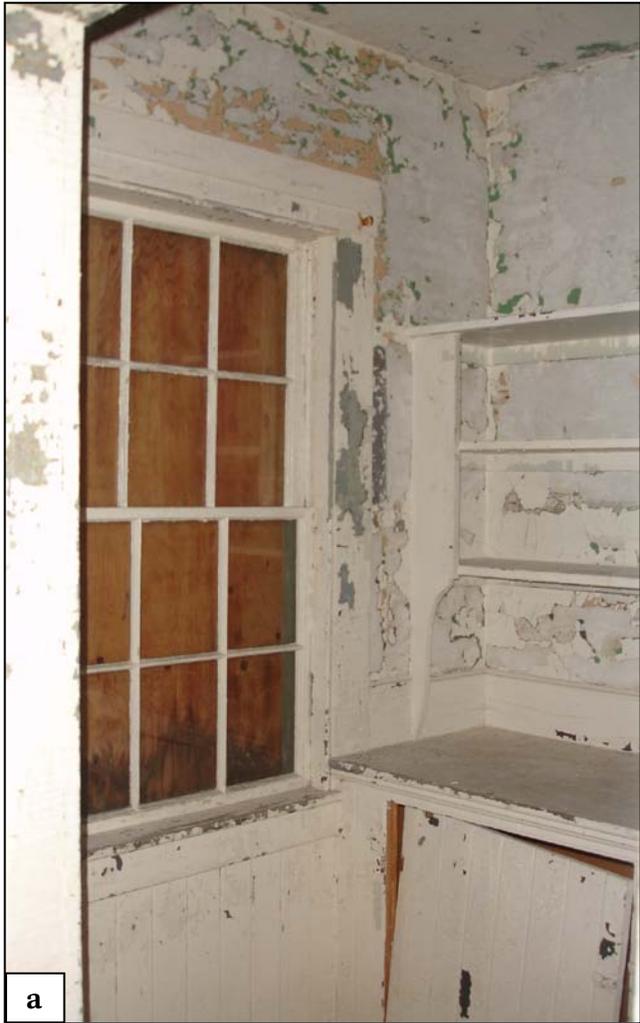
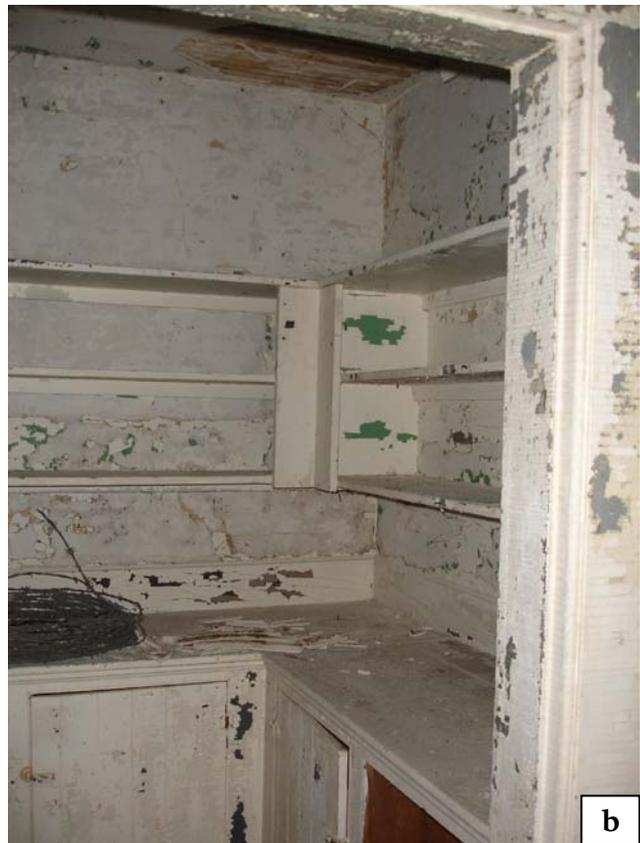
Figure 60. Room 105 (pantry) of the keeper's dwelling, 2012:
(a) southwest corner, and
(b) northwest corner.

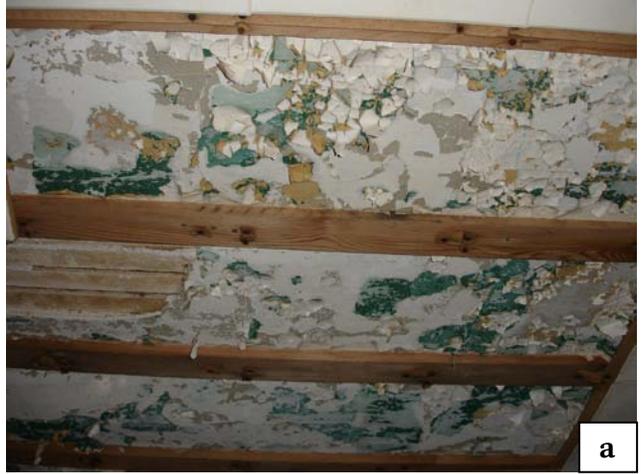
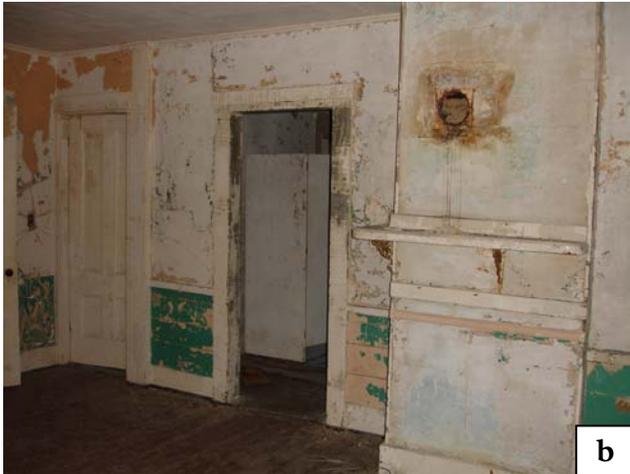
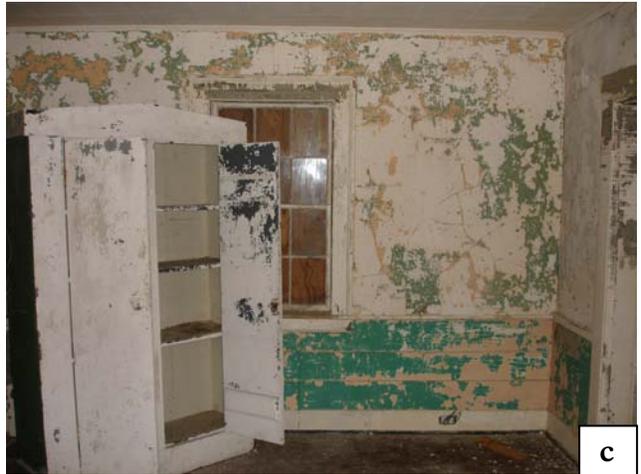
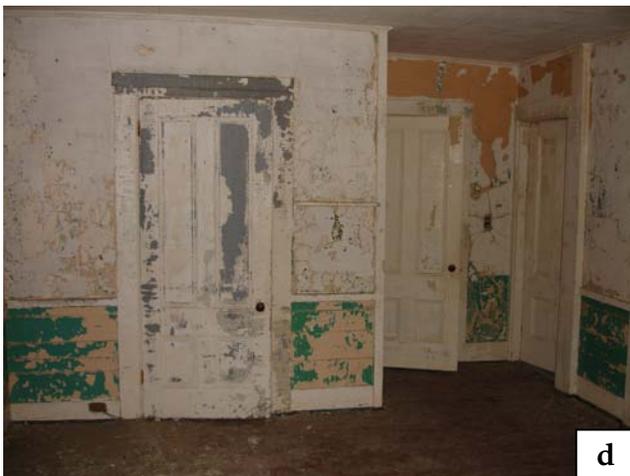
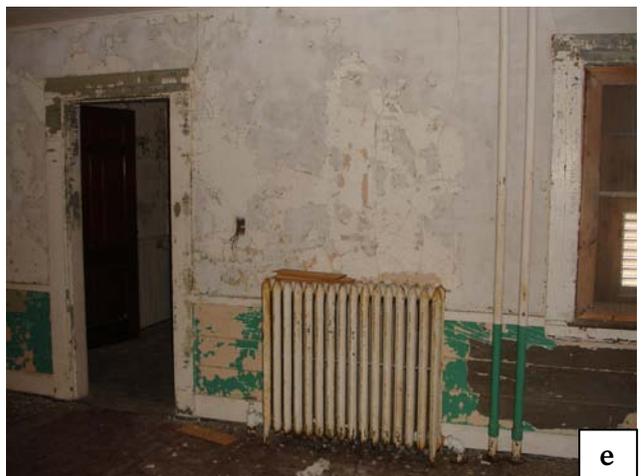
Figure 61. Room 106 (living room) of the keeper's dwelling, 2012: (a) plaster ceiling with wood strapping, (b) north wall, (c) east wall, (d) west wall, and (e) south wall.

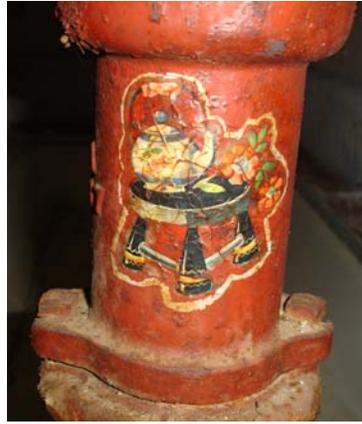
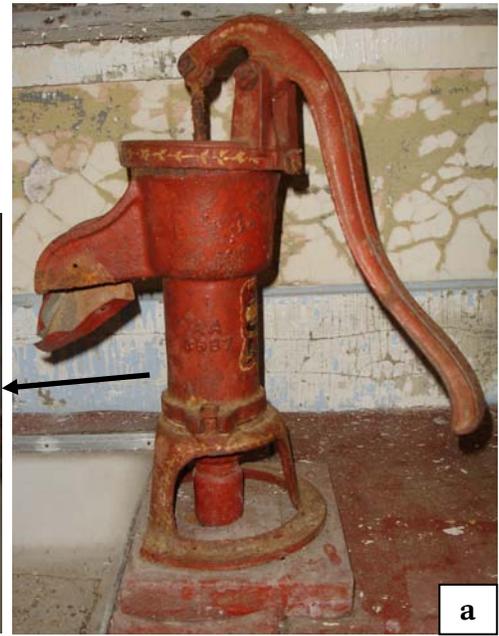
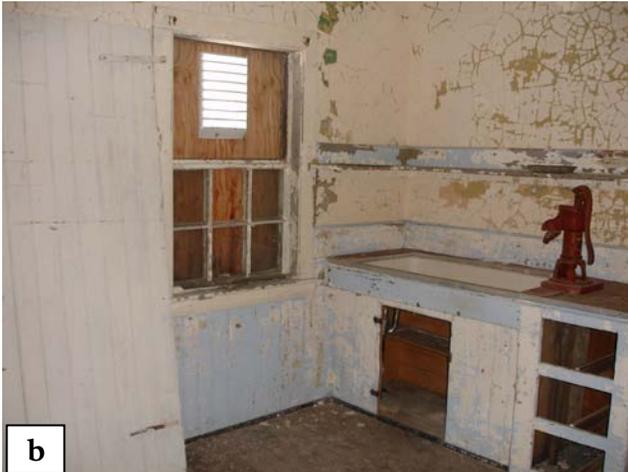
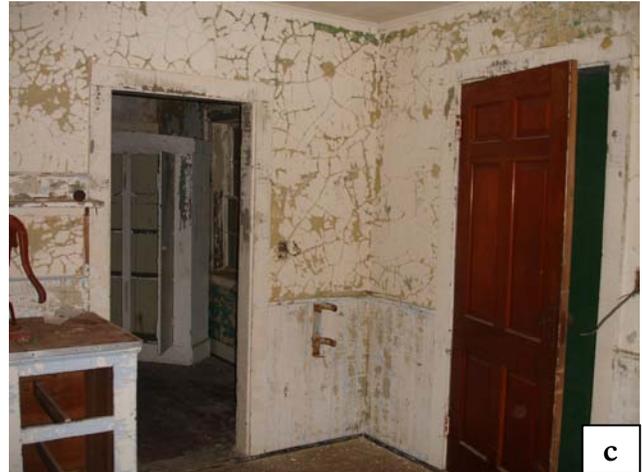
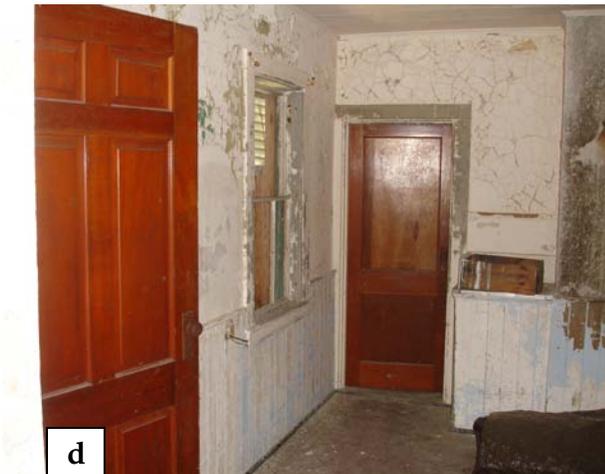
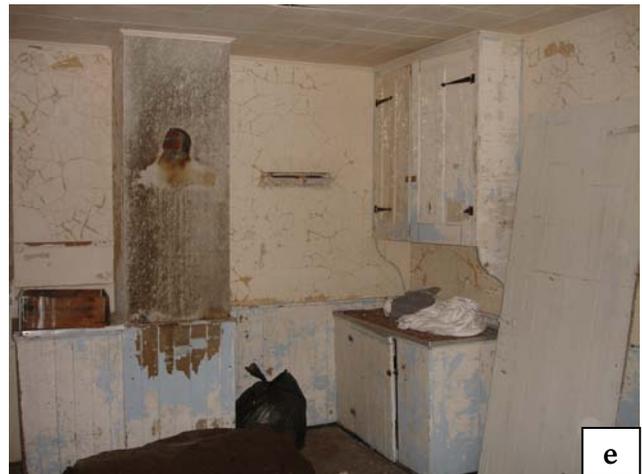
The only source of water was at the kitchen sink that retains a cast-iron hand pump made by The Deming Company of Salem Ohio (1890-2006). This circa-1920 pump is cast with model number "AA3987," and adorned with a hand-painted tea pot on a kitchen stool (fig. 62a). It pumped water from a rainwater cistern in the cellar below. Water drained from the kitchen sink through a pipe in the west exterior wall of the house.

Figure 62. Room 107 (kitchen) of the keeper's dwelling, 2012:
(a) hand pump at the sink,
(b) northwest corner,
(c) northeast corner,
(d) southeast corner, and
(e) southwest corner.

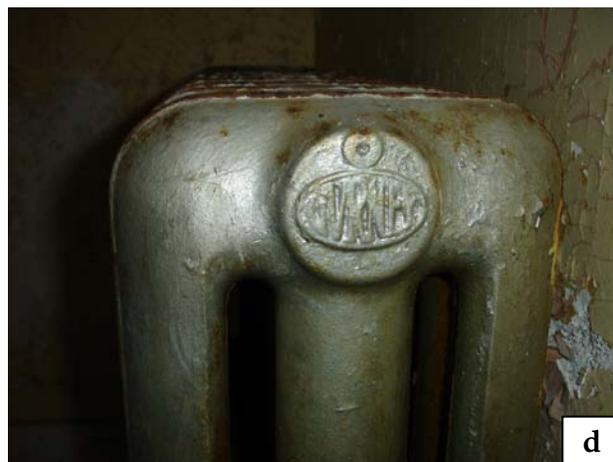
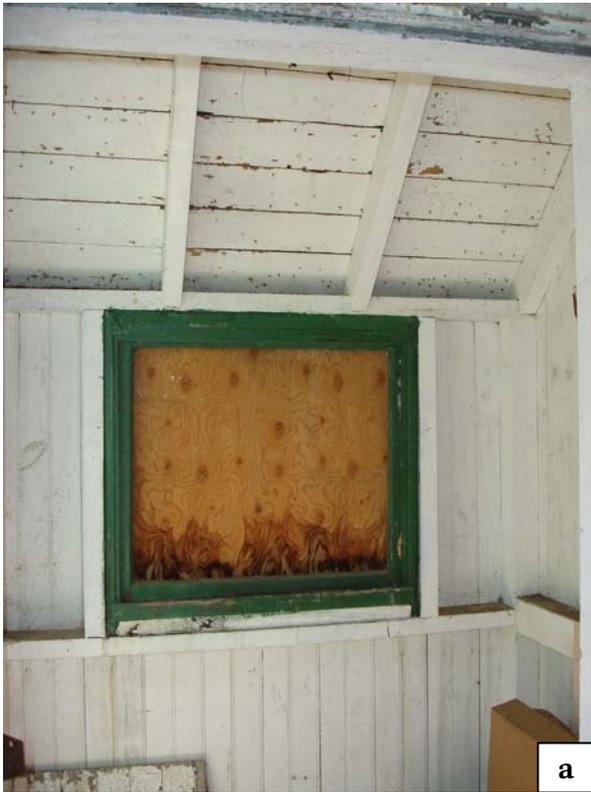
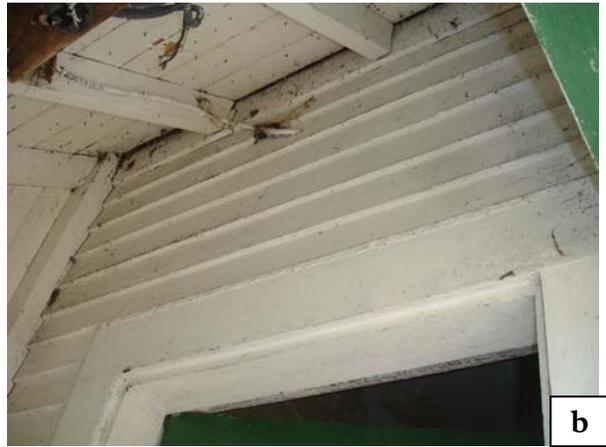
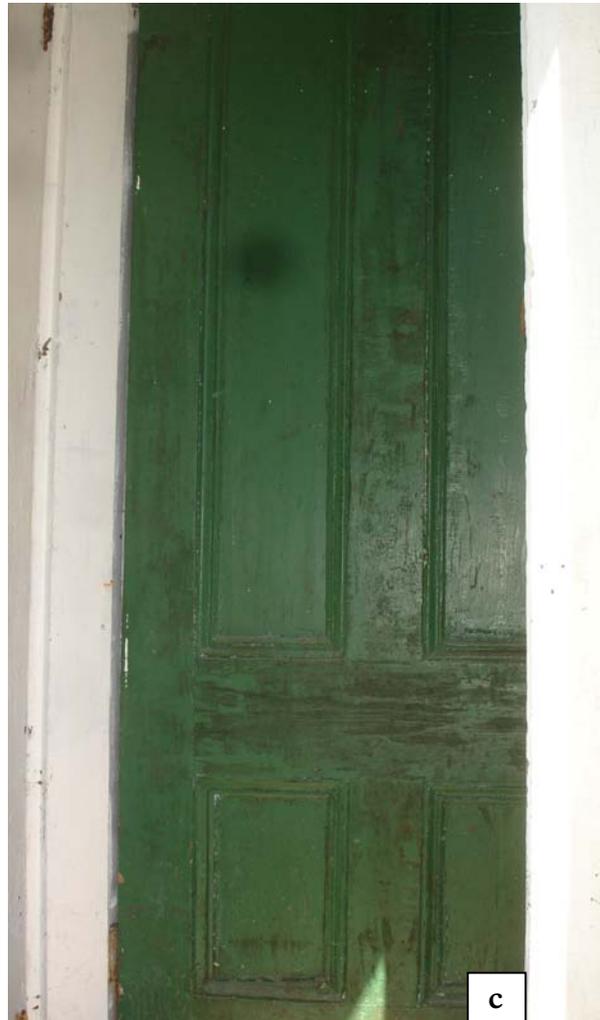
Circa-1920 Heating System. A central hot-water heating system fueled with coal was installed in the house around 1920. It was incorrectly described by the U.S. Coast Guard in a 1957 survey as steam-heating system, with approximately 4 tons of coal on hand. Remnants of this system include a flue opening in the main-house chimney for the now-missing boiler, a coal chute at the south wall of the main cellar, and a coal bin in the cellar of the kitchen wing (figs. 54c and 55c). Hot-water radiators cast with the name "Gurney" are in the rooms of the first and second stories (figs. 63b and 63d). A tank for maintaining water pressure is also concealed in a closet of the northwest bedroom (Room 202). The system was presumably disabled when the house was vacated around 1955-57.

Figure 63. Room 108 (back hall/former “fuel” room) of the keeper’s dwelling, 2012: (a) ceiling and hatch, (b) east wall, (c) west wall, and (d) “Gurney” hot-water radiator.

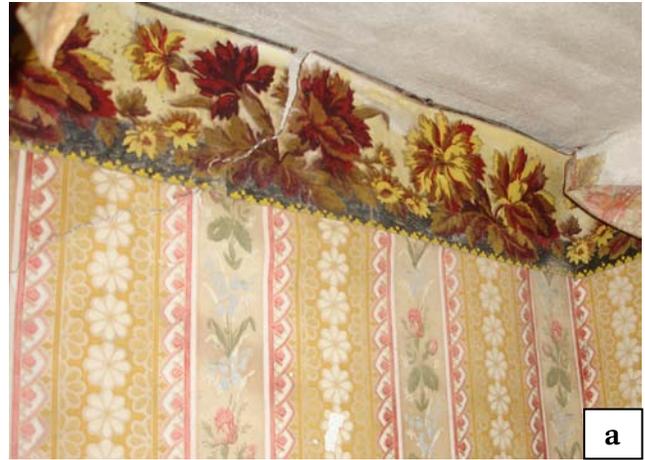
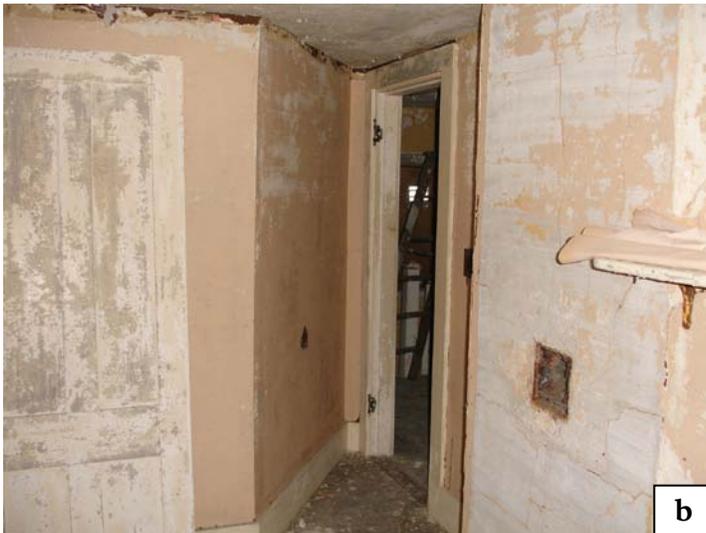
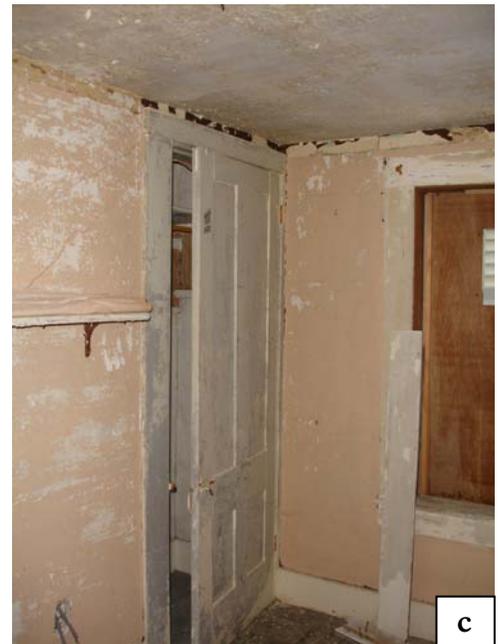
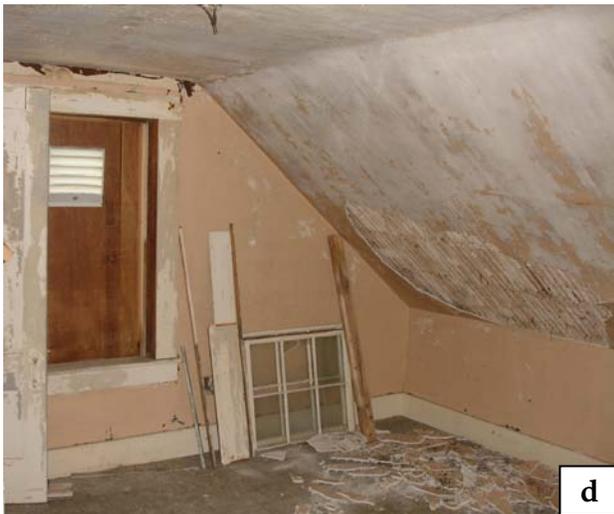
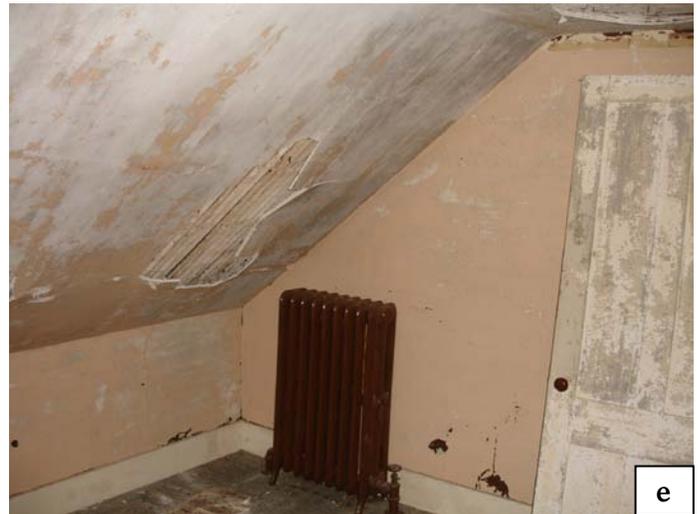
Room 205

The interior walls, ceilings, and most woodwork of the interior rooms of the keeper's dwelling are finished with paint, presumably dating to the 1950s when the house was last occupied. The walls and ceiling of the main cellar are painted with whitewash, and rooms in the first- and second stories with oil-based paints that may contain lead. Wallpaper of circa-1903 vintage with a wide border is preserved in the closet of the southeast bedroom (Room 205—fig. 68a).

Figure 68. Room 206 (southeast chamber) of the keeper's dwelling, 2012: (a) circa-1903 wallpaper in the closet, (b) northwest corner, (c) northeast corner, (d) southeast corner, and (e) southwest corner.

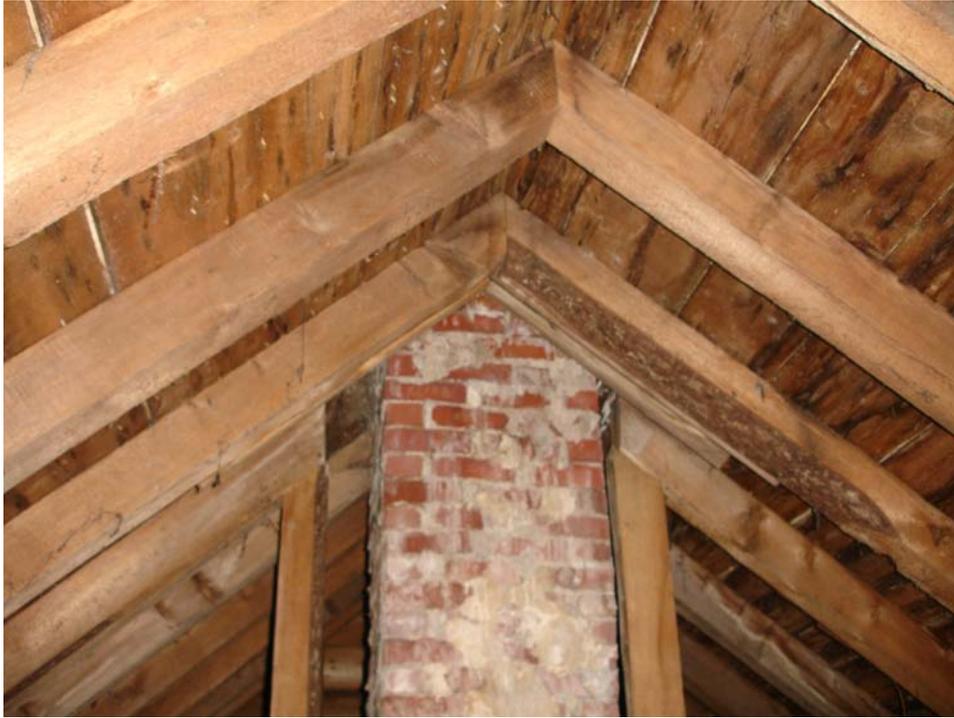
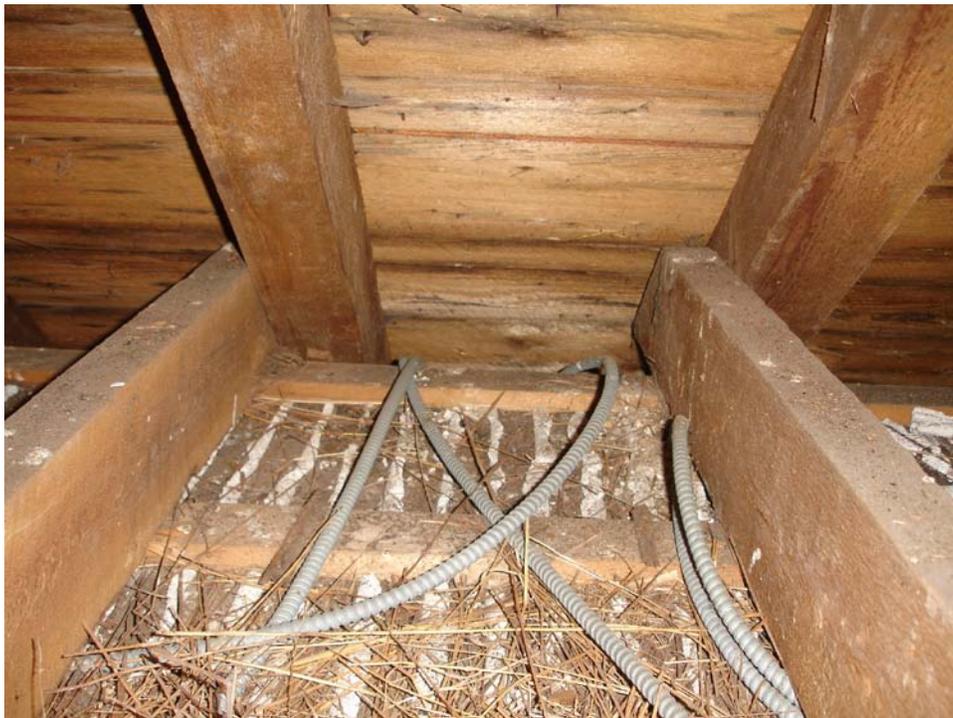
Baker Island Keeper's Dwelling Main Attic

Figure 69. Main attic of the keeper's dwelling, 2012, showing the brick chimney and roof rafters (above), and flexible electrical conduit between floor joists (below).

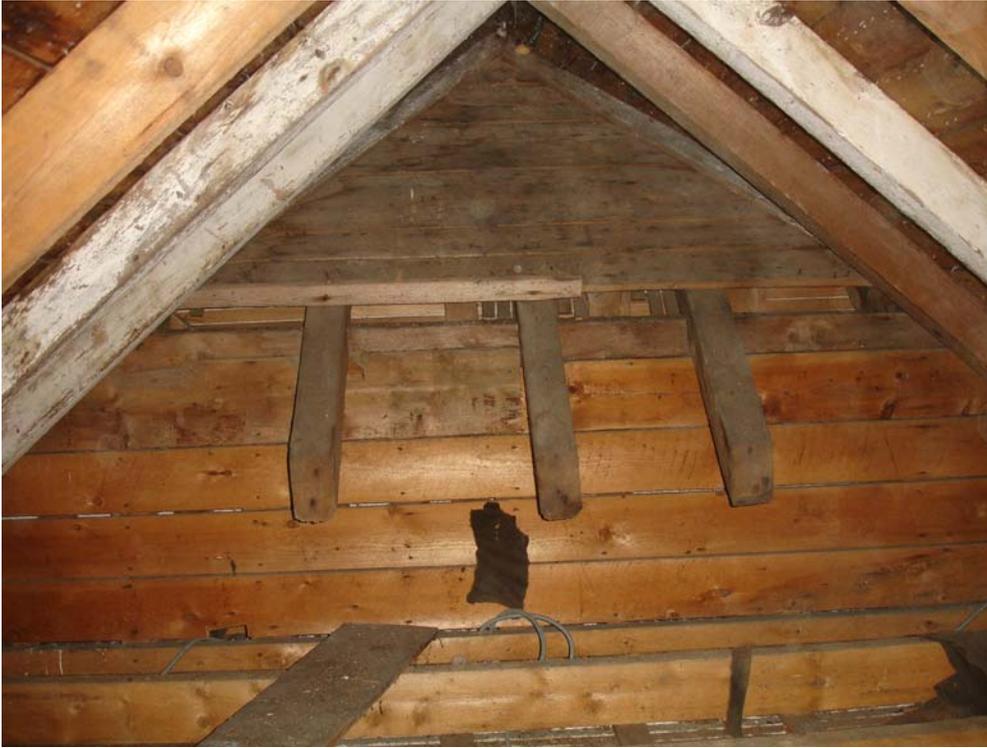
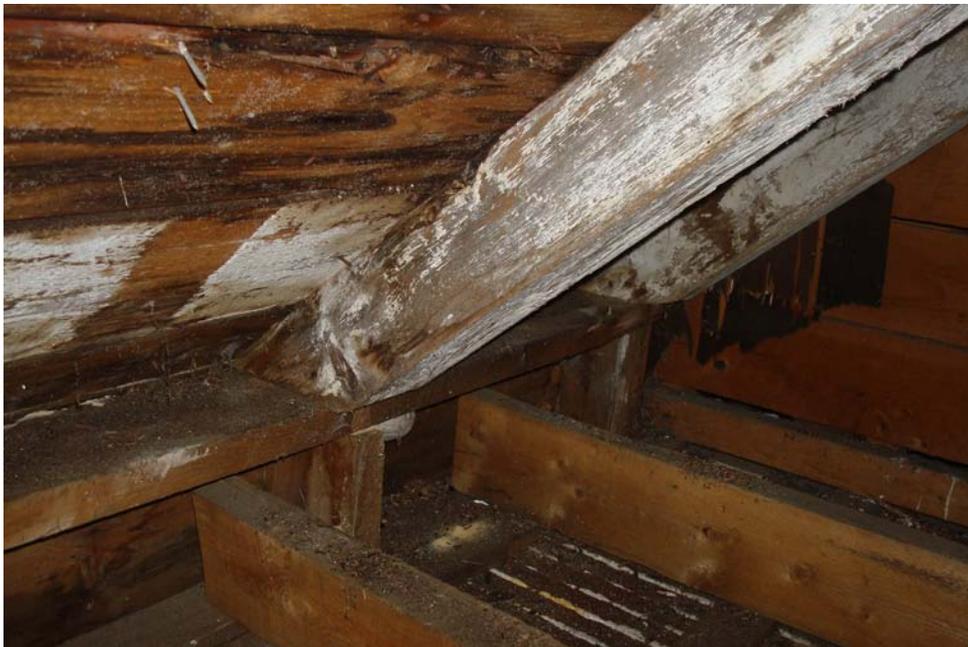
Baker Island Keeper's Dwelling Kitchen-Wing Attic

The keeper's dwelling has two gable roofs: one over the main house dating to 1855, the other over the circa-1868 back wing. Both roofs have rafters that meet with miter joints at the roof ridge, wide sheathing boards, and wood roofing shingles. The wing's roof and other framing elements were assembled with reused building materials, based on remnants of white paint preserved on selected framing members (fig. 70).

Figure 70. Kitchen attic of the keeper's dwelling, 2012. Note the original exposed roof and rafter ends at the north wall (above), and reused painted lumber at the west wall (below).

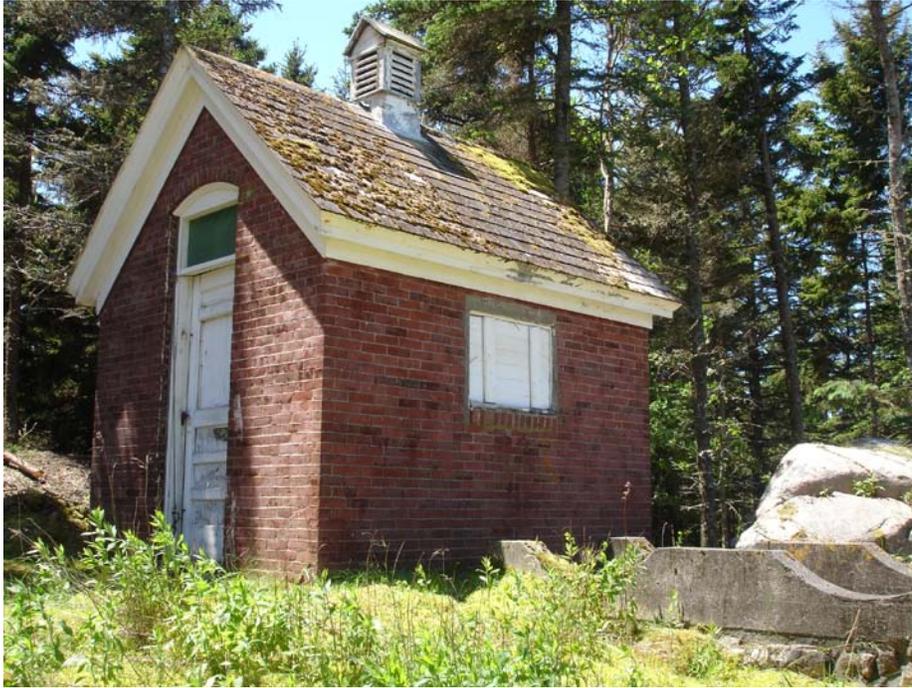
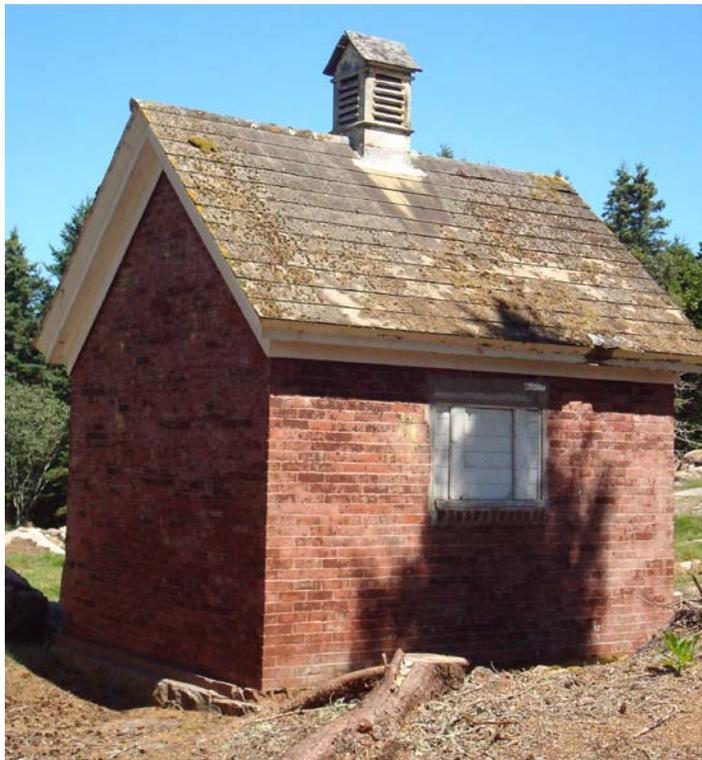
Baker Island Light Station Oil House

Figure 71. Oil House of the Baker Island Light Station, 2012: south and east elevations (above), and north and west elevations (below).

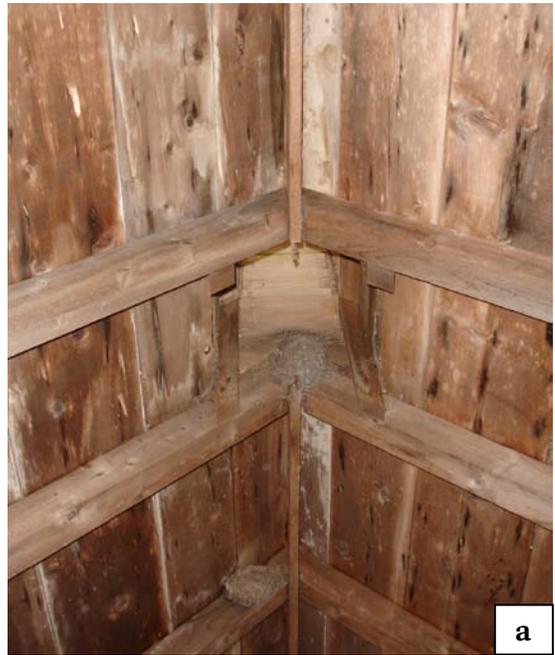
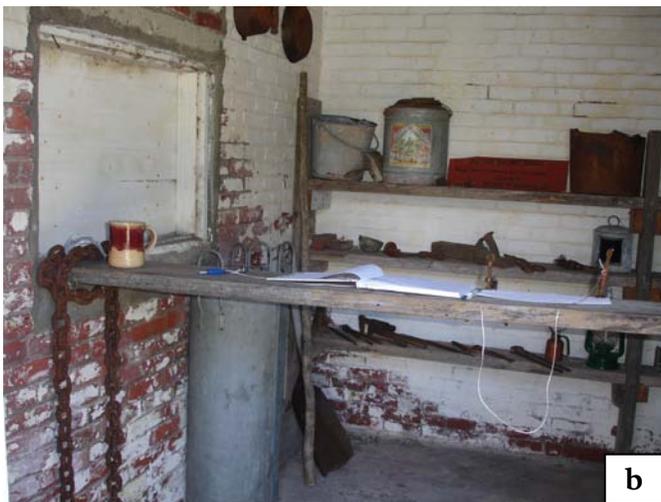
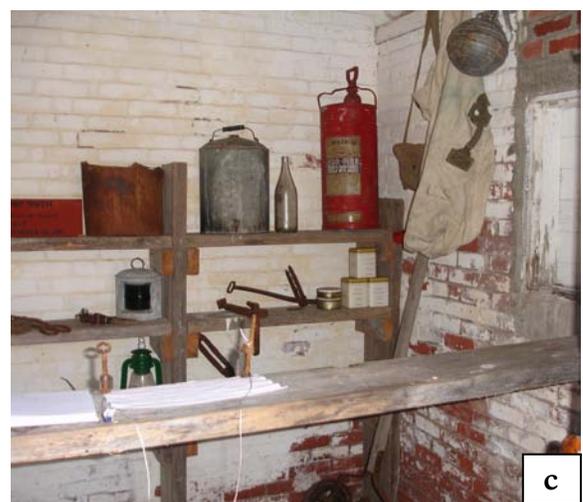
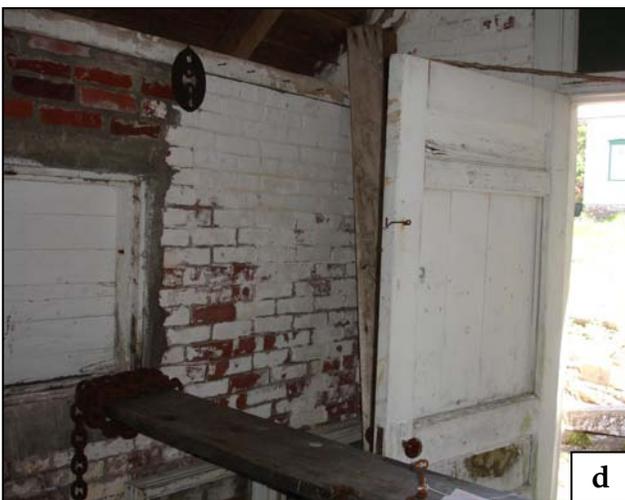
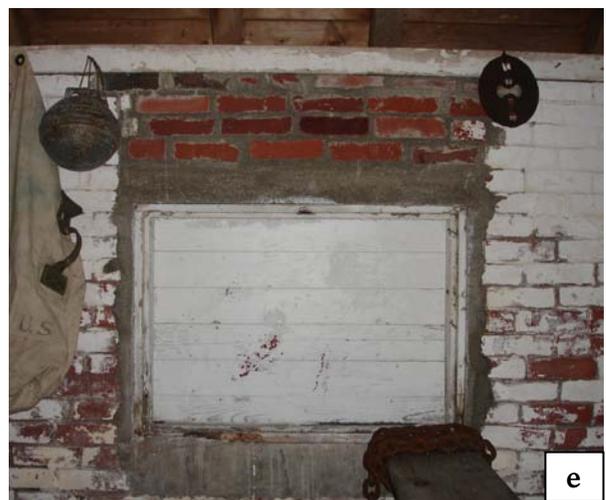
Baker Island Light Station Oil House Interior

The oil house has two windows: one in each of the side walls. These are later openings thought to date to the remodeling of the building as an electrical-generator house in 1954. Sashes are missing from both windows; boards cover the openings today.

Figure 72. Interior views of the oil house, 2012: (a) ceiling, (b) northwest corner, (c) northeast corner, (d) southeast corner, and (e) boarded window at east wall.
