National Park Service
U.S. Department of the Interior

Of Adobe, Lime, and Cement: The Preservation History of the San José de Tumacácori Mission Church (Part II - Structures)

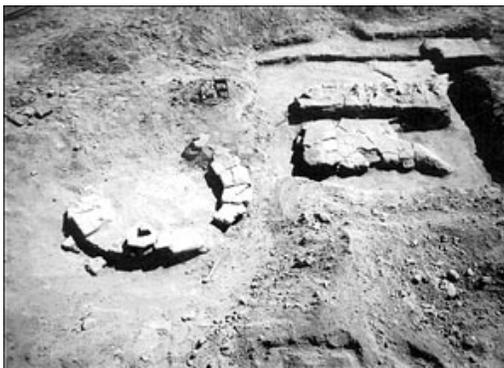
Heating features discovered by Beaubien in 1934 in Area 37A. Beaubien called the horseshoe shaped feature the retort and the square feature the furnace. Photo taken before the features were removed in 1970.

In Area 37a., archeologist Paul Beaubien uncovered evidence for on-site production of the church bells in the form of two heating features he called the furnace and retort. A plaster mould resembling a bell was discovered near the heating features. Beaubien also found pieces of copper everywhere. In 1934, the floor of the circular furnace retort was "covered with a thin layer of copper which had solidified in place."²⁸ Fifty pounds of copper were collected, tested at the University of Arizona, and found to contain no silver.

According to Beaubien, the features in Area 37a are the remains of a metal foundry; however, he was unsure that the plaster mould was for a bell. The idea that the mould was for a bell came from George Boundey who told Beaubien that he had found a plaster "core mould" of a bell that looked similar to the piece Beaubien found. Unfortunately, "while he [Boundey] was conducting some visitors through the mission, another party arrived and dropped a heavy rock on the object".²⁹

At Tumacácori, archeological work often precedes preservation treatment. In the past, archeological sites or features were impacted or removed during preservation treatments. Work done in 1970 to lessen moisture retention in the east wall of the nave is an example of preservation treatments that did not adequately consider the effect on buried archeological resources. In 1970, plastic PVC sheeting was placed along the base of the nave walls in an attempt at directing subsurface moisture away from the structure. During placement of the plastic sheeting archeological features first identified by Paul Beaubien in 1934 were re-excavated, photographed, and completely removed.¹ The features, located near the east wall

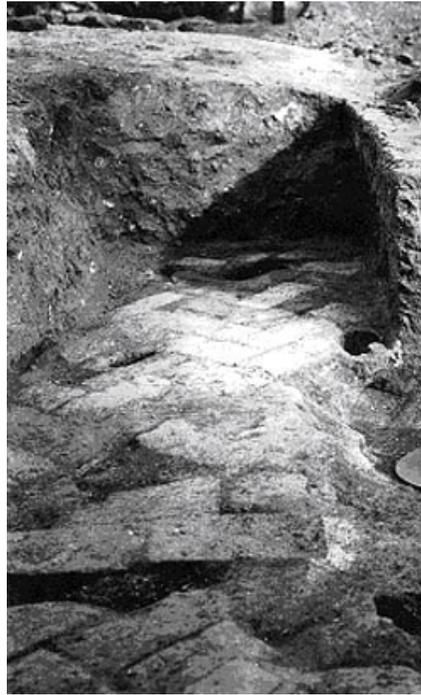
Fired adobe brick floor in the convento, 1934.

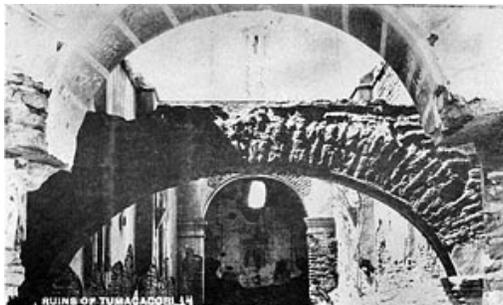
Photos of the church interior taken before 1893 show an intact choir loft. Based on available evidence, the choir loft fell sometime between 1892 and 1907. By circa 1905, the choir loft was no longer intact. Clemensen believes the choir loft fell in 1906.⁷ Tomas Alegria thought the choir loft collapsed in 1901, when the Montez family living at the mission hung a swing for their son from the arch.⁸ However, geologist William Blake visited the mission in 1905 and 1907, and notes from his 1907 visit suggest that the choir loft fell sometime between 1905 and 1907; presumably due to the combined impact of the 1887 earthquake and its use as a swing support.⁹

Close up of the choir loft ca. 1890.

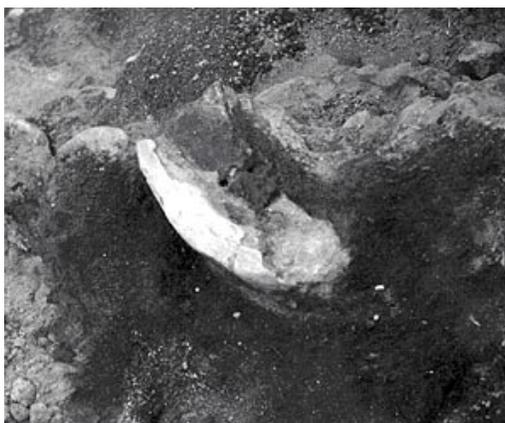
Plaster mould found by Beaubien in 1934. The mould was found twelve feet east of the retort. Beaubien and George Boundey believed it could be a bell mould, suggesting that the bells were made at Tumacacori.
