Doughton Park and Sections 2A, B and C Blue Ridge Parkway Cultural Landscape Report

Cultural Landscape Report

Written by The Jaeger Company

2006

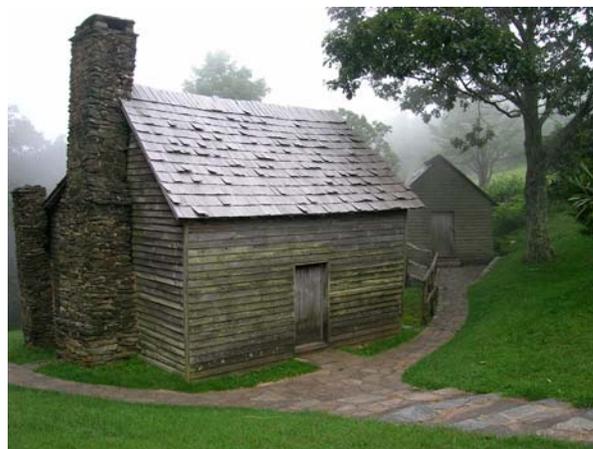
Figure 3.2: Southern facade of Brinegar Cabin, (Photo by I. Firth & K. Gridley, 2005).

The Brinegar Cabin site features four wooden buildings sited in a tight cluster in the southeastern corner of the property. All buildings are sided with wood clapboards and roofed with wood shingles. These buildings are in good condition unless otherwise noted, having been well-maintained since the 1975 NPS restoration.

Brinegar Cabin. The family’s 1889 Cabin is located approximately 60 feet southeast of the interpretive garden and 125 feet south of the Parkway (see Figure 3.2). This one-and-a-half story Cabin sits on a full stone foundation. The Cabin is composed of the original 1889 one-room log building, now sided with wood clapboard, and a clapboard-covered rear shed addition. According to the Brinegar Cabin Historic American Buildings Survey, the Cabin measures 25 feet across the eastern and western facades by 19 feet across the southern and northern sides with a small covered rear porch measuring nine feet in width and four feet, six inches in depth. The southern facade features the Cabin’s solid wood front door on an otherwise blank clapboard wall. Two stone chimneys and a single wooden double-hung window compose the eastern facade. A set of stone stairs lead onto the rear wooden porch. The Cabin’s northern facade features the rear covered porch with a solid wooden back door. Double-hung windows flank the rear door. A single

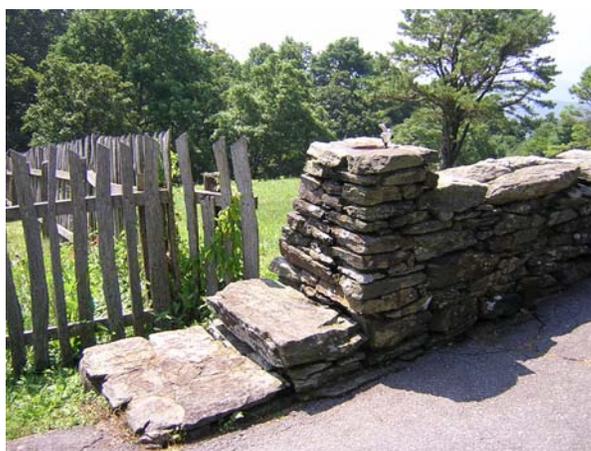
Figure 3.6: Drinking Fountain, (Photo by the Jaeger Company, 2005).

Drinking Fountain. A drinking fountain is incorporated into the parking lot retaining wall. (see Figure 3.6) The fountain is built as an extension of the retaining wall, with the top of the fountain rising an additional foot in height from the top of the wall. Two stone stairs elevate small visitors to an appropriate height to access the fountain. The top of the fountain contains an inset metal bowl with central drain and fountain head. Structurally, the

masonry stone base is in good condition and the fountain was operable in spring 2006.

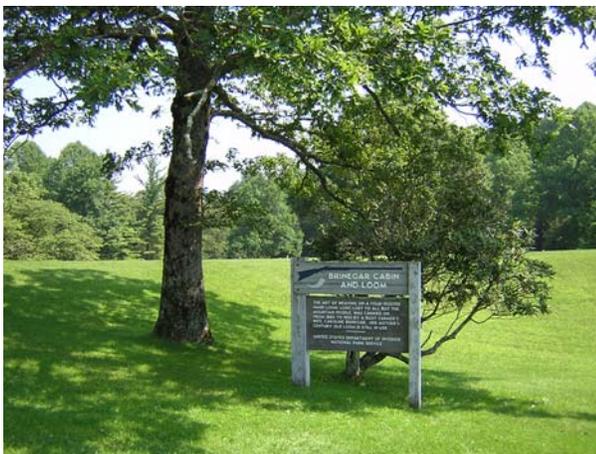
Figure 3.7: “Brinegar Cabin and Loom” Sign, (Photo by the Jaeger Company, 2005).

century. This sign is in fair condition. Rotting wood is evident and the sign base is generally unstable (see Figure 3.7). The “Appalachian Garden” sign is located adjacent to the Interpretative Garden along the entrance walk. This sign interprets garden crop varieties used by subsistence farmers in the Blue Ridge area during the late nineteenth and early twentieth centuries. A metal frame anchors the vandal-resistant integrated graphic board beside the path. This form of sign is representative of contemporary interpretive wayside signage found along the Parkway. A third type of sign is found just beyond the garden. This sign is executed entirely in metal and features a photo of Caroline and Martin Brinegar. The sign lists the birth and death dates of each of the former property owners and lists the nearby location of their graves. These gravesites are not located within Parkway boundaries. The fourth and final interpretive sign is located on the west wall of the Springhouse. This routed wooden sign is mounted flush against the wall and explains the use of this type of structure to cool perishable goods for the Appalachian household. Likely an original or replica of the original sign, this is evocative of early means of interpretation along the Parkway.

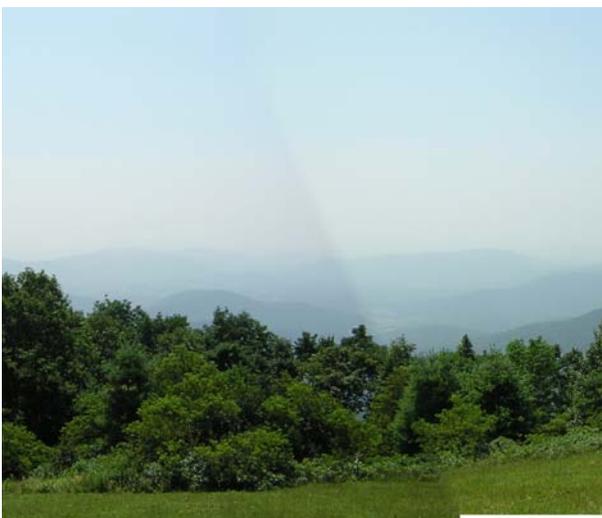
Figure 3.10: Vista from Brinegar parking lot, (Photo by the Jaeger Company, 2005).

The Brinegar Cabin site contains one major vista. From the parking lot, visitors overlook the former orchard and into the distant mountains of North Carolina (see Figure 3.10). The parking lot provides a wonderful vantage to look into the distant

landscape, while also allowing the visitor to gain orientation of the Cabin site upon arrival. NPS contractors clear the vista of vegetation on a three year cycle in order to retain the planned scene. The condition of the vista is good.

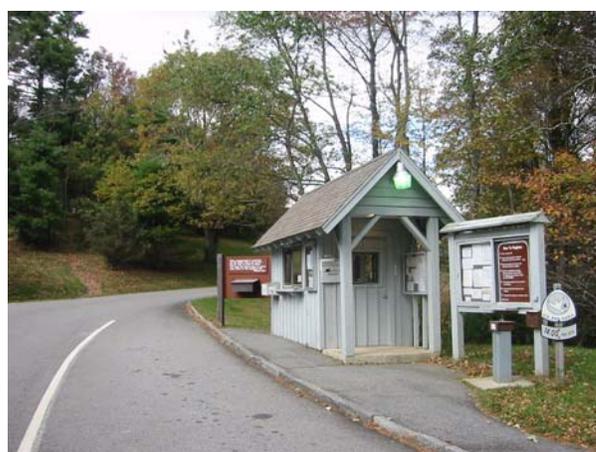
Figure 3.16: Tent Loop Entrance Station and Kiosk, (Photo by the Jaeger Company, 2005).

1970s manufactured-housing unit and an entrance station provide buildings for NPS employees to occupy during busy portions of the season. The manufactured unit is a flat-roofed metal-sided single-bay unit facing the entry road. The Entrance Station is built of wood board-and-batten siding and is roofed with asphalt shingles (see Figure 3.16). These structures are non-contributing resources because both were added to the Parkway after the first three periods of construction. The Entrance Station continues to be used, while the manufactured unit is no longer used. The manufactured unit is in fair condition showing normal wear associated with a thirty year old temporary unit. The Entrance Station appears is in good condition.

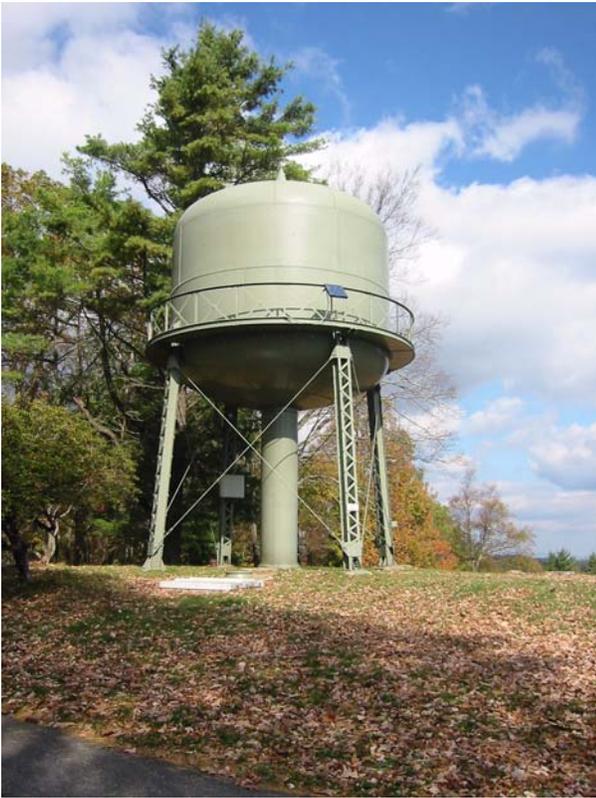
Figure 3.17: Water Tank, (Photo by the Jaeger Company, 2005).

Water Tank. A water tank for the Campground area is located at the high point in the center of Loop A. The structure was completed in 1939 and has serviced the Campground since then. The tank sits atop an approximately 30 foot tall steel tower (see Figure 3.17). The tank has been freshly painted, and is in good condition.

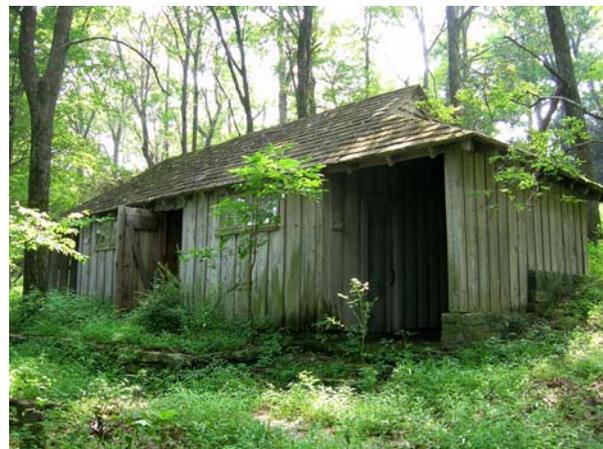
Stone and wood clapboard siding are used in conjunction with wood shingles to cover the building (see Figure 3.24). The style is reminiscent of local Appalachian building forms in terms of massing and roof line. The building is approached from a path running from the parking lot northwest to the rear of the site. Due to the steep slope of the picnic area, the rear of the building is partially below grade. This provides an at-grade entrance to the building on the northwestern side. This comfort station has not been maintained since the picnic area was abandoned nearly 25 years ago. Neglect is evident. Wood rot and a general accumulation of organic debris are leading to diminished integrity of this early Parkway building. Despite this lack of maintenance, the building is in fair condition, retaining its original windows, doors, and siding.

Figure 3.24: Comfort Station #101, (Photo by I. Firth & K. Gridley, 6.25.2005).

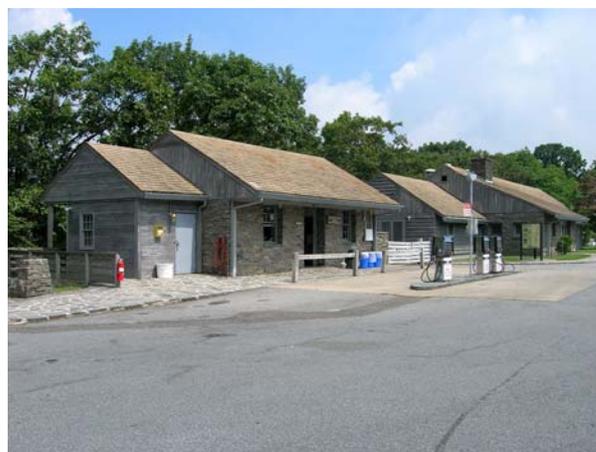
Gift Shop, and Camp Store. Designed and constructed at the same time, the Coffee Shop and Service Station were intended to be a set of buildings. The former Service Station sits twenty feet west of the Coffee Shop. The two buildings are separated by a paved service area. Measuring approximately 40 feet long by 20 feet wide, the former Service Station consists of two rooms with separate entrances which are used for the Camp Store and Gift Shop, two restrooms and a large storage room. This building is constructed of the same materials as the Coffee Shop with the exception of the wooden double hung widows (see Figure 3.26).

Figure 3.26: Bluffs Service Station, (Photo by the Jaeger Company, 2005).

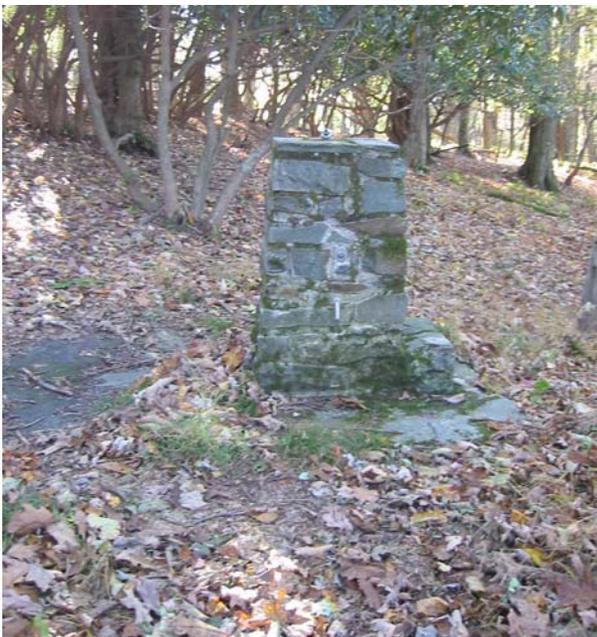
Drinking Fountains. There are five drinking fountains in the picnic area and one located on the northeastern corner of the western parking lot. All six fountains are examples of the second generation of Parkway drinking fountains. The fountains are made of the original mortared stone bases. A stone stair elevates small visitors to an appropriate height to access the fountain. The top of the fountain contains an inset metal bowl with central drain and fountain head (See Figure 3.27). Structurally, the masonry stone base is in good condition, but the fountains were inoperable during August, 2005, and appear to have long been out of service.

Figure 3.27: Drinking Fountain, (Photo by the Jaeger Company, 2005).

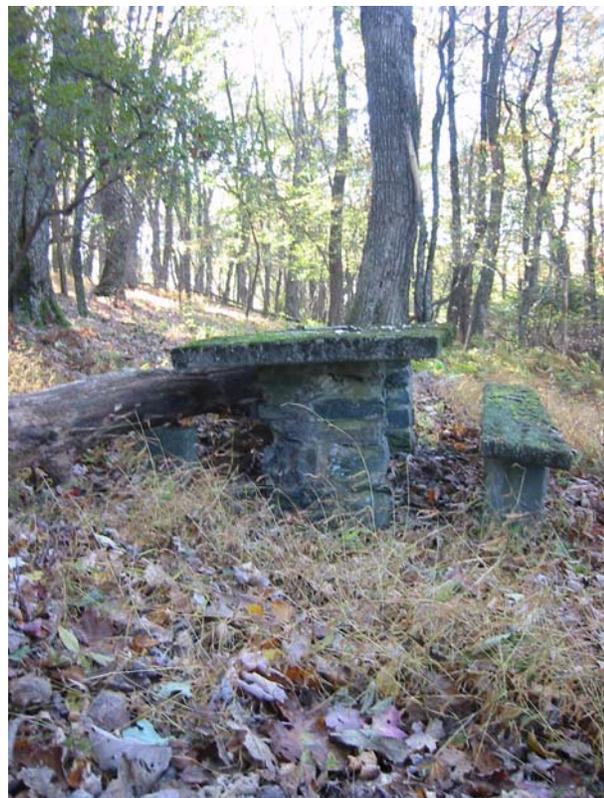
bases which support a concrete slab tabletop. The benches are also constructed with two stone pillars which support a three by twelve inch wooden plank seat. The fireplaces are constructed with U-shaped stone walls and metal grate cooking surfaces. Due to the lack of maintenance of this area over the past 30 years, many of these elements are missing or in poor condition. Many sets are incomplete and many contain broken benches and tables (see Figure 3.28).

Figure 3.28: Abandoned Picnic Table and Benches, (Photo by the Jaeger Company, 2005).

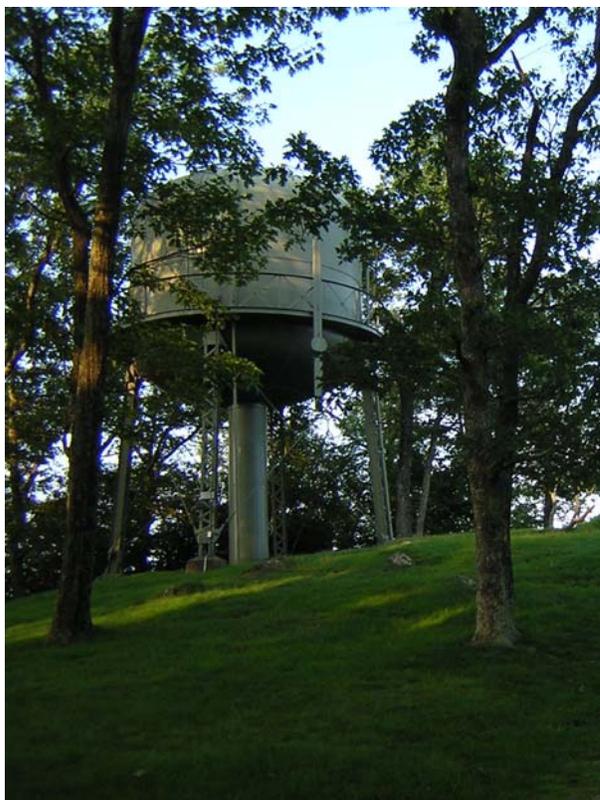
Water Tank. Built in 1939, the water tank is one of the oldest structures in Doughton Park (see Figure 3.31). The tower is located on top of the knoll, just behind Wildcat Rocks Overlook. A steel water tank sits atop an approximately 25' tall steel tower. The structure is painted olive green and is in good structural condition.

Figure 3.31: Bluffs Lodge Water Tower, (Photo by the Jaeger Company, 2005).

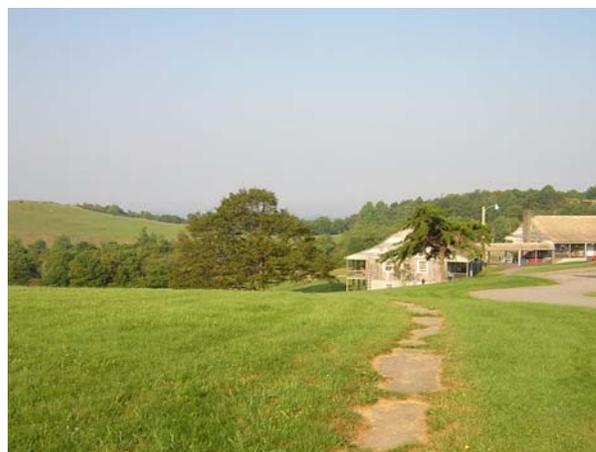
Pedestrian circulation is provided with asphalt paths. Located along the southern side of the Overlook Parking area and Lodge Parking area, a three-foot-wide 780 feet long paved path connects the parking lots and Lodge. Additionally, a three-foot-wide 770 foot long path loops from the eastern end of the Overlook Parking area to the Wildcat Rocks Overlook then continues west to rejoin the aforementioned parking lot path. A 330 foot path loops from the eastern end of the Lodge Parking area to the front of the Lodge and then ends at the western end of the Lodge Parking area. This path is divided by an 85 foot long linear path which connects the center of the Lodge to the center of the Lodge Parking area. The asphalt paths immediately in front of the Lodge are approximately six feet wide and are also used as a vehicular lane for luggage drop-off. Most of the paths are worn. Some areas of path are excessively worn with the worst portions missing areas of asphalt and overgrown with turf (see Figure 3.32). The overall condition of the asphalt on these pedestrian paths is fair.

Figure 3.32: Asphalt pedestrian path, (Photo by the Jaeger Company, 2005).

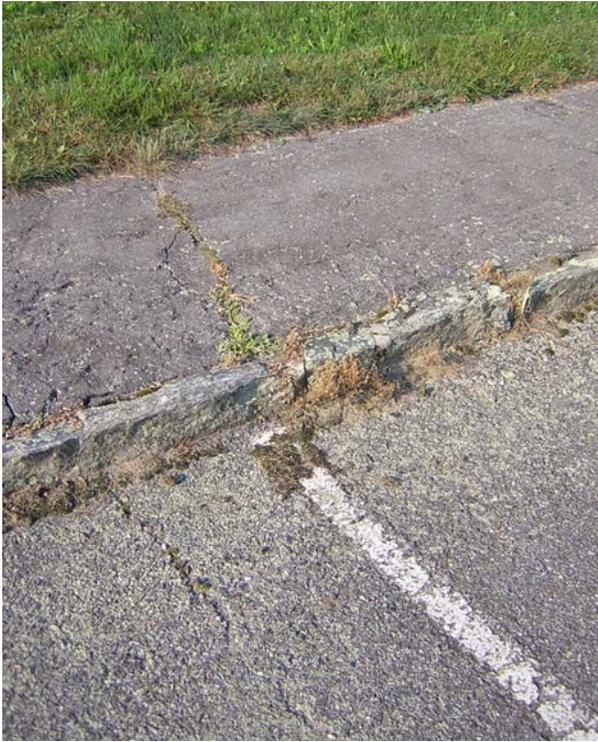
Vehicular circulation at the Lodge is accomplished with a main entrance road which leads from the Parkway past the Lodge and terminates in the Overlook Parking area. The road consists of two traffic lanes and is surfaced with asphalt. On the northeastern side of the Lodge, a parking lot is located south of the entry road. The lot configuration forms a loop with two access points to the entry road. Both parking lots are curbed with stone (see Figure 3.33). The condition of this circulation route is fair. Worn asphalt is evident in

Figure 3.33: Stone curb in Bluffs Lodge parking lot, (Photo by the Jaeger Company, 2005).

many areas and previous asphalt projects have obscured a large portion of the stone curb.

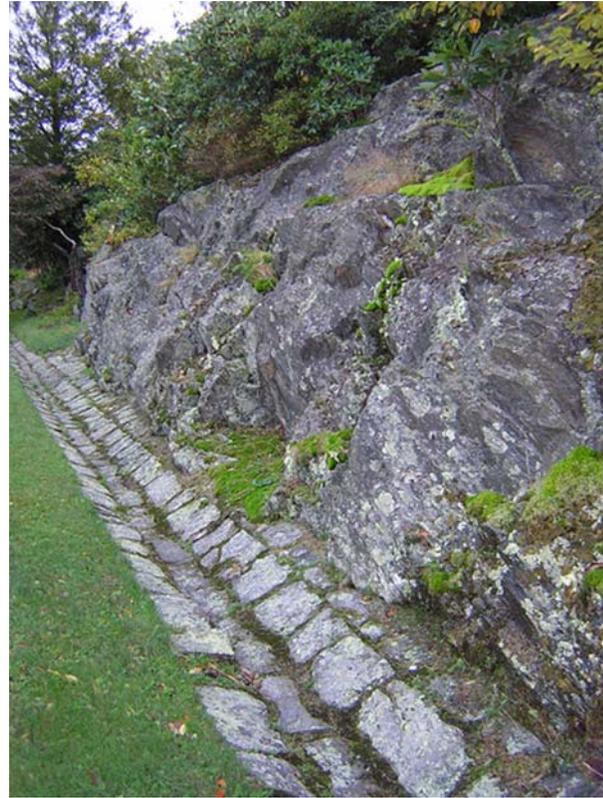
Stone Gutter. Approximately 100 feet of rubble stone gutter is located along the southern side of the entrance road. The gutter is found at the base of a large stone outcrop (see Figure 3.34). This early feature was installed with the original entrance road to Wildcat Rocks Overlook. The gutter is in good condition due to years of regular maintenance and repair.

Figure 3.34: Stone gutter along Entrance Road, (Photo by William Shealy, 2004).

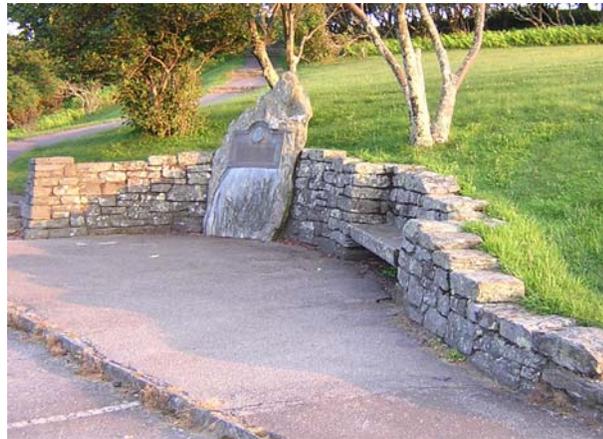
Figure 3.35: Robert Doughton Memorial, (Photo by the Jaeger Company, 2005).

Doughton and an inscription commemorating the life of Congressman Doughton and the dedication of Doughton Park. The plaque is heavily tarnished and in need of cleaning. The drinking fountain is integrated with the stone retaining wall much like the one found at Brinegar Cabin. The fountain is located at the eastern end of the retaining wall rising a foot from the top of the wall to punctuate the end of the feature. A stone stair elevates small visitors to an appropriate height to access the fountain. The top of the fountain contains an inset

metal bowl with central drain and fountain head. The fountain was found to be inoperable in August, 2005, and appears to have long been out of service. The wooden bench is in fair condition due to wood rot and excessive weathering. Structurally, the stone masonry is in good condition. Due to the inoperable fountain, the rotting bench, and tarnished plaque the general condition of this memorial piece is fair.

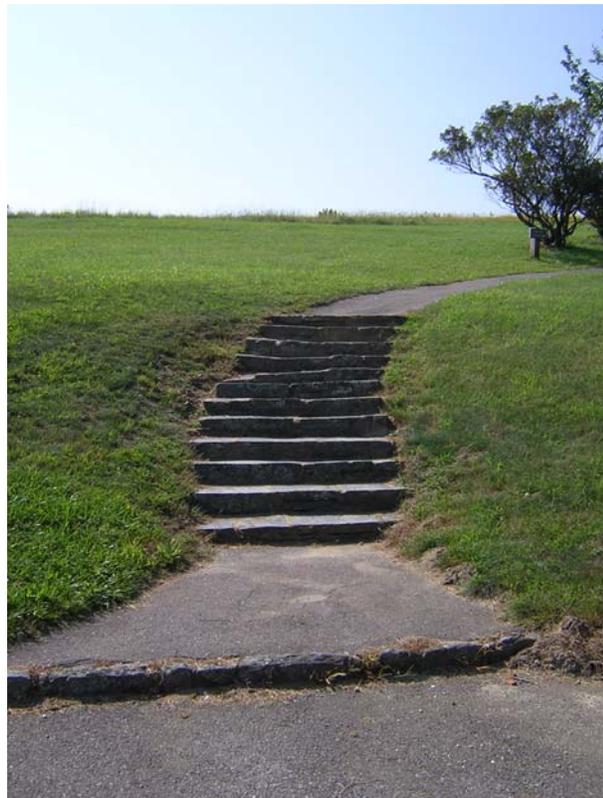
Figure 3.43: Stone stairs near Comfort Station #102, (Photo by the Jaeger Company, 2005).

Stone Stairs. Stone stairs are found near Comfort Station #102 and #104. The set of twelve stone stairs which lead up to Comfort Station #102 are in good condition showing no signs of structural problems (see Figure 3.43). The set of twelve stairs located on the north side of Comfort Station #104 lead from the adjacent parking area to the comfort station and picnic sites. These stairs are in fair condition due to deteriorating mortar joints (see Figure 3.44).

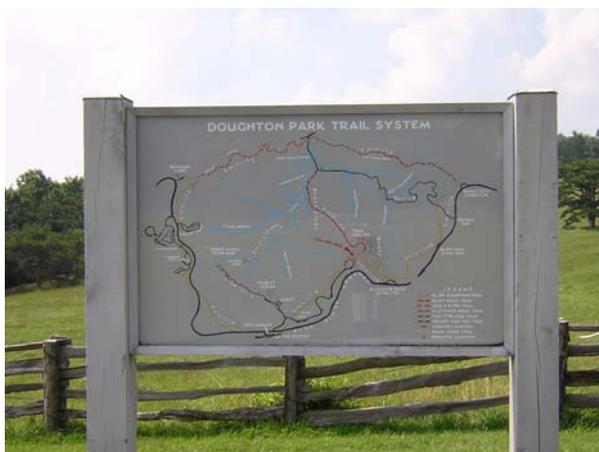
Figure 3.45: Trail System Sign, (Photo by the Jaeger Company, 2005).

Signs. The Bluffs Picnic Area contains several types of signs, most of which are used for trail directions. Located in the cul-de-sac of Ridge Road a large wooden sign describes the entire trail system for Doughton Park (see Figure 3.45). This sign is in good condition showing no signs of rot or instability. Figure 3.46 features a variety of trail signs which are located at the junction of the Bluffs Mountain Trail and the cul-de-sac. These signs record trail distances, landmark directions and camping regulations. Other signs in the area deal issues such as picnic area policies, picnic site locations and direction to facilities.

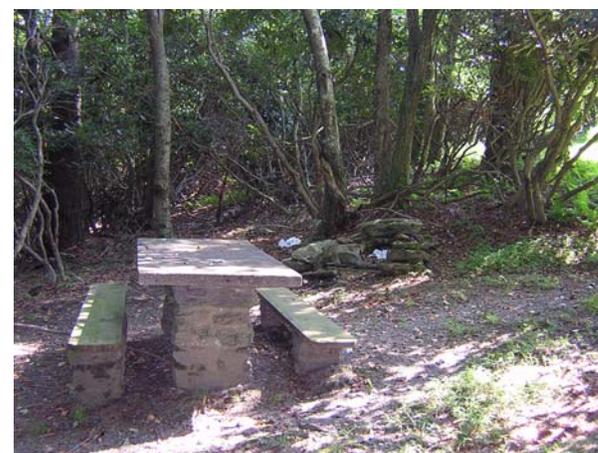
Figure 3.48: Prewar Planning and Construction Era Picnic site, (Photo by the Jaeger Company, 2005).

Many of these original units are still located with in the picnic area. Repairs, often making use of new types of materials, have been made to most units. The general condition of these units is good; however current materials differ from those

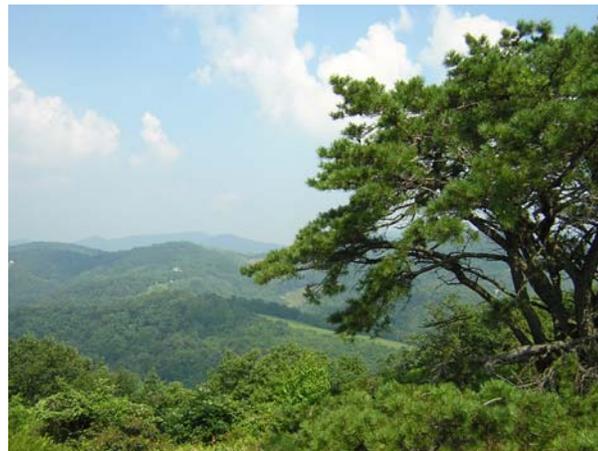
Figure 3.51: View northwest from Bluffs Picnic Area cul-de-sac, (Photo by The Jaeger Company, 2005).

The Bluffs Picnic area features one primary view at the cul-de-sac at the end of Ridge Road. The northwestern portion of this 360 degree panorama is a maintained vista of the mountains beyond the Parkway. (see Figure 3.51) Vegetation is maintained along the northwestern parking bay to create this vista. The remainder of the panorama is composed of a pastoral view. This view consists of rolling grass and wildflower meadow with scattered bays of

shrubs and trees. This view and vista are in good condition and retain the character that was originally intended by Parkway planners for this area.

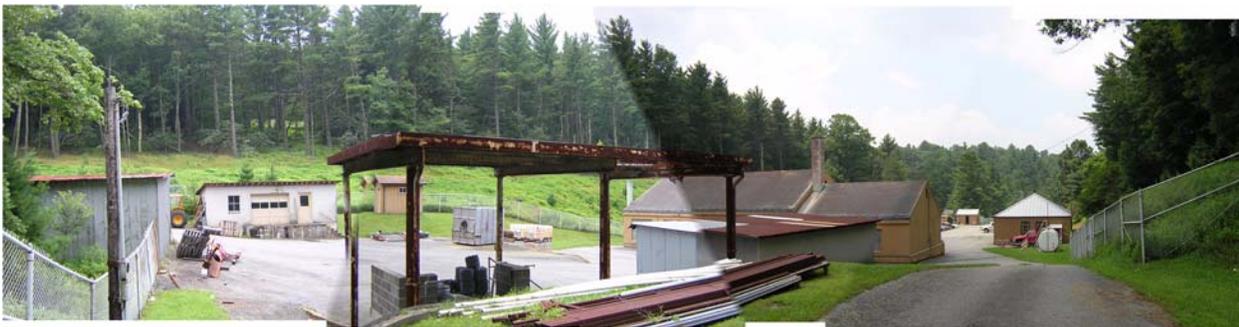
Figure 3.55: View of Storage Yard from former incinerator site, (Photo by the Jaeger Company, 2005).

Incinerator. Constructed before 1953, the incinerator for Doughton Park is located east of the Shop and Fire Equipment Storage building. The Doughton Park CLI lists this building as a contributing resource to this component landscape. At present the building is no longer in use and is only partially standing. Four rusty steel support poles and a partial corrugated metal roof are all that remain (see Figure 3.55). This building is in poor condition.

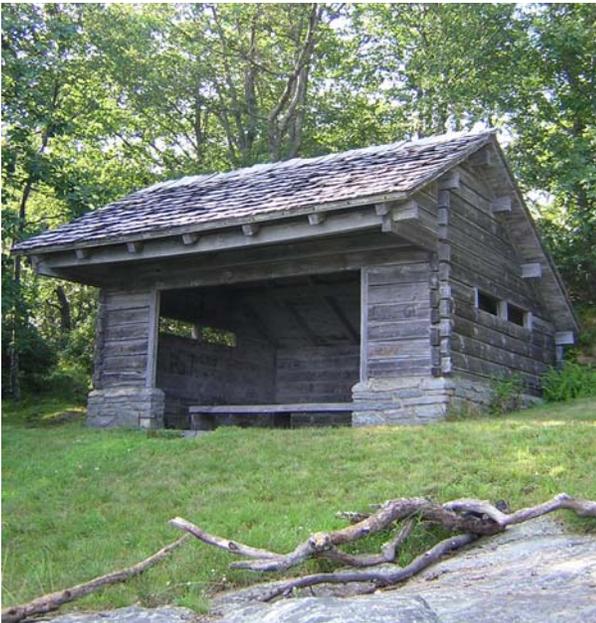
Figure 3.57: Bluffs Ridge Trail Shelter, (Photo by the Jaeger Company, 2006).

sides, and a maintained vista of the Parkway and many layers of distant mountains unfold on the southwestern side. Graffiti is carved into and painted on to the walls of the building; otherwise, the shelter is in good physical condition.

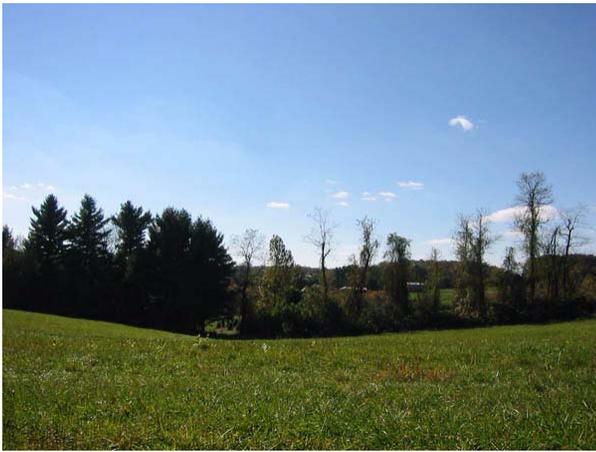
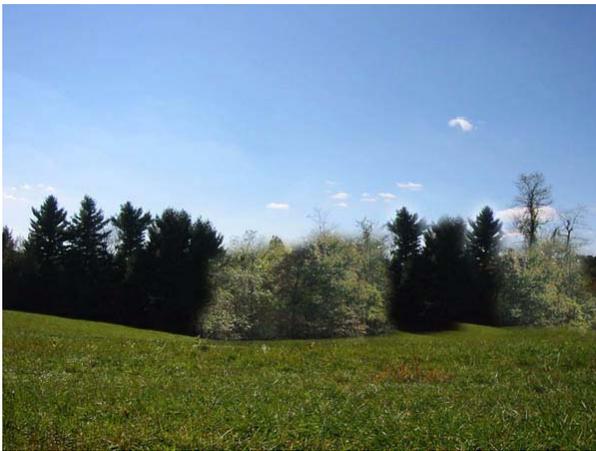
Figure 5.7: Modern farm buildings visible from Parkway at MP 221, Parkway Right (Photo by The Jaeger Company, 2005.)

Figure 5.8: MP 221, Parkway Right with proposed additional screening (Photo enhanced by The Jaeger Company, 2005.)

- o According to the 2005 *Blue Ridge Parkway Scenic Vista Cutting Management Plan*, “Along the roadway, cleared scenic vistas provide the greatest duration of viewing opportunity to the motorist who is traveling along the Parkway at an average speed of 45 miles per hour.”⁵ Maintain diversity in types of views and vistas along the Parkway including canopy views, agricultural views, and extensive ridge top views. See Figure 5.4, Figure 5.5, and Figure 5.6.
- o Add supplemental vegetation to screen modern visual intrusions as needed along these sections of the Parkway. Examples include intrusions at MP 221, Parkway Right, MP 236, Parkway Right, and 247.2, Parkway Right. See Figure 5.7 - Figure 5.11.

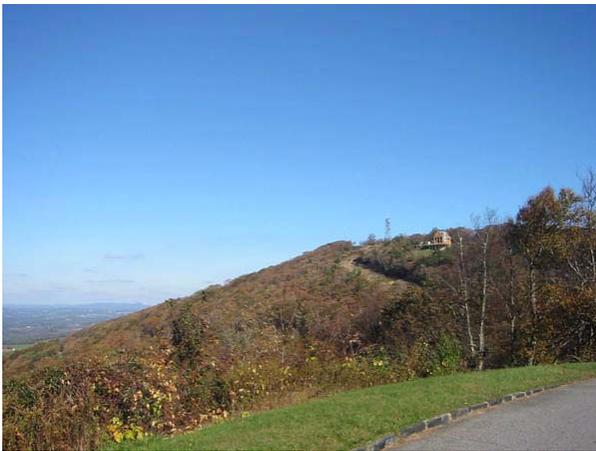
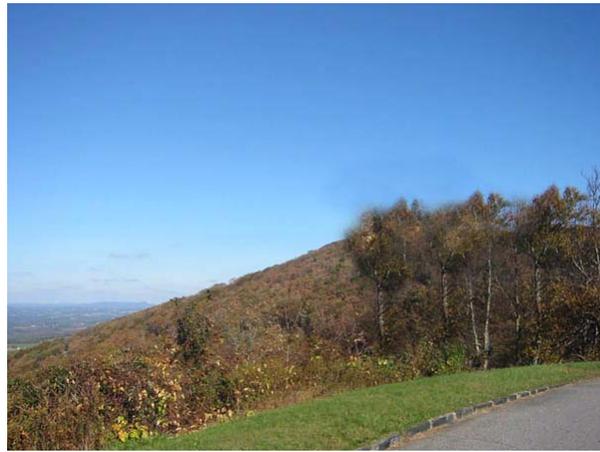
Figure 5.9: Modern residence visible from MP 236, Parkway Right (Photo by The Jaeger Company, 2005.)

Figure 5.10: MP 236, Parkway Right with proposed additional screening (Photo enhanced by The Jaeger Company, 2005.)

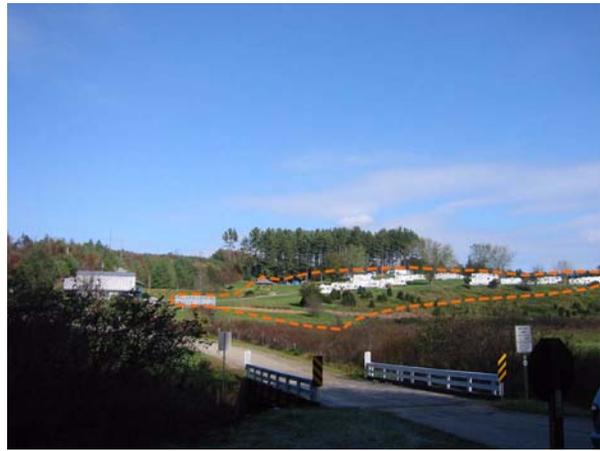
Figure 5.11: Modern modular homes and signs visually intrude on Parkway. Proposed area for screening shown in outline (Photo enhanced by The Jaeger Company, 2005.)

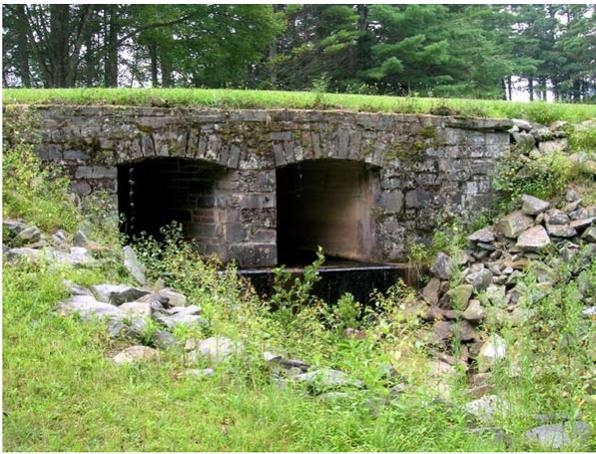
Figure 5.15: Double culvert at Hare Mill Pond. Stonework needs repointing and vegetation is growing on structure (Photo by Ian Firth, 2005.)

- o Preserve all bridges and grade-separated crossings.
 - oOn bridges which show degradation on the underside of the structure (e.g. stone-faced bridge at MP 223), cleaning and/or restoration may be needed. Consult annual bridge inspection reports. See Figure 5.14 and Figure 5.15.
