HISTORIC STRUCTURE REPORT  
ARCHITECTURAL DATA SECTION  
(VOLUME II - SYSTEMS ANALYSIS)

June 1988

OLD STATE HOUSE  
BOSTON NATIONAL HISTORICAL PARK

John B. Marsh  
and  
Morgan Phillips

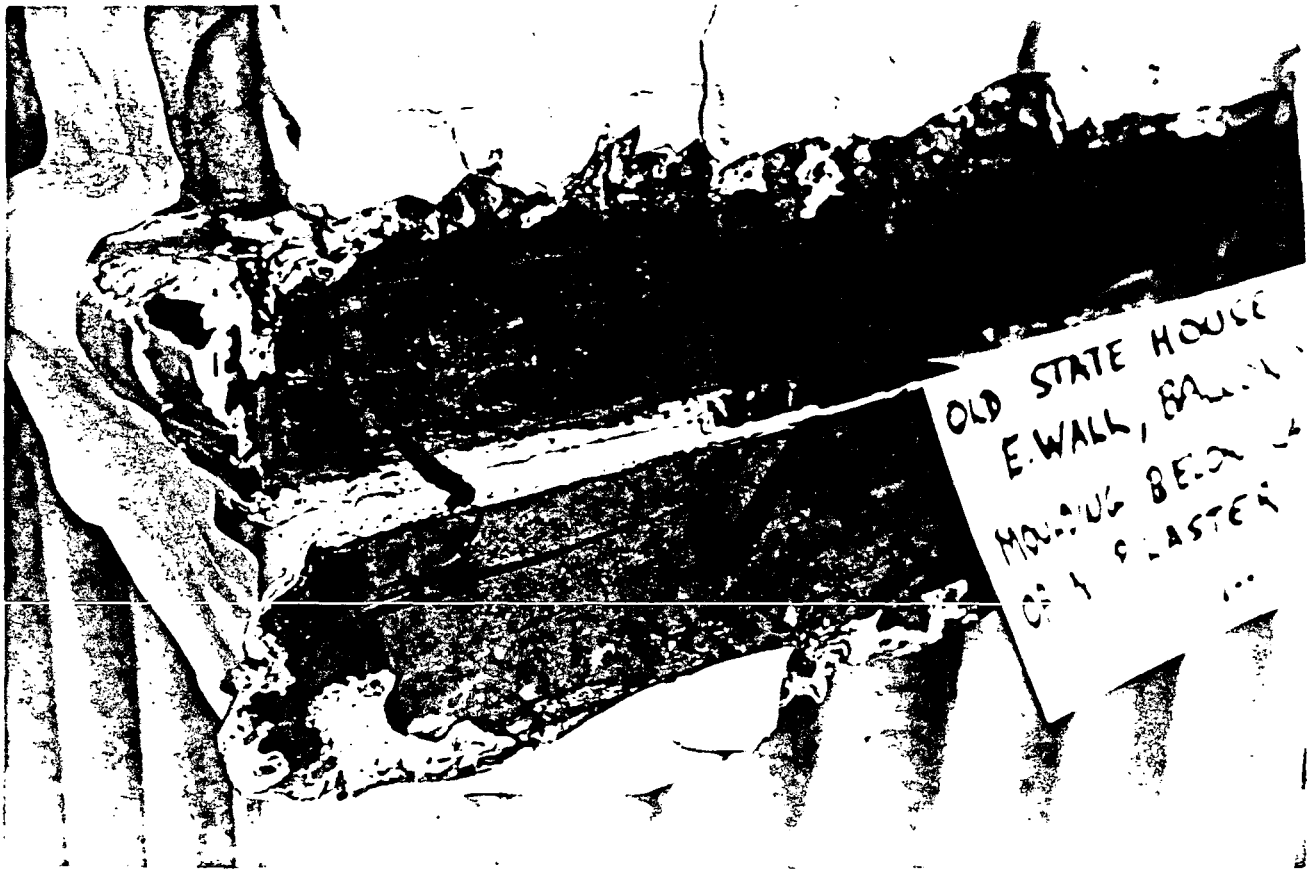
ILLUSTRATION 21. OLD STATE HOUSE: EAST WALL, BALCONY PILASTER, 1977.

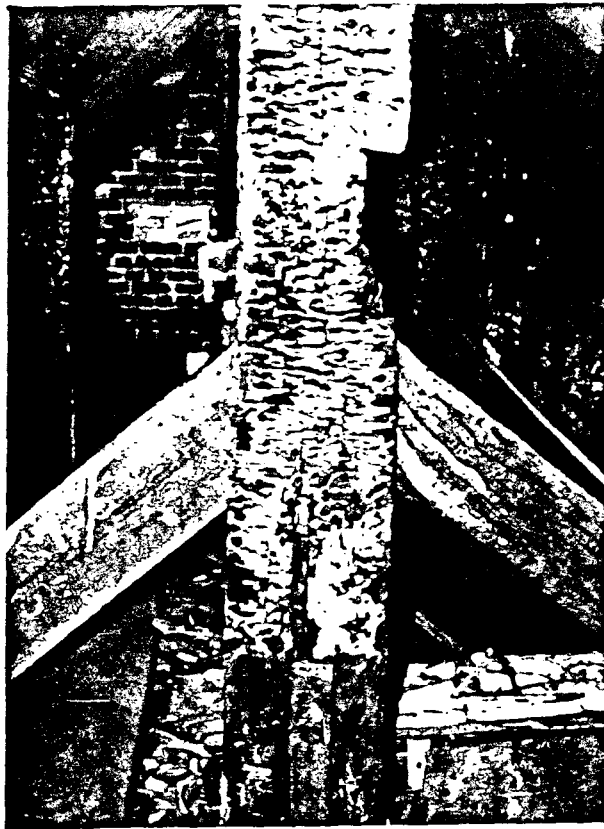
ILLUSTRATION 46. OLD STATE HOUSE: NOTCH IN TRUSS KING POST, 1987.

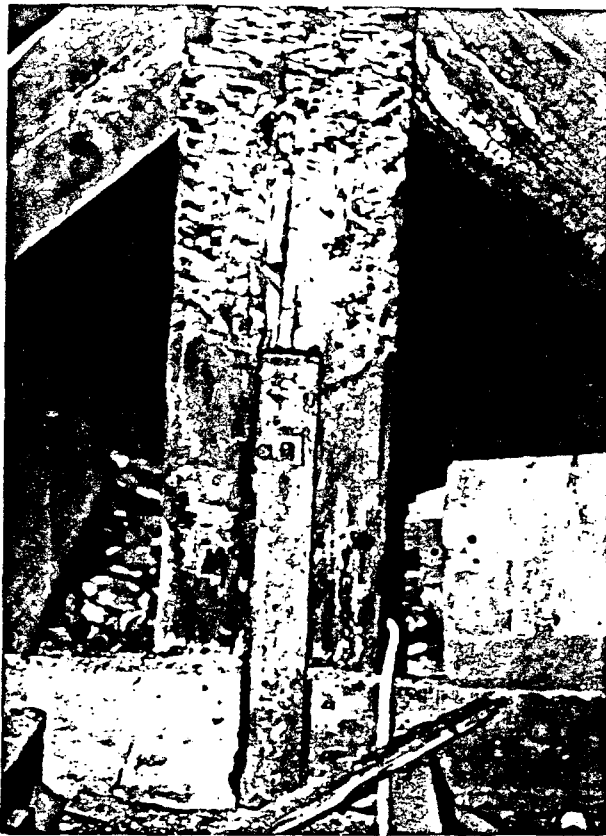
ILLUSTRATION 48. OLD STATE HOUSE: STEEL STRAP AT ATTIC CEILING, 1987.
