DRY DOCK 1

HISTORIC STRUCTURE REPORT

Charlestown Navy Yard • Boston National Historical Park

JUNE 21, 2007

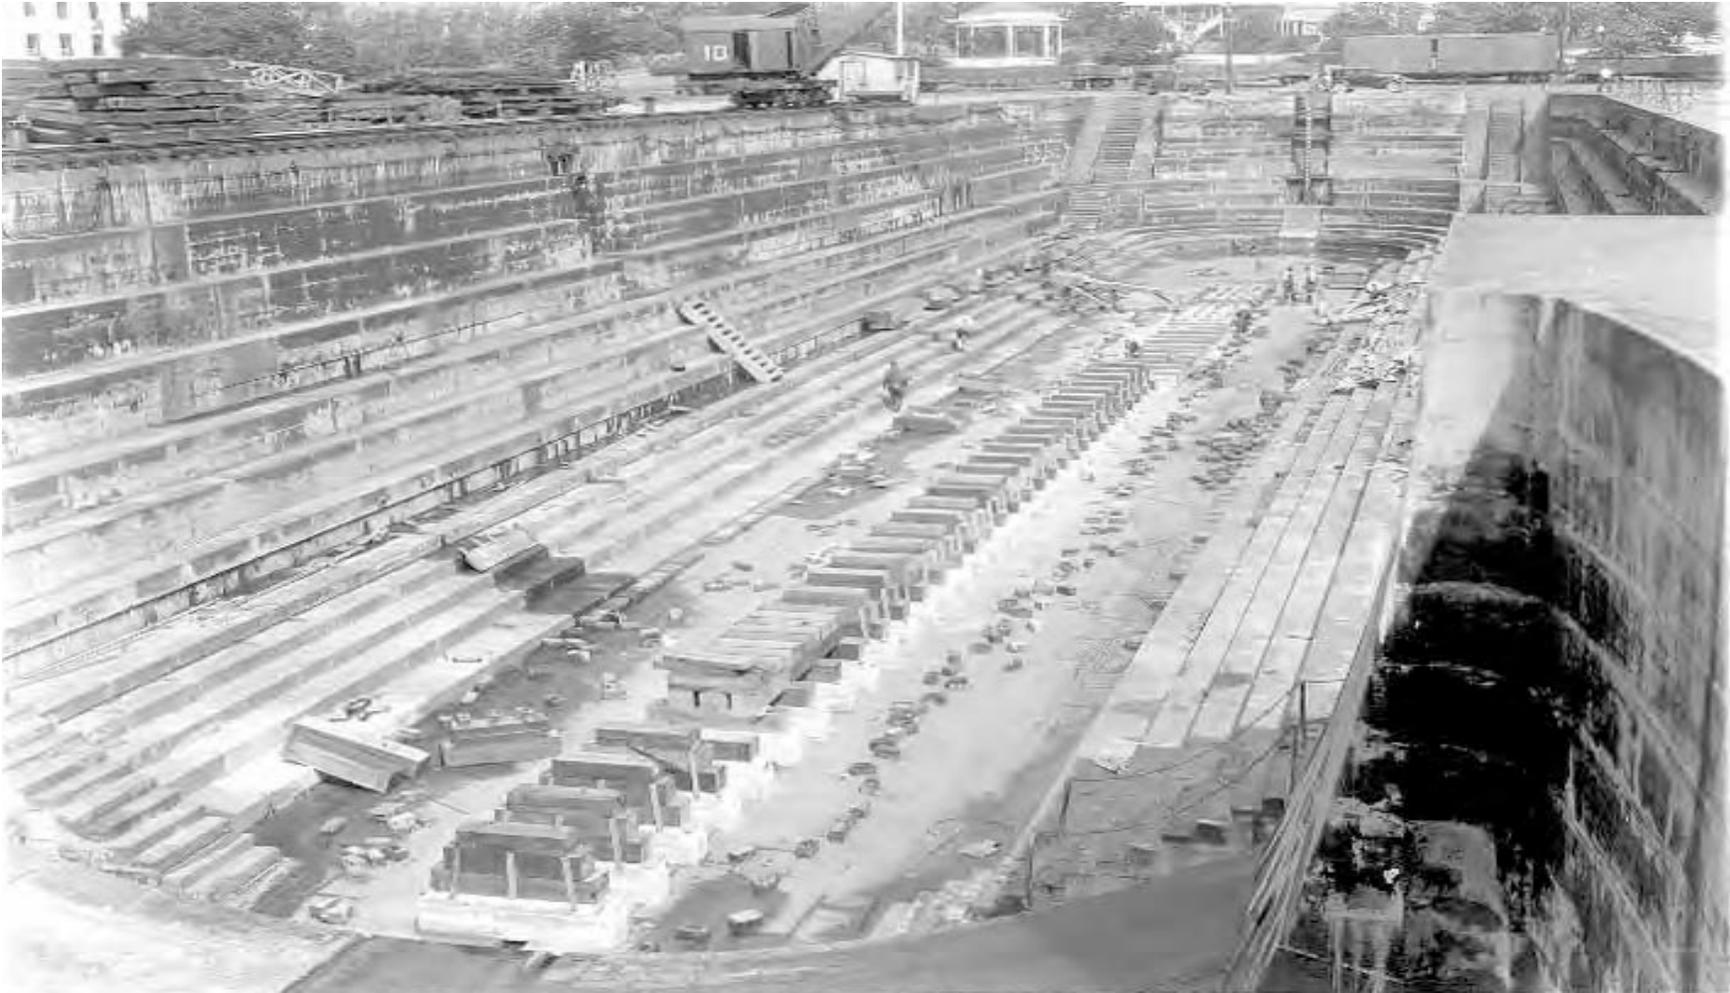
(B10) View of Dry Dock I, from 1930, looking northwest, toward the head of dock, with the turning basin in the foreground. Note that at the middle of the dock, on the west side, a wooden stairway was located above the lower altars and provided access to the dock's floor.

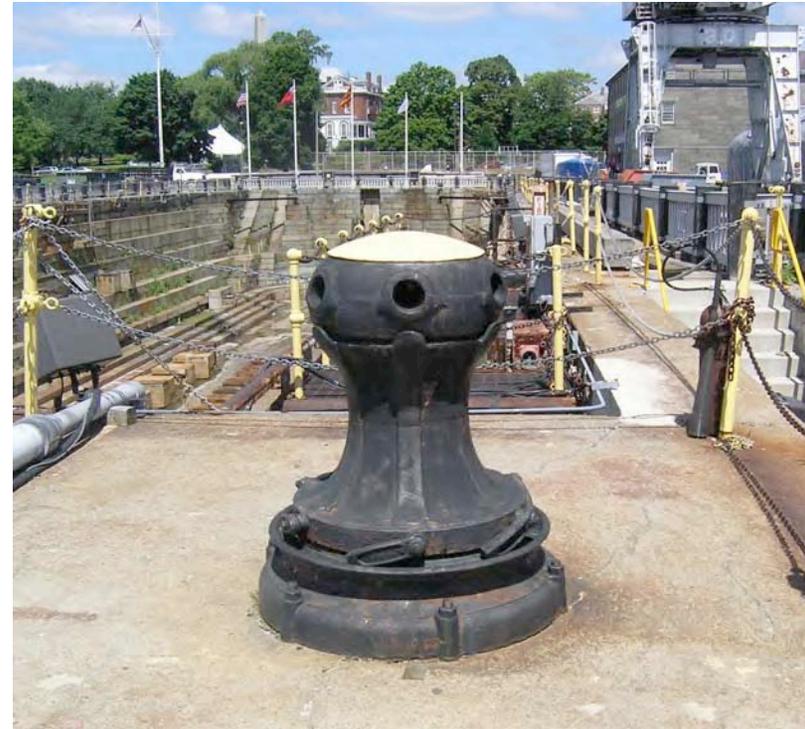
Fig. 1 View of hand-powered capstan on the east side of the dock at the seaward end. This is one of two surviving *in-situ* hand-powered capstans.

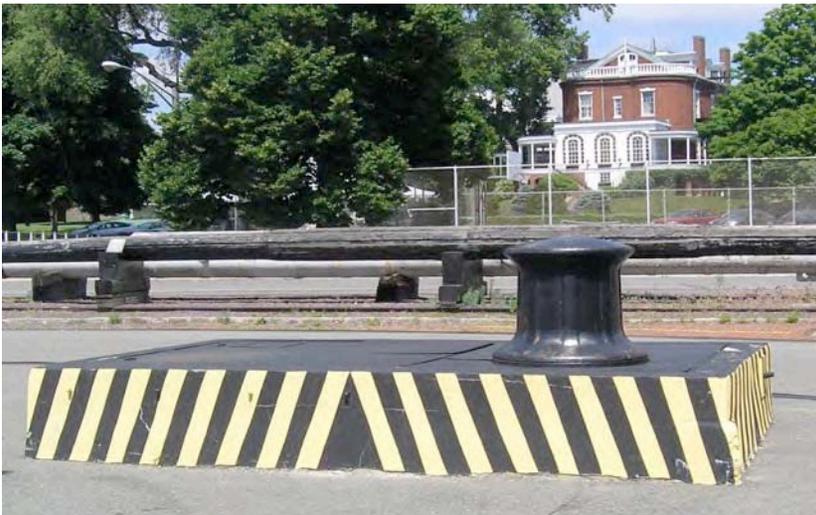
Fig. 2 View of Capstan 2 at the head of dock. This is one of three electric-powered capstans dating from 1942.

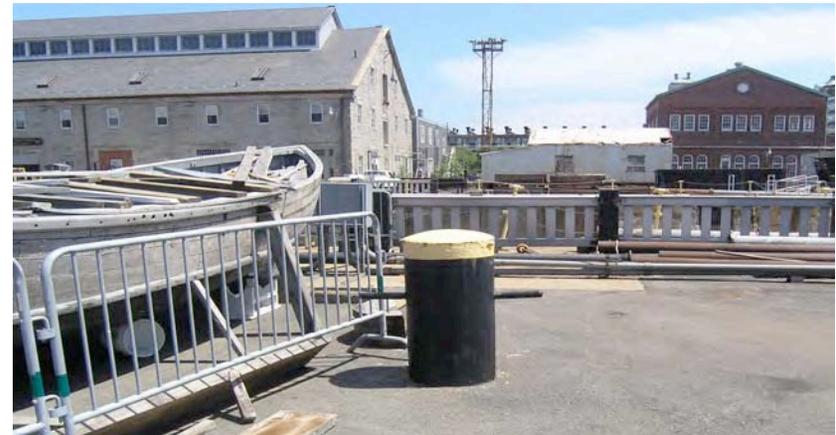
Fig. 3 View of Bollard near the seaward end.

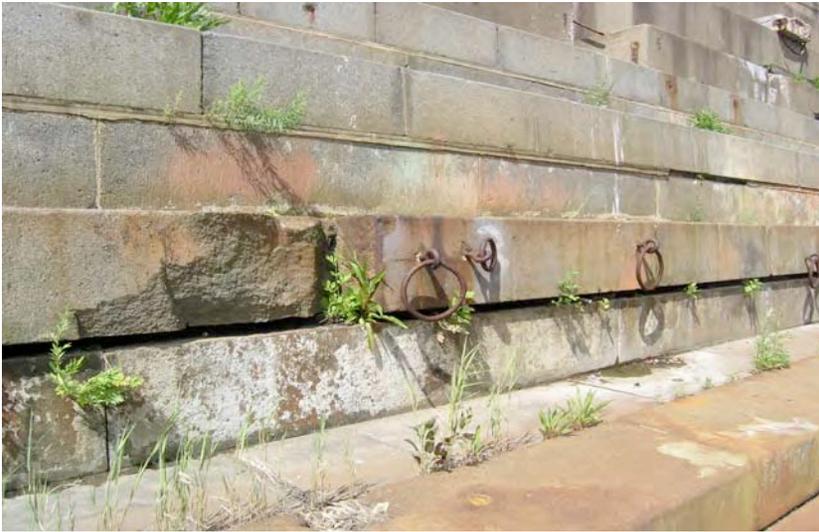
Fig. 4 Detail of iron rings along west wall of dry dock

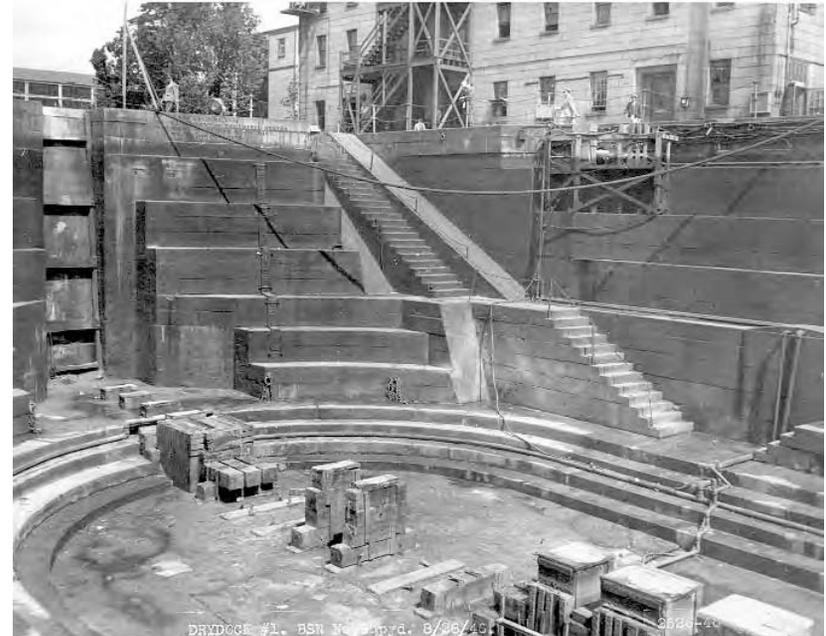
character of the head of dock. The smooth horizontal lines and curvature of the granite blocks gave way to an incised vertical appearance of rough granite edges and exposed concrete at the head of the dock (**B13**). The modifications are shown in a drawing (**C25**), which documents the major changes to the head of dock.

(B13) View in 1946 showing the opening where the center slide formerly stood and the cuts made to the altars on either side of the slide. At the center slide, the spaces between the remaining granite blocks (which formed the backing) were later infilled with brick and the blocks, except for the lower one, were covered with concrete.

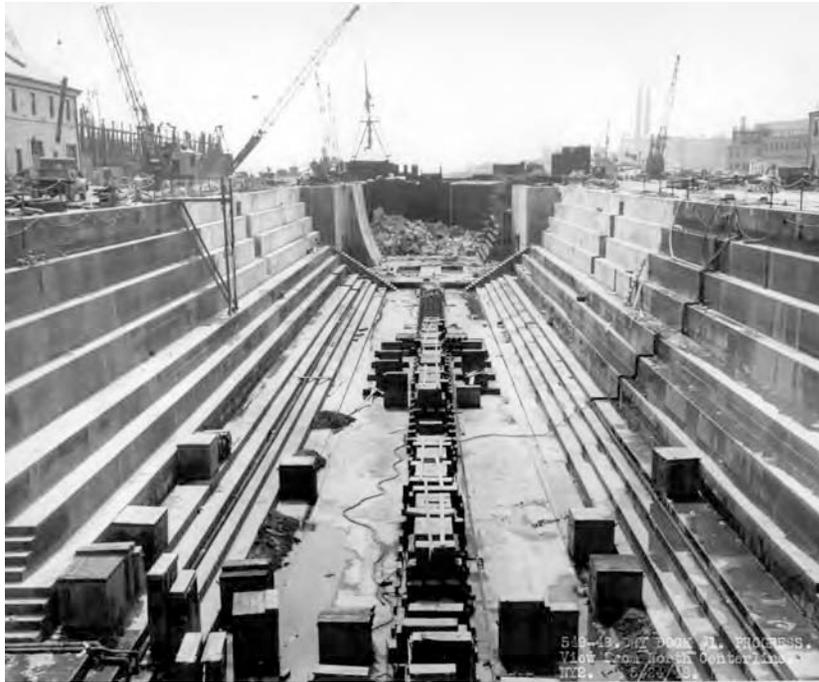
(B22) View in 1948 of seaward extension, looking south. Note that the new concrete altars conformed to the dimensions of the original granite altars.

The quarterly inspection of the dry dock during March 1947 revealed that the side walls had bulged inward at the stairwells in the center of the dock. Blocks on the west wall between the fourth altar and coping had moved as much as 4 inches out of alignment. Somewhat less movement was noted on the east wall. At this time the need for a larger docking facility was manifest and a second extension of the dry dock was planned.

This replacement encompassed the upper four altars below the coping level and extended nearly half of the dock's length. Below Altar No. 4 grouting was pumped under pressure to consolidate the rubble masonry. Additional work included the partial removal of the granite miter sill of the floor and its replacement with a 6-inch concrete floor liner. The dimensions of the new concrete altars were identical to those of the original granite altars (see **B22**).

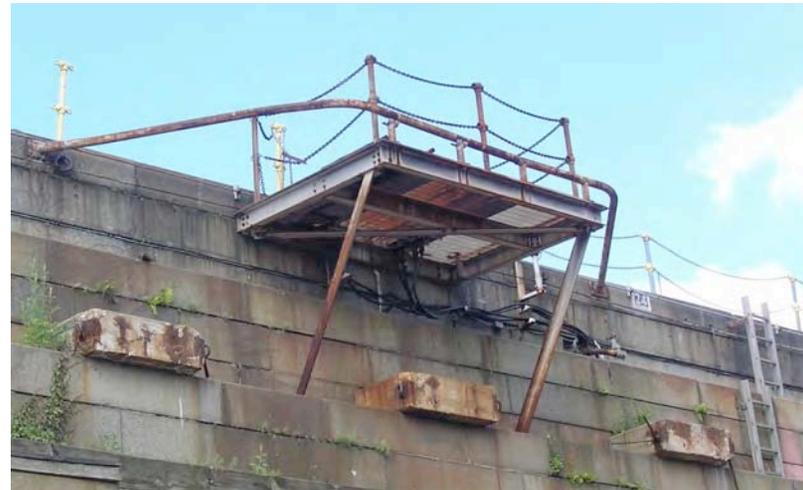
Fig. 5 View of steel platform on west side of the dry dock.

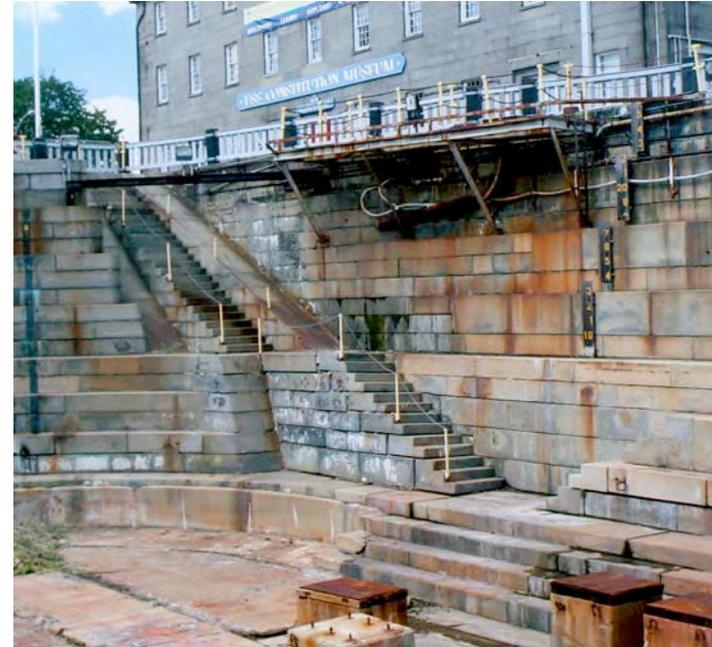
Fig. 6 A nearly identical view of the stairs and platform on the east side at the head of the dock. Note the addition of steel brackets, supporting electrical cable lines, and utilities that run along the east side of the dock.

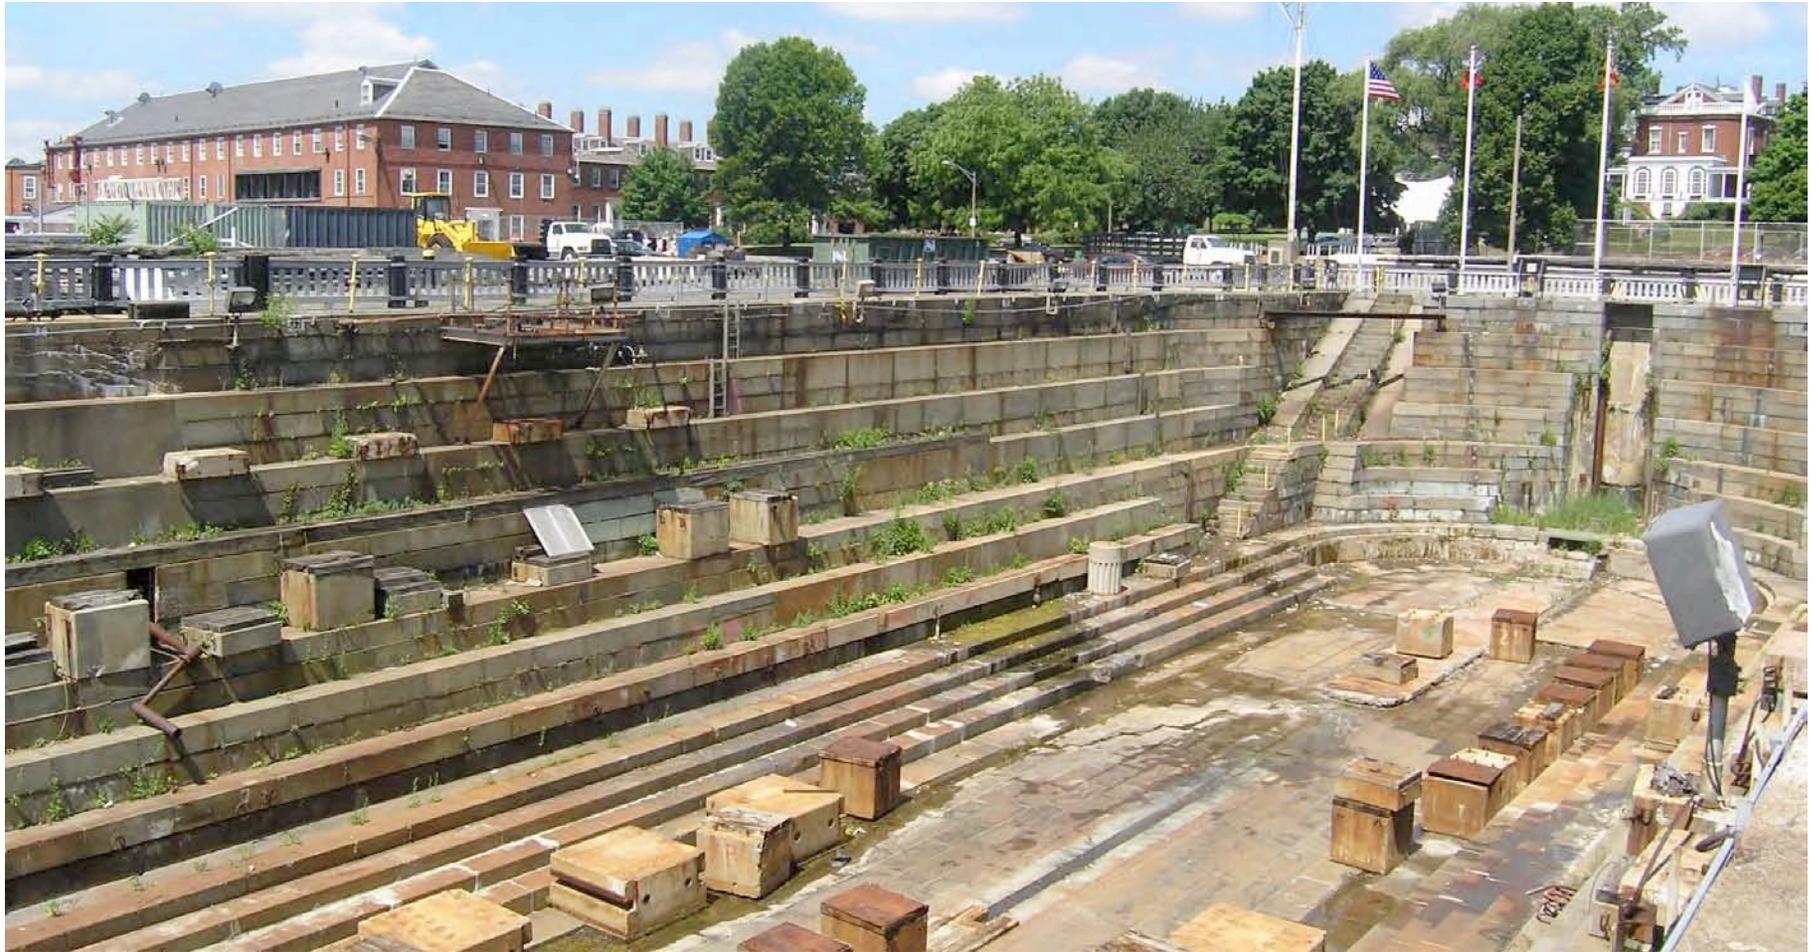
The infill for the new 65-foot section of the chamber was constructed with Cape Ann granite with blocks almost twice the height of the original blocks. The original and mid-19th century sections are distinctive, clearly identifiable features of the dock (**Fig. 9**).

Fig. 9 View looking northwest toward the head of dock. Along the west side of the chamber, from left to right, may be seen the three major construction periods of Dry Dock I. At left are the concrete altars from 1947-1948; adjoining these concrete altars are the original altars of Quincy granite; the large blocks to the right are composed of Cape Ann granite, used to construct the altars as part of the inland extension completed in 1860.

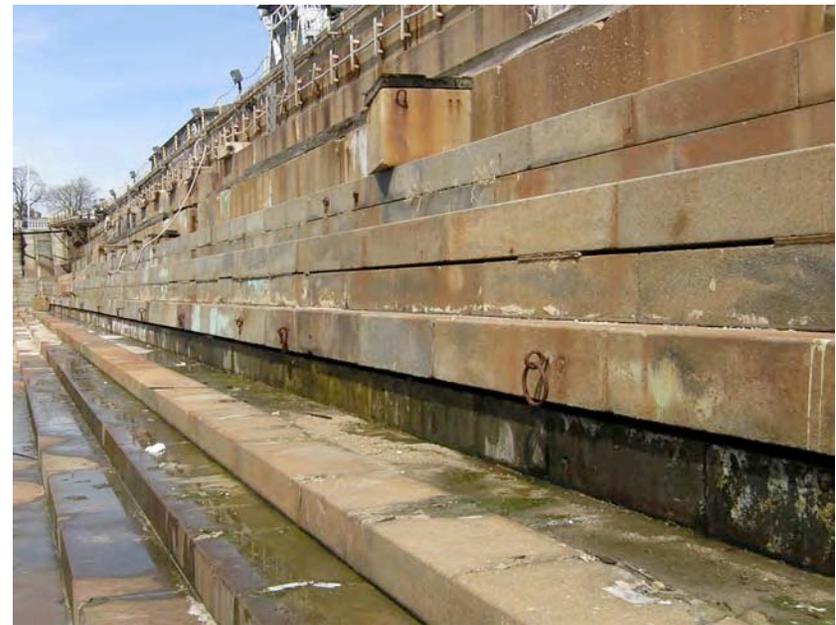
Fig. 12 View looking north showing the east side of the chamber. The lower altars and stairs of granite were retained, while the upper altars were replaced with reinforced concrete nearly half the length of the dock.

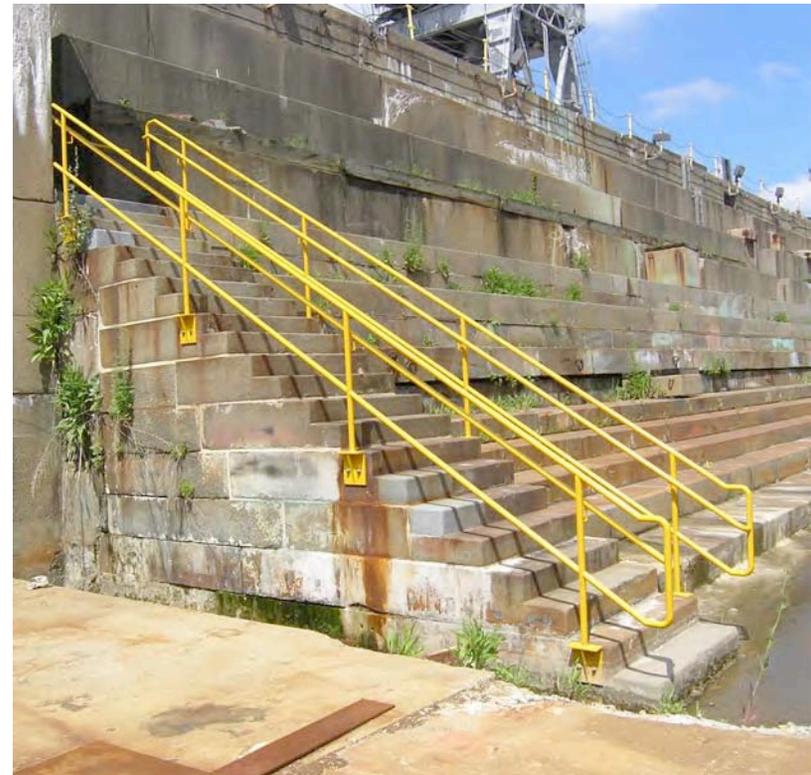
Fig. 14 Lower flight of Stair 2, on west side near the seaward extension. This original section of stair was preserved as part of the 2004 repairs of Dry Dock 1.

By 2000, the concrete of Stairs 1 and 2 was seriously deteriorated and four years later these two stairways were rehabilitated to provide OSHA compliant and safe access to all levels of the dock. This work included replacement of all deteriorated concrete steps. The lower flight of Stair 2 was retained with the stonework reset and repaired, and all mortar joints cleaned and repointed. New railings and security gates were installed for Stairs 1 and 2.

A number of the surviving granite stairs have steel post and chain railings, which are in very poor condition and do not meet OSHA standards. Granite blocks that have moved need to be reset to uniform treads and risers, all joints require re-grouting and repointing, and railings need to be code compliant.

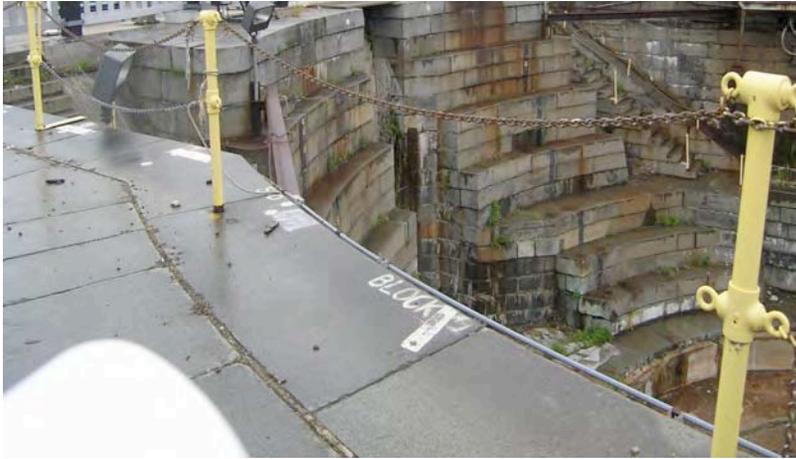
On the west side the original granite coping is generally in good condition (see **Fig. 18**) and, with the exception of some

Fig. 18 Detail of coping on the west side near the head of the dock, where the original granite remains in place.

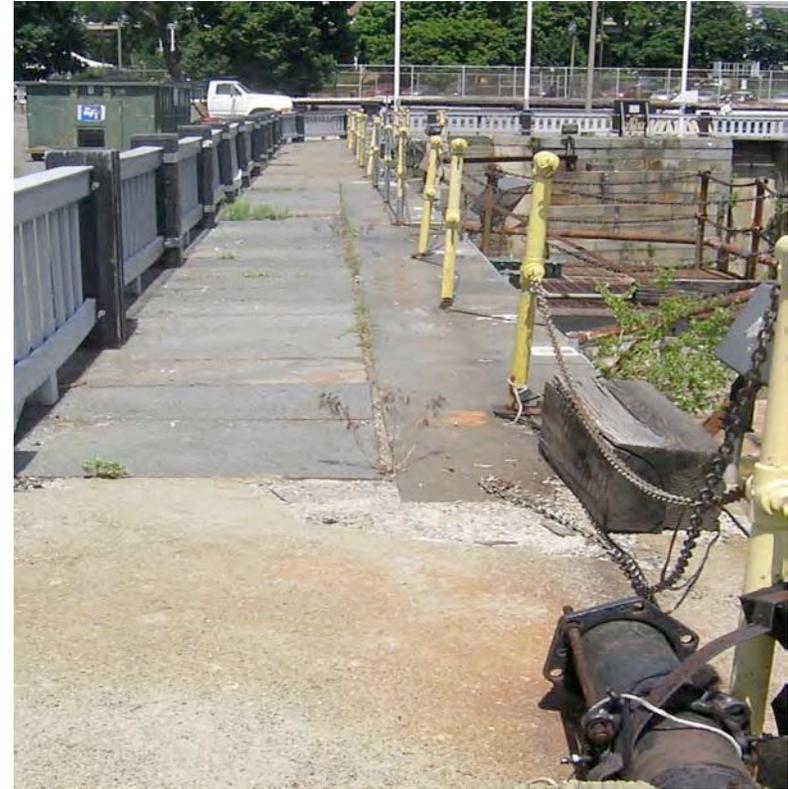
coping has been patched more extensively with concrete or asphalt. Similarly the granite coping at the middle sections of the dock on the east and west sides is largely intact with some concrete patching. The concrete slab that was poured at the coping level as part of the seaward extension is in fair condition.

Fig. 19 View looking north, along west side of dock showing the coping from three different time periods. In the foreground is concrete slab (late 1940s); abutting the concrete is granite (from the late 1850s); and beyond, around the head of the dock, is the original granite coping.

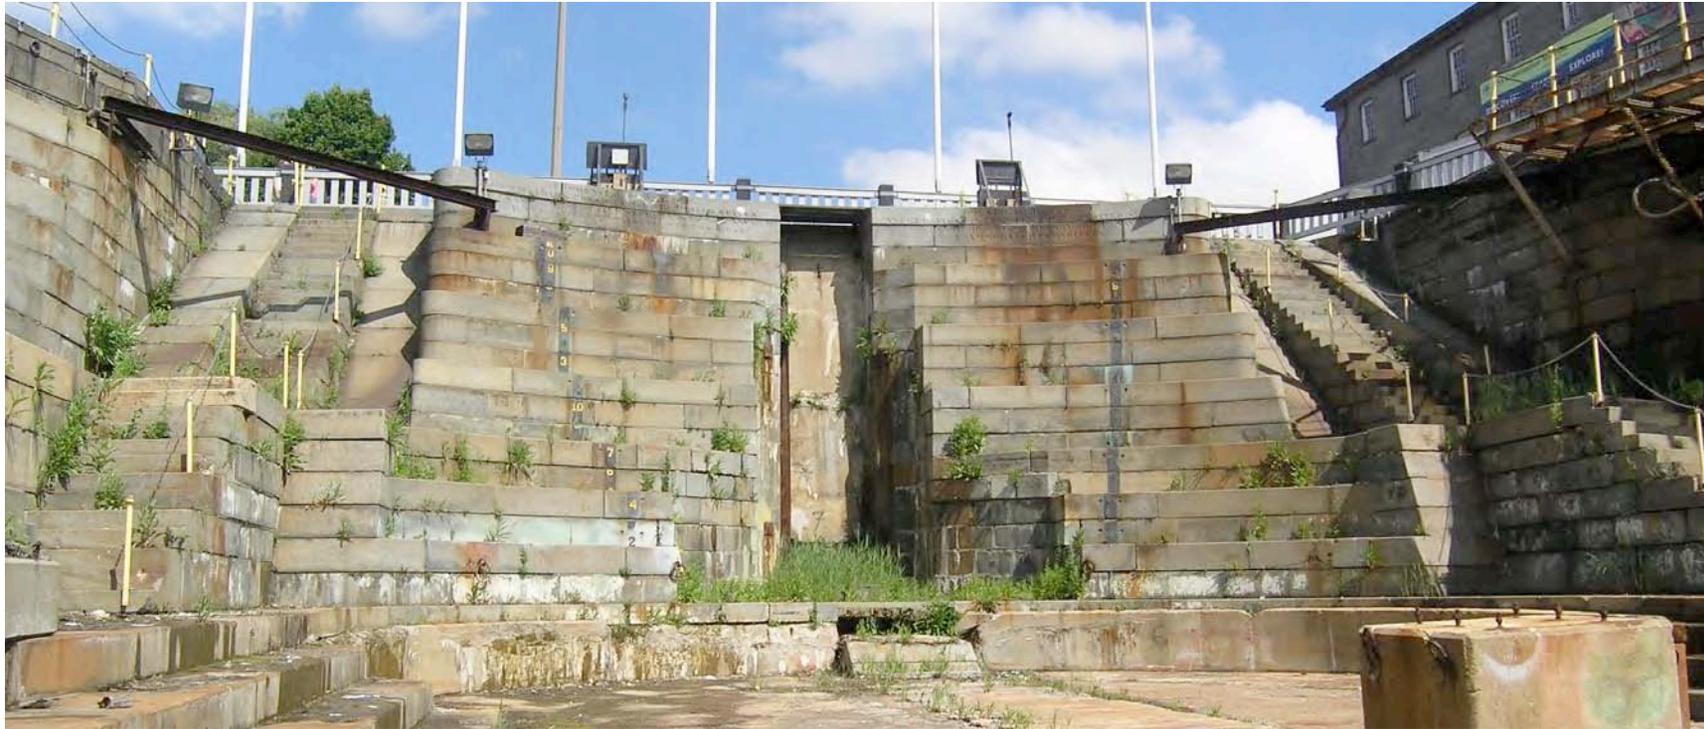
Fig. 20 View of head of dock showing alterations to center slide and lower stairs to the dry dock floor.

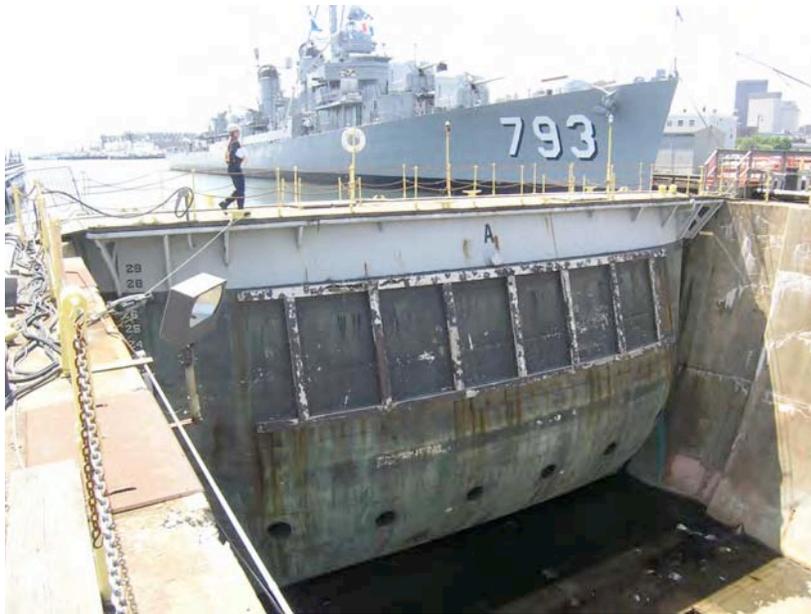
The caisson is currently flooded and seated with the “A” dryside facing the chamber and the “B” wet side facing the harbor. It has been in this position since 1996 when SS *Nobska* was drydocked. The main level (machining deck) was in fairly good condition and very little active corrosion was found on the gate’s interior.

Fig. 22 View of the steel caisson, looking south.

Some rust was evident in isolated locations at floor-to-wall connections but overall the paint coating was clean. The heaviest corrosion was isolated in the southwest corner of the machinery deck where leakage through some rivet holes collected on the floor. Lower levels of the gate were not inspected since it was flooded. The seals (seat) of the caisson appear to be largely watertight; however, when the caisson is overhauled the structural elements that constitute the seat, as well as the gaskets that prevent leakage, should be thoroughly inspected and repaired as required.

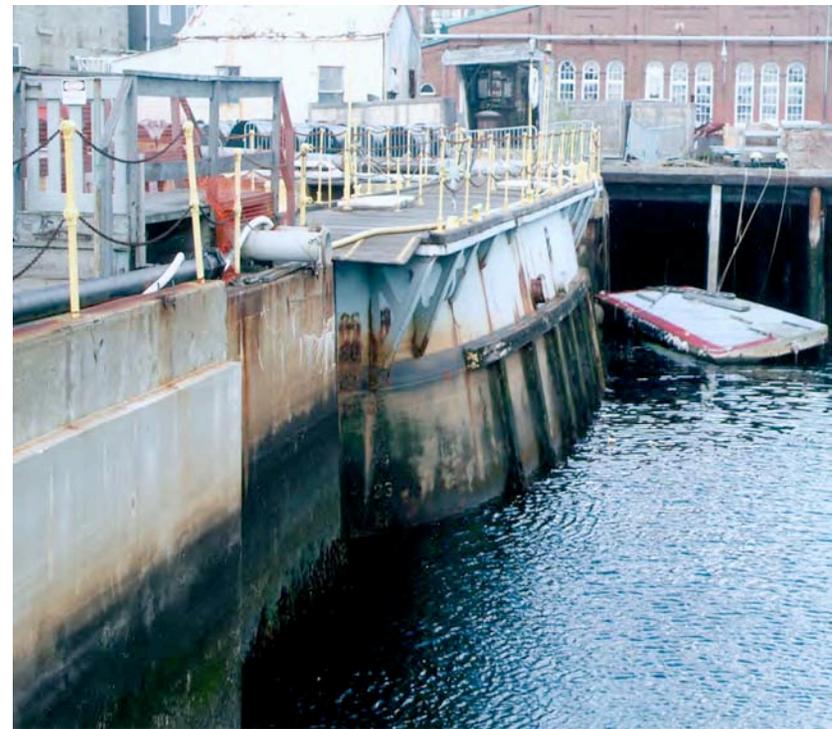
Fig. 23 View of the steel caisson on the seaward side.

were taken of the hull plating and compared with the original thicknesses which revealed that several areas of both sides have a greater than 25% reduction. In general, the entire lower half of the wet side exhibits corrosion beyond the 25% threshold, which is the limiting criterion for dry dock certification by the U.S. Navy.⁸⁶ All sections of steel plating that are less than 75% thickness will require replacement or double plating. Mechanical equipment (including pumps and

valves), electrical equipment, seals, and wood decking should be repaired or replaced as necessary and the installation of a cathodic protection system is recommended.

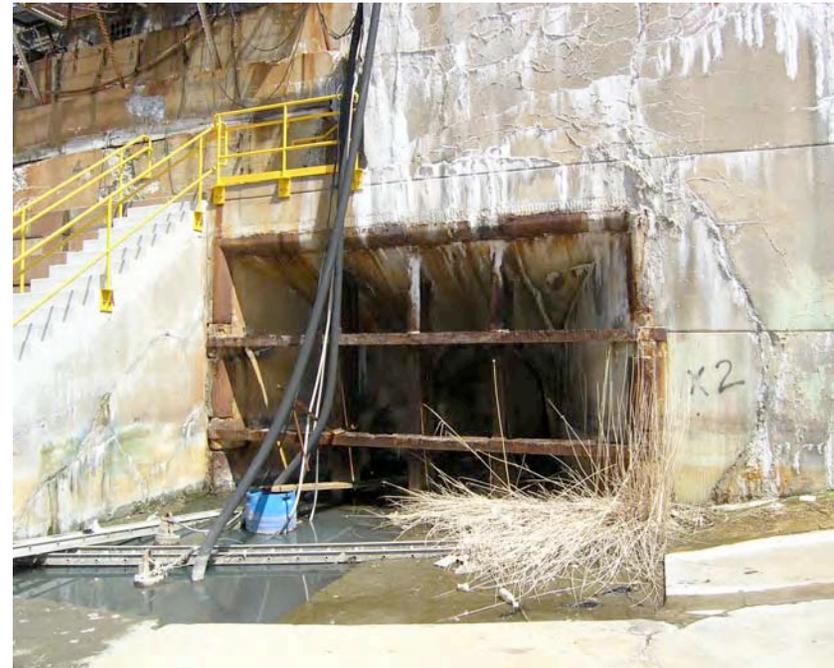
This large intake culvert represents the Navy’s last major construction effort of Dry Dock 1. Completed in 1960, it eliminated the older dewatering system of floor drains and smaller outlets in the chamber’s walls. As seen in **Fig. 27** the culvert contains a steel frame at its intake.

Fig. 27 Detail of tunnel intake and steel frame across its entrance.

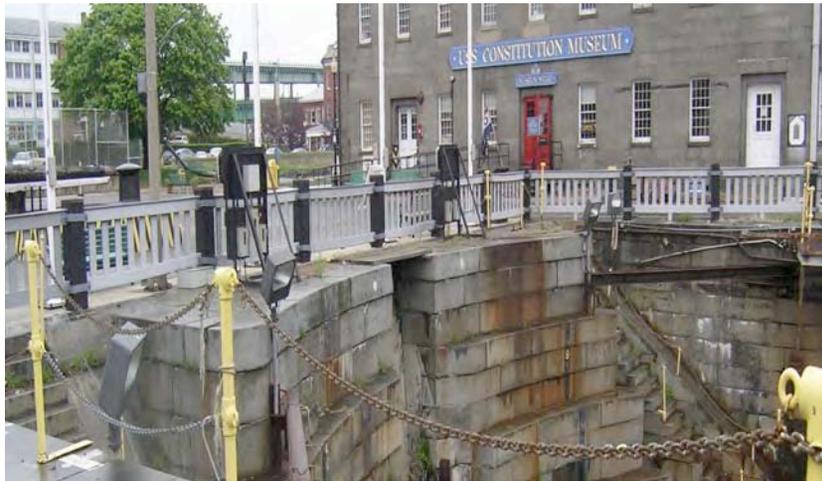
Fig. 28 View of safety fencing, with wood posts and composite railing, at head of dock, looking northeast. In the foreground is the older stanchion and chain fence, with the stanchions painted yellow.

This new safety fence/guardrail is made of a composite plastic material (from recycled materials) and attached to wooden posts with metal brackets. Although in fair condition, the composite railings are beginning to sag from their own weight and the long-term durability of this fence/guardrail is questionable.

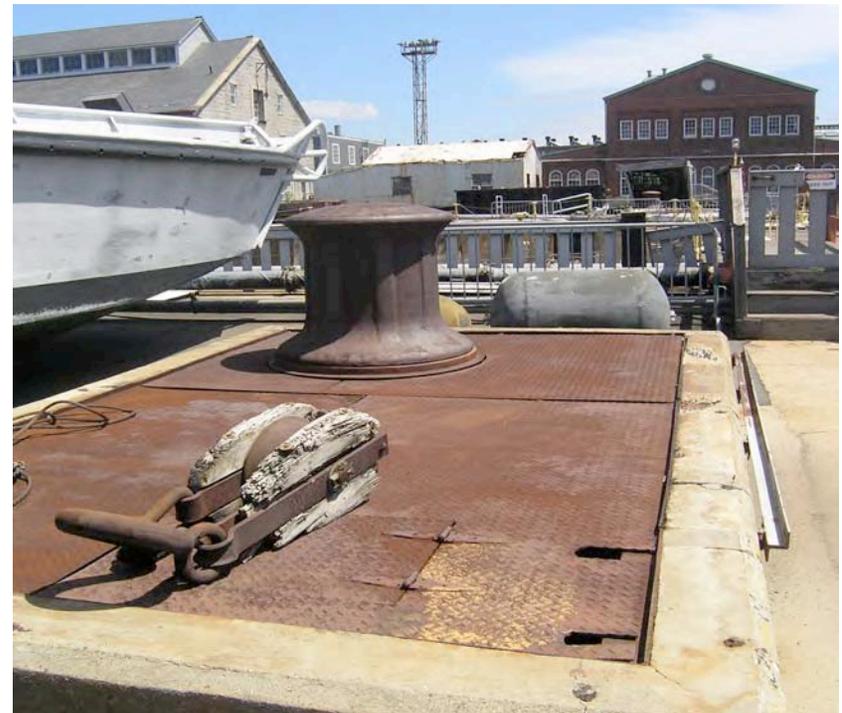
Fig. 29 One of three electric-powered capstans; this one is on the on west side of the dock at the seaward end.

As part of the 1947-1948 seaward extension, two of the electric-powered capstans (No. 1 and No. 3) were relocated to the south. These two capstans are severely corroded and in need of repair. The steel plates that span the reinforced concrete capstan pits are severely deteriorated and in need of replacement. The concrete pits, however, are in good condition.

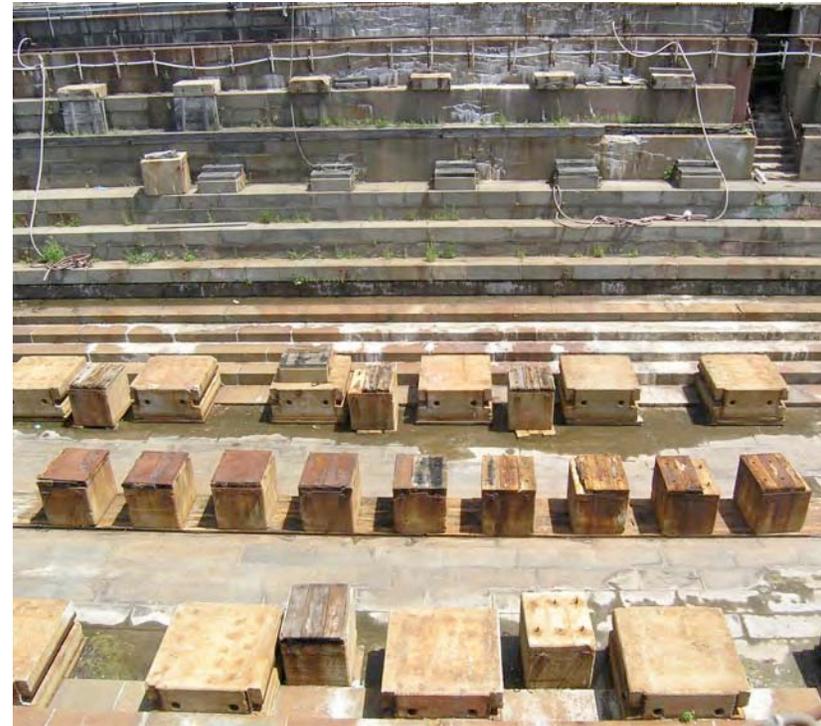
Although the concrete of most of the keel blocks is in good condition, about 15 blocks exhibit cracking and spalling of concrete. Most of the steel U-bolts, which are embedded in the concrete and permit the moving of the blocks, are missing or severely corroded. This deteriorated condition of these U-bolts substantially limits the use of the keel blocks. Moreover, a number of the keel blocks contain rotten timber blocking attached with steel tie downs.

Fig. 31 View of concrete keel blocks showing the three different types of blocks.

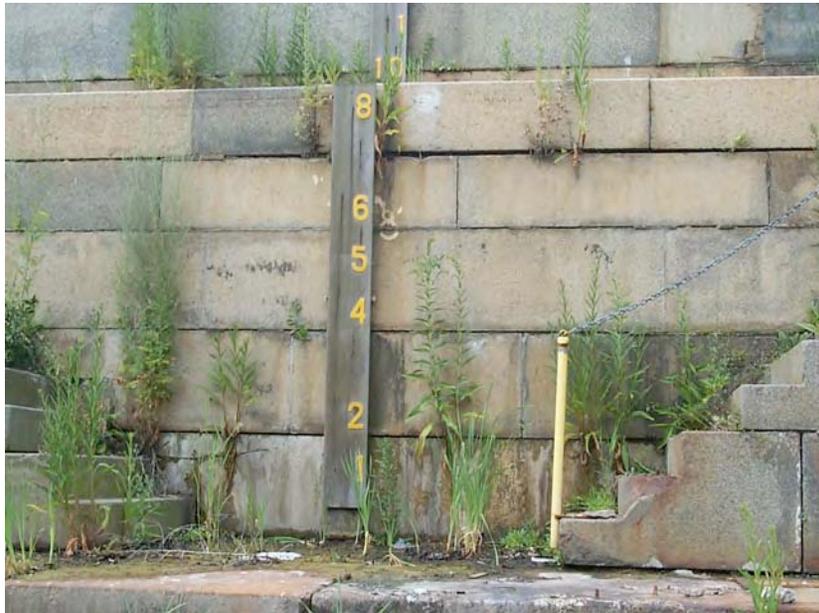
Fig. 32 Detail of draft gauge [file Dry Dock 8/10/05; #6612]

extension. All of the gauges are in deteriorated condition with many faded or missing numbers.

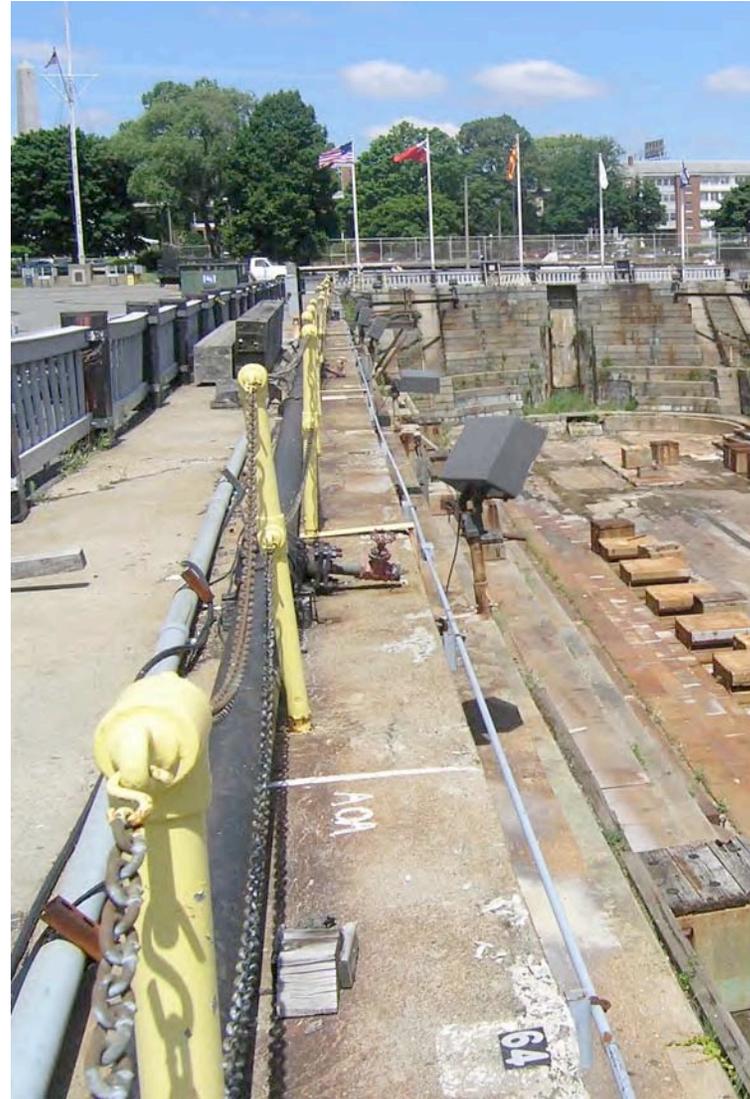
Most of the older utility lines are located along the east side of the dock at or near the coping level. A series of steel brackets, numbering approximately 65 and attached to the uppermost altar, extend along the east side of the chamber. These appear to have carried electrical cables and about a half dozen of these brackets are severely rusted.

Fig. 34 View of pipes, electric cable, and floodlights along the west side of the dock.
