Cape Lookout Village Cultural Landscape Report

Cape Lookout National Seashore
Carteret County, North Carolina

9 May 2005

Cultural Landscape Report

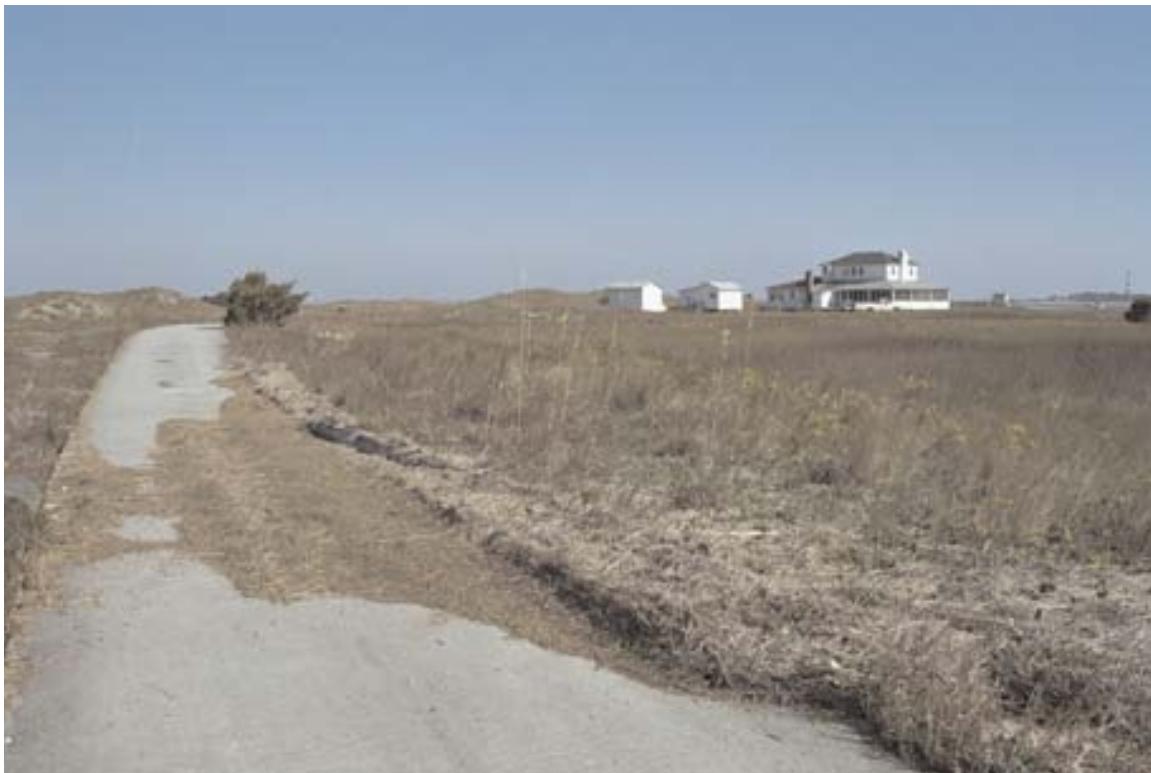
Figure 3-59. Another view of the Concrete Road looking towards Casablanca. Stormwater has deposited rack across the road surface.

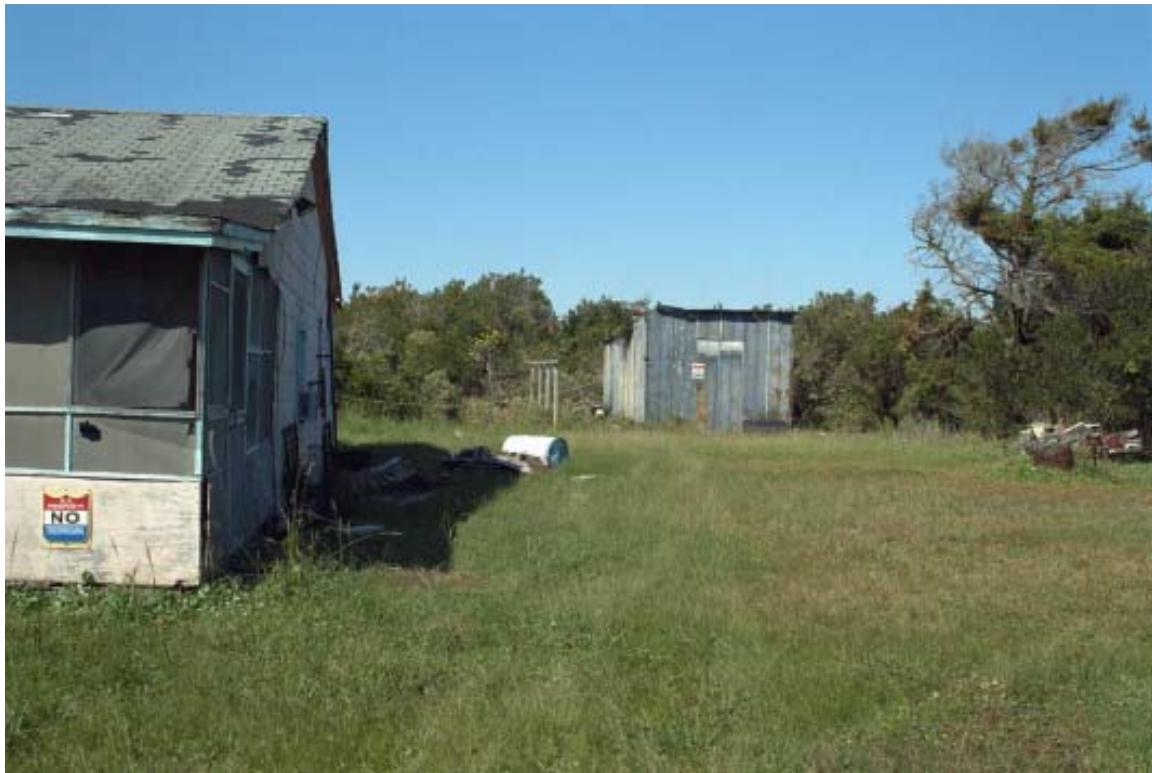
The Lewis-Davis house (Figure 3-95) lies closest to the former Coast Guard Station. It was apparently created in the 1920s by reworking two relocated early 1900s fishing shacks into one house. The building is one story wood frame construction supported on round wooden piers. The walls are sided with cement-asbestos shingles painted pink. The peak of the gable roof is off center and is covered with asphalt shingles. There is an enclosed porch across the front of the house, and the original rear porch was enclosed as a small addition at the rear corner of the house. The Lewis-Davis house is very deteriorated due to water leakage. Behind the house stands a shed, clad with galvanized sheet metal (Figure 3-96).

Figure 3-95. The Carrie Arendell Davis (Lewis-Davis House) is significantly deteriorated.

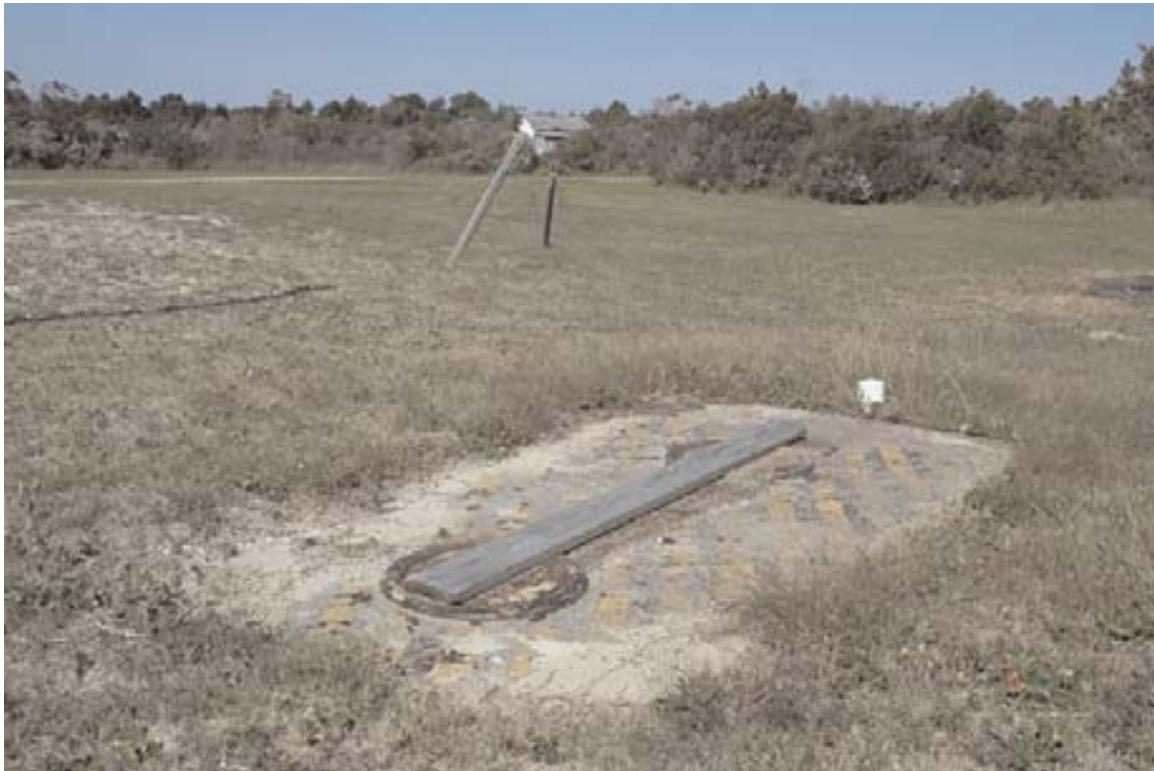
Figure 3-153. Water-related utility features include cistern or septic features associated with the concrete and metal manhole covers around the former Coast Guard Station.

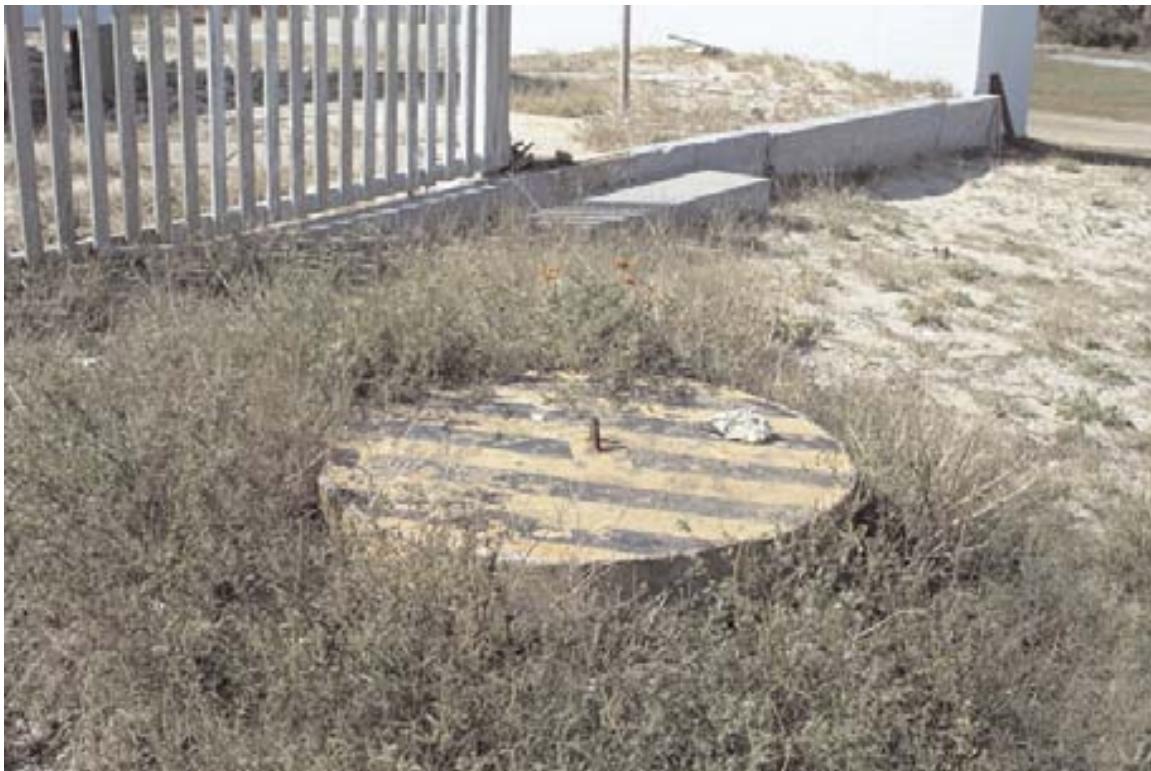
Figure 3-154. Water-related utility features include cisterns and septic systems features associated with the concrete and metal manhole covers around the Coast Guard Station.

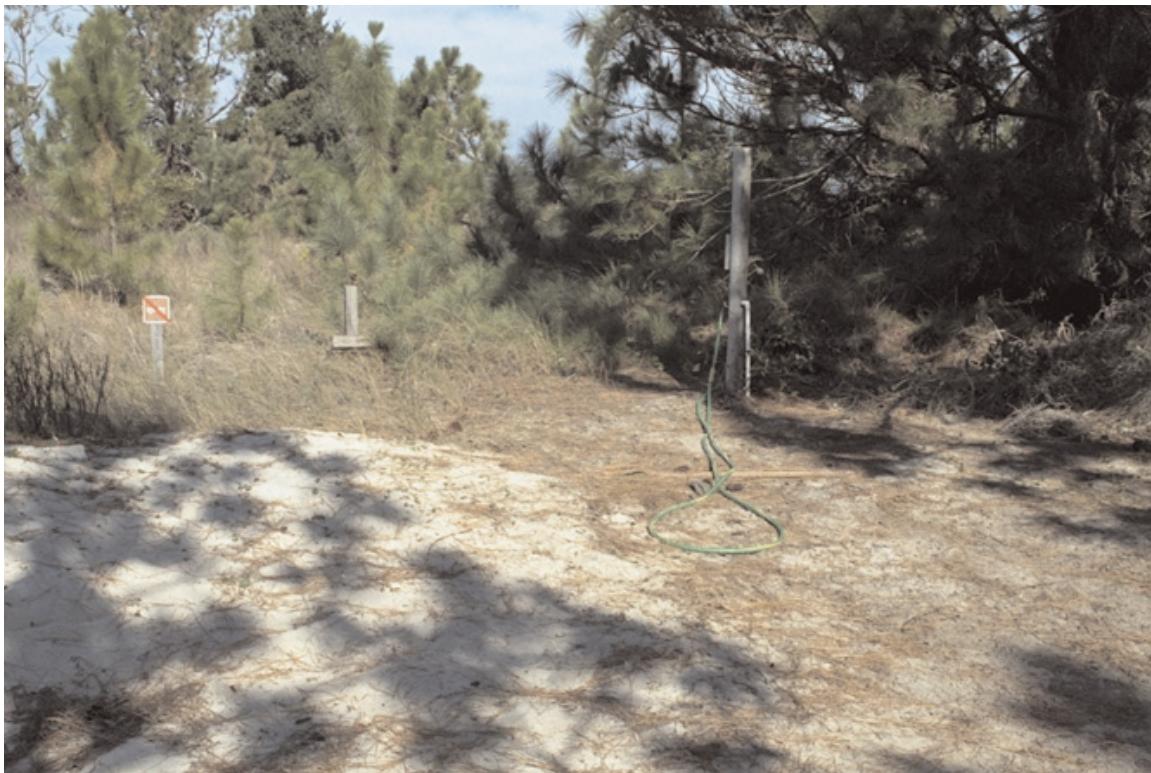
There is a water spigot and hose near the ATV shed (Figure 3-155) within the lighthouse precinct. Also near the lighthouse are a galvanized standing pipe and an exposed PVC pipe (Figure 3-156).

Figure 3-155. A water spigot and hose are located near the ATV shed within the lighthouse complex.

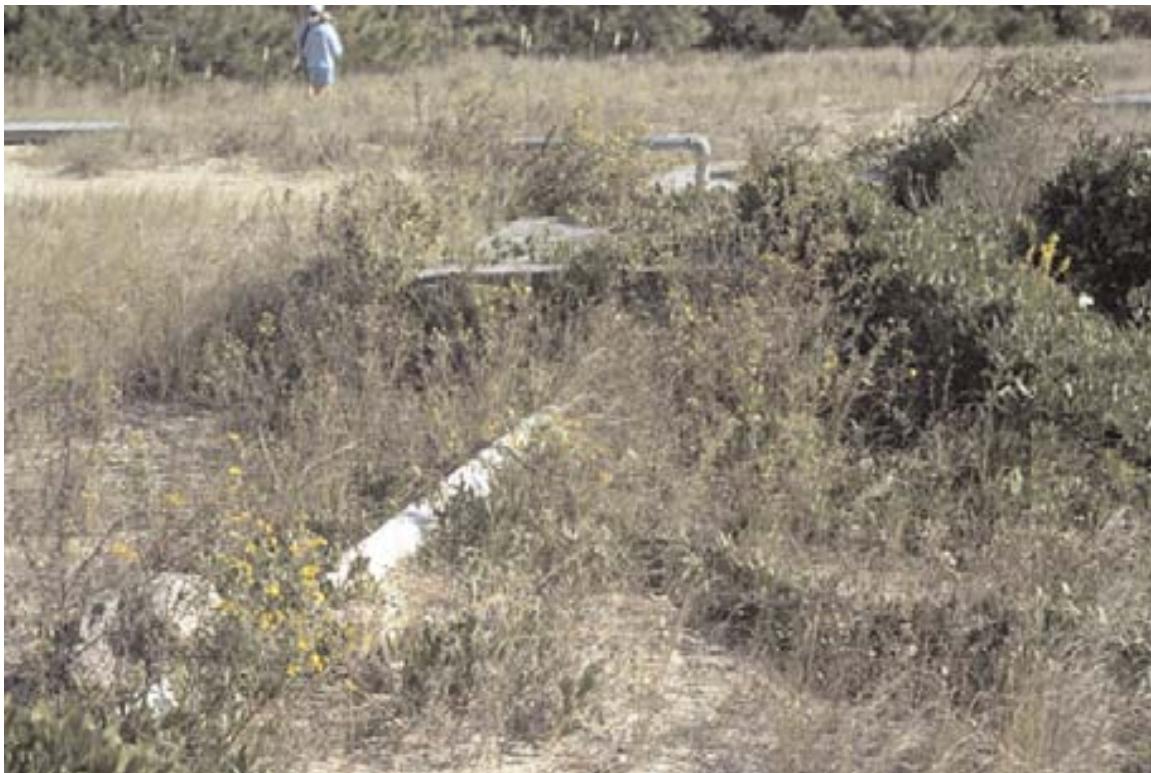
Figure 3-156. Other utility features include a galvanized standing pipe and exposed PVC pipe near the lighthouse.

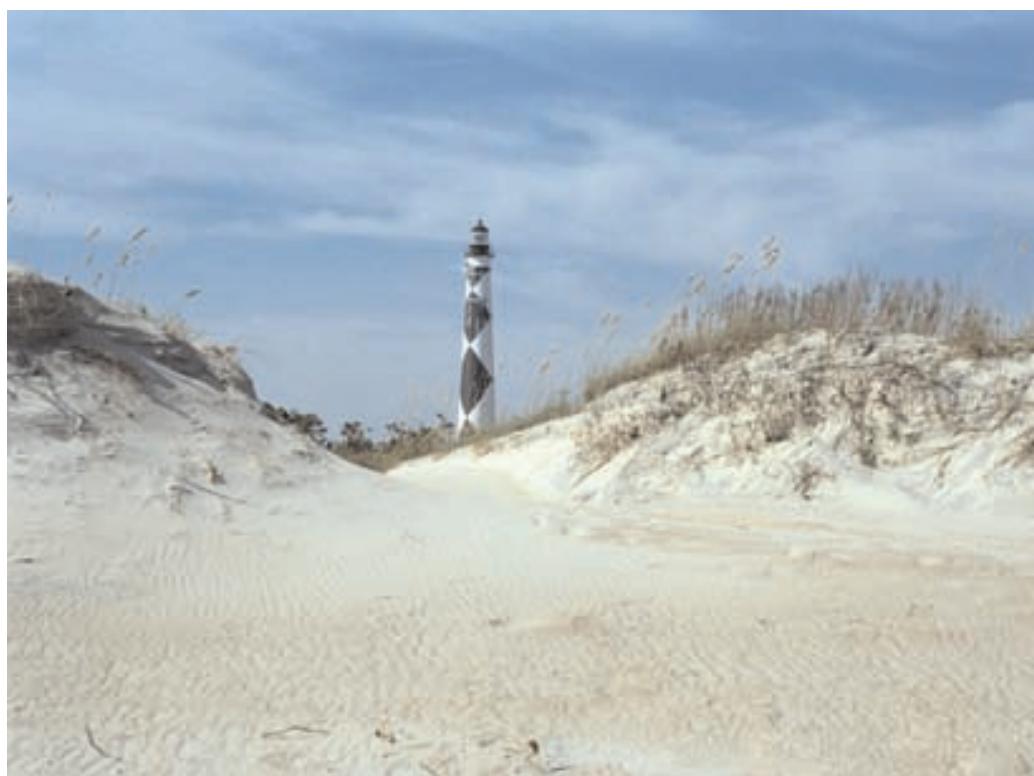
The same view in 2003. Note the change in dune structure obscuring the view to the keeper's dwelling.

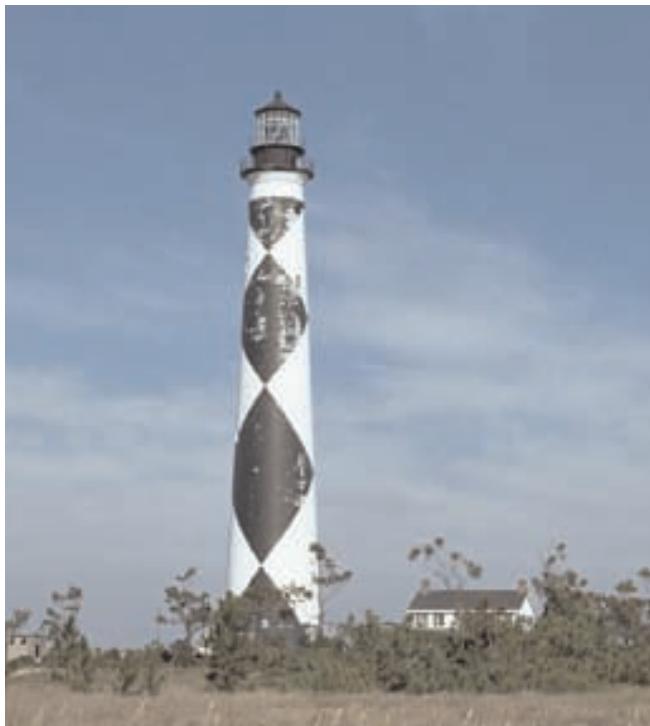
The same view in 2003. Note that loblolly pines now ring the base of the lighthouse. While the 1873 keeper's dwelling is visible on the right, the 1907 keeper's dwelling behind the lighthouse and an outbuilding to its right are no longer in evidence. The fence line visible in the historic post card exists only as a few concrete posts today.

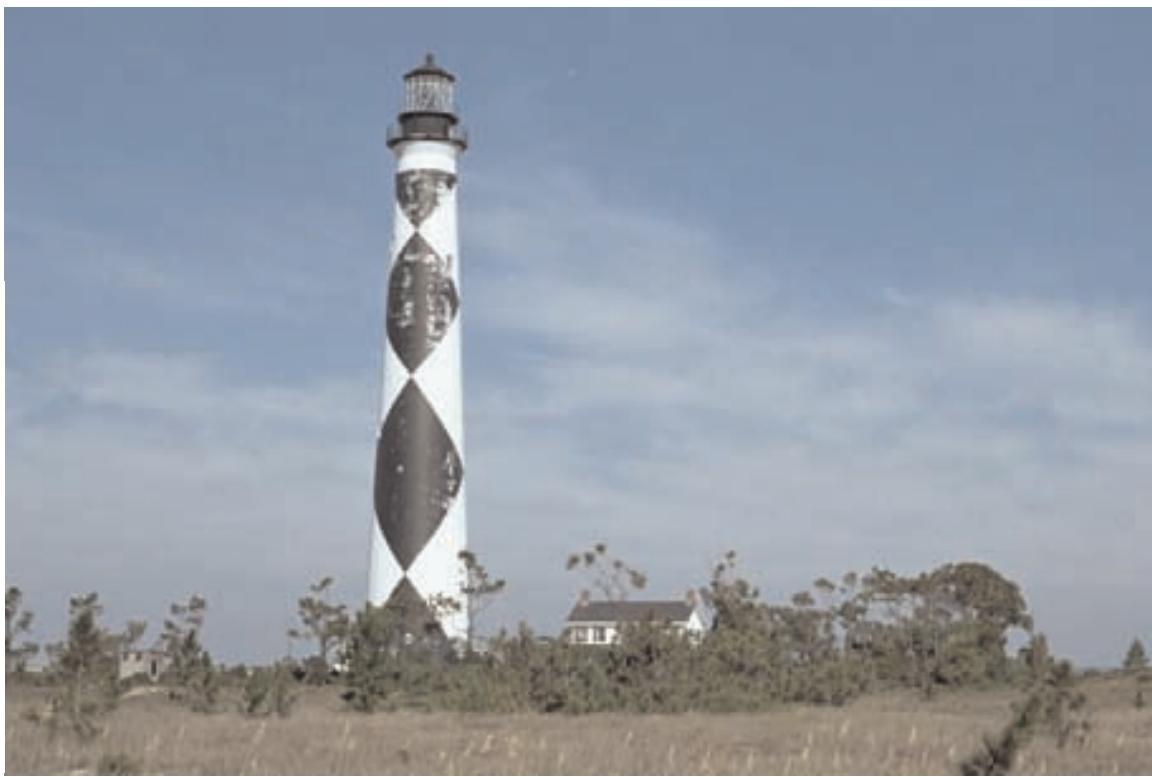
The same view in 2003. Note that the loblolly pine trees encircling the lighthouse have grown considerably, and the paint on the lighthouse is peeling. The utility pole on the left in the photo has been removed.

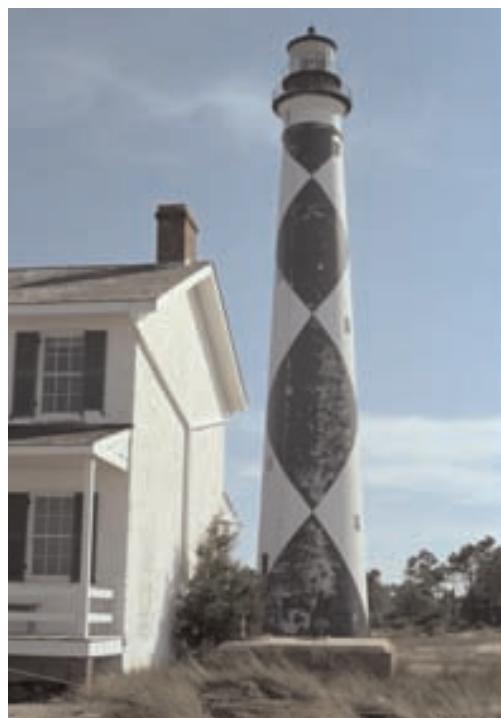
The same view, 2003. Note that the 1873 keeper's dwelling eaves have been extended, the downspouts replaced, shutters have been added, the shed removed, a side door bricked over, and the front porch has received a new railing. A concrete sidewalk has also been removed. The utility post is gone and the wooden stairs on the side of the lighthouse have been replaced.

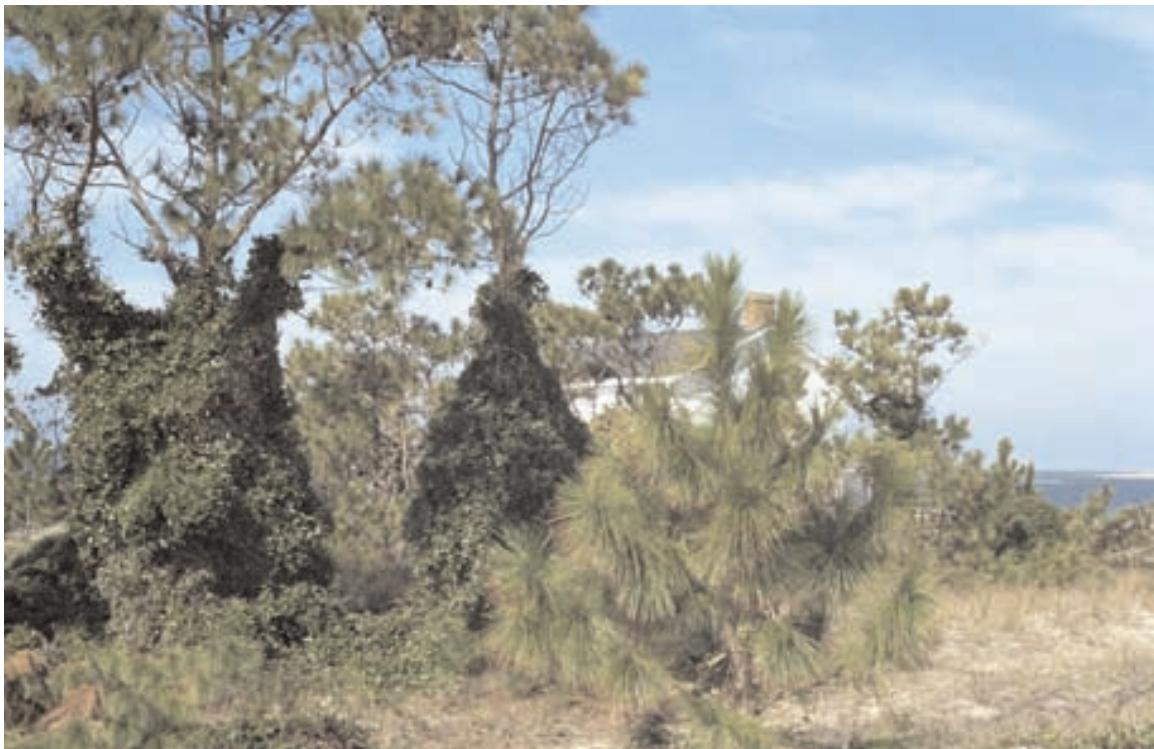
The same view in 2003. Although this view has become overgrown with pine trees and greenbriar vines, it is still obvious that many of the outbuildings seen above are no longer extant, and changes have been made to the roofline of the keeper's dwelling.

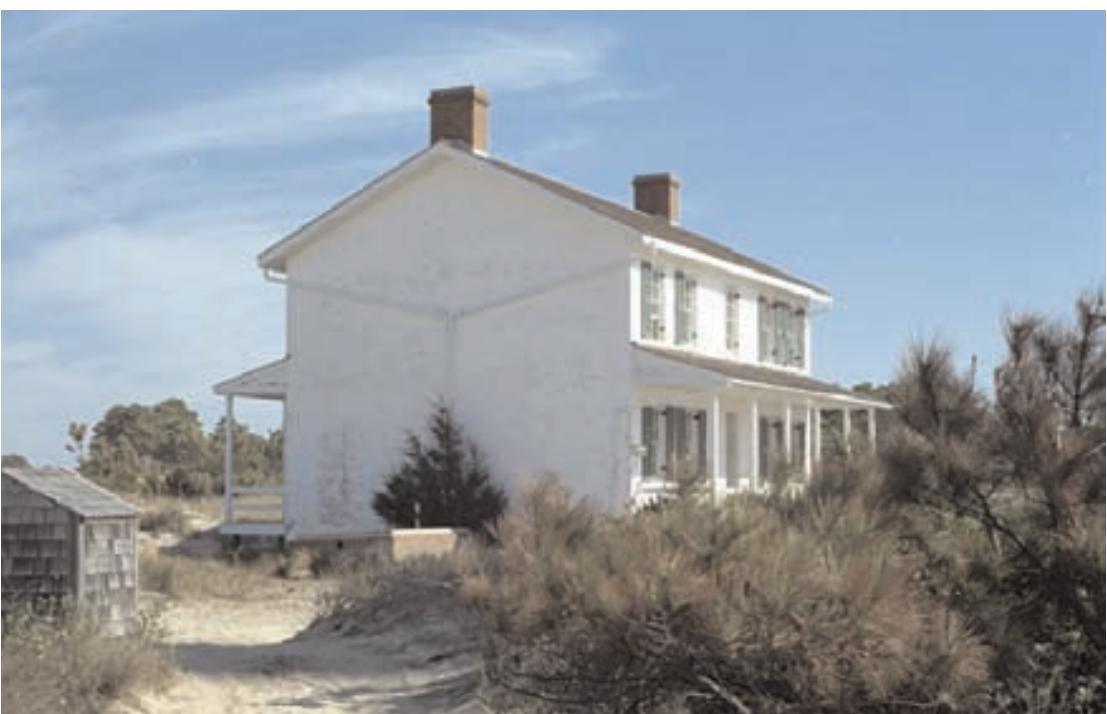
The same view in 2003, after the building has undergone renovation: a rear porch has been added, the front porch has received new railings, the eaves of the roof have been extended, shutters have been added, the downspouts replaced, the shed on side of building removed, and the door to the left of the shed has been bricked over. The concrete cistern, left in the photo, survives but is obscured from view by the shingled shed.

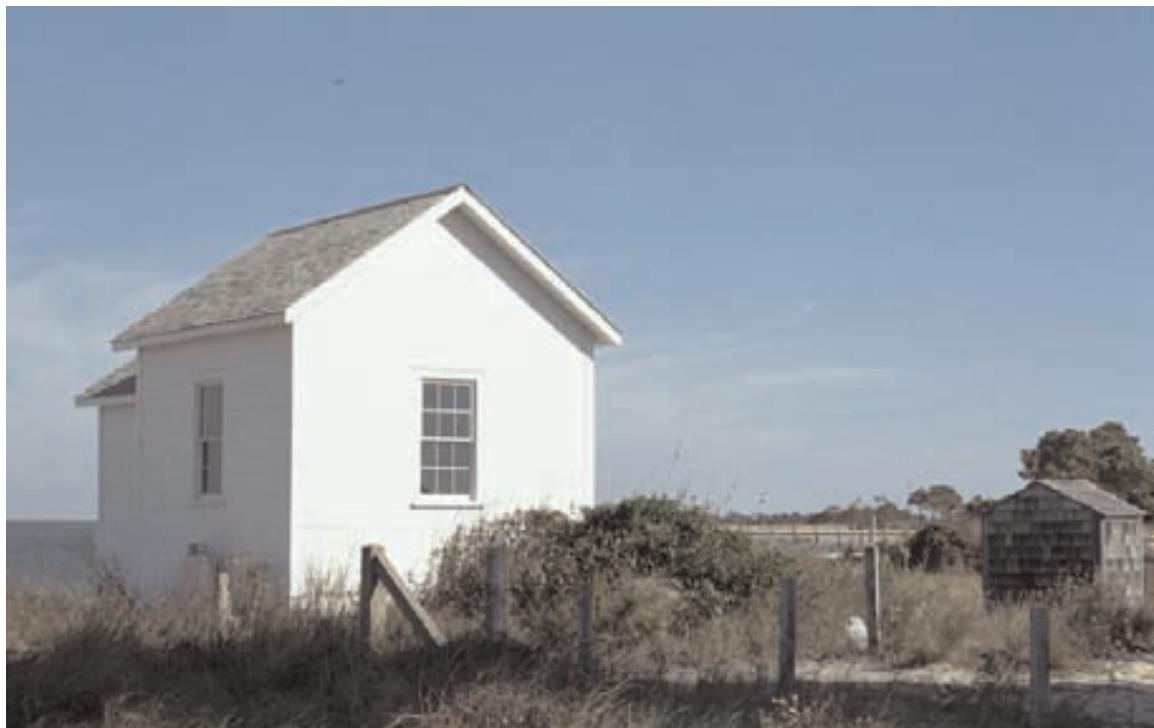
The same view, 2003. Note that the woodshed was lost to Hurricane Isabel in September 2003. The concrete cistern is blocked from view by vegetation, and a wooden shed has been added. The windows of the summer kitchen are unboarded and the chimney flue removed. The fence line has been extended.

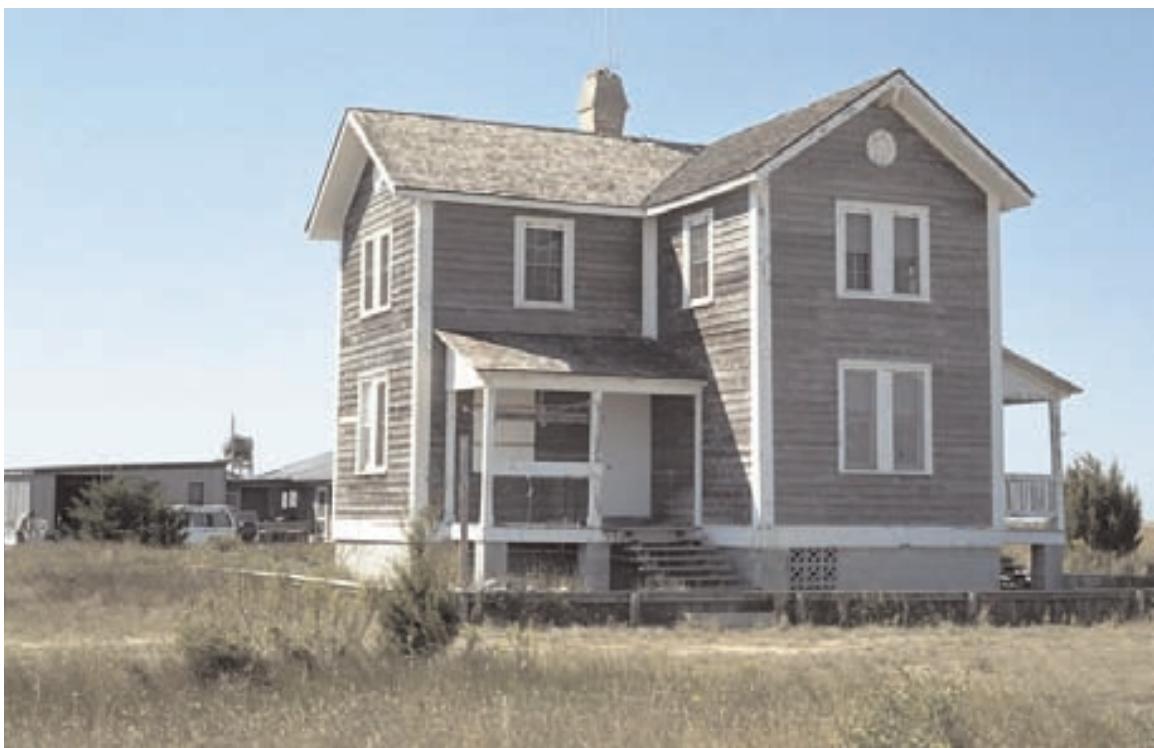
The same view in 2003. Note that a seawall edges the house and an antenna has been added atop the chimney.

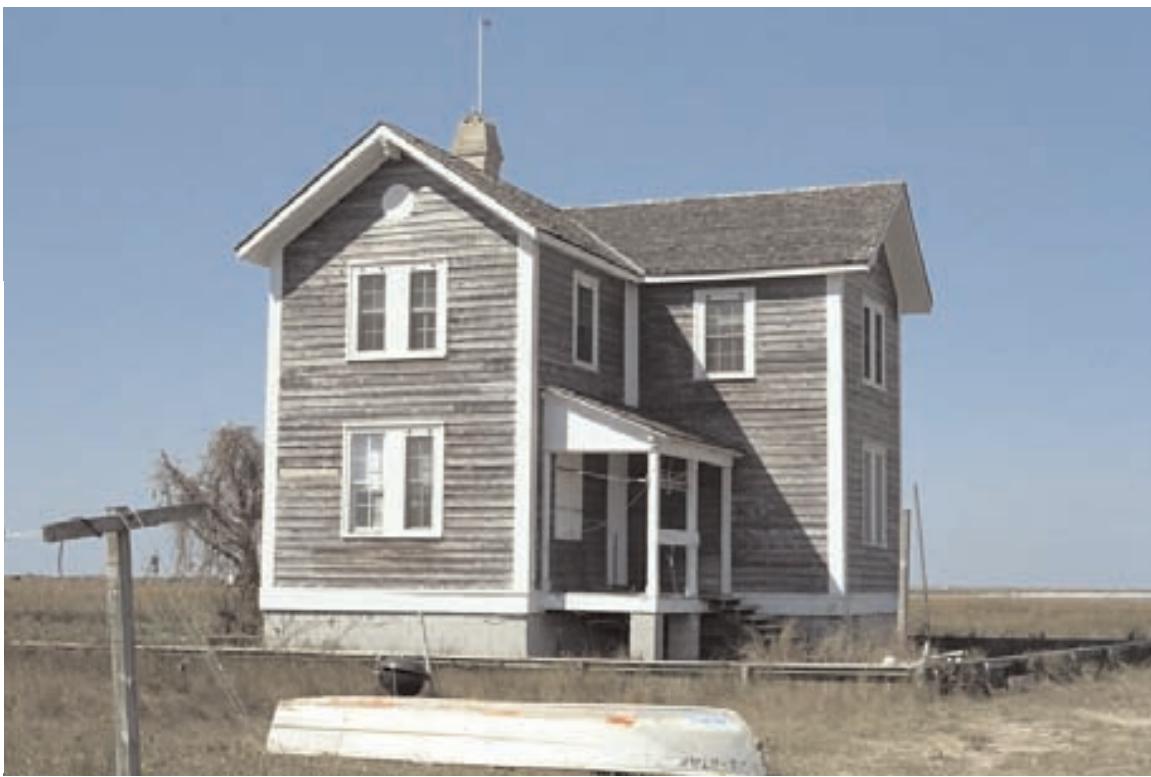
The same view today. Note the addition of a clothesline, a low seawall, and the replacement of the wooden steps leading onto the porch.

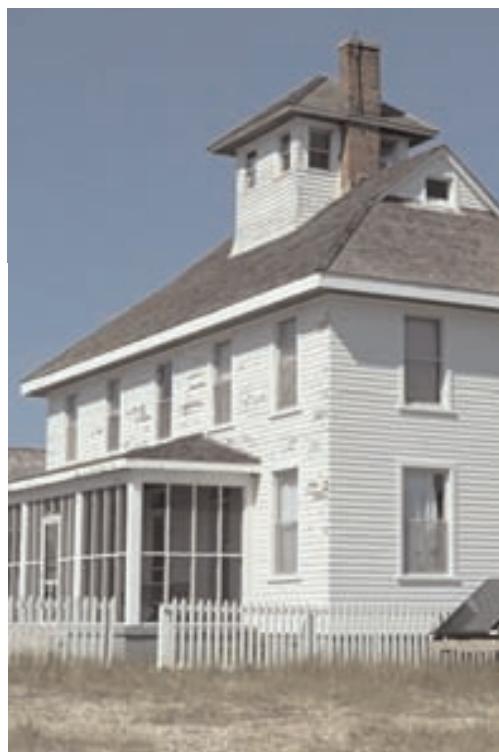
The same view in 2003. Note that the post and rail fencing has been replaced with a picket fence. The porch has been screened, a chimney removed from the far side of the cupola. The tall structure (radio tower?) in the left background is gone. There are now solar panels in the right foreground.

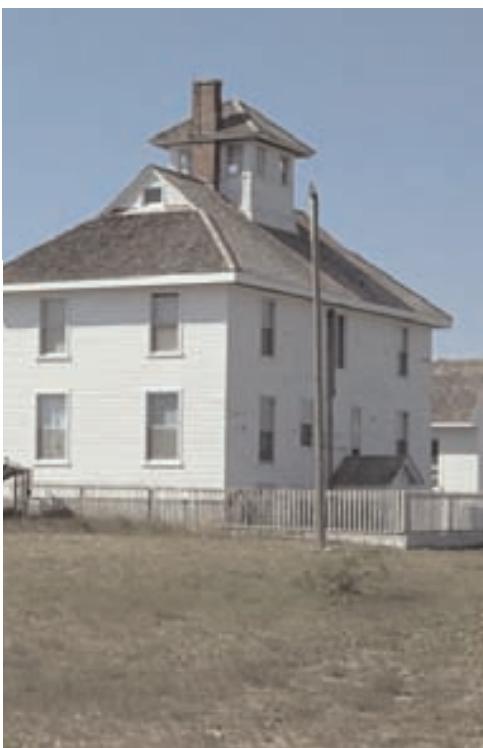
The same view in 2003. As noted previously, the post and rail fence has been replaced with a picket fence that wraps around the back of the building. The chimney on the back of the summer kitchen has been removed, as has the radio tower in the distance. A tall pole has been added outside the fence.

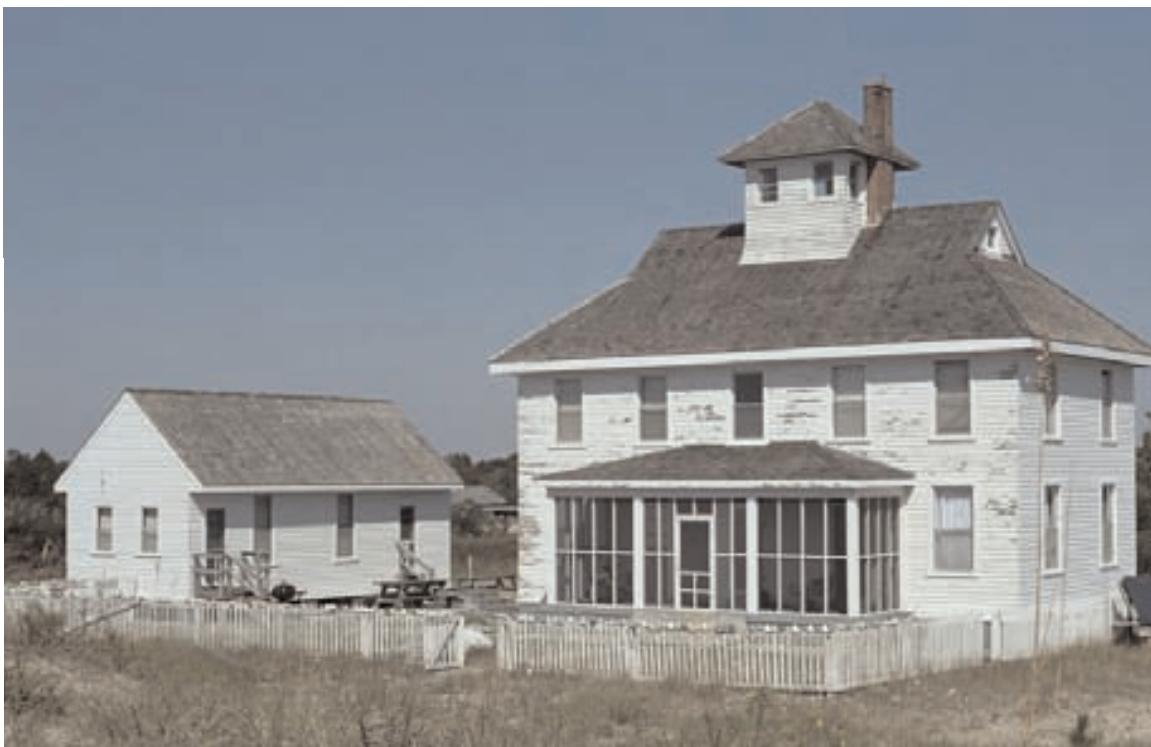
The same view in 2003. The antenna has been removed from the main building, and stair railings have been added to the entrances to the summer kitchen. Welk shells have been placed on top of the fence pickets. The flagpole is tilted down, no longer in use.
