CAPE LOOKOUT LIGHTHOUSE

Cape Lookout National Seashore
North Carolina

HISTORIC STRUCTURE REPORT

December, 2008

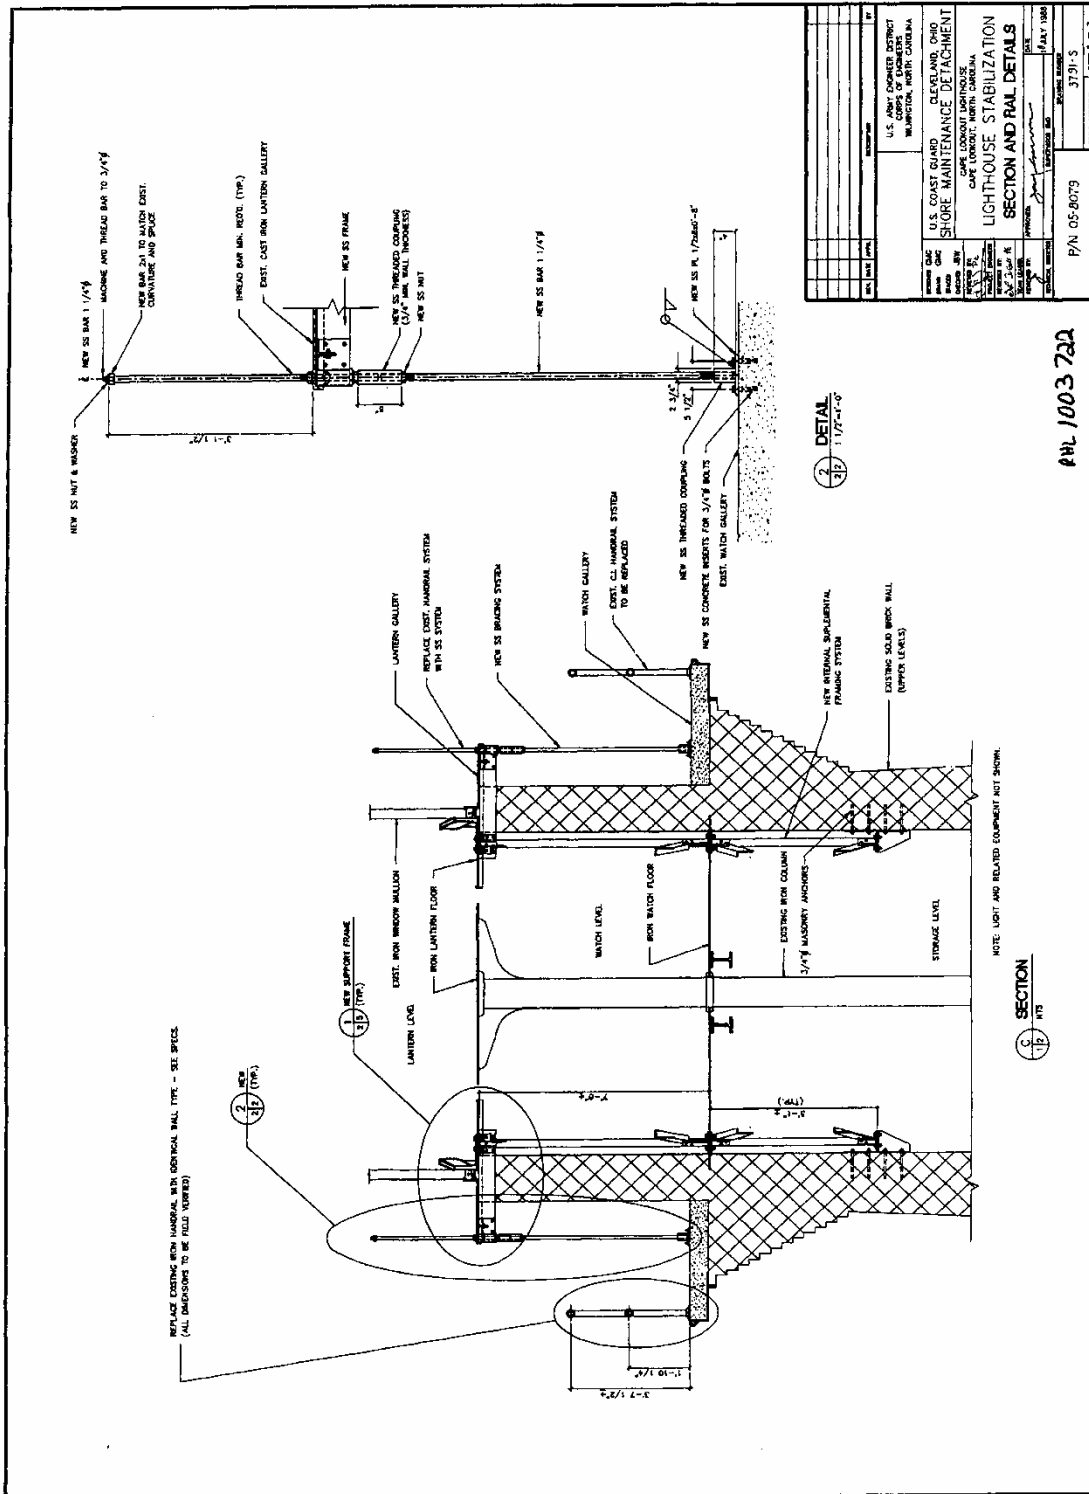
Figure B-16 1989 section of shoring of Gallery.

structure was from the generator area.”⁷⁷ Currently one of the pie-shaped metal plates has been slid aside and replaced with a steel plate, indicating the possible location of a connection between the two levels. The inspector also noted that the wiring was old and frayed and the fuse disconnects in poor condition. Further, the condition of the room housing the air-cooled generators was not ideal with poor ventilation and awkward 90-degree elbows in the exhaust piping. Little corrective action was taken, for these conditions were again recorded in an inspection conducted May 4, 1993. The May 15, 1995 inspection noted the excessively chalky condition of the paint and that the “Door at 3rd level leading out to the cat walk is corroded and hinges broken. This will be replaced and fixed by Group Eng. this summer.”⁷⁸

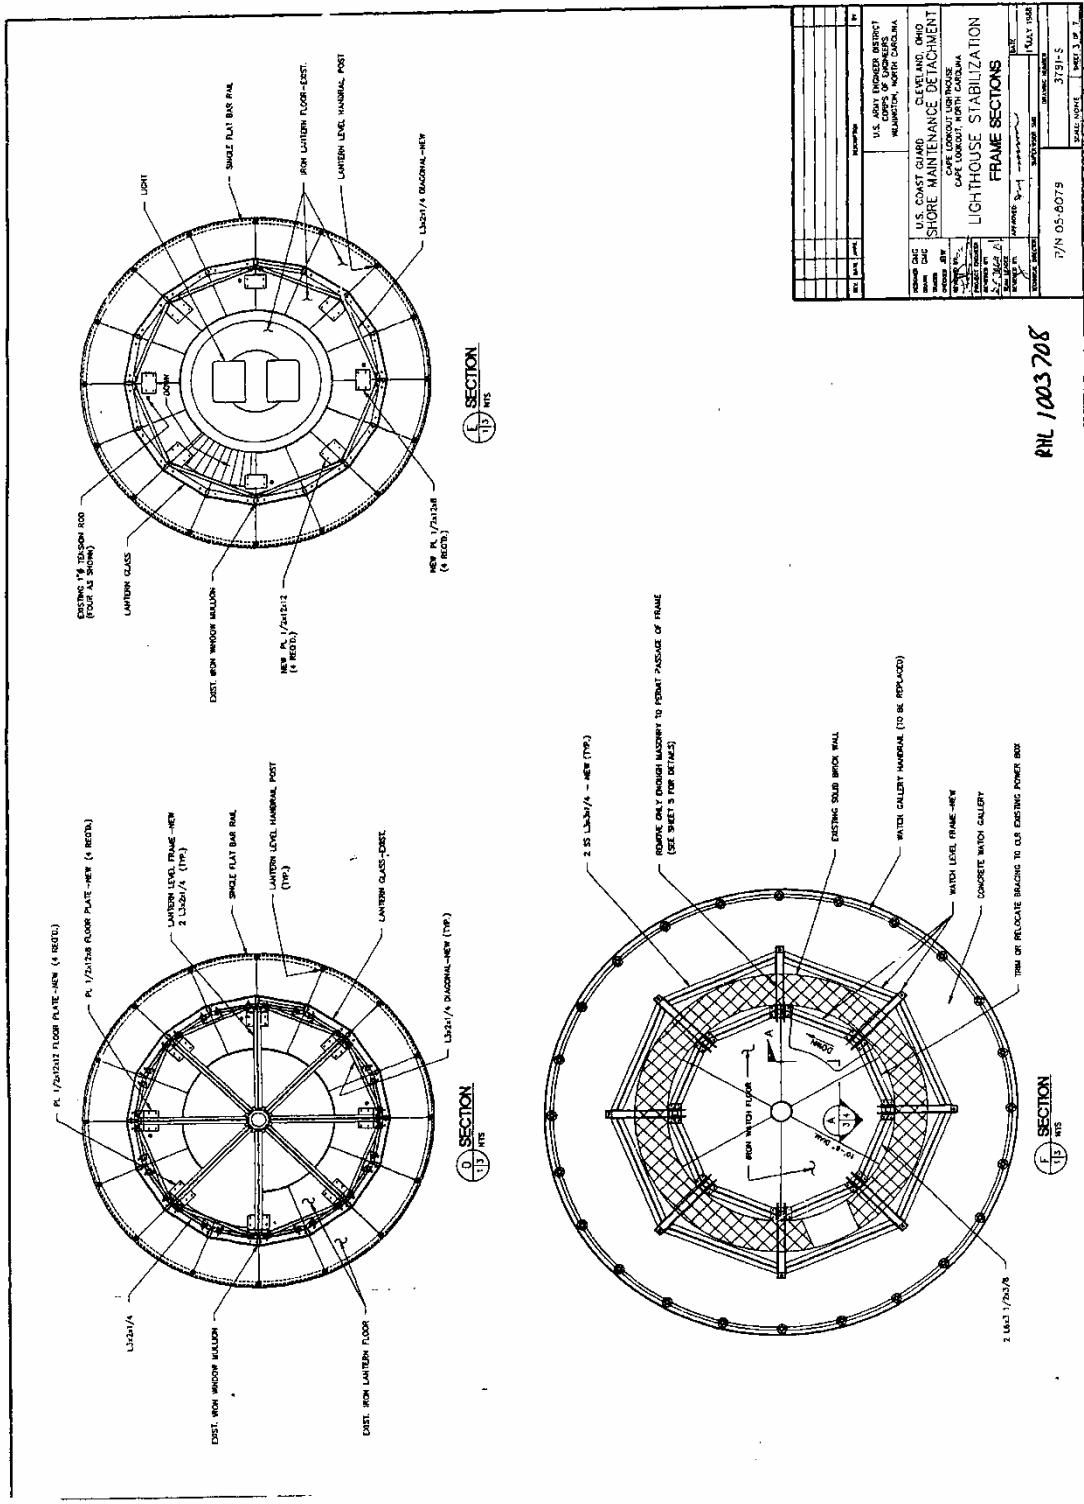
The most significant alteration made to the upper part of the tower since the 1914 gallery enlargement or the removal of the Fresnel lens ca. 1976 occurred in 1989. By 1988, it was clear that above the eighth floor both the ironwork and the masonry had seriously deteriorated. The eighteen inch thick masonry between the eighth and lantern floors had developed severe vertical and horizontal cracks, some of which were over one inch wide. Six vertical cracks completely penetrated the wall and ran the full height. One horizontal crack ran the full circumference and portions of the wall had shifted. It was feared that the structure would collapse in the event of a 130 mph hurricane. One option studied was to encase the wall in steel but ultimately, in order to address concerns over the structural stability of the lantern, watch and service levels, the Coast Guard embarked on a major shoring and stabilization project. The work also included the replacement of the railings on both the Lantern Room and Watch Room galleries. The new posts for the upper gallery extended through the original iron floor plate of the Lantern gallery, through some new horizontal framing then anchored in the floor of the Watch Room gallery. On the interior, a series of metal diagonal cross bracing and horizontal framing lace the

Figure B-17 Plan view of 1989 shoring in tower.

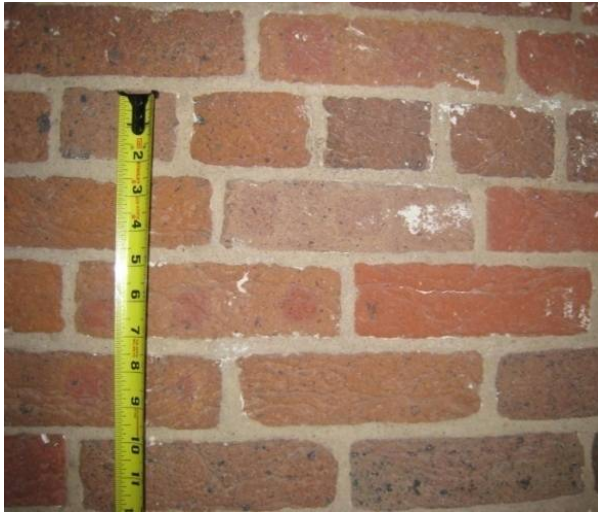
Figure C-9 Brickwork of interior face of core wall.

The mortar joints of both the outside and inside walls have a width of about ½" and are struck flush. However, on the core wall interior face, it is clearly evident that portions of the brickwork have been re-pointed with a hard, Portland cement-rich mortar. The re-pointing mortar is also fairly impermeable as evidenced by the re-pointed joints sitting proud, hard and rigid, while the adjoining bricks have spalled well back from the face of

the mortar. Similar spalling has not occurred on bricks adjoining the earlier mortar.

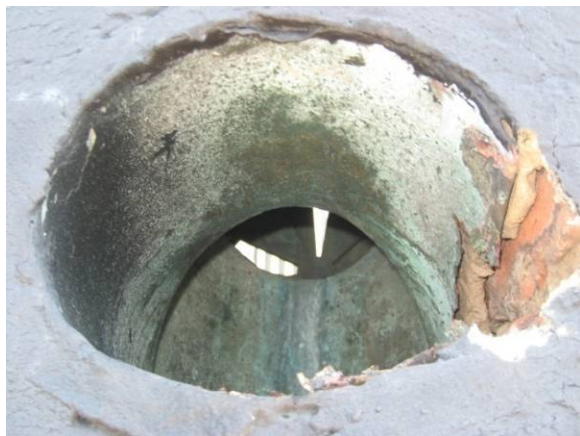
Further, the mortars have held up very well. These will be important considerations for future maintenance repair efforts. It is of historical interest that the cement was identified as American and not a European product. Although the exact provenance of the cement could not be established, it is chemically consistent with cements produced in northwestern Georgia. Further, the sand used for the mortar was identified as a very

Figure C-11 Natural cement bedding mortar exposed at Watch Room air vent.

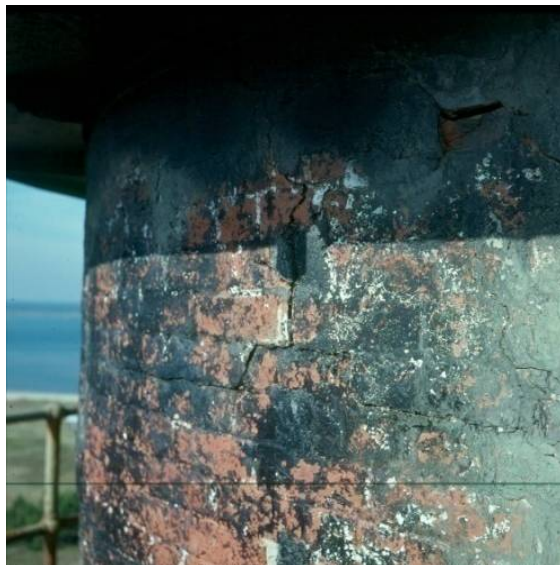
In addition, the condition of the bricks of the exterior wall is not known. These bricks have been water-blasted and subsequently covered with the current, thick, non-breathable coating. These actions are likely to have damaged the brick by removing portions of the fireskin and also trapping moisture,

conditions that may affect their overall water absorption and possibly their compressive strength properties. Additional testing of the exterior brick is recommended to confirm actual performance characteristics. (See *Appendix D: Materials Analysis* for further discussion.)

Figure C-12 A 1976-1981-era photograph of exterior masonry at Observaton Deck.

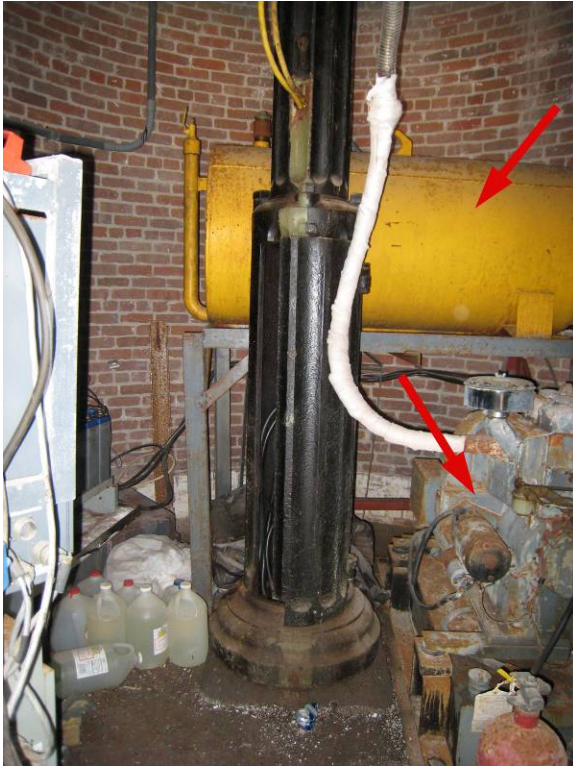
- **Column:** A hollow, round column, made of $\frac{3}{4}$ "-thick iron plate, is bolted together in sections and extends from the masonry floor of the First Floor to the Ninth Floor Lantern platform for the beacon. At all levels the column appears to be sound.

Figure C-13 Center column on sandstone pedestal, abandoned emergency generator and fuel tank nearby.

A 1970s vintage emergency generator is located at the First Floor of the Lighthouse. However, it is disconnected and non-operational.

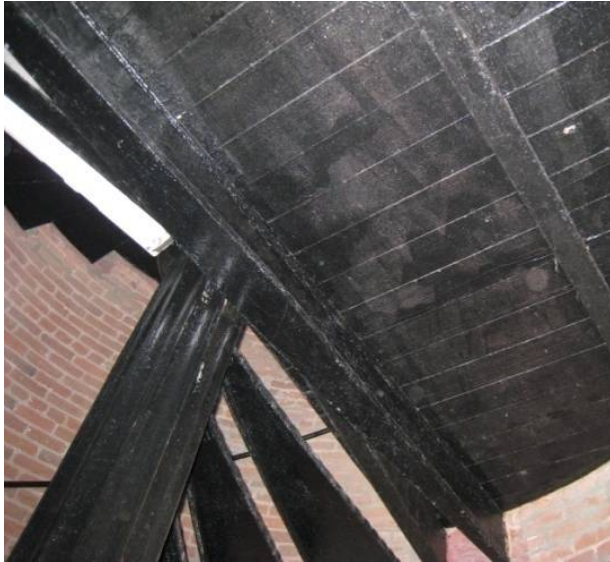
At the Third Floor, a level damaged by the Confederate explosion, the landing was rebuilt in the 1867 repair effort and is comprised of wood plank flooring (3/4" x 5") atop two wooden joists (2 7/8" x 8") in addition to the original I-beam.

Figure C-15 Wood deck and floor joists of rebuilt 1867 Third Floor landing.

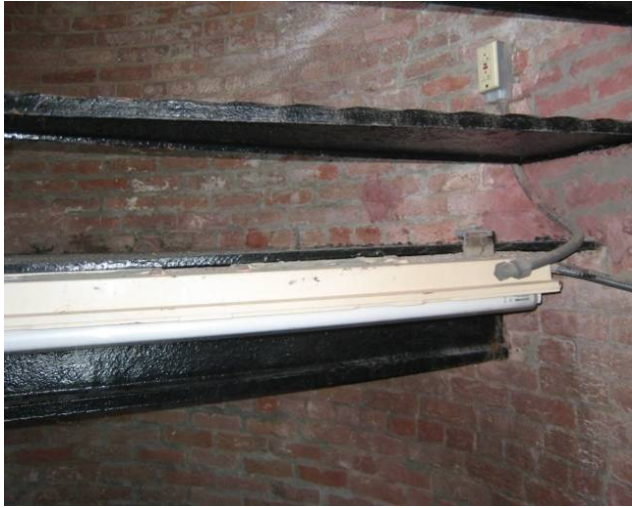
The electrical service in the Lighthouse was upgraded in 1996-97. Upgraded items include new wiring, junction boxes, emergency beacon and power control. Electrical wiring is typically contained in conduit. Along the spiral staircase, a utility shop type fluorescent lighting fixture (having a length of 4'-0" with two bulbs and no lens) is mounted on the surface of the underside of each landing. A grounded electrical outlet is also provided at the landing.

Figure C-19 Typical shop-type utility lighting at spiral stairs floor landing.

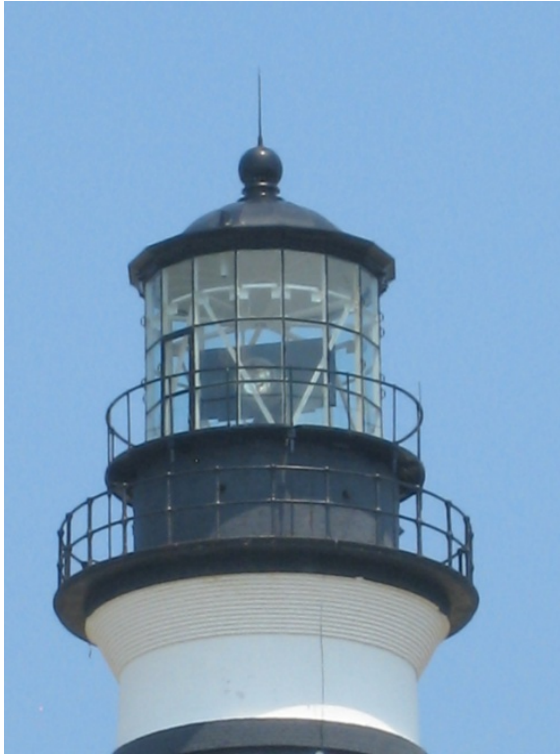
- **Lantern & Lantern Gallery:** The sixteen vertical sections of glass that form the sides of the Lantern are held in place by vertical cast-iron framing members and horizontal cross-bracing of a copper-based material, perhaps brass. An iron sill plate attaches the Lantern atop the masonry tower. There are extensive amounts of corrosion at the iron elements.

Figure C-21 Lantern, Lantern Gallery and Watch Level Observation Deck.

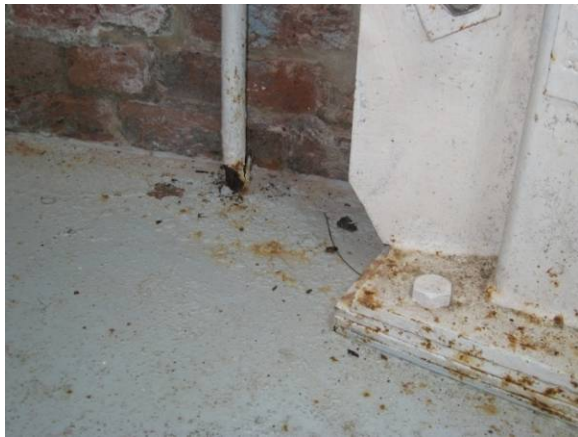
Four presumably original iron rods, each 7/8" in diameter, connect the sill plate of the Lantern to the floor at Watch Level. These rods have extensive corrosion with at least one severely compromised.

Figure C-22 Corroded connecting rod at Watch Room floor plate.

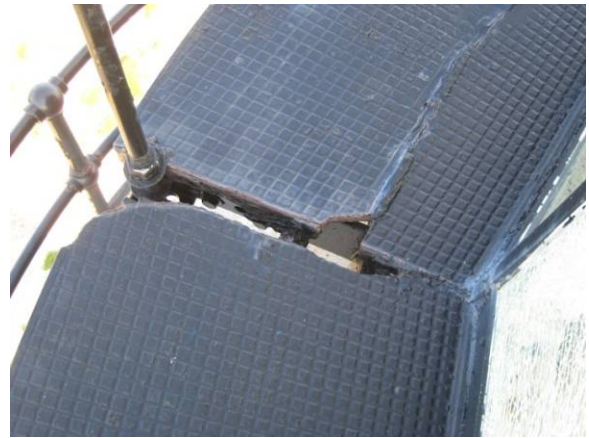
Along the outside perimeter of the Lantern is the narrow Lantern Balcony. This Balcony has sixteen cast-iron floor plates, probably the original. These plates are in very poor condition with extensive corrosion, numerous breaks and some loss of material. Stainless steel angles were added in 1989 for support beneath the floor plates. During those same repairs, the current stainless steel railing system was installed. This railing consists of 1½" round stanchions with a flat 1" x 2" handrail 38" above floor level.

Figure C-23 Broken floor plates of Lantern Gallery.

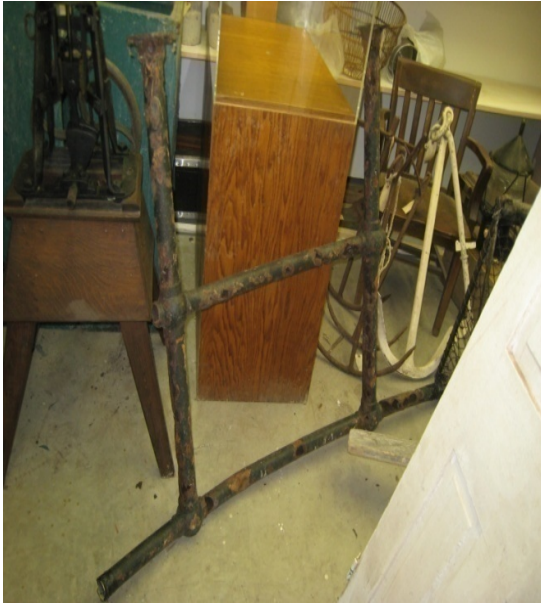
Figure C-24 Section of 1914 Observation Deck railing at North Carolina Maritime Museum.

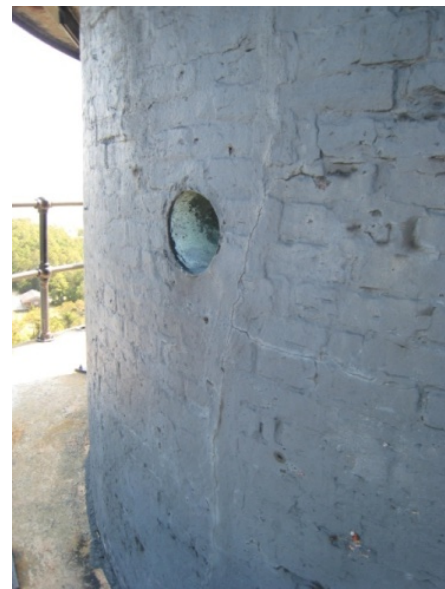
- **Air Vents:** Four round 8"-diameter vents constructed of sheet copper are equally spaced in the perimeter wall at the Watch Level. Apparently original, each vent is Z-shaped with the exterior opening approximately 12" below the interior opening where a manually-operated, five-point, cast-brass closer adjusts airflow.

Figure C-26 Exterior view of one of four Watch Room air vents.

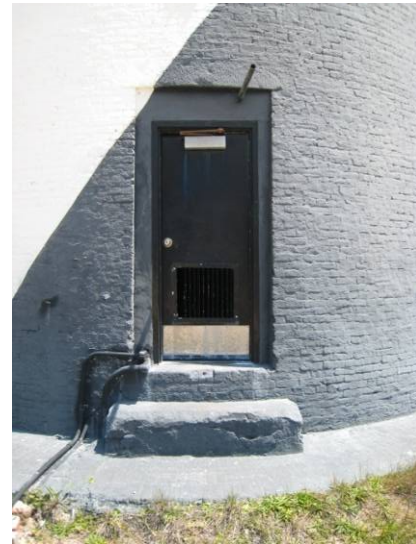
Figure C-28 Original masonry opening for First Floor doorway with modern infill and steel door.

At the Second Floor, the steel door frame and door are of the same installation periods as those of the First Floor and physically match as well except that this door measures 2'-6" x 6'-6" x 1¾". Both this and the First Floor door suffer from extensive corrosion, are in poor condition but remain operational.

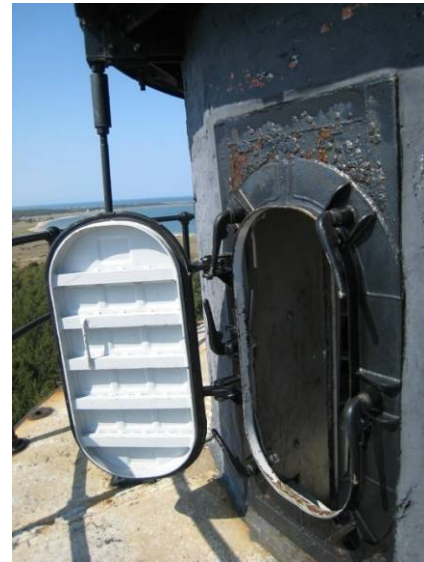
The exterior door plate is steel and has extensive wear and corrosion suggesting that it may date to a much earlier period with a steel door of similar design to the current aluminum one.

The original masonry opening is sound and the hatch door is in good condition and operational.

Figure C-30 Ship's Hatch at Observation Deck.

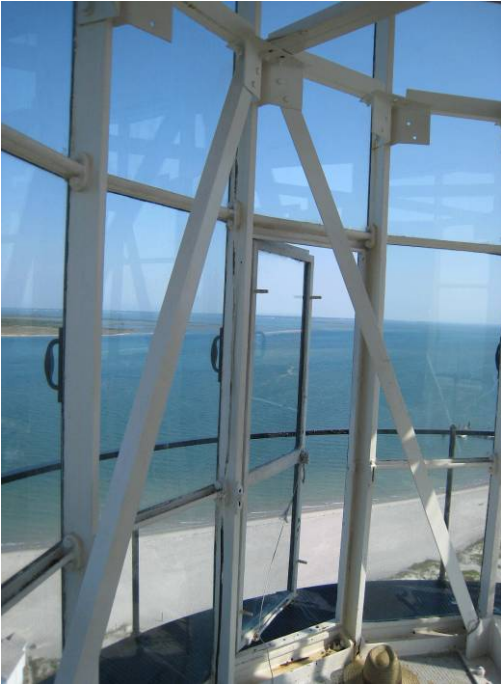
A fourth doorway is at the Lantern. Apparently an original feature, it is made of brass framing with two, glass panels, designed to conform to the framing configuration of the Lantern. This door permits passage between the Lantern and the Lantern Gallery. The door metal is heavily encrusted with paint and difficult to operate.

Figure C-31 Doorway to Lantern Gallery.

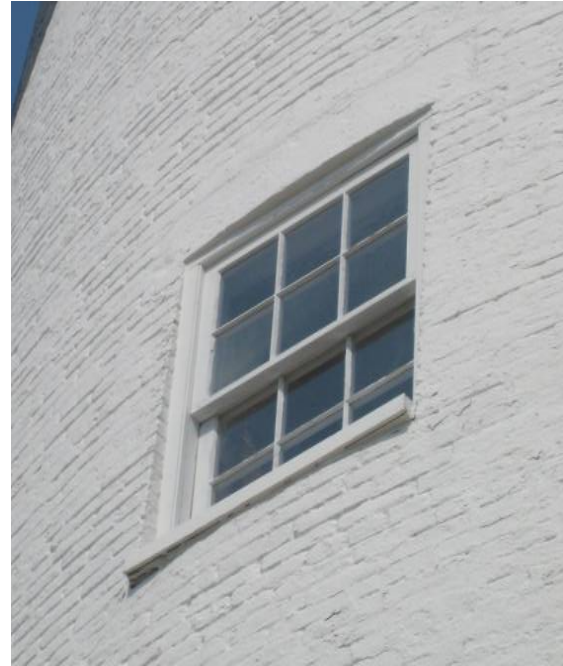
Figure C-32 Typical replacement window unit.

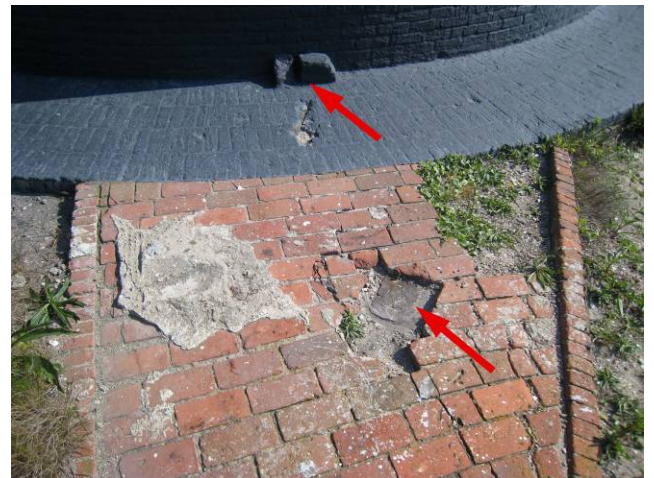
Figure C-33 Brick Apron at intersection with brick walk to Keeper's Quarters. Note post and stone base for previous stairs.

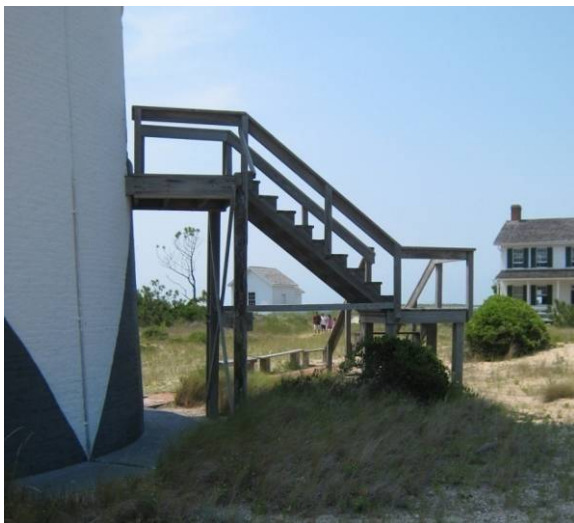
Figure C-35 Stairs for Main Entrance.

The earlier elements include two 6" x 6" posts and their 2½" x 9¼" cross beam, all of which are attached to two modern 5 3/8" x 5 3/8" posts that support the entrance landing. These two early posts have extensive rot. The 1980s elements remain in good condition though the entrance landing posts would benefit from additional support as the earlier, now supplemental, posts continue to deteriorate.

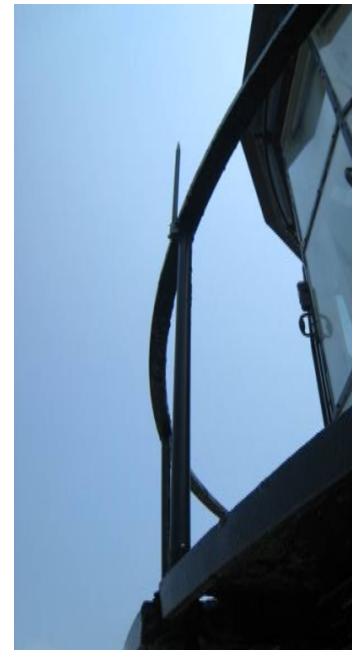
Figure C-36 Modern lightning rod at Gallery railing.

• *Lightning Protection:* The prototype drawings indicate a lightning rod atop the roof finial. Today, a group of modern lightning rods include one atop the dome and four at the Lantern Balcony rail. Two grounding cables connect to this rail, one at the north side and one at the south, and then run down the face of the masonry to grade. The south ground cable is disconnected at the Eighth Floor.

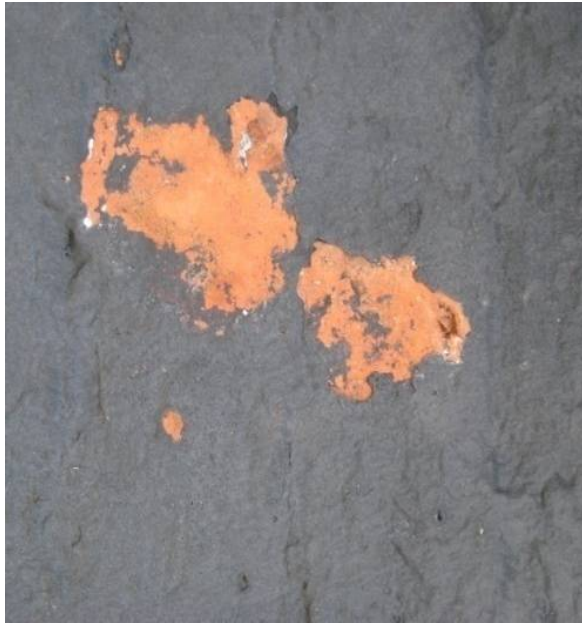
Figure C-37 Physical evidence of red limewash on tower's exterior masonry.

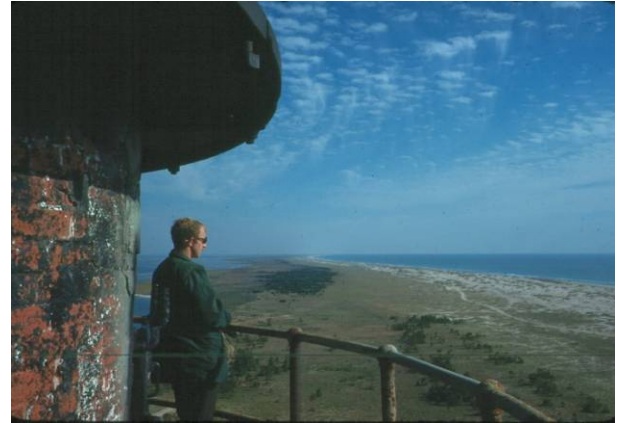
The later black and white paints apparently post date the 1873 decision of the federal Light House Board to implement the current distinctive diamond pattern. The recent paints applied to the masonry are synthetic based, very rubbery and non-breathable. Probably applied for their waterproofing capability and durability, they belong to a category of paint that has proven to be harmful to soft, handmade bricks, especially in combination with the use of hard, non-permeable repointing mortars as are found at this lighthouse.

Figure C-38 Tower finishes c. 1976-1981.

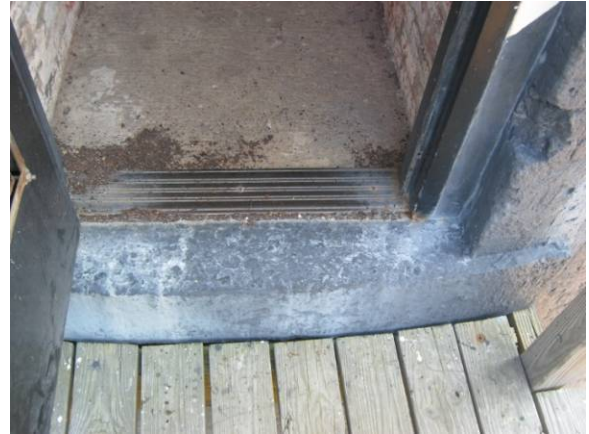
Figure C-40 Granite doors sill at Second Floor entrance. Note modern infill, door frame, and door.

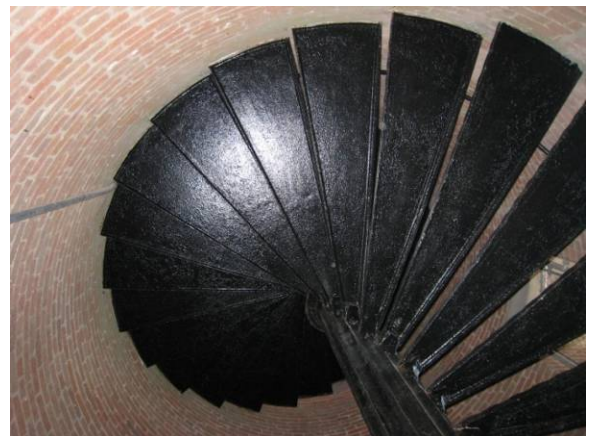
Figure C-41 Typical Spiral Staircase section as found from Second Floor to Seventh Floor.

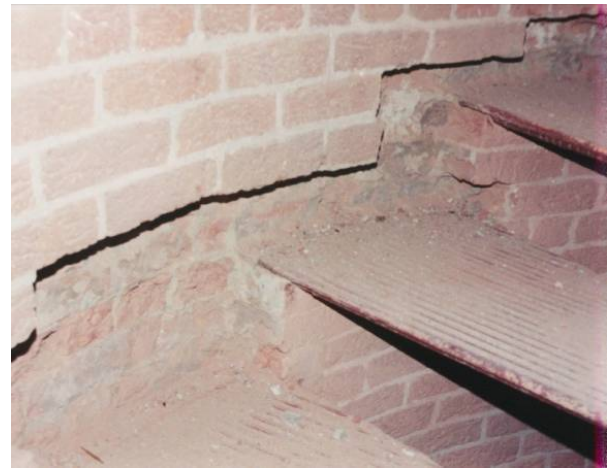
Figure C-43 Photograph from 1999 inspection. (CALO Coll.)

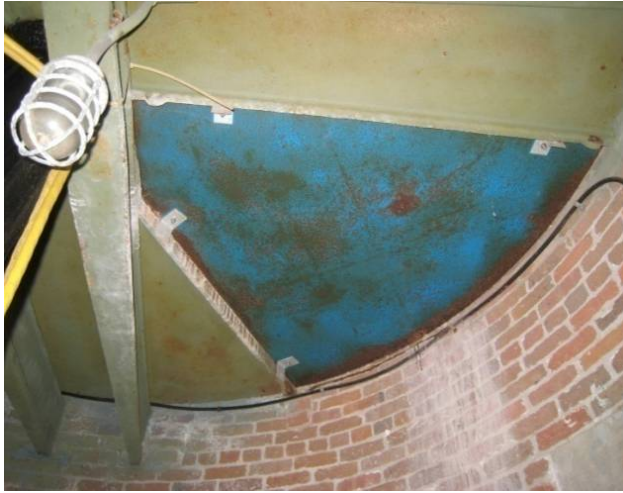
One exception is a single plate among the six at the Second Floor which is clearly a modern replacement. Its design is unlike any other floor plate and it is painted a different color as well. It is not known when or why this plate was installed. The original floor plate is stored nearby. The reason the original plate was removed is not clear; perhaps it was removed to accommodate the operation of added equipment. Why the early floor plate was not reused when the decision was made to close up the floor again is also not clear; perhaps the early floor could not be located.

Figure C-44 Modern replacement floor plate at Second Floor landing.

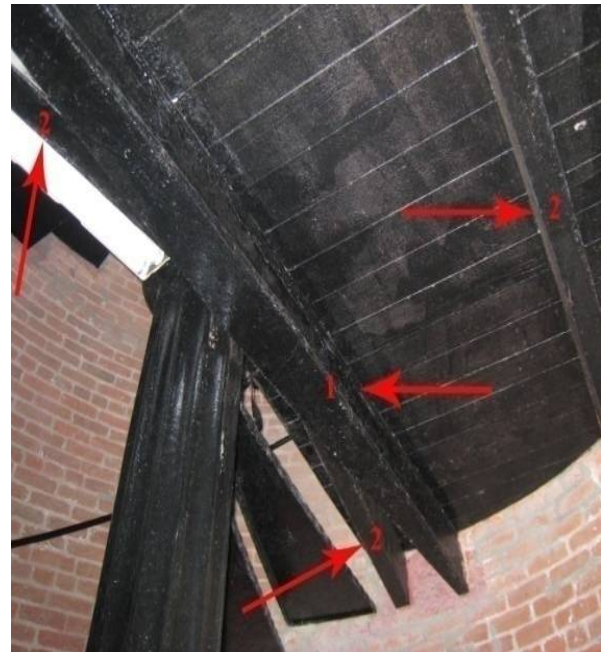
The Second Floor landing apparently was rebuilt with replacement iron floor plates, but the Third Floor landing is instead made of wood. The original cast-iron beam apparently was reused, but there are two added wood joists to help support a wood board deck. No documentary explanation for this change in planning has been identified.

Figure C-45 Third Floor Landing with reused 1859 cast-iron I-beam (1) and 1867 wood framing (2).

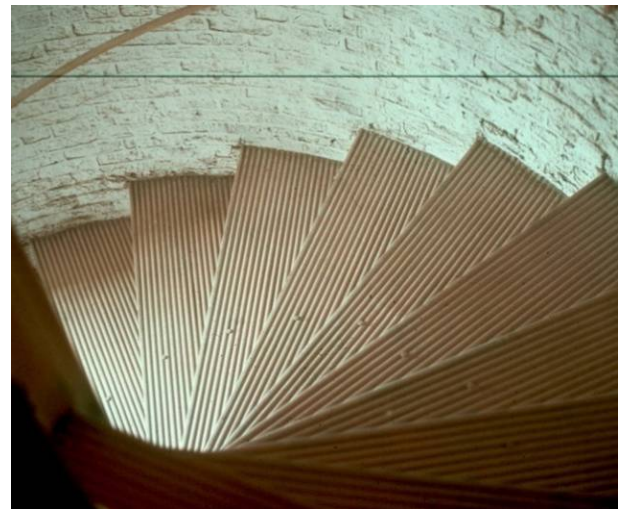
The interior brick surfaces contain minimal evidence of finishes, having been thoroughly blasted in the 1990s. The walls not easily cleaned, such as the narrow passages of the entry vestibules and window wells, generally

Figure C-47 Spiral stair and masonry finishes, 1976-1981 photograph. (CALO Coll.)

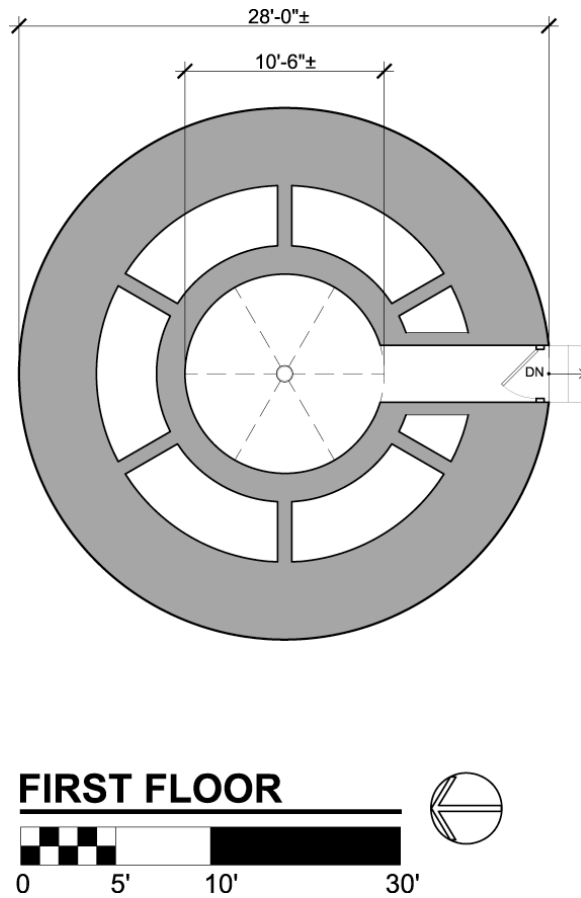
Figure C-54 First Floor Plan.

• **Walls:** The wall surface is constructed of handmade brick laid in a 1-to-5 common bond. In 1999 the brickwork was water blasted. The bricks' outer protective surfaces that faced the room were severely eroded in the process, exposing the softer interior of the bricks. This brickwork was then spot-repointed with a much too hard, impervious mortar. The combination of damaged brick

and impervious mortar is causing the bricks to suffer further damage from moisture migration and spalling.

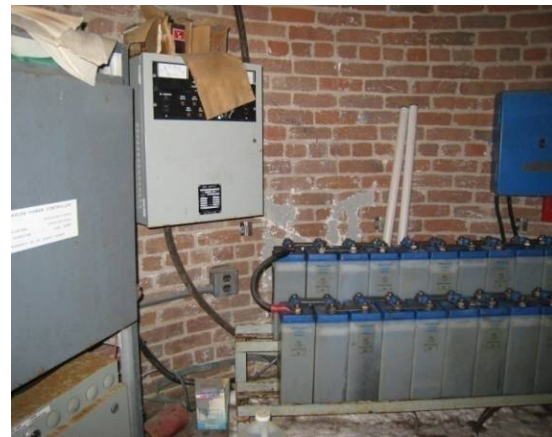
Figure C-58 Abandoned power controller and fuel cells.

The nonoperational emergency generator is just east of the center column. Its fuel tank is just north of the column.

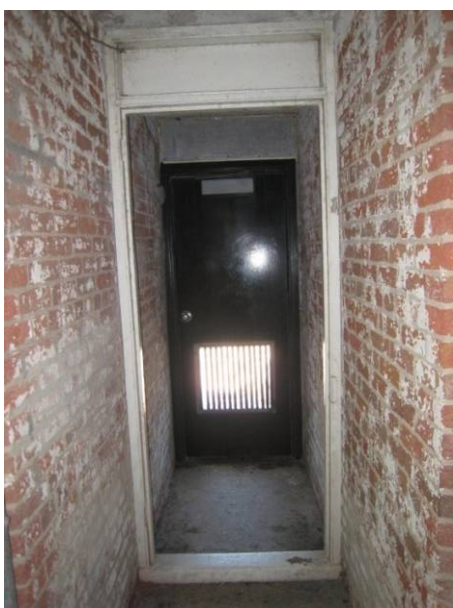
Figure C-61 Modified original exterior doorway and c.1914 interior door/transom framing in foreground.

Partway down the passageway are the framing remnants of a wood doorway and transom framing. The door and transom sash are missing. Although associated documentary evidence has not been found, the construction is similar to the 1914 work at the Service Room and may be remnants of another air lock, part of the effort of that period to better isolate and protect the new occulting device.

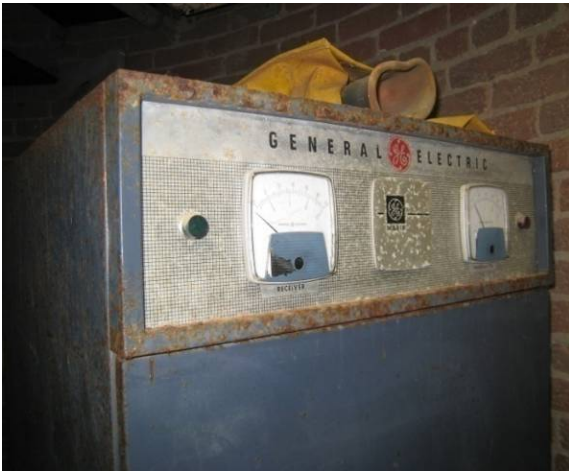
Figure C-63 Abandoned GE transmitter/receiver.

Abandoned electronic equipment includes a General Electric Master Transmitter/Receiver.

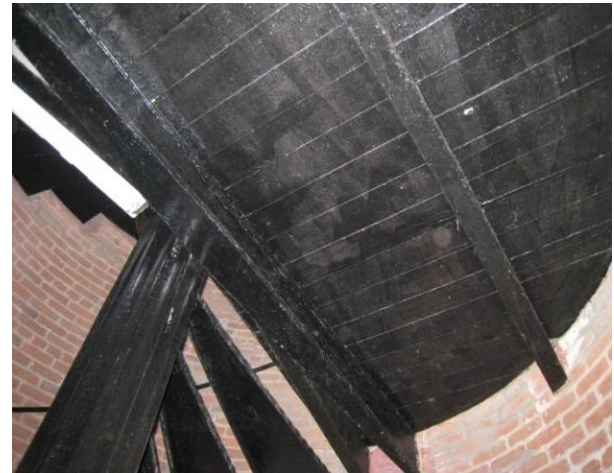
Third Floor: Although the Union forces submitted an assessment indicating the need for cast-iron floor panels to replace those that had been damaged by the Confederate explosion, this landing was not rebuilt accordingly. The reason is not clear from the documentary records.

The original I-beam was apparently reused. However, two wood joists measuring 2 7/8" x 8" were added and a new flooring of boards measuring 1 3/4" x 5" was installed in place of iron floor plates.

Figure C-66 Third Floor wood Landing.

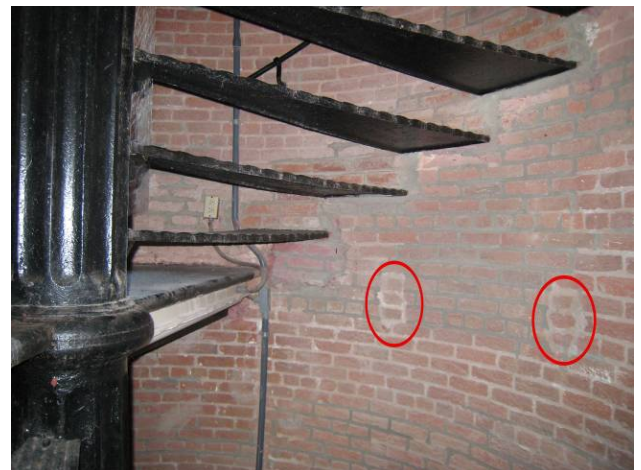
- *Other Features:* There are two sets of evidence of the 1863 temporary stairs in the core wall brickwork. One set is along the northeast surface of the wall, at the same level as the 8" deep joists that support the Third Floor landing. Each of the two patches is 8" tall and the width is irregular.

Figure C-68 Two masonry patches presumably associated with the 1864 framing for temporary stairs.

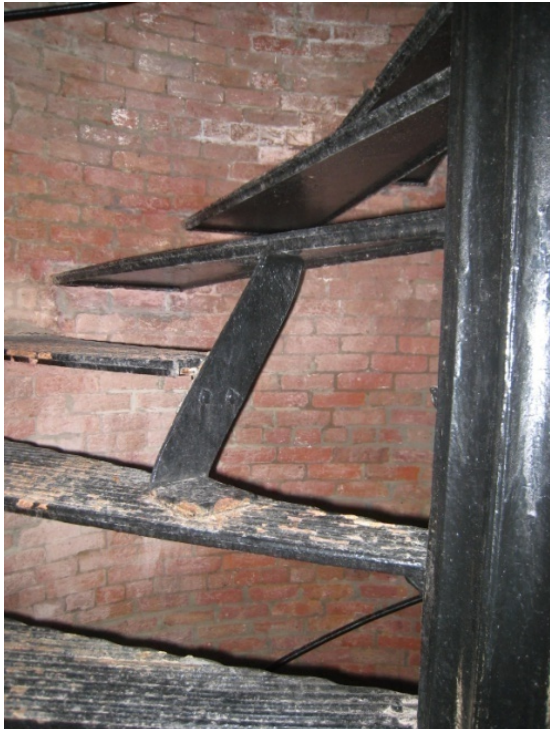
One step is missing half of its tread and is supported by an added vertical brace. This modification was made in 1914 to two treads in order to accommodate the chains for the new oscillating device.

A number of the treads have a metal strap added to make connection between steps in sequence. The date of installation of this additional support is unknown.

Figure C-73 1914 tread modification to accommodate the weight for oscillating mechanism.

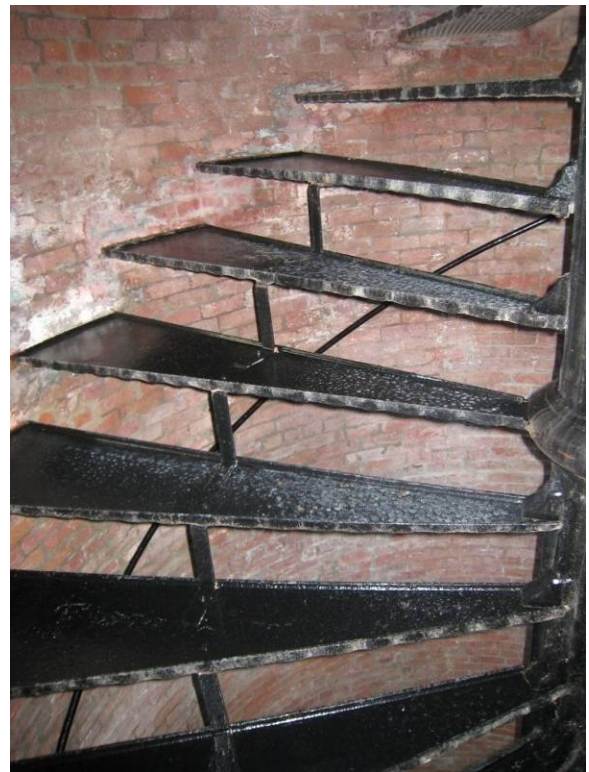
Figure C-74 Metal strap reinforcement of unknown installation date.

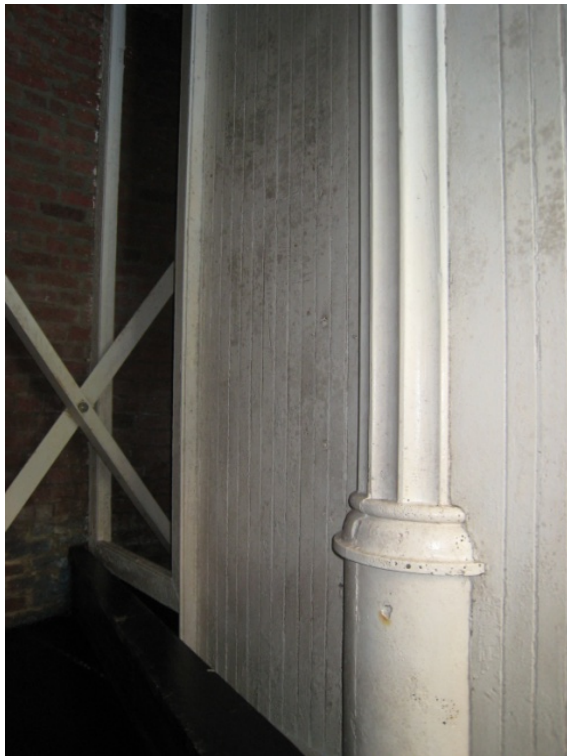
Figure C-77 1914 board wall and doorway at Seventh Floor landing. Note 1989 steel reinforcement added at masonry perimeter.

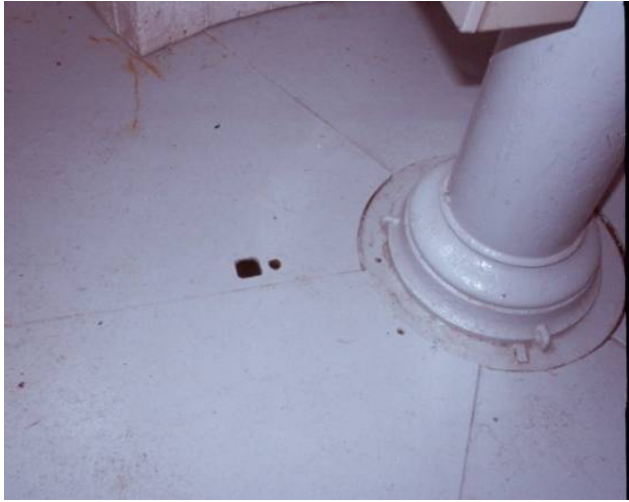
Figure C-84 Floor cuts for 1914 drive chain for occulting mechanism.

Near the center column there are two small holes cut in 1914 for the occulting chain.

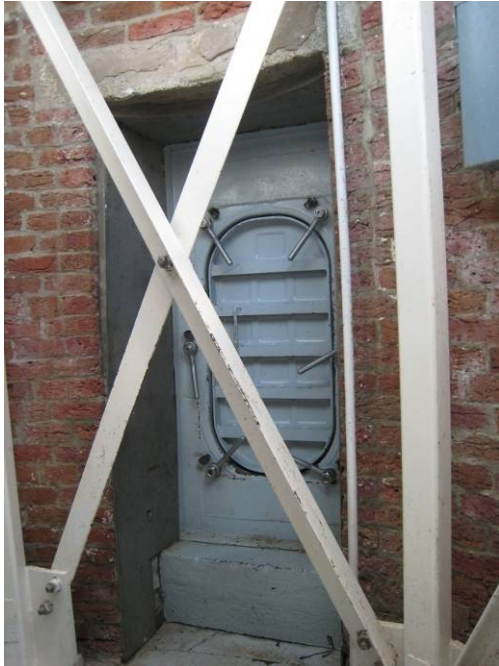
Figure C-87 Reinforcing steel added in 1989 partially blocks ship's hatch to Observation Deck.

- Corrects the causes of structural deterioration of the upper masonry
- and cast-iron lantern rather than applying yet another temporary repair;
- Improves safe passage through the interior spaces of the lighthouse by removing the 1989 steel from egress doorways and stairs, adding reinforcement to certain early character-defining elements (cast-iron stair treads) and adding visually unobtrusive elements (a second spiral-staircase handrail).

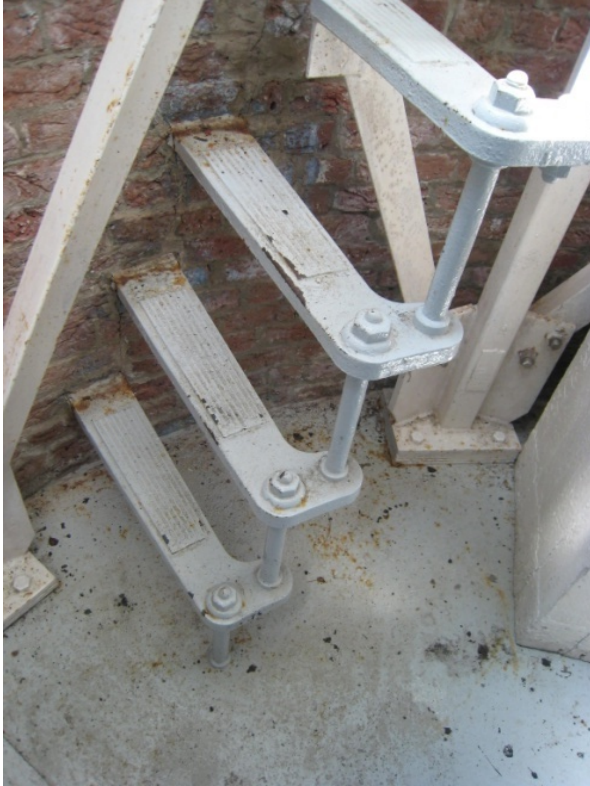
- **Stairs:** The original cast-iron ladder stairs provide the access to the Lantern. These steps are also in the shape of a boot like those at the level below, but narrower and with a greater rise between treads. The steps begin along the southeast exterior wall (whereas the prototype plan has the steps beginning along the northeast wall.) Each tread measures 1'-9 1/2" wide x 3 1/2 to 4 1/2" deep and 1" thick. The wider flange of each tread is connected to the masonry wall, while the narrow end is connected by two, separate 1" diameter rods with both the step above and the step below. The riser height is 9 1/2". Portions of two of the eight treads have been removed to

accommodate the steel reinforcement framing installed in 1989. Otherwise, this original ladder stair is intact and in good condition.

Figure C-90 Close-up view of ship's ladder to Lantern.

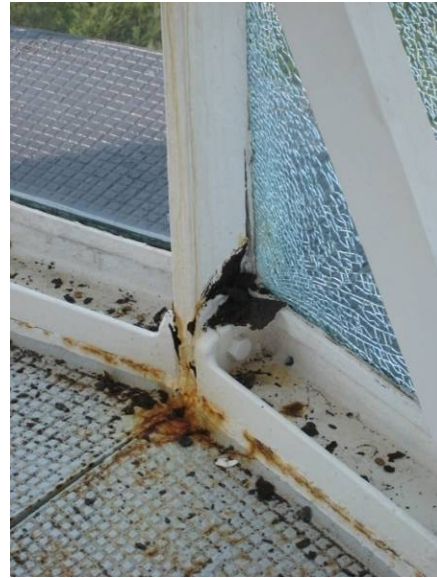
• **Walls:** The vertical framing elements are cast iron. The connecting horizontal framing elements are brass with small refined details. There is much corrosion and surface loss of the cast iron, especially at the floor plate and at some connection points with the brass. A few of the glass panels are damaged.

Figure C-98 Deteriorated iron framing.

At the lantern, the ferric-based framing elements show numerous pockets of severe rusting. The lantern's iron sill plate, which attaches to the top of the masonry, has the most serious deterioration with extensive rust and severe buckling.

The 1989 installation of steel supplemental framing and tie rods provides much-needed reinforcement, but it does not address the cause of the problems. The damaged iron will continue to deteriorate and weaken, and in expanding it will continue to cause collateral damages as well. The only long-term solution and ultimately the most cost-effective, is to make repair to the damaged iron.

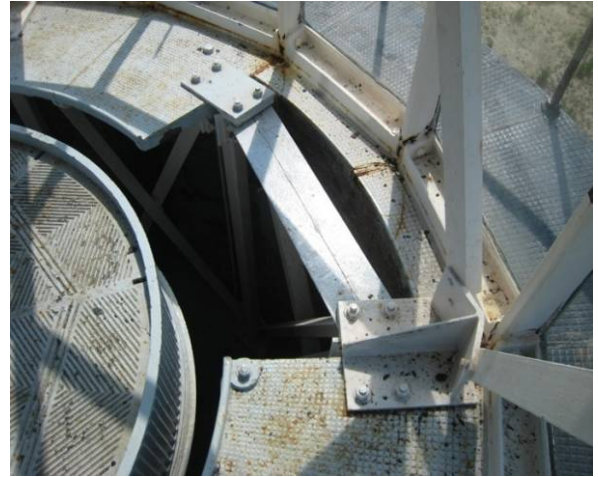
- *Stairs:* An opening in the perimeter cast-iron walkway allows access to the original cast-iron ladder stairs that connect with the Eighth Floor (Watch Level). The opening is partially blocked by framing for the 1989 steel reinforcement.

Figure C-102 Access to stairs to Watch Level partially blocked by 1989 reinforcing steel.

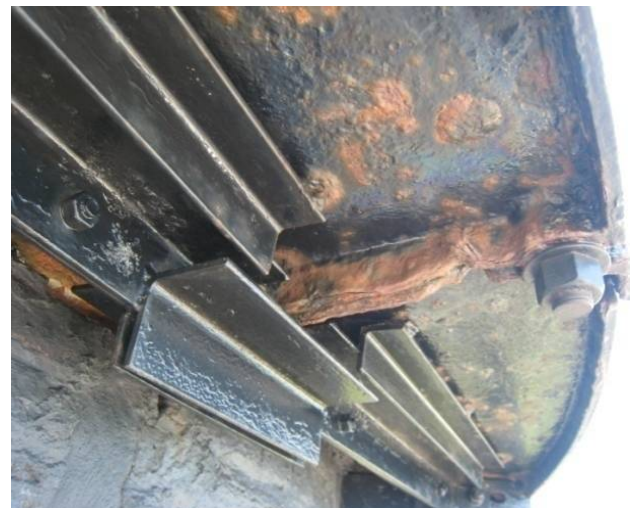
Figure C-106 Underside of Lantern Gallery reinforced in 1989.

- Addresses the deterioration of significant historic fabric before it progresses to the point of requiring replacement;
 - Eliminates the necessity for, and thus allows for the removal of, the modern steel square-pipe-and-angle shoring which distracts from the lighthouse's historical character and hinders access through interior spaces;
