CAPE LOOKOUT LIGHTHOUSE

Cape Lookout National Seashore
North Carolina

HISTORIC STRUCTURE REPORT

December, 2008

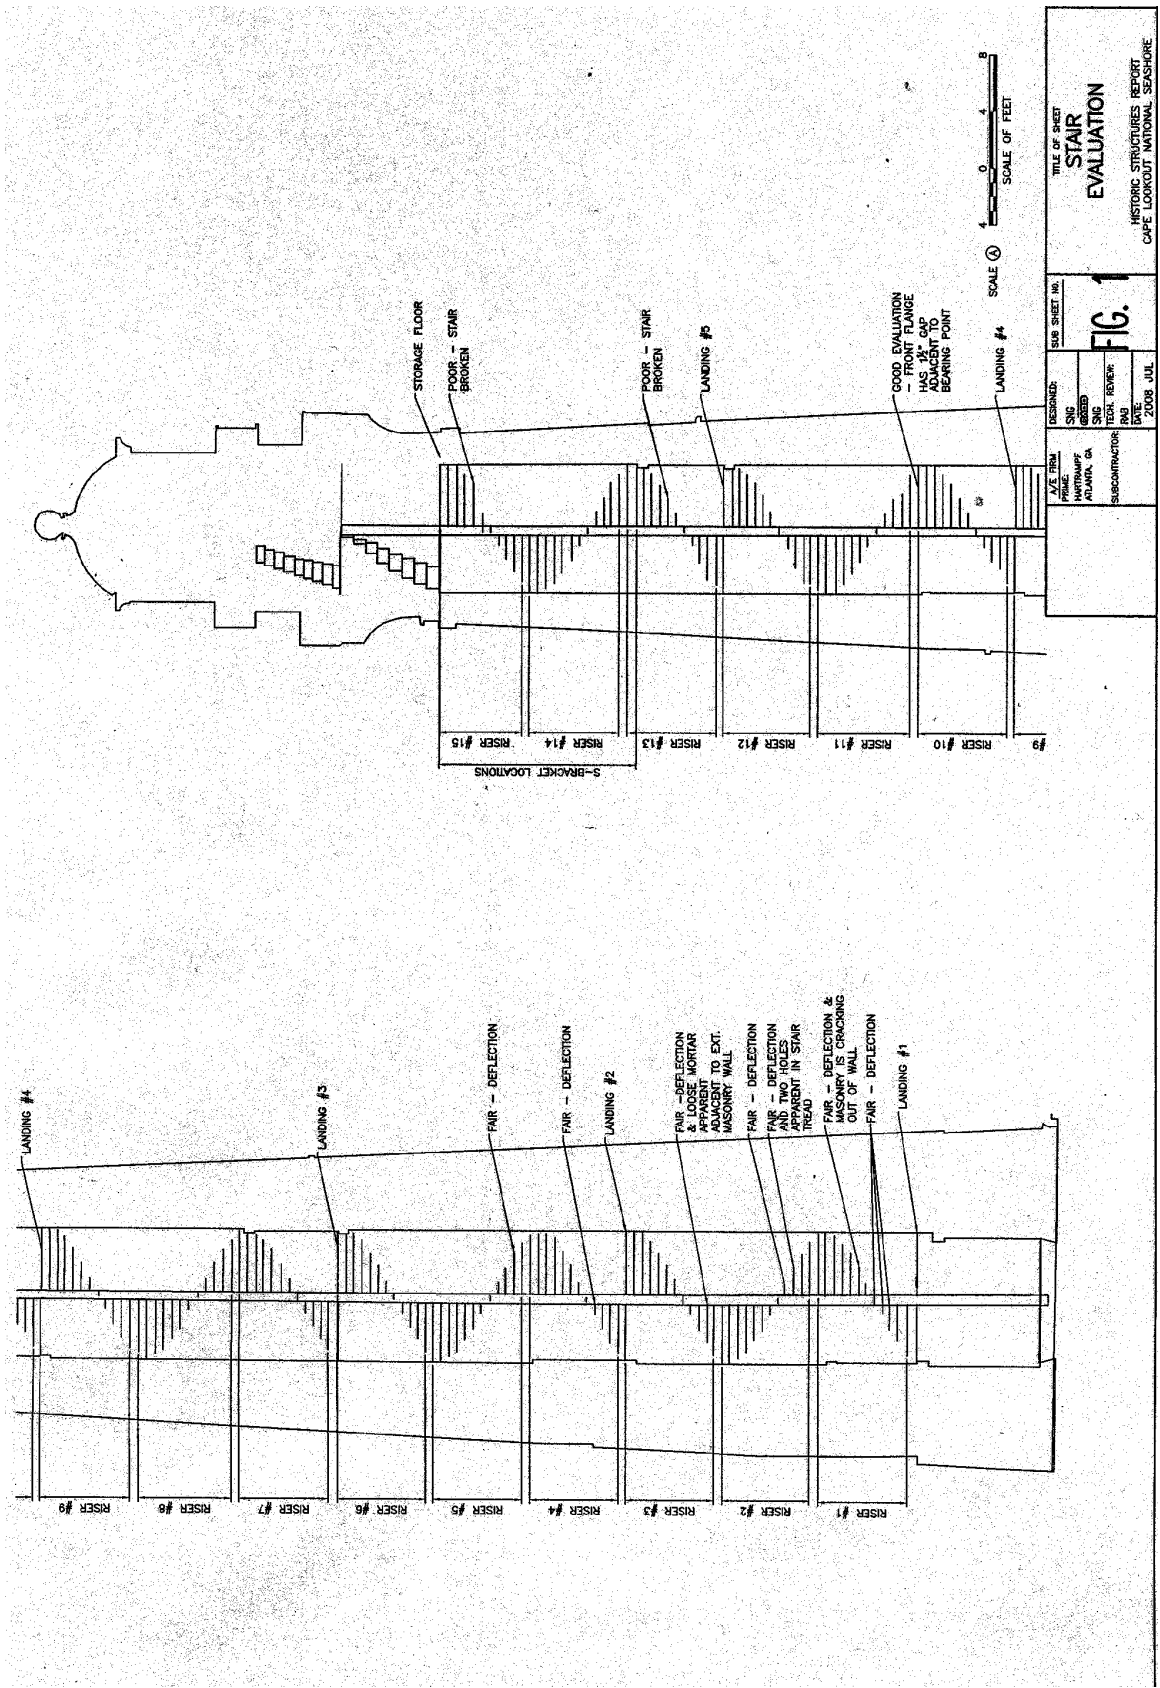
FIG. 1 HISTORIC STRUCTURES REPORT CAPE LOOKOUT NATIONAL SEASHORE	
TITLE OF SHEET STAIR EVALUATION	SUBSHEET NO. 1
DESIGNER SNG CHECKED SNG DATE 2008 JUL	REVIEWER RAJ DATE 2008 JUL
A/E/FIRM HARTRAMP ATLANTA, GA	SUBCONTRACTOR

The majority of the spiral stair treads are in good condition, though some are in fair or poor condition. The source of concern for the fair or poorly evaluated stairs was primarily deflection criteria. Engineering of the stair system allows each of the stairs to act independently, but also allows for different deterioration to have occurred at each individual connection. It was observed that some of the mortar which helps provide the connection at the masonry wall has deteriorated and fallen away over time (see Figure 2), and may therefore cause treads to deflect more readily. Also, due to imperfections that may occur during casting and connections, the pin connections at the interior column could allow additional deflection (see Figure 3). Additionally some of the stairs may have received additional traffic or impact over time from unknown sources and therefore would show increased deflection at the time of analysis. (See Figure 1 for noteworthy stairs which were evaluated as fair or poor during the May 2008 structural evaluation.)

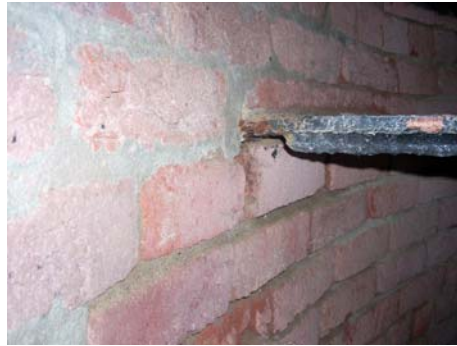
Figure 2 – Stair Connection at Exterior Masonry Wall

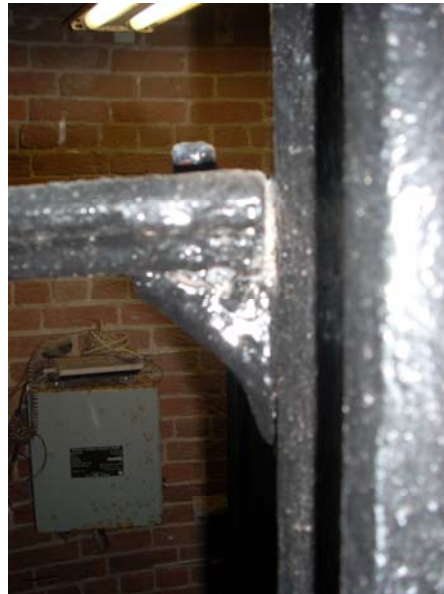
Figure 3 – Pin Connection at Interior Support Column

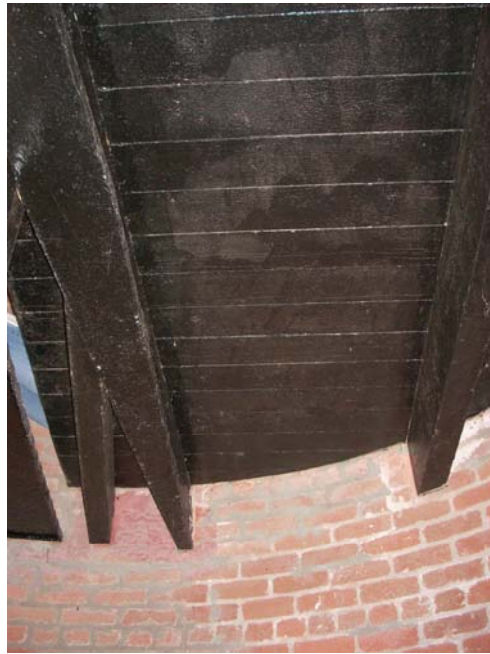
One landing differs in construction from the remainder of the other landings. The third floor landing is of wood construction with wood support beams (see Figure 4). Analyses were also performed on this landing to determine if it may provide adequate capacities to support the traffic which will occur. In addition, since this is the first landing that visitors will reach it is more likely that it will receive the most traffic and impact. Interest was expressed by both the park service staff, and the architect to preserve this landing during the May 2008 site visit. In an earlier report “Engineering Study of Cape Lookout Lighthouse” issued on May 12, 2005, issues concerning the fire resistivity of this landing were expressed. Recommendations for these concerns may be found in the recommendations section below. The flexural and shear capacities used in analysis were that of visually graded sawn Southern Pine No. 2. It is known that the lumber present during the construction of the lighthouse had a greater available capacity, but the decrease in allowable values ensure that the actual landing capacities are conservative.

Figure 4 – Wood Landing

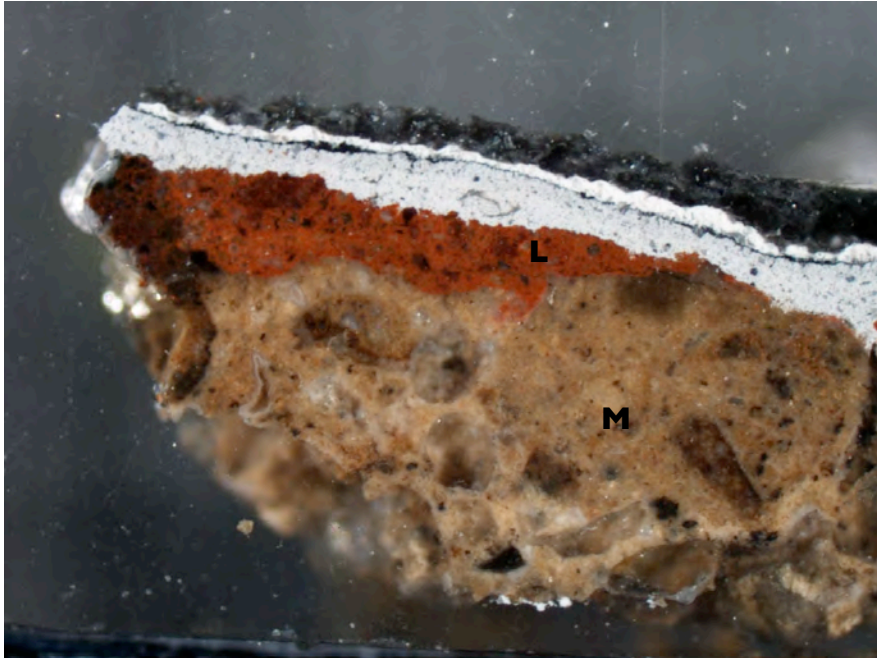
Analysis of paint samples indicates that the exterior brick masonry of the lighthouse contains two early campaigns of red limewash followed by four to six campaigns of black and white paint (always applied in a checkered pattern). The red limewash is also visible under the existing exterior paint coatings, on the surface of both the brick and mortar, in numerous locations. Archival research, performed by Joseph K. Oppermann Architect, P.A. as part of the HSR, revealed that the lighthouse was historically red in color. An 1859 *Notice to Mariners* states that: “The color of the tower is red.”⁶ Until now, the source of the red color was unknown. The color could have been achieved through the application of an oil paint or the description could have simply referred to the color of the brick masonry construction. The current research, however, provides proof that the first finish applied to the lighthouse’s exterior masonry was in fact a pigmented red limewash. While it is possible that the exterior brickwork of the lighthouse was originally unpainted and that the red-colored limewash was applied subsequently in order to refresh its red brick appearance, the lack of a distinct dirt layer between the surface of the brick and the first pigmented limewash suggests that the first red limewash layer is original. (Figures 5 and 6)

Figure 5. Cape Lookout Lighthouse. Photomicrograph of Sample CALO.E.11, removed from the exterior of the lighthouse shows the original red limewash (L) applied over brick mortar (M), followed by layers of modern black and white paint coatings. Photograph by author, 40x magnification.

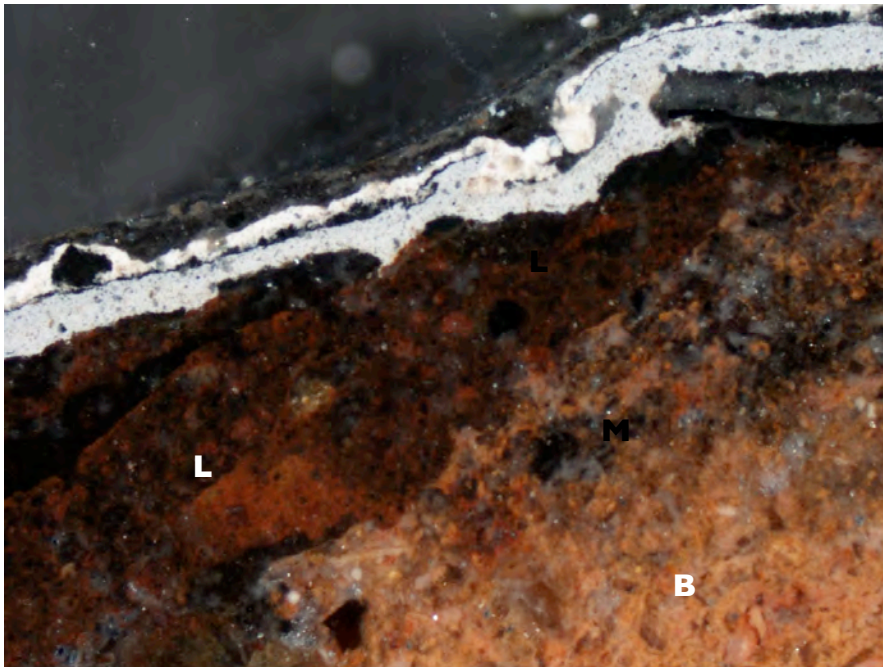
Figure 6. Cape Lookout Lighthouse. Photomicrograph of Sample CALO.E.10, removed from the exterior of the lighthouse shows the original red limewash (L) applied over brick substrate (B). Subsequent layers of black and white paint coatings are also visible. Photograph by author, 40x magnification.

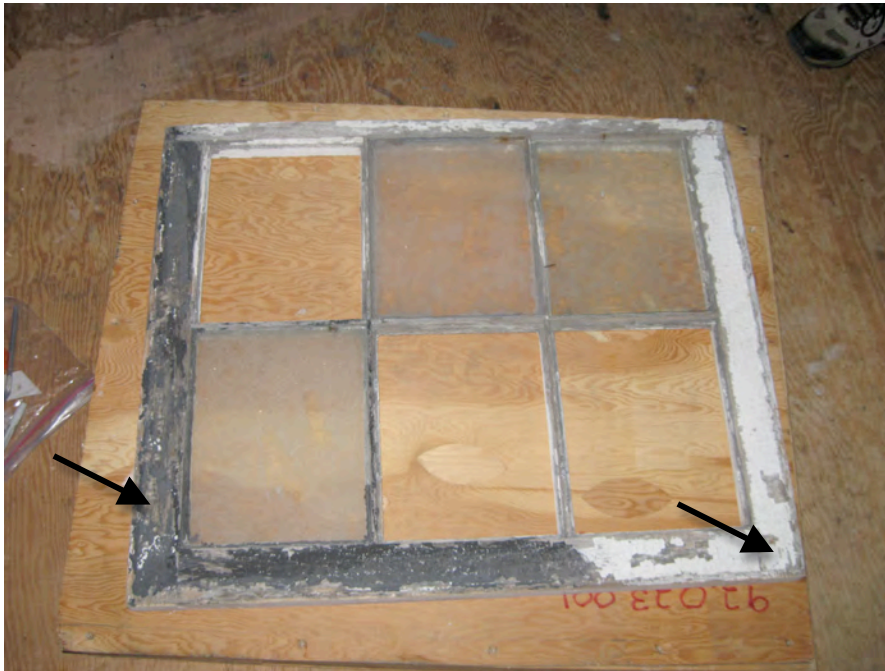
As previously mentioned, the majority of the exterior woodwork on the lighthouse was damaged by Hurricane Fran and replaced in 1996. However, the historic (presumably original) window sash were salvaged and are in storage at the North Carolina Maritime Museum in Beaufort, North Carolina. These sash were examined as part of this study and were found to retain much of their paint history. Unfortunately, the original exterior doors were not located. (*Figure 9*)

Figure 9. Cape Lookout Lighthouse, October 2008. A salvaged window sash currently located at the North Carolina Maritime Museum. Two samples were removed from the exterior face of the sash (arrows). Photograph by author.

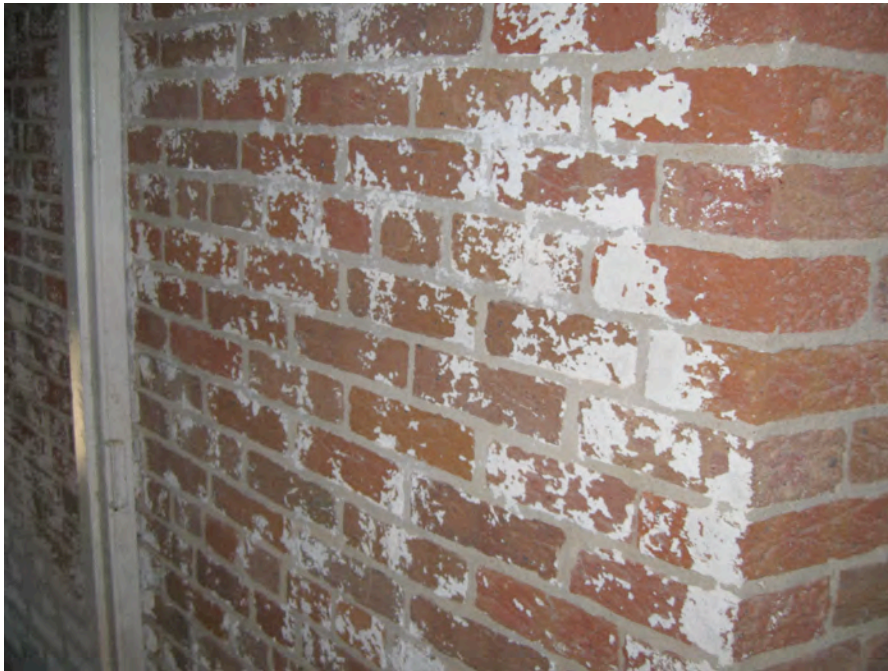
The interior brick walls, which were blasted in 1996, currently contain minimal evidence of paint finishes. The entry vestibule walls and the floors of window wells contain some evidence of limewashes, but all other walls throughout the lighthouse are exposed brick. Historical accounts of other lighthouse in the same region, namely the Bodie Island Lighthouse to the north, indicate that the interior was typically whitewashed on a regular basis.¹² This would certainly be in keeping with nineteenth century practices of maintenance and hygiene. White limewash was found on the entry vestibule walls and also on the bottom four courses of brick in the boiler room (in a location that would have been under a wood platform and therefore protected), suggesting that historically a white limewash treatment may have been applied to the interior of the lighthouse. Unfortunately, the lack of physical evidence prevents this from being documented with any degree of certainty. (*Figures 11 and 12*)

Figure 11. Cape Lookout Lighthouse, September 2008. Evidence of white limewash on the entry vestibule walls. All other finishes have been removed from the interior brick walls. Photograph by author.

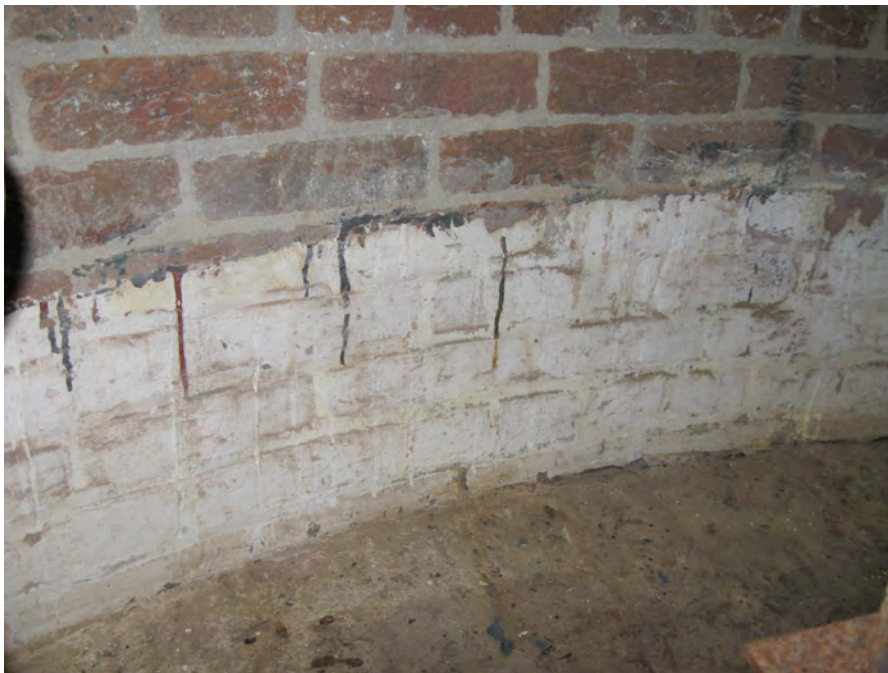
Figure 12. Cape Lookout Lighthouse, September 2008. Additional evidence of limewash was found in the boiler room, in an area previously covered by a wood platform. Photograph by author.

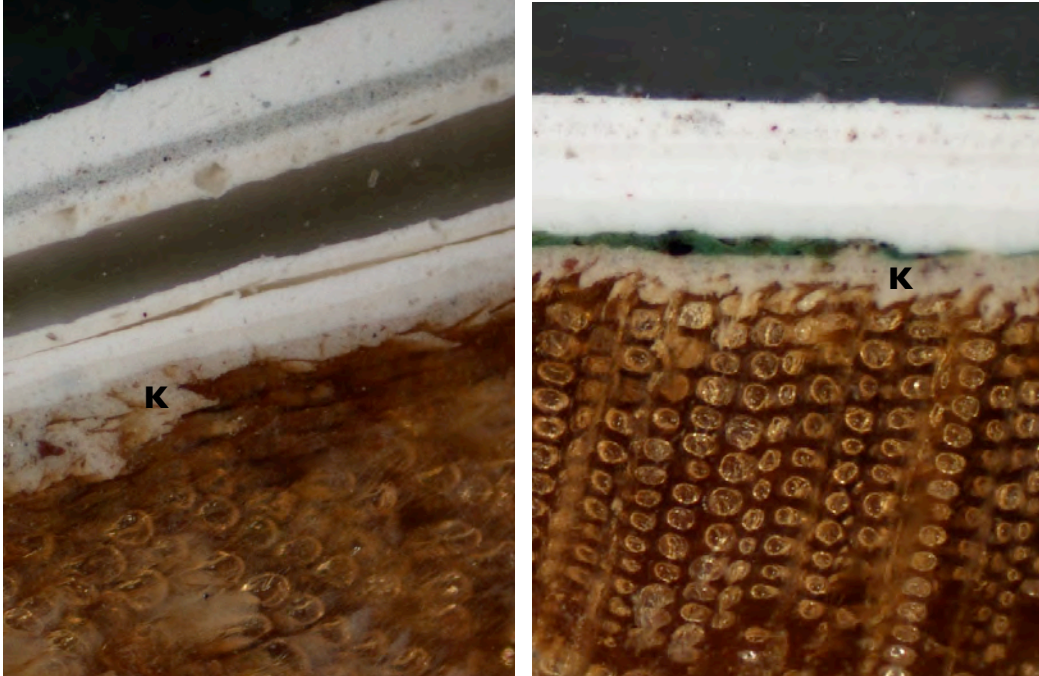
The interior woodwork of the Cape Lookout Lighthouse has a richer finishes history. In general, there is consistency between the paint evidence found on the salvaged woodwork and the pieces that remain in situ. On several pieces of interior woodwork, the earliest existing paint color is khaki. This color was found on a section of salvaged beadboard wall and associated interior door and frame, as well as on an in situ section of beadboard wall located on the service level of the lighthouse. These components of the lighthouse are believed to be contemporaneous, dating from a 1914 period of modification for the lighthouse.¹³ On the salvaged interior door, the khaki color was documented on rails and stiles but the panels were picked out in a dark green. (*Figures 13 and 14*)

Figure 14. Cape Lookout Lighthouse. A comparison of two paint samples, CALO.SALV.4 (left) and CALO.SALV.5 (right), removed from the stile (left) and the recessed panel (right) of a salvaged interior door. Note the layer of dark green applied over the original khaki (K) paint only on the sample removed from the panel. This evidence suggests polychromy. Photograph by author, 100x magnification.

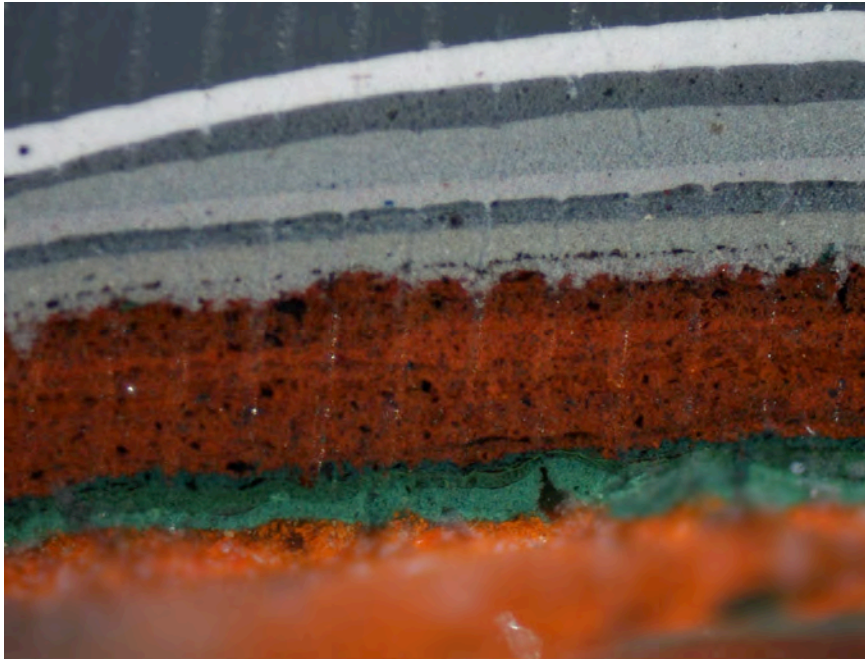
Other metal components of the interior were painted differently. The earliest paint color on the central cast iron column was dark green (two layers), followed by numerous red-browns and grays. The dark green was applied directly over a red primer on the metal, indicating it may have been original. In total, however, there were twelve layers of paint applied to the column. The earliest color on the cast iron stair treads was dark gray, followed by several red-browns and dark grays. This area also contained approximately twelve layers of paint. Although there are a fair number of paint layers on both of these interior elements, the lighthouse would have been well maintained and one would expect to find evidence of even more paint layers. There is unfortunately no way to determine whether or not the early dark green and gray paint colors on these metal components are original. (*Figures 17 and 18*)

Figure 17. Cape Lookout Lighthouse. Photomicrograph of Sample CALO. I.3, removed from the astragal of the center cast iron column (at the Watch Level). Note the early red-orange primer followed by a dark green paint finish at bottom of photograph. This campaign may be original. Photograph by author, 100x magnification.

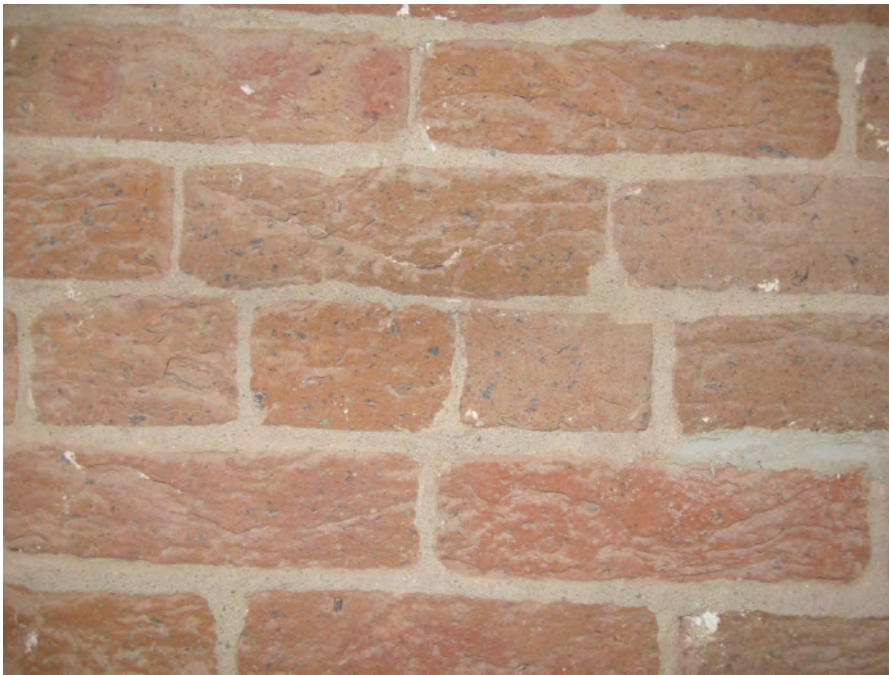
Figure 19. Cape Lookout Lighthouse, September 2008. Area of typical interior brickwork showing the brick's hand-pressed, low-fired quality and appearance. Photograph by author.

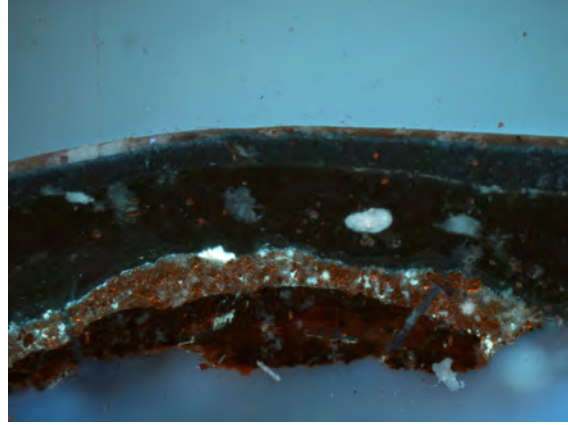
SAMPLE NO:	CALO.E.3b
LOCATION:	Watch Level, metal railing

LAYER*	COLOR (VL)	COLOR (UV)	NOTES
Substrate	Metal		
1	Silver	Red	
2	Black	Black	
3	Black	Black	
4	Black	Brown	
5	Black		
6			
7			
8			
9			
10			
11

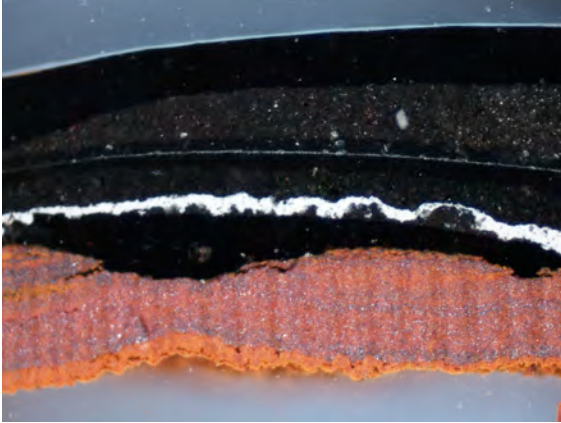
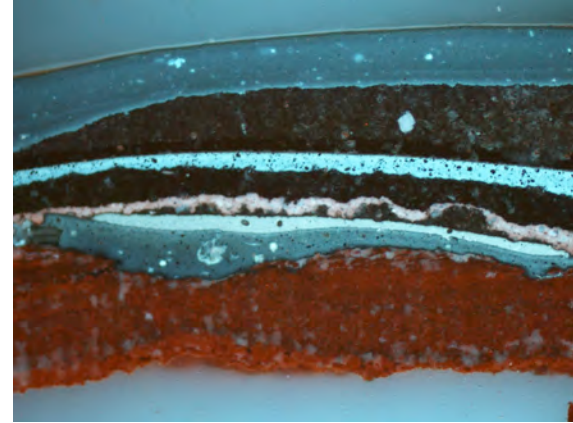
SAMPLE NO:	CALO.E.4
LOCATION:	Watch Level, copper sheet metal conical cover

LAYER*	COLOR (VL)	COLOR (UV)	NOTES
Substrate			
1	Red-orange		Primer
2	Red		
3	Black	Blue-green	
4	Black	Light blue-green	
5	Black	Dark gray	Uneven, weathered
6	White	White	
7	Black	Black	
8	Black	Bright blue-green	
9	Black	Black	Thick
10	Black	Light blue-green	Thick
11	Black	Dark gray	Very thin
12

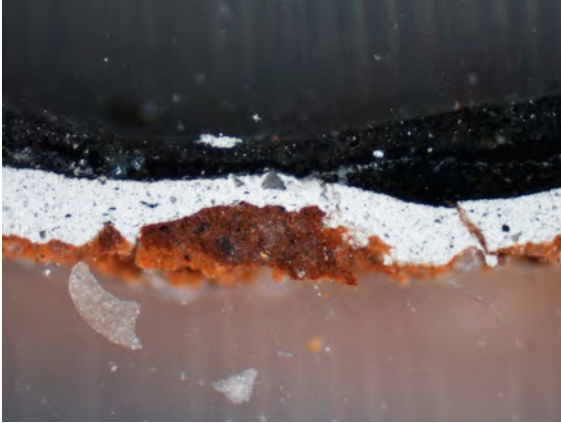
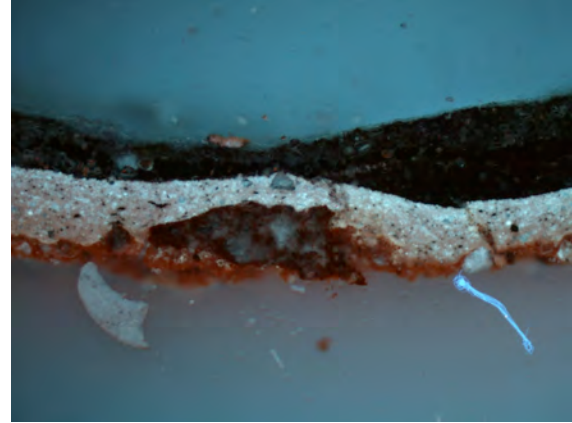
SAMPLE NO:	CALO.E.5a
LOCATION:	Watch Level, brick masonry

LAYER*	COLOR (VL)	COLOR (UV)	NOTES
Substrate	Brick		
1	Red-orange	Red-orange	Limewash
2	Red	Dark red	Limewash? Brick?
3	White	White	
4	Black	Black	
5	Black	Gray	
6			
7			
8			
9			
10			
11

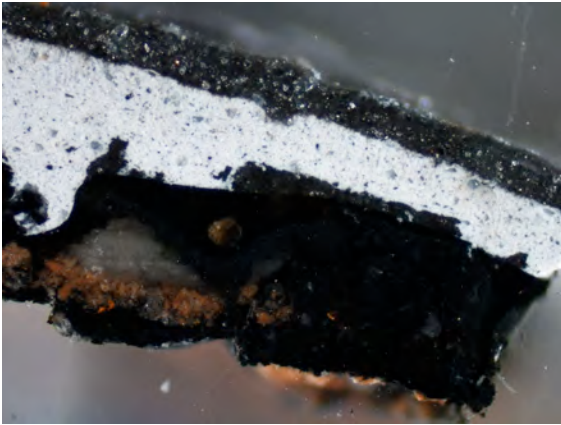
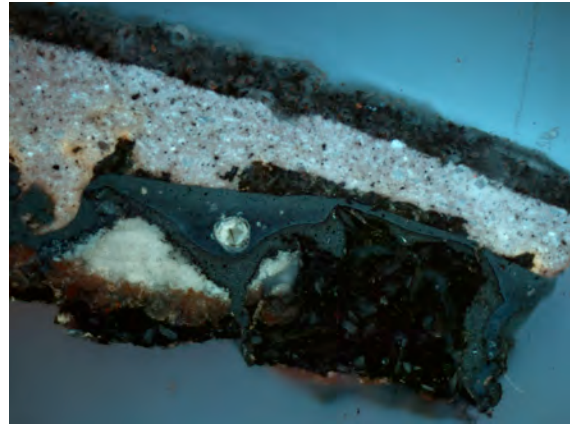
SAMPLE NO:	CALO.E.5b
LOCATION:	Watch Level, brick masonry

LAYER*	COLOR (VL)	COLOR (UV)	NOTES
Substrate	Brick		
1	Black	Dark gray	
2	Black	Dark blue-gray	Smooth
3	Black	Dark Gray	Not continuous
4	White	White/iridescent	
5	Dark gray	Gray	
6			
7			
8			
9			
10			
11

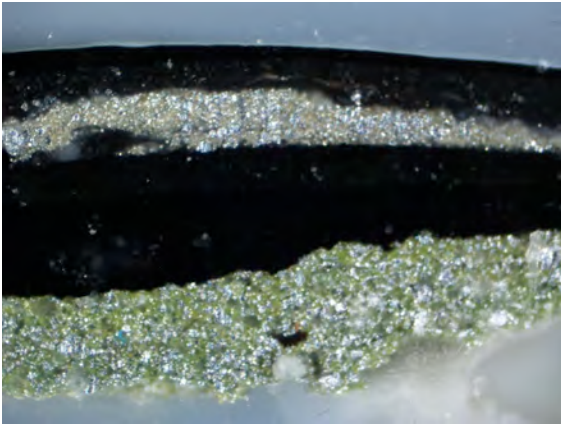
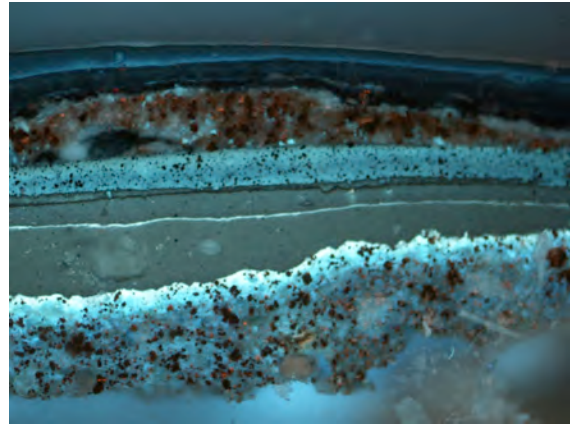
SAMPLE NO:	CALO.E.6
LOCATION:	Lantern Level, Observation Deck, cast iron plate floor

LAYER*	COLOR (VL)	COLOR (UV)	NOTES
Substrate			
1	Reflective green	Blueish-white matrix	Heterogenous pigment particles fluorescing differently; primer
2	Black	Gray	Smooth
3	Black	Blue-green	Very thin
4	Black	Gray	Smooth
5	Dirt		
6		Gray	Very thin
7	Dirt		
8	Black	Blue-green	
9	Silver	Multi-color	
10	Black	Gray	
11	Black	Blue	
12	Black	Gray

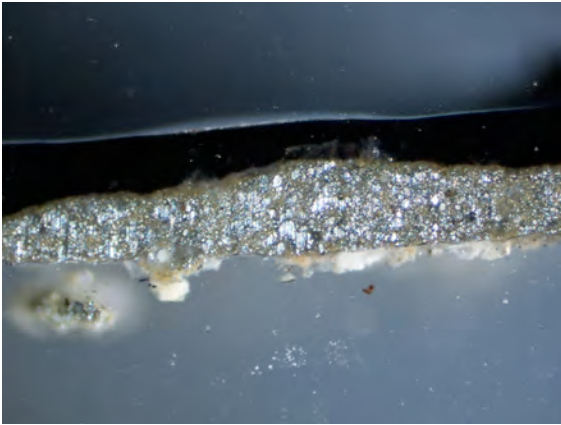
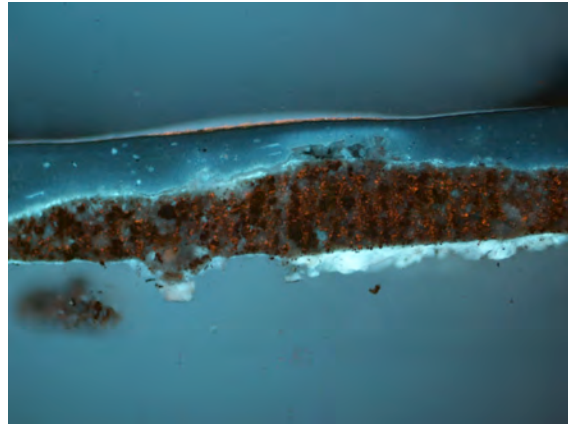
SAMPLE NO:	CALO.E.7
LOCATION:	Lantern Level, Observation Deck, copper alloy vertical member

LAYER*	COLOR (VL)	COLOR (UV)	NOTES
Substrate			
1	White/tan	Blue-green	Paint? Oxidation?
2	Silver	Multi-color	Thick; primer – seems to match to later layers in CALO.E.6 suggesting this is a later finish and was either unpainted or had earlier paint removed
3	Black	Blue	
4			
5			
6			
7			
8			
9			
10			
11

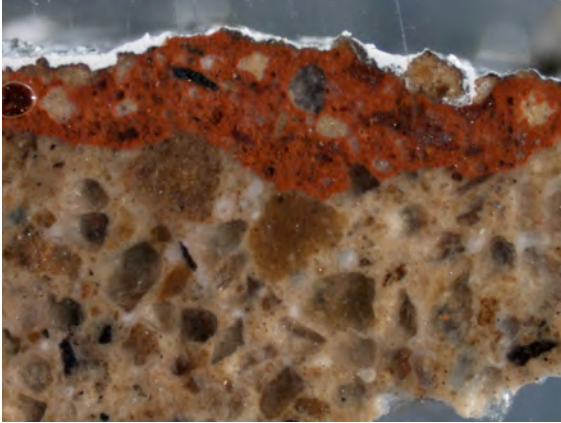
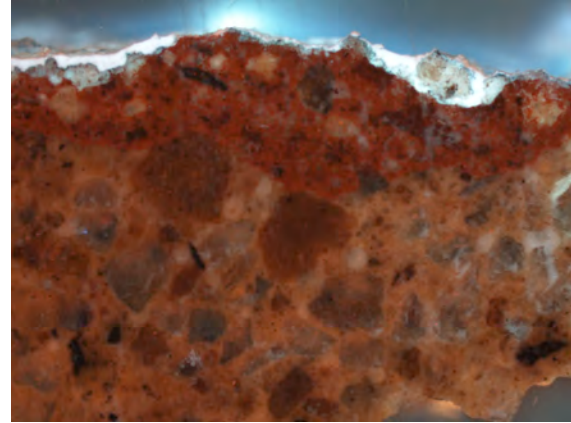
SAMPLE NO:	CALO.E.8a
LOCATION:	Exterior paint on brick

LAYER*	COLOR (VL)	COLOR (UV)	NOTES
Substrate	Mortar		
1	Red	Red	Limewash
2	White	White	Paint
3			
4			
5			
6			
7			
8			
9			
10			
11

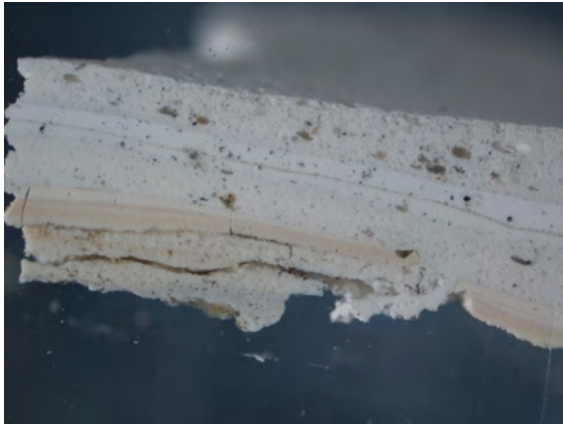
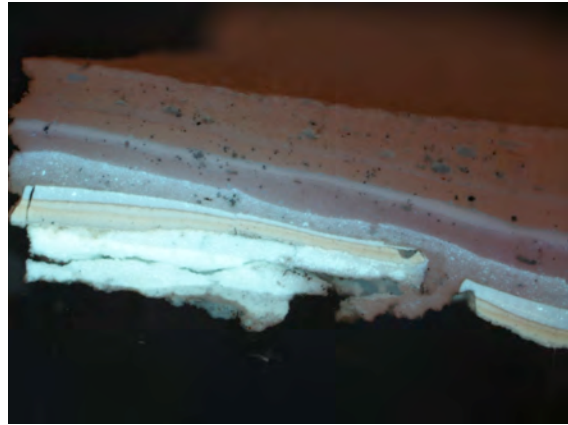
SAMPLE NO:	CALO.E.8b
LOCATION:	Exterior paint on brick, currently white

LAYER*	COLOR (VL)	COLOR (UV)	NOTES
Substrate	Brick		
1	Red		Limewash (see sample E.8a)
2	Gray-white	Bright gray	
3	Creamy white	Bright white	Separated within – not continuous
4	Off-white	Blue-green	
5	Dirt/separation		
6	Pinky-white	Off-white	
7	Pinky-white	Bright pinky-white	
8	Pinky-white	Cream	
9	Creamy white	Bright blue-green	Thin
10	White	Blue-green	
11	White	Pink	
12	White	White	
13	Dirt		
14	White	Pink	
15	Gray-white	Pink	
16

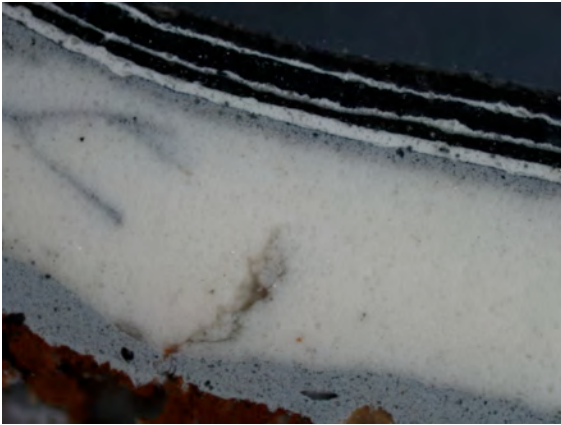
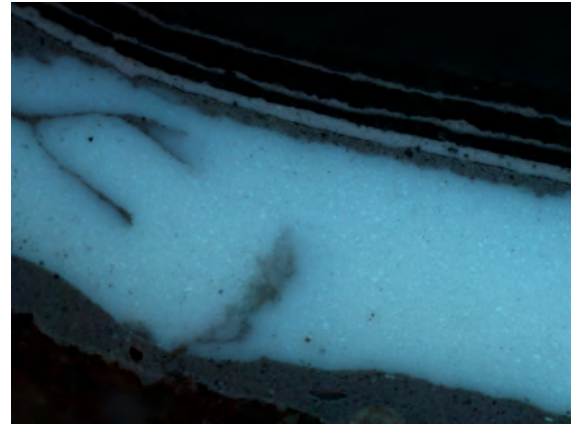
SAMPLE NO:	CALO.E.9
LOCATION:	Exterior paint on brick, currently black

LAYER*	COLOR (VL)	COLOR (UV)	NOTES
Substrate	Brick		
1	Red		limewash
2	Gray	Gray	
3	White	Blue-green	Very thick
4	Gray	Gray	
5	Dirt		
6	White	White	
7	Black	Black	
8	White	White	Thin
9	Black	Black	
10	White	White	Thin
11	Black	Black

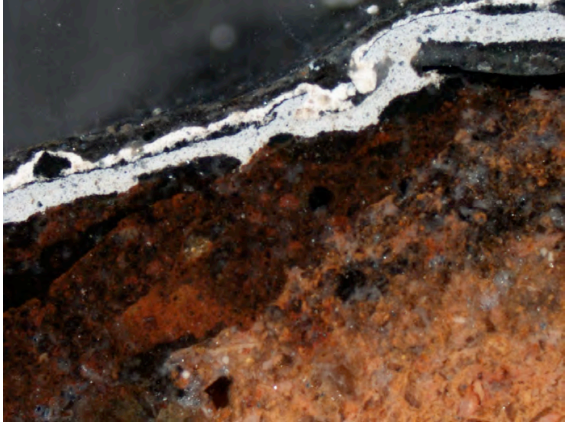
SAMPLE NO:	CALO.E.10
LOCATION:	Exterior paint on brick.

LAYER*	COLOR (VL)	COLOR (UV)	NOTES
Substrate	Brick		
1	Orange-red		limewash
2	Brown-red		limewash
3	Black		
4	Black		
5	Gray		
6	White		
7	Black		
8	White		
9	Black

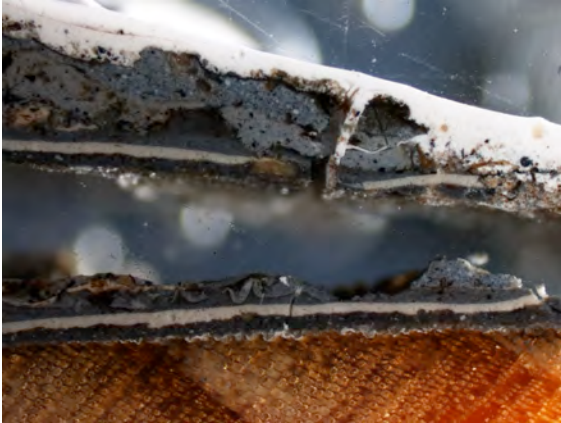
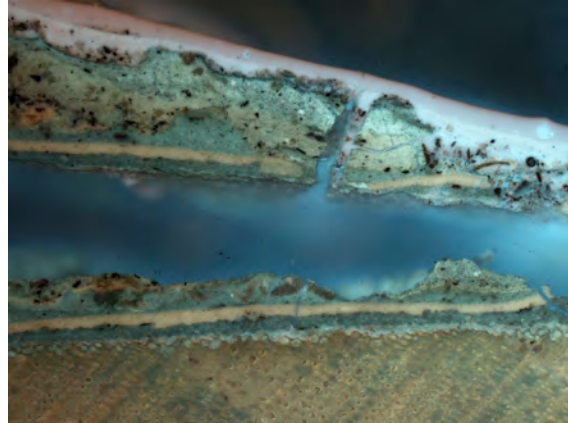
SAMPLE NO:	CALO.I.I
LOCATION:	Watch Level, wood cabinet, top

LAYER*	COLOR (VL)	COLOR (UV)	NOTES
Substrate	Wood		
1	White/Light gray		Very, very thin and uneven
2	Gray	Gray	
3	Dirt		
4	White	Cream	
5	Gray	Gray	Uneven, weathered
6	Dirt		
7	Light gray	Green	Uneven – separation at this layer
8	Dirt		
9	White		
10	White	Pink	
11			
12			
13

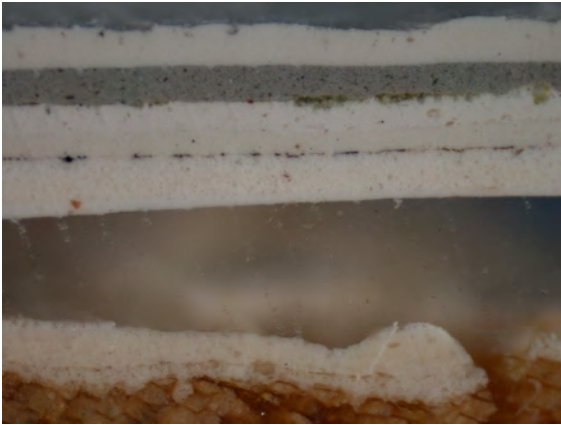
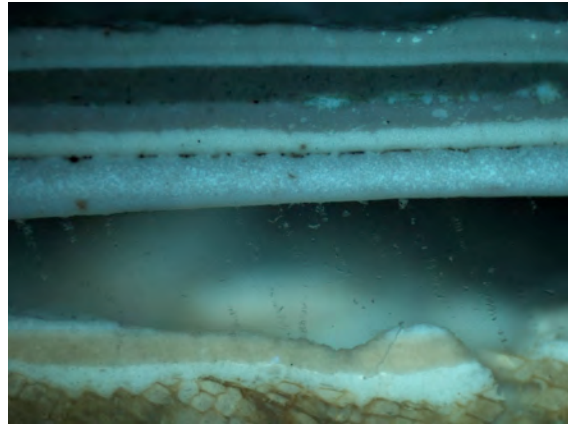
SAMPLE NO:	CALO.I.2
LOCATION:	Watch Level, wood cabinet, front

LAYER*	COLOR (VL)	COLOR (UV)	NOTES
Substrate	Wood		
1	Beige	Bright white	
2	Creamy White	Bright beige	Separation at this layer
3	White	Blue-green	
4	Dirt		
5	Creamy White	Bright white	
6	White	Bright gray	
7	Dirt		
8	Gray	Dark gray	
9	White	Blue-green	
10			
11

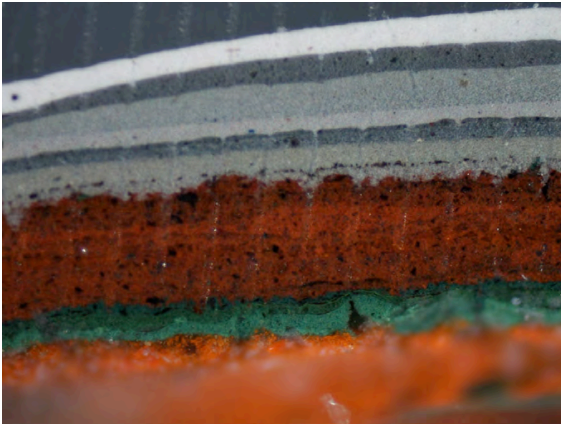
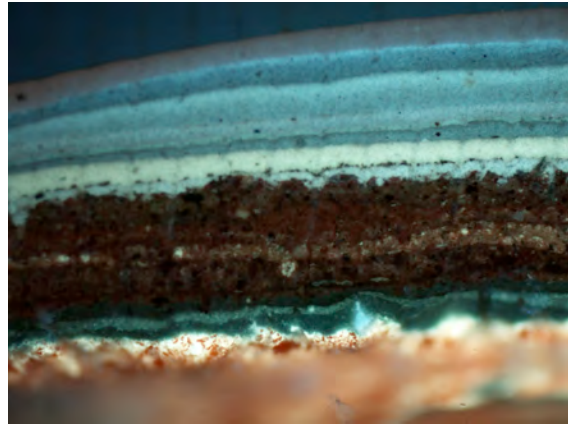
SAMPLE NO:	CALO.I.3
LOCATION:	Watch Level, center column shaft, astragal

LAYER*	COLOR (VL)	COLOR (UV)	NOTES
Substrate	Metal		
1	Orange		Primer
2	Green		
3	Dark Green		
4	Dark Green		
5	Red		Thick, primer, heavily prepped surface
6	Light gray		
7	Blue-gray		
8	Gray		
9	Light Gray		
10	Blue-gray		
11	Gray		
12	White

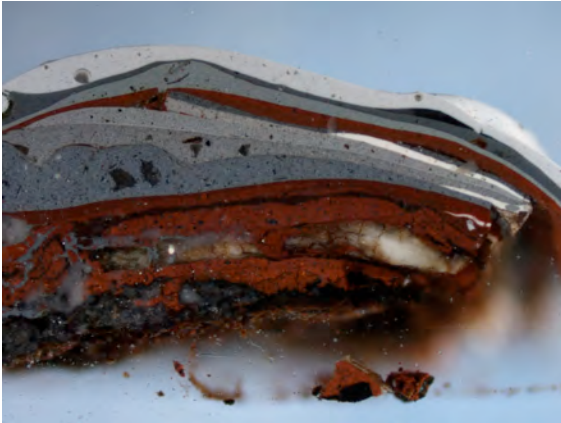
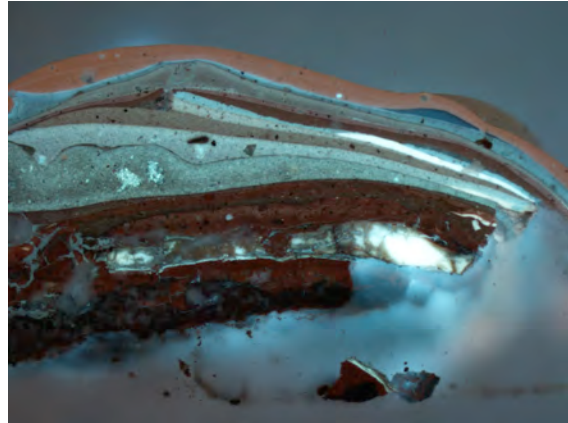
SAMPLE NO:	CALO.I.4
LOCATION:	Watch Level, Cast iron stair, tread, between watch and lantern levels

LAYER*	COLOR (VL)	COLOR (UV)	NOTES
Substrate	Metal		
1	Gray		
2	Dark Gray/Black		
3	Red		Primer
4	Red		Primer
5	White?		Very distressed layer
6	Red		
7	Red		
8	Brown-red?		
9	Red		
10	Blue-gray		
11	Gray

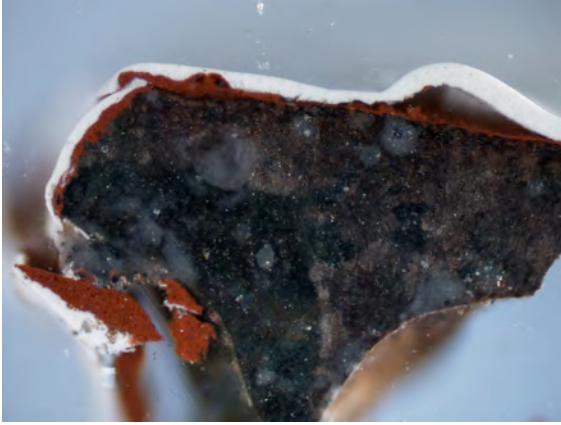
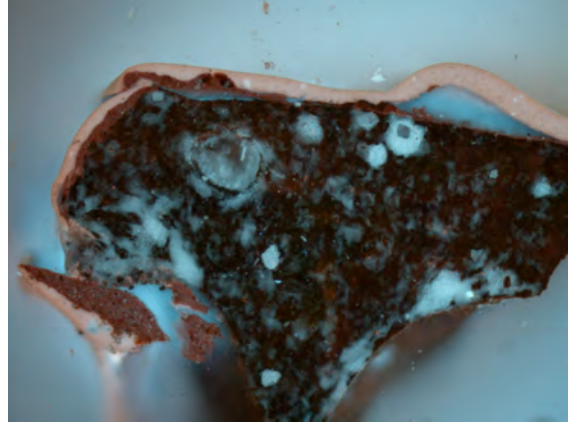
SAMPLE NO:	CALO.I.5
LOCATION:	Watch Level, door to balcony, surround, interior face

LAYER*	COLOR (VL)	COLOR (UV)	NOTES
Substrate	Metal		
1	Dark Gray		Fill
2	Black		
3	Red	Red	
4	White	Pink	
5			
6			
7			
8			
9			
10			
11

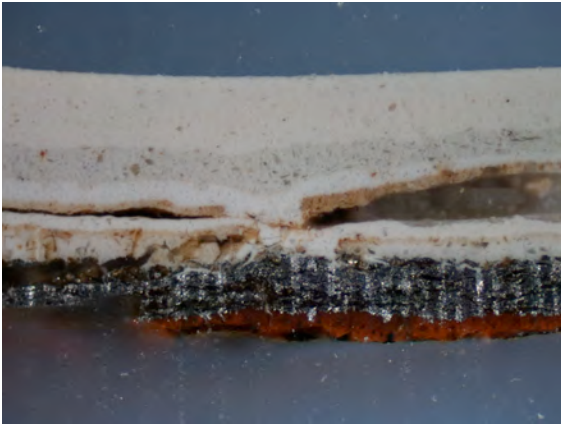
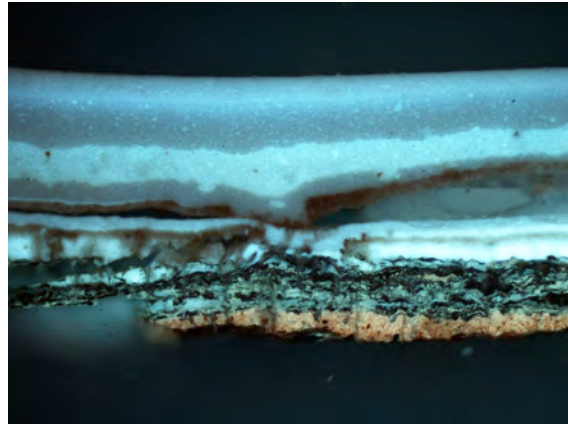
SAMPLE NO:	CALO.I.6
LOCATION:	Lantern Level, glass lantern vertical frame member, interior face

LAYER*	COLOR (VL)	COLOR (UV)	NOTES
Substrate	Metal		
1	Red	Brown	Primer
2	Silver	Multi-color	Primer
3	White	Blue-green	
4	Beige	Beige	Thin
5	White	Blue-green	Separation at this layer
6	Beige/Tan	Brown	
7	White	Light gray	
8	Light gray	Blue-green	
9	White	Bright gray	
10	White	Bright blue-green	
11

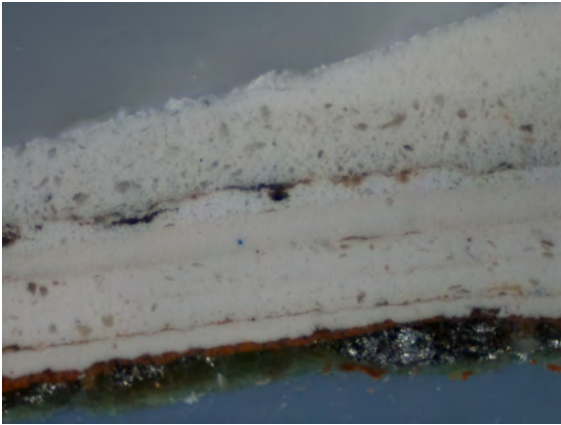
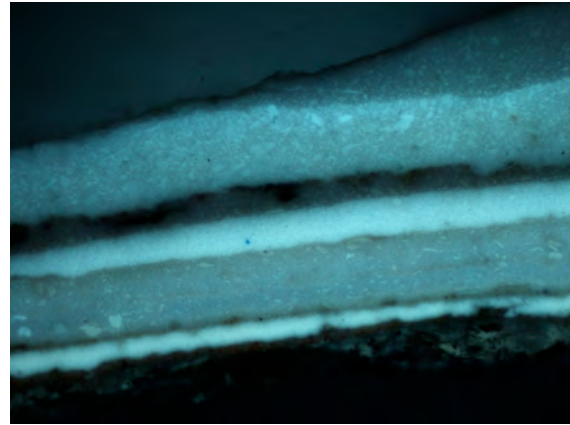
SAMPLE NO:	CALO.I.7
LOCATION:	Lantern Level, glass lantern horizontal frame member, interior face

LAYER*	COLOR (VL)	COLOR (UV)	NOTES
Substrate			
1	Green	n/a	Thin, uneven
2	Silver	Multi-color	Not continuous
3	Red-orange	n/a	Thin, uneven
4	White	Blue-green	
5	Dirt/separation		
6	White	Blue-green/gray	
7	White	Blue-green	
8	White	n/a	
9	White	n/a	Uneven
10	Dirt		
11	White	Bright blue-green	
12	White	Blue-green/gray

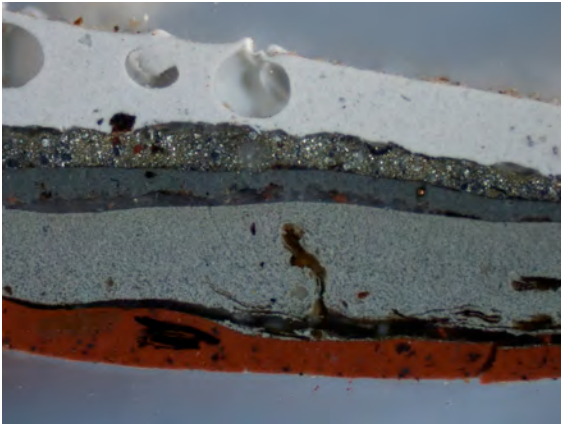
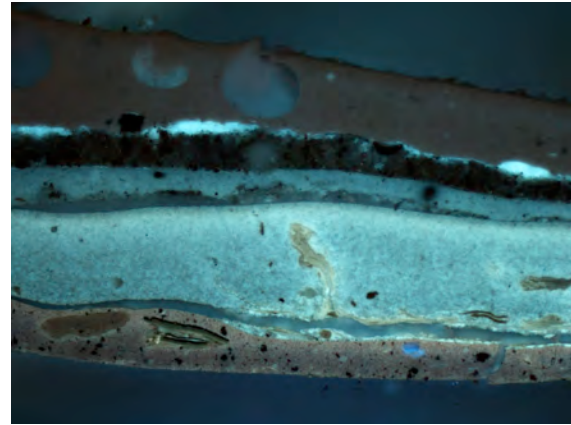
SAMPLE NO:	CALO.I.8
LOCATION:	Lantern Level, cast iron platform, below rotating lens

LAYER*	COLOR (VL)	COLOR (UV)	NOTES
Substrate			
1	Red	Beige/Pink	Primer
2	Dirt/separation		
3	Light gray	Bright blue-green	Primer
4	Gray	Gray	Uneven
5	Gray	Blue-green	
6	Silver	n/a	
7	Dark gray	Bright blue-green	
8	White		
9			
10			
11

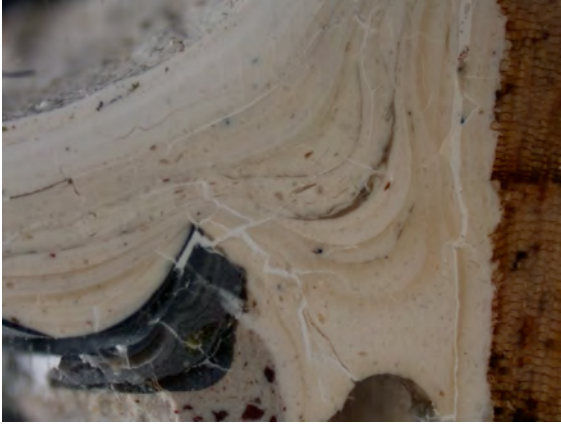
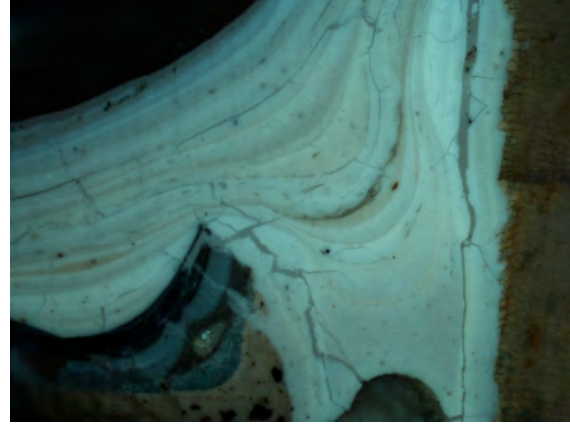
SAMPLE NO:	CALO.I.9
LOCATION:	Service Level, tongue and groove boardwall board

LAYER*	COLOR (VL)	COLOR (UV)	NOTES
Substrate	wood		
1	Lt. khaki/wm. gray	Dark	
2	Cream	Blue-white	
3	Off-white		
4	White		
5	White	Blue-white	
6	White	Blue-white	
7	cCeam	Blue-white	
8	Cream	White	
9	Cream	Blue-white	
10	Cream		
11	Off-white	Dark	
12	White	Blue-white	
13	White

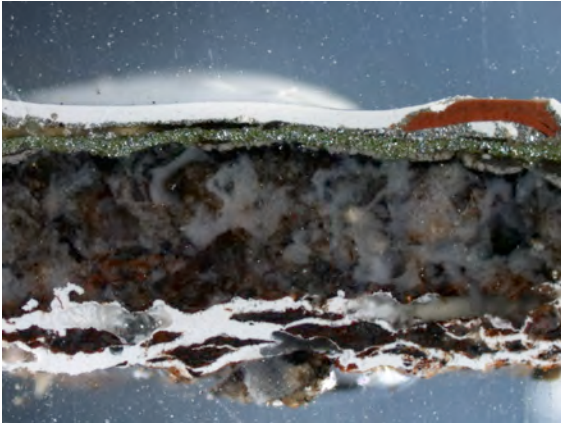
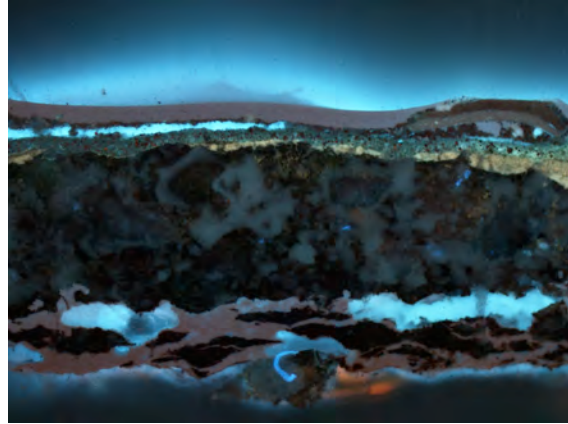
SAMPLE NO:	CALO.I.I.I
LOCATION:	Service Level, Stair tread, underside, between service and watch levels

LAYER*	COLOR (VL)	COLOR (UV)	NOTES
Substrate	Metal		
1	Dark gray		Thick
2	Black		Partial
3	Beige	Brown	
4	Dark Gray	Brown	
5	Iridescent green		
6	Silver		Partial
7	Red		Partial
8	Red		Partial
9	White		
10			
11

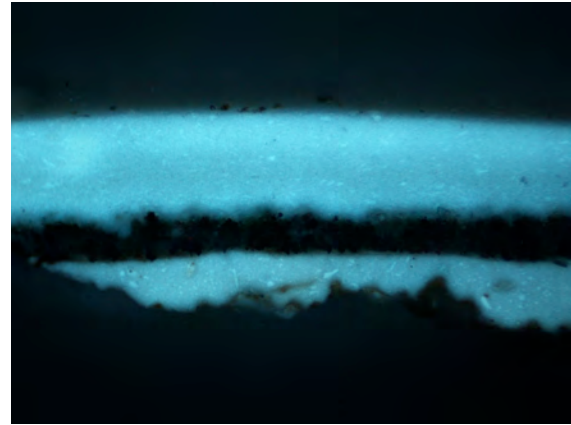
SAMPLE NO:	CALO.I.I2
LOCATION:	Service Level, cast iron column, from landing

LAYER*	COLOR (VL)	COLOR (UV)	NOTES
Substrate			
1	Brown	Brown	
2	White	Blue-green	
3	Orange		Partial
4	Silver	n/a	
5	White	Blue-green	
6			
7			
8			
9			
10			
11

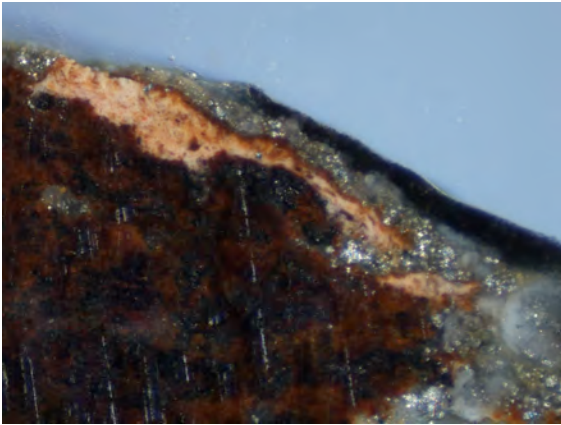
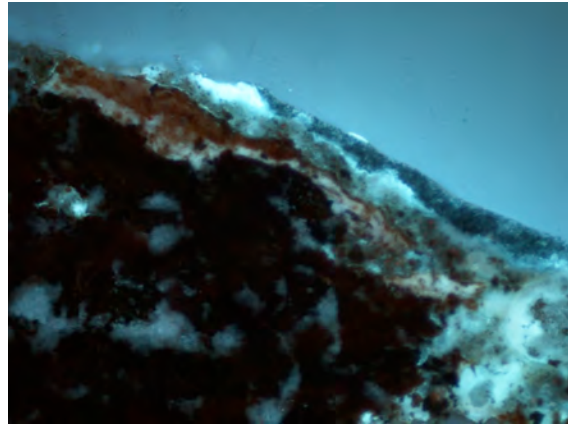
SAMPLE NO:	CALO.I.13
LOCATION:	Service Level, handrail, just before beadborad wall of service level

LAYER*	COLOR (VL)	COLOR (UV)	NOTES
Substrate			
1	Beige	Multi-color	
2	Beige	n/a	
3	Red	n/a	
4	Silver/green		
5	Black	Blue	
6			
7			
8			
9			
10			
11

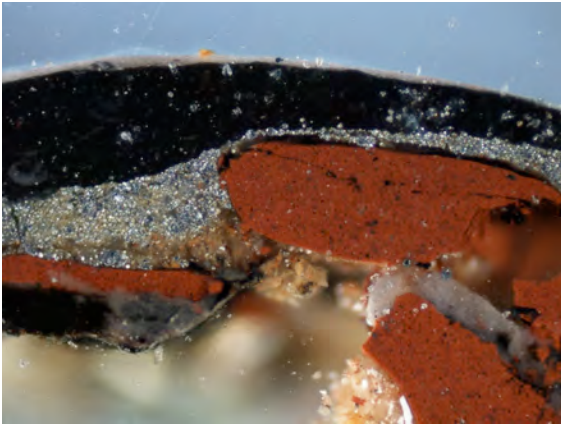
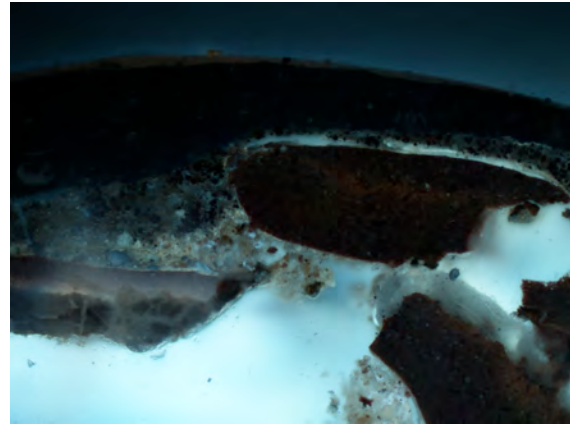
SAMPLE NO:	CALO.I.14
LOCATION:	Service Level, stair tread between service level and landing

LAYER*	COLOR (VL)	COLOR (UV)	NOTES
Substrate			
1	Black	Gray	
2	Red	Beige	
3	Silver		
4	Black	n/a	
5	White	n/a	
6			
7			
8			
9			
10			
11
