CAPE LOOKOUT LIGHTHOUSE

Cape Lookout National Seashore
North Carolina

HISTORIC STRUCTURE REPORT

December, 2008

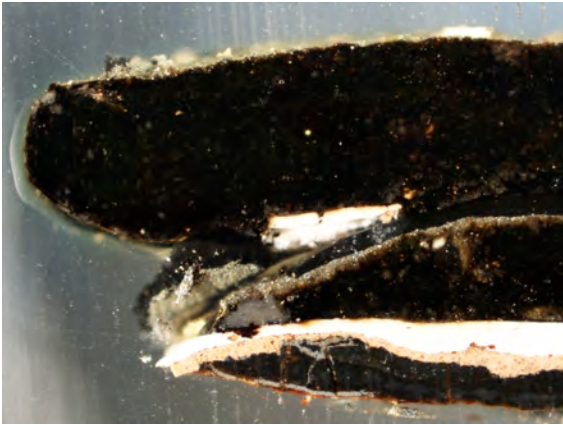
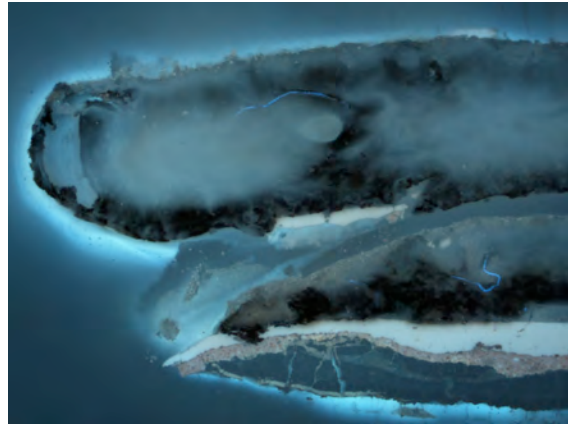
SAMPLE NO:	CALO.I.I15
LOCATION:	Service Level, center column, between service level and landing

LAYER*	COLOR (VL)	COLOR (UV)	NOTES
Substrate	Metal		
1	Light Gray		
2	Dark gray/Black		
3	Dark gray/Black		
4	Light Gray		
5	Beige		
6	White		
7	Brown		
8	Silver		
9	Black		
10			
11

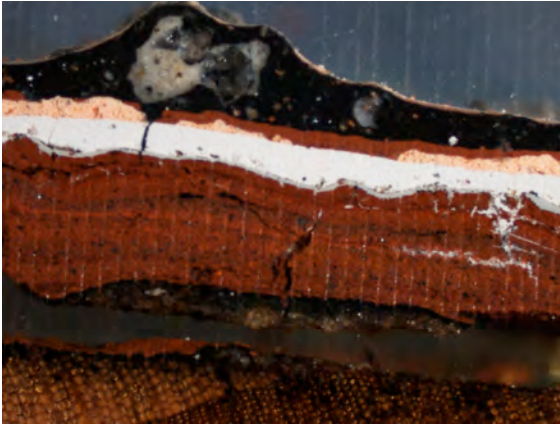
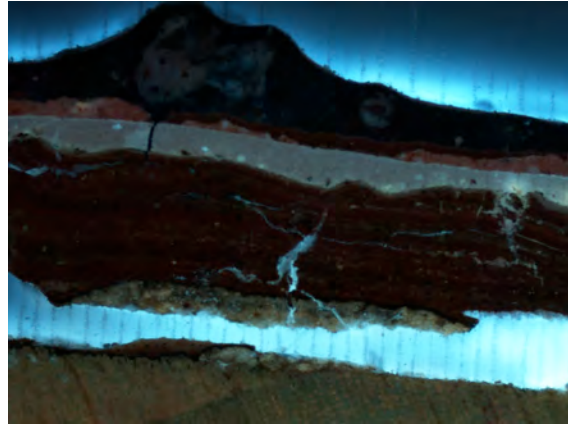
SAMPLE NO:	CALO.I.17
LOCATION:	Service Level, wood stair landing

LAYER*	COLOR (VL)	COLOR (UV)	NOTES
Substrate	Wood		SHOULD RELATE TO I.14
1	Brown		
2	Black		
3	Red-brown	n/a	Cracks within
4	Red-brown		
5	Red-brown		
6	Red-brown		
7	Light gray	Light gray	
8	Dirt		
9	White	Light gray	
10	Beige	Pink	Should relate to other samples
11	Red	n/a	
	Black	n/a

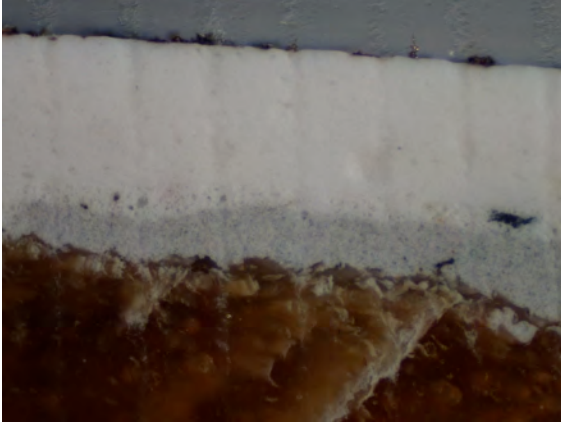
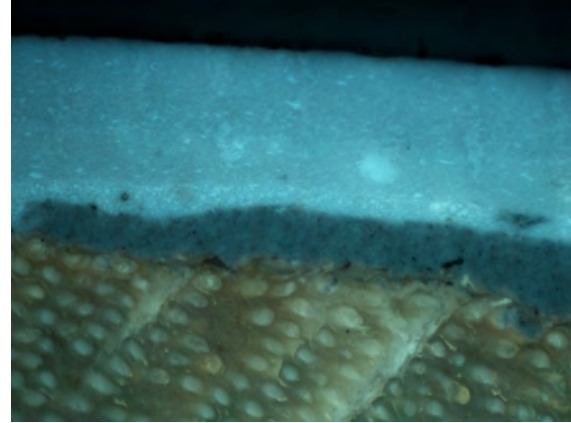
SAMPLE NO:	CALO.I.18
LOCATION:	Service Level, door frame at entry to second floor level

LAYER*	COLOR (VL)	COLOR (UV)	NOTES
Substrate	Wood		Stripped surface
1	Blue-gray	Gray	
2	White	Bright blue-green	Thin
3	White	Blue-green	Thick
4			
5			
6			
7			
8			
9			
10			
11

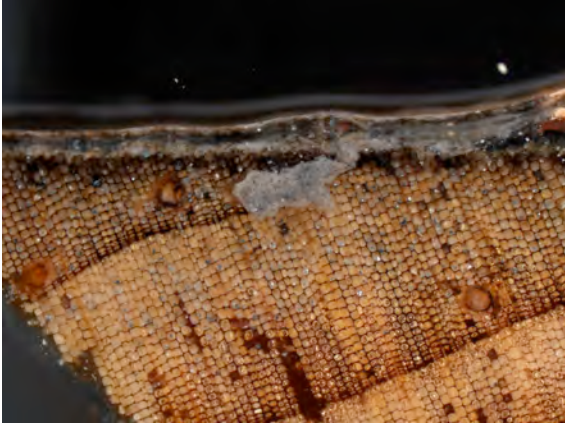
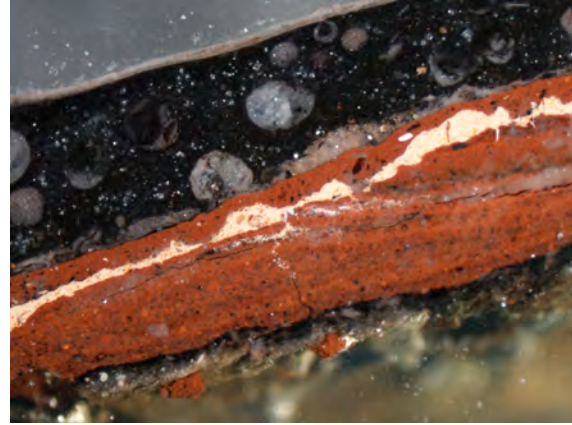
SAMPLE NO:	CALO.I.20
LOCATION:	Wood Stair Landing, Floor.

LAYER*	COLOR (VL)	COLOR (UV)	NOTES
Substrate	Wood		
1	Warm gray		
2	Res. brown		
3	White		
4	Red-orange		
5	Gray		
6	Black		
7	Red-orange		
8	Red-orange		
9	Red-orange		
10	Peach		
11	Red-orange		
12	Black		
13	Brown

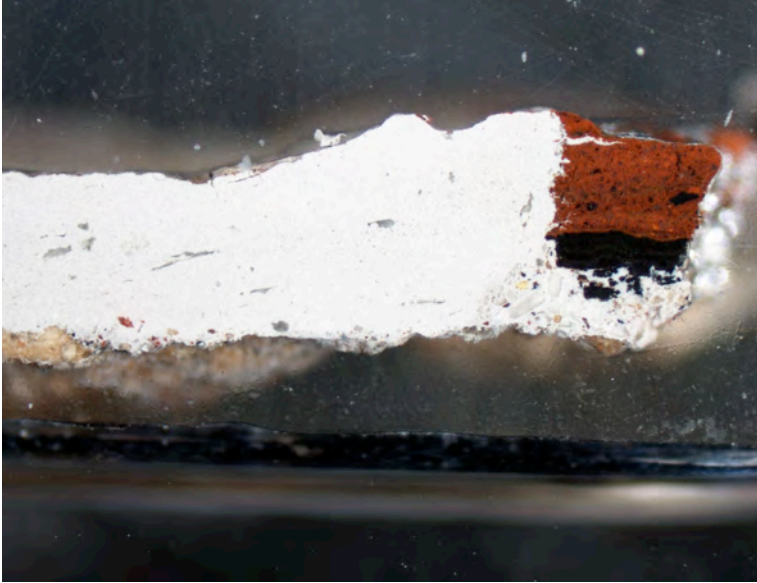
SAMPLE NO:	CALO.I.21
LOCATION:	Wood Stair Landing, Brick Window Well Floor.

LAYER*	COLOR (VL)	COLOR (UV)	NOTES
Substrate	Brick		
1	Red-brown		
2	Red-brown		
3	Black		
4	Black		
5	Black		
6	Black		
7	Off-white		limewash
8	Off-white		limewash
9	White

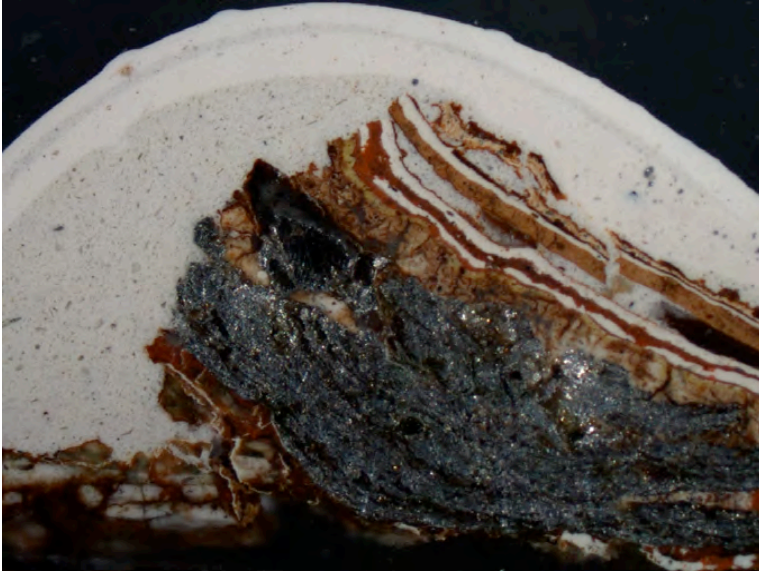
SAMPLE NO:	CALO.I.22
LOCATION:	Lantern, bronze frame piece.

LAYER*	COLOR (VL)	COLOR (UV)	NOTES
Substrate			
1	Red-orange		
2	Cream		
3	Cream		
4	Silver		thick
5	Cream		
6	Yellow-green		
7	Orange		
8	White		
9	Orange		
10	White		
11	Orange		
12	White		
13	Salmon		
14	White		
15	White		
16	Red-orange		
17	White		
18	White		
19	White

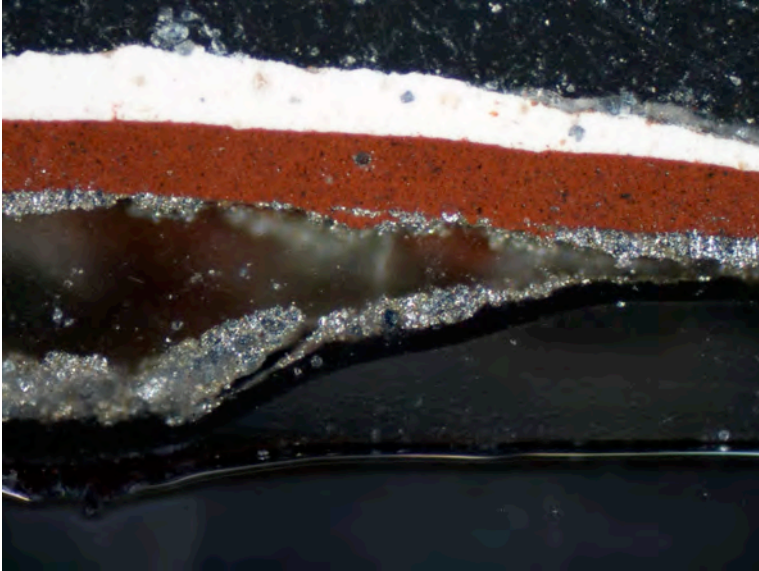
SAMPLE NO:	CALO.I.23
LOCATION:	Interior hand rail

LAYER*	COLOR (VL)	COLOR (UV)	NOTES
Substrate			
1	White		
2	Red		
3	Green		
4	Silver		
5	White		
6	Black		
7	Black

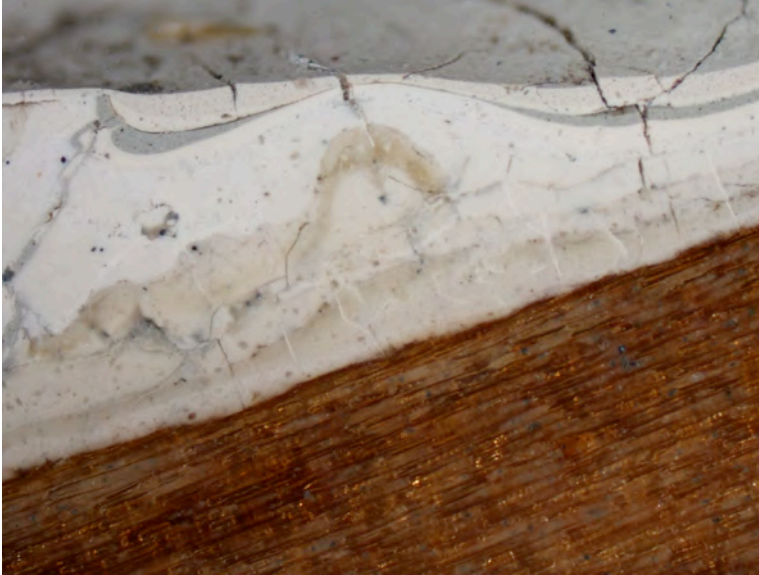
SAMPLE NO:	CALO.SALV.I
LOCATION:	Salvaged interior window sash, interior face.

LAYER*	COLOR (VL)	COLOR (UV)	NOTES
Substrate	Wood		
1	White		
2	White		
3	White		
4	White		
5	White		
6	White		
7	Light Gray		
8	White		
9	Off-White		grayish

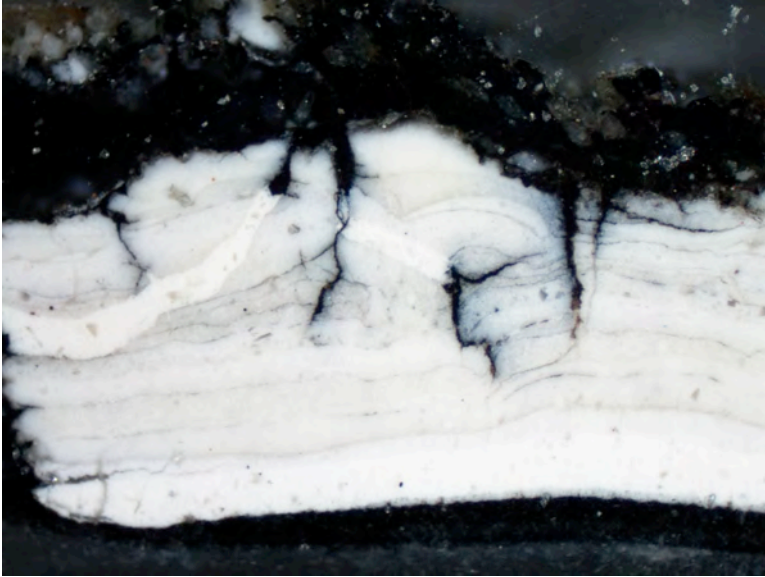
SAMPLE NO:	CALO.SALV.2
LOCATION:	Salvaged interior window sash, exterior face (black)

LAYER*	COLOR (VL)	COLOR (UV)	NOTES
Substrate	None		
1	White		
2	White		
3	White		
4	White		
5	White		
6	White		
7	White		
8	White		
9	White		
10	Black		Leaked down through earlier layers
11	Black

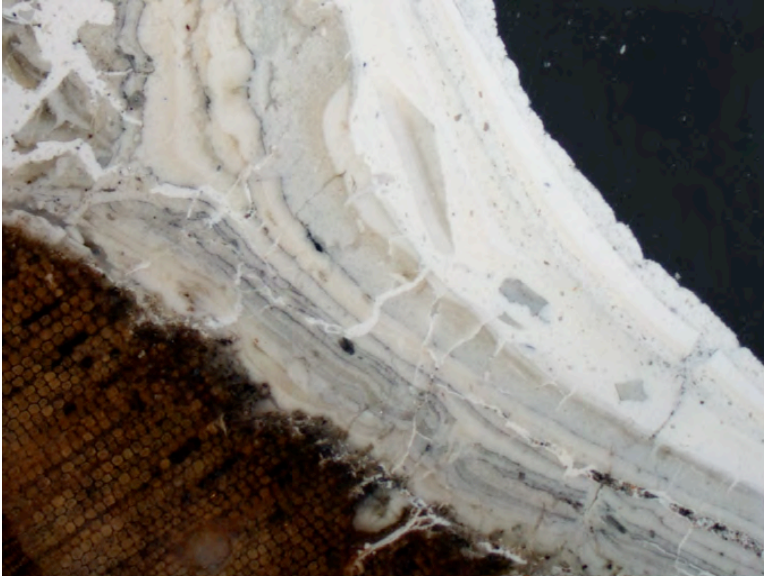
SAMPLE NO:	CALO.SALV.3
LOCATION:	Salvaged interior window sash, exterior face (white)

LAYER*	COLOR (VL)	COLOR (UV)	NOTES
Substrate	None		
1	White		Creamy
2	White		Grayish
3	White		Grayish
4	White		Grayish
5	White		Creamy
6	White		
7	White		Creamy
8	White		Creamy
9	White		
10	White		
11	White		Grayish
12	White		
13	White		
14	White		Creamy
15	White		
16	White		
17	White		
18	White		
19	White

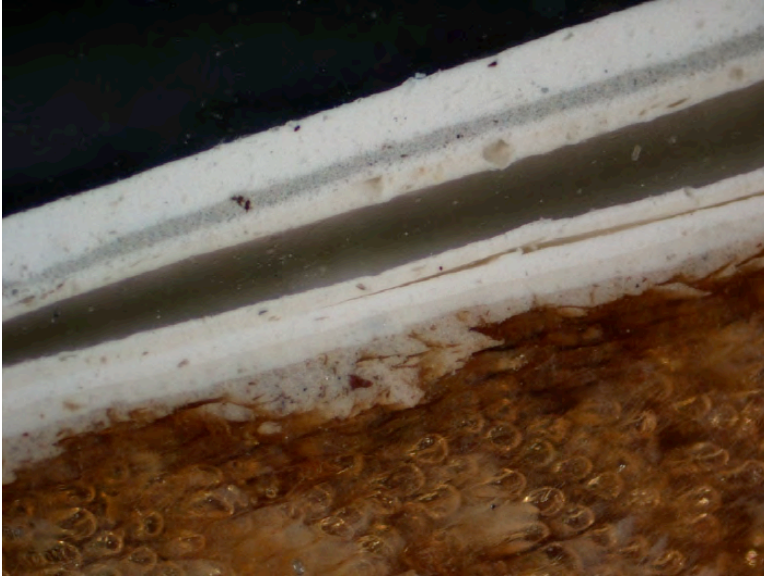
SAMPLE NO:	CALO.SALV.4
LOCATION:	Salvaged interior door, stile

LAYER*	COLOR (VL)	COLOR (UV)	NOTES
Substrate	None		
1	Light khaki/warm gray		
2	White		
3	White		
4	White		
5	White		
6	White		
7	White		
8	White		
9	Gray		
10	White

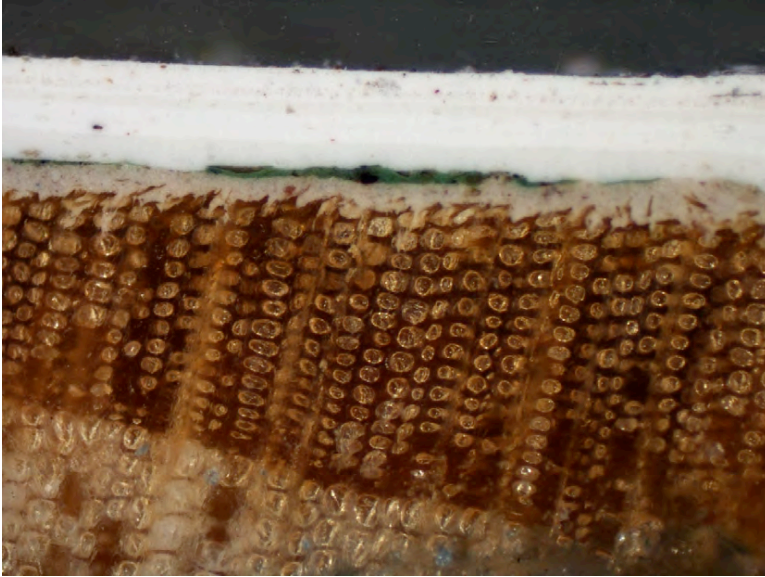
SAMPLE NO:	CALO.SALV.5
LOCATION:	Salvaged interior door, panel

LAYER*	COLOR (VL)	COLOR (UV)	NOTES
Substrate	None		
1	Light khaki/warm gray		
2	Dark kelly green		
3	White		
4	White		
5	White		
6	White		
7	White		
8	White		
9	White

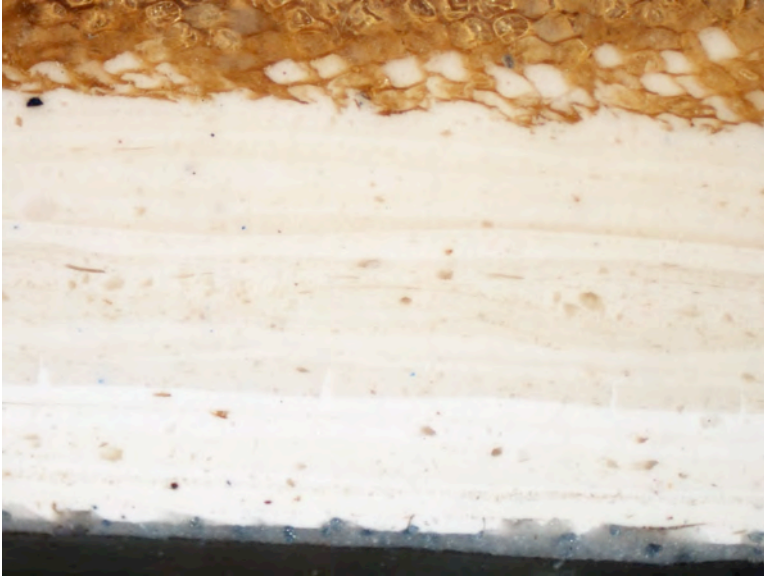
SAMPLE NO:	CALO.SALV.6
LOCATION:	Salvaged interior door frame

LAYER*	COLOR (VL)	COLOR (UV)	NOTES
Substrate	None		
1	White		
2	White		
3	White		
4	White		Grayish
5	White		Creamy
6	White		
7	White		
8	White		
9	White		
10	White		
11	White		Grayish
12	White		
13	White		
14	White		
15	White		
16	White		
17	White		
18	White		
19	White

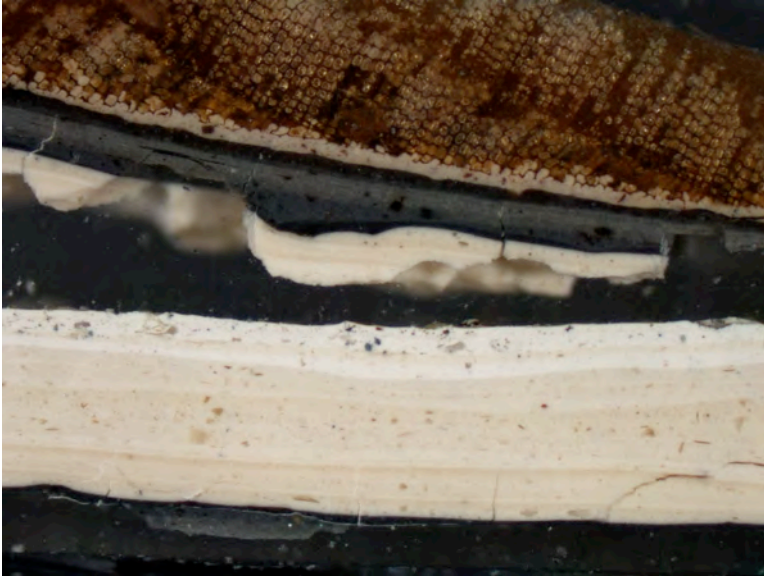
SAMPLE NO:	CALO.SALV.7
LOCATION:	Salvaged interior beadboard wall

LAYER*	COLOR (VL)	COLOR (UV)	NOTES
Substrate	None		
1	Khaki		
2	Dark gray		brownish
3	Blue-gray		
4	Medium gray		
5	Medium gray		
6	Blue-gray		
7	Dark gray		
8	White		
9	White		
10	White		
11	White		
12	White		
13	White		
14	White		
15	White		
16	White		
17	White		
18	White		
19	White		
20	White		
21	White		
22	White

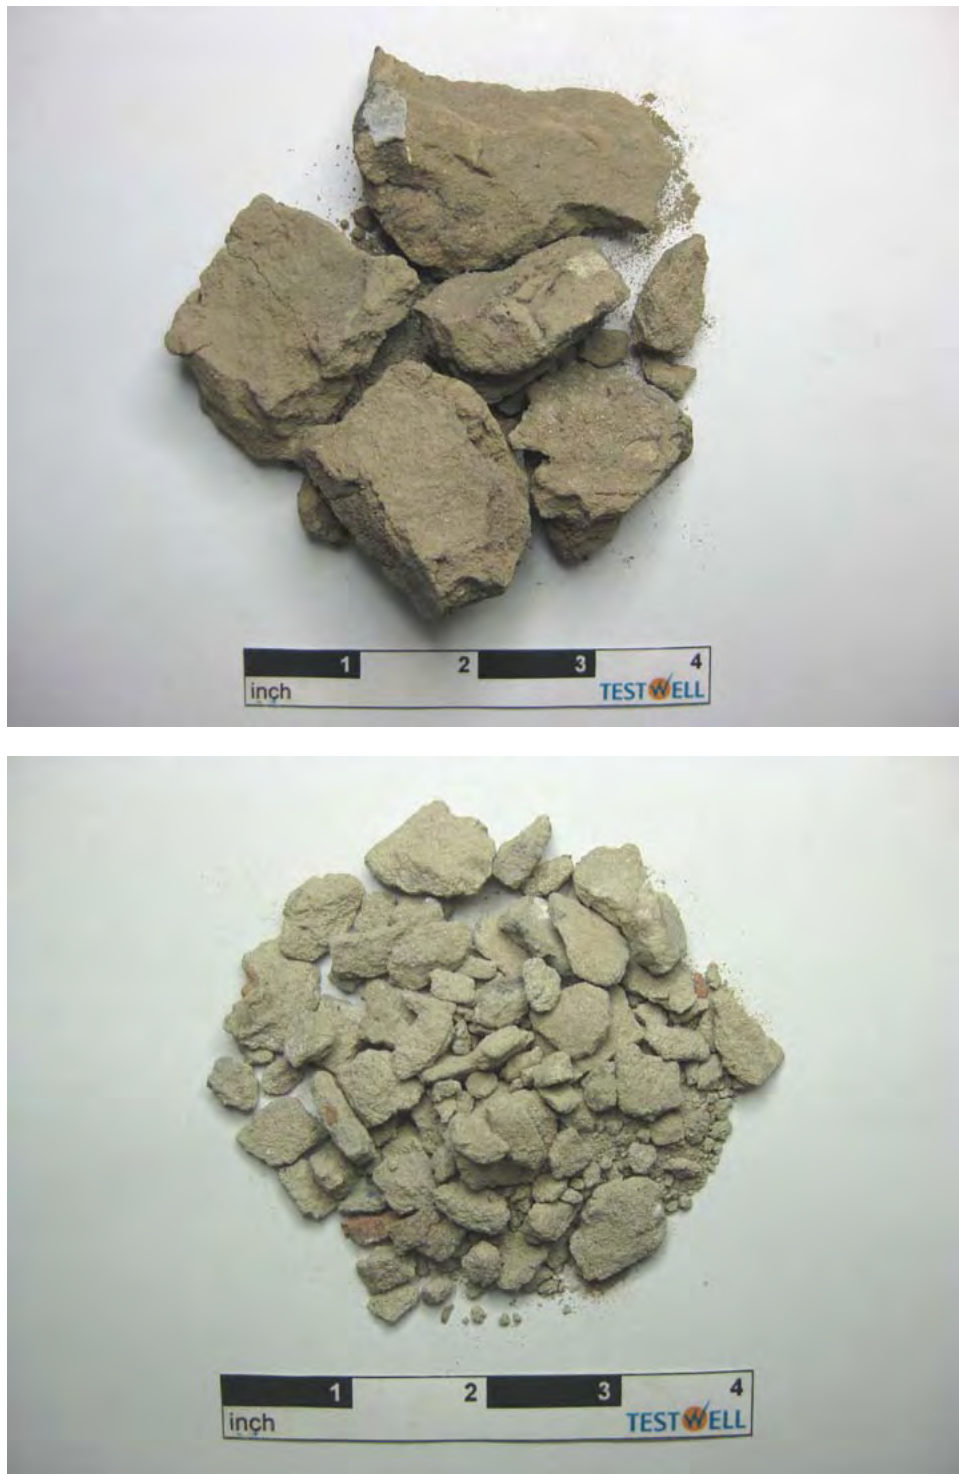
Figure 1: Mortar samples CALO.Mortar.1 (top) and CALO.Mortar.2 (bottom) received by Testwell for comprehensive analysis.

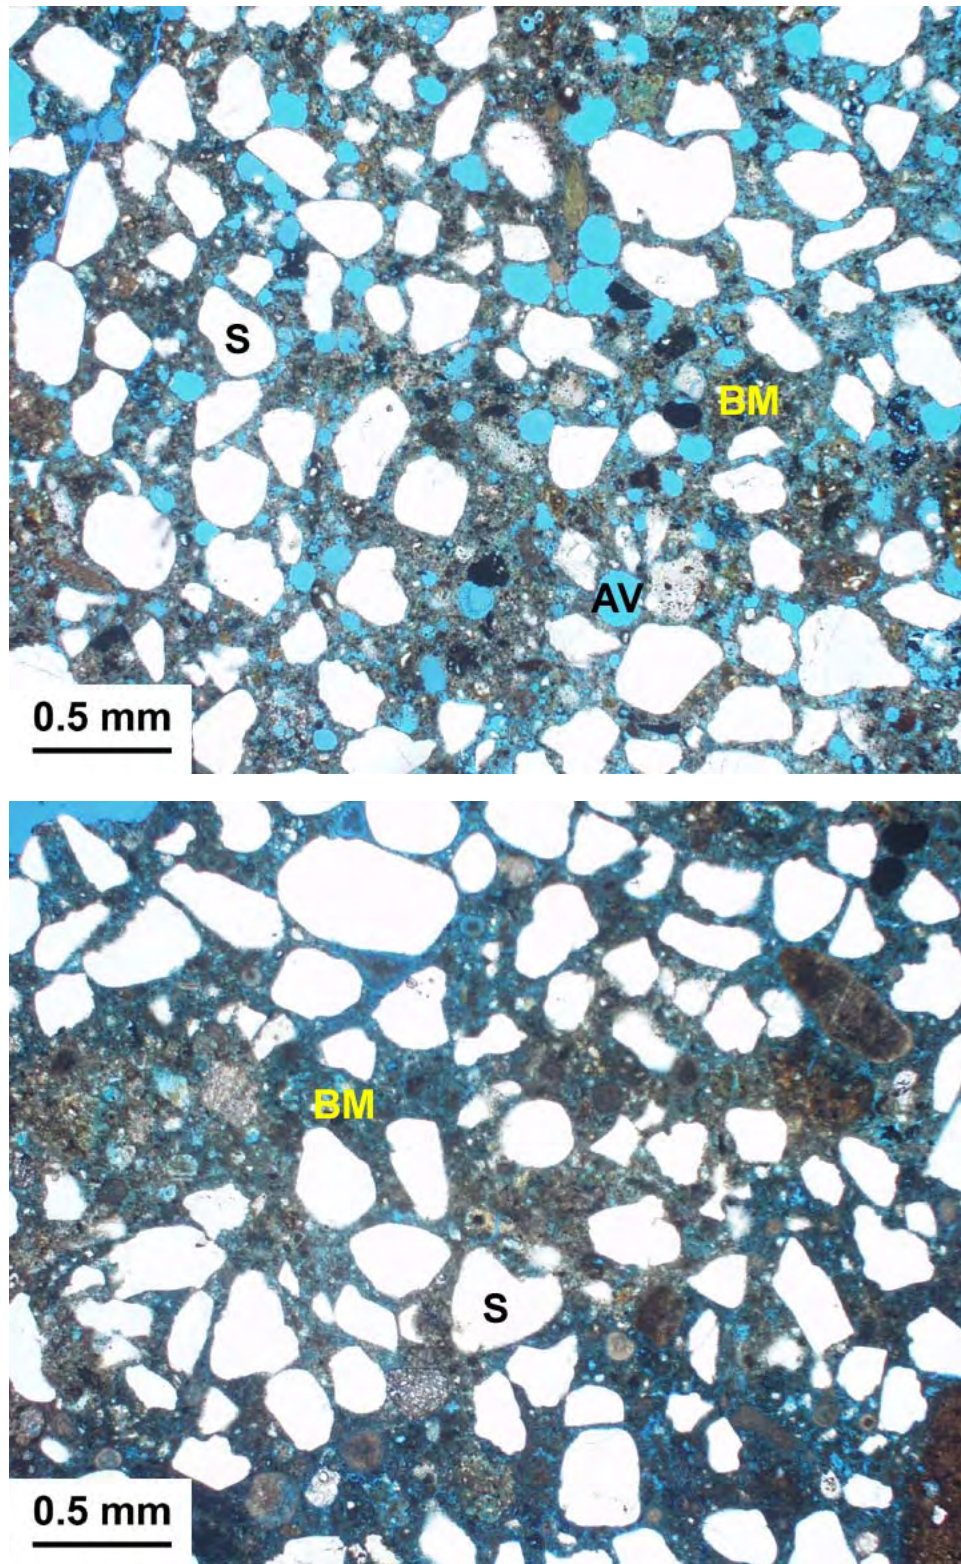
Figure 2: PPL photomicrographs illustrating the microtexture of mortar samples CALO.Mortar.1 (top) and CALO.Mortar.2 (bottom). Relatively rounded and narrowly graded sand grains (S) are well distributed throughout the binder matrix (BM). The cementitious matrix has a moderate capillary porosity as indicated by the blue-dyed epoxy used in the sample preparation. Air-voids (AV) are shown for sample CALO.Mortar.1 and these are abundant. Voids are nearly as abundant in sample CALO.Mortar.2 but are mostly filled with secondary calcium carbonate rendering them nearly invisible at this scale (see Figure 6).

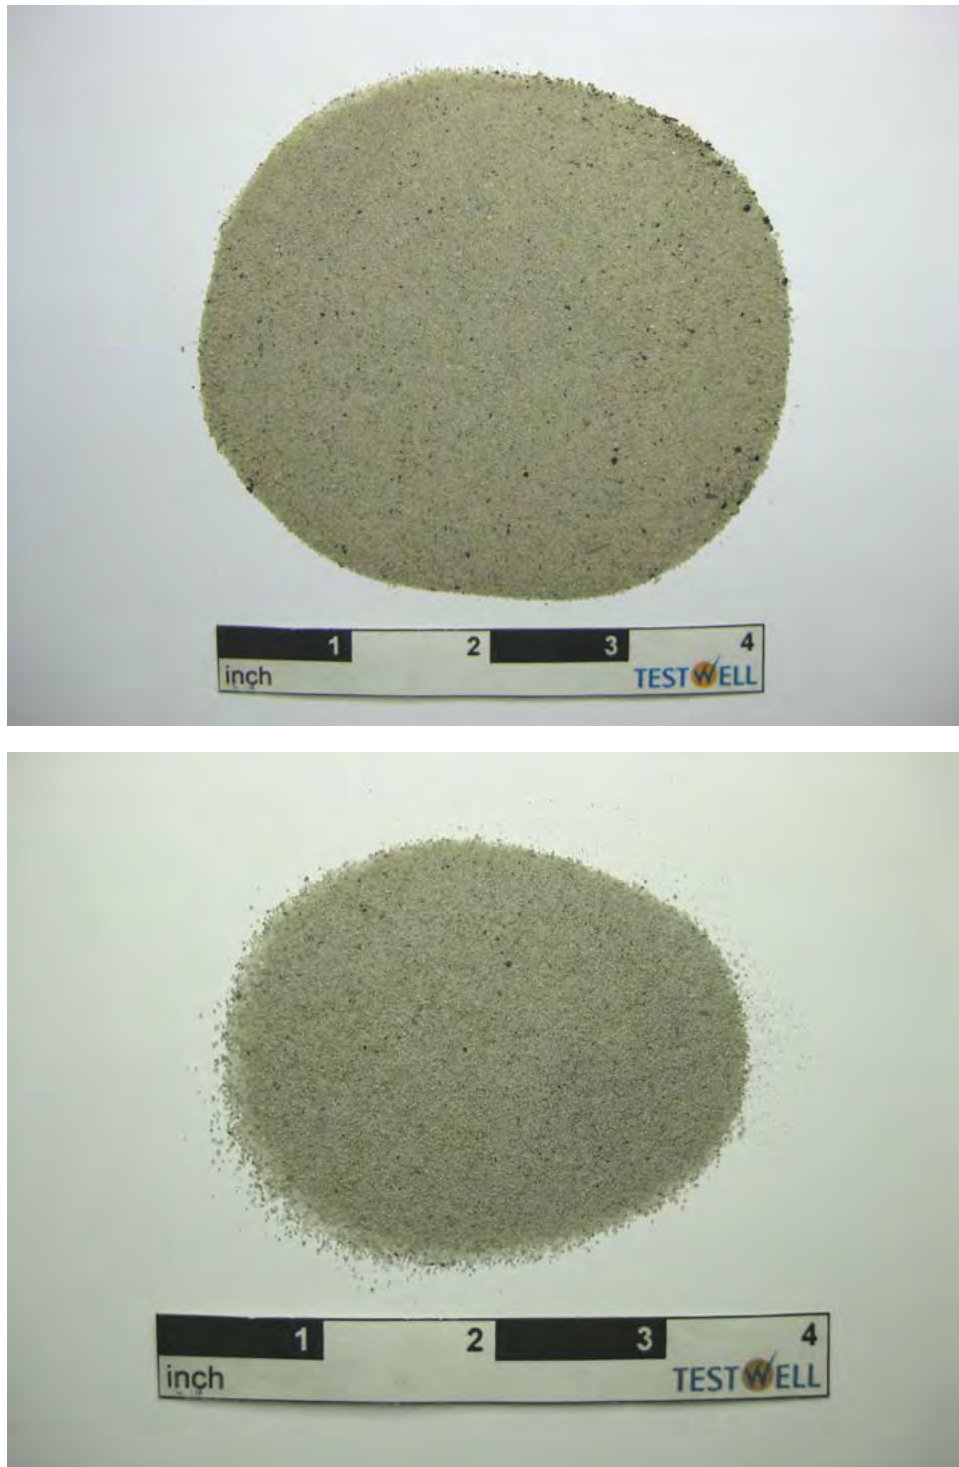
The sand in both samples is a fine-grained and bright-lustered aggregate characterized as a siliceous natural sand. The color is a uniform light brownish gray. Traces of dark colored coal dust in the recovered aggregate are interpreted to represent a contaminant from the binder. The sand consists predominantly of quartz with traces of fine shell fragments and heavy minerals. Grain shapes are soft being mostly rounded to subrounded. The gradation is narrow with a vast majority of material found between the No. 30 and No. 100 sieve sizes. The sand has a nominal top size at the No. 16 and No. 30 sieve for Samples CALO.Mortar.1 and CALO.Mortar.2 respectively. Nevertheless, the sands are considered virtually identical in both samples. The softness, narrow gradation, and mineralogy of the sand are all consistent with a well-sorted and mature beach sand. Details of the gradation may be found in Section 4 above. Recovered sand samples are provided with this report.

Figure 3: Photographs of sand separated from mortar samples CALO.Mortar.1 (top) and CALO.Mortar.2 (bottom). The sands are virtually identical appearing as uniform, fine-grained, and light-colored sands. The trace dark grains are identified as coal dust that likely represent a minor contaminant from the cement.

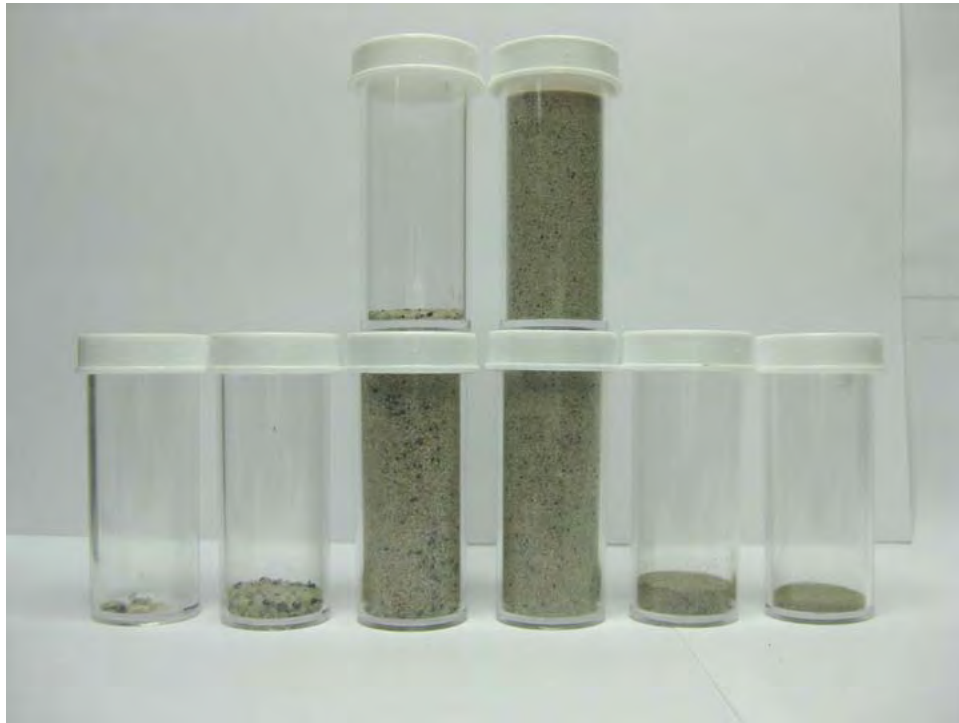
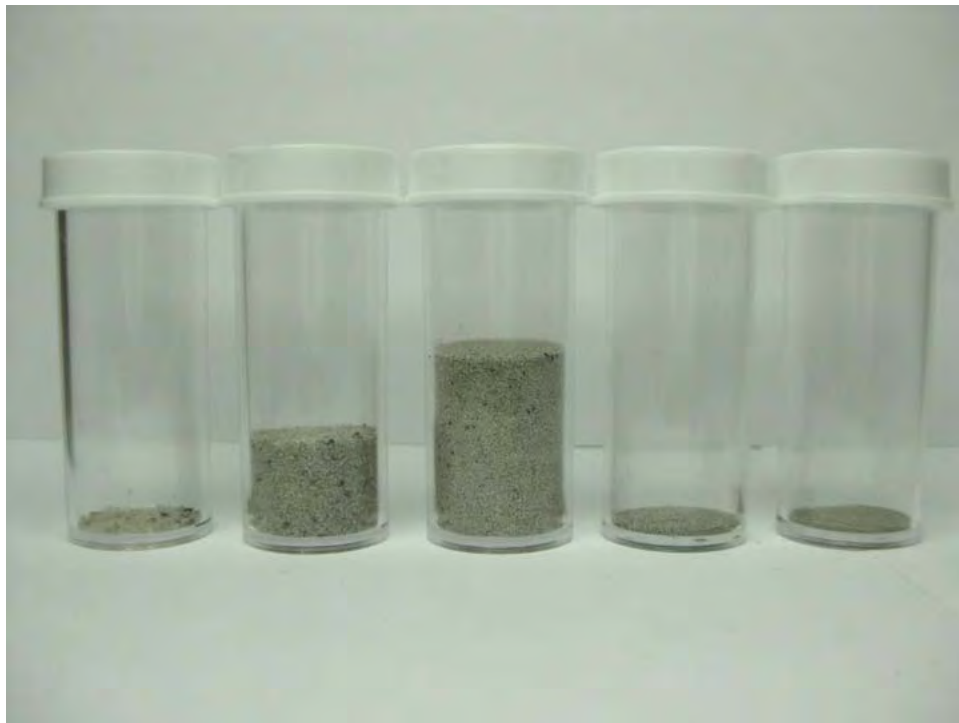
Figure 4: Photographs of the graded sand separated from mortar samples CALO.Mortar.1 (top) and CALO.Mortar.2 (bottom). The sands are both narrowly graded with a vast majority of material found between the No. 30 and No. 100 sieves.

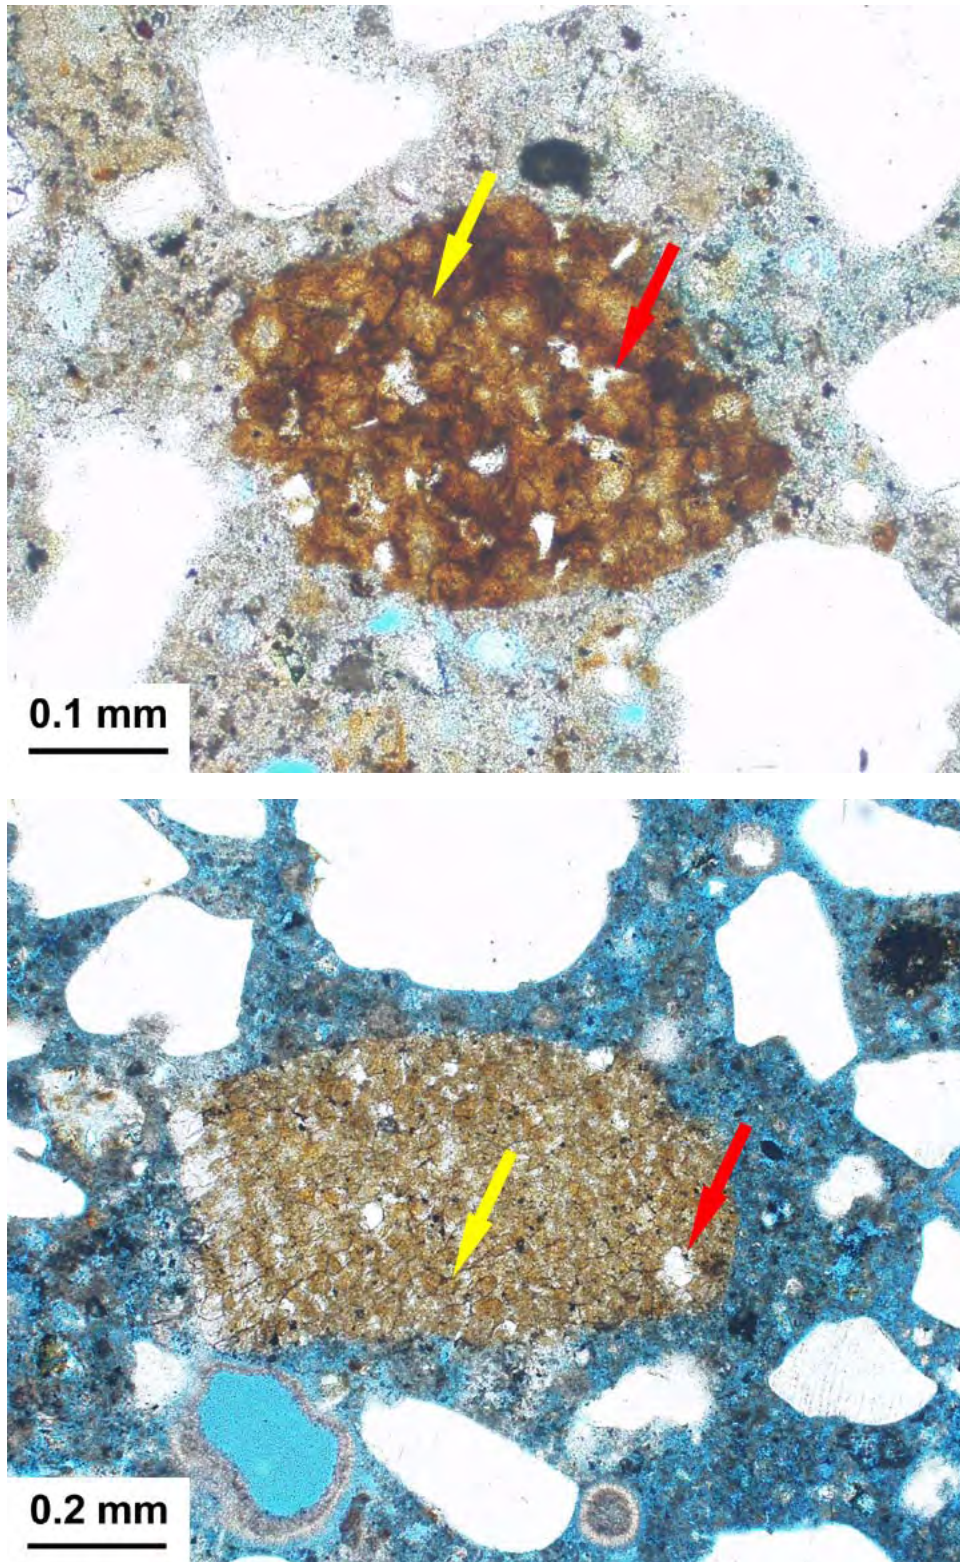
Natural cement relicts are found in high abundance as variously sized grains with internal textures consistent with the calcination of an argillaceous, dolomitic limestone.

Figure 5: PPL photomicrographs illustrating natural cement grains in mortar samples CALO.Mortar.1 (top) and CALO.Mortar.2 (bottom). The yellow arrows indicate original dolomite crystals now lined with iron-bearing cement phases. The red arrows represent quartz silt grains that have not combined during cement calcination. These textures are typical of nineteenth century American natural cements. No residual lime binder is detected petrographically in either sample.

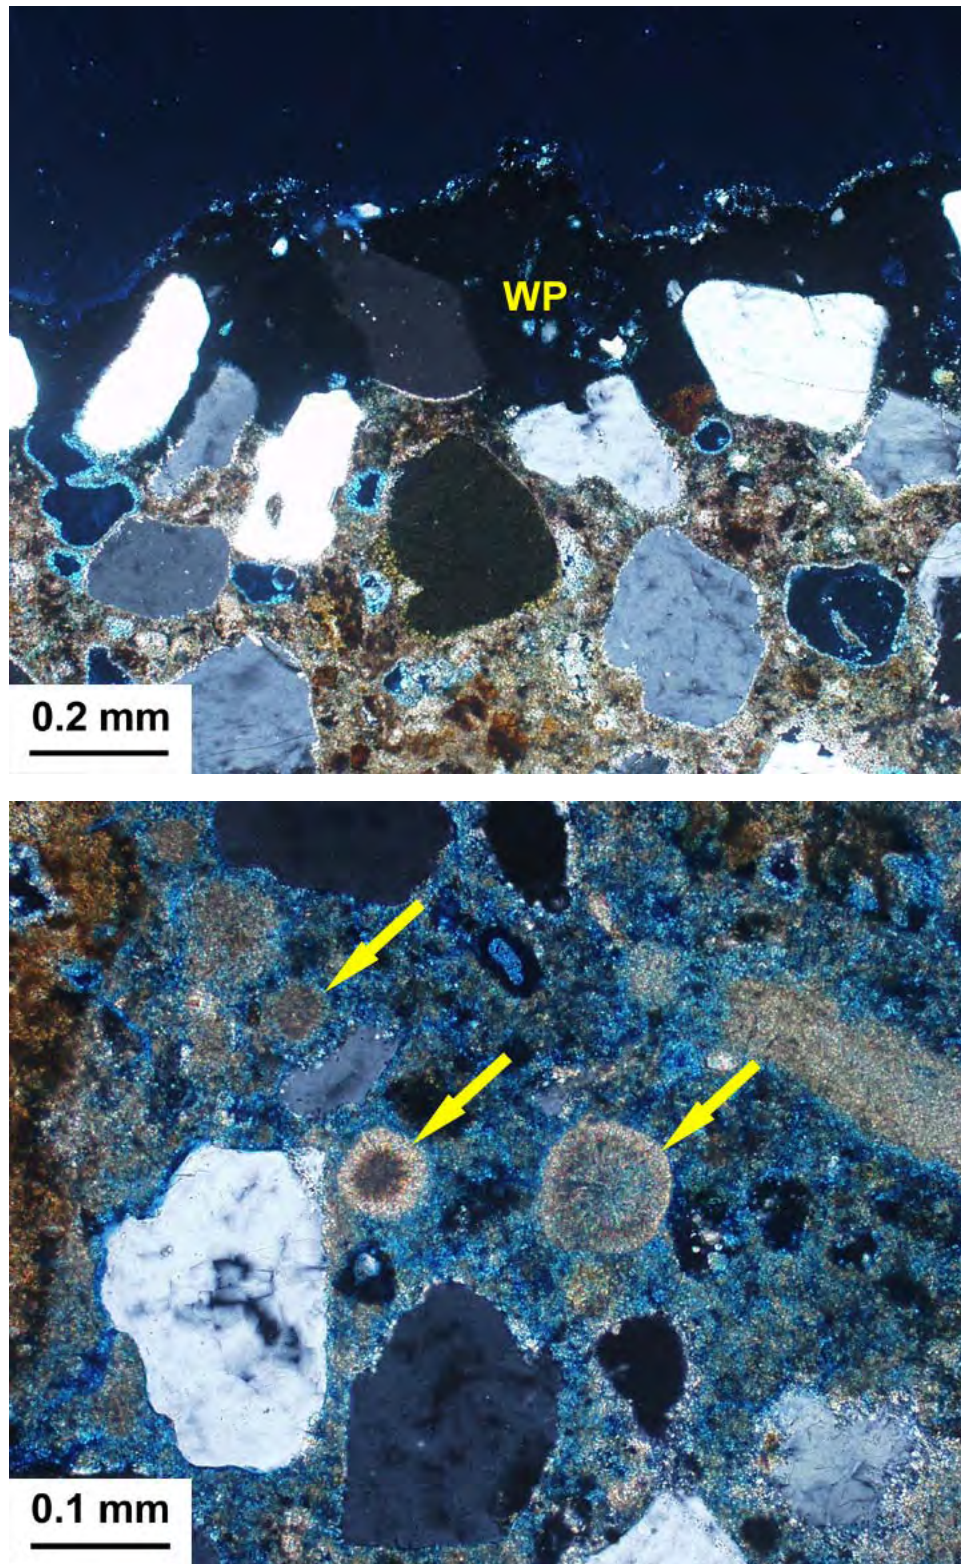
Carbonation The outer several millimeters of the sample is fully carbonated along most edges while the interior is partially carbonated.
Other A somewhat continuous veneer of paste exhibiting textures consistent with acidic leaching is found around most edges of the sample. No other secondary mineral deposits are detected.

Both samples exhibit typical carbonation. Other minor chemical reactions are detected within no associated distress. Exterior portions of Sample CALO.Mortar.1 exhibit a thin veneer of weathered paste consistent in texture with minor acidic leaching of soluble cement phases. Sample CALO.Mortar.2 contains abundant calcium carbonate deposits in air-voids but no cracking nor evidence for significant paste deterioration.

Figure 6: XPL photomicrographs illustrating minor secondary chemical reactions. (Top) Sample CALO.Mortar.1 exhibits a rind of weathered paste (WP). The golden color of the paste below is due to normal carbonation. The dark color within the rind indicates dissolution of this secondary carbonate along with other acid-soluble phases. The weathered paste is consistent in texture with that affected by acidic solution. (Bottom) The arrows indicate air-voids in Sample CALO.Mortar.2 that are filled with secondary calcium carbonate. These are visible in hand sample as fine white spots that should not be confused with lime inclusions.

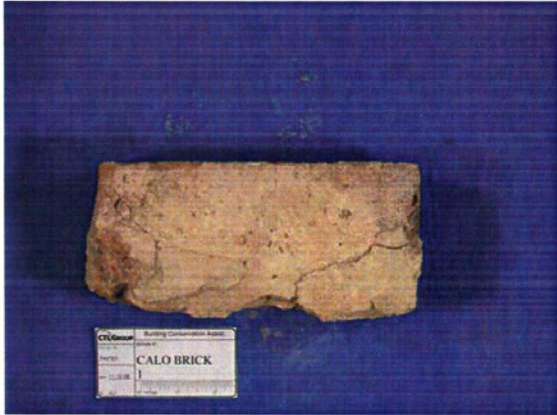
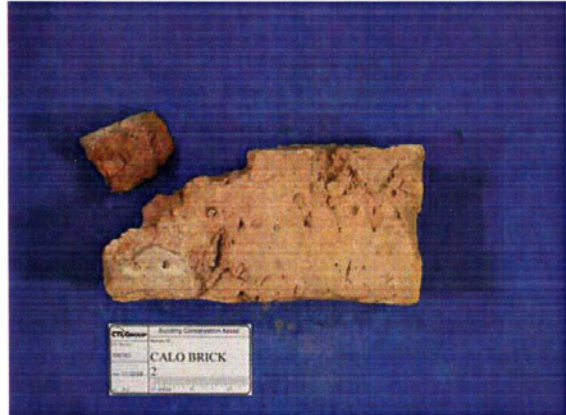
Figure 1. As-received photos of "Calo. Brick 1" and "Calo. Brick 2"

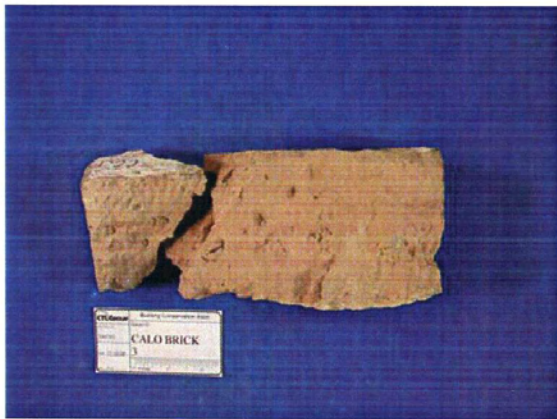
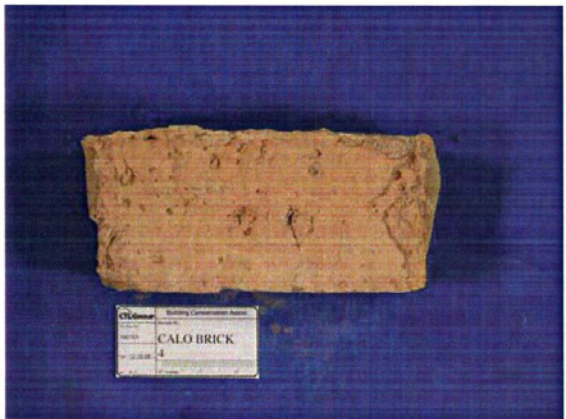
Figure 2. As-received photos of "Calo. Brick 3" and "Calo. Brick 4"

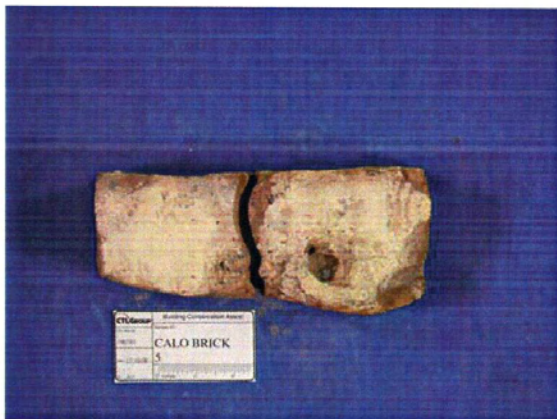
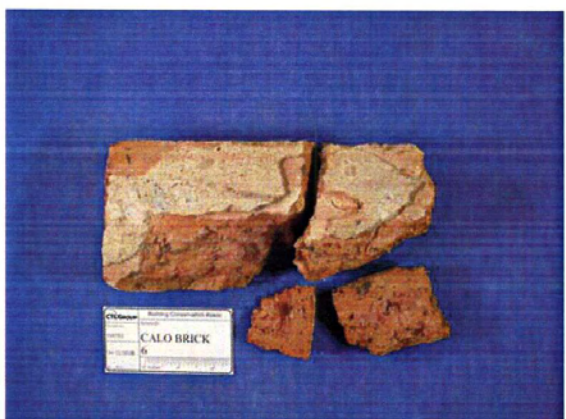
Figure 3. As-received photos of "Calo. Brick 5" and "Calo. Brick 6"
