Tom & Lucy Gilgo House
Portsmouth Village
Cape Lookout National Seashore

Historic Structure Report

December 2015

JOSEPH K. OPPERMAN-ARCHITECT, P.A.

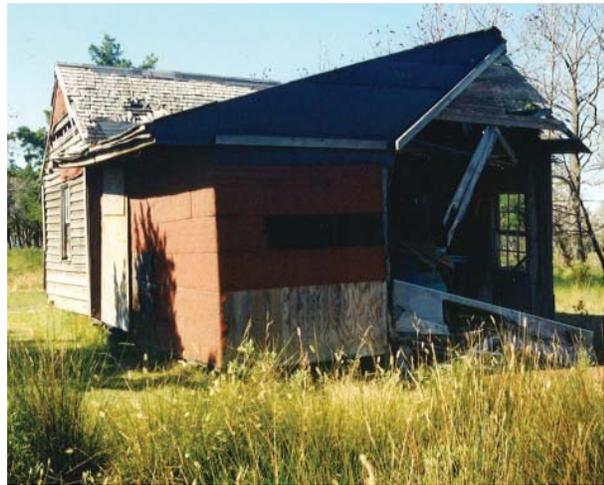
Photographs taken before the work began are undated, but deciduous trees suggest perhaps late winter or early spring (*Figs. 28-29*). The house retains its form of main block with simple porch, rear wing, and 1970s corner addition. An altered roof form over the addition is probably the temporary structure built in 1983, and the roof covering seen in 1996 is no longer present. The mix of board-and-batten and weatherboard siding remains, as well as wood wall shingles at the west gable end.

Figure 28. Back of the house showing 1970s addition with temporary roof structure; back wall of wing is missing. (undated, probably March or April 2002, CALO album)

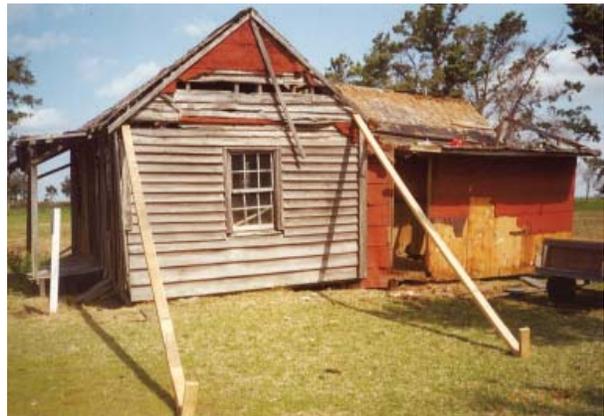
Figure 29. East elevation in April 2002, showing front porch and 1970s addition. Temporary roof has been removed. (date stamped 4/23/2002, CALO album)

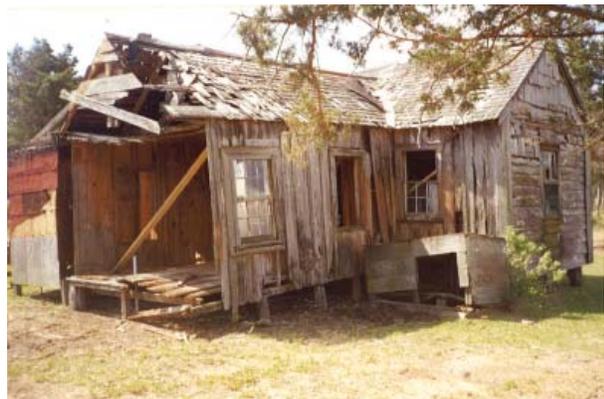
Figure 30. The back wing has been emptied and braced. Bathroom addition is at the left. Wood shingles cover weatherboards in west upper gable. Cistern remains in northwest corner, collapsed, and plumbing pipes and electrical wiring are visible under the house. (undated, possibly 4/23/2002, CALO album)

The large rectangular wood-plank cistern remains in place at the northwest corner where it was better shielded from the sun. Partially collapsed, its west and long north elevations are of wide flush horizontal boards; a squared opening has been cut for unknown purpose (*Fig. 30*).

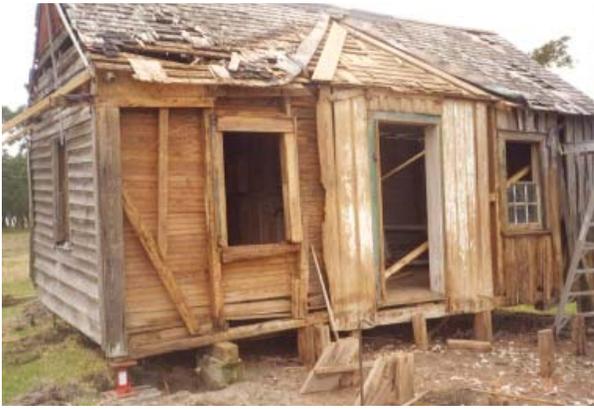
Figure 31. Back of house after removal of rear wing exposes original back wall and roof shingles. Flush vertical boards flank the back door; above door is a shallow section of board-and-batten. (date stamped 5/1/2002, CALO album)

Work progressed quickly during the week. A photograph taken the next week shows that the entire kitchen wing was removed, leaving only its foundation posts and the original two-room house (*Fig. 31*). This and other images show the wood roofing shingles that were covered when the wing

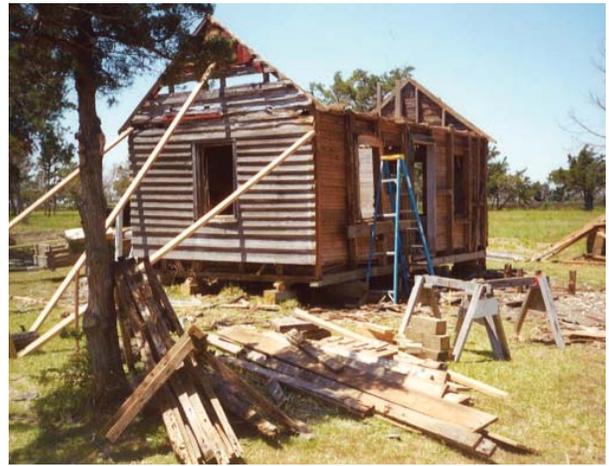
Figure 33. Only the two-room block remains. Roof structure, foundation, front board-and-batten siding, and all sash doors have been removed. (date stamped 5/15/2002, CALO album)

By May 15, only the two-room block remained, and the roof and roof structure had been removed. Large holes in the ceiling attest to its condition. The house was lifted, placed on temporary beams, and rotted foundation posts removed. The front wall with board-and-batten siding was removed, along with all sash and doors (*Fig. 33*). Inside, workers began dismantling. Beaded-board sheathing at walls and ceilings was taken down, and casings removed from the bedroom windows. More significantly, the vertical board wall dividing the house into living room and bedroom was removed (*Fig. 34*).

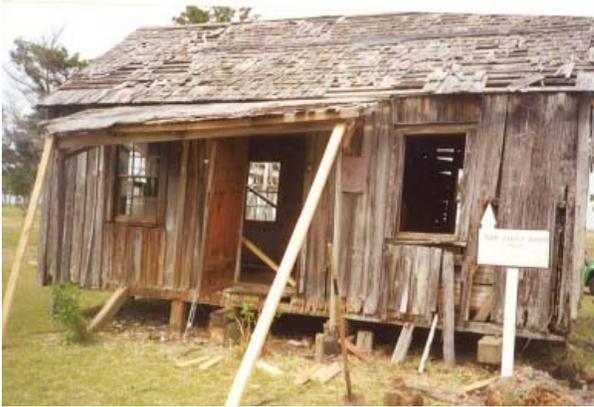
Figure 32. Removal of front porch in process. (date stamped 5/1/2002, CALO album)

was brought up and attached to the house. The original back wall is also exposed, revealing full-height flush vertical boards flanking the back door. Above the door is a shallow section of board-and-batten siding. The casing of the back door is simple, painted what is now a blue-green color, and retains an exterior hinge and wood swivel latch. At the front, the porch foundation, floor, and posts were removed, with the shed roof braced before removal (*Fig. 32*).

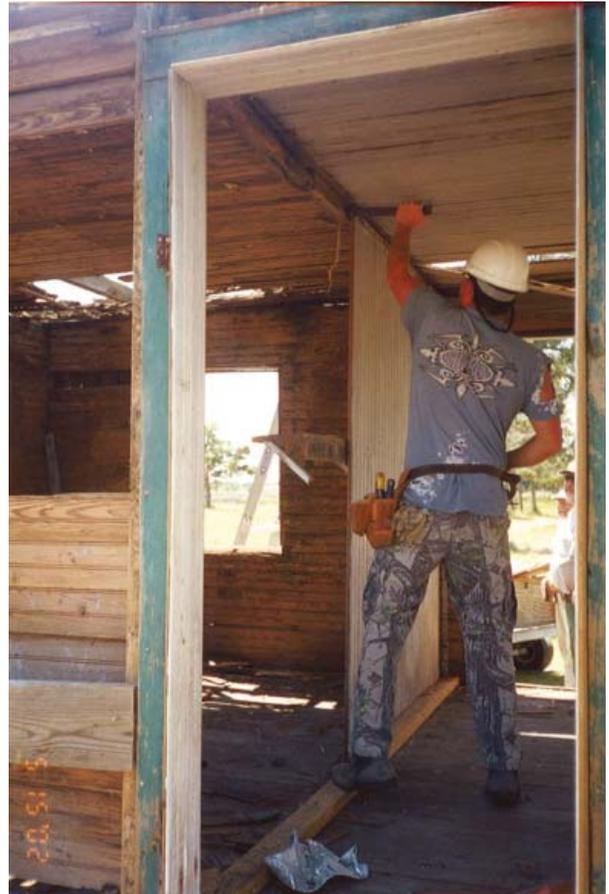
Figure 34. Looking from the back of the house during removal of interior partition. The painted finish of the living room and unpainted walls of the bedroom are visible. Casing has been removed from bedroom window, and the interior beaded boards of the back wall are being taken down. A large hole is in the ceiling. (date stamped 5/15/2002, CALO album)

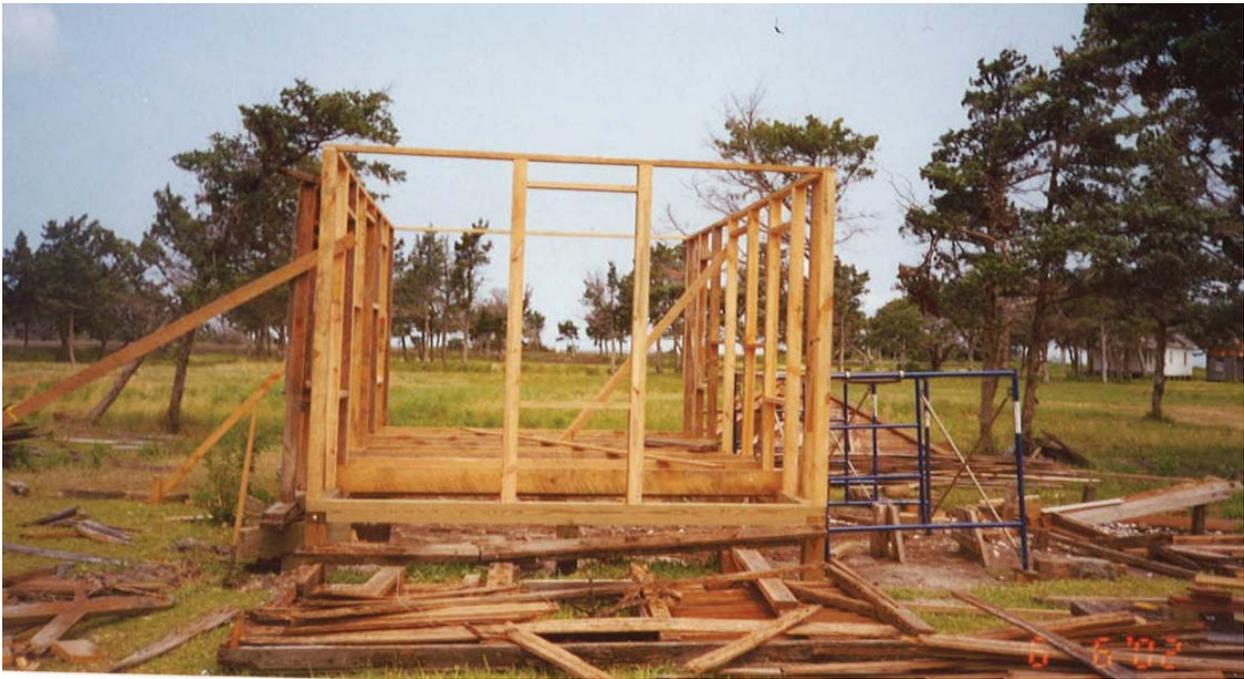
Figure 35. Construction of new frame for main block begins in June. (date stamped 6/6/2002, CALO album)

Demolition and dismantling was complete by the beginning of June, and construction of a new structural frame began. Photographs show the new framing on June 6. A salvaged sill is visible, and salvaged siding is laid on the ground near the house (*Fig. 35*).

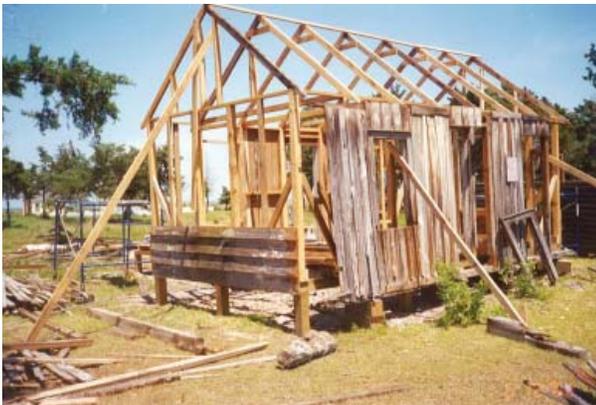
Figure 36. By June 12, roof structure has been built and salvaged areas of siding are being attached to the frame. (date stamped 6/12/2002, CALO album)

board-and-batten siding was attached, though not the casing, as well as the wider, lower weatherboards of the gable ends (*Fig. 36*). These wider boards are visible in the 1970 photograph, probably added to replace boards rotted by splash from rain runoff, and possibly salvaged from an earlier building.

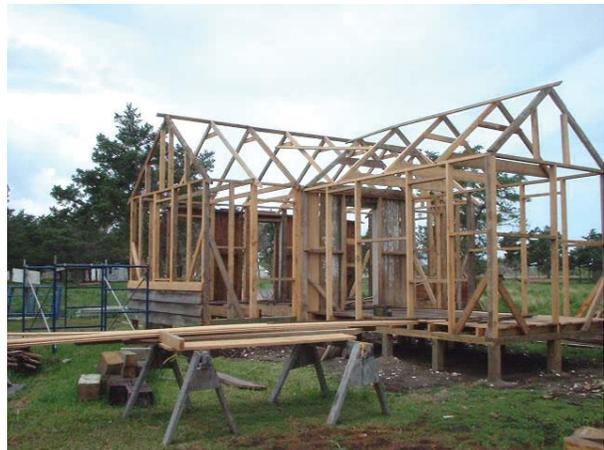
Figure 38. Structural frame is complete by late June.

By the end of June, construction of the structural frame of the kitchen wing was complete (*Fig. 38*). Additional portions of exterior siding were retained in large portions, including a section of weatherboarded wall, the shingle-on-weatherboard siding of the upper west gable, and the weatherboarded siding of the back gable (*Figs. 39-41*). These and other salvaged boards were replaced onto the new frame before the new siding was installed. The upper boards of the east gable end had been covered with asphalt sheeting for several decades, which apparently protected them from weather. They were returned to the same area and remain a lighter color today.

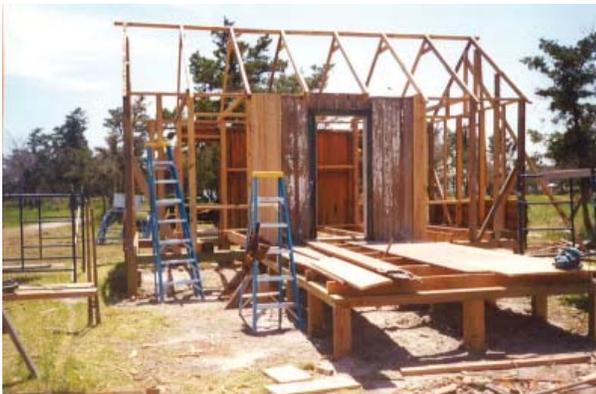
Figure 37. New foundation for back wing, and attachment of original vertical flush boards flanking back door of main block. (date stamped 6/12/2002, CALO album)

At the back, foundation posts, sill and joists for the back wing were in place. The original back doorway and flanking vertical-board walls were reattached to the main block (*Fig. 37*).

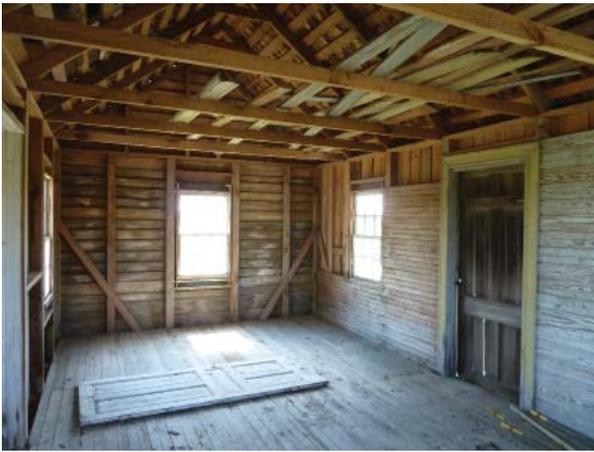
Figure 55. Wall framing of main block is exposed in east wall and part of north wall.

In the main block, the great majority of visible wall framing is replacement material from the 2002 project. The early reused material measures 2" by 4" and 4" by 4". Replacement material is rough cut and circular sawn to modern dimensions. Replacement corner posts and window posts measure 3⁵/₈" by 3⁵/₈". Replacement wall studs, irregularly spaced, and replacement diagonal corner braces measure 1⁵/₈" by 3⁵/₈" (Figs. 55-56). The replacement wall plates measure 1⁵/₈" by 3⁵/₈"

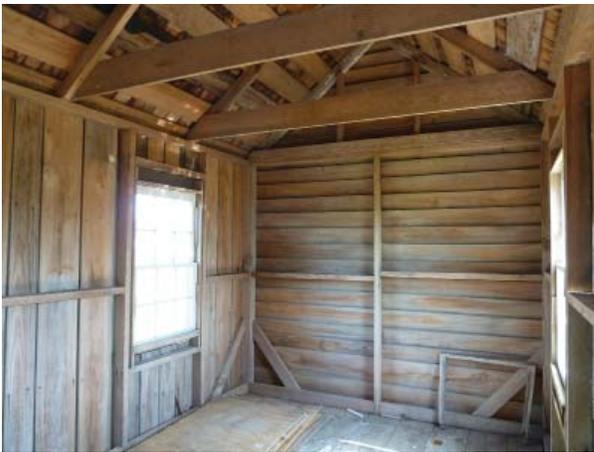
Figure 56. Wall framing of rear wing is exposed in east, north, and west walls.

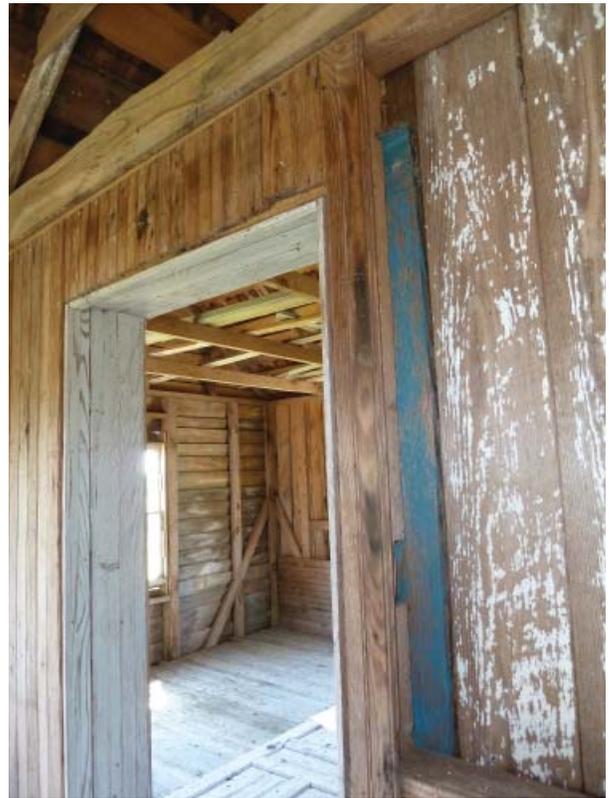
Figure 57. Retained early framing of the rear wing south wall was notched to fit around the casing (blue) of the original rear door of the main block when the two buildings were first joined.

The opening of the cased doorway to the rear wing measures $2'-9"$ wide by $6'-5"$ tall (Fig. 57). The floor level of the rear wing is $3\frac{1}{2}"$ below the level of the flooring in the main block.

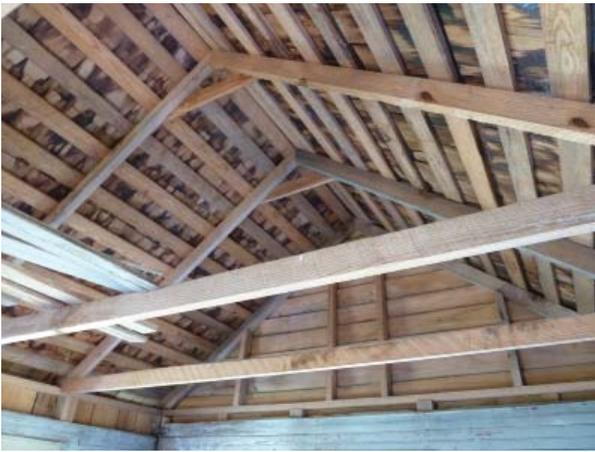
Figure 58. Roof framing of the main block.

the west gable end is also early. Each of these early rafters measures 2" by 4". The replacement rafters measure 1⁵/₈" by 3⁵/₈" and have tapered ends. The pairs of rafters are irregularly spaced. Each pair is nailed together at the ridge. There is no ridge pole. Each pair of rafters has a collar beam measuring 1" by 4" by approximately 2'-0" long. All deck boards are replacements, measuring 1" by 3³/₄" and set 8" o.c. (Fig. 58).

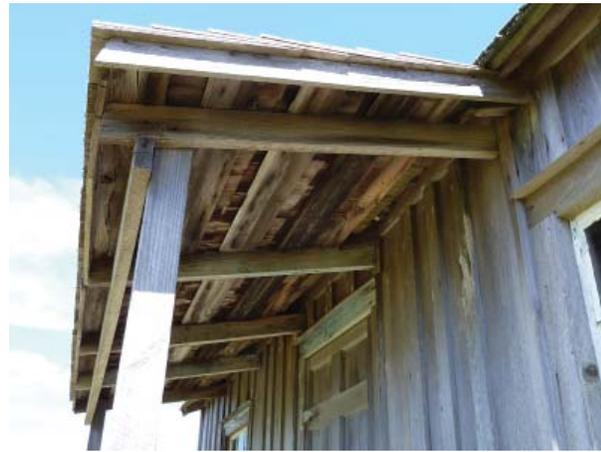
by $5\frac{1}{2}$ " and both are aligned along the south or front edge of the porch (Fig. 60).

Figure 60. Replacement roof framing at front porch.

At the front porch's shed roof, all materials are replacements. The rafters measure 1⁵/₈" by 3⁵/₈" and are set 36" o.c. The replacement beam atop the porch posts and the replacement ledger board nailed to the front wall of the main block, which together support the porch roof rafters, also measure 1⁵/₈" by 3⁵/₈". The replacement deck boards measure 7⁷/₈" by 5⁵/₈" and are set 9" o.c. (Fig. 60).

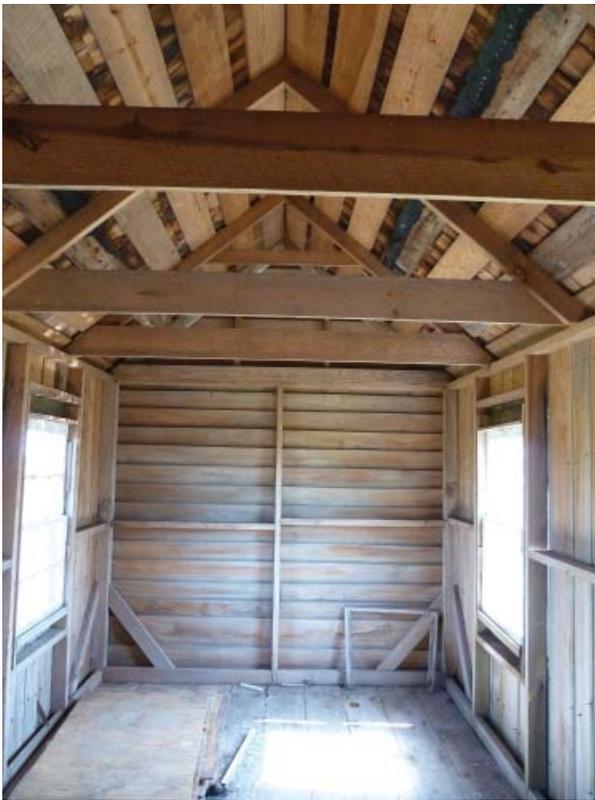
In the rear wing, also, most of the visible wall framing is replacement material dating from the 2002 project (Fig. 59). The early reused material measures 2" by 4" and 4" by 4". Replacement material is rough cut and circular sawn to modern dimensions. Replacement corner posts measure $3\frac{5}{8}$ " by $3\frac{5}{8}$ " while replacement window and door framing, the mid-height horizontal braces between vertical framing, and the diagonal corner braces measure $1\frac{5}{8}$ " by $3\frac{5}{8}$ ". The replacement wall plates measure $1\frac{5}{8}$ " by $3\frac{5}{8}$ " and are half-lapped and nailed at the corners. Replacement ceiling joists measure $1\frac{5}{8}$ " by $3\frac{5}{8}$ " and are set 48" o.c.

Figure 59. Roof framing of the rear wing.

At the rear wing's gable roof, as at the main roof, only the two end pairs of roof rafters are early. The other rafters are replacements dating from the 2002 project. The early rafters measure 2" by 4" and are nailed together at the ridge. The replacement rafters measure 1⁵/₈" by 3⁵/₈" and are also nailed together at the ridge. The rafter pairs typically have an upper and lower collar beam. At the early pair of rafters at the south end of the grouping, the upper collar measures 1" by 6" while the lower collar measures 1" by 8". The replacements are made with modern dimensioned wood elements. The replacement upper collar beams measure about 7⁷/₈" by 3⁵/₈" while the lower collar beams measure about 7⁷/₈" by 7⁵/₈". The rafters are set 48" o.c. Early deck boards measure 1" by 8" while replacements measure about 7⁷/₈" by 7⁵/₈" (Fig. 59).

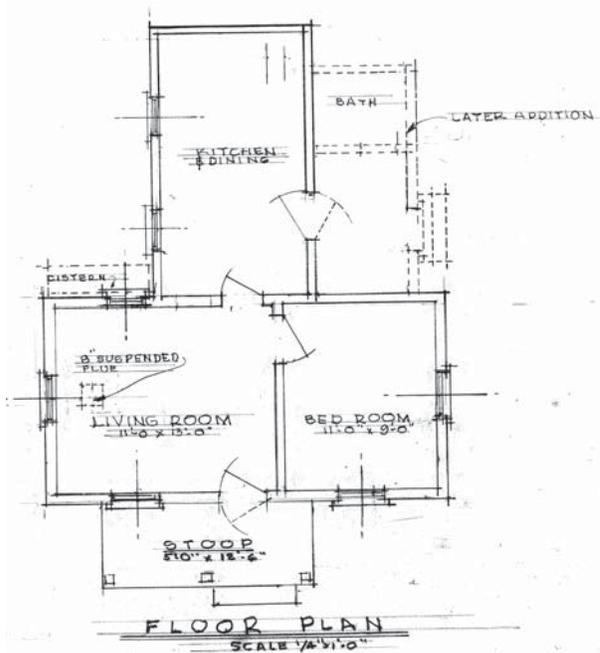
Figure 61. Field sketch by architect John Thompson notes a “suspended flue” in the room he identifies as the living room. Measurements are approximate.

Sketch drawings of 1979-80 indicate there was at that time an “8-inch suspended flue” in the west room of the main block (*Fig. 61*). Presumably this was a heat source.

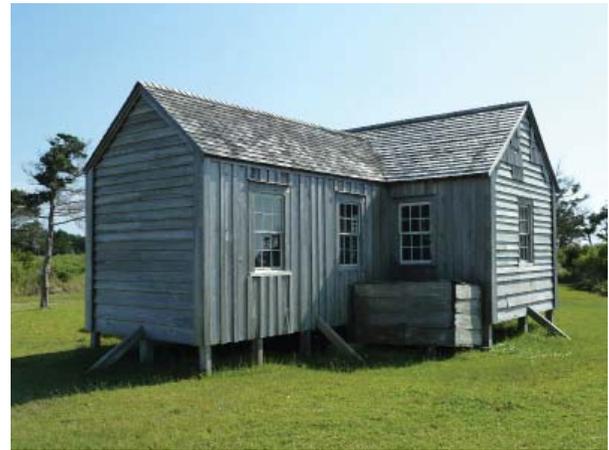
Figure 62. Early wooden cistern.

A box cistern, partially rebuilt in 2002, is located outside in the northwest corner created by the living room and the rear wing (*Fig. 62*). It sits on low posts made of sections of trees with a diameter ranging from 5” to 8”. The measurements of the cistern are approximately 6’-0” long by 3’-0” wide by 3’-0” tall. The sides and bottom are constructed of plank boards 1” thick of various widths and attached with both wire and cut nails. The modern top is constructed in sections to allow access for retrieving water; the boards there are thinner, just $\frac{5}{8}$ ” thick, in various widths. The wood may be cypress, as was often the case for storing water.

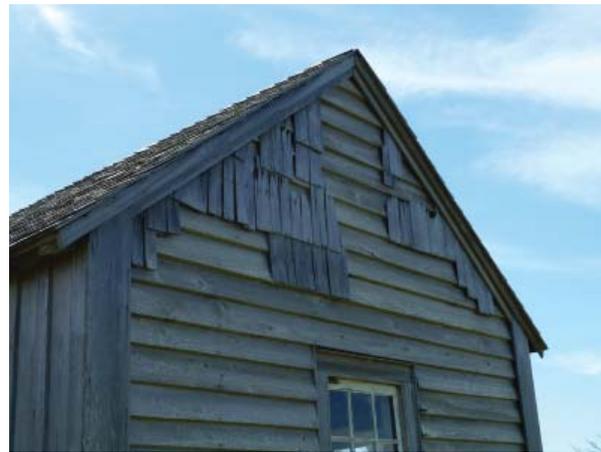
Figure 64. Salvaged shingle siding at the west end wall.

The upper portion of the west gable-end was reused during the 2002 project and retains wood shingles (Fig. 64).

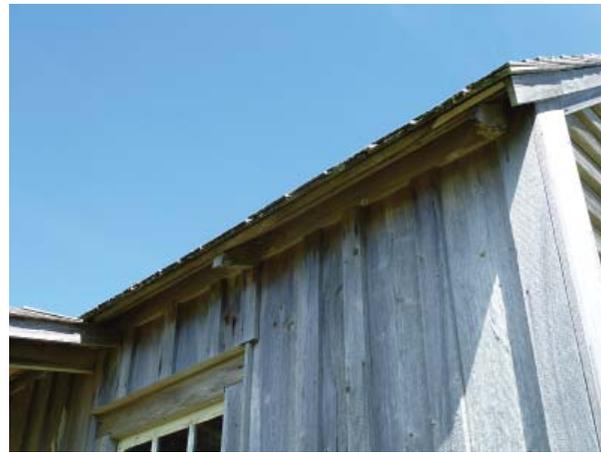
Figure 65. Tapered rafter tails, board-and-batten siding, plank board and composite cornices, and plank corner boards.

vertical board-and-batten siding. The boards are 1" thick with widths varying from 6⁵/₈" to 10⁵/₈" wide, some early boards mixed in with replacements; the battens are 5/8" thick by 2⁵/₈" or 3³/₈" wide. A group of early boards and battens were apparently reinstalled along the front wall of the main block. The replacement corner boards measure 5/8" thick by 8¹/₄" wide. The replacement cornice is a 3/4" thick by 3⁵/₈"-wide plank board (Fig. 65).

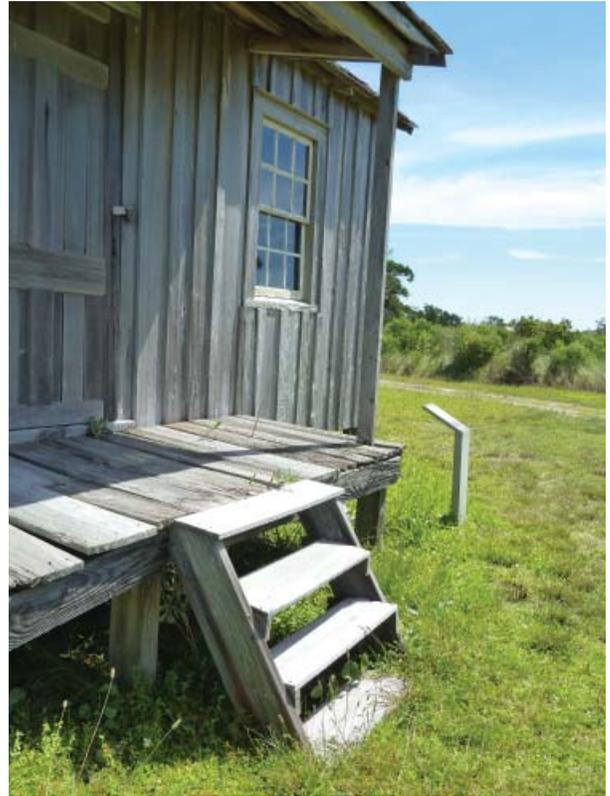
Figure 68. Steps to front porch.

The front steps are replacements. Wood treads set in an open stringer lead from grade onto the front porch. The two stringers measure $\frac{3}{4}$ " thick by 8" wide. Each tread measures $\frac{3}{4}$ " by 8" and spans 2'-8" between two 1" by 2" ledger boards. The lowest tread is at grade. The rise is 8" at each of the three steps up to the porch deck (*Fig. 68*).

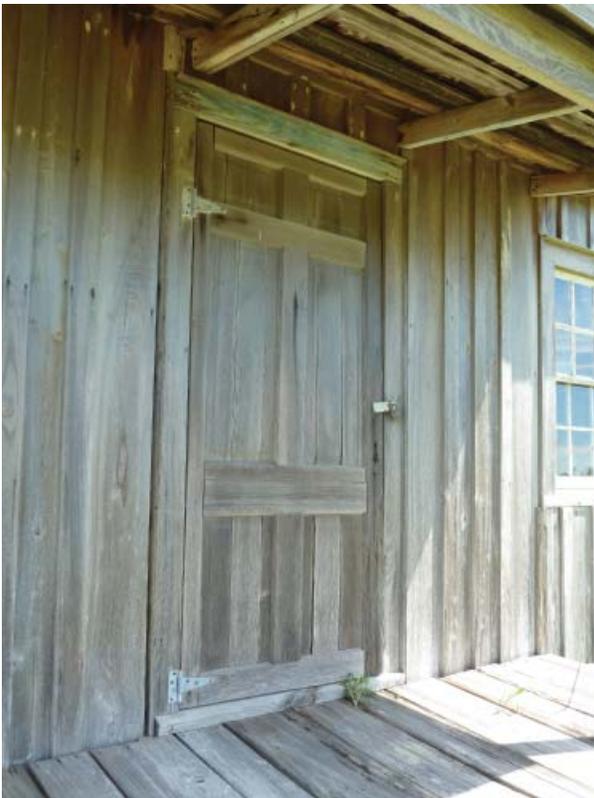
Figure 67. Front entrance doorway with reproduction six-panel door.

The front doorway is on the south elevation of the main block. The opening measures 2'-10" wide by 6'-6" tall and holds a replacement six-panel door.

Casing is made up of plank boards that measure $\frac{3}{4}$ " thick by $3\frac{5}{8}$ " wide with a lintel cut (*Fig. 67*).

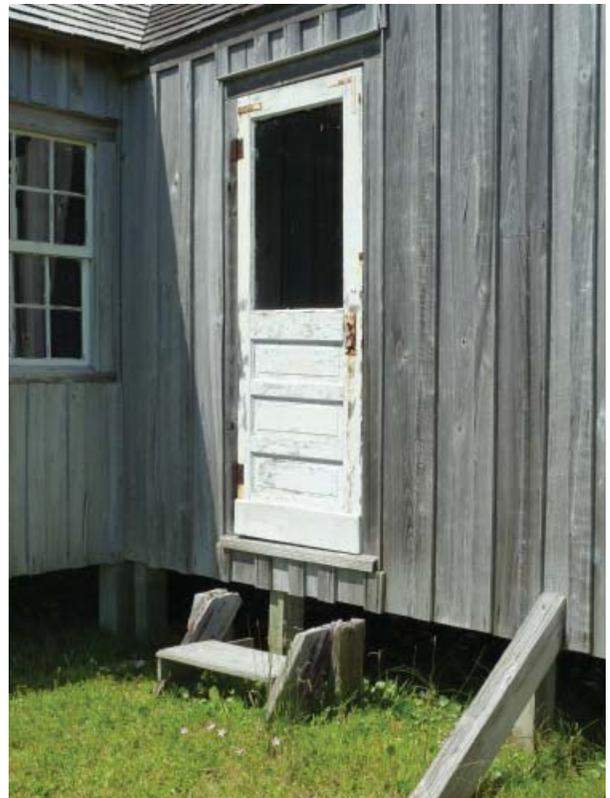
Figure 69. Side entrance with sash door likely dating to second quarter of twentieth century.

The side entrance doorway is on the east elevation of the rear wing. The opening measures 2'-5" wide by 6'-6" tall and holds a sash door. New entrance steps were built when a 1970s addition was removed in 2002 (*Fig. 69*).

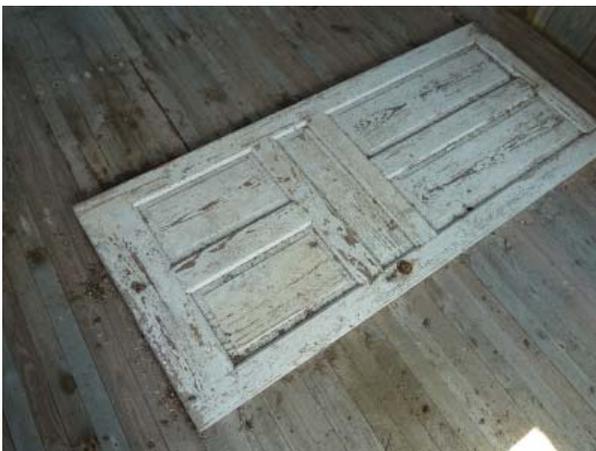
Figure 77. Stored turn-of-the-century five-panel door may have been used in doorway of board wall that previously separated Rooms 101 and 102.

A five-panel door of a style popular in the late-nineteenth/early-twentieth centuries is stored in this room (Fig. 77). It measures $2'-10"$ wide by $6'-6"$ tall by $1\frac{3}{8}"$ thick. It may be the door for the doorway in the demolished board wall that separated the two rooms of the main block. The thickness suggests it was intended for an interior rather than exterior doorway.

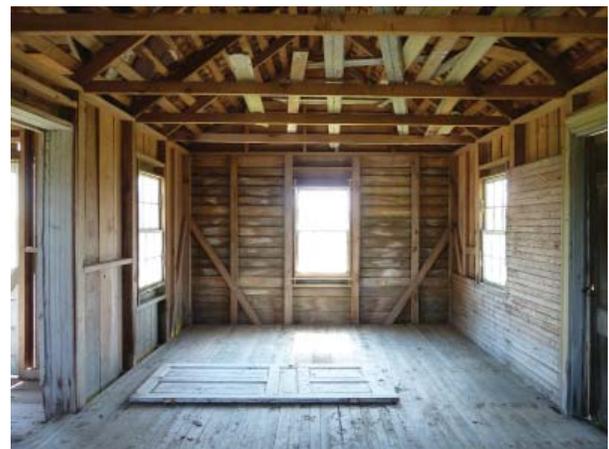
Tongue-and-groove beaded boards measuring $\frac{7}{8}$ " thick by 4½" wide are on the south wall only, reinstalled during the 2002 project (*Fig. 79*). At the other walls the framing is exposed. According to

Figure 79. Beaded-board sheathing of ceiling and walls was left unpainted in the bedroom (Room 102). Note additional casing trim boards and beaded-board sheathing stored atop ceiling joists.

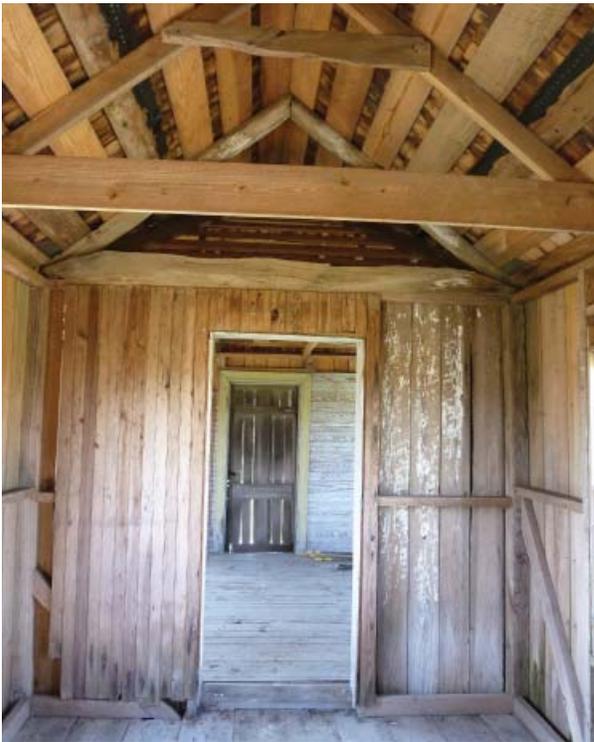
Figure 80. Rear wing interior looking south.

of the main block's board-and-batten exterior siding are visible just beyond the framing. Above the doorway are six more boards, and two boards are visible east of the doorway (*Fig. 80*). The plank boards measure 1" by a variety of widths including $6\frac{3}{4}$ ", $6\frac{7}{8}$ ", and $7\frac{5}{8}$ ".

East of the doorway are two types of beaded board applied vertically. Both types measure $\frac{3}{8}$ " thick by $2\frac{3}{8}$ " wide. One type has a $\frac{3}{16}$ "-wide edge bead and center bead while the other has only $\frac{3}{16}$ "-wide center bead (*Fig. 80*).

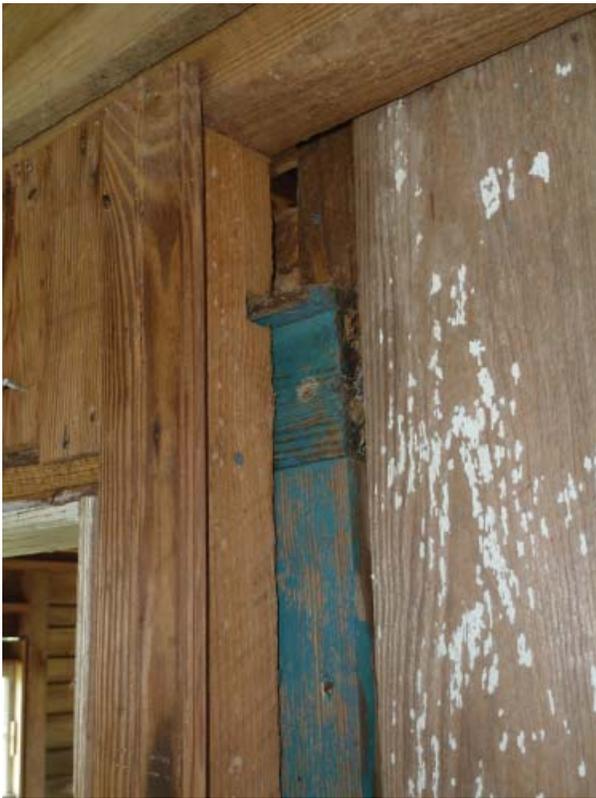
Figure 84. Close-up view, Room 103, of south wall framing notched around doorway weather cap.

casing (Fig. 84 & 85). This casing, like that of the front doorway, is comprised of unadorned plank board casing with a lintel cut. The weatherboard has a beveled top surface.

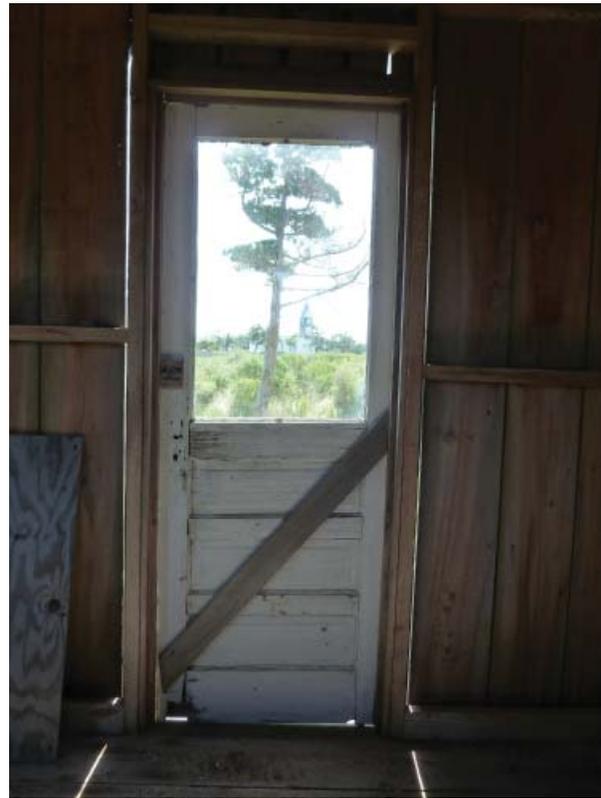
Figure 86. Secured three-panel sash door in side entrance doorway of Room 103.

The doorway on the east wall leading to the exterior is discussed in part in *Exterior Features – Doorways*. The wood sash door with one large glass light and three horizontal wood panels probably dates to the second quarter of the twentieth century (Fig. 86). It measures 2'-5" wide by 6'-6" tall. Because the door is secured in a closed position, the door thickness could not be confirmed. The door hardware includes two 3½" butt hinges, a 2¼" by 7" beveled plate with no doorknobs, and a 1½" barrel bolt on the interior face of the door stile.

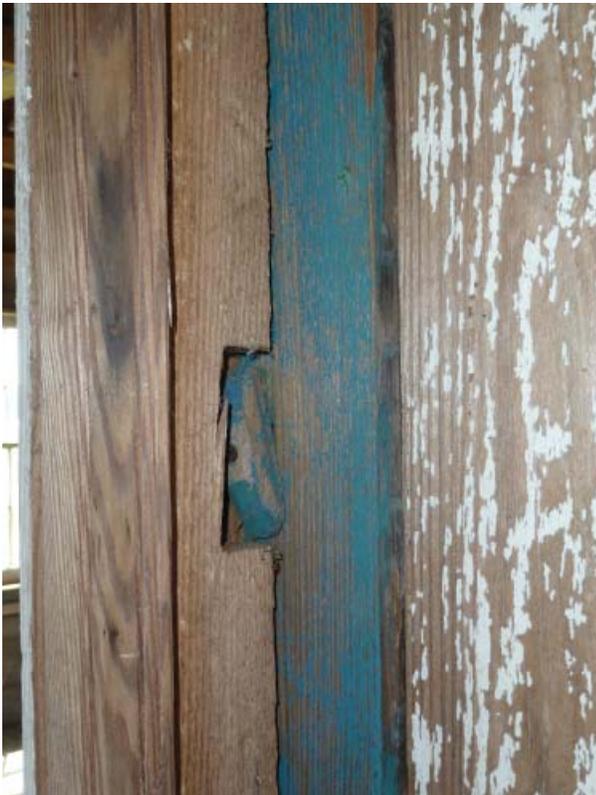
Figure 85. Close-up view, Room 103, of south wall framing notched around doorway swivel latch.

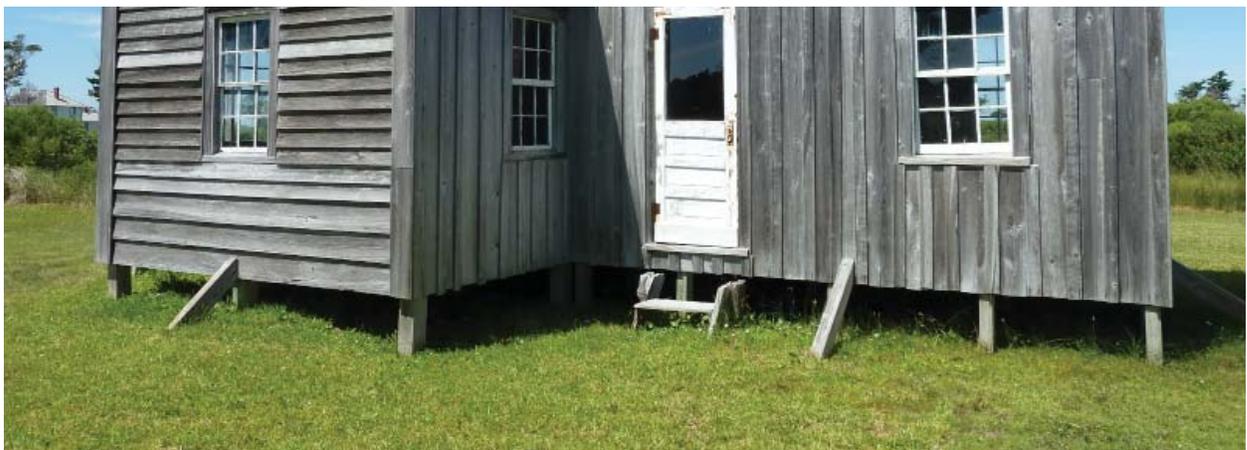
- Shingled gable roofs.
- Tapered rafter tails.
- Diagonal hurricane braces anchored into the ground along the house perimeter (*Fig. 91*).
- Wooden board cistern in northwest corner.

Figure 91. Diagonal ground braces/hurricane braces.
