BADIN-ROQUE HOUSE PRESERVATION STUDY

07/26/2018

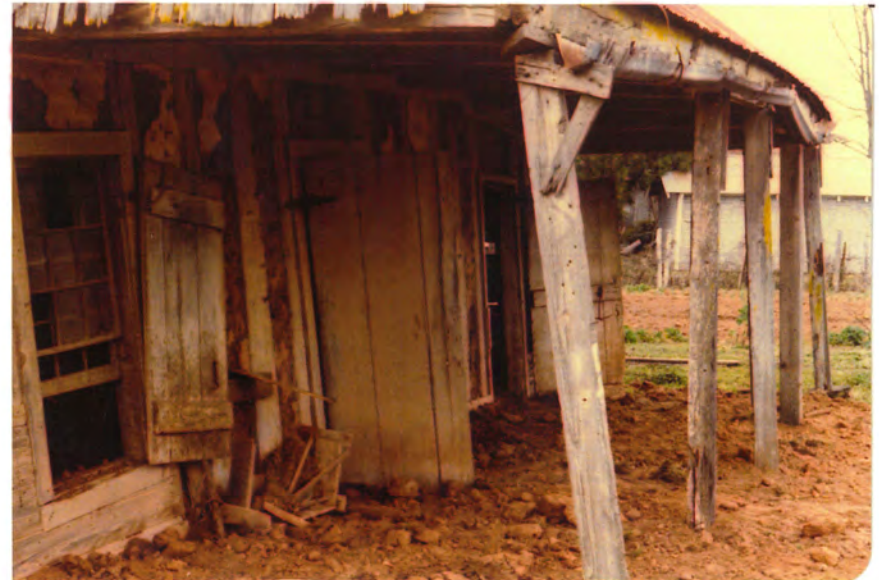
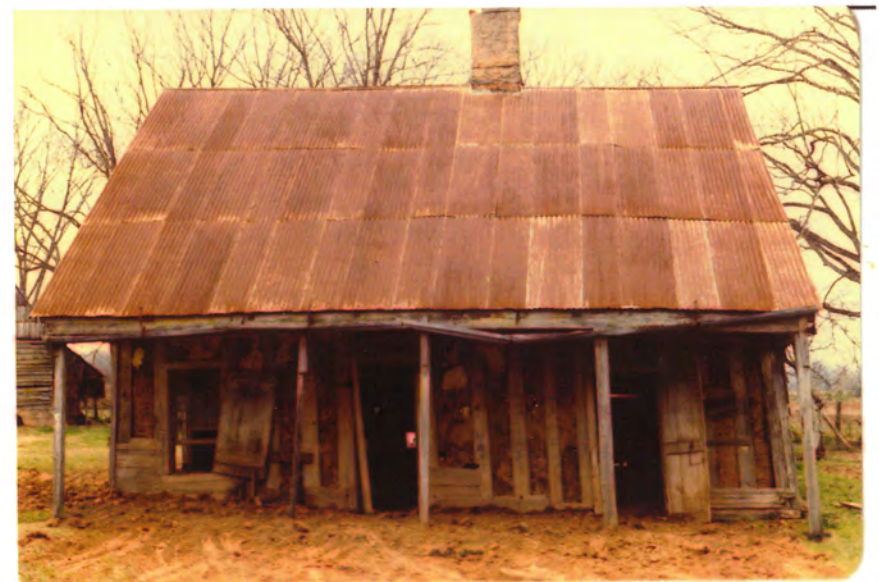
Above and Below: Badin-Roque House prior to the most recent restoration work (photos courtesy of the National Park Service).
