Barn Complex
Carl Sandburg Home National Historic Site
Historic Structure Report

December 2014

JOSEPH K. OPPERMAN – ARCHITECT, P.A.

Goat Barn: HS-16, LCS 005161, FMSS 69819
Milk House: HS-16A, LCS 005162, FMSS 69690
Horse Barn: HS-17, LCS 005163, FMSS 69863
Silo: HS-20, LCS 005166 (s-o-w gives no FMSS)
Shavings Shed: HS-19, LCS 005165, FMSS 69691
Cow Shed: HS-18, LCS 005164, FMSS 69697
Buck Kid Quarters: HS-15, LCS 005160, FMSS 69689
Corn Crib: HS-14, LCS 005159, FMSS 69698
Barn Garage: HS-13, LCS 005158, FMSS 69895
Isolation Quarters: HS-12, LCS 005157, FMSS 69817

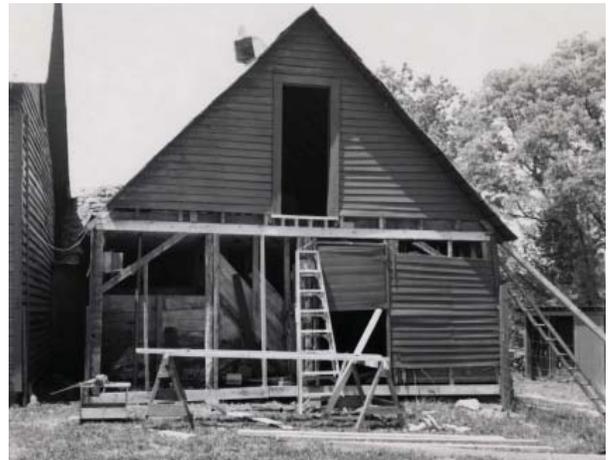
Figure 75. "View of Horse Barn during Restoration," showing new sill, plate, joists, and upper door sill. The covered passage between horse barn and goat barn is visible in the background. Spring 1972. Gordon Gay, photographer, NPS. (CARL 4008-19-07P)

NPS work on the horse barn began in spring 1972. Photographs taken during the work show that all front weatherboards west of the door were replaced with new boards. Boards east of the door and those on the gable were retained. The full lengths of the front sill and plate were replaced, as well as one front stud and the sill of the loft window. The scalloped pressed-metal sheet roofing was replaced with 5-V metal. The bottom of the lower Dutch door was cut parallel to grade to allow it to close. A bottom hinge was added and the latch changed.

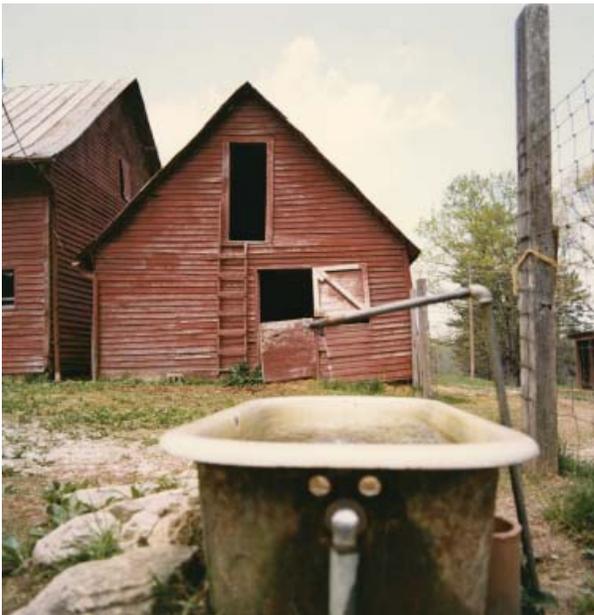
Figure 74. Front of horse barn in 1971 before NPS repairs, showing Dutch door, position of ladder, and missing gate. Tom Gray, photographer, NPS. (CARL 4009-2-1-G-101)

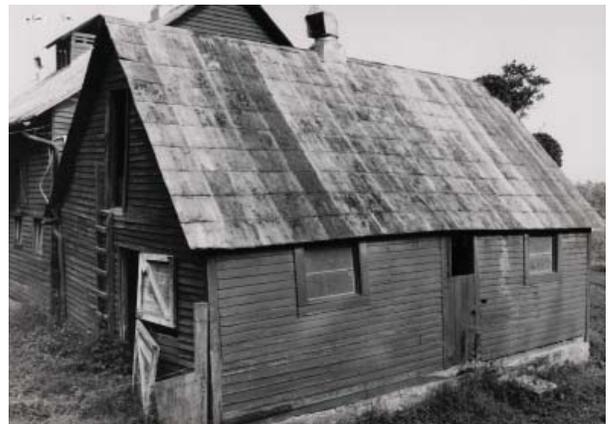
Figure 76. East side of horse barn and roof "prior to restoration," showing tall four-flush-board lower Dutch door and surround; spring 1972. Gordon V. Gay, photographer, NPS. (CARL 4008-19-04P)

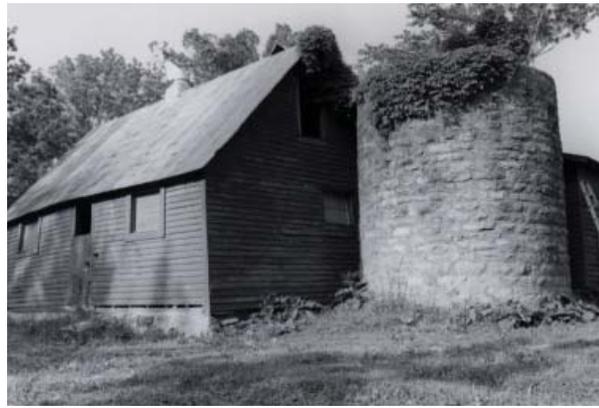
Figure 83. The silo was built immediately adjacent to the horse barn (left) and main barn. NPS photograph "prior to restoration" shows a tree and vines at the top. 2 January 1972. Gordon V. Gay, photographer, NPS. (CARL 4008-19-02P)

The roofless silo was poorly maintained. In the 1970s, NPS removed a tree and vines growing from the top, made necessary repairs, and installed a wood cover over the metal ladder rungs to prevent visitor accidents.

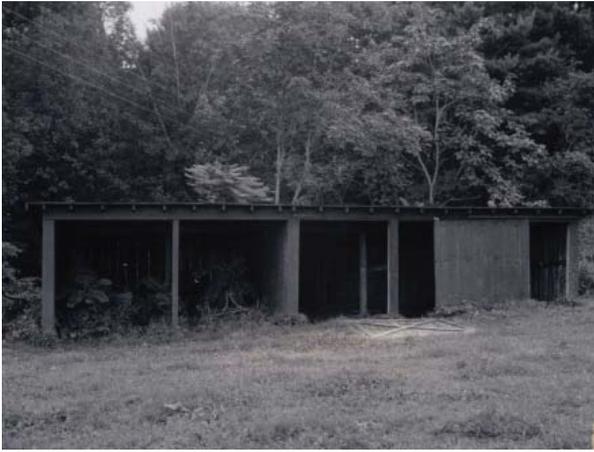
Figure 84. Shavings shed in September 1969 showing configuration of openings and fallen door; Harold J. (Pete) Stout, photographer. (CARL 4008-21-01P)

A 1969 photograph shows the poor condition of the building before NPS work. NPS repaired or replaced a fallen door and its supporting track, and removed high weeds from the two northernmost bays. The roof was replaced in 1991. The Assessment of Actions identifies the then-existing roof as 90-lb. black roll roofing, and notes, "this roof goes bad quickly. It is proposed to put a layer of plywood under the roofing to keep it from cracking and buckling. The plywood will be installed so that it will not be seen."²¹⁵

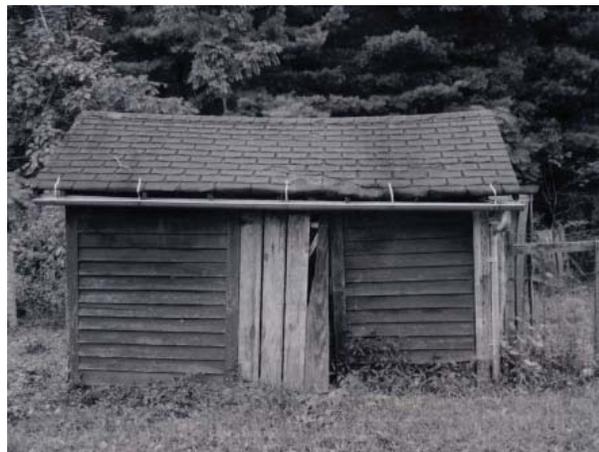
Figure 88. Front (west) elevation in September 1969 showing poor condition; Harold J. (Pete) Stout, photographer. (CARL 4008-20-01P)

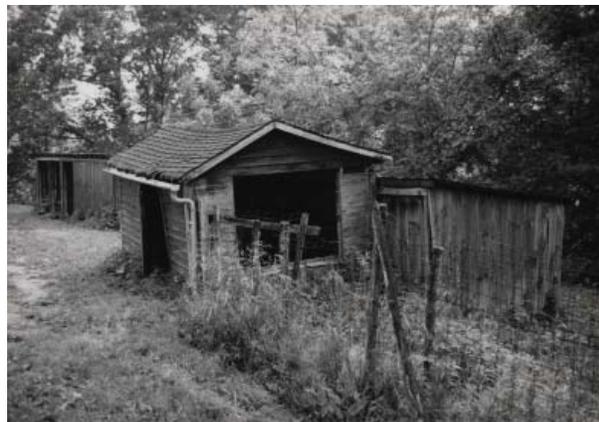
Figure 89. Photograph taken spring 1972 “prior to restoration” shows flush siding on south elevation, failing roof, and shifted front wall; Gordon Gay, photographer, NPS. (CARL 4008-20-03P)

side show its condition. The deteriorated asphalt shingles of the gable roof caused the roof structure to sag; a portion of the front wall had shifted from its sill; and the front door and south window sash were missing.

The 1972 photograph shows that the walls of the south elevation flanking the large window opening were faced with flush boards, in contrast to the front weatherboards.

Work conducted by NPS in the spring of 1972 included replacement of the roof, though the extent of replacement of roof structure is not known; the roof was covered with asphalt shingles. A vertical board door was installed in the front doorway.

Replacement of siding appears to have been extensive. The flush boards of the south elevation were replaced with weatherboards. Window surrounds and mullions were added, and three glazed sash, the outer two hinged, were installed over screened openings. Many if not most of the front weatherboards were replaced with new boards.

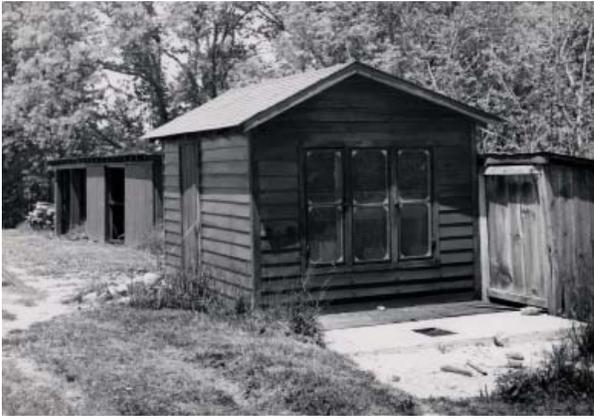
Figure 90. Photograph taken spring 1972 “during restoration.” Work included installation of a door, windows, and considerable replacement of siding; Gordon Gay, photographer, NPS. (CARL 4008-20-04P)

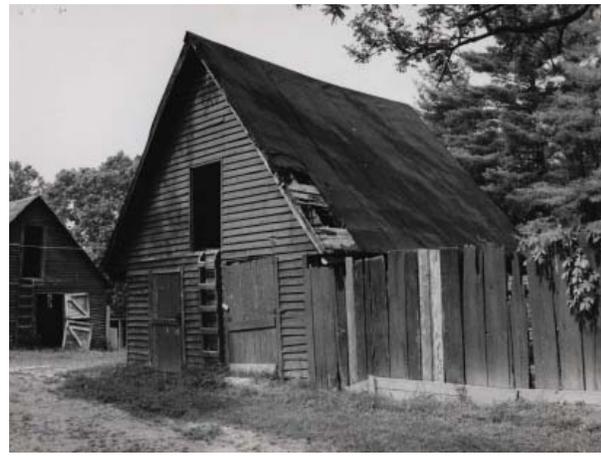
The condition of the buck kid quarters declined in the 1960s. By 1972 the roof, still sheathed, shows large holes in the southwest corner. In July 1972, NPS removed the entire roof structure. A photograph labeled "restoration work" shows the two freestanding end walls propped up by diagonal 2 x 4s resting on the loft floor. The rakeboards also are missing, leaving the cut ends of the gable weatherboards visible. The new roof was covered with 5V metal roofing. Materials and construction details of the original roof are not known.

Figure 97. Hole in roof of buck kid quarters, 1972. In the background is the horse barn. 2 June 1972. Gordon Gay, photographer, NPS. (CARL 4008-16-05P)

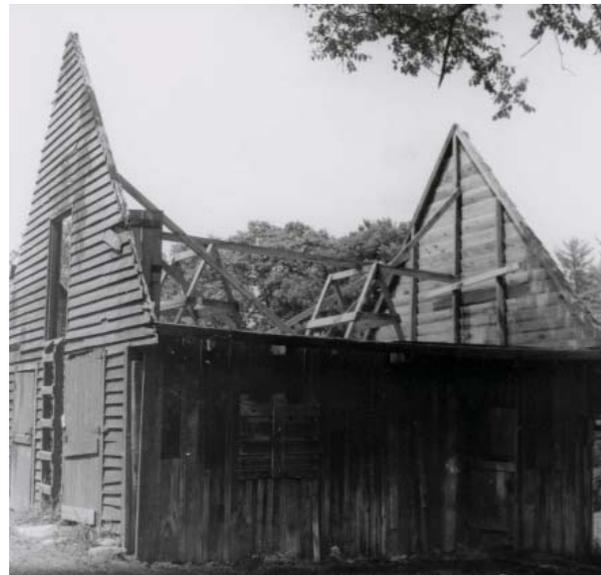
Figure 98. Total removal of roof structure of buck kid quarters. 11 July 1972. Gordon V. Gay, photographer, NPS. (CARL 4008-16-13P)

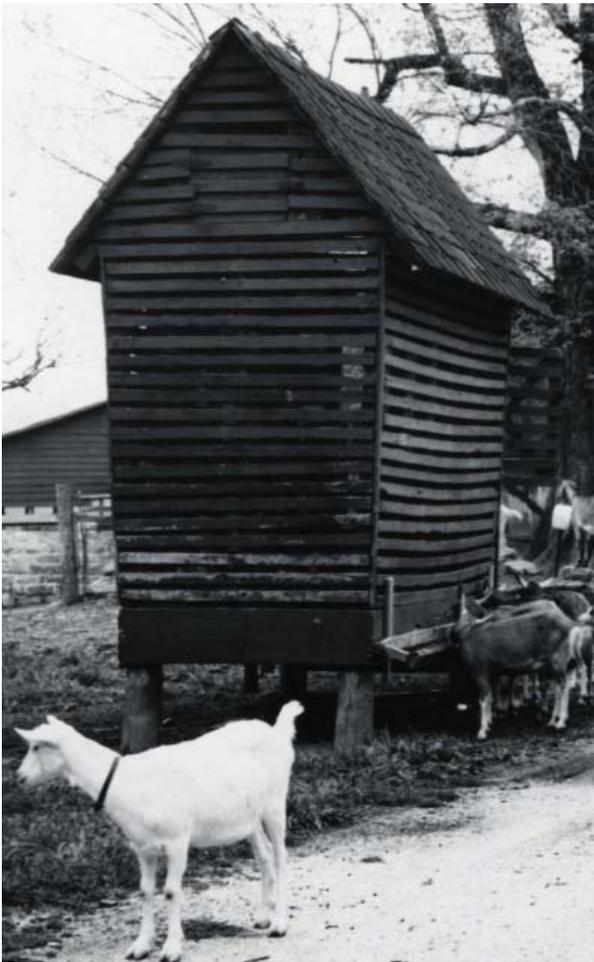
The Sandburgs for some years stored corn here for their horses and the few cattle they kept, later using the building to store small tools.²³⁵ The crib is shown in the foreground of the 1956 panorama. The stone footings seen in Smyth photographs have been replaced by round wood piers, and there is no stone wall beneath the east wall. In this and later Sandburg photographs, the building is painted a dark color, probably the red of other barns (as seen in later color photographs). This 1956 image already shows weathered or chewed paint on the south elevation. The upper half of the north door is open and visible at the northeast corner of the crib, and a feeding trough, very much in use, is attached to the east skirt board.

Figure 101. Corn crib in 1956 showing post footings and a feeding trough on east skirt board. The dark paint is probably the red of other barns. (Enlarged portion of CARL 3003-2.3-1)

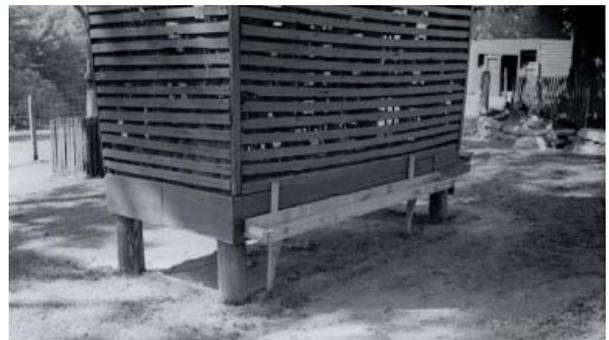
NPS photographs taken in 1971 and 1974 show the crib before and after the first repairs. The diagonal brace in the 1971 photographs suggests the building was listing. The wood trough, missing in 1971, was replaced during repairs, the new wood clearly seen in the 1974 photograph.

Figure 103. The crib in the summer of 1974 after repairs. The wood trough has been rebuilt on the east skirt board, and the northeast post footing has been replaced. In the background is the large elm tree, protected from the goats by a vertical slat fence. The tree fell in 1985. Ron Thoman, photographer. (CARL 4008-15-07P)

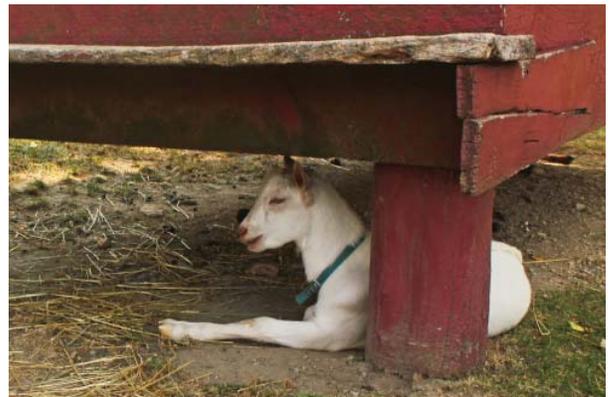
Figure 104. Wood post footing at northwest corner of corn crib, 2012.

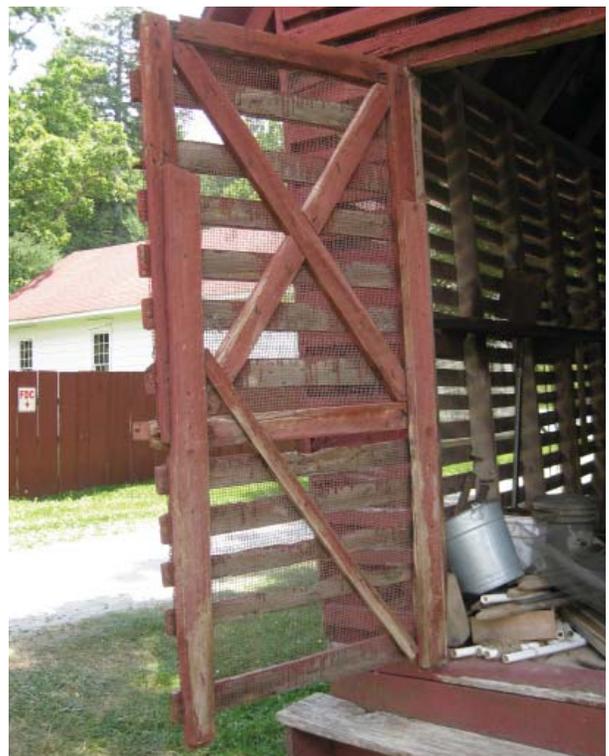
Figure 105. Boards nailed to interior edges of corn crib door join upper and lower sections as one. 2012 photograph.

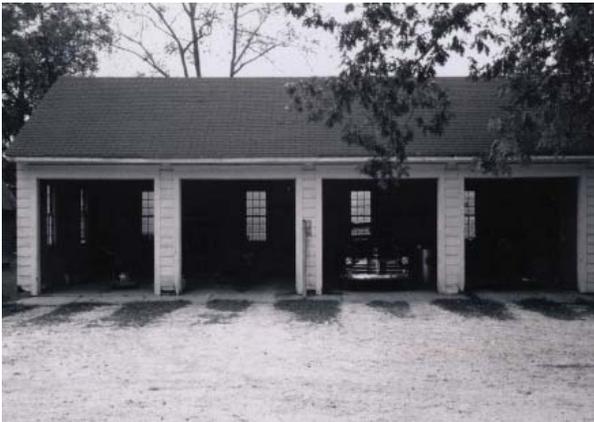
Upon acquisition of the property, NPS used the barn garage as its maintenance building.²⁴⁵ Major rehabilitation work in 1972 included significant rebuilding of portions of the structure. A 1969 photograph shows the building before work began. No doors are present, the asphalt roofing shingles are worn, and the bottom of some surrounds and bottom boards between bays are rotted.

Figure 108. Barn Garage in September 1969 before work began. Harold J. (Pete) Stout, photographer. (CARL 4008-13-01P)

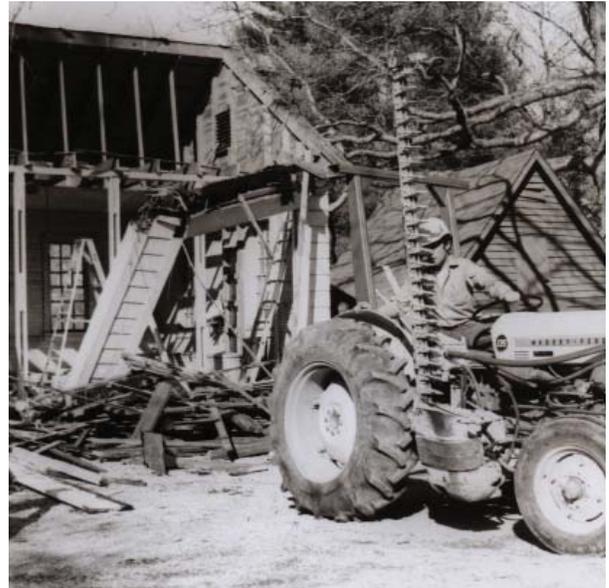
Although other deterioration is not visible, there must have been significant decay. In January 1972, the entire front of the building was taken down. Three photographs, labeled both “restoration” and “reconstruction,” show the progression of the work. In the first, a tractor and rope are felling one of the narrow front walls. The south slope of the gable roof has been removed, its lumber piled on the ground.

Figure 109. Demolition of front façade, January 1972. Photograph is labeled, "restoration in progress." Shown in foreground is Farmer Demonstrator, Leroy Levi on tractor." Another label reads "to show reconstruction." Gordon Gay, photographer, NPS. (CARL 4008-13-10P)

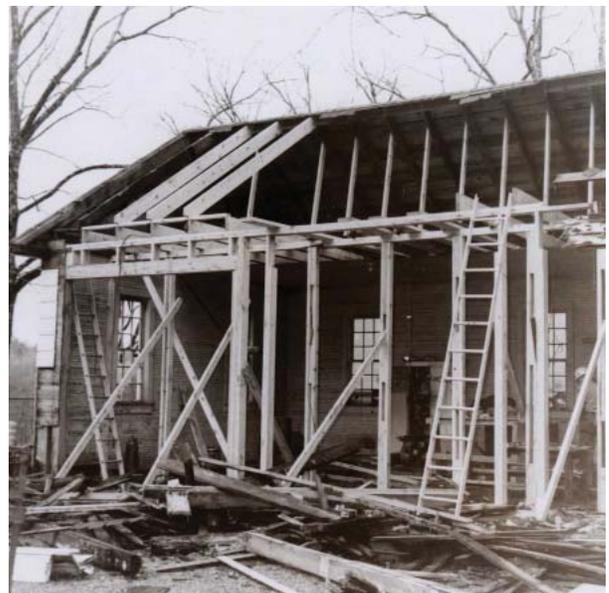
The second photograph shows construction of the roof and façade underway. Two original rafters were retained at the west end. By late March the front was close to completion, and an interior partition with doorway was under construction to enclose the western bay, though was later removed.

Figure 110. Rebuilding of the front façade, January 1972, labeled, "restoration in progress," with purpose noted as "to show reconstruction." Gordon Gay, photographer, NPS. (CARL 4008-13-15P)

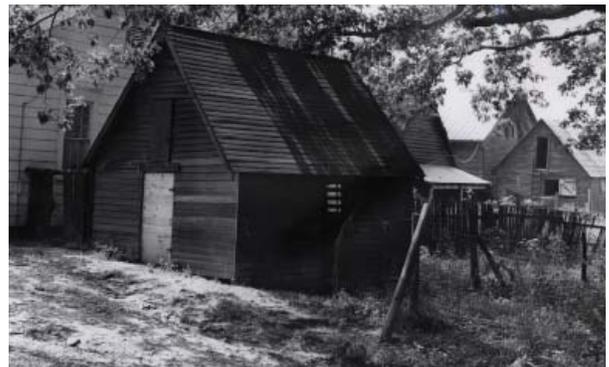
Figure 114. Isolation Quarters photographed in July 1971 "to show condition." New board door has not been painted. Photographer Jim Kretschmann (appointed manager and historian in 1970, later superintendent). (CARL 4008-12-02P)

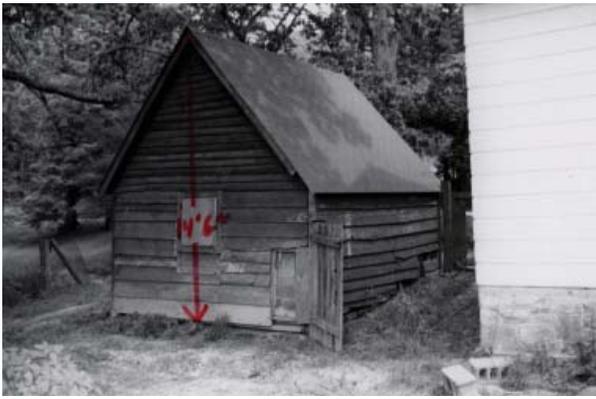
Figure 115. North (rear) façade of the Isolation Quarters showing height measurement, boarded window, corner door cut for goats, 2 June 1972. Gordon V. Gay, photographer, NPS. (CARL 4008-12-05P)

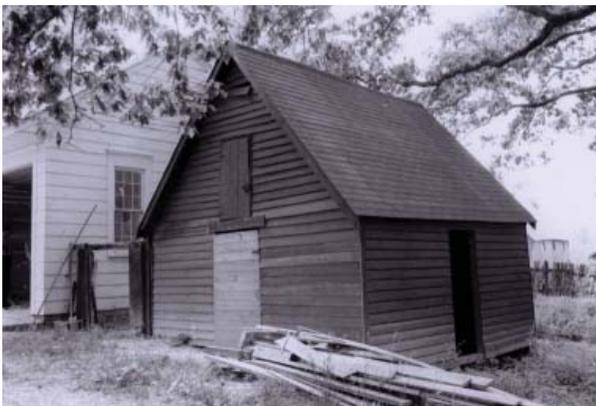
Figure 116. The building, labeled "ca. 1974," after the roof was resingled. The front door was later painted, the side door installed, and the west gate replaced. (CARL 4008-12-06P)

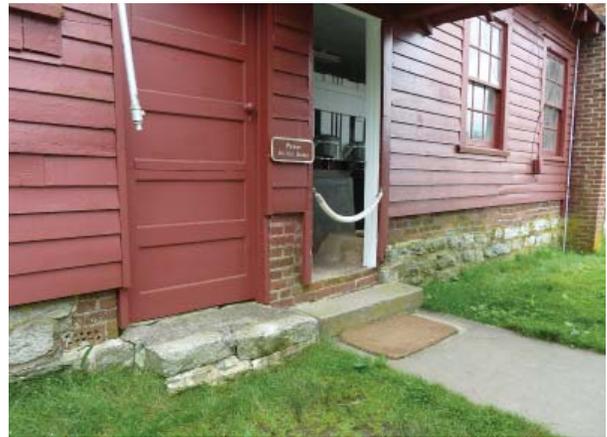
Figure 124. Goat Barn: foundation wall of North Shed Addition rebuilt using brick matching those of the chimneys of both this barn and the Milk House.

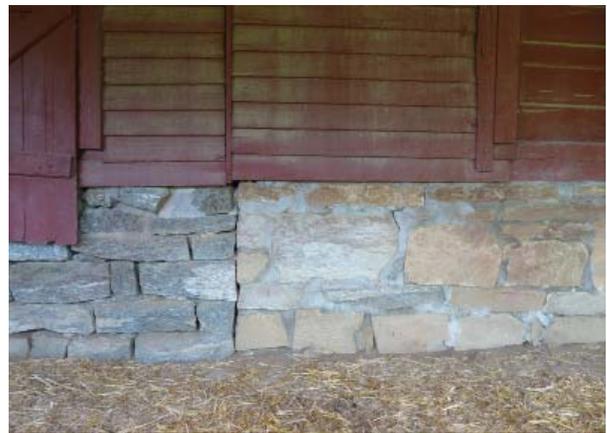
Figure 125. Goat Barn: seam in foundation wall where North Shed Addition (L) meets Original Dairy Barn.

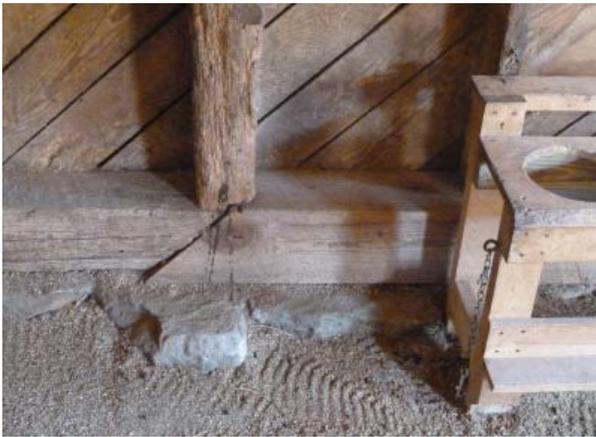
Figure 126. Goat Barn: seam between old sill (L) and new sill (R) at east wall of Room 103.

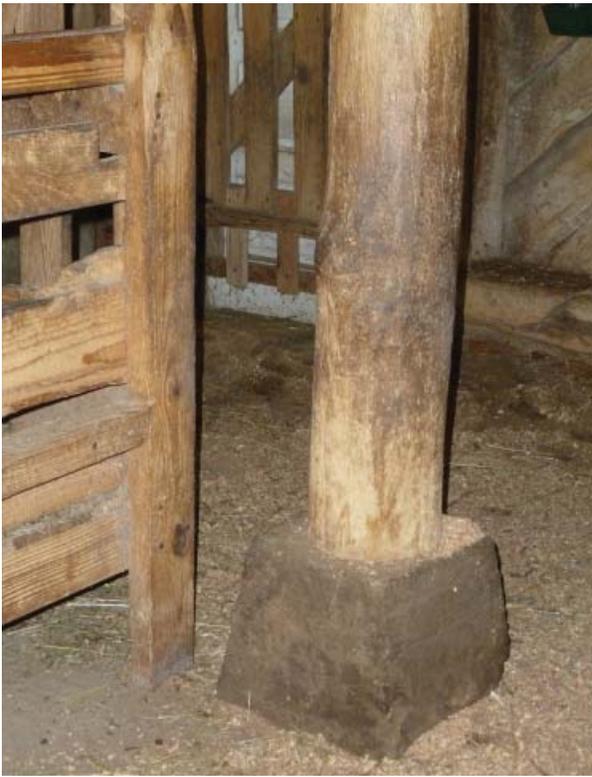
Figure 128. Goat Barn: posts on piers with beams added by Sandburg to strengthen Loft flooring.

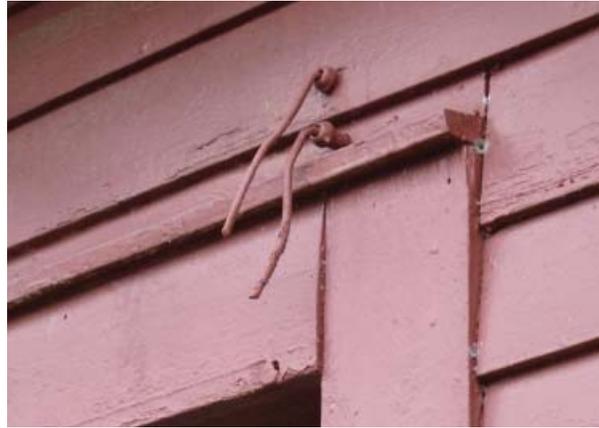
Figure 134. Goat Barn: ceramic tubes for early electrical knob-and-tube wiring at north exterior wall.

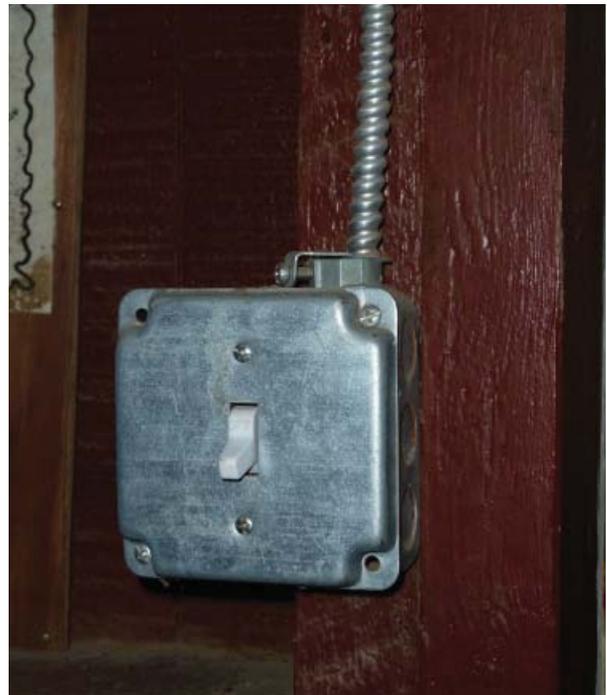
Figure 141. Goat Barn: modern light switch box with flex-conduit installed by NPS.

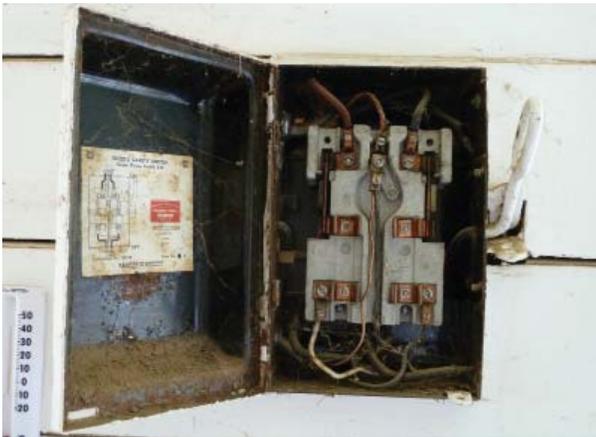
Figure 142. Goat Barn: interior of Sandburg-era fuse box on north wall of Room 107.

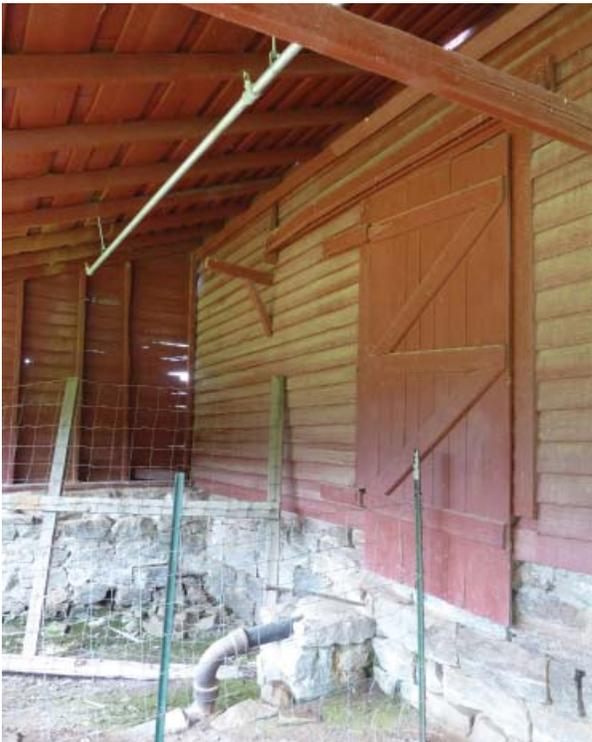
A cast iron drain pipe exits at the west side of the building.

Figure 147. Goat Barn: water drain pipe exits the North Shed Addition at west exterior wall.

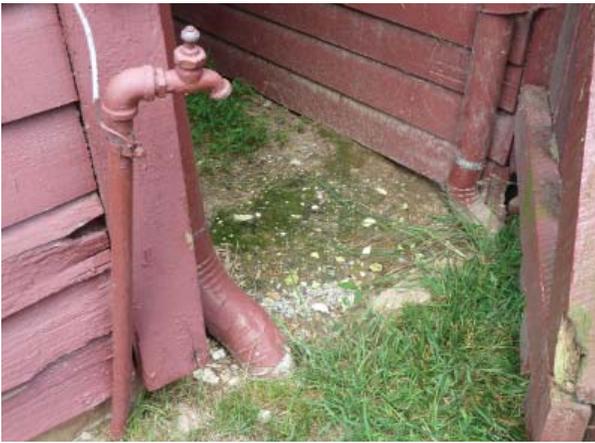
Figure 150. Goat Barn: east section of front gutter connects to drain line. Hose bib is nearby.

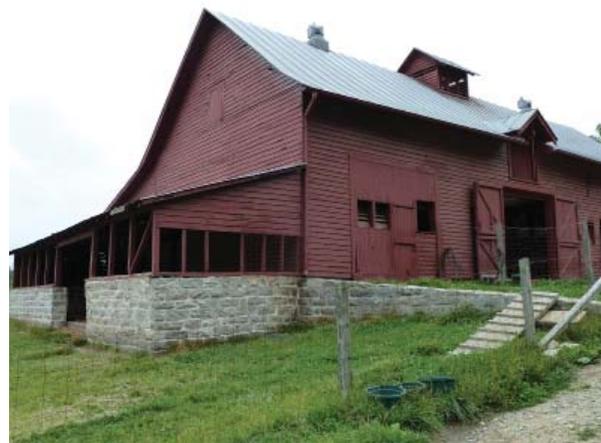
Figure 160. Goat Barn: an original board-and-batten door in each gable of Hay Loft level. Original vehicle doorway (L) infilled with windows and pedestrian door probably by Sandburg.

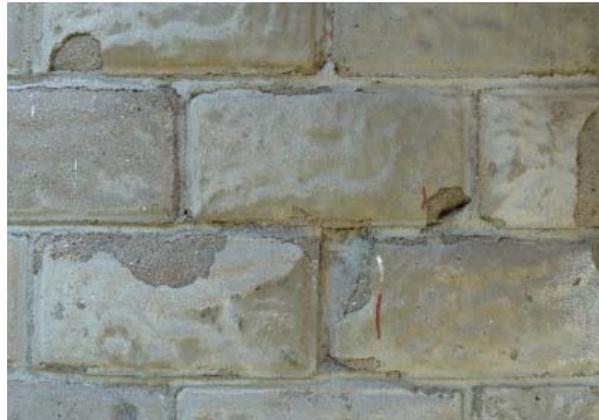
Figure 282. Milk House: deteriorated CMU of South Section.

- The loss of surface material by the CMUs of the South Section of the building.
- The wall crack that emanates from the top east corner of the restroom doorway.
- The pooling of water in the area between the Milk House and the Goat Barn.
- Reliance on asphalt coating for flashing at chimney and intersection of roofs and vertical surfaces.

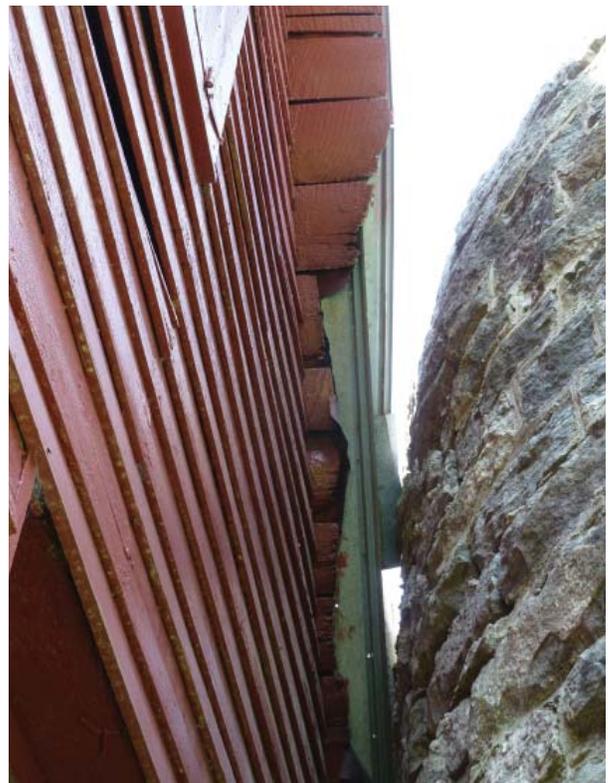
Figure 290. Horse Barn: north gable roof trimmed for Silo.

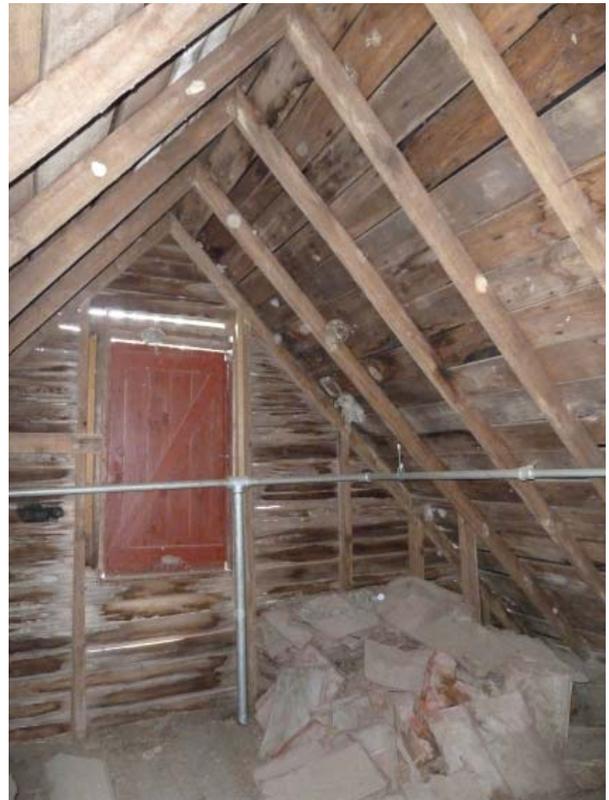
Figure 296. Horse Barn: loft looking northeast. Rafters are joined with wire nails.

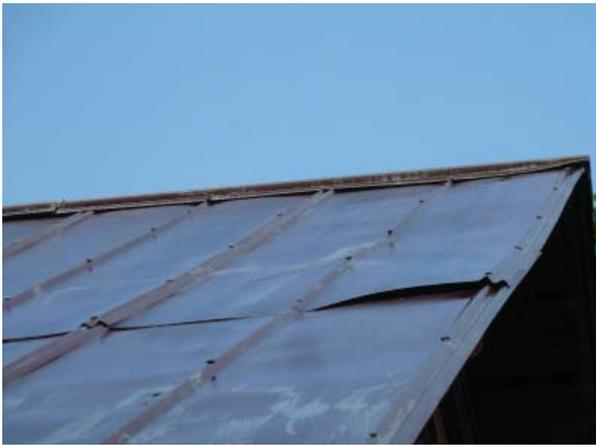
The roofing system is a major concern. The 5-V panels have extensive rust. But more seriously, a large number of nails that hold the panels in place

Figure 297. Horse Barn: rusting, loose, 5-V metal roof panels.

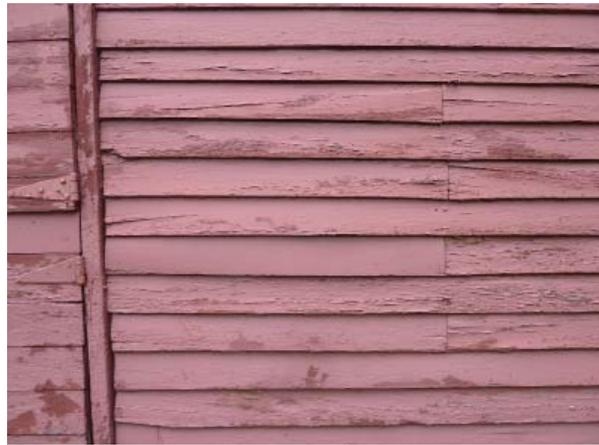
Figure 299. Horse Barn: split, checked, twisted weatherboard siding and failing paint.

A number of boards have rot, especially the replacement boards along the north elevation where conditions remain damp for longer periods of time.

The paint on the exterior surfaces appears to be failing at the substrate level, an indication of inadequate preparation prior to repainting.

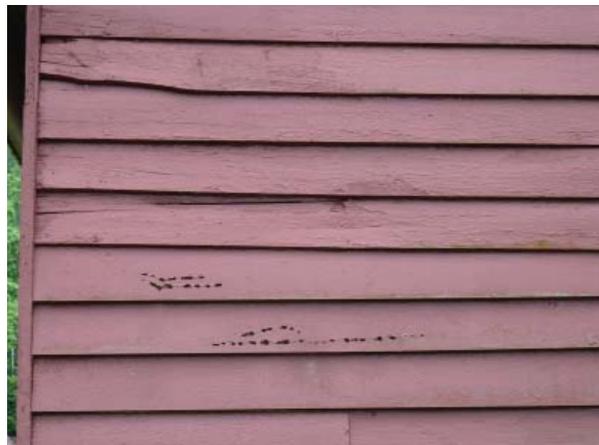
Figure 300. Horse Barn: damage caused by carpenter bees.

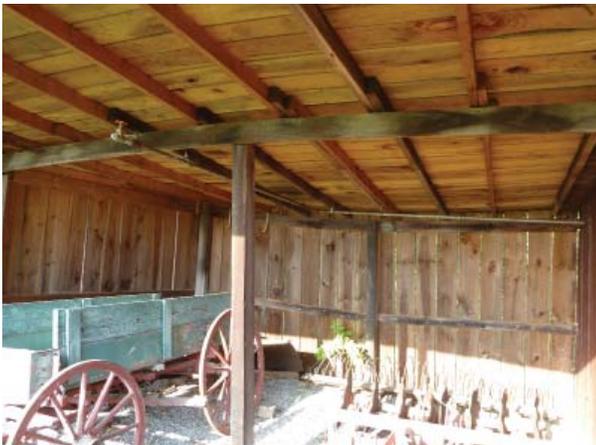
Figure 304. Shavings Shed: deflection of walls and roof due to undersized framing.

Shingles are not a desirable roofing material for low-pitched roofs such as the one on this structure. The extensive amount of replacement roof deck boards and framing can likely be attributed to the use of roof shingles without supplementary protection.

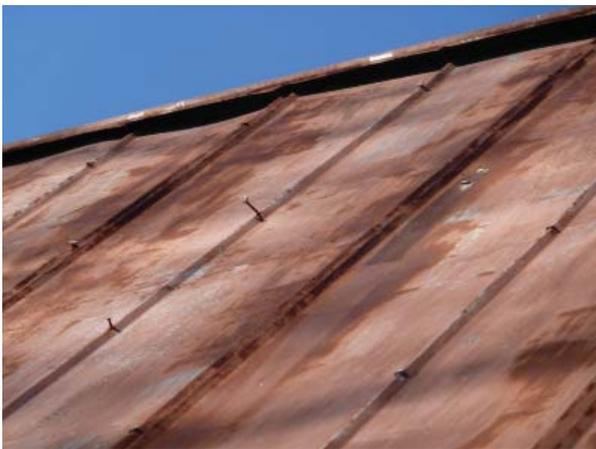
Figure 325. Buck Kid Quarters: loose fasteners and extensive rust of roof.

The replacement roofing system is a major concern. The 5-V panels have extensive rust. But more seriously, a large number of nails that hold the panels in place have worked their way up and out of a secure bond; the panels are susceptible to be blown out of position or even off the building in a strong wind.

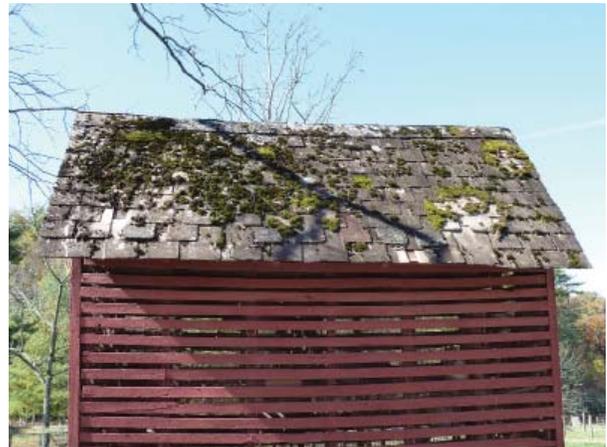
Figure 328. Corn Crib: damaged and missing roof shingles.

Several roofing shingles are broken or dropped out of position. Fortunately, additional shingles have been stockpiled and can be installed as replacements.

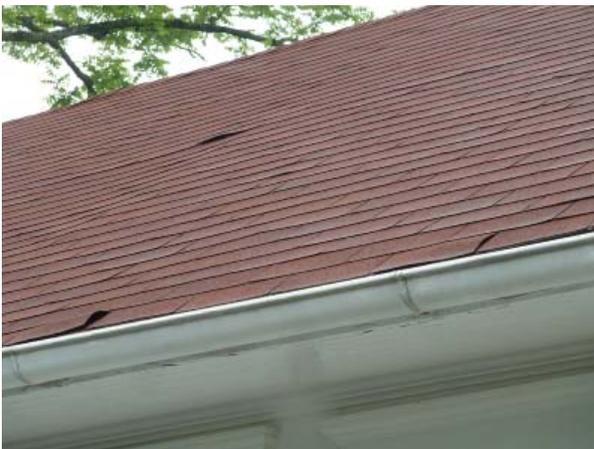
A number of roofing shingles are cupped and thus prone to be damaged by a strong wind.

Figure 344. Barn Garage: a number of composition shingles are cupped making them prone to wind damage.

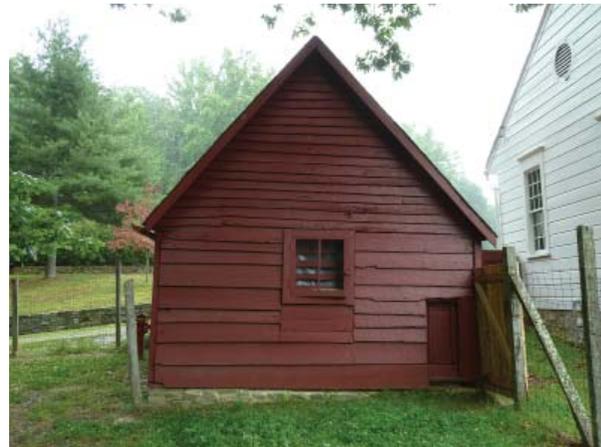
Figure 347. Isolation Quarters: north elevation. Note change in siding sizes.

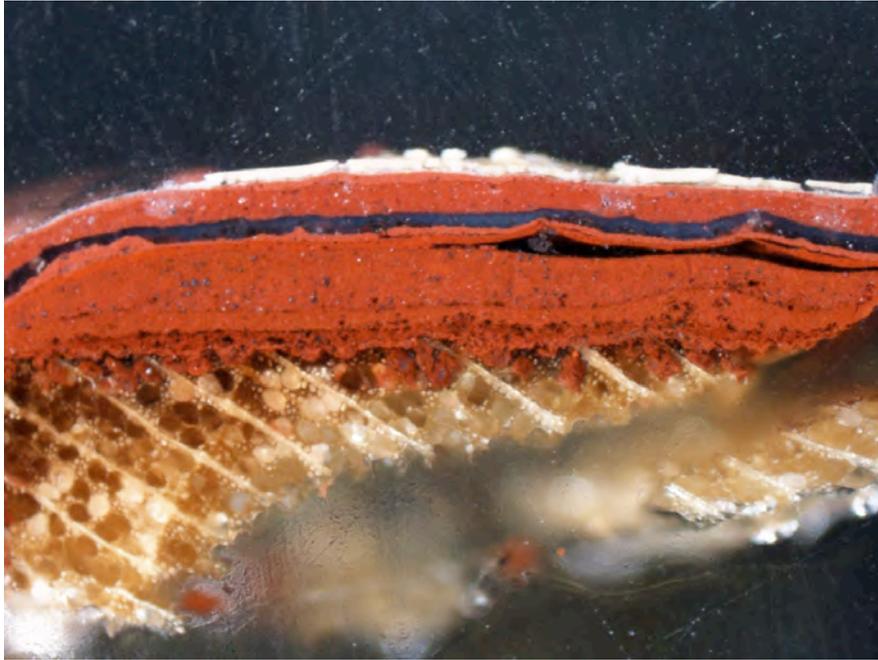
Image 7. Cross-section of sample CSB.36, removed from one of the weatherboards in the gable of the hayloft opening added by the Sandburgs to the front of the Goat Barn. Note the presence of only dark red paint. (40x, Visible Light)

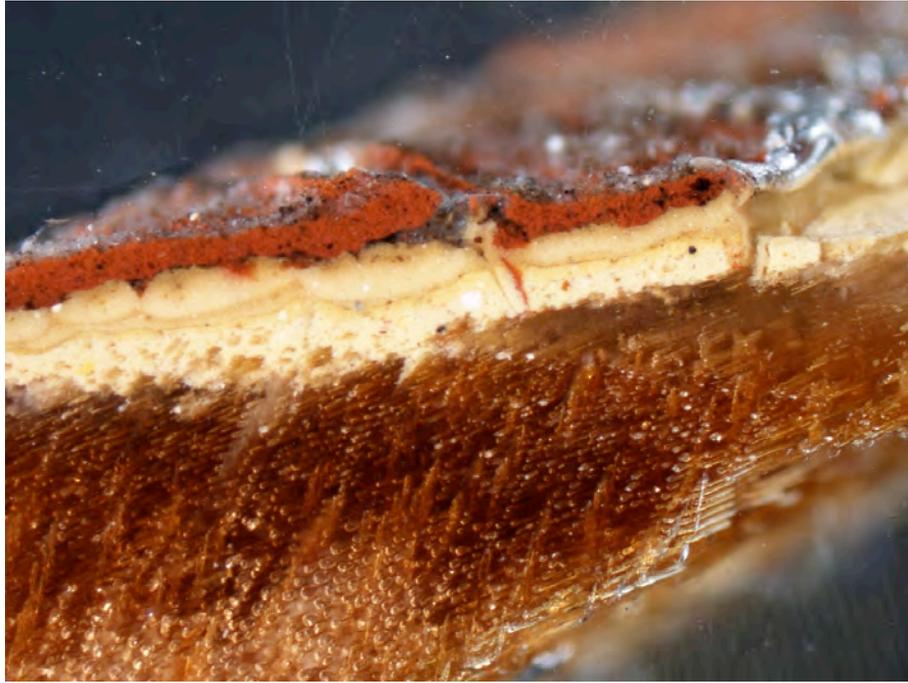
Image 13. Sample CSB.37, removed from the siding of the original rear elevation of the Goat barn, now enclosed by the second story hayloft. Note early pale yellow and cream layers below a single layer of red paint. (40x, Visible Light)

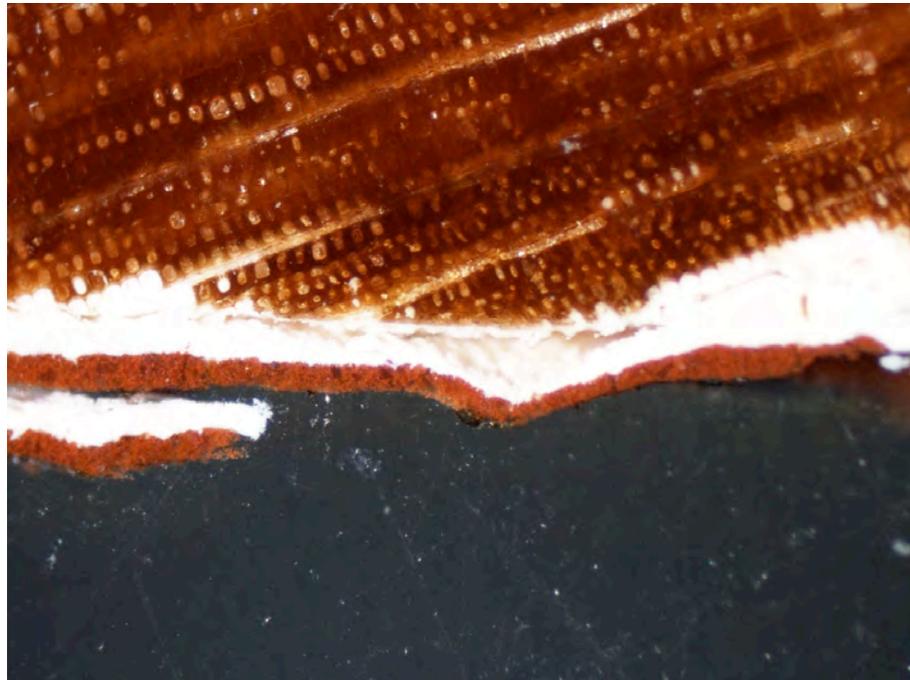
The exterior window and door trim were also investigated. The trim around window openings on the original rear elevation of the Goat Barn (now enclosed) was painted white. Samples removed from the first and second floor level in this location (CSB.29 and CSB.38) both have two layers of white before being painted red. It is possible, however, that these windows were added by the Sandburgs because of the few number of paint layers they possess. (*Image 16*) For instance, a sample removed from the door trim on the west elevation of the main block of the Goat Barn (CSB.27) has seven layers of white finishes (a combination of lime wash and white paint) before being painted red six times. This sample most likely represents the full spectrum of trim colors from the original period of construction through current day, indicating the trim was painted white until some time during the Sandburg period. (*Image 17*)

Image 16. Sample CSB.38 was removed from the same area as Sample CSB.37, the now enclosed second floor level rear elevation of the Goat Barn. This sample was removed from the window casing and shows only two layers of white and then a layer of red paint. (100x, Visible Light)

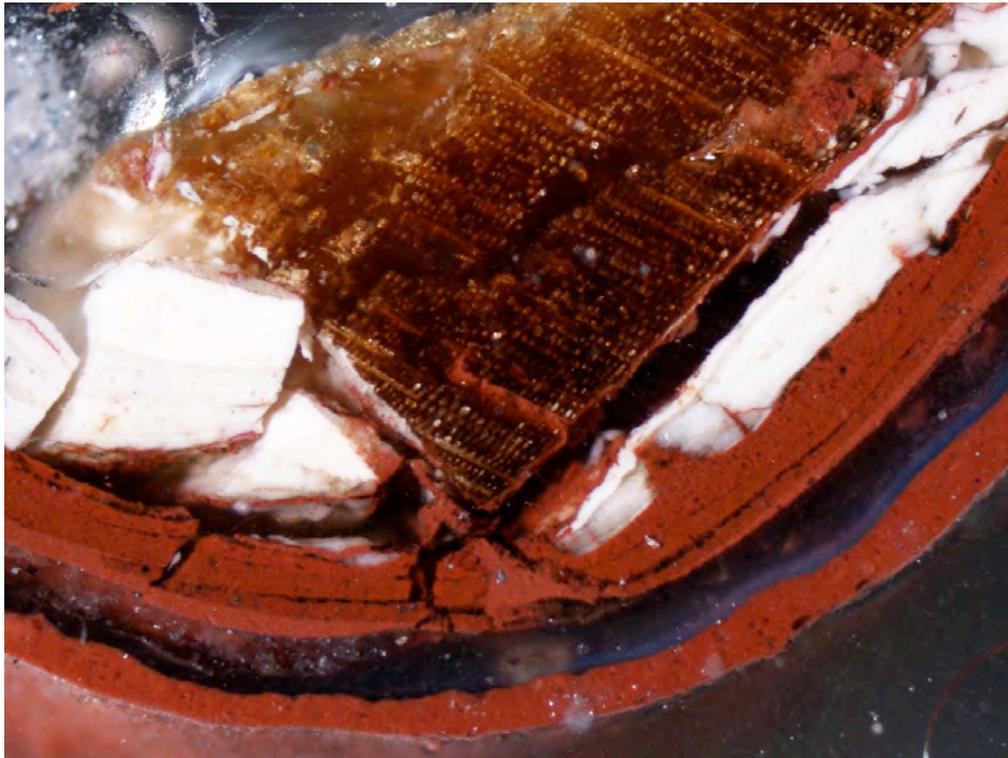
Image 17. Sample CSB.27 was removed from the door trim on the west elevation of the Goat Barn and contains several layers of white finishes before red paint began to be applied. (40x, Visible Light)

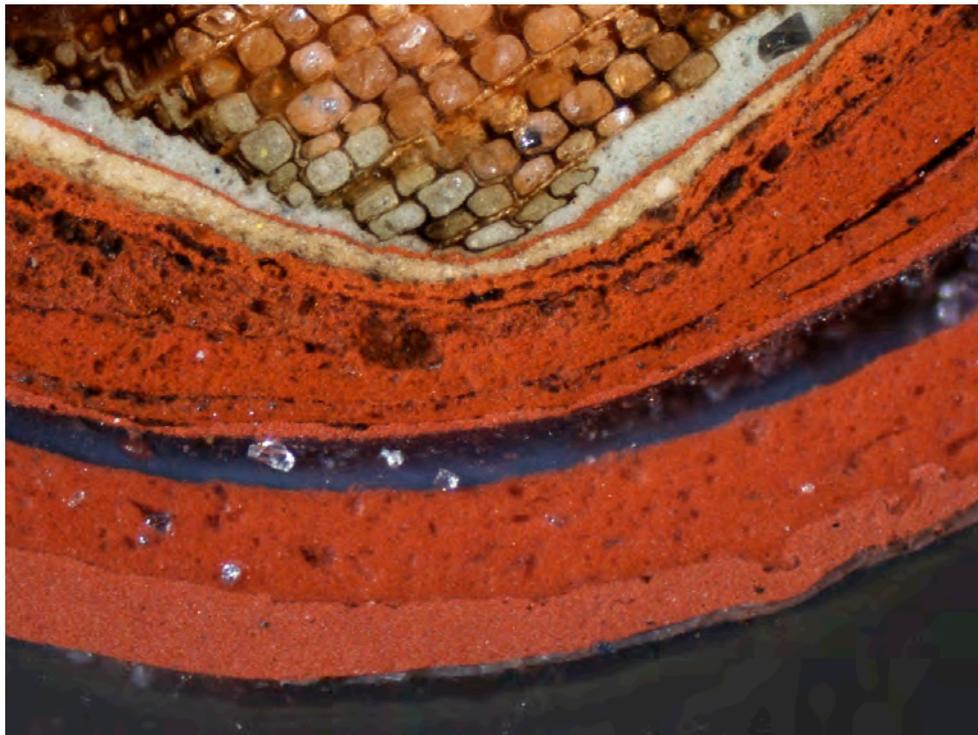
Image 22. Sample CSB.7 was removed from the upper area of siding on the front elevation of the Horse barn, the area that was not modified. The early pale blue-green and cream paint colors visible at the top of the photograph are believed to be original to the barn. (100x, Visible Light)

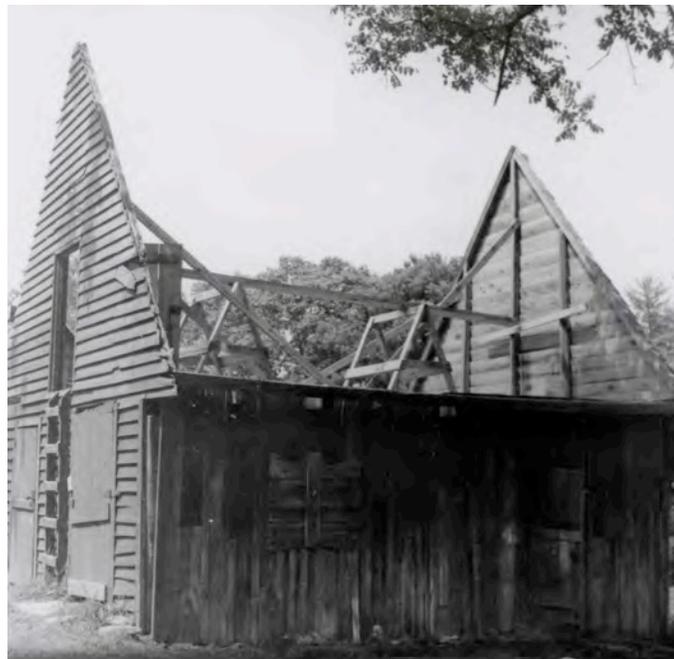
Image 26. The Buck Kid Quarters, 1972, when the NPS performed significant repairs on the building. (CARL 4008-16-13P)

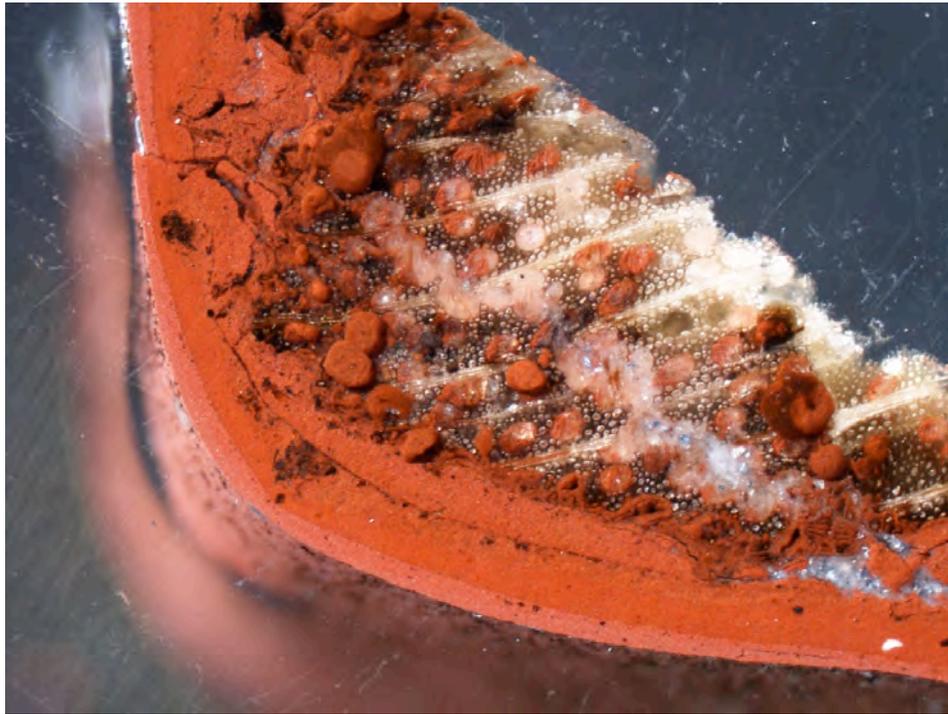
Image 28. Sample CSB.4, removed from a plank between joist ends on the north elevation of the Buck Kid Quarters, has only four layers of red paint. The wood substrate is highly weathered. (40x, Visible Light)

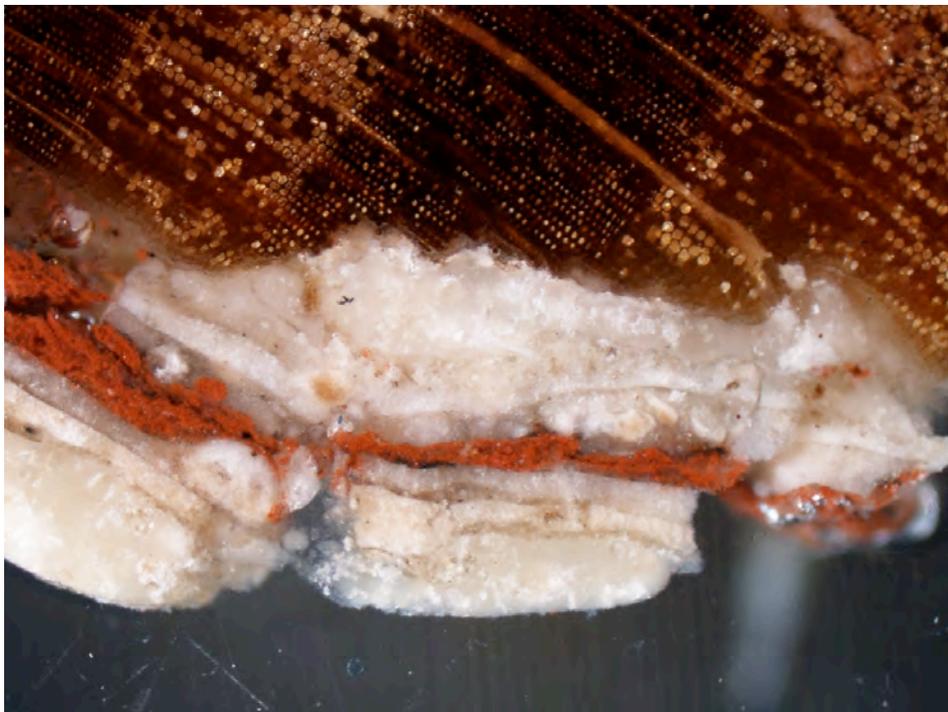
The sample removed from the interior of the building (CSB.6) has a different paint layering sequence. This sample, removed from a diagonal framing brace that was most likely exposed prior to the Sandburgs enclosing this elevation, contains six layers of white lime wash and one layer of red paint. (*Image 29*)

Image 29. Sample CSB.6, removed from a diagonal brace inside the Buck Kid Quarters, shows evidence of whitewash and a layer of later red paint. This element appears to be original to the building. (40x, Visible Light)
