Barn Complex
Carl Sandburg Home National Historic Site
Historic Structure Report

December 2014

JOSEPH K. OPPERMAN – ARCHITECT, P.A.

Goat Barn: HS-16, LCS 005161, FMSS 69819
Milk House: HS-16A, LCS 005162, FMSS 69690
Horse Barn: HS-17, LCS 005163, FMSS 69863
Silo: HS-20, LCS 005166 (s-o-w gives no FMSS)
Shavings Shed: HS-19, LCS 005165, FMSS 69691
Cow Shed: HS-18, LCS 005164, FMSS 69697
Buck Kid Quarters: HS-15, LCS 005160, FMSS 69689
Corn Crib: HS-14, LCS 005159, FMSS 69698
Barn Garage: HS-13, LCS 005158, FMSS 69895
Isolation Quarters: HS-12, LCS 005157, FMSS 69817

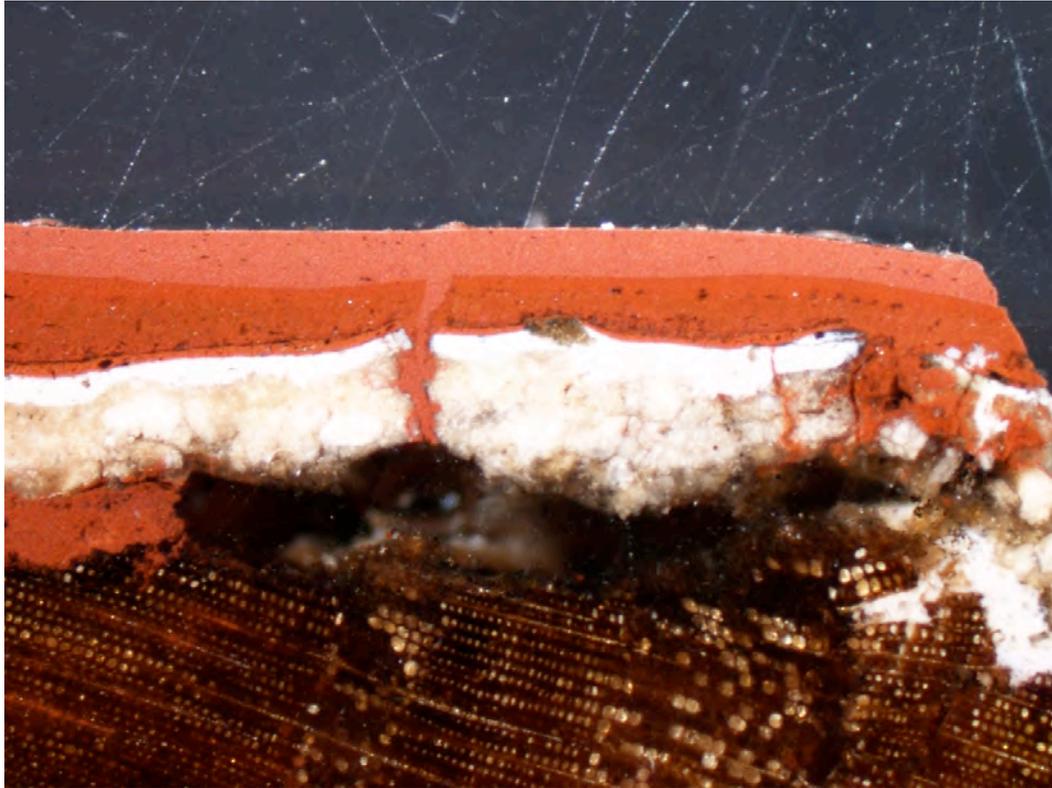
Two samples were removed from the exterior wide plank weatherboards of the Isolation Quarters, one from the north elevation and one from the west elevation. The latter sample was removed from a protected area and contained more layers of finishes, and was therefore examined in cross-section. In this location, a total of seven layers of finishes were documented, two layers of white lime wash, one layer of white paint and four layers of red paint. (*Image 30*)

Image 30. Sample CSB.44 was removed from the west elevation of the Isolation Barn and contains early lime wash and white paint finishes, as well as more recent reds. (40x, Visible Light)

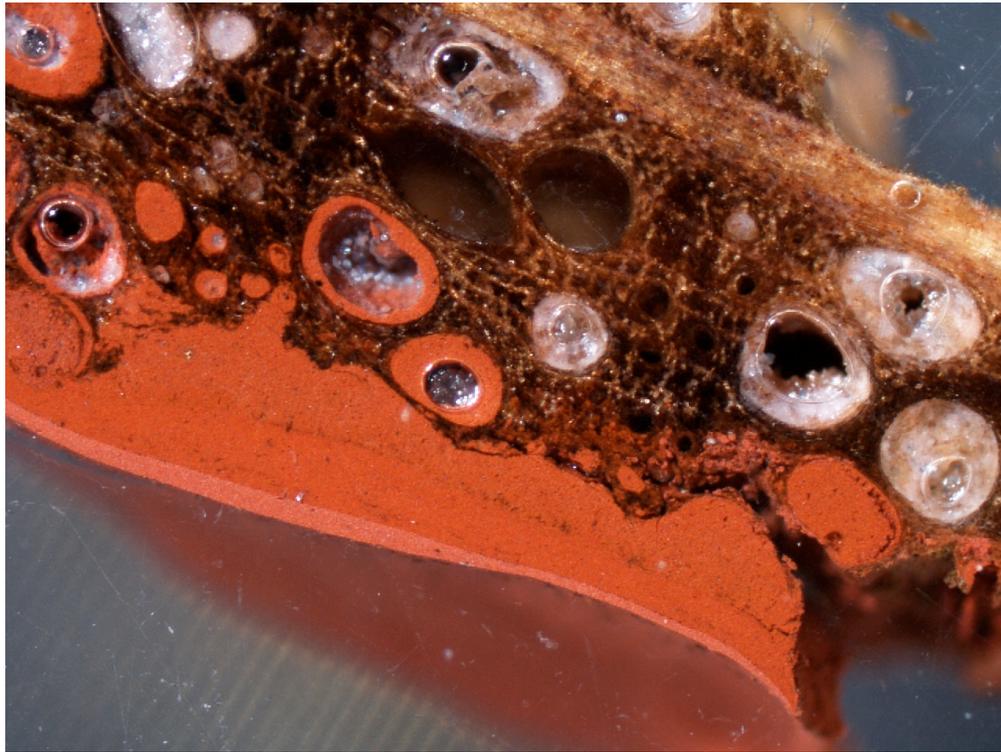
Samples were removed from protected areas of the building, under the roof overhang. One sample was removed from the wood slat above the door and the other from the uppermost piece of lath under the roofline. The door was also investigated in situ. In all of the locations that were examined, only recent campaigns of red paint were observed. In the samples viewed in cross section, five layers of red paint are present on top of a weathered wood substrate. (*Image 32*)

Image 32. Sample CSB.2 was removed from a slat above the door of the Corn Crib. Note highly weathered wood substrate. (40x, Visible Light)

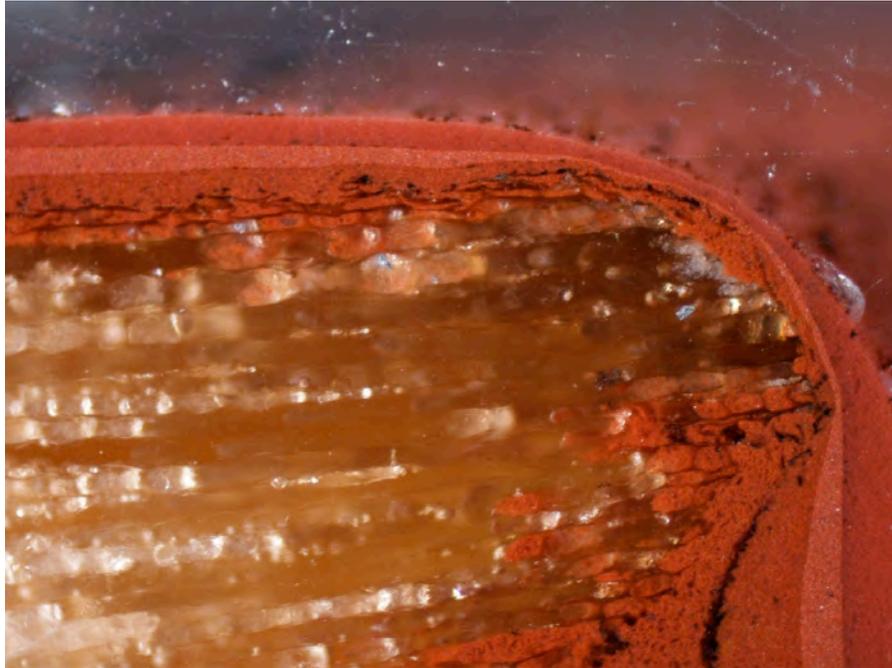
Paint samples were removed from five locations on the exterior of the Buck House, including four from the main building block and one from the enclosed rear shed. In all locations, the wood substrate appears rough and weathered, suggesting the earliest paint in these areas is most likely not original. Three of the five samples have the exact same paint layering sequence: four layers of dark red paint. The locations of these samples include the siding of the rear shed, the siding on the south elevation of the main portion of the building and the cornice on the south elevation of the main portion of the building. (*Image 36*)

Image 36. Sample CSB.47 was removed from the siding of the enclosed rear porch of the Buck House. (40x, Visible Light)

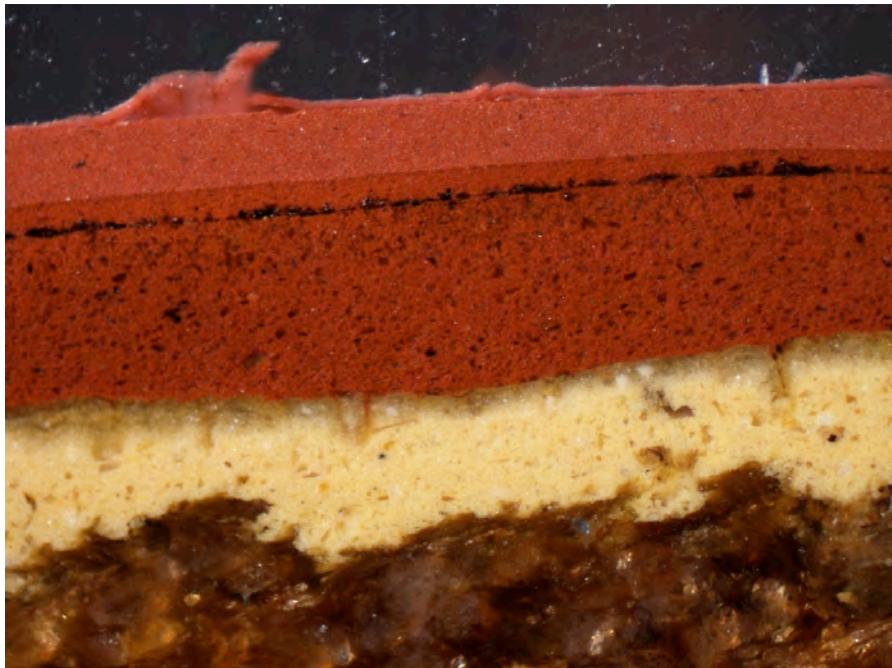
A sample removed from the front (east) elevation that is protected by a porch contains the same four layers of dark red paint. However, underneath the red paint is a pale yellow paint that looks very similar to the pale yellow found on the Goat Barn. As stated previously, this pale yellow is probably not the Buck House's original paint color, given the disturbed surface of the wood substrate on which it was applied, but it is still likely early. Although it is not known when it was applied, if it the same as the pale yellow on the Goat Barn, then it most likely dates to the Smyth period. (*Image 37*)

Image 37. Sample CSB.49 was removed from a protected area of the exterior siding of the Buck House, under the front porch. It contains earlier paint layers, including a yellowish-cream similar to that seen on the Goat Barn. (100x, Visible Light)

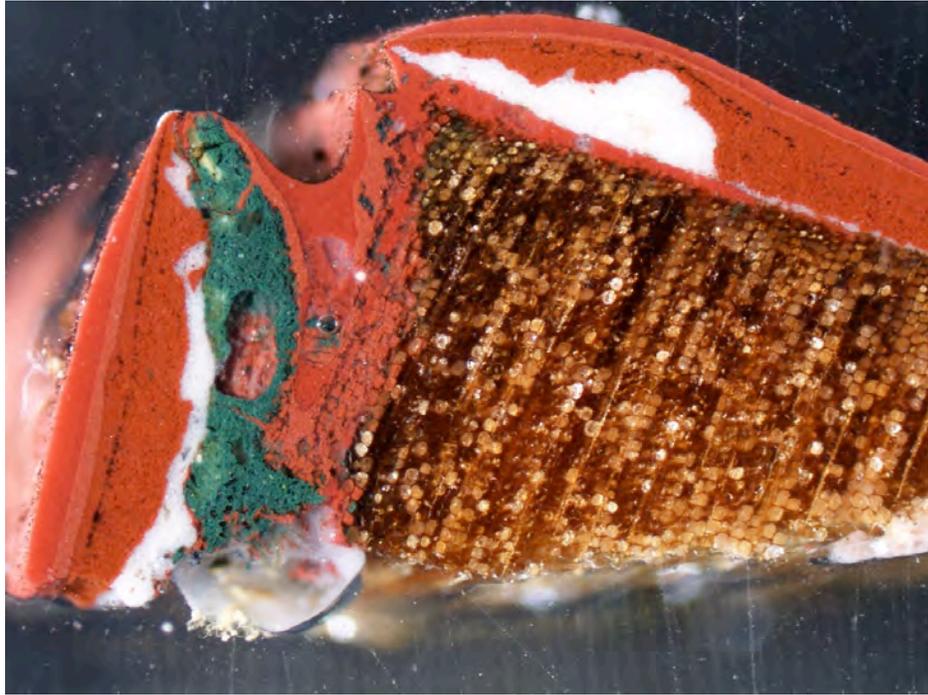
A sample removed from the corner trim of the main portion of the house (where it meets the enclosed rear porch) also has traces of earlier paint finishes. This trim piece contains evidence of dark green and white paint, suggesting the trim was treated differently from the weatherboards on the body of the house. The green was most likely applied to the house when the siding was pale yellow and the white when the first layer of dark red was applied. (*Image 38*)

Image 38. Sample CSB.48 was removed from the vertical corner trim of the main portion of the Buck House. Note the early dark green and white paint colors. (40x, Visible Light)

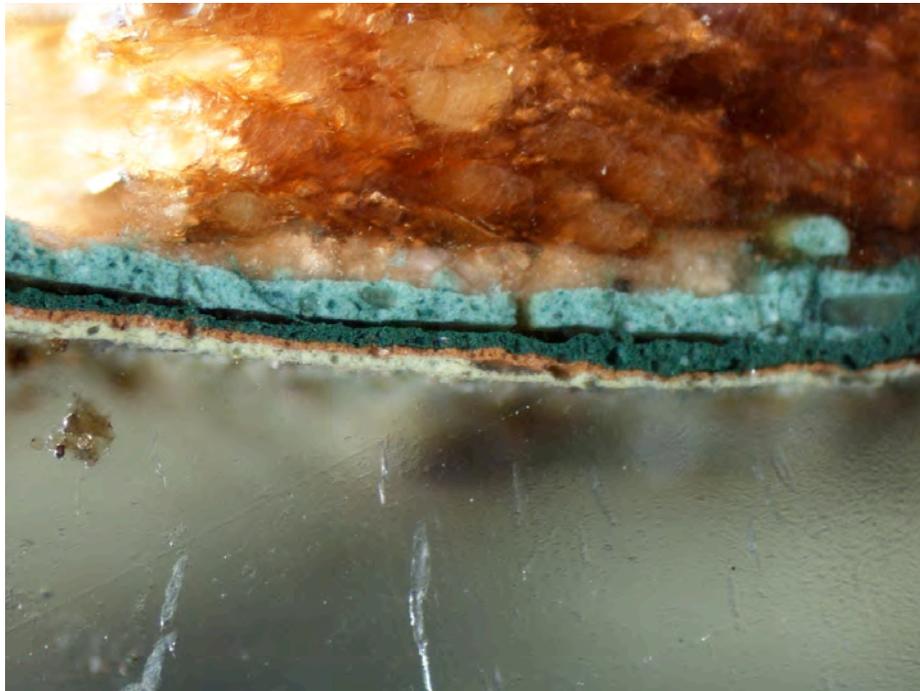
Image 39. Sample CSB.51, removed from a window casing in the south interior room of the Buck House, has four layers of paint, including an original pale blue-green. (100x, Visible Light)

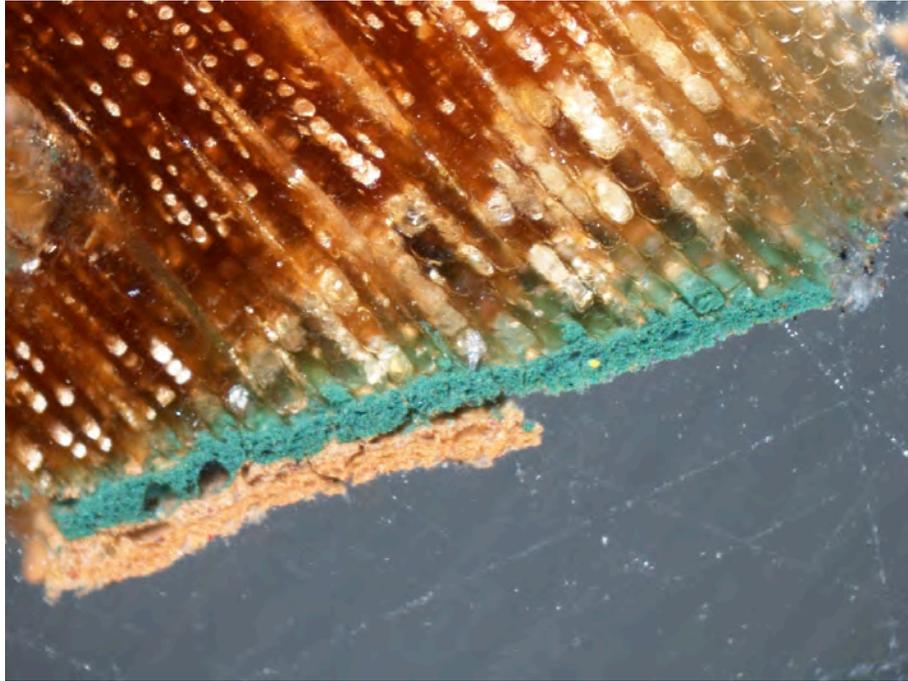
Image 40. Sample CSB.54, removed from a door casing in the north interior room of the Buck House, has only two layers of paint (which are the same as the later layers in Sample CSB.51 above). (100x, Visible Light)

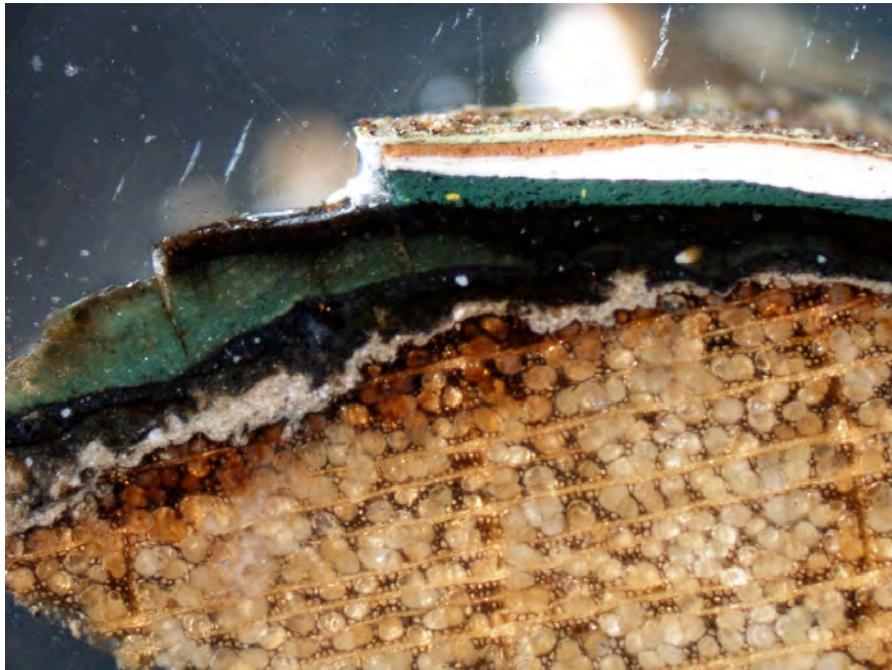
The mantelpiece (CSB.52) retains a good bit of paint evidence and appears to have been varnished originally. It is a hardwood, possibly mahogany, so a varnish treatment would not have been

surprising. After the varnish, the mantelpiece was painted dark gray twice, then dark green, dark orange and light green. The latter three colors directly relate to the window and door trim paint colors. (*Image 41*)

Image 41. Sample CSB.52, was removed from the mantelpiece of the Buck House. It contains an original varnish layer followed by dark grays and dark green, before being painted the same dark green and dark orange found on other trim inside the building. (40x, Visible Light)

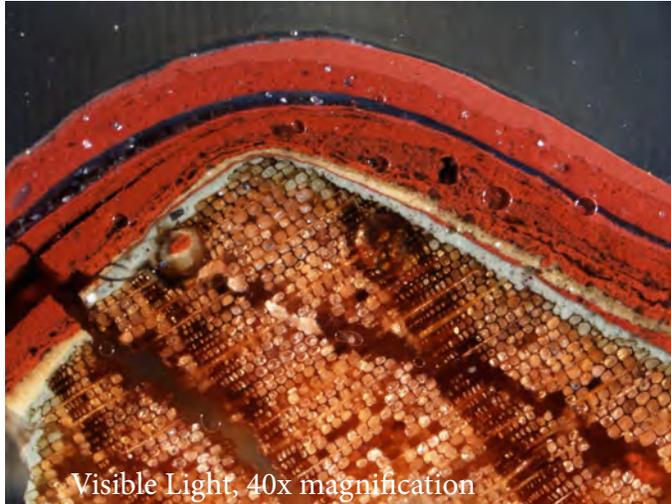
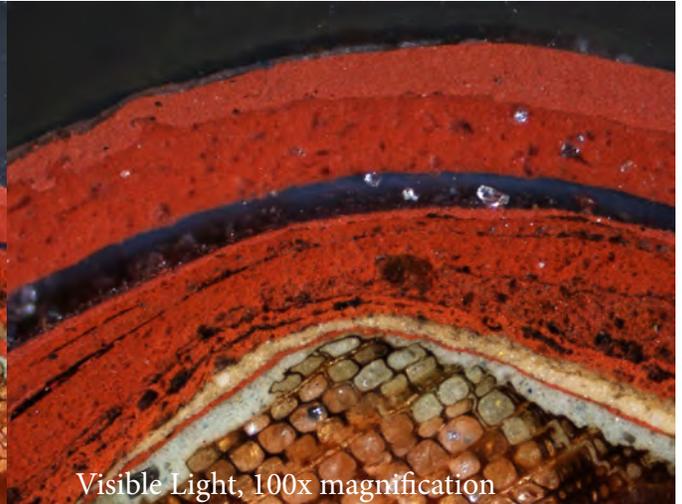
SAMPLE: CSB 7	LOCATION: Horse Barn 1st Floor
DESCRIPTION: 2nd Clapboard below roof sheathing.

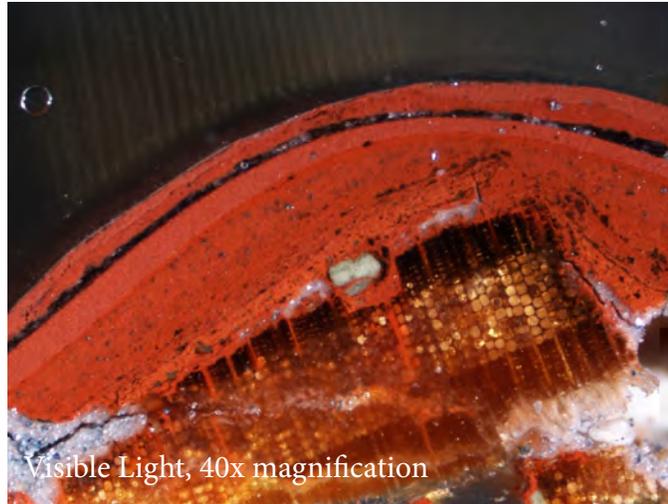
SAMPLE: CSB 8	LOCATION: Horse Barn 1st Floor
DESCRIPTION: Clapboard under roof sheathing.

LAYER	REFLECTED LIGHT COLOR	NOTES
Wood		
1	Pale Green	Traces
2	Red	
3	Red	
4	Red	
5	Red	
6	Red	
7	Red	
8	Red	
9	Red	
10	Red	
11	Red	
12	Red	
13

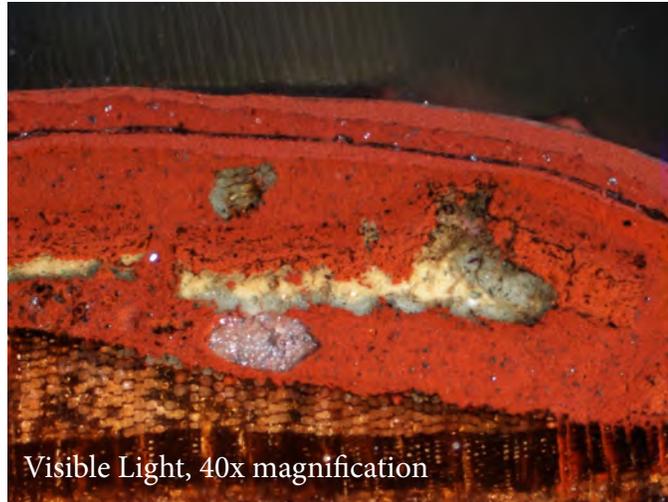
SAMPLE: CSB 9	LOCATION: Horse Barn 1st Floor
DESCRIPTION: Large split wood sample.

LAYER	REFLECTED LIGHT COLOR	NOTES
Wood		
1	Red	
2	Pale Green	Traces
3	Pale Yellow	Traces
4	Red	
5	Red	
6	Red	
7	Red	
8	Red	
9	Red	
10	Red	
11	Red	
12		
13

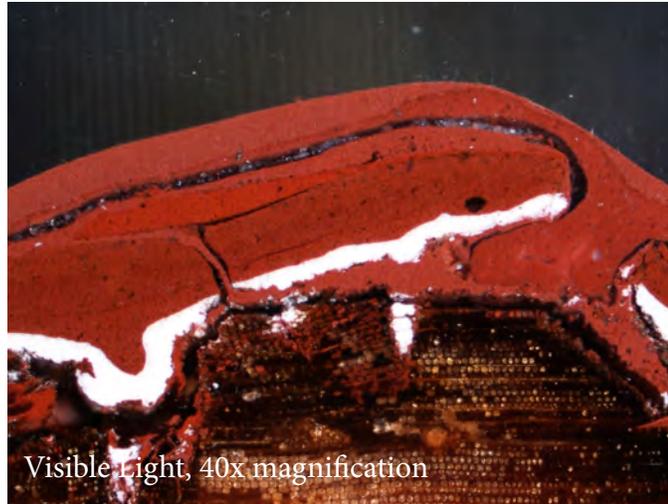
SAMPLE: CSB 10	LOCATION: Horse Barn 1st Floor
DESCRIPTION: Door frame.

LAYER	REFLECTED LIGHT COLOR	NOTES
Wood		
1	Red	
2	White	
3	Red	
4	Red	
5	Red	
6	Red	
7	Red	
8	Red	
9	Red	
10		
11		
12		
13

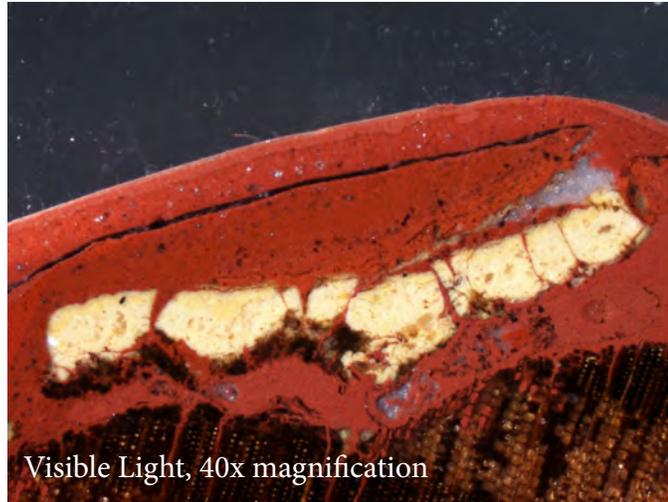
SAMPLE: CSB 11	LOCATION: Goat Barn 1st Floor
DESCRIPTION: Clapboard 6' above ground. (Should be original part of barn.)

LAYER	REFLECTED LIGHT COLOR	NOTES
Wood		
1	Red	Leak Down
2	Pale Yellow / Cream	
3	Pale Yellow	
4	Red	
5	Red	
6	Red	
7	Red	
8		
9		
10		
11		
12

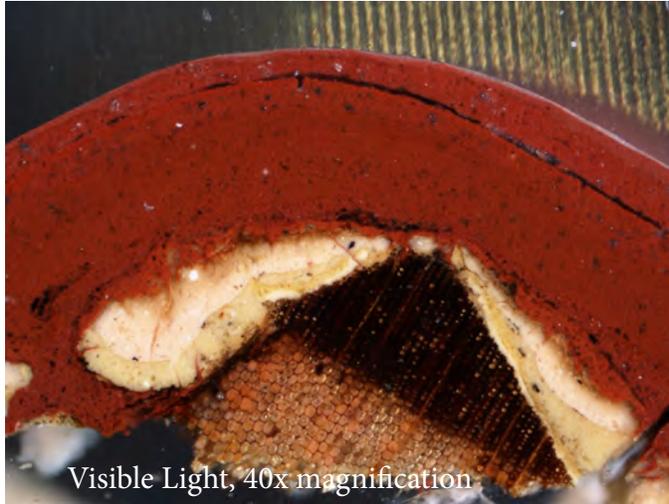
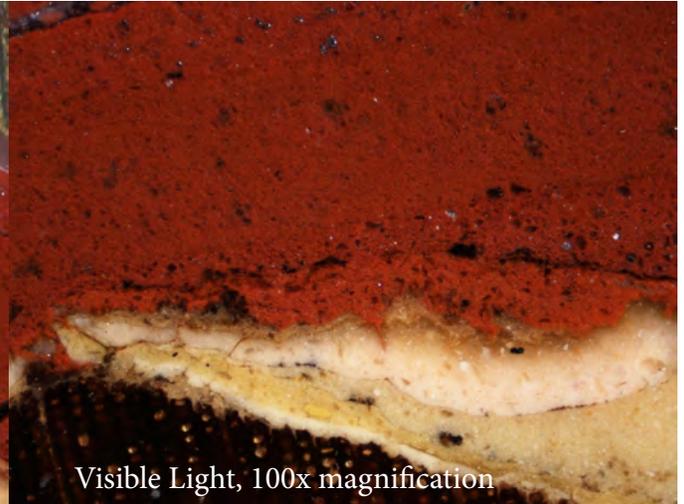
SAMPLE: CSB 13	LOCATION: Goat Barn 2nd Floor
DESCRIPTION: 2nd clapboard below roof sheathing

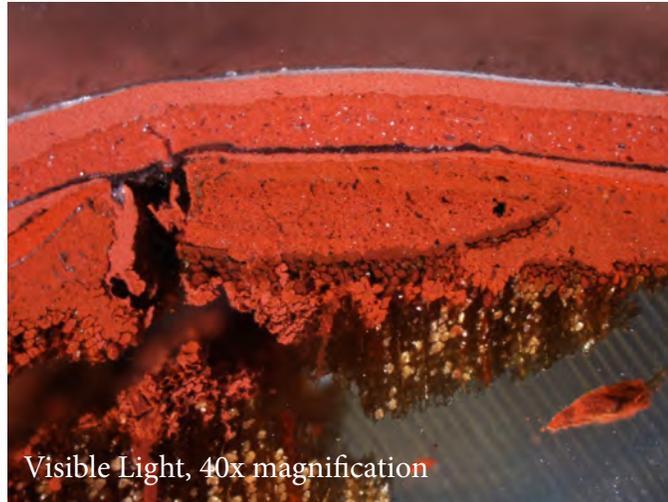
SAMPLE: CSB 14	LOCATION: Goat Barn 2nd Floor
DESCRIPTION: Door jamb.

LAYER	REFLECTED LIGHT COLOR	NOTES
Wood		Weathered
1	Red (Dark)	
2	Red	
3	Red	
4	Red	
5	Red	
6	Red	
7	Red	
8	Red	
9		
10		
11		
12		
13

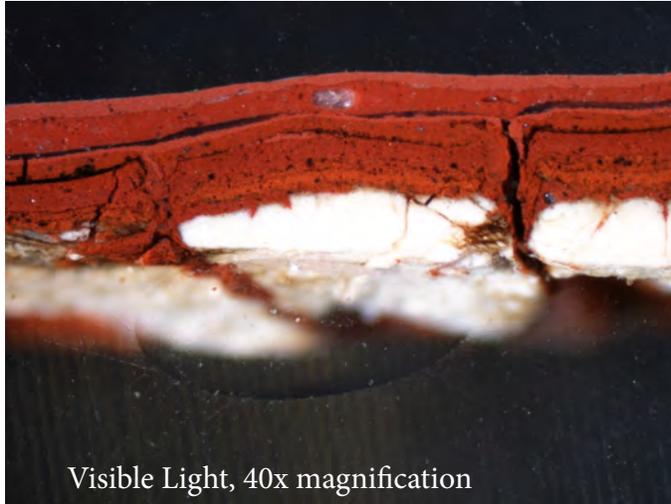
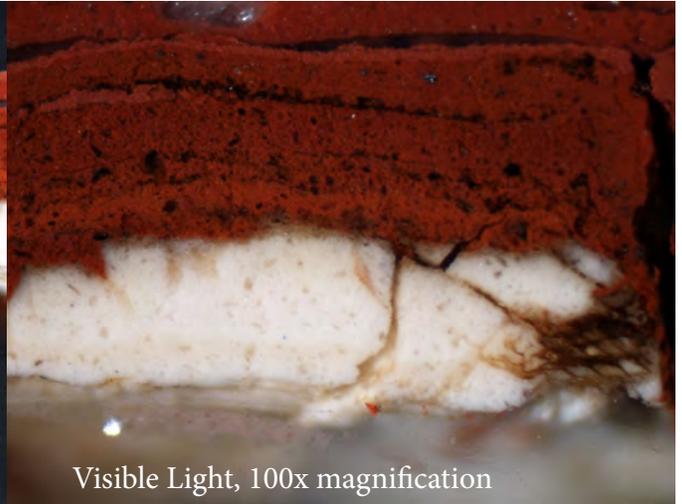
SAMPLE: CSB 15	LOCATION: Goat Barn 2nd Floor
DESCRIPTION: Rafter end (5th rafter westward of east elevation)

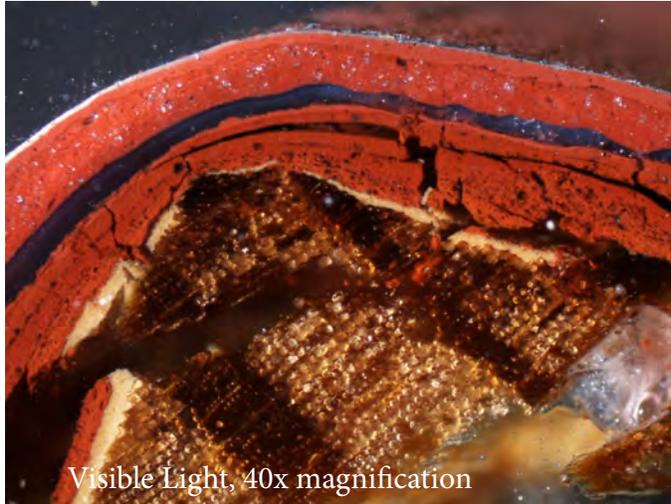
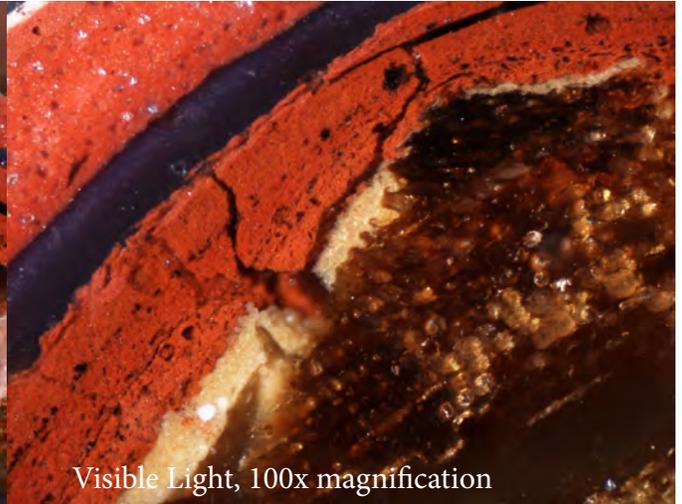
SAMPLE: CSB 16	LOCATION: Goat Barn 2nd Floor
DESCRIPTION: Sample taken in hard-to-reach area next to silo that only has earlier paint

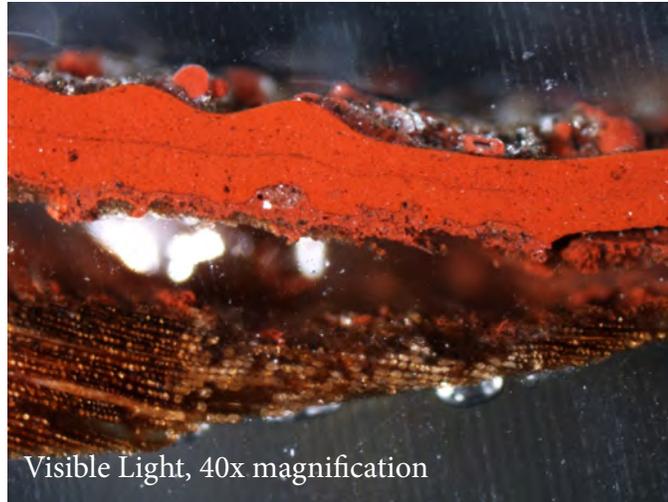
SAMPLE: CSB 17	LOCATION: Goat Barn 1st Floor
DESCRIPTION: Sample taken in hard-to-reach area next to silo that only has earlier paint

LAYER	REFLECTED LIGHT COLOR	NOTES
Wood		
1	Red Brown (medium)	
2	Red	
3	Red	
4	Red	
5		
6		
7		
8		
9		
10		
11		
12

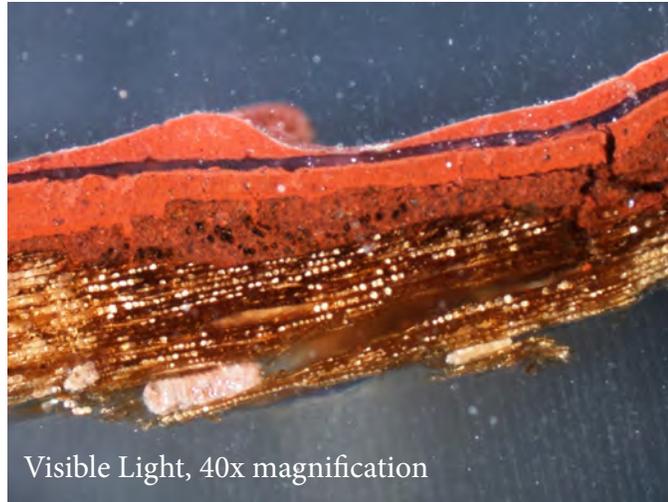
SAMPLE: CSB 18	LOCATION: Goat Barn 1st Floor
DESCRIPTION: Underside of roof sheathing.

LAYER	REFLECTED LIGHT COLOR	NOTES
Wood		
1	Reddish Brown (medium)	
2	Red	
3	Red	
4		
5		
6		
7		
8		
9		
10		
11		
12

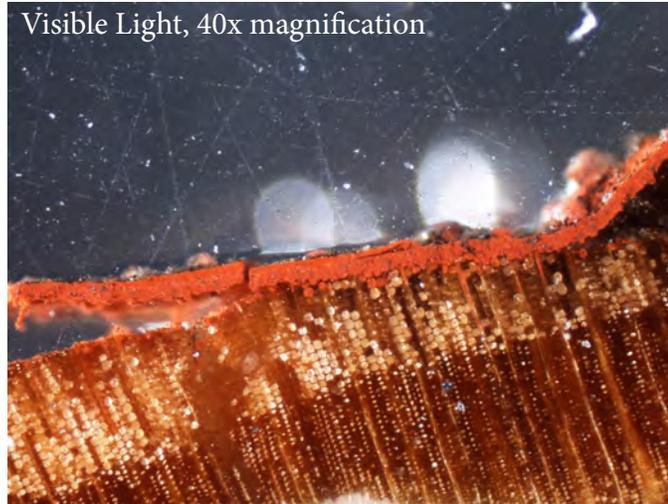
SAMPLE: CSB 19	LOCATION: Goat Barn 1st Floor
DESCRIPTION: Siding behind old phone connection box.

LAYER	REFLECTED LIGHT COLOR	NOTES
Wood		
1	Red	
2		
3		
4		
5		
6		
7		
8		
9		
10		
11		
12		
13

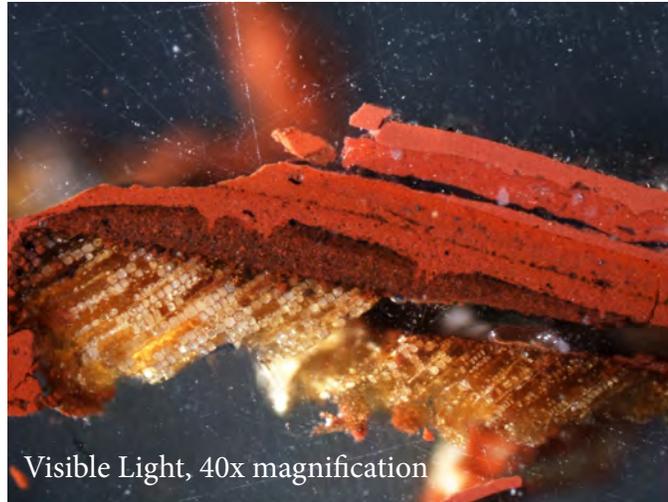
SAMPLE: CSB 20	LOCATION: Goat Barn 1st Floor
DESCRIPTION: 3rd clapboard below roof sheathing (above door).

LAYER	REFLECTED LIGHT COLOR	NOTES
Wood		
1	Red - Brown	
2	Dark Red - Brown	
3	Red	
4	Red	
5	Red	
6	Red	
7	Red	
8		
9		
10		
11		
12

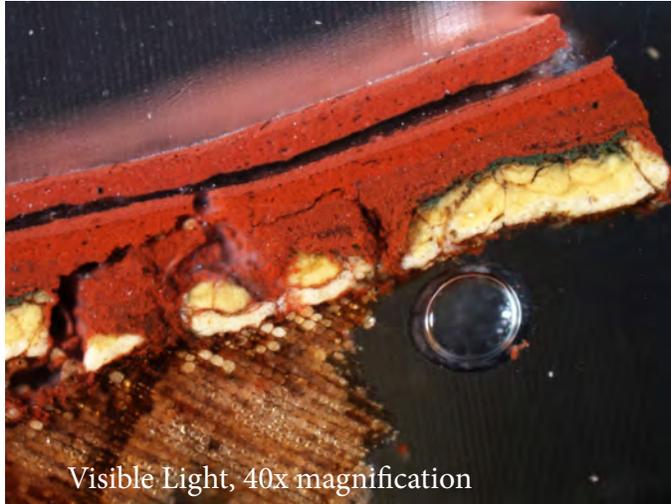
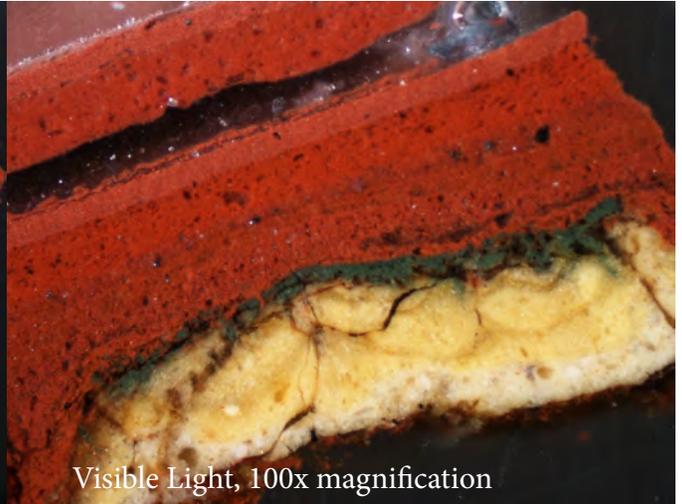
SAMPLE: CSB 21	LOCATION: Goat Barn 1st Floor
DESCRIPTION: Window casing at lintel.

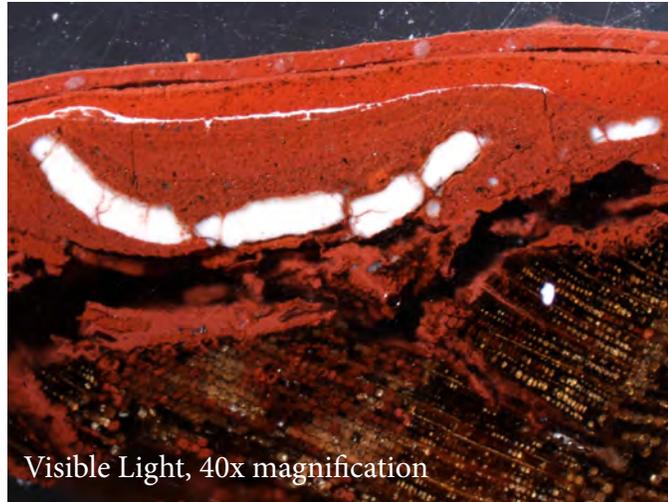
SAMPLE: CSB 22	LOCATION: Goat Barn 1st Floor
DESCRIPTION: Window casing at jamb.

LAYER	REFLECTED LIGHT COLOR	NOTES
Wood		
1	Red	Leak Down
2	Red	Leak Down
3	White	
4	Red	
5	Red	
6	Red	
7	Red	
8	Red	
9	White	
10	Red	
11	Red	
12	Red	
13

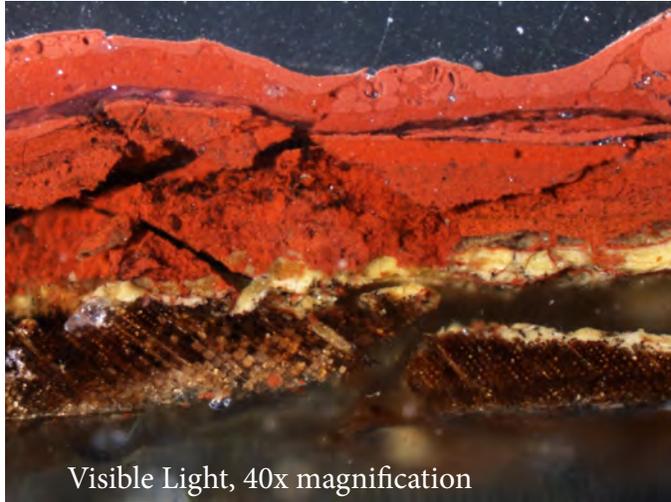
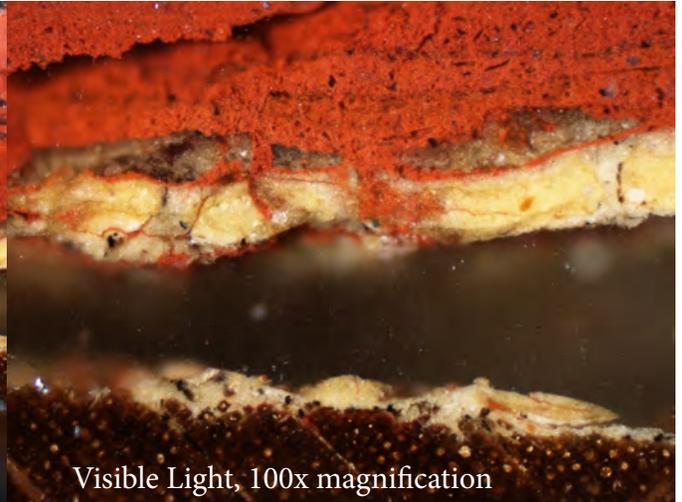
SAMPLE: CSB 23	LOCATION: Goat Barn 1st Floor
DESCRIPTION: Top clapboard below roof sheathing. Also, 3rd clapboard below sheathing.

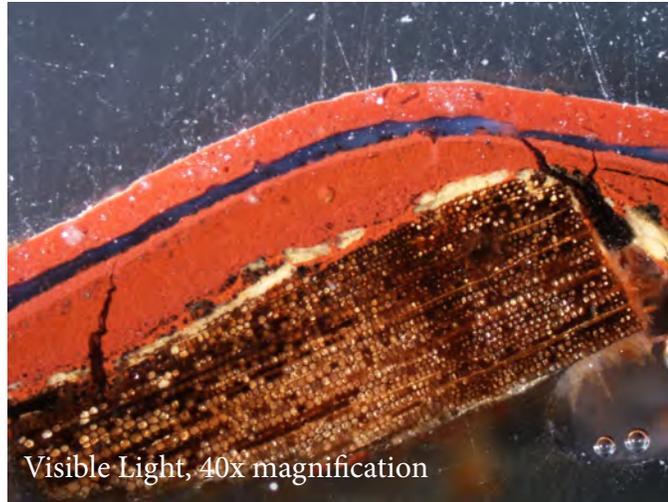
SAMPLE: CSB 24	LOCATION: Goat Barn 1st Floor
DESCRIPTION: (South of seam) clapboard approx 6' above ground.

LAYER	REFLECTED LIGHT COLOR	NOTES
Wood		
1	Cream	Disrupted
2	Red	
3	Red	
4	Red	
5		
6		
7		
8		
9		
10		
11		
12		
13

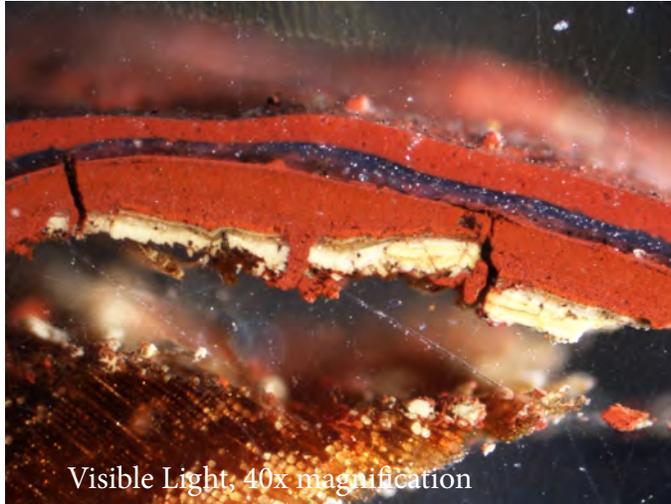
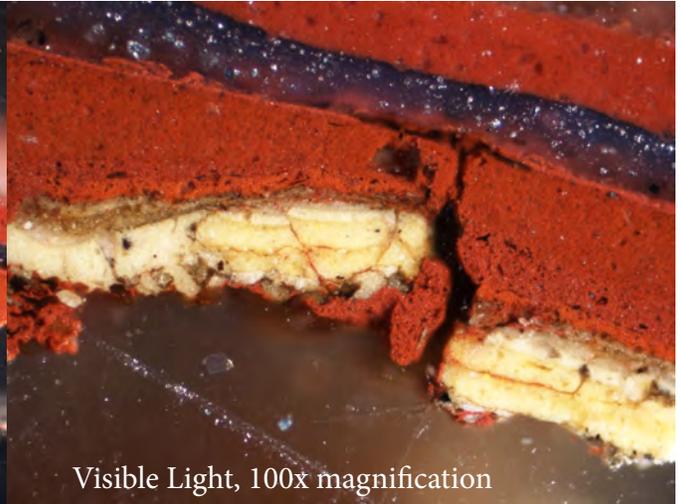
SAMPLE: CSB 25	LOCATION: Goat Barn 1st Floor
DESCRIPTION: (North of seam) claboard approx 6' above ground.

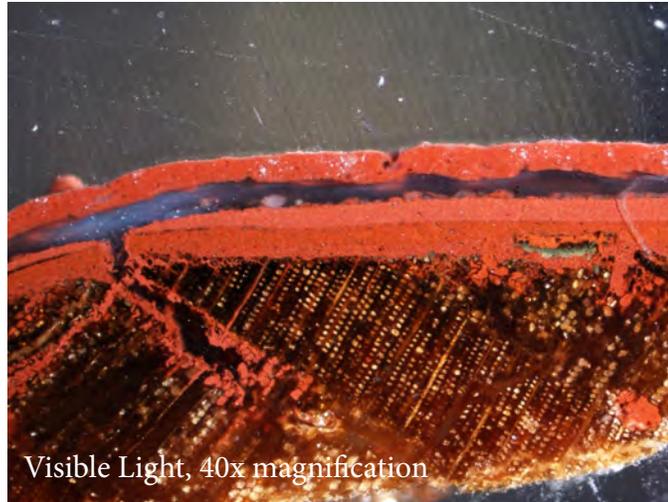
SAMPLE: CSB 26	LOCATION: Goat Barn 1st Floor
DESCRIPTION: Door trim at jamb, south side of opening

LAYER	REFLECTED LIGHT COLOR	NOTES
Wood		
1	Cream	
2	Kelly Green	Fragments
3	Red	
4	Red	
5	Red	
6	Red	
7	Red	
8		
9		
10		
11		
12		
13

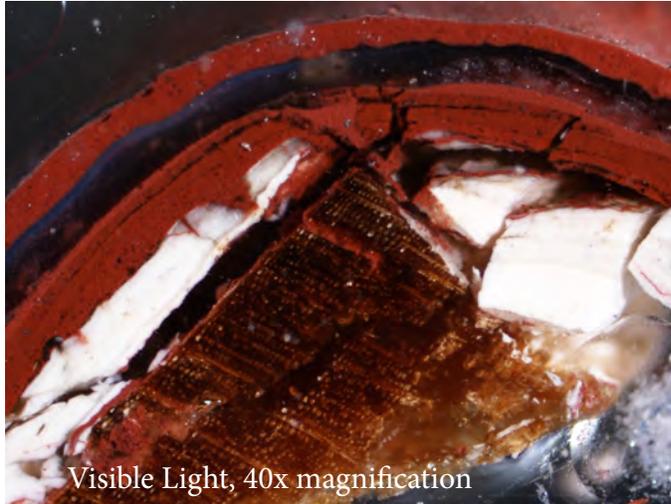
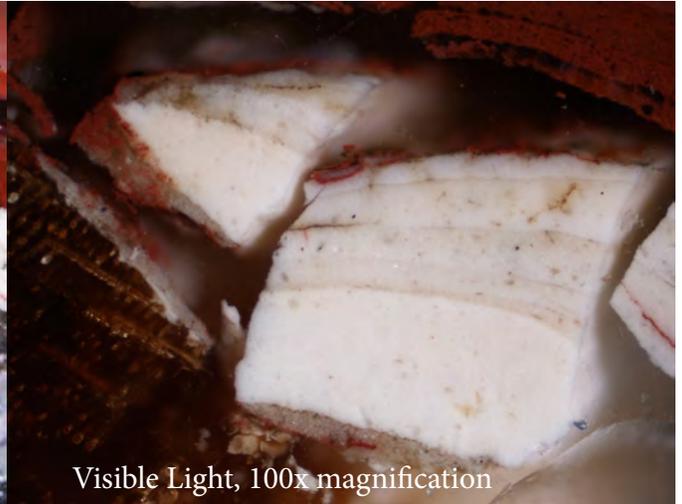
SAMPLE: CSB 27	LOCATION: Goat Barn 1st Floor
DESCRIPTION: Door trim at jamb south side of opening.

LAYER	REFLECTED LIGHT COLOR	NOTES
Wood		
1	Light Gray/ White	Limewash?
2	White	
3	White	
4	White	
5	White	
6	White	
7	White	
8	Red	
9	Red	
10	Red	
11	Red	
12	Red

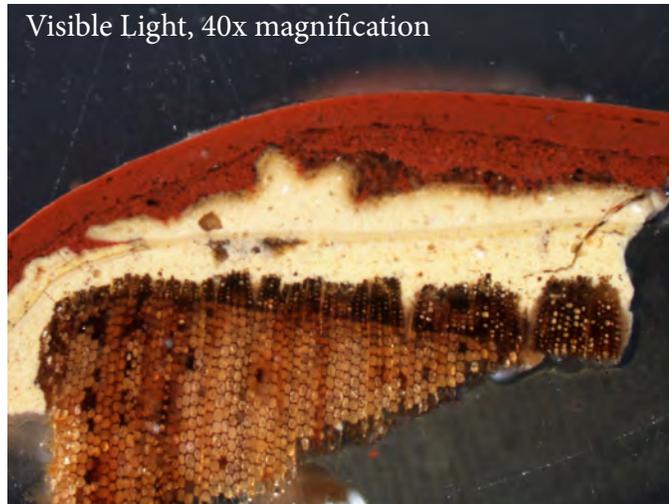
SAMPLE: CSB 28	LOCATION: Goat Barn 1st Floor
DESCRIPTION: Clapboard west of window jamb.

LAYER	REFLECTED LIGHT COLOR	NOTES
Wood		
1	Cream	
2	Pale Yellow	
3	Cream	
4	Light Brown	Discoloration?
5	Red	
6	Red	
7	Red	
8	Red	
9		
10		
11		
12		
13

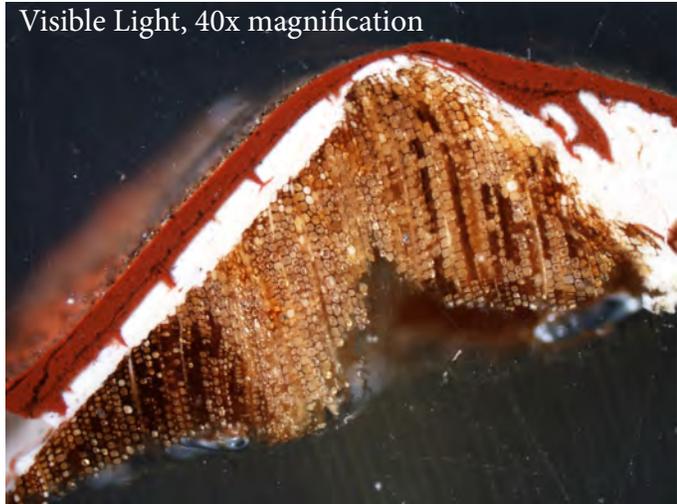
SAMPLE: CSB 29	LOCATION: Goat Barn 1st Floor
DESCRIPTION: Window casing at jamb.

LAYER	REFLECTED LIGHT COLOR	NOTES
Wood		
1	White	
2	White	
3	Red	
4	Red	
5		
6		
7		
8		
9		
10		
11		
12		
13

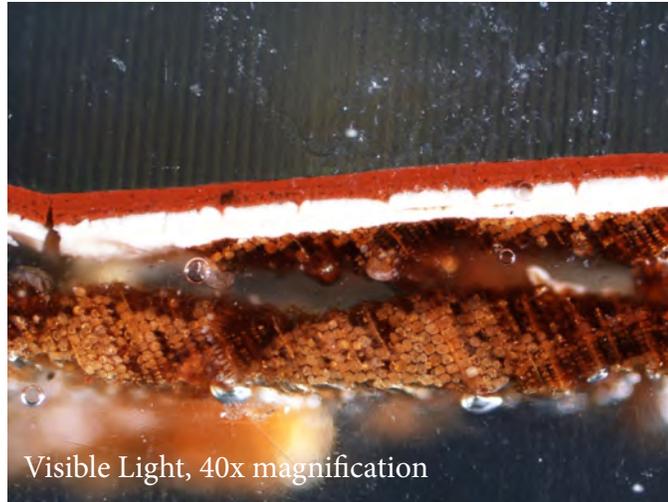
SAMPLE: CSB 30	LOCATION: Goat Barn 1st Floor
DESCRIPTION: On shutter. (Shutter red on north side, whitewash(?) on south side).

LAYER	REFLECTED LIGHT COLOR	NOTES
Wood		
1	White	
2	White	
3	Red	
4	Red	
5	Red	
6		
7		
8		
9		
10		
11		
12		
13

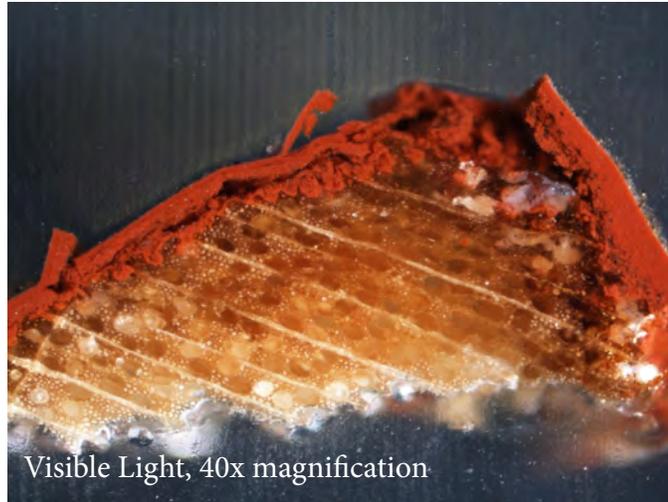
SAMPLE: CSB 31	LOCATION: Goat Barn 1st Floor
DESCRIPTION: Clapboard east of window.

LAYER	REFLECTED LIGHT COLOR	NOTES
Wood		Weathered
1	Red	
2	Red	
3	Red	
4		
5		
6		
7		
8		
9		
10		
11		
12		
13

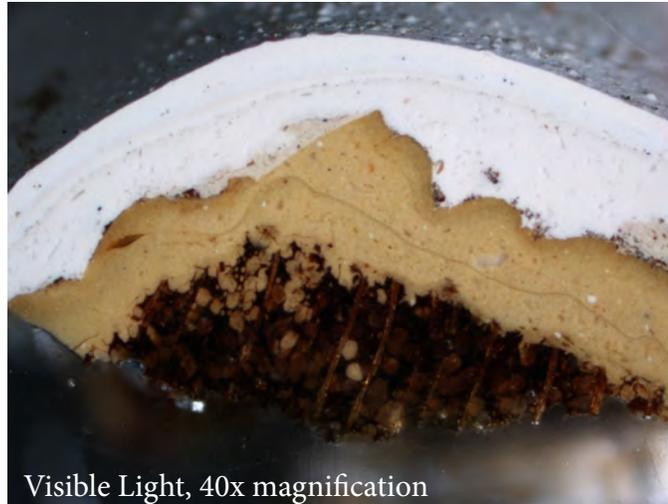
SAMPLE: CSB 32	LOCATION: Goat Barn 1st Floor
DESCRIPTION: North wall of original building.

LAYER	REFLECTED LIGHT COLOR	NOTES
Wood		
1	Cream	
2	Cream	
3	White / Light Gray	
4	White	
5	White	
6	White	
7		
8		
9		
10		
11		
12

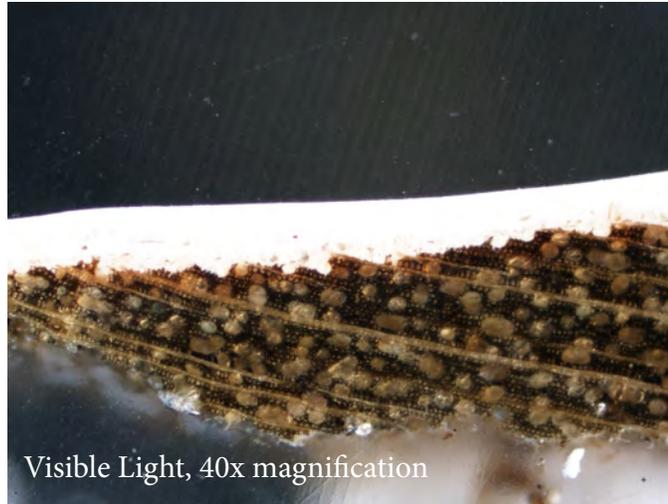
SAMPLE: CSB 33	LOCATION: Goat Barn 1st Floor
DESCRIPTION: West end wall of north shed addition.

LAYER	REFLECTED LIGHT COLOR	NOTES
Wood		
1	White	
2	White	
3	White	
4		
5		
6		
7		
8		
9		
10		
11		
12		
13

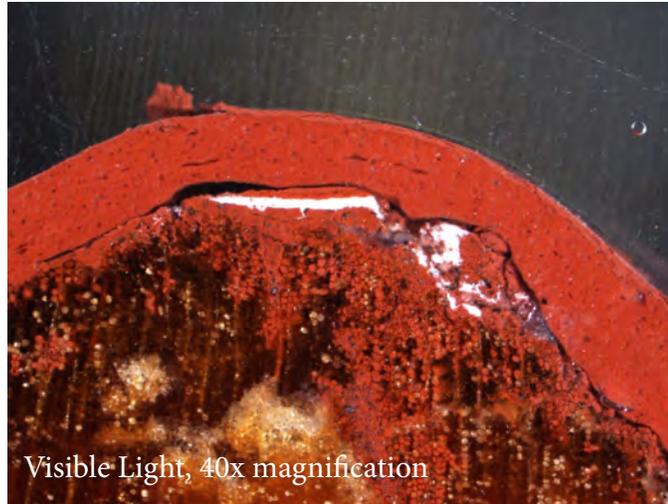
SAMPLE: CSB 34	LOCATION: Goat Barn 1st Floor
DESCRIPTION: Window trim, west side of window, jamb trim.

LAYER	REFLECTED LIGHT COLOR	NOTES
Wood		Weathering
1	Red	Leak down
2	White	
3	Red	
4	Red	
5	Red	
6		
7		
8		
9		
10		
11		
12		
13

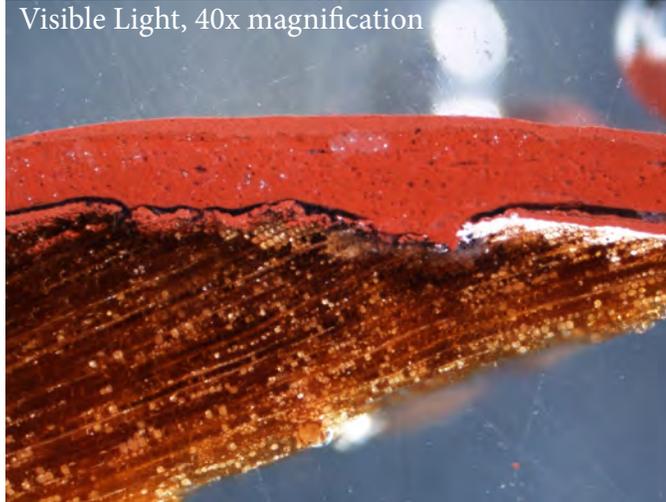
SAMPLE: CSB 35	LOCATION: Goat Barn 1st Floor
DESCRIPTION: Window trim, east jamb.

LAYER	REFLECTED LIGHT COLOR	NOTES
Wood		
1	White	
2	Red	
3	Red	
4	Red	
5		
6		
7		
8		
9		
10		
11		
12		
13

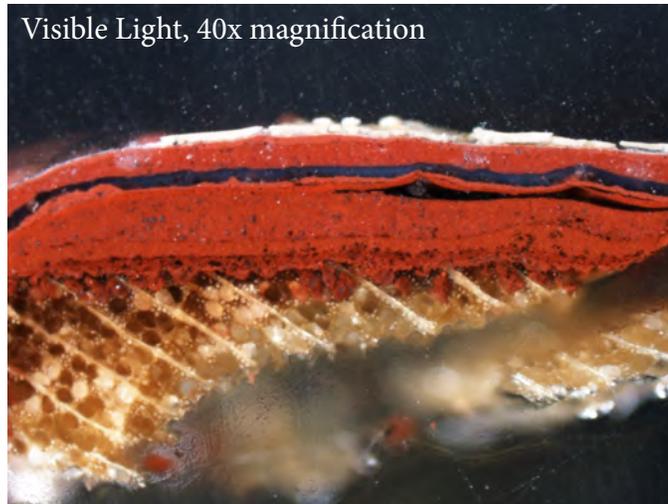
SAMPLE: CSB 36	LOCATION: Goat Barn 2nd Floor
DESCRIPTION: Clapboards in gable of dormer, above door opening.

LAYER	REFLECTED LIGHT COLOR	NOTES
Wood		
1	Dark Red (Browning)	
2	Red	
3	Red	
4	Red	
5	Red	
6	White	
7		
8		
9		
10		
11		
12

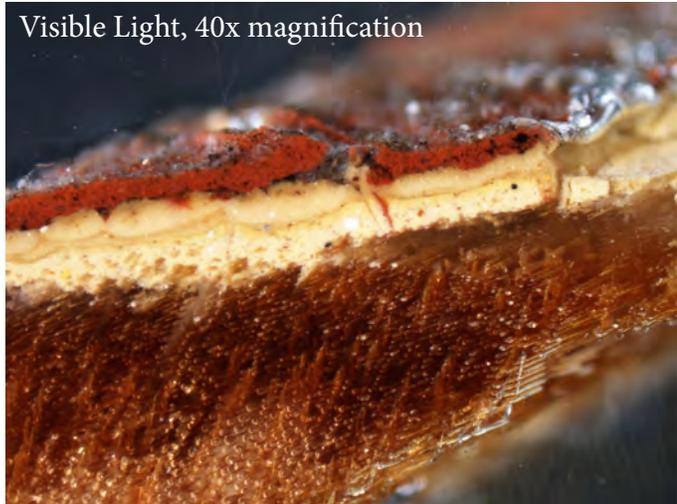
SAMPLE: CSB 37	LOCATION: Goat Barn 2nd Floor
DESCRIPTION: Clapboards.

LAYER	REFLECTED LIGHT COLOR	NOTES
Wood		
1	Cream	
2	Pale Yellow	
3	Cream	
4	Cream	
5	Red	
6		
7		
8		
9		
10		
11		
12		
13

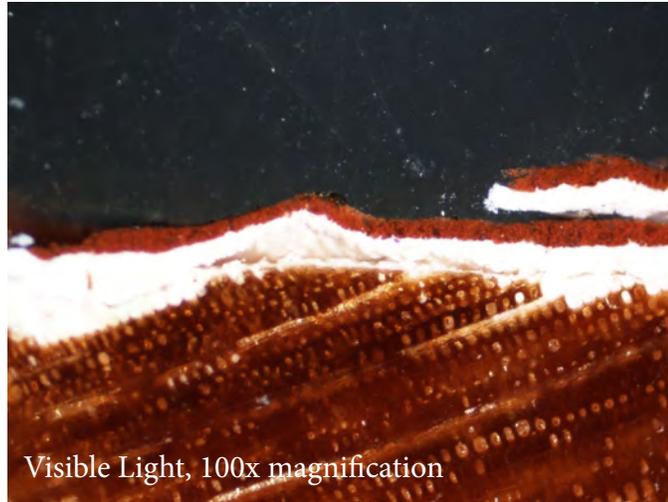
SAMPLE: CSB 38	LOCATION: Goat Barn 2nd Floor
DESCRIPTION: East jamb of window opening, trim.

LAYER	REFLECTED LIGHT COLOR	NOTES
Wood		
1	White	
2	White	
3	Red	
4		
5		
6		
7		
8		
9		
10		
11		
12		
13

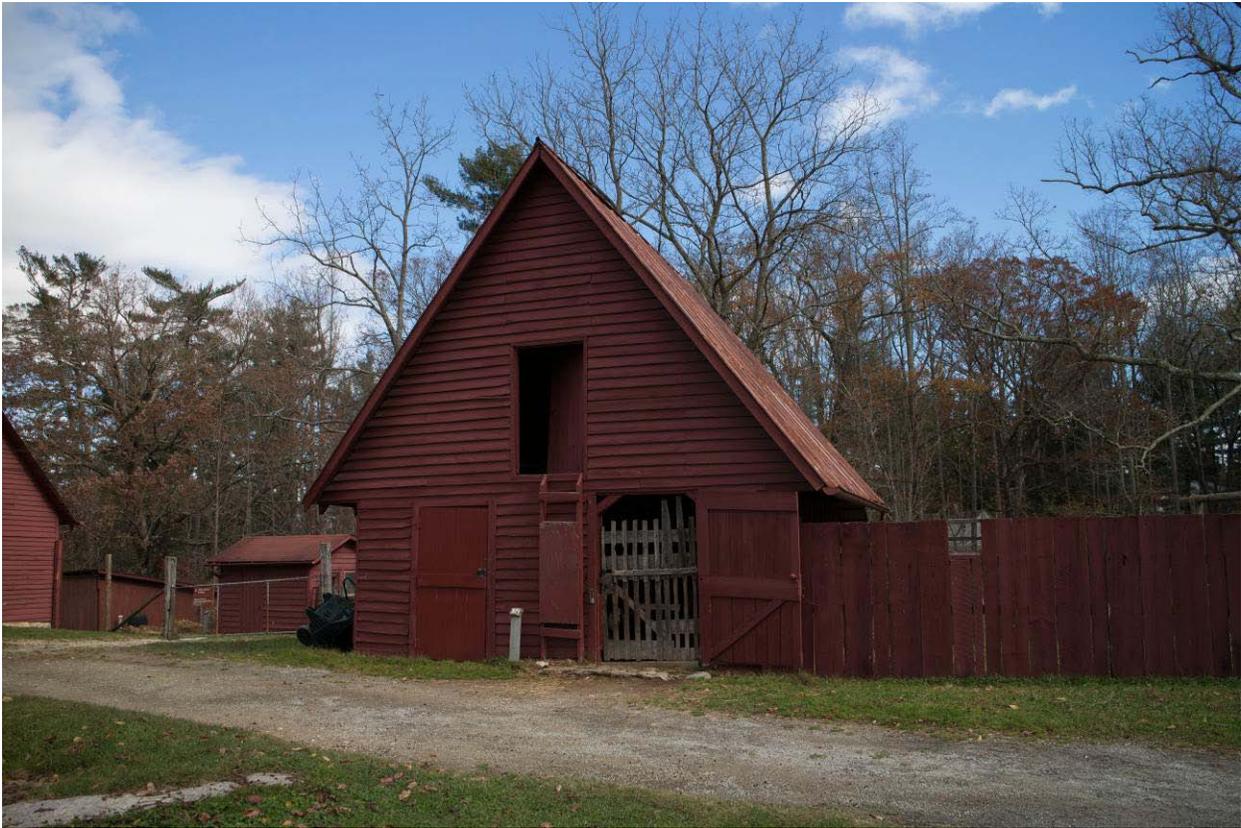
Findings

The discovery that the database for tree-ring dating is not sufficient for the Flat Rock region was a disappointment. Laboratory analysis of the Sandburg samples revealed that this section of the Blue Ridge Mountains has a unique microclimate causing tree growth unlike the patterns of surrounding areas where the tree-ring databases have been compiled. This newly-recognized lack of a database for this area makes tree-ring dating, and therefore dating of building components, impossible at this time.

However, it is heartening that the samples collected from the barns by the dendrochronologists are stored and accessible. Those samples can be retested when a tree-ring database is compiled for the Flat Rock area by the scientific community.
