Barn Complex
Carl Sandburg Home National Historic Site
Historic Structure Report

December 2014

JOSEPH K. OPPERMAN – ARCHITECT, P.A.

Goat Barn: HS-16, LCS 005161, FMSS 69819
Milk House: HS-16A, LCS 005162, FMSS 69690
Horse Barn: HS-17, LCS 005163, FMSS 69863
Silo: HS-20, LCS 005166 (s-o-w gives no FMSS)
Shavings Shed: HS-19, LCS 005165, FMSS 69691
Cow Shed: HS-18, LCS 005164, FMSS 69697
Buck Kid Quarters: HS-15, LCS 005160, FMSS 69689
Corn Crib: HS-14, LCS 005159, FMSS 69698
Barn Garage: HS-13, LCS 005158, FMSS 69895
Isolation Quarters: HS-12, LCS 005157, FMSS 69817

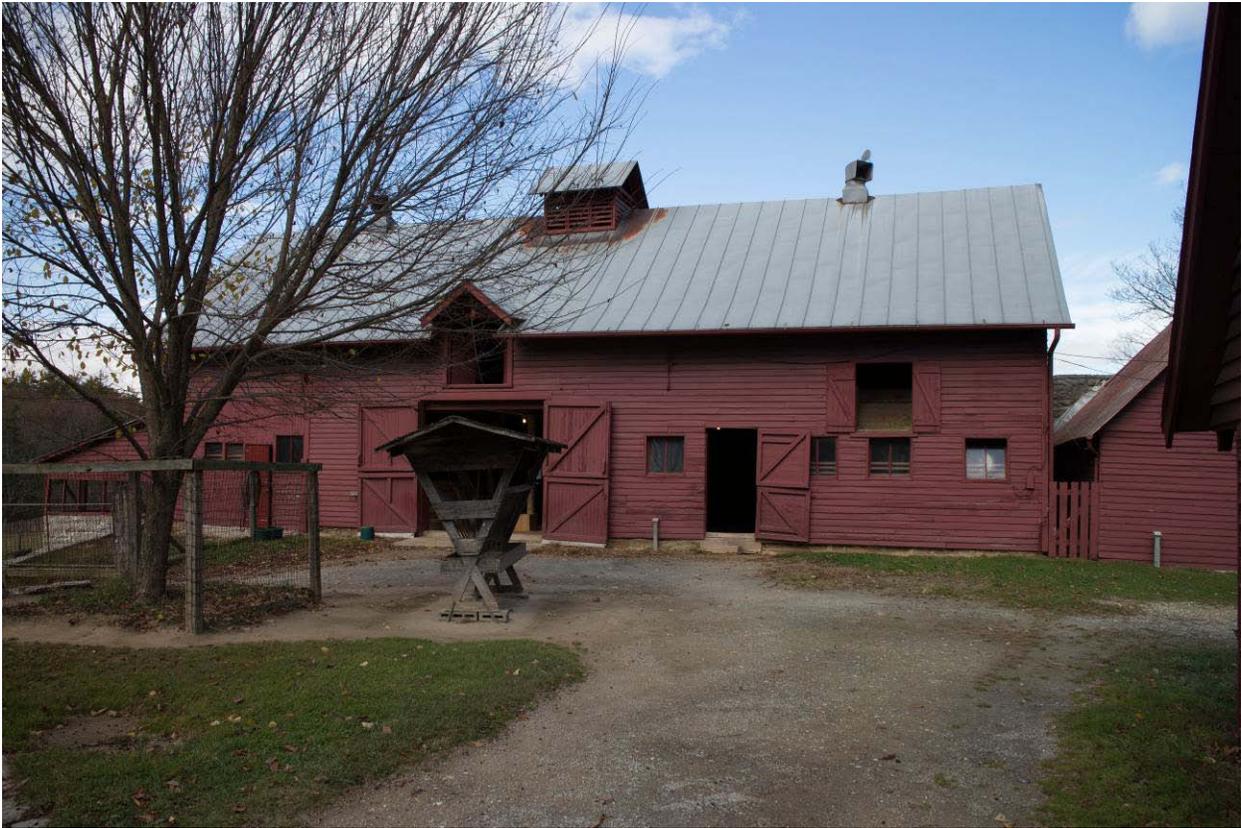
The Memmingers, Greggs, and Smyths had the desire and financial means to have full-time as well as seasonal staffs, including a crew to maintain the estate. The buildings give evidence of skillful work executed using superior materials. Smyth's Garage,

though later altered by the Sandburgs, exhibits more expensive detailing (mitered joints), building material (German siding), and high style flourishes (ornate molded window hood and casings). In contrast, the Sandburg construction work typically exhibits a lesser skill level and materials of varying quality. In addition, consistency of style appears to have been of secondary importance to availability. Odds and ends are often incorporated into the Sandburg work. Architectural elements such as doors and window sash were often recycled from other buildings of the estate and from their Michigan farm.

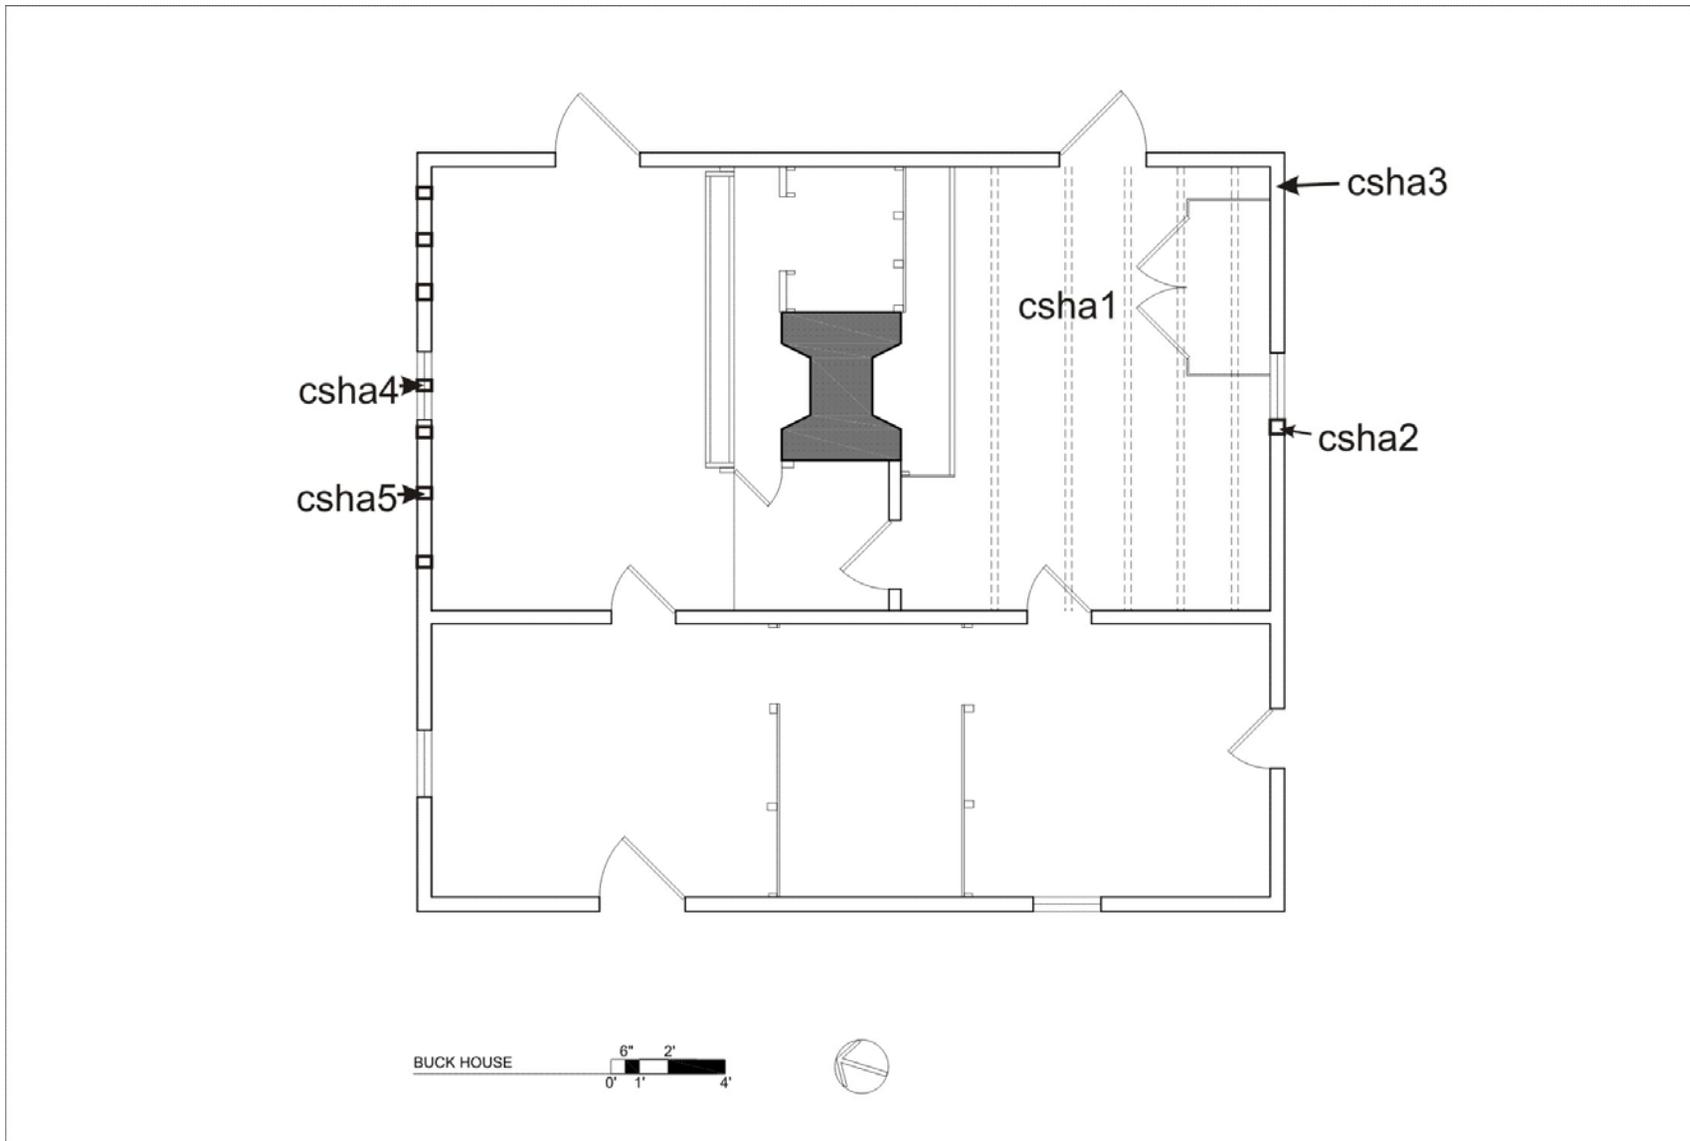
Figure 8. Drawing showing location of samples taken from the first floor of the Buck House at the Carl Sandburg Home (after Joseph K. Oppermann - Architect 2011)

Five timbers were sampled from the first floor of the Buck House: three studs, one rafter, and one joist. All were of Southern yellow pine. Each timber sample was given the code **cs**ha (for Carl Sandburg Home, building a) and numbered 1 to 5 (see table 1a). The position of each sample was noted at the time of sampling (see figure 8).

Bark edge survived on three of the five timbers deemed suitable for analysis. The outer wood on some of the timbers was extremely friable and therefore difficult to keep intact during coring. Multiple samples were taken from two of these timbers in order to maximize the chances of retaining a complete core. Samples from one of these timbers were found to match together successfully, with the samples being combined to form the new individual sample sequence **cs**ha2, which was used in the rest of the analysis (see table 2a). The multiple samples from timber **cs**ha3 did not match together and were used individually in the rest of the analysis.

All of the timber sequences from the Buck House were compared with each other, but none of the timbers were found to match each other. The individual samples were then compared with more than 700 dated regional reference chronologies. None were found to date, and therefore the Buck House remains undated.

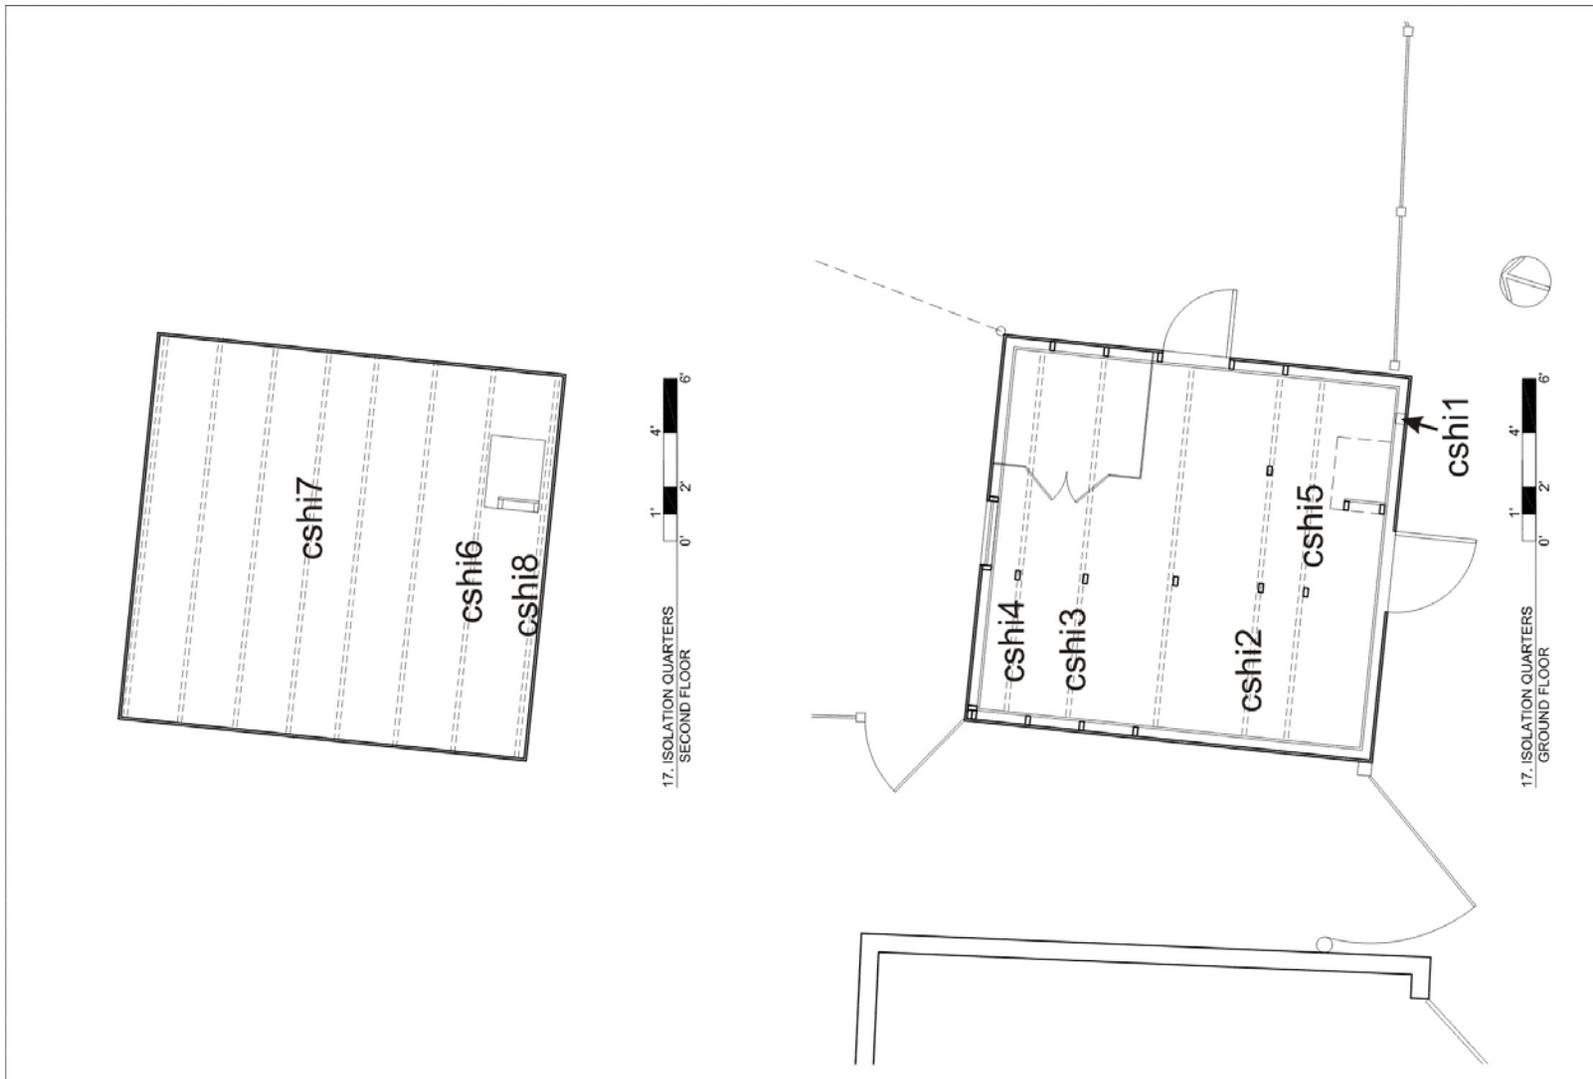
Figure 9. Drawing showing location of samples taken from the Isolation Quarters attic (left) and first floor (right) at the Carl Sandburg Home (after Joseph K. Oppermaann - Architect 2011)

Eight timbers were sampled from the Isolation Quarters: four joists and one stud from the first floor and three rafters from the attic. The stud and all of the rafters were of Southern yellow pine. Two joists were of white oak, one was of American chestnut, and a fourth was of shagbark hickory. Each sample was given the code **cs**hi (for Carl Sandburg Home, Isolation Quarters) and numbered 1 to 8 (see table 1b). The position of each sample was noted at the time of sampling (see figure 9).

Bark edge survived on six of the eight timbers deemed suitable for analysis. The outer wood on some of the timbers was extremely friable and therefore difficult to keep intact during coring. Multiple samples were taken from five of these timbers in order to maximize the chances of retaining a complete core. Samples from two of these timbers were found to match together successfully, with the samples being combined to form the new individual sample sequences **cs**hi3 and **cs**ha6, which were used in the rest of the analysis (see table 2b). The multiple samples from timbers **cs**hi1, **cs**hi4, and **cs**hi5 did not match together and were used individually in the rest of the analysis.

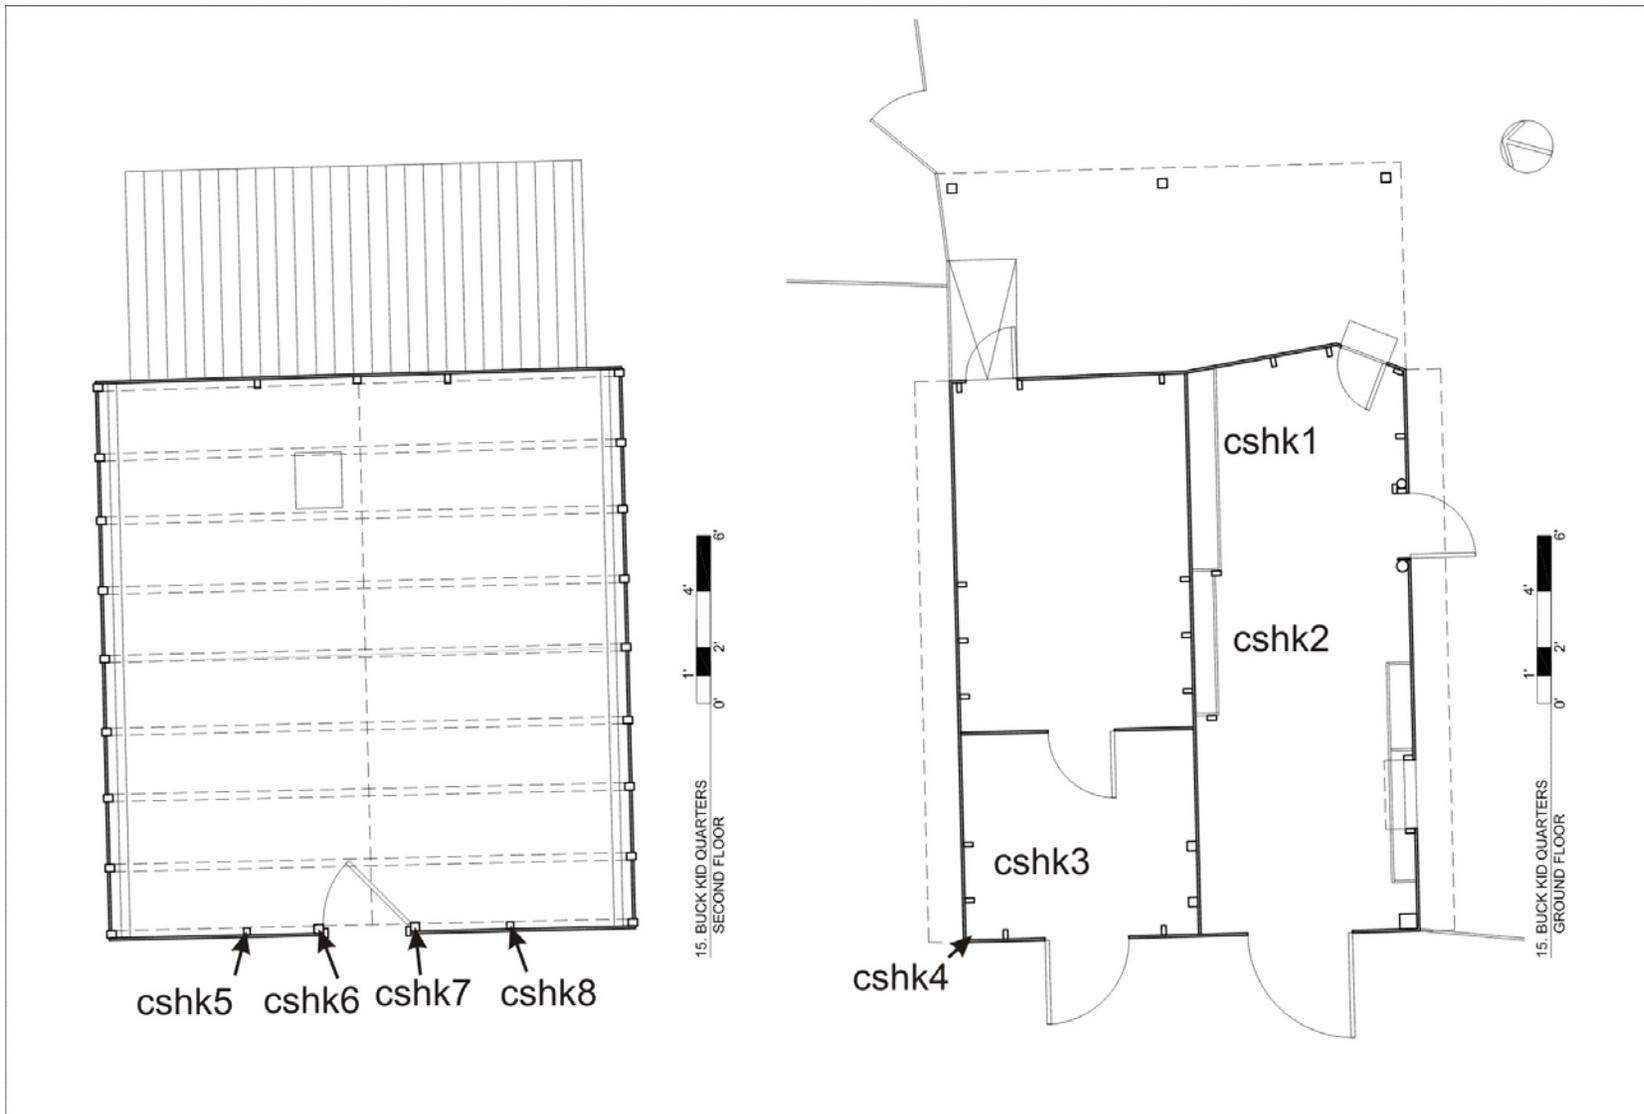
Figure 10. Drawing showing location of samples taken from the Buck Kid Quarters attic (left) and first floor (right) at the Carl Sandburg Home (after Joseph K. Oppermann - Architect 2011)

Eight timbers were sampled from the Buck Kid Quarters: three joists and one brace from the first floor and four studs from the attic. All of the timbers were of Southern yellow pine. Each sample was given the code **csHk** (for Carl Sandburg Home, Kid Quarters) and numbered 1 to 8 (see table 1c). The position of each sample was noted at the time of sampling (see figure 10).

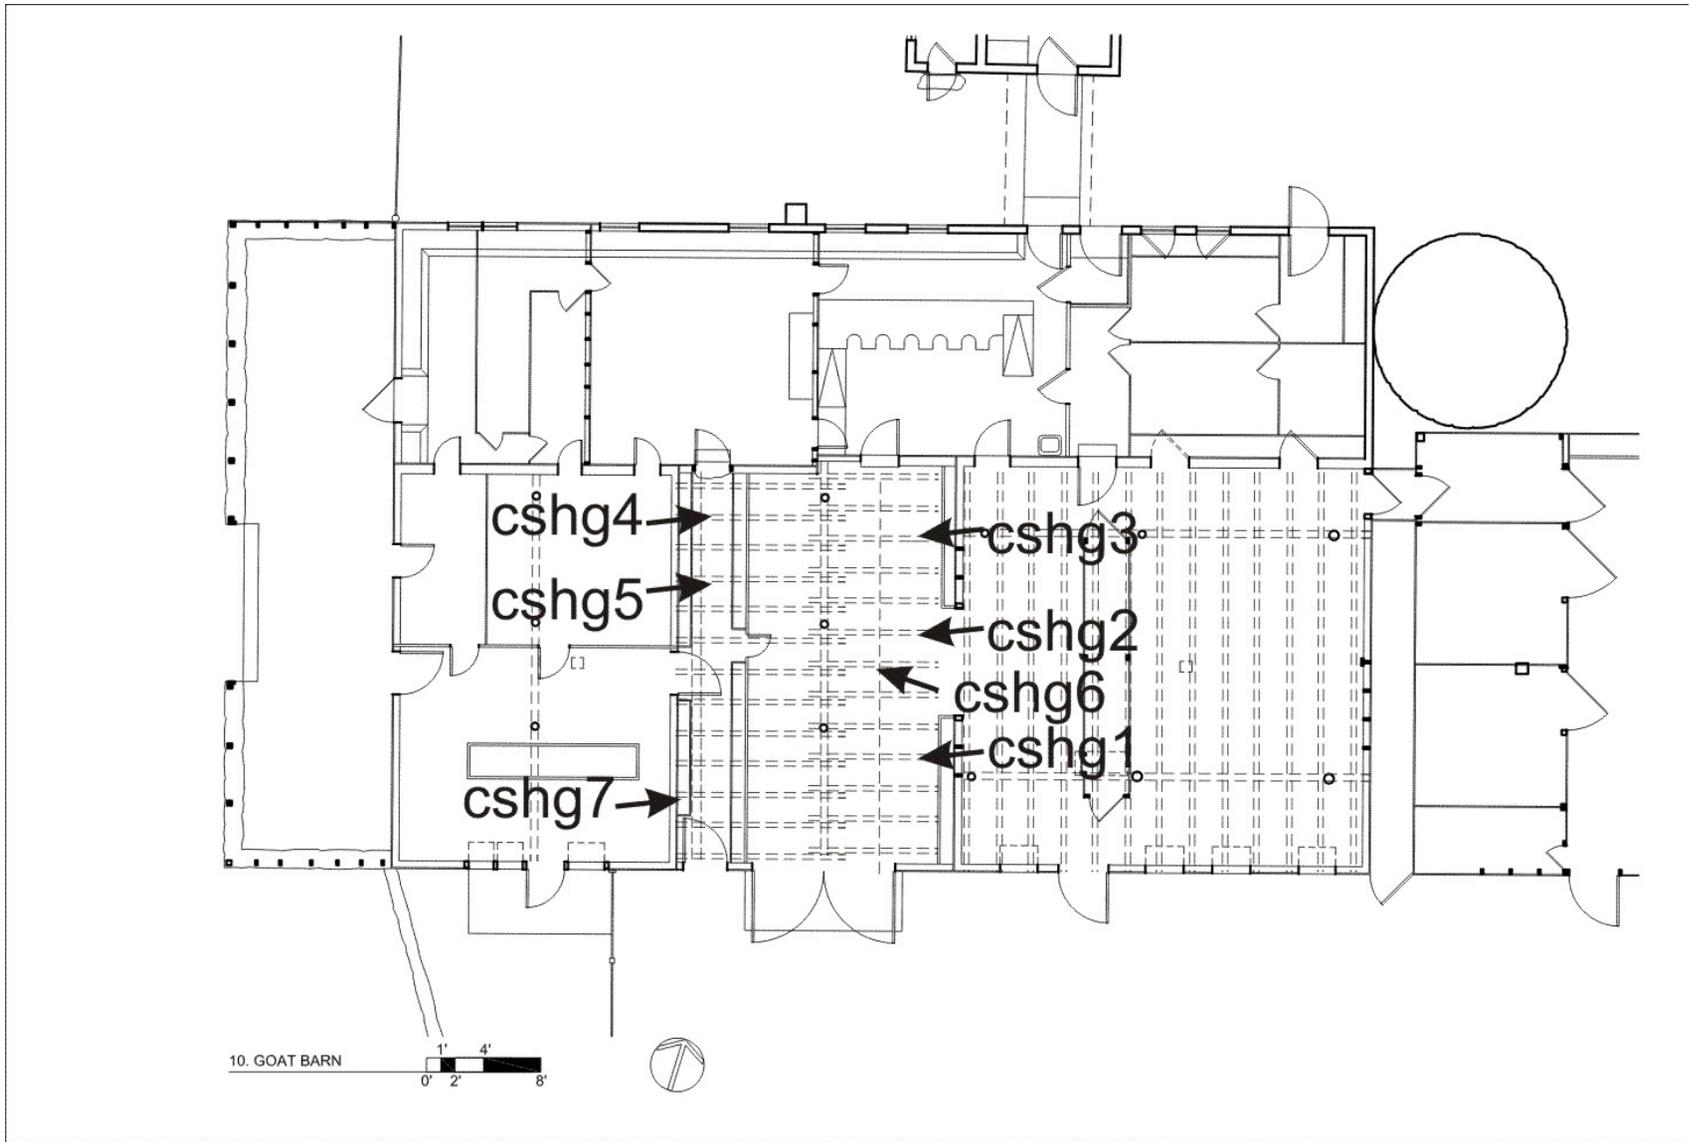
Figure 11. Drawing showing location of samples taken from the Main Barn at the Carl Sandburg Home (after Joseph K. Oppermann - Architect 2011)

Seven timbers were sampled from first floor of the Main (or Goat) Barn: six joists and one stud. All were of Southern yellow pine, except for one of the joists, which was of white oak. Each sample was given the code **csHg** (for Carl Sandburg Home, Goat Barn) and numbered 1 to 7 (see table 1d). The position of each sample was noted at the time of sampling (see figure 11).

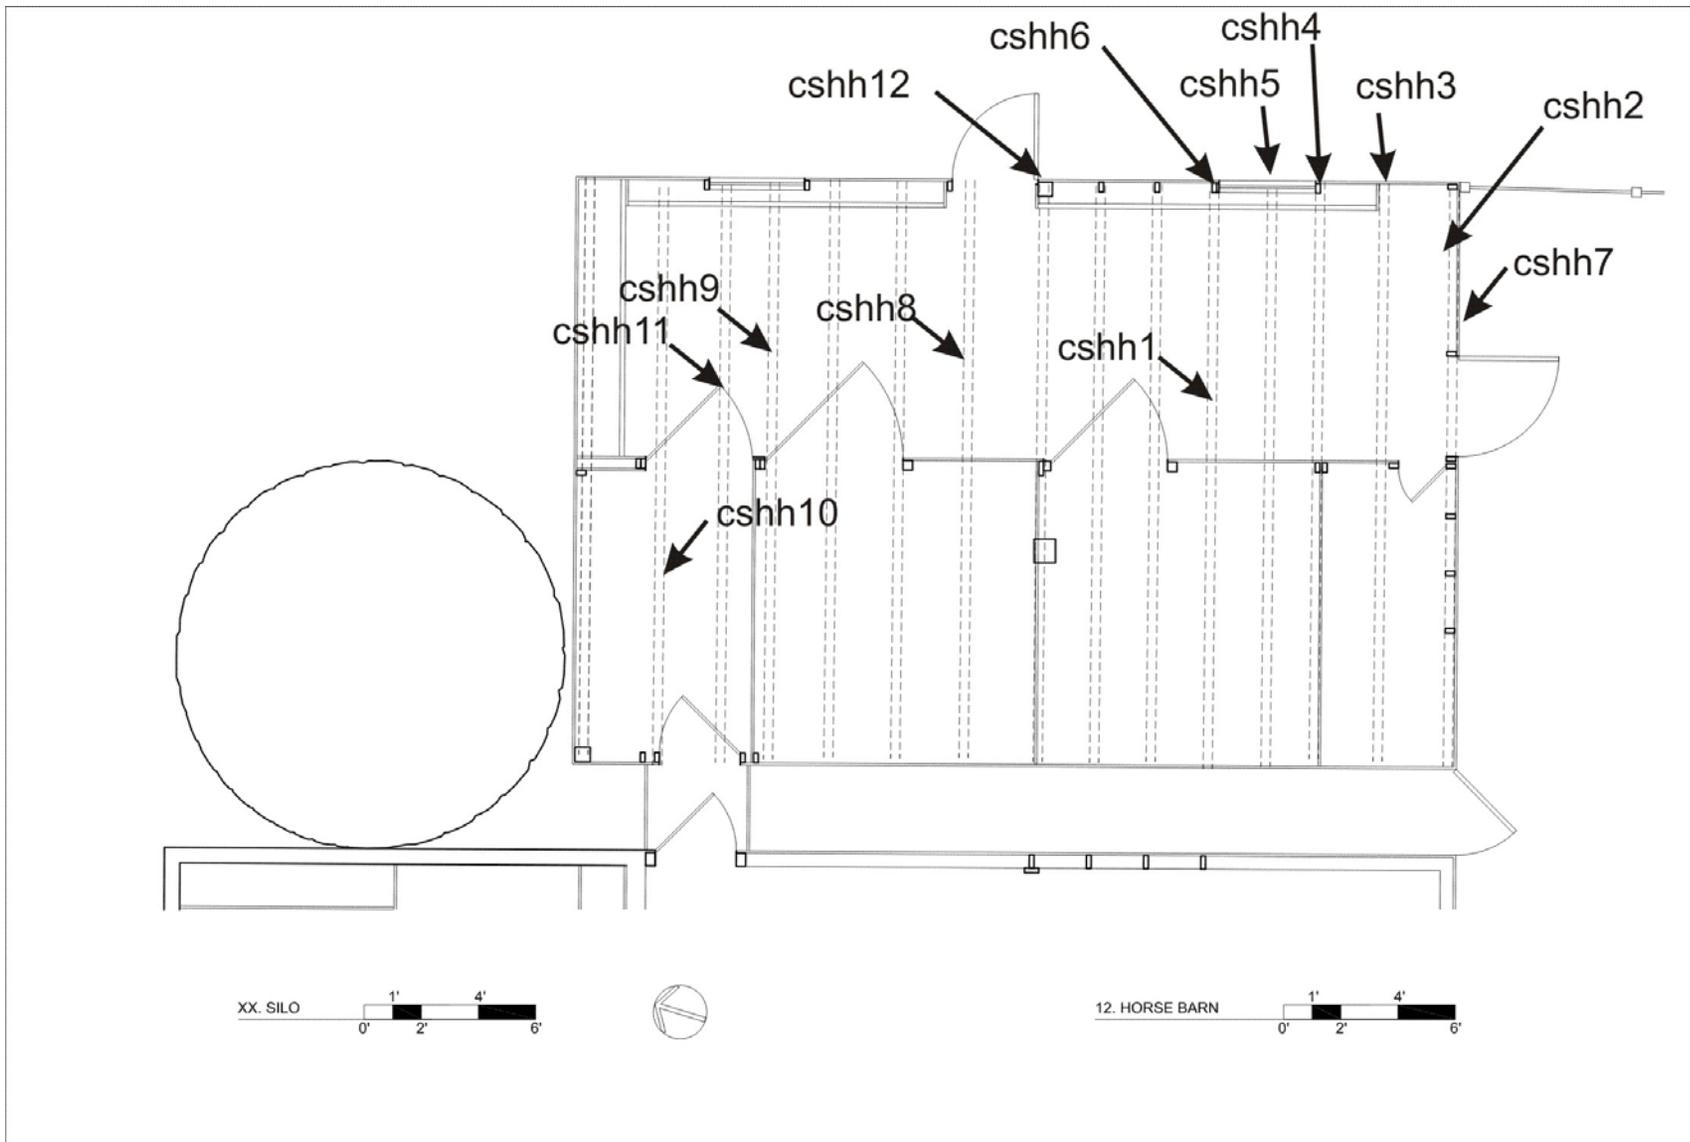
Figure 12. Drawing showing location of samples taken from the Horse Barn at the Carl Sandburg Home (after Joseph K. Oppermann - Architect 2011)

Twelve timbers were sampled from the first floor of the Horse Barn: five joists, five studs, one brace, and one door post. Four of the joists were of shagbark hickory while the rest of the timbers were of white oak. Each sample was given the code **csHh** (for Carl Sandburg Home, Horse Barn) and numbered 1 to 12 (see table 1e). The position of each sample was noted at the time of sampling (see figure 12).

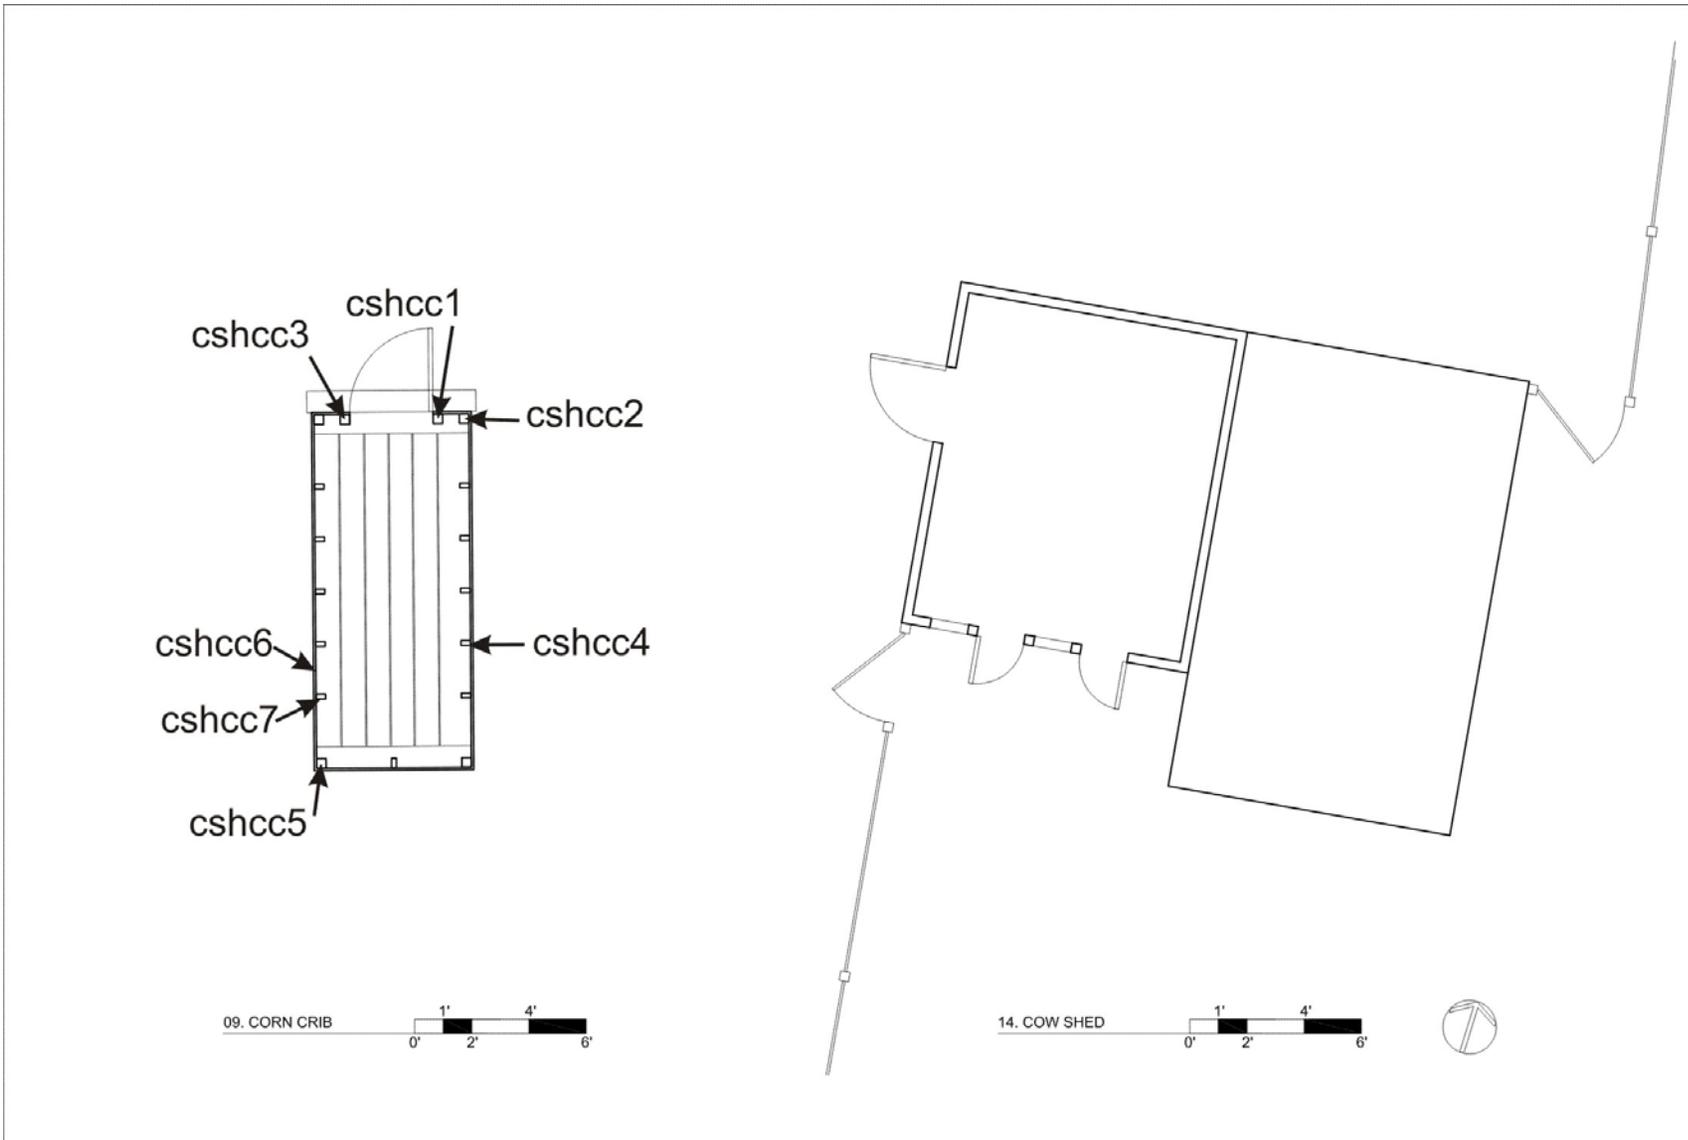
Figure 13. Drawing showing location of samples taken from the Corn Crib at the Carl Sandburg Home (after Joseph K. Oppermaann - Architect 2011)

Seven timbers were sampled from the Corn Crib: two door posts, two corner posts, two studs, and a wall plate. All of the timbers were of white oak. Each sample was given the code **csbcc** (for Carl Sandburg Home, Corn Crib) and numbered 1 to 7 (see table 1f). The position of each sample was noted at the time of sampling (see figure 13).
