Chesapeake & Ohio Canal National Historical Park
Potomac, MD

Great Falls Tavern Historic Structure Report

Final Submission

July 2020

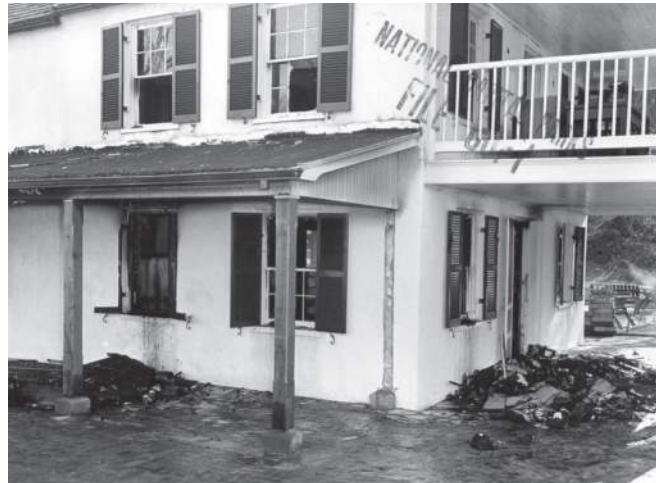
In 1954, the south wing was damaged by an electrical fire. At the time, the south wing first floor was used as a refreshment area/ snack bar and featured electric cooking equipment (Figure 73 to Figure 77). A Park Police substation, whose exact location is unknown, also occupied space in the building and suffered fire damage.⁵⁸ No information regarding repairs after the fire has been found.

Figure 73: Fire Damage to South Wing Exterior Looking Northeast, March 1954 (NPS)

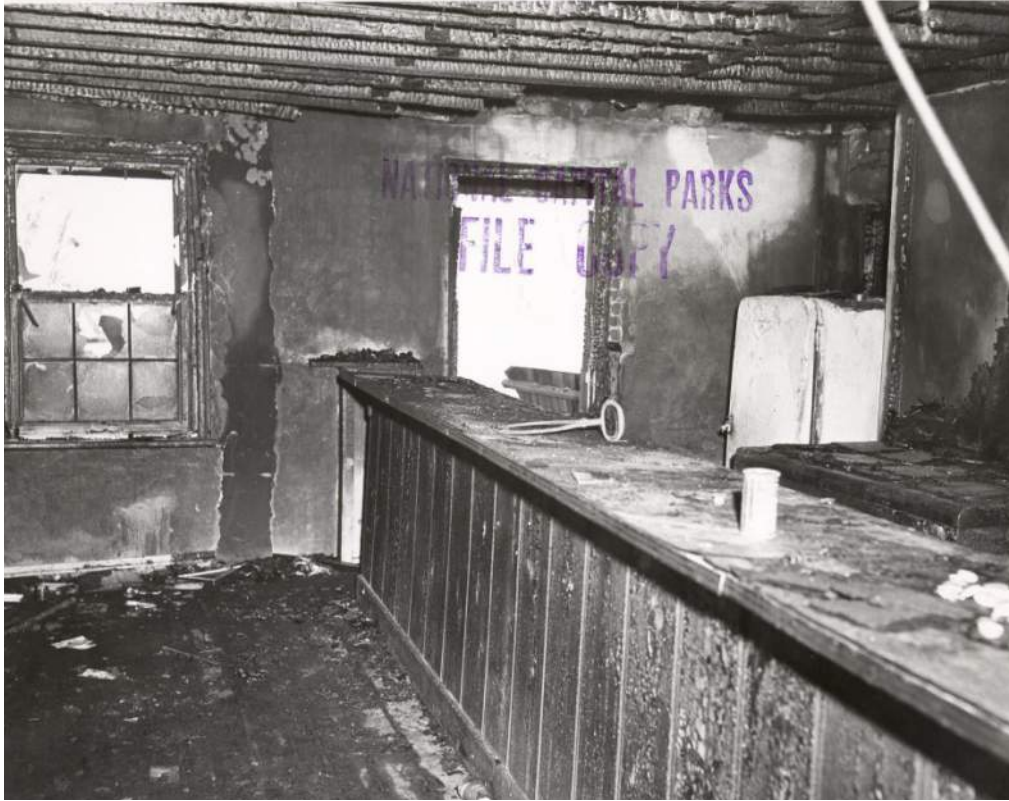
Figure 74: Fire Damage to South Wing Interior Looking Northwest, March 1954 (NPS)

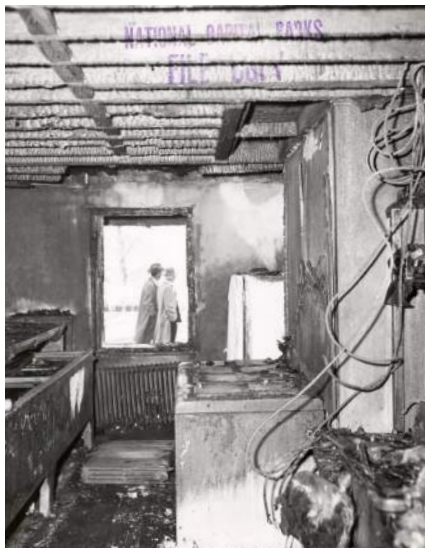
Figure 75: Fire Damage to South Wing Interior Looking West, March 1954 (NPS)

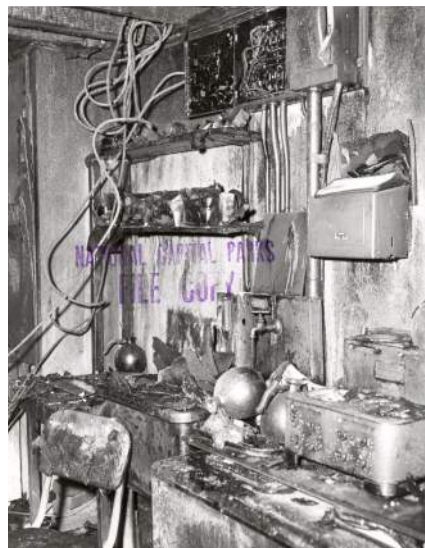
Figure 76: Fire Damage to South Wing Interior Looking Northwest, March 1954 (NPS)

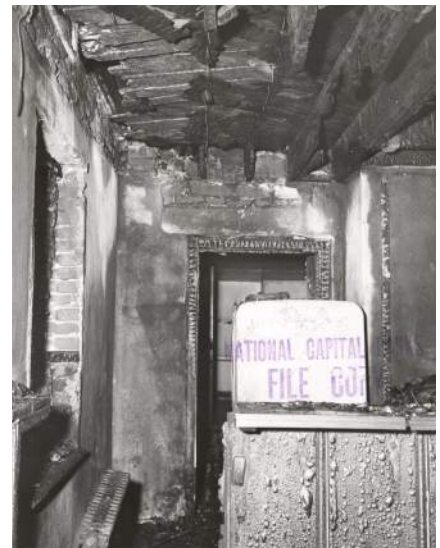
Figure 77: Fire Damage to South Wing Interior Looking North to Center Section, March 1954 (NPS)

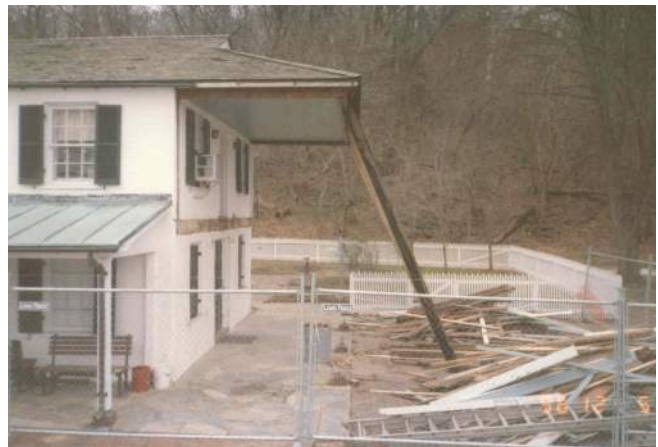
While a 1994 inspection by a structural engineer confirmed that the porches needed only partial repair, not full reconstruction, a photo from December 1996 shows

Figure 90: South Porch Structure Removed, December 12, 1996. (NPS)

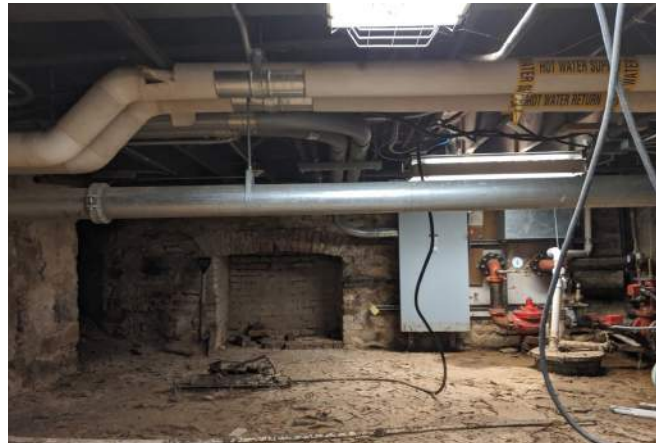
Figure 125: South Wing Cellar Looking Southeast (BBB 2019)

A cellar runs beneath the center section and the south wing of the building. The walls are stone and the floors are dirt. The cellar likely dates to the original building construction from 1828-1831. A brick fireplace is located on the east wall of the south wing cellar. This area may have served as a kitchen at some point (Figure 125 and Figure 126).

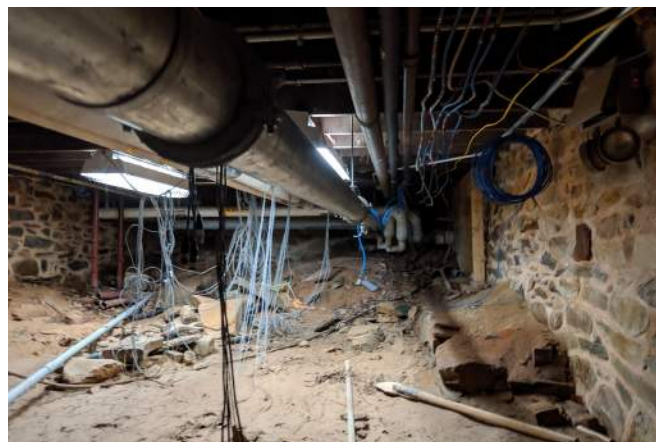
Figure 127: Center Section Cellar Looking Northeast. (BBB 2019)

The ceiling height decreases moving north, as past flooding events have deposited mud and silt, raising the floor level over the years (Figure 127).

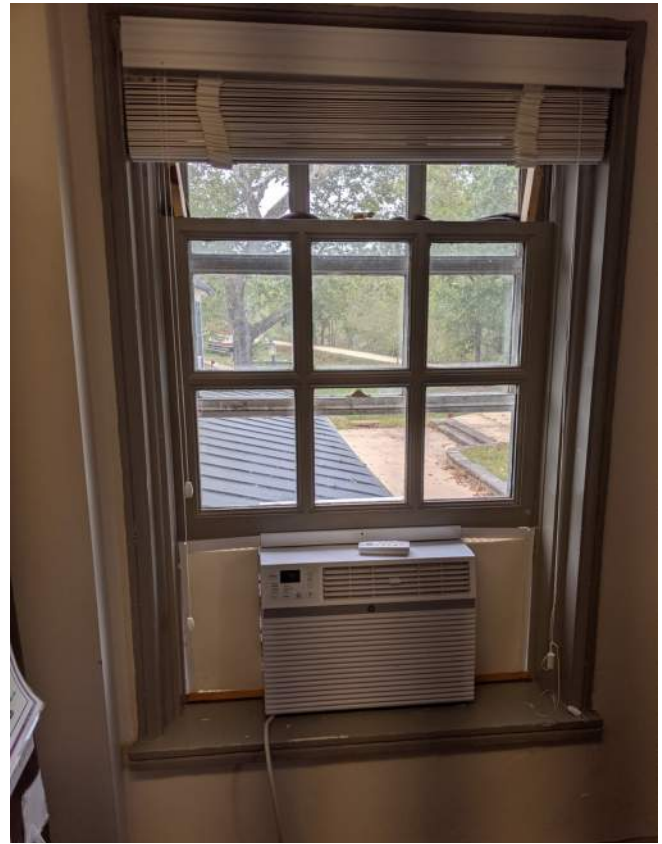
Figure 144: North Wing, Second Floor, South Window in Kitchen (Rm 211) Looking South (BBB 2019)

All windows on this floor were replaced in 2002; however, the south window in the kitchen (Window 223, Figure 144) retains its original frame, stool, and interior trim. The tripartite window on the north wall of Room 208 may also retain its original stool (Figure 145).

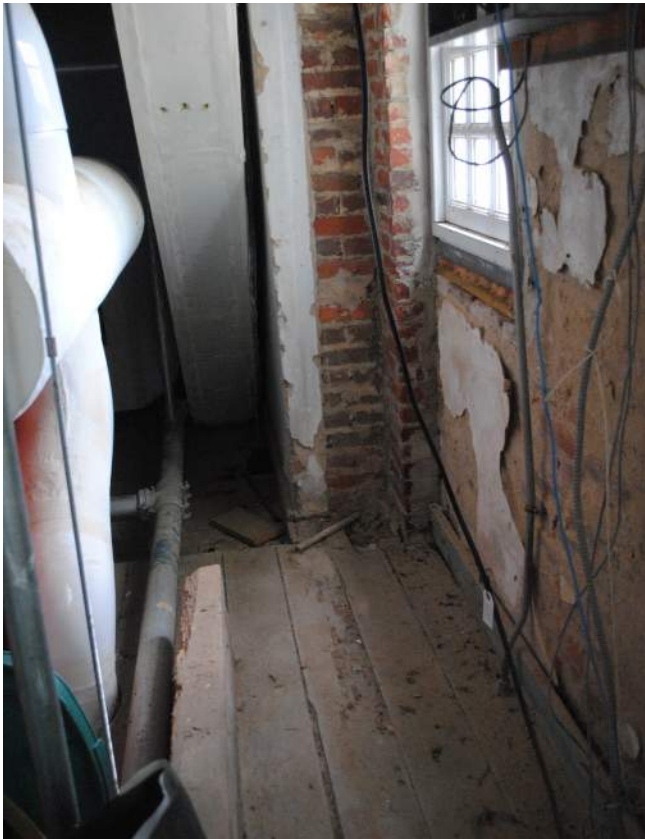
Most of the historic wood tongue and groove flooring remains in the attic. Plaster was applied directly to the perimeter brick walls, but the plaster is currently in poor condition and missing in most locations.

Figure 155: North Wing Attic Exterior Wall and Floor, (BBB 2019)

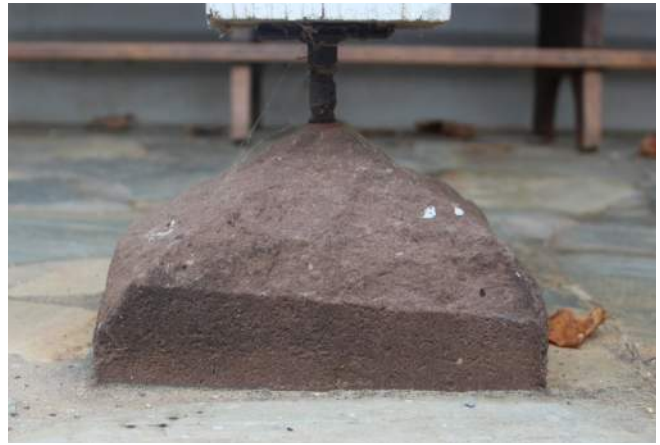
The structure also has three extant porches: a one-story porch along the west side, a two-story porch at the south elevation, and a two-story porch adjacent to the center section at the east side. Wood porch framing is supported on the existing masonry walls and 6x6 wood posts. At grade, the post bases have been retrofitted with a 10"x10" sandstone pier, 3/4" diameter rod, and a 3"x3" square plate, presumably to minimize wood rot during flood events or wet conditions (Figure 162). At the second floor of the south elevation, the wood posts are supported on U-shaped door pull presumably also to stop moisture from moving up into the posts (Figure 163).

Figure 162: West Porch Post Base at Grade (Silman 2019)

- Repoint brick and repair finishes in areas with cracking and excessive moisture infiltration (primarily the north wing).
- Replace framed concrete slab within the east porch.
- Remove the metal bar supports at the west porch posts and replace with an appropriate detail.

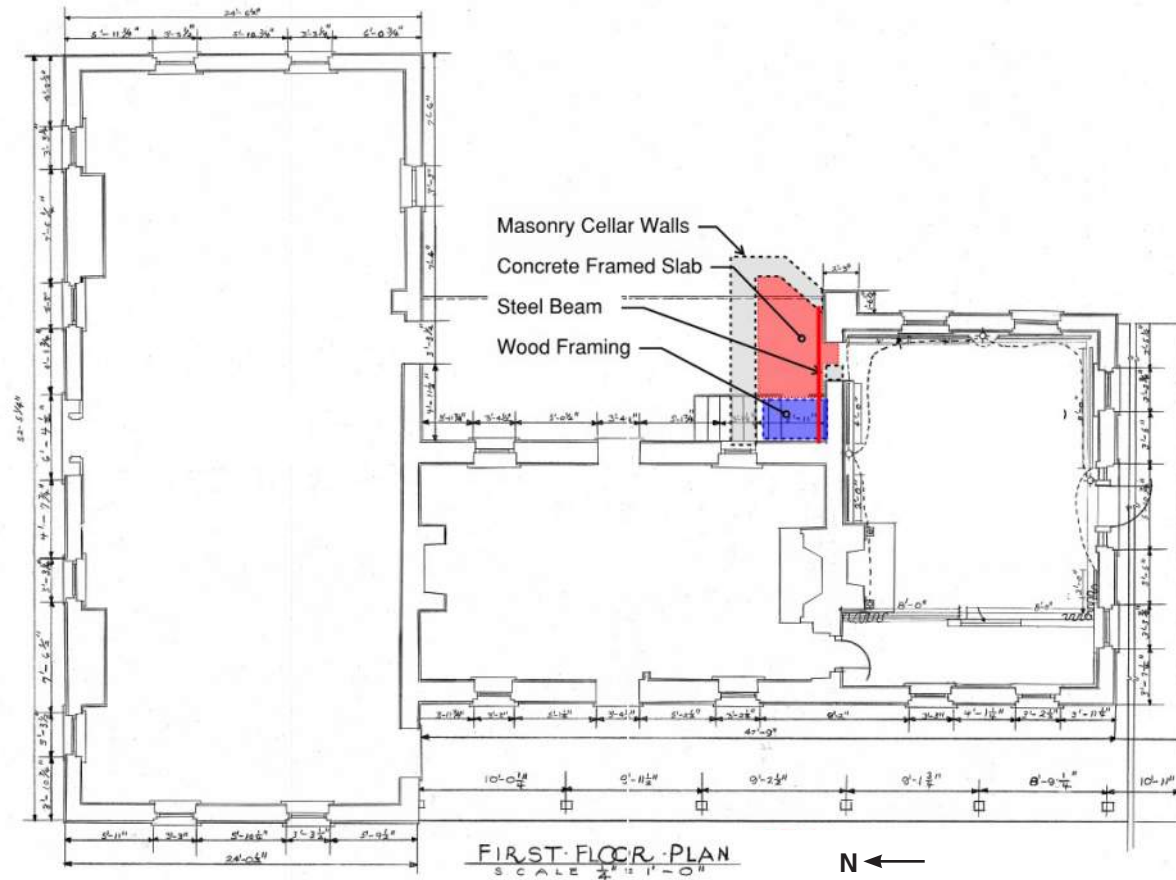
Figure 169: Markup of First Floor Plan Showing Area of Framed Concrete Slab (Silman 2019)

A small section of the exterior slab is framed with a steel beam and 6 1/2" concrete flat slab above the cellar extension to the south wing. This area falls within the east porch of the center lockhouse (Figure 169).

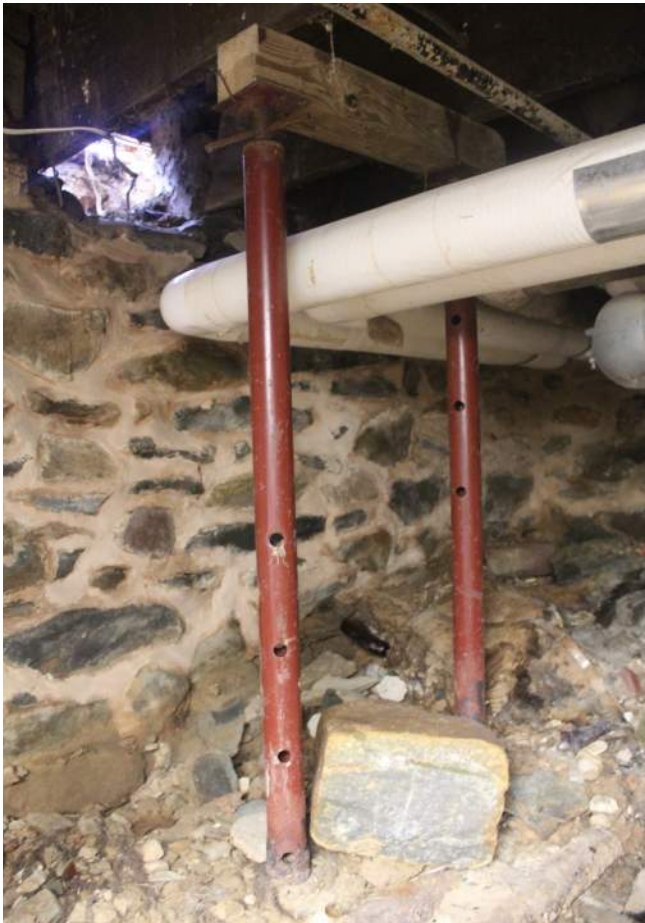
See conditions assessment for additional discussion of the concrete framing. At the center section, the three first floor joists framing are supported on wood and metal shoring posts at locations where openings have been added through the foundation walls (Figure 170).

Figure 170: Cellar Shoring Posts (Silman 2019)

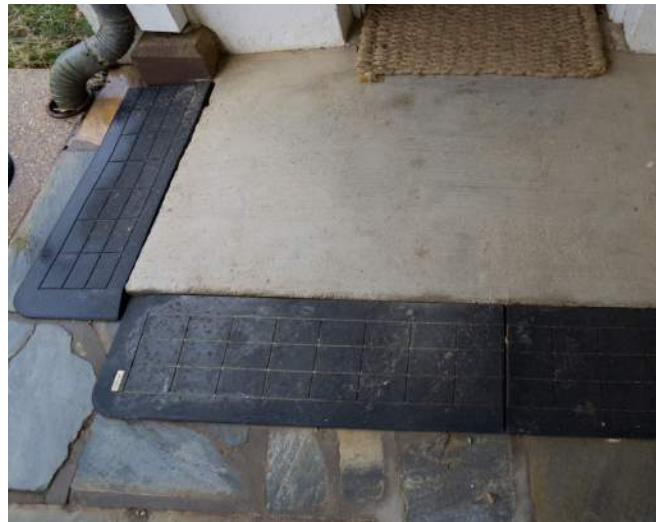
While most of the first floor public doors meet or exceed the 32" minimum ABAAS required width, most of the door thresholds do not, and none of the operating hardware meets ABAAS requirements. Exhibit rooms 101 and 102 can be accessed through doors 101 and 102 that are ABAAS compliant except they lack ABAAS compliant lever hardware. There is no ABAAS compliant access to exhibit room 103, as there is a 6 inch step at door 103A, a 4 inch step at door 103, and door 102C lacks the 36 inch clearance required for doorways deeper than 24 inches.

Figure 176: Temporary ramp at exterior concrete pad at Door 101A (BBB 2019)

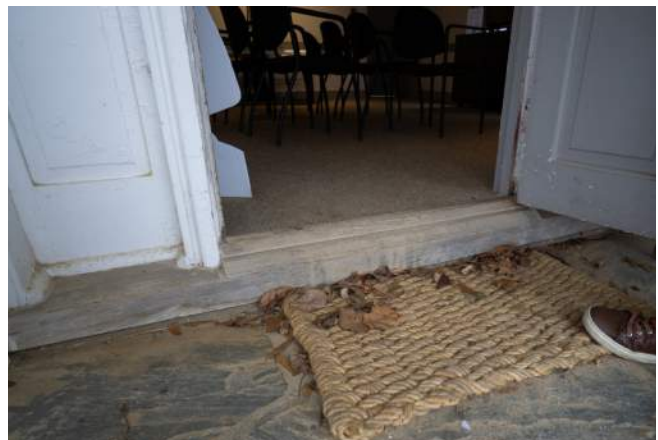
Figure 177: Six-inch step at Door 103A (BBB 2019)

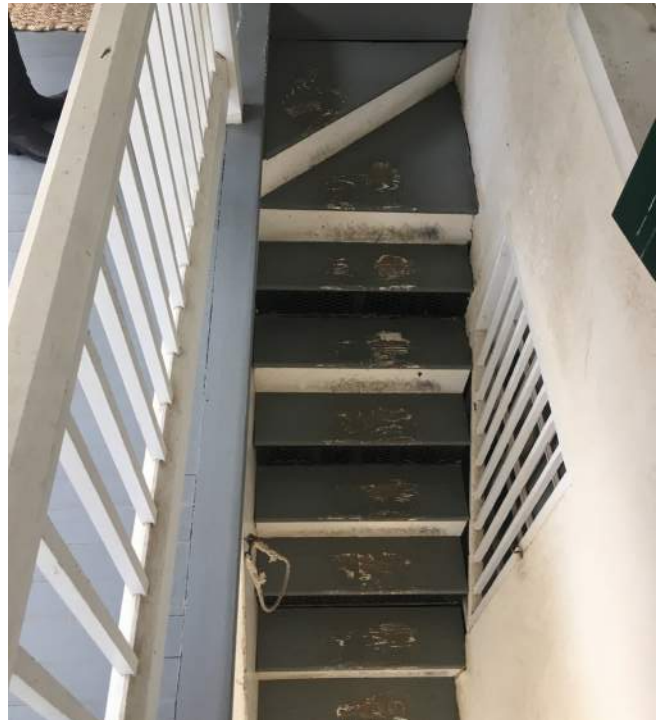
The stairs that lead to the second floor do not comply with International Building Code (IBC). IBC requires 36 wide stairs. The existing stairs are only 32 inches wide. Additionally, the quarter turn at the top of the stair is not ABAAS compliant and the stairs lack an ABAAS compliant handrail. Door 201 that leads from the east

porch to the offices lacks the IBC and ABAAS required landing on the push side of the door and the stairs lack a handrail.

Figure 178: Non code and ABAAS complaint stair at east porch (BBB 2019)

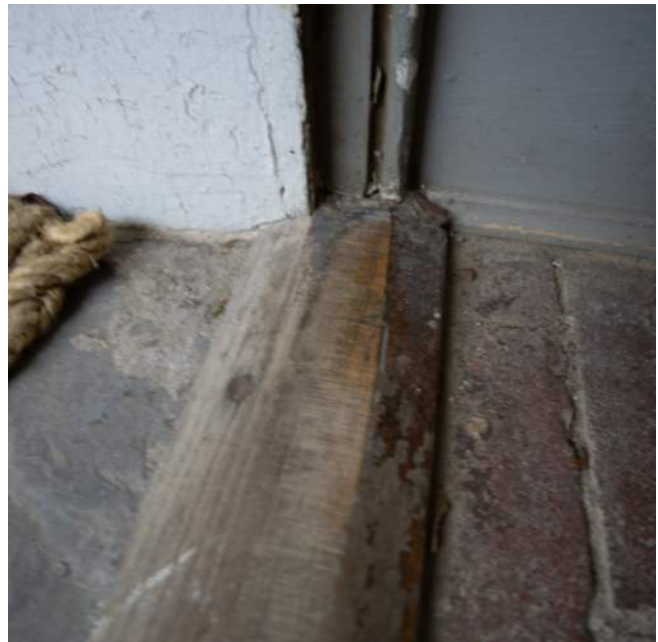
Figure 179: Non-ABAAS compliant threshold at Door 101B (BBB 2019)

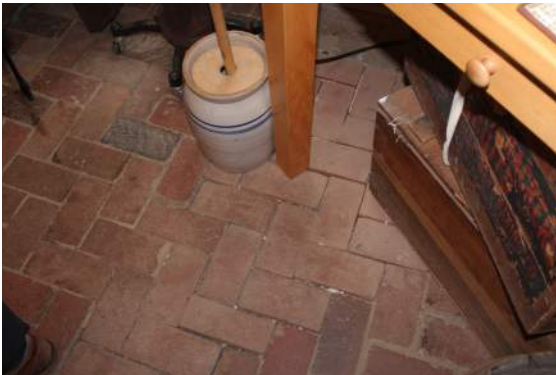
The first-floor slab on grade could not be viewed below brick paving but is assumed to be in fair to good condition given the condition of the brick paving. Some mortar was observed to be missing between the brick units. Floor joists could not be observed except for in small gaps through the floor sheathing but is assumed to be in good condition due to the condition of floor and wall finishes. The floor framing at the second and third floors date to the building’s original construction.

Figure 191: Brick Paving in North Wing Built over a Concrete Slab on Grade (Silman 2019)

Recommendations: Brick pavers on the first floor should be locally reset in replacement mortar to improve the condition and safety of the floor. During any brick replacement, the condition of the slab on grade should be investigated to confirm it is in good condition. At the upper floors, special attention should be given to any future repairs and modifications at the second and third floors of the north wing at the floor framing to maintain and properly preserve the only extant wood framing from the nineteenth century. Storage in the third floor should be limited to 20psf. During field survey, the amount of storage currently in the third floor appears to be approaching this capacity. NPS should not allow any additional storage on the third floor. Alternately, the floor should be reinforced to allow additional storage.

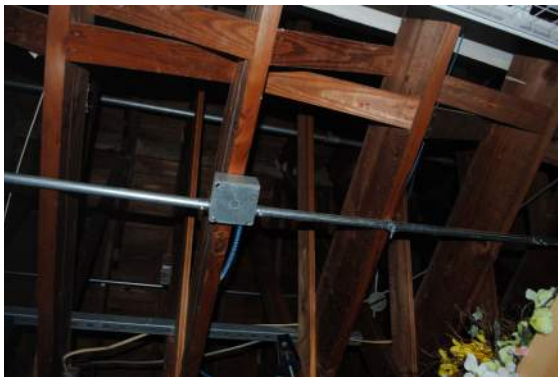
Description: Roof structure of the north wing is a wood truss system with rafters bearing on masonry and a steel beam at the third floor (Figure 194). The roof system also includes wood ties and diagonal struts. Steel beams in the roof structure bear on masonry end walls. The steel beam does not have fireproofing, which is acceptable in Type III B Unprotected Combustible Construction.

The roof structure appears to be in good condition.

Figure 194: Roof Framing, North Wing (BBB 2019)

Recommendations: Monitor for roof leaks; any leaks should be locally repaired.

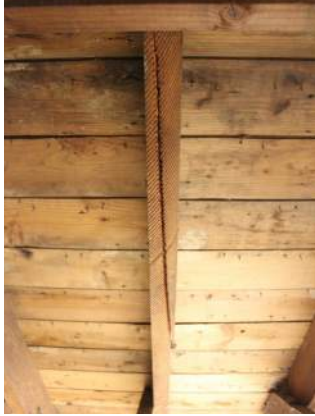
Feature(s)	Location	Condition	Deficiency	Photo(s)
B1020 Roof Construction	Center Section	Good	Minor	
<p>Description: Roof structure of the center section is wood rafters, third floor joists, and diagonal ties. See structural description for framing sizes.</p> <p>The roof structure appears to be in good condition. One split rafter was observed near the south end of the structure (Figure 189).</p> <p>Recommendations: Repair split roof joist with a 2x6 sister. Monitor for roof leaks; any leaks should be locally repaired.</p>				
B1020 Roof Construction	South Wing	Good	Minor	
<p>Description: Roof structure of the south wing is also wood rafters, third floor joists, and vertical and diagonal ties. Like other roof systems, the structure is in good condition.</p> <p>Recommendations: Monitor for roof leaks; any leaks should be locally repaired.</p>

<p>Figure 195: Split in Roof Rafter, Center Section (Silman 2019)</p>

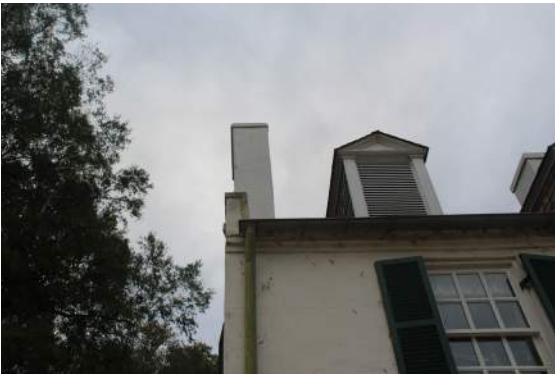
B20: EXTERIOR ENCLOSURE				
Feature(s)	Location	Condition	Deficiency	Photo(s)
B2012 Parapets and Chimneys	North Wing, North Elevation	Fair	Serious

<p>Figure 203: North elevation parapet (BBB 2019)</p>
<p>Description: The north wing features a tall brick parapet at the north elevation and three chimneys; two integral with the north parapet and one at the south elevation of the north wing. The 2015 investigation noted that the north wing parapets are two wythes deep with a stucco coating. Displacement and cracking of parapet and chimneys was observed. The brick structures were observed to have tilted to the north, and cracking was observed at the east, west, and north sides of the tall slender brick structures. Extent of displacement could not be accurately determined from the ground. It is unknown if the damage was caused by the 2011 Mineral Earthquake.</p> <p>Recommendations: Cracking of the parapets and chimneys should be monitored for continued movement. In the short-term, cracking and displacement should be visually monitored. In the near term, inexpensive tell-tale crack monitors should be installed across existing cracks and visually monitored by Park staff to determine if the parapets and chimneys are actively moving. For cost estimating purposes, it can be assumed that six monitors should be installed. See field notes in appendix for suggested location of crack monitors.</p>

<p>If more than 5mm of movement is observed, the Park should engage a structural engineer to investigate further and develop appropriate repairs. Crack monitors can also be installed to accurately quantify continued movement of the chimneys. Existing cracking should be repaired by removing the stucco and repointing deteriorated areas. Given the extent of cracking, it would also be appropriate to rebuild sections of the brick masonry to address existing conditions during a future long-term restoration project.</p> <p>Unreinforced masonry parapets and chimneys are typically not seismically compliant. In order to achieve seismic compliance and increase the site's safety during a seismic event, the chimneys and parapet should be reinforced or reconstructed as a reinforced wall.</p> <p>A seismic analysis of the existing chimneys and parapets following current code requirements shows that the chimneys will experience 20 - 30psi of tensile stress in a design level seismic event. A brick masonry chimney in good condition may be able to withstand these tensile forces, but given the observed exterior condition and typical masonry deterioration in a chimney flue, we recommend planning for chimney reinforcement within a long-term restoration project. Similarly, the parapet at the north elevation may experience upwards of 100psi in a design level seismic event, exceeding the capacity of unreinforced masonry.</p> <p>Options for chimney and parapet reinforcement include adding a brace point at the mid-height of the parapet, such as a kicker supported on the roof framing. The chimneys could also be reinforced by infilling the flue with reinforced concrete that extends down past the roof height.</p> <p>Previous paint and whitewash treatments have contained latex, which is non-permeable. No known hazardous materials testing has been conducted on exterior surfaces; however, it is assumed that paint and whitewash treatments performed in or prior to 1949 contain lead. If stucco is to be removed from the exterior, the stucco and paint should be tested for lead and asbestos and removed under containment if needed. If the stucco remains in place, lead-based paint may need to be encapsulated prior to any repair.</p>

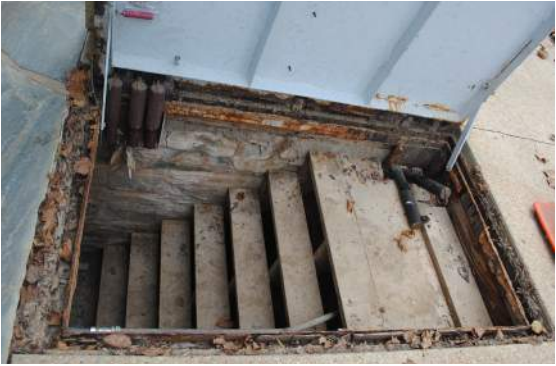
<p>Description: A watertight steel door clad with wood boards leads to stairs to the cellar, located immediately south of the south porch. This door was installed in 2007. The door requires a removable key wrench to open. During survey in 2019, staff on site were unaware of how to open the door. This poses serious safety risks should an emergency occur and on-site staff are unable to operate the hatch. Three of the six lifting mechanisms also appear to be broken and the door has experienced rusting.</p> <p>Recommendations: Cellar door should be repaired or replaced as soon as possible. Replacement with an integrated opening mechanism with a lock that does not create a tripping hazard is recommended so that an independent key wrench is not necessary to operate the door.</p>				<p>Figure 208: Cellar Door in Open Position Showing Broken Lifting Mechanisms at Right (BBB 2019)</p>

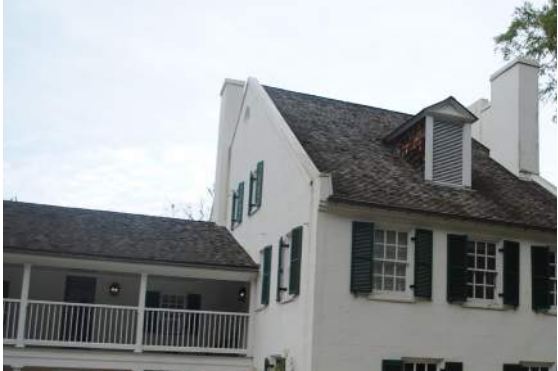
<p>Figure 209: Red Cedar Shingles on Roof of North Elevation and Center Section (BBB 2019)</p>
<p>Description: Square red cedar shingles cover the main building roof. According to as-built drawings, shingles were installed in 2002. The shingles currently exhibit cupping and splitting, and there are isolated areas of biogrowth. The ridge cap is also failing. The dormers on the north wing have red cedar shingle cladding on their cheeks. This cladding is stained and weathered. Previous inspection by the Park determined that the cedar shingle roof was fast approaching the end of its service life.</p> <p>Standing seam copper covers the roof over the west porch. The standing seam cladding was installed in 2002 and is in good condition. A roof cladding replacement project was approved in January 2020.</p> <p>Recommendations: Proceed with cedar shingle roof replacement project as approved and monitor standing seam roofs.</p>

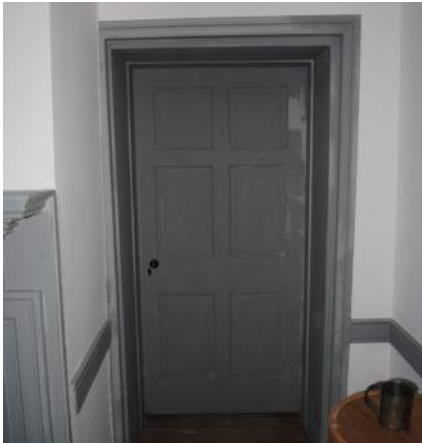
<p>Figure 211: Door 102C looking south; no doorknob (BBB 2019)</p>
<p>Description: Several of the interior wood doors are dented and paint has flaked off due to constant use. Existing hardware does not meet ABAAS and many doors lack ABAAS required clearances.</p> <p>Recommendations: All interior doors should be repaired and repainted, and any malfunctioning hardware should be repaired.</p>

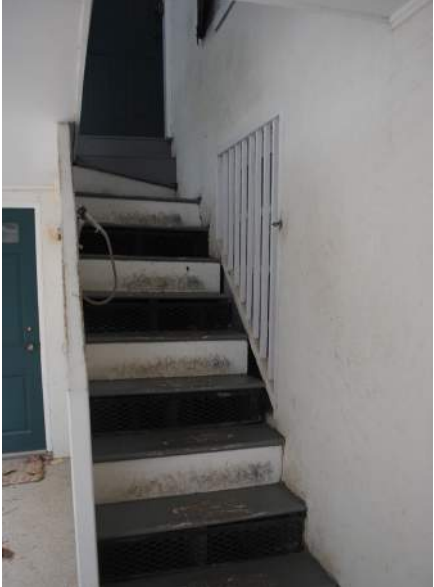
<p>Description: Stair treads throughout the building are uneven. The only stairs from the first floor to the second floor are located on the exterior of the building (connecting the east covered porch to the balcony above). These stairs do not meet current Life Safety Code or ABAAS requirements. Additionally, the stairs from the second floor porch to the north wing do not have a code-required landing at the top of the stairs.</p> <p>Recommendations: It is assumed that in order to preserve the integrity of the Tavern, the second floor will not be made ABAAS accessible and the stairs will not be replaced with code-compliant alternatives.</p>

Figure 212: Exterior Stairs from First to Second Floor (BBB 2019)

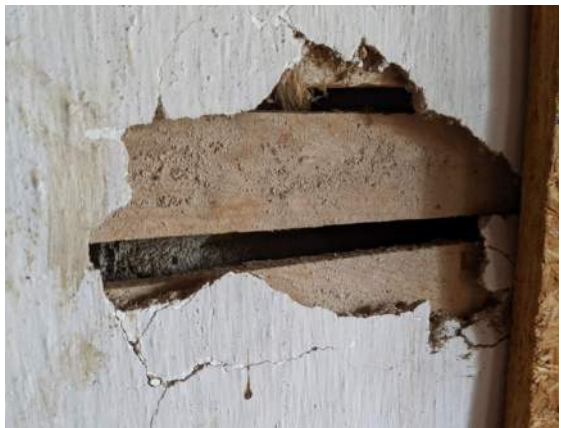
Description: The plaster finishes on the second and third floors of the north wing date to 1830 according to the 2007 Interior Historic Integrity report. Contemporary drywall finishes, installed in 2007, are located in portions of the kitchen and bathroom (Rooms 211 and 212). Most interior walls feature lime and sand-based plaster with animal hair binder laid up against sawn wood lath. The walls of Rooms 206 through 210 are furred with wood paneling likely installed around the 1970 renovation; however, from exploration undertaken by the Historic Integrity investigation in 2007, it appears that historic plaster finishes remain beneath paneling. The 2007 investigation also postulated that original plaster applied directly to perimeter walls is intact on the second floor. On the third floor, the plaster applied directly to the perimeter masonry walls is visible. See B2010 Exterior Walls for a description and recommendations for the interior face of the third floor.

Figure 215: Historic Plaster Applied to Wood Lath on Third Floor (BBB 2019)

Recommendations: Monitor historic plaster finishes and repair in kind as necessary. If a future renovation is undertaken, consider removing 20th century paneled wall coverings and restoring historic plaster finishes.

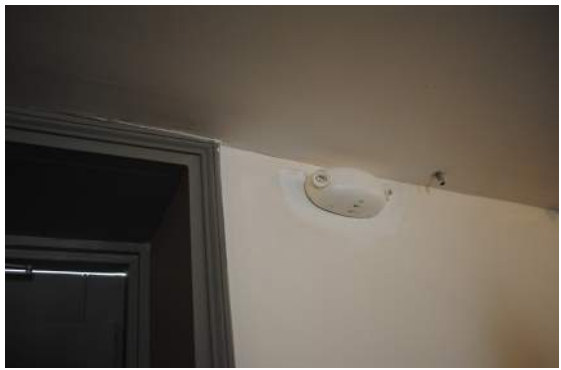
Description: The walls in the Center Section and South Wing are finished with replacement plaster on expanded metal lath. Some walls have been furred and clad with gypsum board.

Figure 216: Replacement Plaster Applied to Metal Lath on Center Section, First Floor (BBB 2019)

Recommendations: Monitor and repair as necessary.

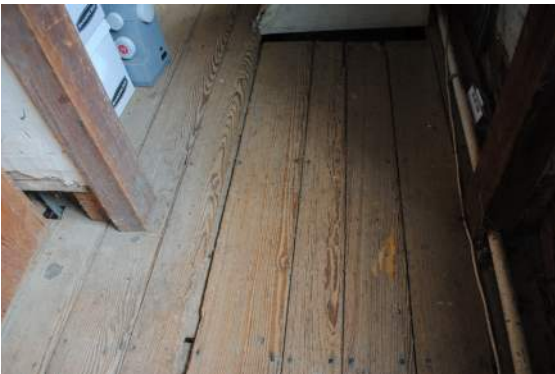
<p>Figure 217: Wood Flooring in Attic, North Wing (BBB 2019)</p>
<p>Description: The first floor has brick paver flooring in the north wing. There is evidence of water damage, especially at the north elevation, where there has been flooding in the past. Additionally, there is some missing mortar and bricks have become loose.</p> <p>On the second floor, the historic wood flooring has been covered with carpet in most rooms. In the kitchen and bathroom, there is laminate wood flooring. The third floor retains its historic wood flooring and is in fair condition.</p> <p>Recommendations: Repair and re-set loose or uneven brick pavers with compatible mortar on first floor. Clean first floor flooring after all flood events. Consider removing carpet in second floor and refinishing wood floor below.</p>

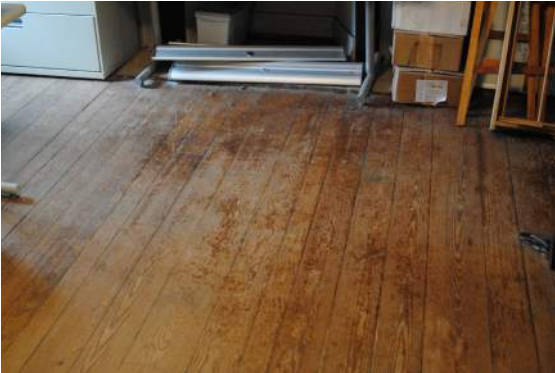
<p>Figure 218: Wood Flooring in Second Floor, Center Section (BBB 2019)</p>
<p>Description: The center section has replacement wood flooring on the first floor and historic wood flooring on the second floor. The south wing has carpeting on the first floor and historic wood flooring on the second floor.</p> <p>Recommendations: Polish and seal wood floors on second floor to preserve historic material.</p>

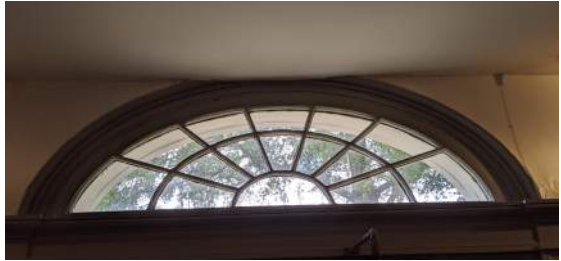
Description: Ceilings throughout the building are finished with plaster or gypsum board. In the north wing, the ceilings are finished with gypsum board. In locations on the first floor along the north wall, the ceilings are buckling and sagging due to the weight of exhibit boards suspended from the ceiling (Figure 219 and Figure 220). The ceiling in the first floor of the center section is cracked. All ceilings suffer from incompatible patching. In many locations, there are cracks at the seam where the historic plaster over lath walls meet the gypsum board ceiling. Additionally, the ceilings in the first floor rooms intersect the top of door and window molding (Figure 219).

Figure 219: Bowed Ceiling at North Wall, First Floor North Wing (BBB 2019)

Recommendations: Remove suspended exhibit boards in north exhibition space and repair sagging drywall. Exhibit boards should be reconfigured to be freestanding or attached in a different manner or to another feature. Repair cracked ceilings and open joints where ceilings meet walls. In future renovations, raise ceilings if possible to allow the full door and window moldings to remain exposed.

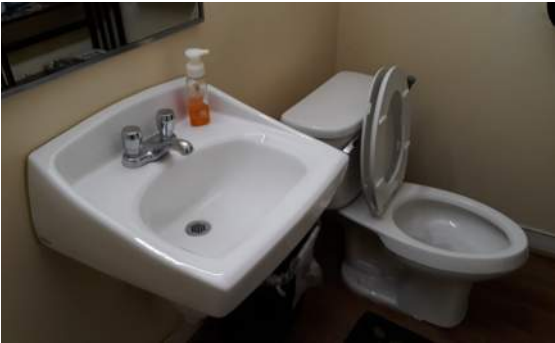
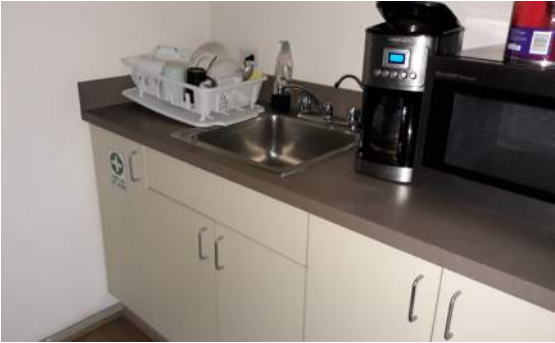
<p>Figure 221: Bathroom Plumbing Fixtures (JPA 2019)</p>

<p>Figure 222: Kitchen Plumbing Fixtures (JPA 2019)</p>
<p>Description: The facility includes a single user restroom. The restroom fixtures included a floor mounted, tank-type water closet and a wall mounted lavatory with a manually activated, metering type faucet. The fixtures and all trim accessories are in good condition.</p> <p>The restroom is not ABAAS compliant. The toilet lacks the required clearance from the wall, adequate turning space is not provided, and there are no grab bars. The restroom would require enlargement and reconfiguration to meet ABAAS. It is not recommended to add ABAAS grab bars to the restroom to improve accessibility as the toilet is already located too close to the wall and grab bars would further constrict the free area adjacent to the toilet. Also, the restroom is located on a level that is not accessible.</p> <p>Kitchen plumbing fixtures include a counter mounted sink with a deck-mounted faucet with individual hot and cold leavers. The fixture and all associated trim accessories are in good condition.</p> <p>Recommendations: Maintain as required.</p>

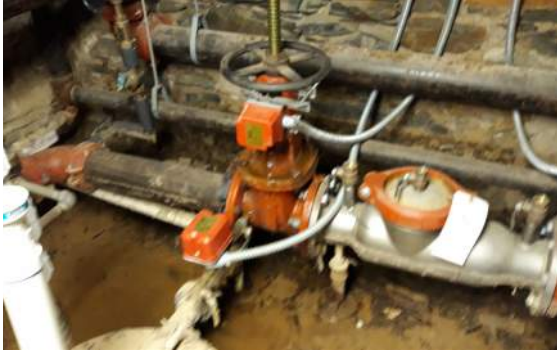
<p>Figure 223: Water Service Entrance (JPA 2019)</p>
<p>Description: The building's water supply consists of a 4" combination fire/water service. Once inside the building, the service splits into a 4" fire service and a 3/4" domestic water service.</p> <p>The domestic water system piping includes a pressure reducing valve and a water meter. No backflow prevention device or strainer is installed on the domestic water main serving the plumbing fixtures in the building. The domestic water piping system consists of copper piping and fittings. The fire service entrance piping included a double check valve backflow preventer.</p> <p>The domestic water piping main enters the building in the cellar and is routed a few inches above the floor. The 4" piping main is steel with grooved ends.</p> <p>The cellar experienced flooding recently, and the service entrance piping mounted near the floor was exposed to the water. No visible damage was noticed; however, piping was covered in dirt and mud from the flood (Figure 223).</p> <p>The shut-off valve on the inlet of the fire service backflow preventer was leaking at the stem (Figure 224).</p>

<p>Figure 224: Fire Service Backflow Preventer (JPA 2019)</p>
<p>Recommendations: It is recommended that all piping exposed to the water while the cellar was flooded be cleaned and inspected for damage. It is recommended that the leaking gate valve on the inlet of the fire protection backflow preventer be replaced.</p> <p>It is recommended that a double-check backflow preventer and y-type strainer be installed on the domestic water service. The backflow device will make the installation compliant with the latest plumbing codes. The addition of the strainer will protect the meter and other fixtures from debris in the system.</p>				
D2022 Hot Water Service	North Wing, Second Floor	Good	Minor

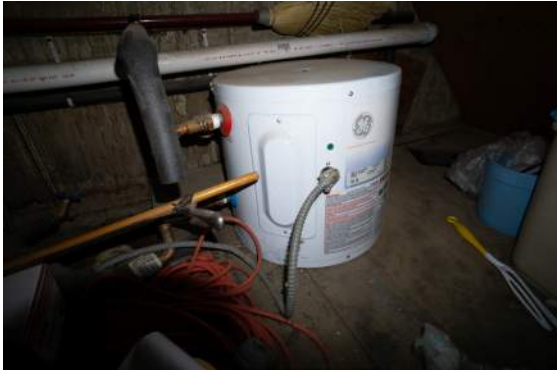
<p>Figure 225: Water Heater (BBB 2020)</p>
<p>Description: The building's hot water service consists of a small, storage type electric water heater. The heater is located in a storage closet below the stairs to the third floor on the second floor. The heater was installed in 2013.</p> <p>Domestic hot water piping extends directly from the heater to the lavatory and the kitchen sink. The piping and the heater did not appear to have any visible deficiencies.</p> <p>Recommendations: It is recommended that the water heater be monitored. Tank type electric heaters typically have 10-year life spans. When discolorations appear in the hot water, it is a sign that the heater is about to fail. It is recommended that this particular heater be replaced at 10 years since it is located on a wood floor above occupied space. Replacement before failure would be a preventive maintenance item.</p> <p>To avoid potential water damage to the facility due to a heater failure, it is also recommended that the heater be placed on a drain pan with moisture sensor. If a failure were to occur, the pan would help prevent water damage. The moisture sensor is recommended to be connected to a solenoid valve. Upon detection of water in the drain pan, the valve would shut-off the water supply.</p> <p>It is recommended that the storage room where the water heater is located be re-organized so that the equipment is visible and accessible. In its current condition, maintenance staff would not be able to pick up visible indications on the surface of the tank that would signal a potential tank failure (Figure 225).</p>

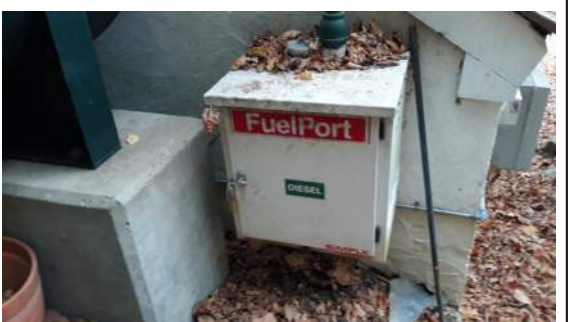
The fuel oil supply system consists of a fuel port for filling the storage tank from a supply truck. The fuel port is mounted on the exterior wall of the boiler house (Figure 227). Fuel oil supply and return piping extend from the exterior storage tank and route to the boiler.

Figure 227: Fuel Port (JPA 2019)

Recommendations: The fuel oil supply system is approaching 14 years of age. While it appears to be functioning, it should be replaced in the next 5-7 years.

It is recommended that the piping and equipment be replaced within the next 5-7 years, or whenever the associated boiler is replaced.

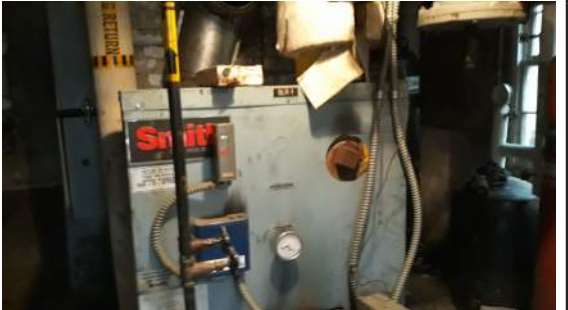
Figure 228: Boiler (JPA 2019)

The boiler is the only heat generating equipment for the Tavern, and it also supplies heat for the adjacent, stand-alone restroom facility. The boiler, heating water piping and specialties, and propylene glycol feed system date to the 2007 renovation project.

The cast iron section boiler includes a fuel oil burner and is rated for 285 MBH (output). The heating water system operates with 35% propylene glycol as the fluid (Figure 228). The boiler is approaching the end of its useful life.

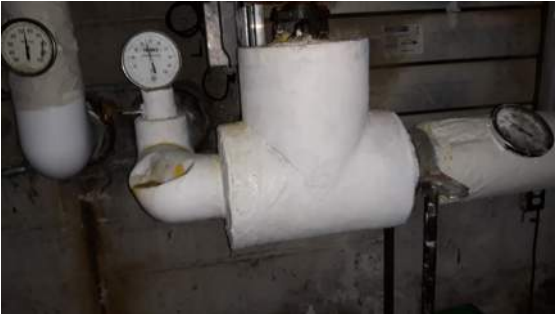
D30: HVAC				
Feature(s)	Location	Condition	Deficiency	Photo(s)
D3020 Heat Generating Systems	Boiler House	Fair	Minor

<p>Figure 229: Boiler Room Piping Insulation (JPA 2019)</p>
<p>The heating water piping is expected to last 20 more years or more if proper water treatment continues. Insulation on the piping and equipment within the boiler room is in fair condition. Most of the insulation is intact, with only a few areas noticed to have minor damages (Figure 229).</p> <p>Recommendations: Replace boiler, burner, associated trim, glycol feed system, specialty valves, expansion tanks, and air separators in the next 5-7 years. Maintain piping and repair damaged insulation in the boiler room.</p> <p>It is recommended that the boiler, burner, and associated trim be replaced in the next 5-7 years. The heating water specialties, such as the expansion tank and air separator, as well as the propylene glycol feed system for the heating water system are recommended to be replaced when the boiler is replaced, in the next 5-7 years.</p>

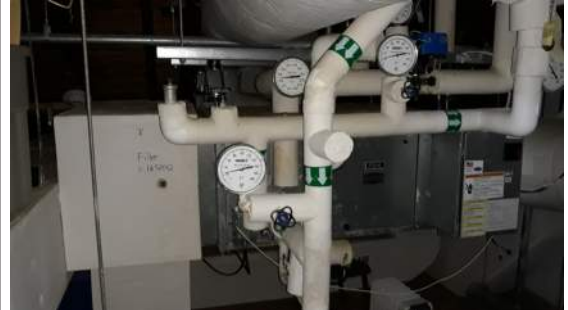
Figure 231: Typical Attic Fan Coil Unit (JPA 2019)

Description: All spaces in the Tavern are conditioned and ventilated by ducted 4-pipe fan coil units. The fan coil units are all located within the third floor space. Although difficult, all components that require regular maintenance are accessible (Figure 231).

The fan coil units are configured with chilled water coils and heating water coils. The coil control valves react to the associated thermal zone's temperature sensor. The configuration of the fan coil units and the current control sequences do not provide any opportunity to manage humidity. Since the fan coil units supply fresh air to the space, there is a great potential that building humidity levels are exceeded during the warmer, more humid months of the year.

Many of the larger spaces located in the Tavern had window air conditioning units installed, even though they are conditioned by dedicated fan coil units. The window A/C units were installed to provide conditioning when the central system is out of service. The window A/C units were also used during a period when the FCUs were not properly maintained. Filter boxes were reported to be left open, and unconditioned third floor air was being returned through the FCUs. The situation was corrected. Additionally, the HVAC systems were recently balanced. From a preservation perspective, however, it is not desirable to have A/C window units.

Recommendations: Equipment replacement is recommended within the next 10 years. With the physical space limitations of the third floor, it is recommended that a similar fan coil design approach be used in a replacement project. However, it is recommended that the new design incorporate new technology to improve comfort and energy efficiency. It is recommended that the fan coil units utilize supply fans with EC motors, which will enable variable speed control of the supply fan speed to match the load in each zone. The variable speed design will better manage humidity levels in the space and make the installation compliant with the latest energy codes.

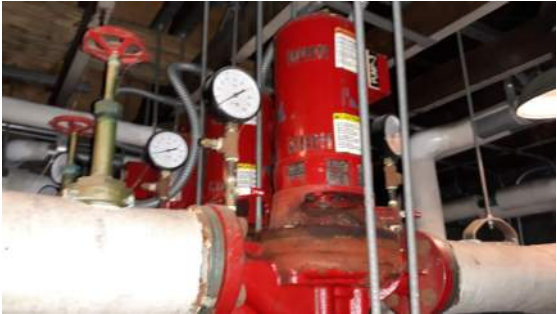
Figure 232: Heating Water Pumps (JPA 2019)

D3040: HVAC DISTRIBUTION SYSTEMS				
Feature(s)	Location	Condition	Deficiency	Photo(s)
D3042 Exhaust Ventilation Systems	North Wing, Second Floor Restroom	Good	None	
<p>Description: The exhaust ventilation systems in the Tavern consists of an inline ceiling exhaust fan, located above the restroom. The fan connects to a ceiling mounted register in the restroom. The exhaust fan is activated by the light switch in the restroom.</p> <p>Exhaust discharge extends from the fan to an exhaust air louver, which is integrated into the existing window opening of an third floor dormer. The exhaust system is in good condition and has useful life remaining.</p> <p>Recommendations: Continue routine maintenance.</p>				
D3044 Hot Water Distribution	Boiler House	Fair	Minor	
<p>Description: The heating water distribution system consists of two, fully redundant, inline pumps. The pumps are located in the boiler house and operate as a constant volume system. The inline pumps have some visible deficiencies which appears to be from leaky pump seals (Figure 232).</p> <p>The distribution piping extends from the boiler house and routes, below grade, into the cellar of the Tavern. Once in the cellar, the heating water piping splits into two main risers. The risers extend to the two main portions of the third floor, which house the fan coil units.</p> <p>The coil connections to the fan coil units include 3-way modulating control valves. It is expected that the heating water piping system has at least 20 years of useful life remaining, assuming proper water treatment is maintained.</p> <p>Recommendations: The distribution pumps are recommended to be replaced when the boiler is replaced in the next 5-7 years. It is recommended that replacement heating water pumps be provided with variable speed drives that modulate the pump motor speed based on demand. The variable speed control will make the installation compliant with the latest energy codes. In order to achieve variable speed control, the 3-way valves, located at each fan coil unit, will need to be replaced with 2-way control valves.</p>

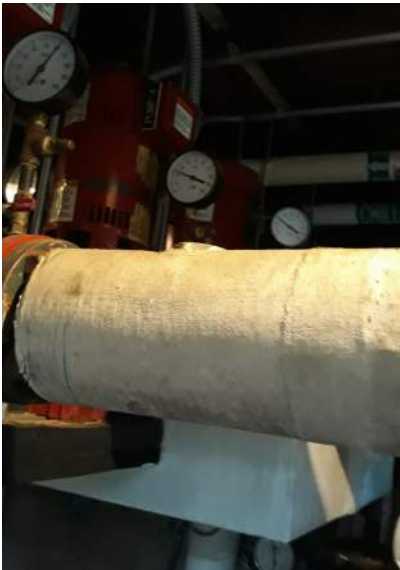
Figure 233: Chilled Water Distribution. (JPA 2019)

<p>Description: The chilled water distribution system consists of two, fully redundant, inline pumps. The pumps are located in the boiler house and operate as a constant volume system.</p> <p>The distribution piping extends from the boiler house and routes, below grade, into the cellar of the Tavern. Once in the cellar, the chilled water piping splits into two main risers. The risers extend to the two main portions of the third floor, which house the fan coil units.</p> <p>The chilled water coil connections to the fan coil units include 3-way modulating control valves. It is expected that the chilled water piping system has at least 20 years of useful life remaining, assuming proper water treatment is maintained.</p> <p>Recommendations: The distribution pumps are recommended to be replaced when the chiller is replaced in the next 5-7 years. It is recommended that replacement chilled water pumps be provided with variable speed drives that modulate the pump motor speed based on demand. The variable speed control will make the installation compliant with the latest energy codes. In order to achieve variable speed control, the 3-way valves, located at each fan coil unit, will need to be replaced with 2-way control valves.</p>

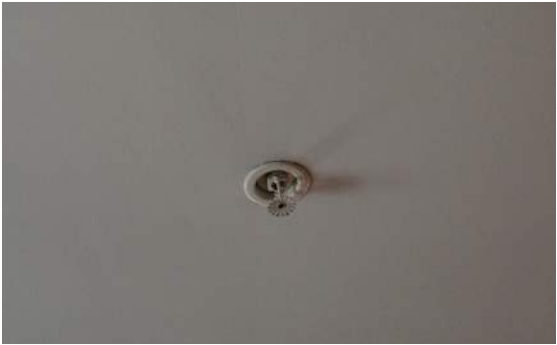
<p>Figure 234: Ceiling Sprinkler Head in North Wing, First Floor (BBB 2019)</p>

D40: FIRE PROTECTION				
Feature(s)	Location	Condition	Deficiency	Photo(s)
D4010 Sprinklers	All	Fair	Minor	
<p><i>Description:</i> The main water service to the Tavern is a 4" combination fire / water service. Refer to section D2021 for more information about the incoming service entrance pipe and accessories.</p> <p>The fire service main pipe routes near the floor of the cellar. Extending off of this 4" fire main is a wet-pipe sprinkler zone valve assembly and a dry pipe sprinkler zone valve assembly.</p> <p>The wet-pipe sprinkler zone valve assembly monitors and reports flow for the entire wet-pipe sprinkler system. The entire Tavern is protected by the wet-pipe sprinkler system, with the exception of the third floor.</p> <p>Two main wet-pipe sprinkler risers extend from the cellar to the occupied floors. Horizontal sprinkler piping routes below the ceiling of each space. The exposed sprinkler pipe generally routes along the exterior wall with side wall-style sprinkler heads connected directly to the pipe.</p>

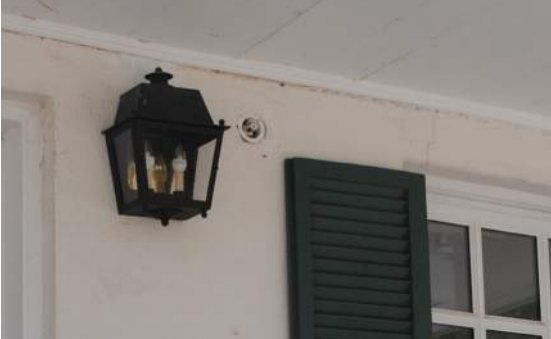
<p>Figure 235: Sprinkler Head on South Elevation (BBB 2019)</p>

D40: FIRE PROTECTION				
Feature(s)	Location	Condition	Deficiency	Photo(s)
D4010 Sprinklers	All	Fair	Minor	
<p>Dry, sidewall sprinkler heads also extend from the wet-pipe system to provide sprinkler protection along the covered porches of the Tavern.</p> <p>The main exhibit space on the ground floor has sufficient ceiling space, where horizontal sprinkler pipe is routed. Ceiling-mounted, pendant style sprinkler heads are used in the exhibit space.</p> <p>The majority of the sprinkler piping and heads are in good condition.</p> <p>The fire main in the cellar was exposed to the flood waters and requires cleaning and inspection for any damage.</p> <p>A dry pipe sprinkler assembly, consisting of a dry pipe system control valve and air compressor, taps off the fire main in the cellar. The dry pipe sprinkler system is used to protect the third floor of the Tavern.</p> <p>Recommendations: Piping exposed to the cellar flood should be cleaned and inspected for damage.</p>

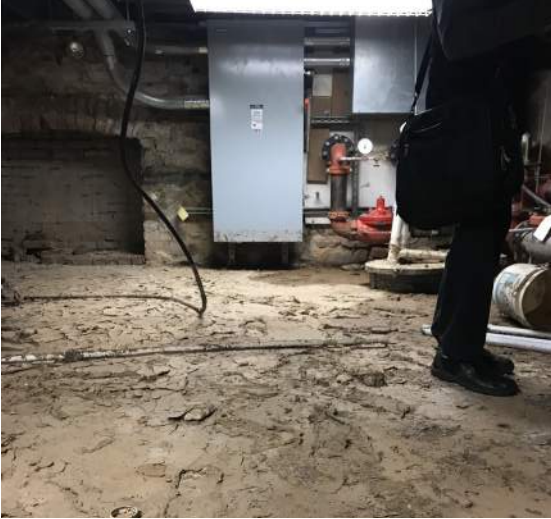
<p>Figure 236: Low Tension Service Entrance In Cellar (JPA 2019)</p>

D50: ELECTRICAL				
Feature(s)	Location	Condition	Deficiency	Photo(s)
D5010 Electrical Service & Distribution		Good	None	
<p>Description: The low tension (a.k.a. low voltage) service system serving the Tavern was installed with the 2007 renovation and consists of a single 400A, 120/208V, 3 phase, 4 wire underground feeder. This feeder originates from distribution panel MDP-1 located in the Pump House. The feeder terminates at a 3P-400A service disconnect switch located on the cellar level (Figure 236).</p> <p>The low tension distribution system serving the Tavern was installed with the 2007 renovation and consists of three branch circuit panelboards:</p> <ul style="list-style-type: none"> • Panelboard P1 – 3P-4W-120/208V-400A with 300A main circuit breaker. • Panelboard P2 – 3P-4W-120/208V-225A with 150A main circuit breaker. • Panelboard P2 – 3P-4W-120/208V-100A with 50A main circuit breaker. <p>Recommendations: Monitor and repair as necessary.</p>
