Chesapeake & Ohio Canal National Historical Park
Potomac, MD

Great Falls Tavern Historic Structure Report

Final Submission

July 2020

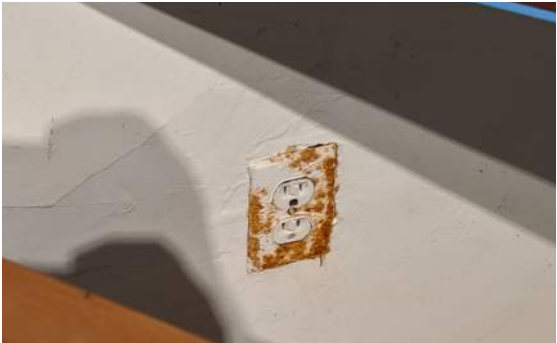
Figure 237: Corroded Receptacle in North Wing, First Floor (BBB 2019)

Description: Branch wiring devices in the Tavern includes wall mounted manual lighting control switches and receptacles. The age of the Branch Wiring Devices is unknown. Multiple receptacles in the north exhibit space are corroded (Figure 237).

Recommendations: All water damaged receptacles and conduit should be replaced. Consider replacing manual lighting switches with wall box type occupancy sensor for energy savings.

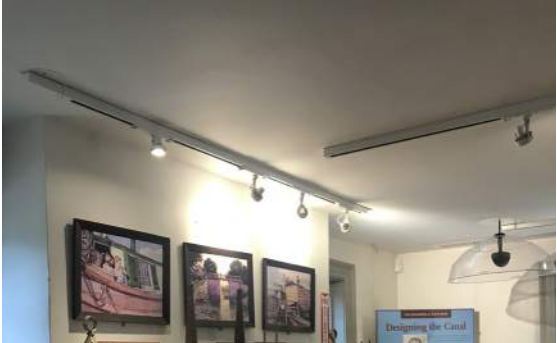
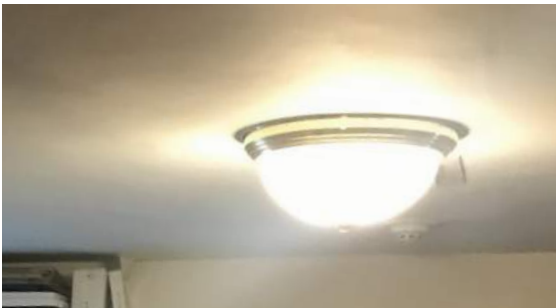
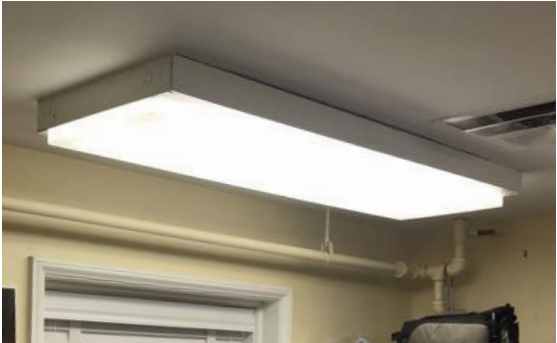
- Exhibit Areas - Incandescent track style spot lighting or surface mounted incandescent decorative fixtures (Figure 238)
- Offices - Ceiling mounted incandescent decorative fixtures or surface mounted architectural fluorescent fixtures with linear lamps (Figure 239 and Figure 240)
- Utility Spaces (e.g. cellar, third floor) - Surface mounted fluorescent utility style fixtures with linear lamps.

The lighting equipment in the third floor was installed with the 2007 renovation. The age of the remaining lighting equipment is unknown.

Recommendations: Consider replacing incandescent and fluorescent lamps with LED direct-fit replacements for energy savings.

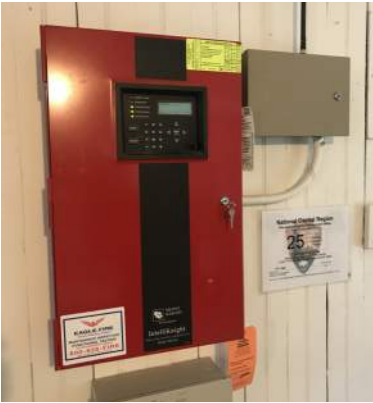
<p>Figure 241: Fire Alarm System. (JPA 2019)</p>
<p>Description: The fire alarm system serving the Tavern was installed in the 2007 renovation and is based on a Silent Knight Model 5820XL control panel. The system is an addressable type and consists of the control panel, a fire alarm annunciator panel, a cellular dialer, manual pull stations, audible/visual signaling devices, smoke detectors, heat detectors, sprinkler system flow switches, sprinkler system valve tamper switches, and monitoring modules. The control panel and cellular dialer are located in Room 203 (Figure 241).</p> <p>Recommendations: Monitor and repair as necessary.</p>				
D5038 Security and Detection Systems		Fair	Minor

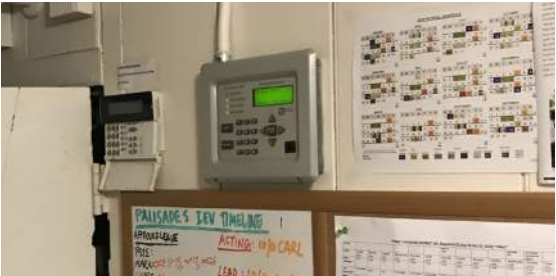
<p>Figure 242: Security and Detection System. (JPA 2019)</p>
<p>Description: The Security and detection system serving the Tavern was install prior to the 2007 renovation and is based on a Maxsys control panel manufactured by Digital Security Controls. The control keypad for the system is located in the entrance corridor of the office suite. The system configuration is unknown.</p> <p>Recommendations: Consider replacing the system in the next 10 years to avoid obsolescence.</p>

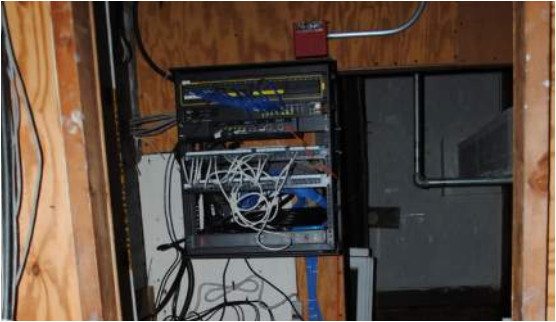
<p>Figure 243: Data Rack in Attic (BBB 2019)</p>
<p>Description: An Ethernet-style Local Area Network (LAN) serves the Tavern. The LAN was installed in 2012 and consists of a data rack (located in Room 302), data cabling, and data outlets. Data outlets are located throughout the facility.</p> <p>Recommendations: Monitor and repair as necessary.</p>

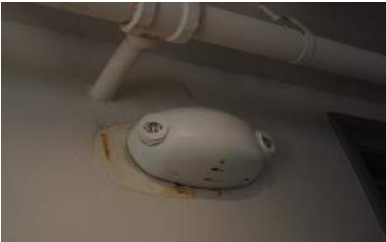
<p>Figure 244: Emergency Lighting. (BBB 2019)</p>
<p>Description: Emergency lighting in the Tavern is provided by wall mounted emergency battery units located throughout the facility. These unit were installed in the 2007 renovation.</p> <p>Recommendations: Monitor and repair as necessary.</p>
