CRATER LAKE NATIONAL PARK

Historic Structure Report & Rehabilitation Guidelines:

Employee Stone Houses #24, 25, 28, 30, 31, 32

Prepared by Patience Churchward
September 4, 2009

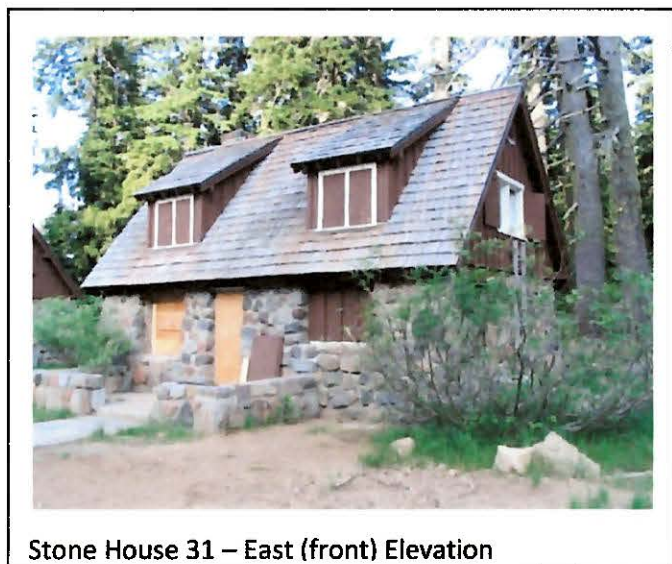
Stone House 31 – East (front) Elevation

The house was built in 1928 and is the located in the center of the row of three identical stone houses on the lower level. Several of the windows and both doors

have been removed for repair. The house is currently undergoing interior renovation to increase the thermal insulation value, resolve several deferred maintenance issues, and upgrade the overall livability. This renovation reflects the park's intentions to rehabilitate all of the 'stone houses' and will be used as a precedent for the rehabilitation planning of the five buildings.

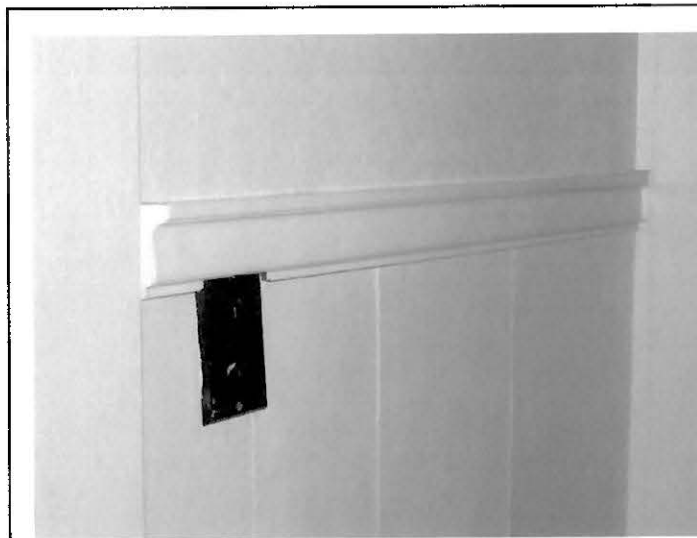
- **Knotty Pine** was installed as part of the 1939 renovations and likely still exists in some parts of the houses, such as the painted paneling in the kitchen of #30. The drawings indicating this aesthetic addition do not specify whether or not to paint the knotty pine, but by the detailed illustration of the wood grain, it can be presumed that William G. Carnes, Chief of Planning in 1938, intended for the wood to be left unpainted.

Knotty pine still exists in the kitchen, with celotex fiberboard above. The knotty pine has been painted since its installation. The picture mould, H-1010, is still in production and can be found at local lumber stores.

- **Celotex Fiberboard** was specified in the original drawings for the 30s series stone houses and is still evident in some of the kitchens. **Homasote** is a sustainable alternative to celotex. Made primarily of 100% recycled paper, this product has very high insular qualities, moisture, fungal, and insect resistance, and can be painted as a surface

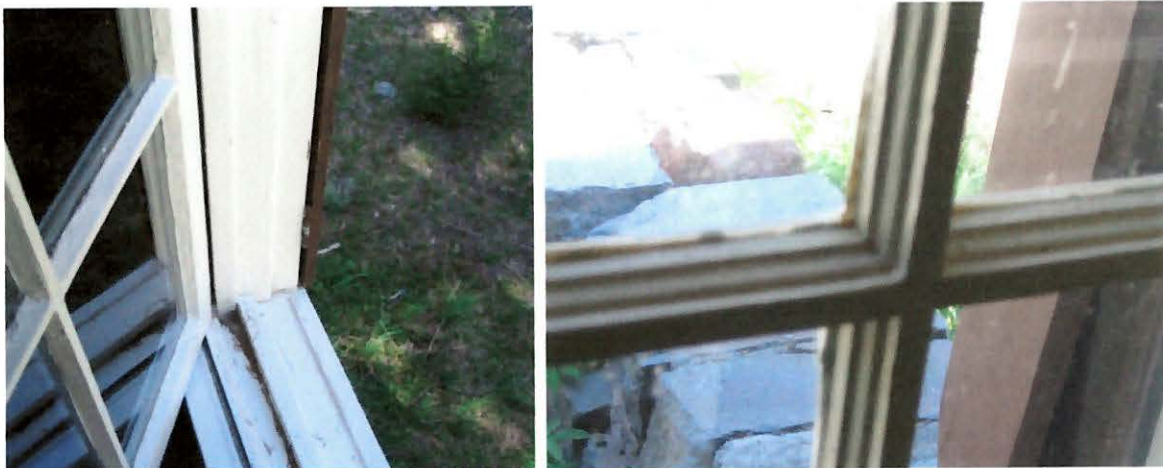
The window frame is composed of several members and all details should be carefully noted and reproduced if windows are rebuilt

Secretary of the Interior's Standards for Rehabilitation. For now, it is important to recognize the reversibility (or lack there of) of replacing character-defining historic windows. If the windows are severely deteriorated and must be replaced, it is important to be detail-oriented in several aspects of design. Smith recommends that "the new windows, of either wood or metal, should closely match the historic windows in size, number of panes, muntin shape, frame, color and reflective qualities of the glass." Regardless, any solution in the stone houses must be compatible with the original wood or steel windows. See the *Winterizing* section for recommendations on shutters and storm windows. For House #31, the wood casements were repaired and the wood window frames were rebuilt for added structural support, especially in the dormers. It is recommended that this practice continue for the wood windows. The steel casements in the 20s series are to be repaired and preserved as well.

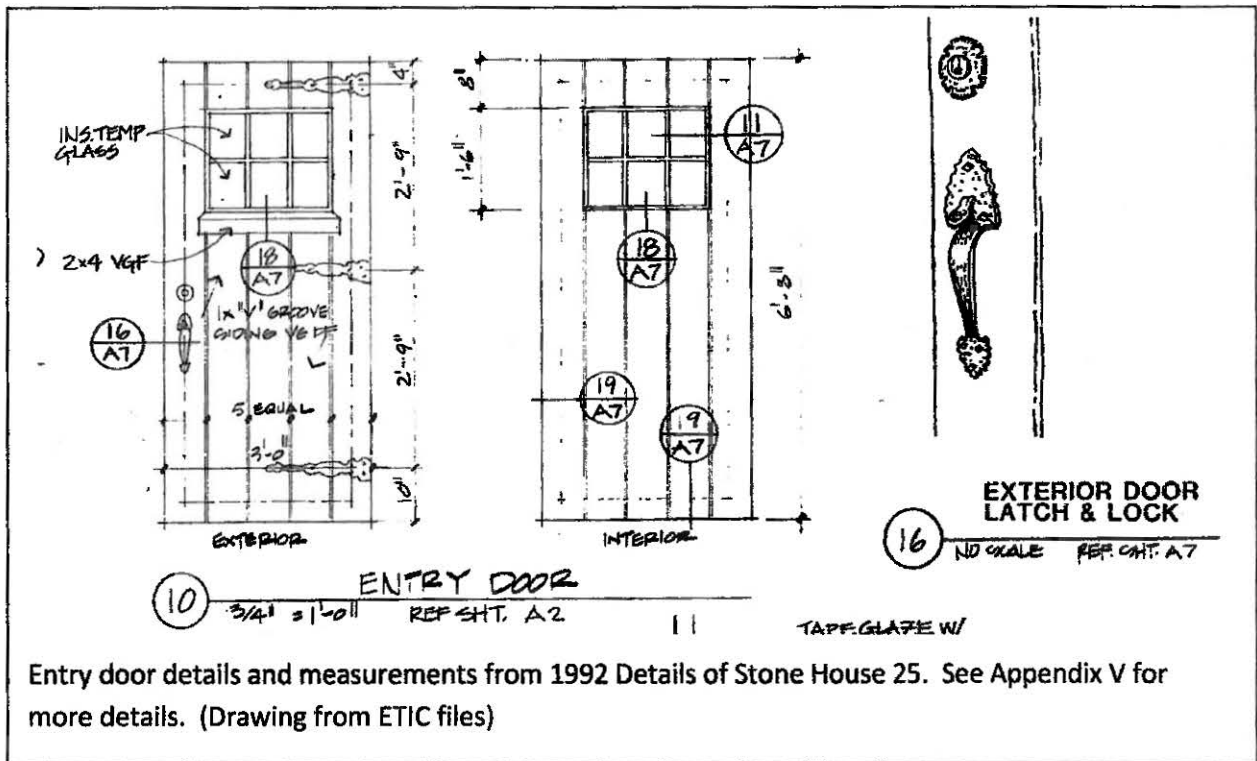
Entry door details and measurements from 1992 Details of Stone House 25. See Appendix V for more details. (Drawing from ETIC files)

- If the doors are to be replaced as part of the rehabilitation, a reconstruction of the character-defining historic doors with the iron strap hinges would tremendously improve the buildings’ architectural integrity. This replacement can also be justified by improving insulation, using long-lasting materials, and valuing high quality craftsmanship. One window, like on the main doors on Houses 19 and 20, might be sufficient.

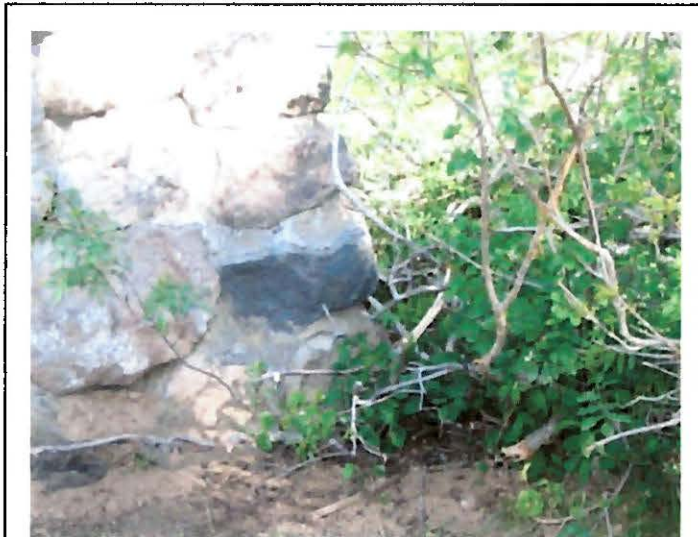
Sorbus sitchensis (**Mountain Ash**) is planted in close proximity to all six stone houses. Several of these landscape shrubs are overgrown and crowd the houses, trapping moisture, creating rodent habitat, and the encroaching root systems could potentially compromise the building structure. Roots were found on the inside of the foundation of House #31 during its crawlspace excavation. The Mountain Ash, however, is one of few surviving species from the original landscape design that park specialists are currently working to restore. These shrubs were planted over seventy years ago at the corners of the buildings to aid the rustic architecture style by creating an illusion that the stone houses emerge from the landscape.

Mountain Ash tightly planted against stone base

Currently, the plants appear to have grown larger than what was intended and should be pruned to a smaller size. Overall, careful consideration should be taken to determine a solution that protects and preserves both the historic fabric of the buildings and of the landscape design. Some options include:

- Prune the shrub to no more than 3-foot tall and wide.
- Prune the roots to limit the sub-surface threats to the structure.
- Re-plant the shrubs at a farther distance (three to five feet) from buildings as opposed to their current placement right next to the stone cladding.

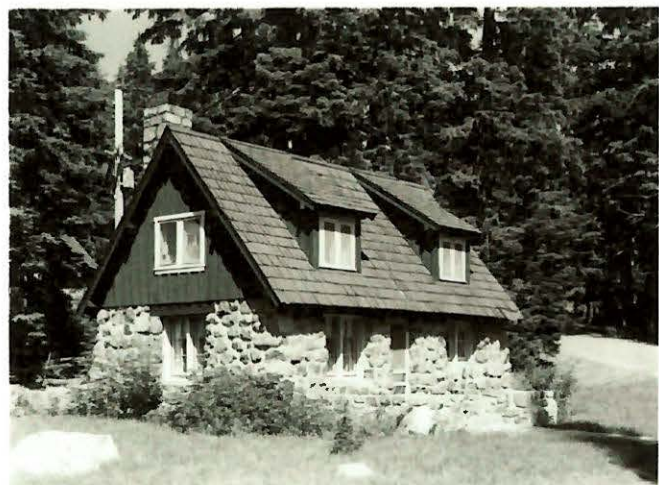
Historic photo showing shrubs at approximately three feet tall and wide (CRLA Museum & Archives)
