# Redwood Preservation at Scotty's Castle Death Valley National Park

School of Engineering, University of Vermont  
Cooperative Agreement No: H8W07060001  
Task Agreement No: J8W07070030

## Redwood Preservation at Scotty's Castle, Death Valley National Park

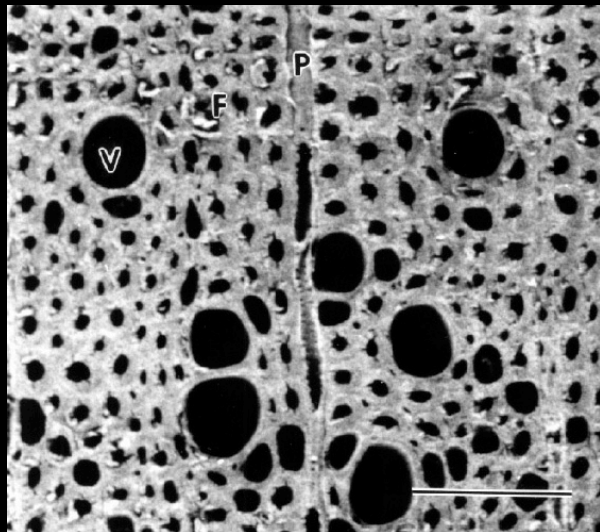
Healthy cell structure

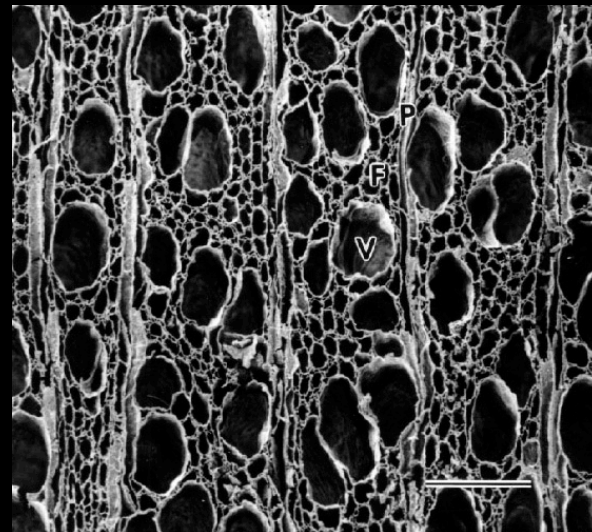
Weathering of wood is characterized by chromophoric (color) changes at the surface.

As the lignin is changed by exposure to light, the chemical byproducts are chemically unstable and dissolve readily in water.

Small amounts of water are enough to wash away the deterioration products on the surface, exposing new wood to light so that the process continues.

Weathered & deteriorated  
cell structure

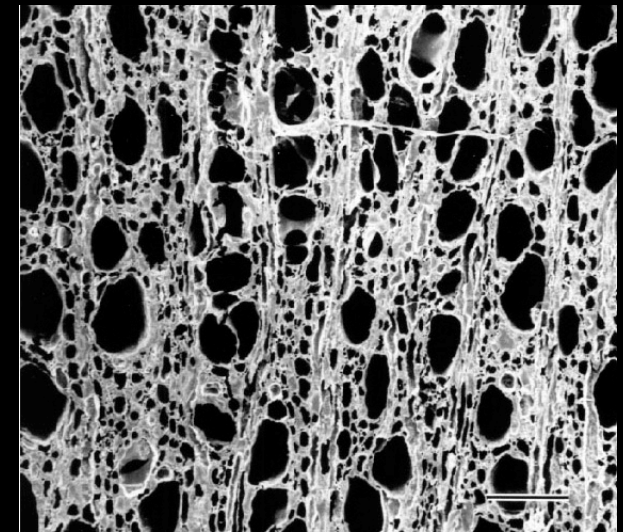
Consolidated with B-98

Ultimately, B-98 became the consolidant of choice due to its known performance properties.

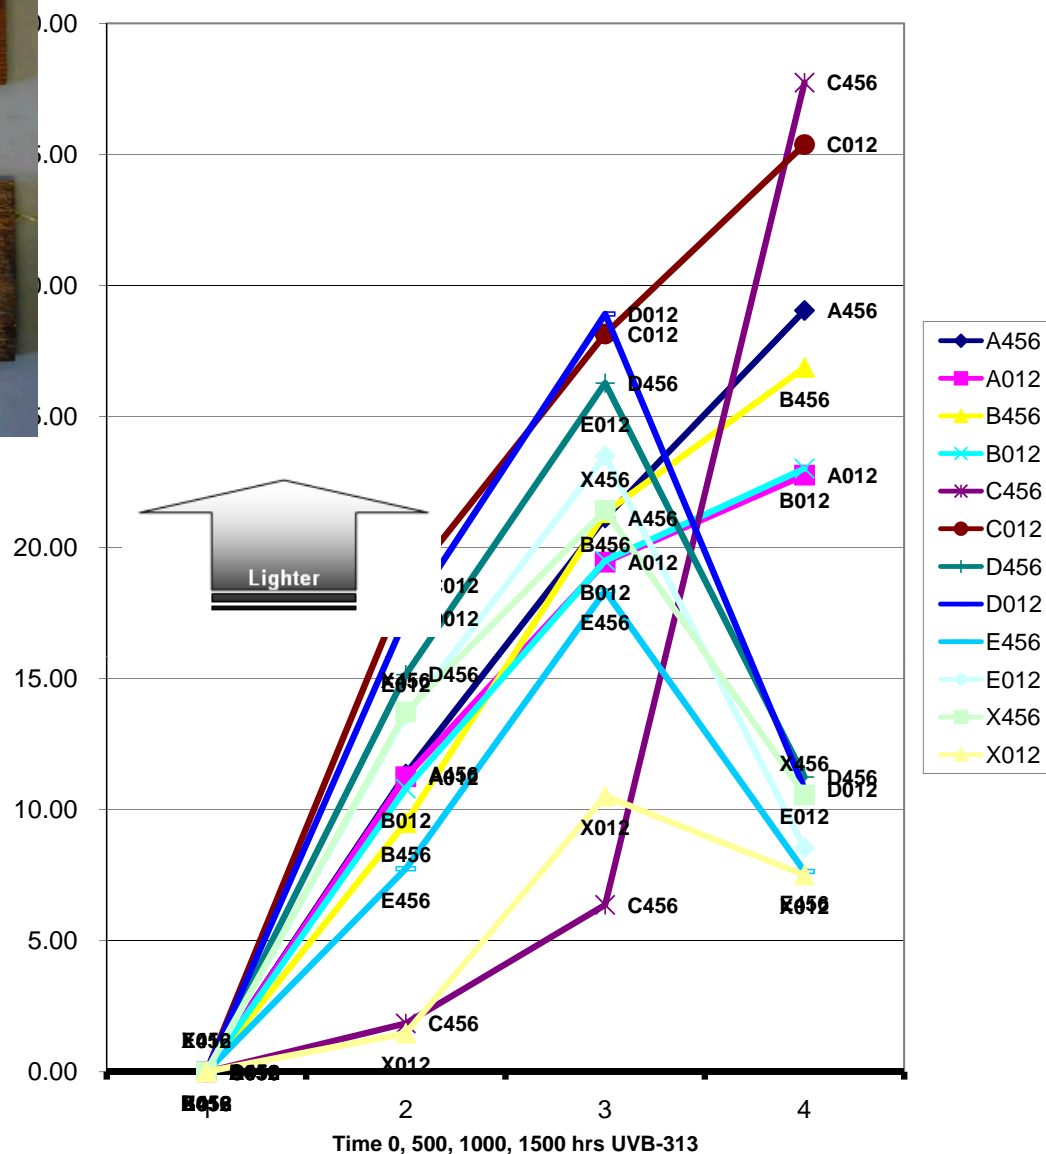
### PRE-WEATHERED %Change dL

A number of finishes were subjected to natural and accelerated weathering. While all provided some level of light protection, B-98, amended with a UVA / HALS blend, was one of the highest performers.
