HISTORIC STRUCTURE REPORT

DE REMER HOUSE

Delaware Water Gap National Recreation Area

March, 1994

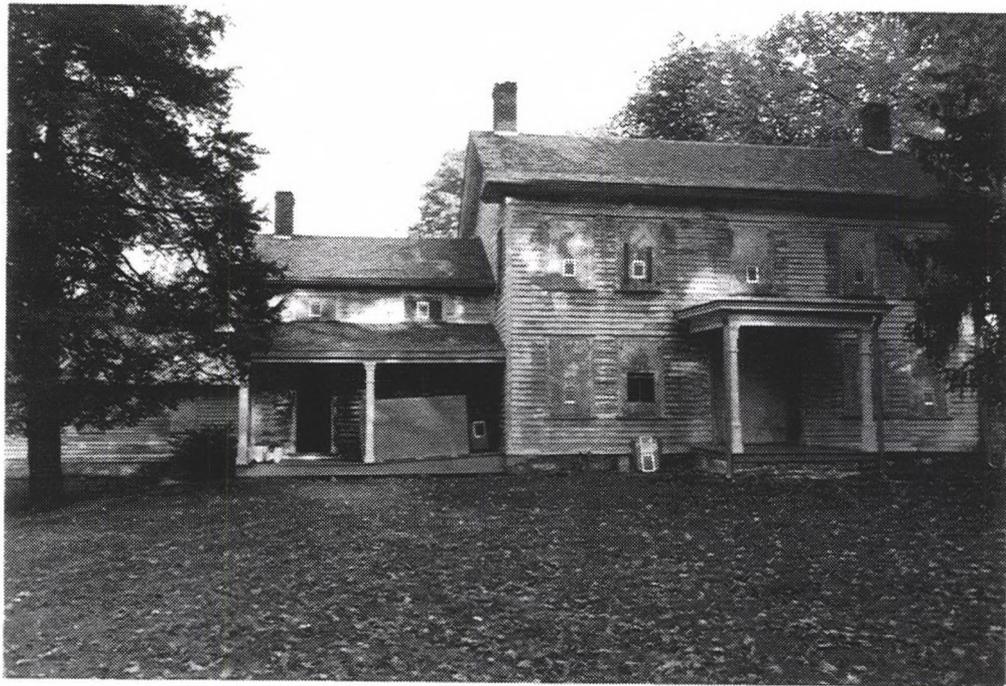
FIG. 1

East Elevation

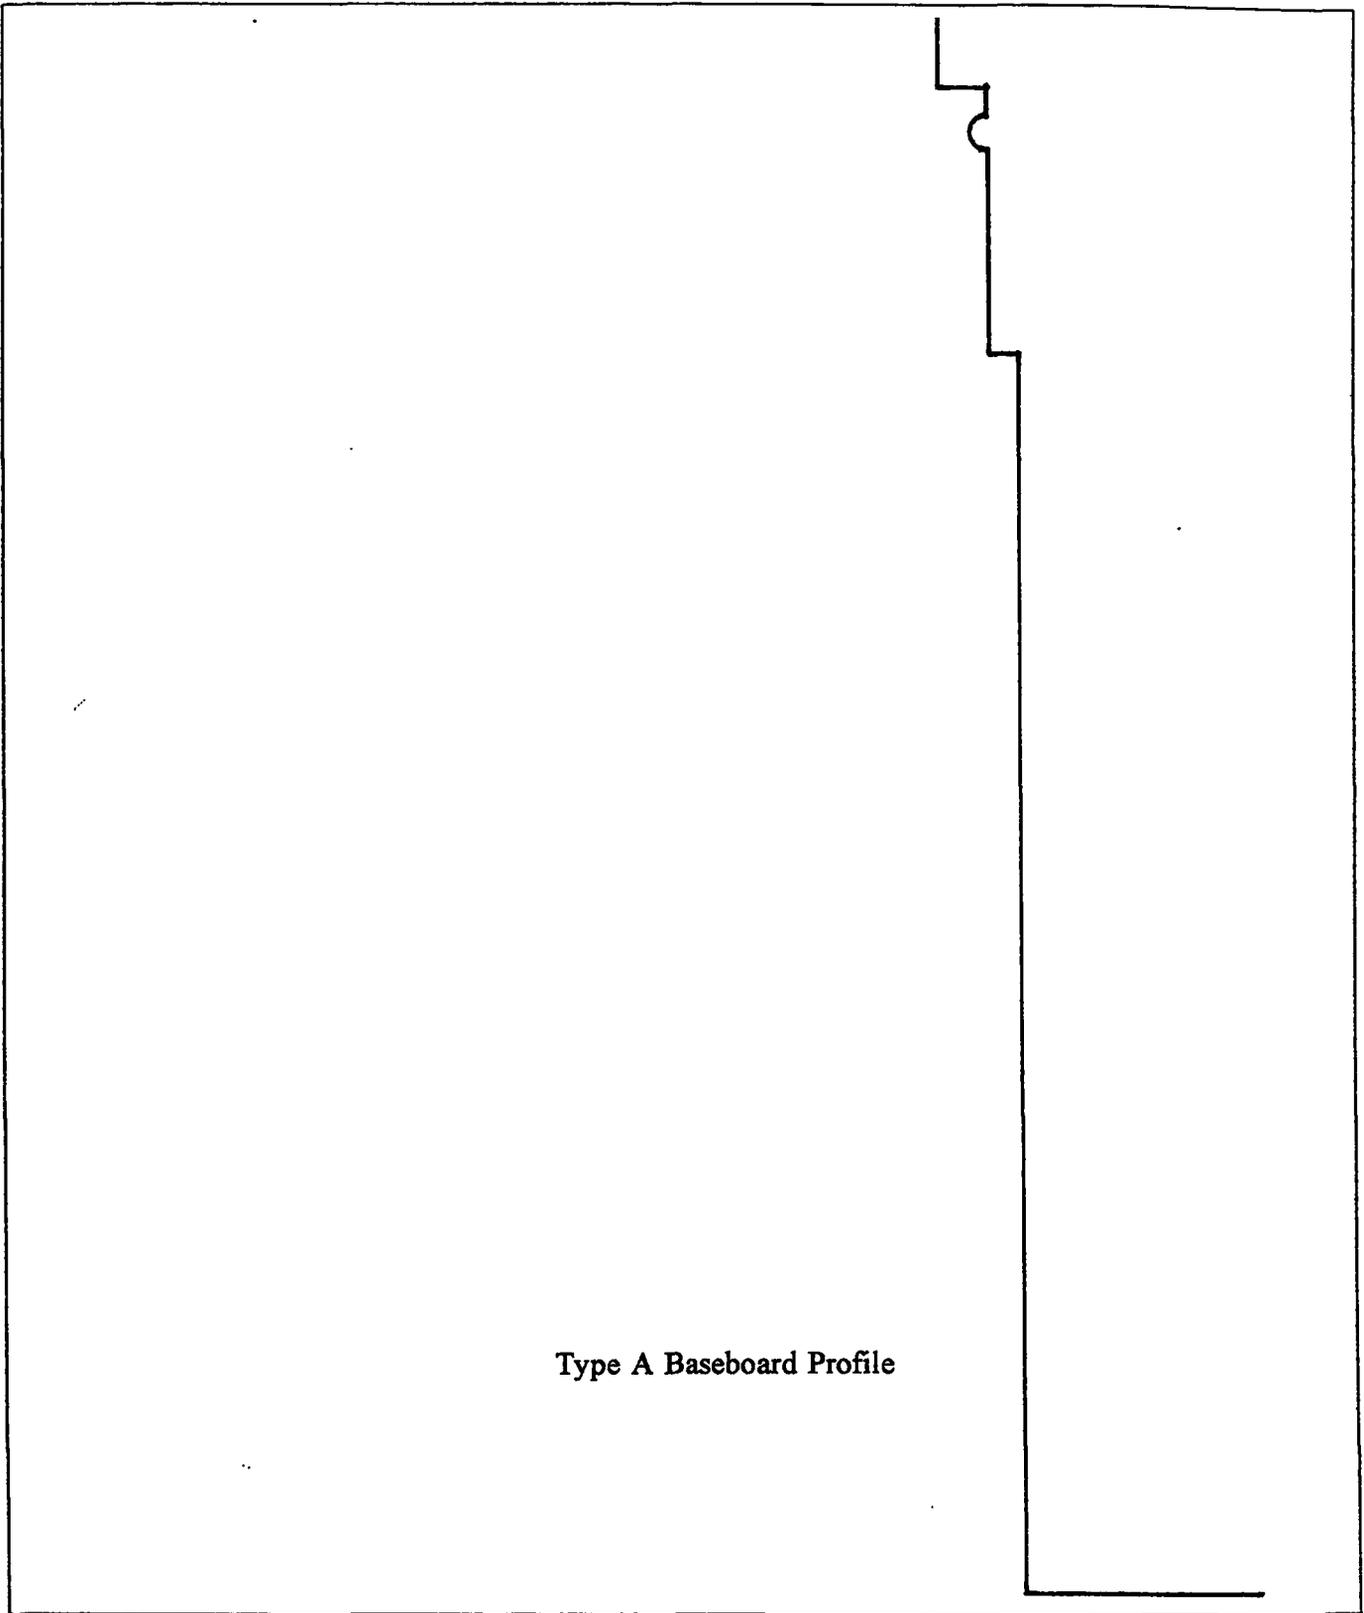
FIG. 9.

Description: * Painted wood, baseboard approximately 10-1/4" high. (See Figure #9).

Type A Baseboard Profile

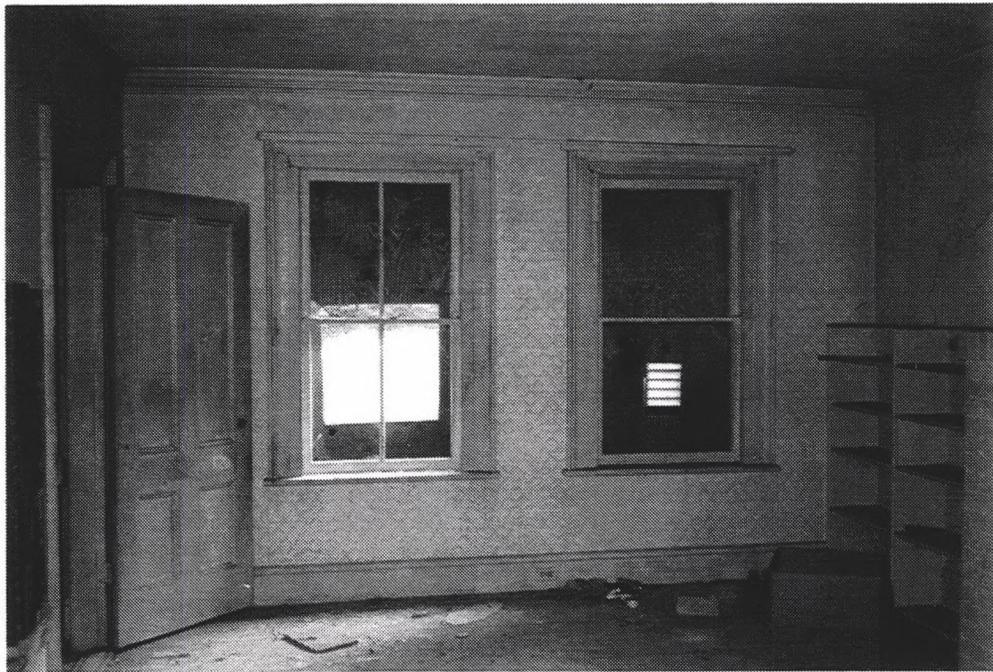
FIG. 15

Description: * The windows are painted, 2/2, double hung units. (See Figure #15). They measure approximately 32"w x 62"h. Their sills are 25" above finished floor.

Room #103; Note Wood, Double Hung Windows

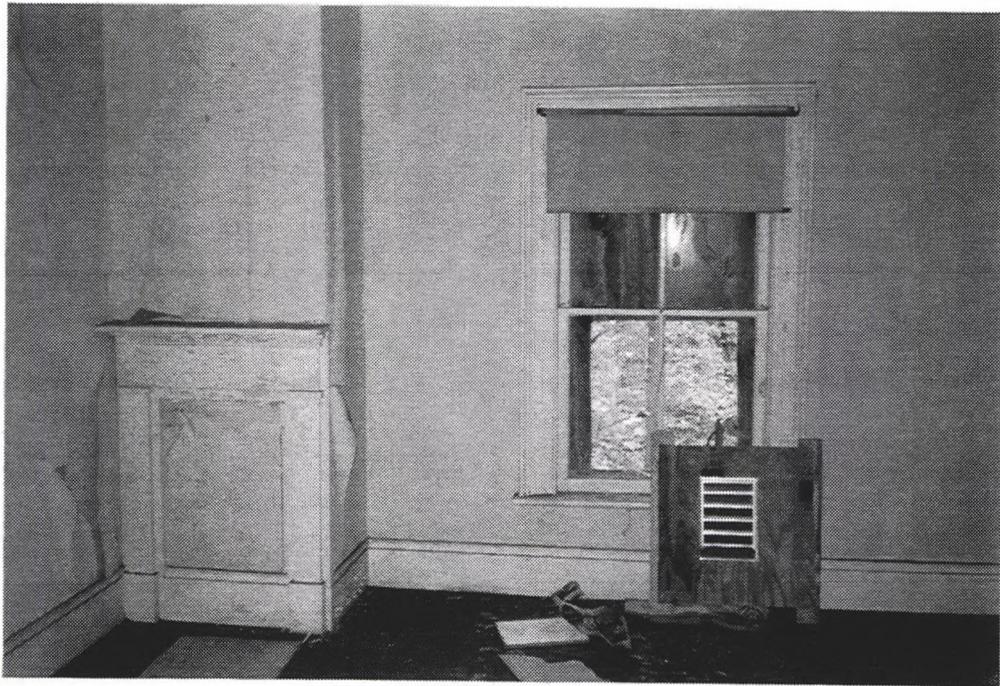
FIG. 23

Description: * There are three 2/2 pegged wood windows (sash Type A), which probably date from the original construction of the room. Windows never had meeting rail latches or pulley cords (See Figure #23).

Room #201; North Wall, Window Sash Type A

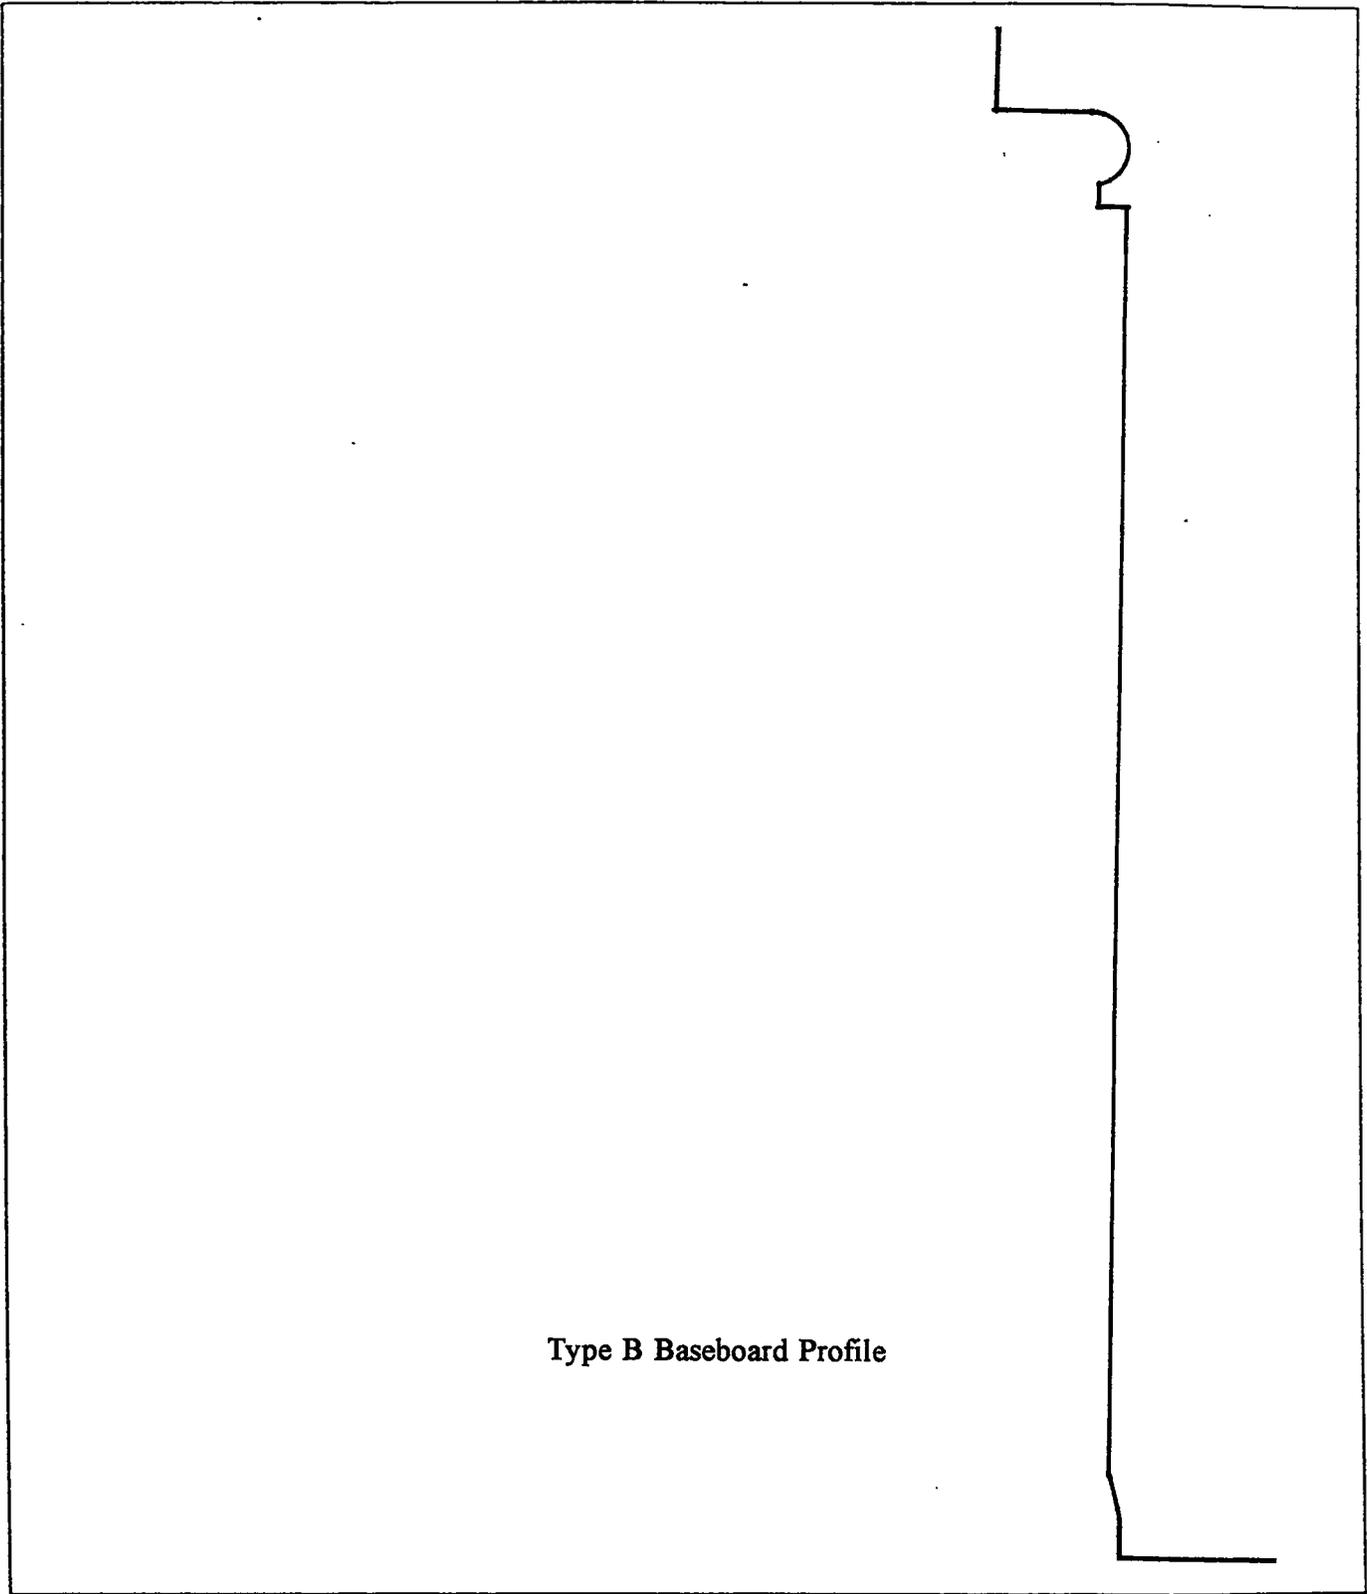
FIG. 24

Description: * Painted wooden baseboard Type B profile. (See Figure #24).

Type B Baseboard Profile

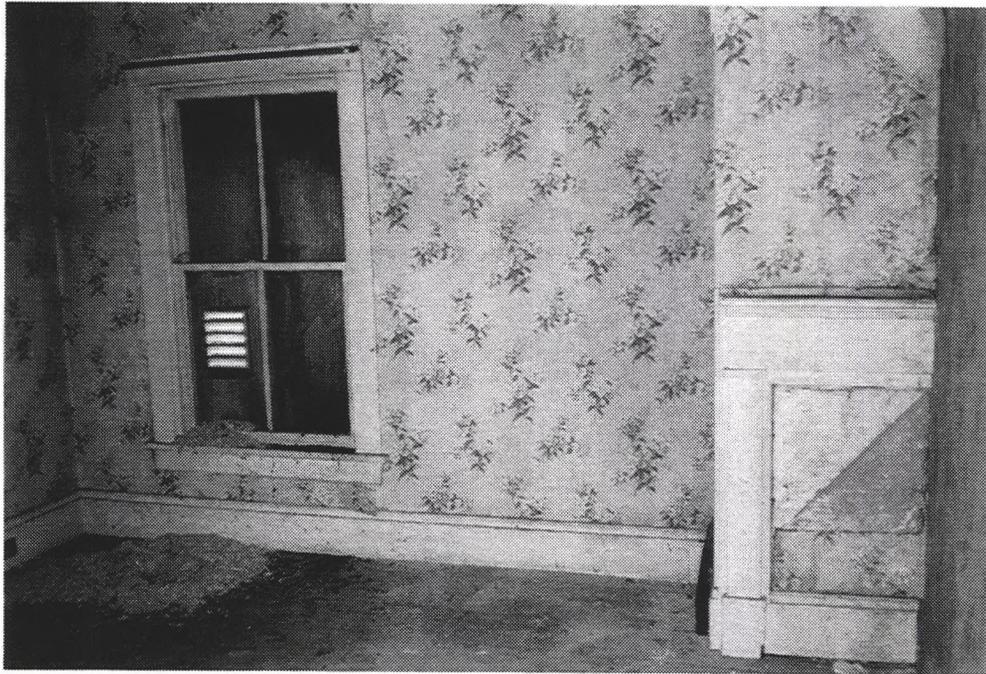
FIG. 27

Description: * Half on wood mantel in southwest corner (See Figure #27). Mantel matches the one in Room #201. Although there is no hole for stove evident, undoubtedly would have had a stove, as this was never a working fireplace. Original baseboard continues along base of "opening" which is filled with plaster on lath. Mantel is 2'-1/2" x 3'-8". On the east side of flue stack is a 15" x 13" cast iron radiator grille.
Condition: Painted finish on mantel is deteriorated.

Room #104; South Wall, Type B Window Sash

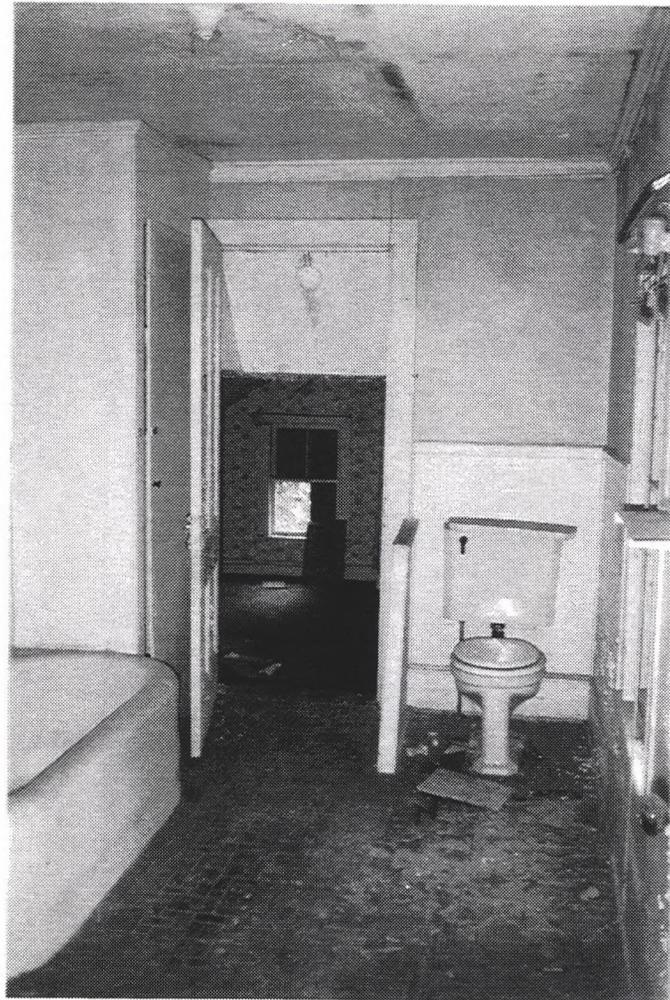
FIG. 28

Description: Painted plaster with "tile" board to 3'-9-1/2" chair rail. Board is trimmed above base and around window and doors with 1/2" molding. (See Figure #28).

Room #205; Bathroom

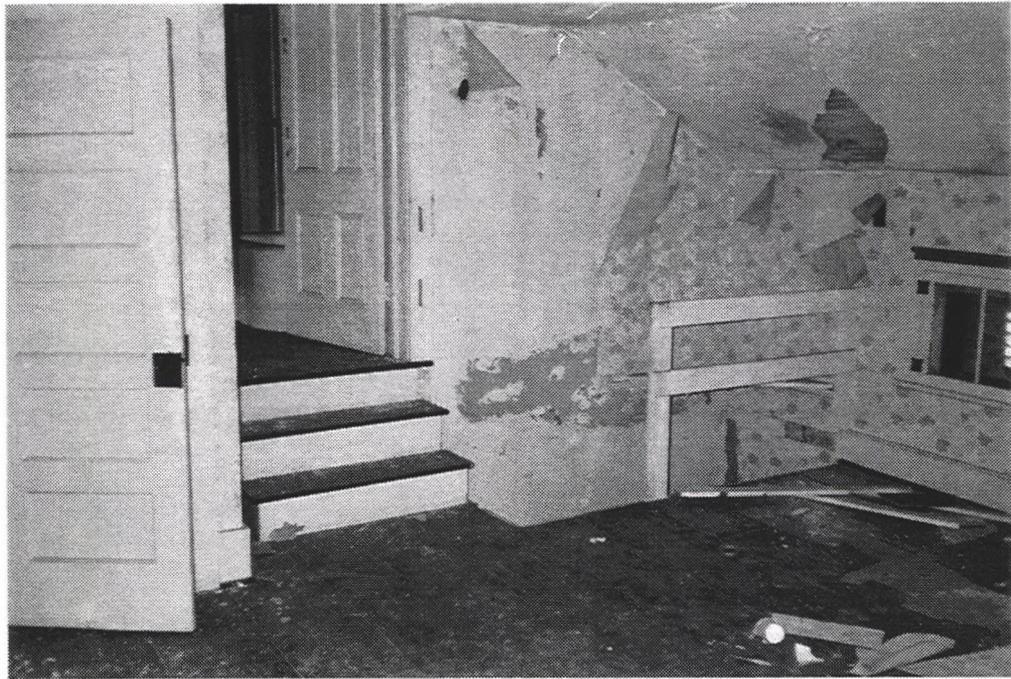
FIG. 29

Description: Paper over paint over plaster over lath. (See Figure #29).

Room #206; Bedroom

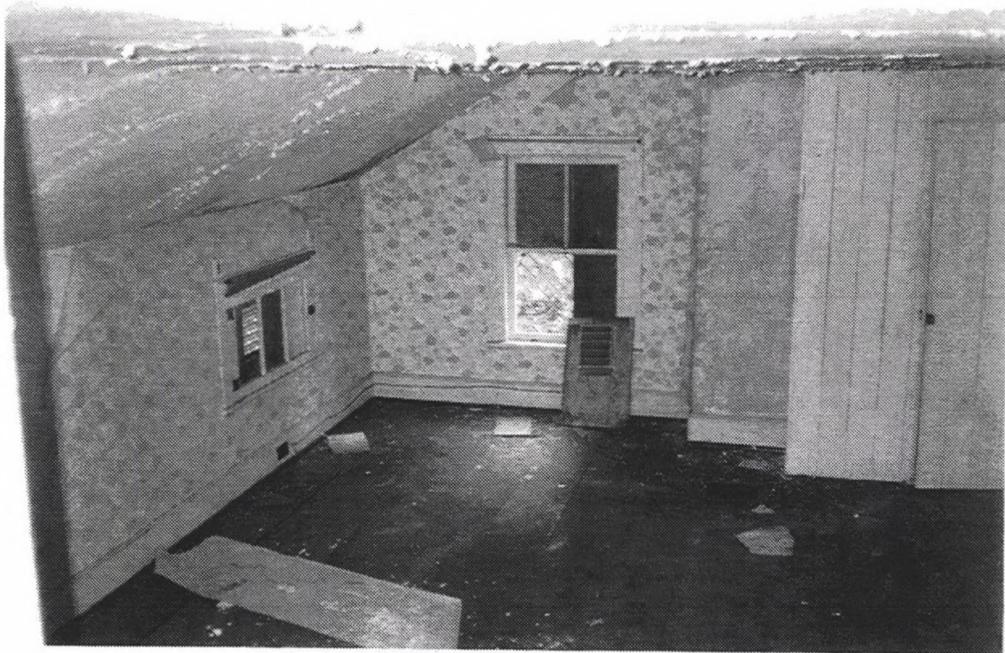
FIG. 30

Description: * Two side hinged wood pegged windows. 2'-10" x 1"-8-
1/2" (See Figure #30). Sash have three divided lites.
Hinges are 2-1/2" high. Hinges and knobs appear newer
than sash. Muntins unlike others in house.
Condition: Painted finish is deteriorated, glazing broken, muntin
broken in one sash, hardware finish is pitted.

Room #206; Eyebrow Window on Left
