HISTORIC STRUCTURE REPORT

**THE
RUNDLE FARMHOUSE**

**Walpack Township,
Sussex County, New Jersey**

1994

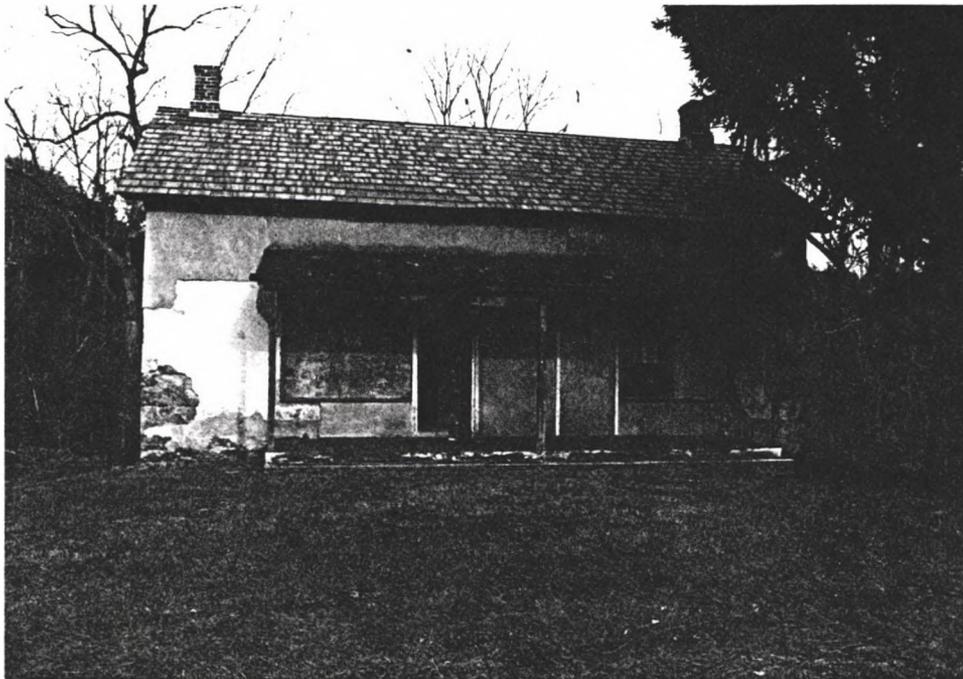
The original portion of the building is a simple, four-bay, single-pen structure, constructed of semi-dressed fieldstone, stuccoed on the front elevation. The gable roof is covered with slates, interior brick chimneys are located at the east and west ends, and a shed-roofed porch shelters two-thirds of the front elevation. Paired, 2/2 windows, located on either side of these doors are a later modification; in all likelihood they replaced single 6/6 vertical sliding sash. A stone located at the peak of the west gable is inscribed "1844" (*Photos 3 & 4*).

Photo 3. Front elevation.

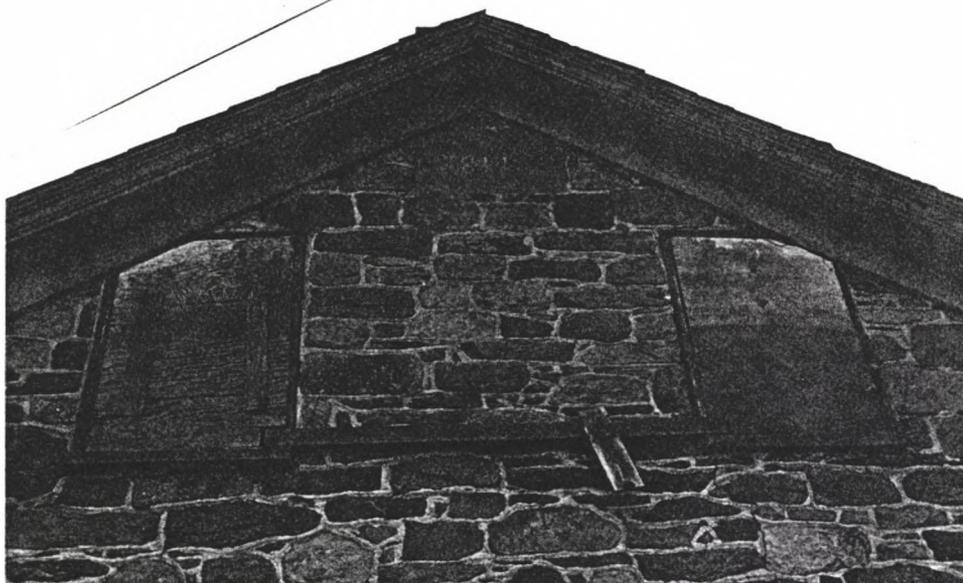
Photo 4. Date stone and second level windows in west gable.

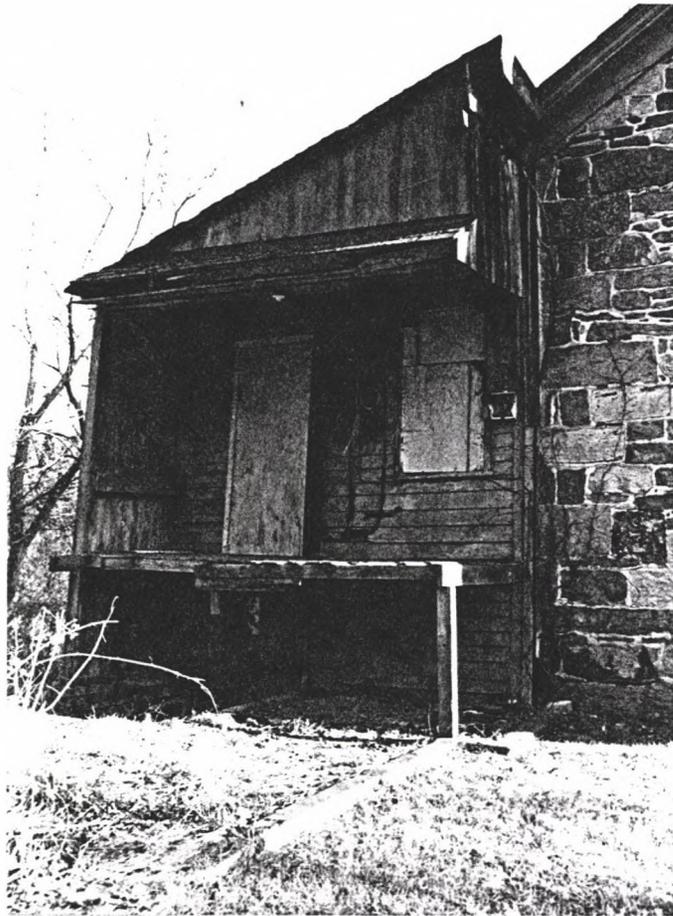
The walls of the rear extension are finished with beveled siding, with exposures varying from $4\frac{3}{4}$ " to $6\frac{1}{2}$ ". The uppermost, reciprocally-sawn boards are secured with cut nails; those closer to the ground are secured with wire nails, indicating that earlier material has been replaced. At the west end of the rear addition, enclosing the north side of the small porch, are vertical boards, extending from the top of the stone foundation to the eaves. Much of the siding at the rear of the house has rotted or is missing entirely, leaving the interior lath exposed. On the east elevation vines have grown around the boards into the interior of the house (*Photo 8*). The material on the west side of the house is in slightly better condition, as the siding is protected by the broad overhang of the porch.

Photo 6. West side of frame addition. Note ghost of original stair below platform.

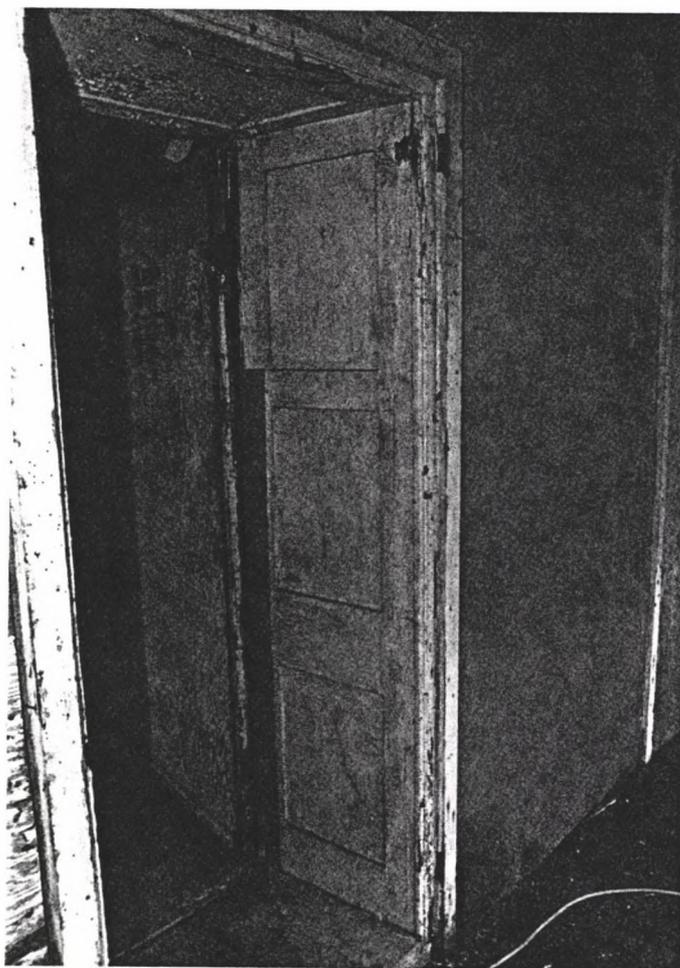
Because of the thick masonry construction, both of the front doors at the Rundle House are set in 2'-0" deep reveals, which are lined with unmoulded panels; a half-inch bead occurs at the juncture of the door reveal and the exterior wall (*Photo 9*). An original door with three pairs of equally-sized panels, trimmed with edge mouldings on the exterior face, is located at the entry to the keeping room. This narrow door has been altered by the addition of glazing in the top two panels. Currently leaning against the west wall of the parlor, the second front door is a 20th Century

Photo 9. Paneled reveal at front door.

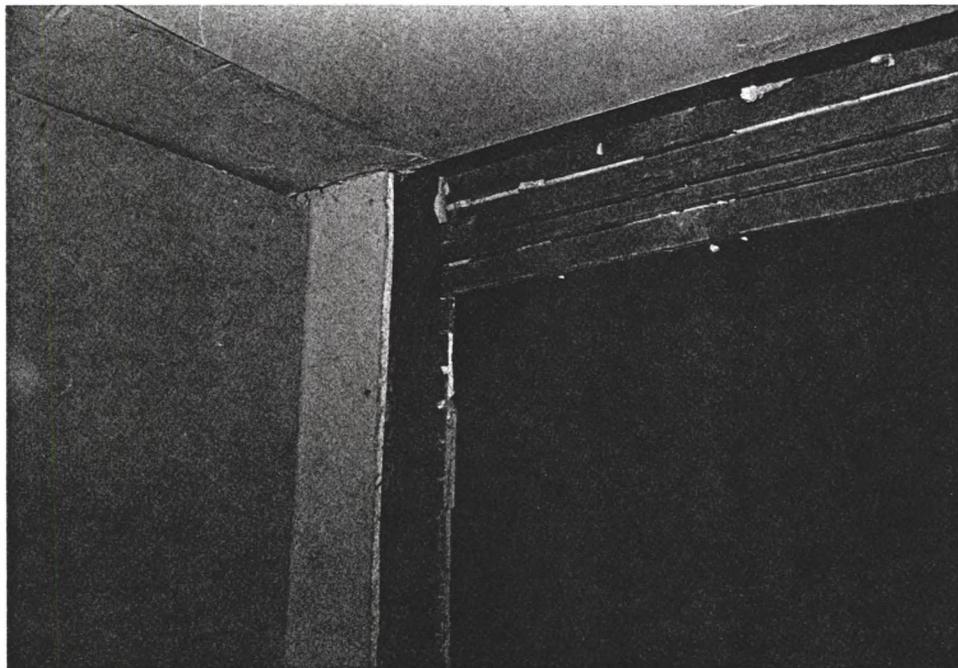
was constructed during the 1960's, in the southwest corner of the main bedroom. Shortly before the house was vacated, two doorways were cut into interior partitions and a partition was added, creating a hallway from the master bedroom to the bathroom (*Photo 11*).

Photo 11. Doorway created between wall studs on second floor.

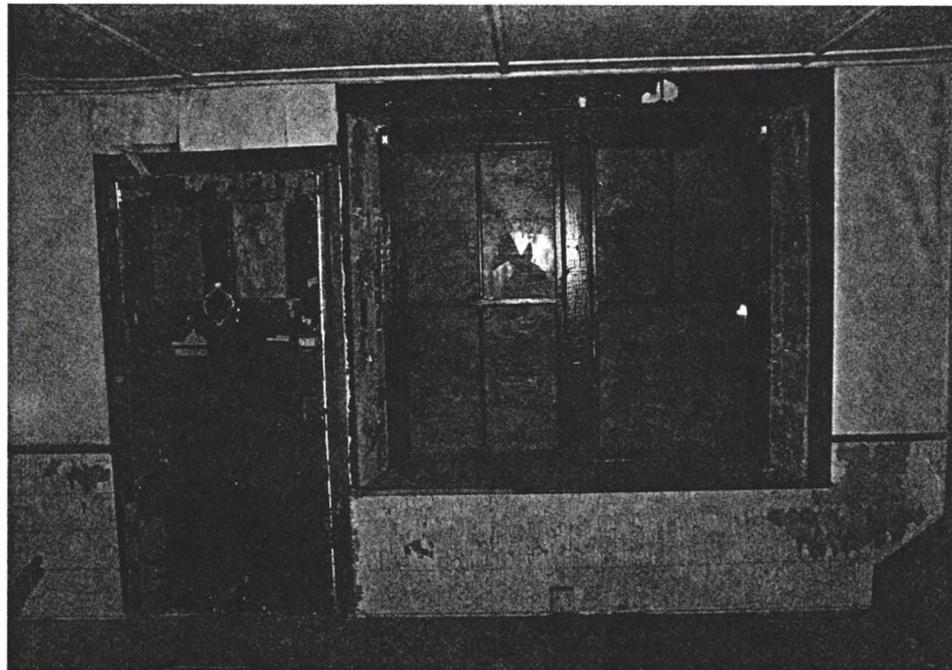
Photo 13. South wall of keeping room. Note beaded board wainscot with dado rail, paired 2/2 windows and original six-panel door.

The interior walls and ceilings of the original house were covered with plaster on circular sawn lath, except in the keeping room where beaded board wainscotting was applied to the walls (*Photo 13*). A similar beaded board dado is also found in the basement kitchen of the frame addition. In most rooms the plaster walls have been covered with gypsum board and the ceilings have been sheathed in gypsum board, plywood or beaded ceiling boards. Because very little of the plaster is visible, it is impossible to assess the condition and extent of the original material. A study of the original fabric, including analysis of the paints and extant wall-papers must be conducted before undertaking restoration. Future plans for the keeping rooms must include the restoration of the wood wainscot, and in all areas where the plaster is largely intact, the original fabric should be retained.

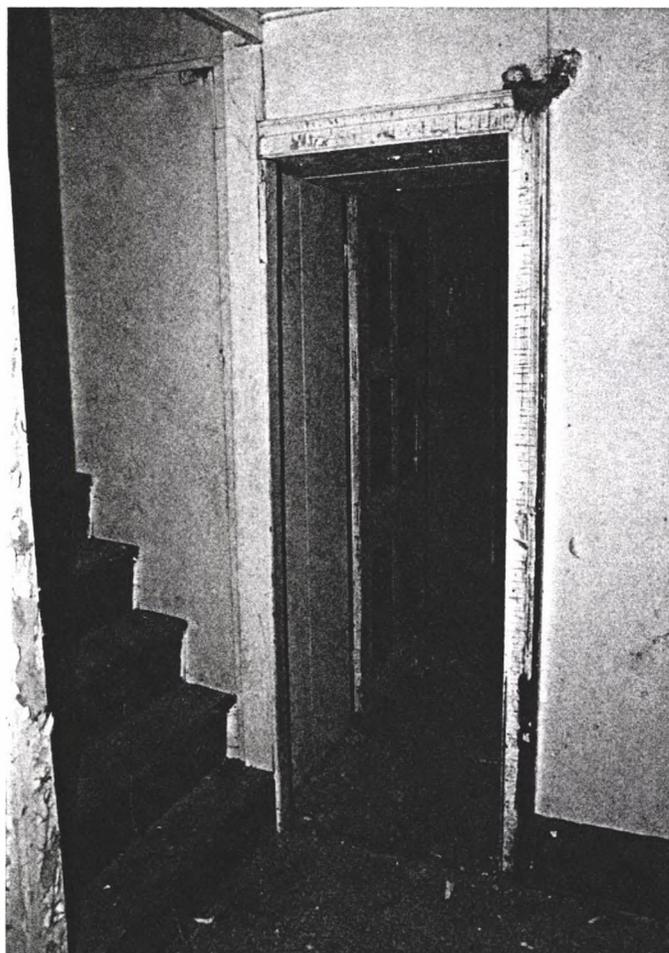
During the construction of the frame addition, three of the original windows on the north side of the house were converted to interior doorways; two of these were located at the first floor and the third was at the east end of the basement. In Room 1-3 on the first floor is a six-panel door which may have been relocated from between the keeping room and the parlor (*Photo 14*). The single-panel door to Room 1-5 dates to approximately the 1930's. Both of the doors adjoining Rooms 1-3, 1-4 and 1-5 are missing. Although the architrave of the parlor door is ornamented with a quirk ogee moulding, the remaining casings are not decorated.

Photo 14. Six-panel door at location of original window, and parlor stair, added during the 1940's.

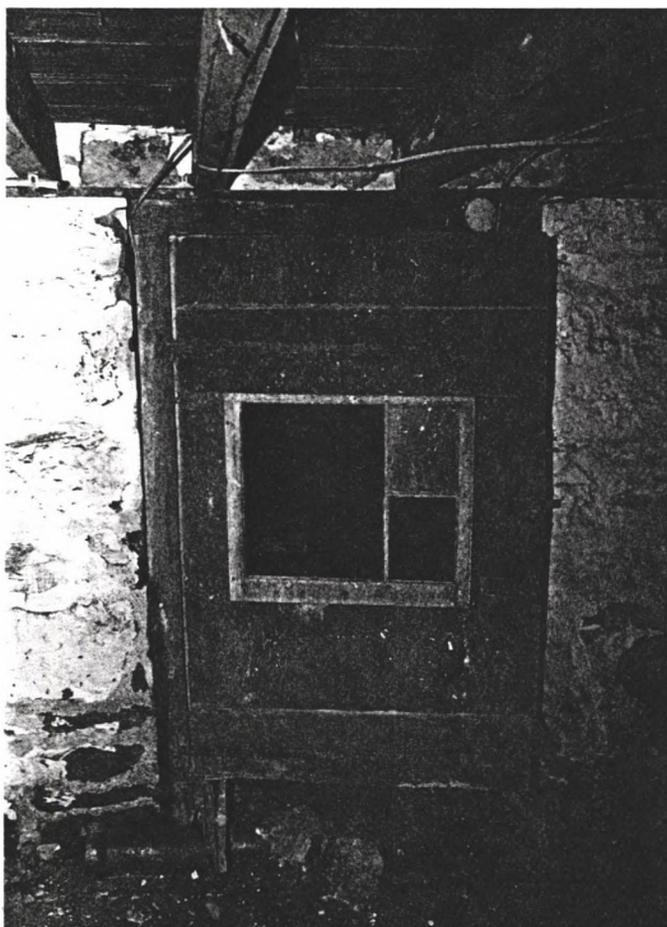
The original exterior door that was located at the basement level of the rear elevation, is now an interior door connecting Rooms B-1 and B-4. Rustic and worn, this 3'-6" wide, board and batten door appears to be one of the oldest elements of the house. The narrow chamfers of the cut-nailed battens match those on the door between Rooms 2-1 and 2-2, and the unadorned, unpainted, 3³/₄" casing is pegged together. Hung on 2'-5" strap hinges which are mounted on pintles, this door opens by means of a rusty Suffolk latch with spade-shaped cusps. The thumb latch penetrates below the cusp and the opposite side is curved down, both of which are later improvements to this style of hardware (*Photo 15*).

Photo 15. Now separating two rooms of the basement, this was originally an exterior door. Note strap hinges, pintles and Suffolk latch.

All of the six-panel doors and the board and batten doors date to the earliest years of the Rundle House and must be retained. If the original second floor plan is restored, the six-panel door that separates the bathroom from the make-shift hallway should be removed and, if not too greatly damaged, reused at another location. As explained, this was probably the original east front door, and constitutes valuable historic fabric.

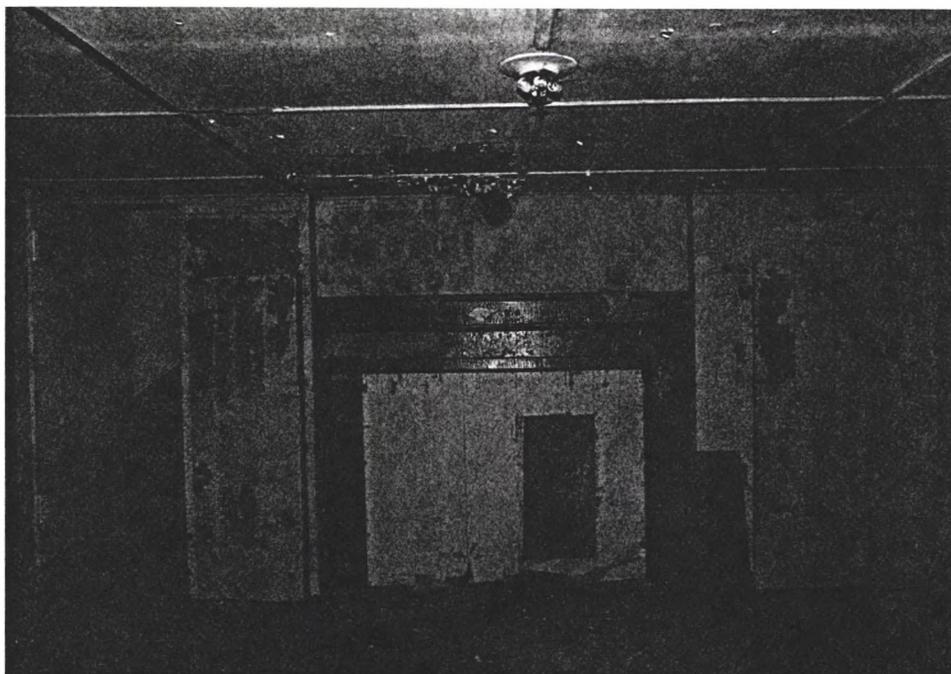
Four fireplaces are located in this house, three in the original portion, and one in the rear addition. The largest and most important of these occurs in the original keeping room, where the stone chimney breast is ornamented with an austere, but well-proportioned mantelpiece. Originally, this was the cooking fireplace for the house, as evidenced by the eye for a crane embedded in the north side. After the rear extension was added, this fireplace opening was closed with vertical beaded board paneling, and the cooking operations were relocated to the lower floor of the new addition. A stove, vented into the flue, was later used to heat the keeping room (*Photo 16*).

Photo 16. West wall of keeping room with mantelpiece. Closet door is on right, doors to stairs on left.

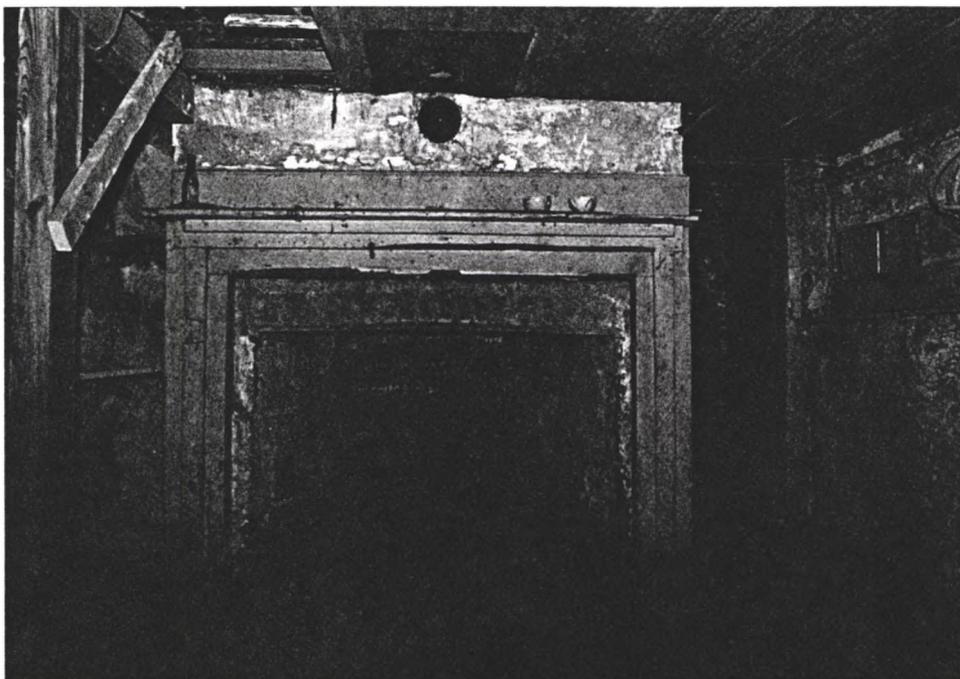
Photo 17. Basement cooking fireplace. Note horizontal stones of fireback.

The stone fireplace in the basement of the frame extension displays a tall, vernacular mantelpiece, and a fireback that is constructed of five long, horizontal stones, stacked one above the other. This, the only other operable fireplace in the house, was also used for cooking and a crane eye is set in a mortar joint at the right side of the firebox (*Photo 17*).

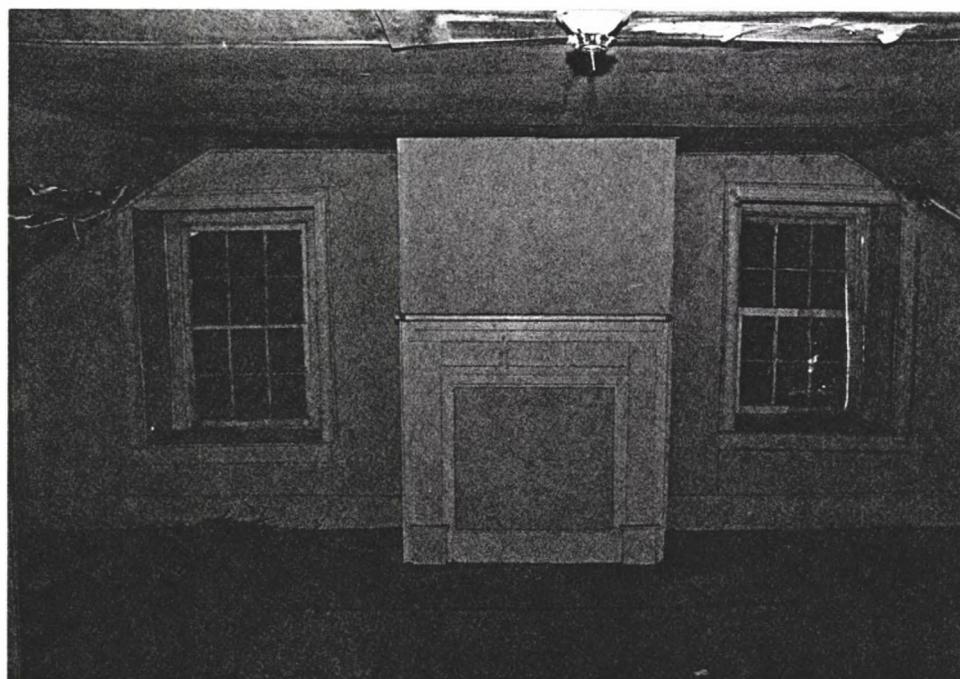
Photo 18. Mantelpiece in second floor bedroom.

The two remaining mantelpieces, located in the parlor and main chamber, were strictly ornamental; these rooms were heated with stoves which were vented directly into the chimney stack. Unfortunately, the mantelpiece is missing from the parlor; however, a photograph was located, and is included in Appendix C. This mantle appears to have been fashioned in the Greek Revival style, and although more elaborate than the remaining trim, remains highly vernacular in style and execution. In the east bedchamber, a simple mantelpiece with three un moulded panels decorates the chimney breast (*Photo 18*).

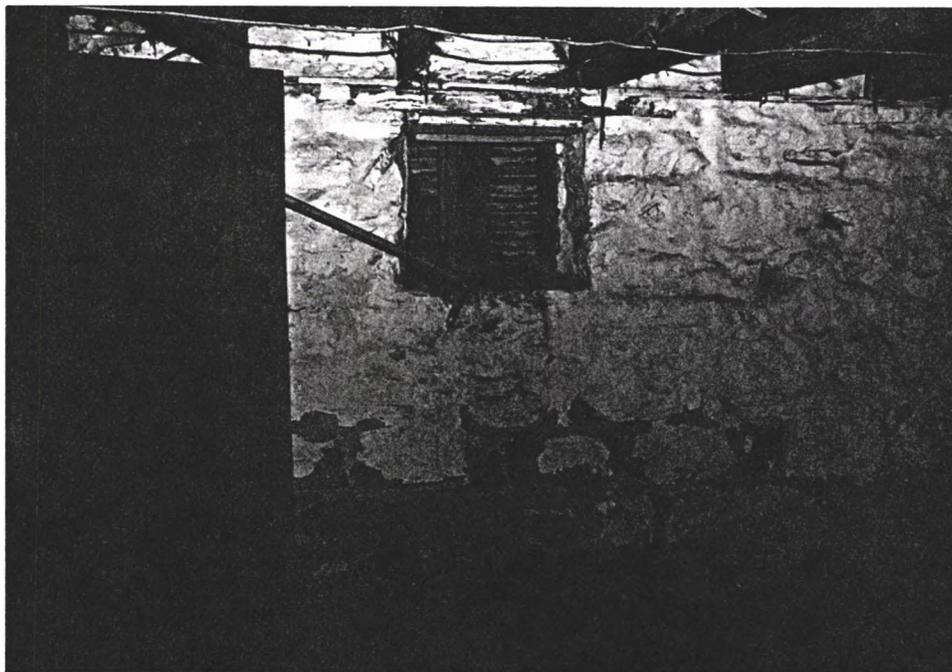
Viewed from the basement, the reciprocally-sawn, 3" x 7" floor joists in the original portion of the house run from north to south, and are spaced two feet on center. The stone wall steps in slightly, creating a ledge on which these joists bear, while the opposite ends frame into a summer beam which runs from east to west (*Photo 20*). This hand-hewn summer is 8" high x 10³/₄" wide, and is supported approximately midway on one 7¹/₂" square post which rests on a flat stone in the basement floor. Although not visible, it is assumed that the second level framing is similar to that of the first floor.

Photo 20. Floor joists bearing on stone wall. Note original window, now partially enclosed behind plaster and lath.

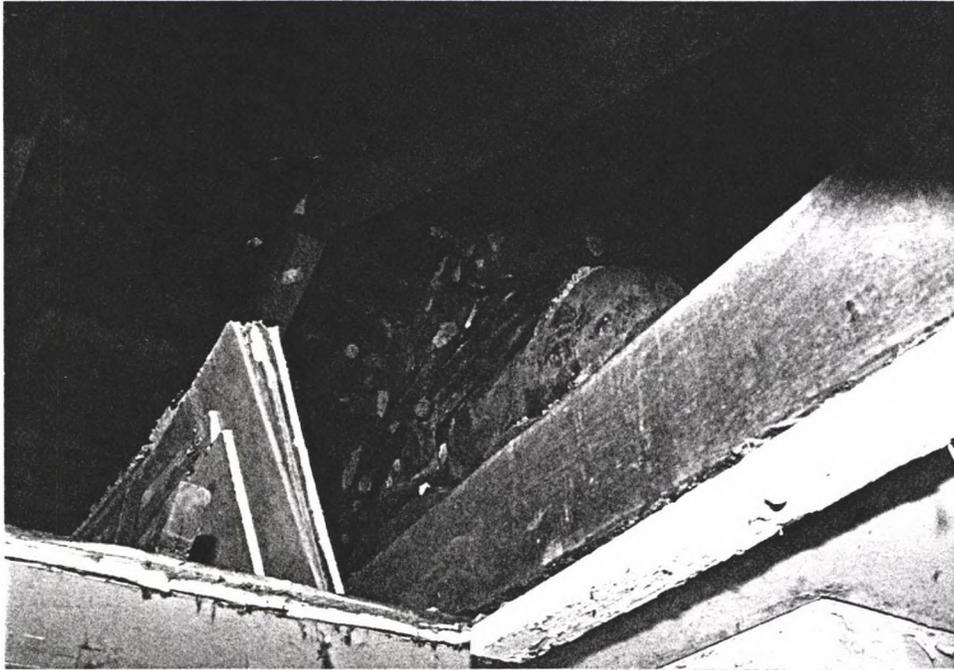
The reciprocally-sawn rafters for the gable roof are approximately 3" x 5", and are spaced 2'-0" on center. They are nailed together at the peak, rather than pegged, a construction practice more common after the middle of the 19th Century. In its original configuration, the roofing lath was let into the backs of the rafters; this was changed during an early reroofing when the lath was nailed directly to the top surface of the rafters (*Photo 21*).

Photo 21. Roof framing members and chimney in original portion of the house.

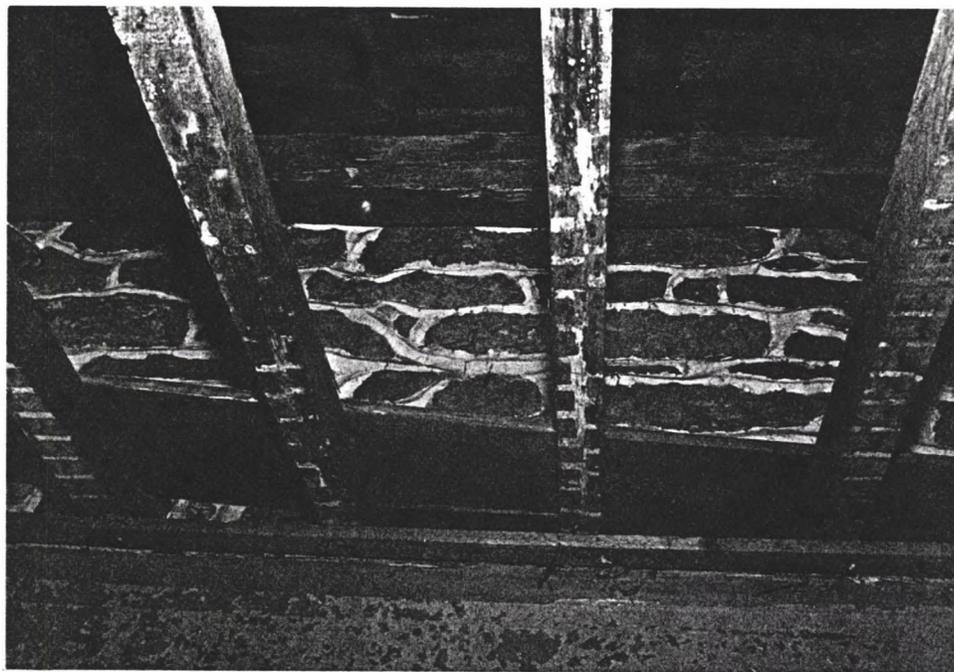
Photo 22. Original stone wall at rear of house and braced frame of addition.

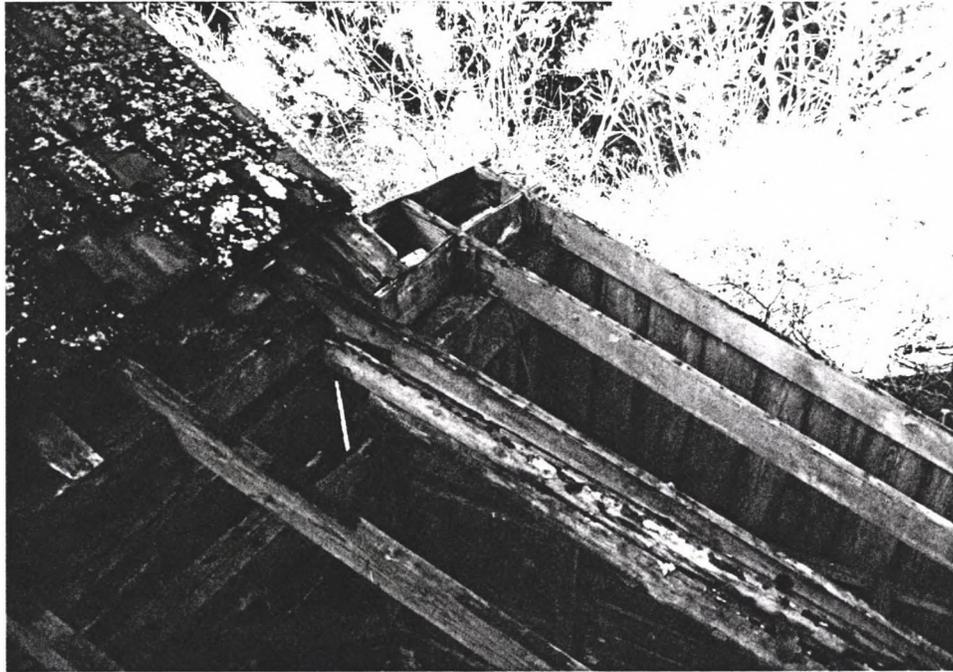
Abutting the masonry on the north side of the Rundle House are three rough-hewn posts, each of which is approximately eight inches square. One post is located at both the east and west corners of the building, with the third situated approximately half-way between the two. The bottoms of these members are mortised into a hewn sill that rests on a stone wall which is 3'-10" high; the tops of the three posts are fitted into a hand-hewn beam, which is located slightly below the roof of the original house, and is held against the stone wall with iron brackets (*Photo 22*). This top-most horizontal member is approximately eight inches square, and extends 5'-0" beyond the stone face of the original building, creating what is now a small porch on the west side (*Photo 23*).

Photo 23. Framing of west side of rear extension.

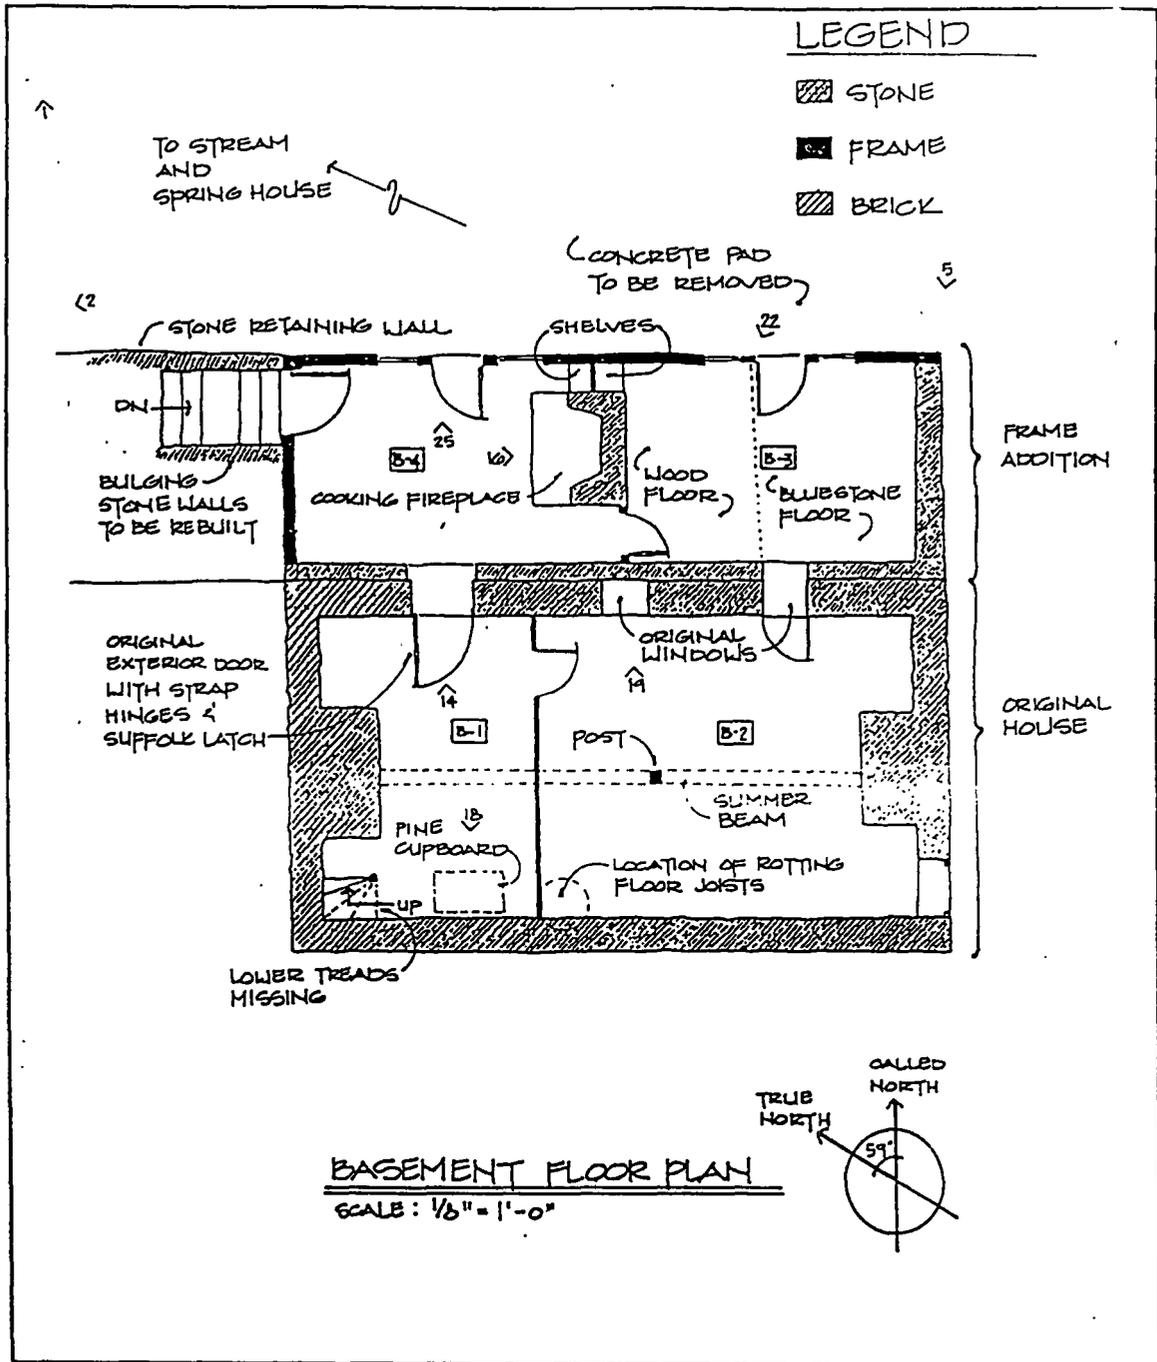
The entire cellar area was visually inspected (Figure 2). Portions of what appear to be cobble flooring were exposed in two areas in the original full cellar during routine maintenance activities (Figure 3). Both areas are located in the southern portion of the full cellar. These areas were brushed to remove dust and loose dirt. Both areas were mapped and photographed. A small portion of the larger exposed cobble floor had been disturbed, probably by a burrowing rodent. This portion was excavated by a pointed trowel to produce a vertical profile. The profile consists of approximately 1 in. (2.54 cm) of a mortar or cement (sand, lime, clay, and sorted pebbles), over a single course, of an average size of 2 in. (5.08 cm) rounded cobbles (Figure 3). The single course of cobbles were laid over a packed prepared clay floor of approximately 3 in. (7.62 cm) in depth (Figure 3). The profile was drawn and photographed. No artifacts were observed nor collected during this investigation.

Figure 2. Copy of Basement Floor Plan, Rundle Farmhouse, from Dodd (1994).

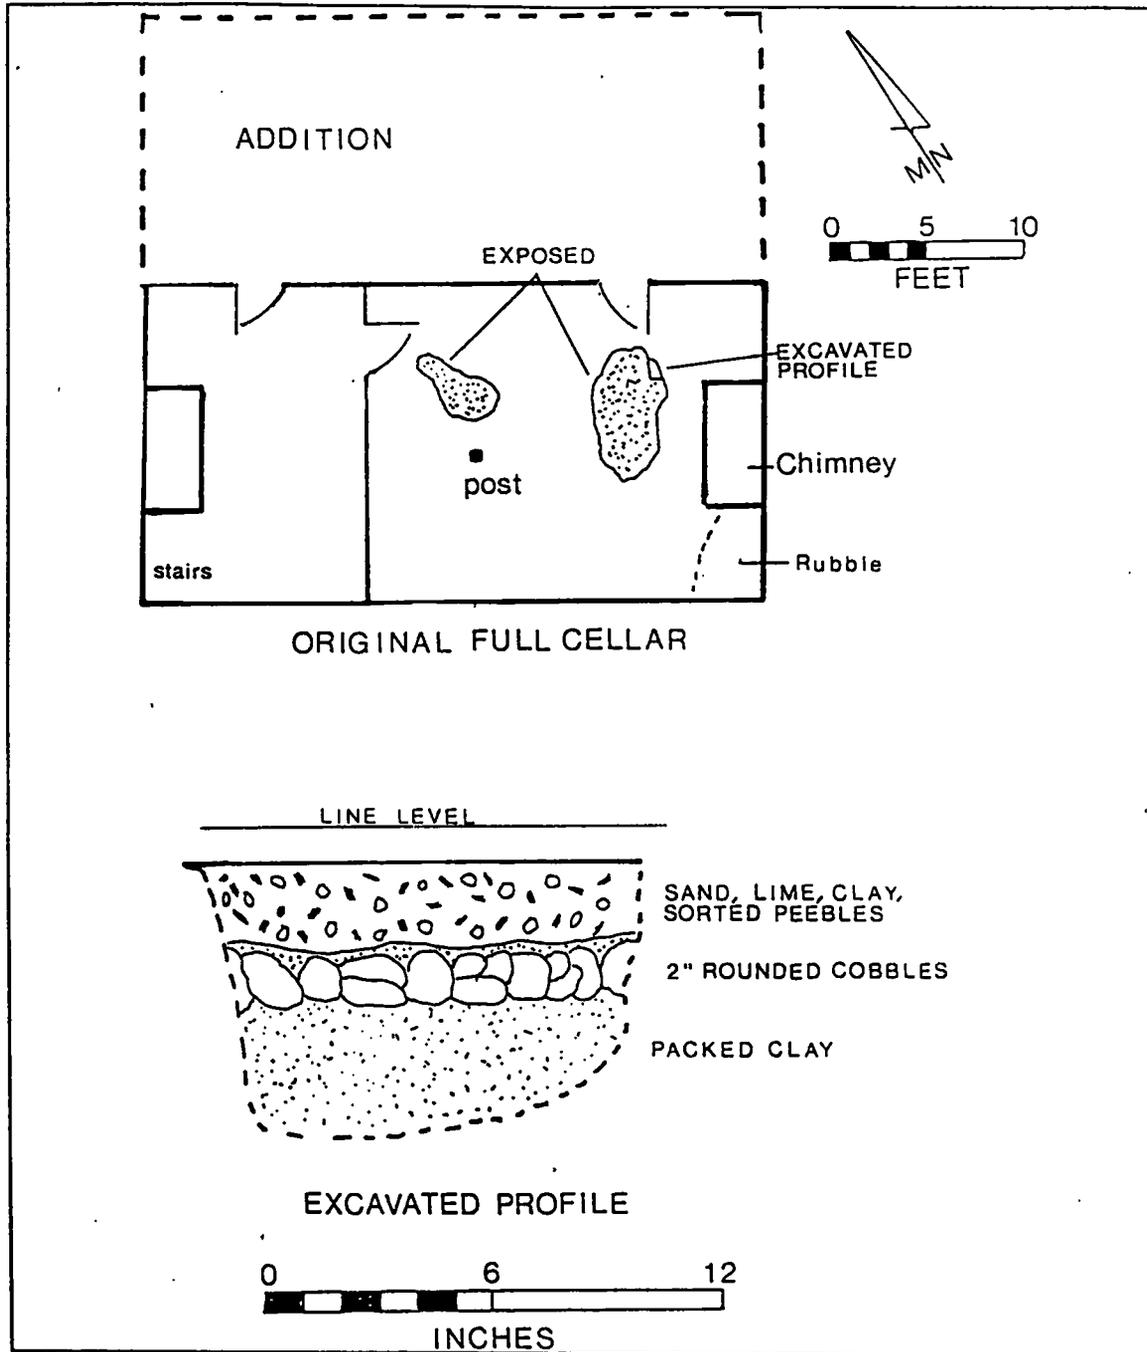
Figure 3. Schematic drawing of original full cellar showing portions of cobble floor exposed during routine maintenance, Rundle Farmhouse and south wall profile of cobble floor.

Recommendation. The existence of the prepared cobble floor appears to indicate some permanency to the structure. It also indicates that the full cellar certainly served other functions associated with farmstead subsistence. Since no associated artifacts were recovered, and the construction method appears throughout the Colonial and Early American periods, dating of this feature was not possible during the confines of this investigation. Should a more definitive date be needed, limited archeological investigations utilizing specific data collection strategies, may be undertaken to address the period of construction.
