HISTORIC STRUCTURES REPORT - PART II (PORTION)

THE DEN CEILING, EDISON HOME, BUILDING NO. 10

Subject: Historic Structures Report - Part II (Portion)
The Den Ceiling, Edison Home, Building No. 110,
Administrative and Historical Data

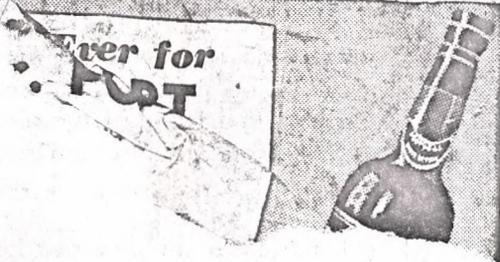
Copy of part of August 14, 1935 newspaper found by Gordie Whittington on February 3, 1966, stuffed into the void which was left when the wooden chandelier, formerly in the south bay of the Den (and now stored on the third floor, Building No. 5), was removed. This ties in with the recollection of Landscape Gardener C. Thore Hallstrom that the domed section of the Den ceiling was closed in between Christmas 1934 and Christmas 1935.
