Fort Donelson Cemetery Carriage House/Stable
& Pump House
Fort Donelson National Battlefield
Historic Structure Report

Historic Structure Report

Fort Donelson Cemetery Carriage House/ Stable
LCS#: 007170

Fort Donelson Cemetery Pump House
LCS#: 000066

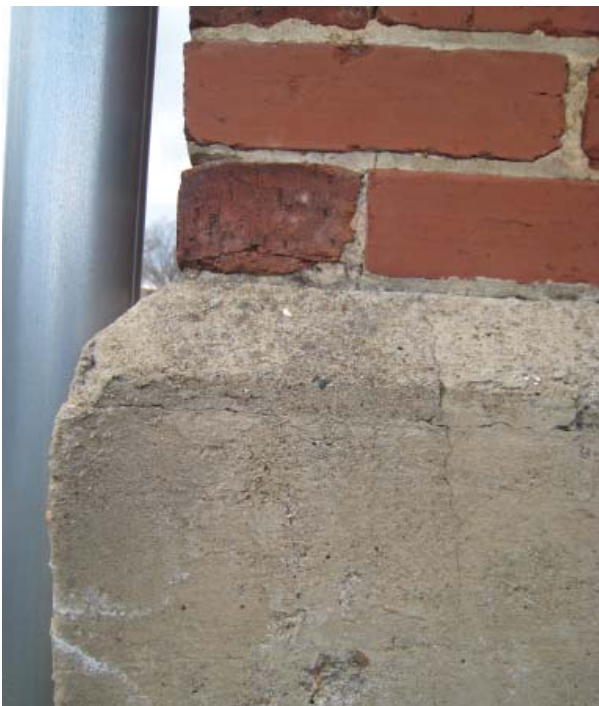
The foundation consists of poured-in-place concrete walls at grade with perimeter concrete footings. Its exact design characteristics are not known; construction plans have not been located and subsurface investigations are beyond the scope of this report. However, the exposed sections of the original walls' footing visible in the basement room indicate that, in that location at least, the concrete footing is irregularly shaped, fitting the contours of the dug pit, and extending only a few inches beyond the outside surface of the perimeter concrete wall.

The perimeter exterior walls are made of brick and sit atop the concrete foundation. These walls measure 8" in depth.

Figure 46. Concrete foundation with brick exterior walls.

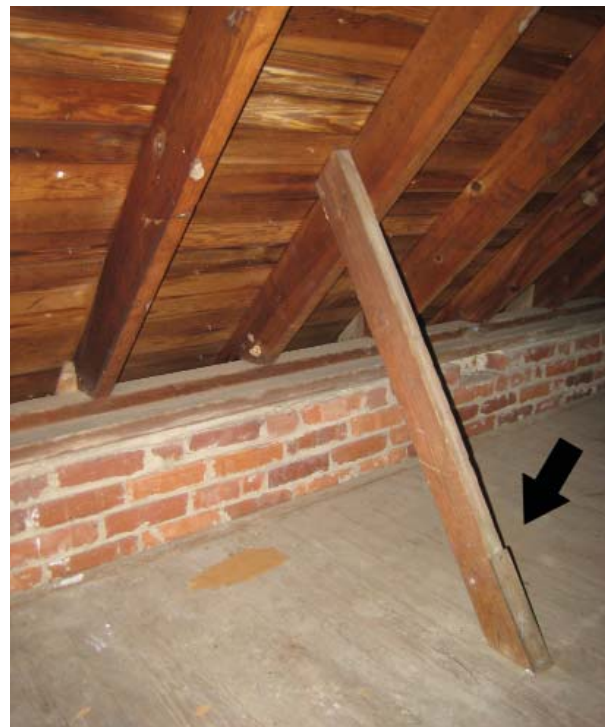
Rafters with a bird's-mouth cut lock onto the outer board. The rafters measure 1½" by 5½" and are spaced at varying widths ranging from 17" to 19½".

Figure 47. Rafters have bird's-mouth joint at wall plate. Diagonal tie-down bracing between rafters and floor joists with metal strap to attach to joist.

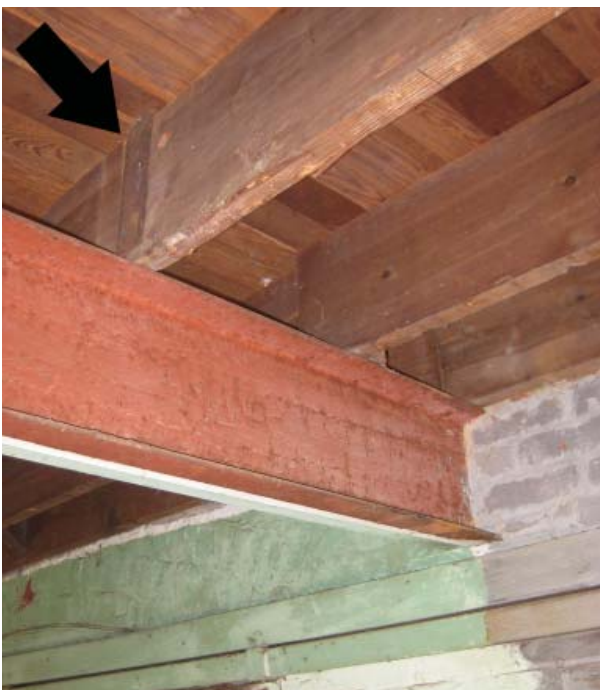
Five original wood tie-down struts are located along each of the north and south elevations. Each strut measures 1½" by 3½", is nailed to a rafter, extends through the loft flooring, and is attached to a floor joist with a metal strap measuring ¼" thick by 2" wide by 9" long.

Figure 49. Rafter tie-down strap attached to joist spanning from steel I-beam girder to perimeter wall.

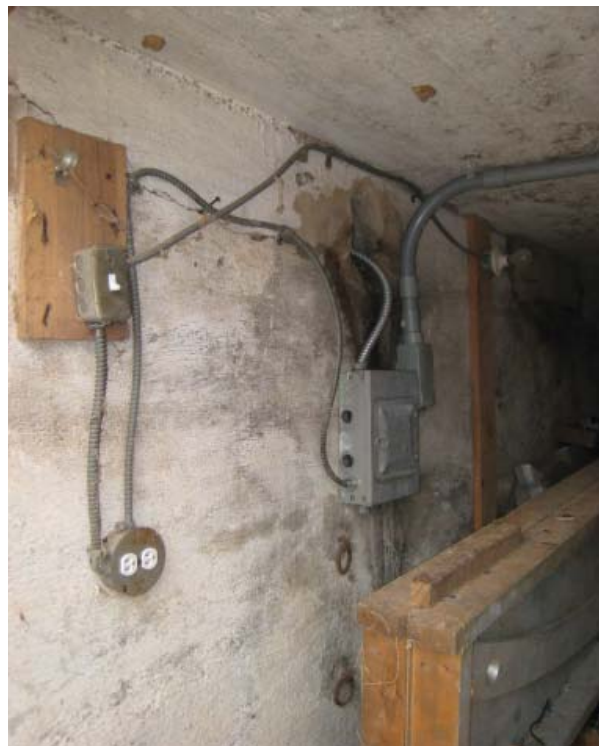
Figure 50. Electrical panel and wiring in basement Room 001.

Though there currently is no power at the site, the electrical service line enters the site underground to a disconnect box on the east wall of the basement room. An electrical service panel with a 30-amp breaker is on the west wall. Also in the basement are early sections of metal-clad cable, a surface-mounted metal switch box with metal utility type switch cover, a surface-mounted outlet box and metal utility type outlet cover, and a wall-mounted porcelain utility light fixture.

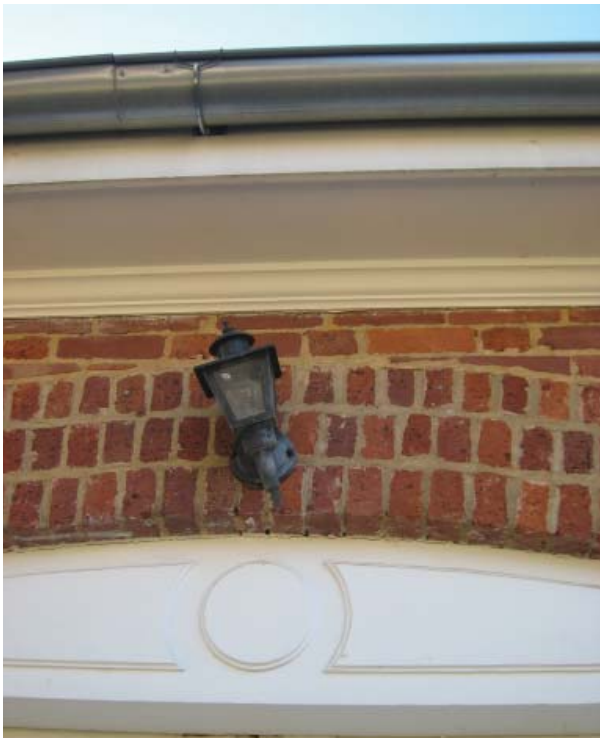
Figure 51. Typical carriage light exterior fixture.

On the exterior, there remain two modern carriage-type lighting fixtures; one is above the carriage doorway and the other is above the doorway on the east elevation. Also, at the southwest corner of the building at the roof cornice, there is a modern double-light floodlight fixture directed at the stone steps below.

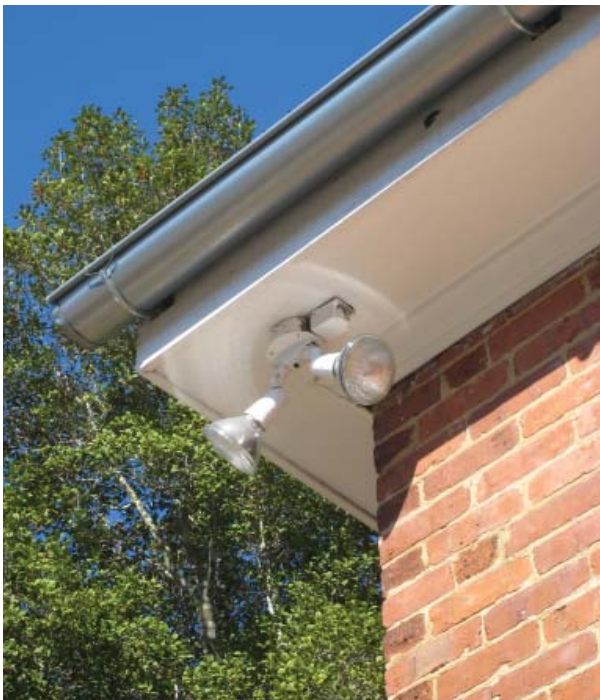
Figure 52. Floodlights at stone steps.

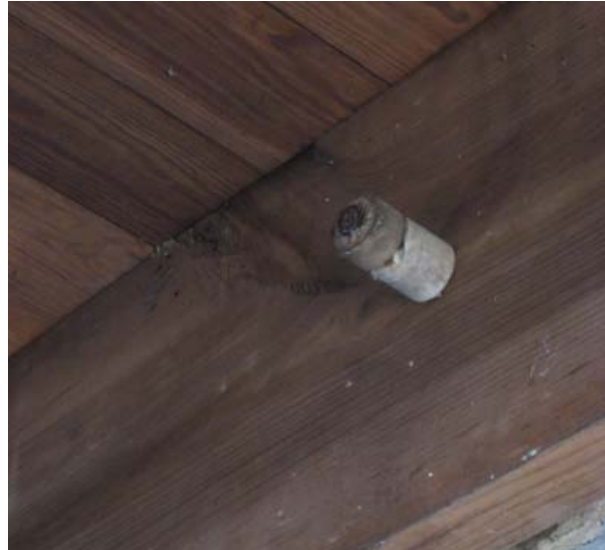
Most vestiges of previous electrical systems have been removed from the upper-level interior spaces. Wiring and apparatus for fire detection remain in place.

Figure 53. Rare surviving ceramic knob for early electrical wiring.

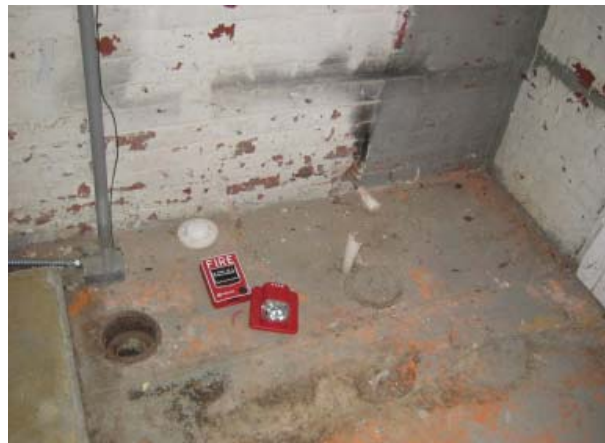
There currently is no active plumbing system in the building, though there are remnants of previous systems and other associated evidence. The remnants include a metal hose bib on the west end of the exterior face of the south wall, and pipe remnants in the southwest corner of Section 103.

Figure 54. Remnants of plumbing lines and drains at southwest corner of first floor.

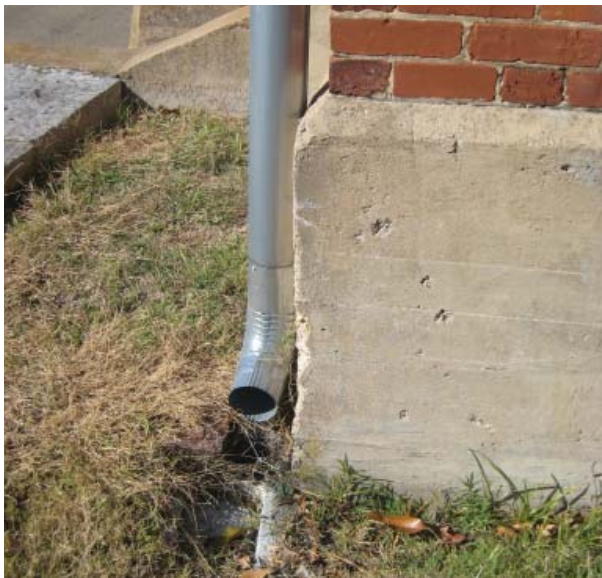
The roofing material, probably installed in 1979-80, is a painted standing-seam terne metal. The roof pans measure about 17” wide by 25” long. The recently installed unpainted half-round gutters are on the north and south elevations with 4” diameter round downspouts at the east ends of the gutters. The collected rainwater empties at grade with no additional provision for dispersal.

Figure 55. Downspouts dump rainwater at grade.

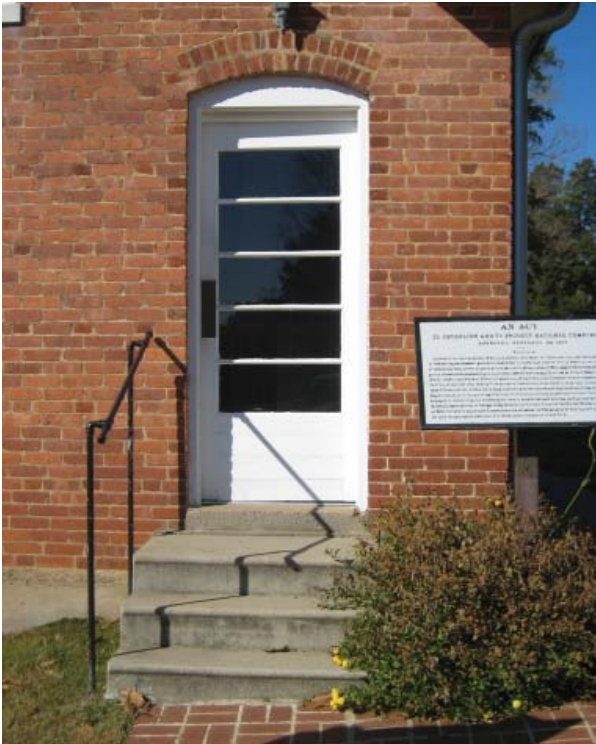
On the east elevation, the upper portion of the first-floor masonry opening for the original pedestrian doorway remains intact; however, the lower portion was infilled in 1931 when the basement room was created and the east section of the first floor was raised. The original transom and door were removed at that time and a new shorter door was installed in the modified door opening. The current door, measuring 2'-10" by 6'-8" by 1¾", may date to this 1931 change but stylistically appears to be later. The two 4" ball-pin butt hinges are likely the originals from 1911.

Figure 64. Original doorway at first-floor east elevation. Transom and door were removed when floor raised in 1931.

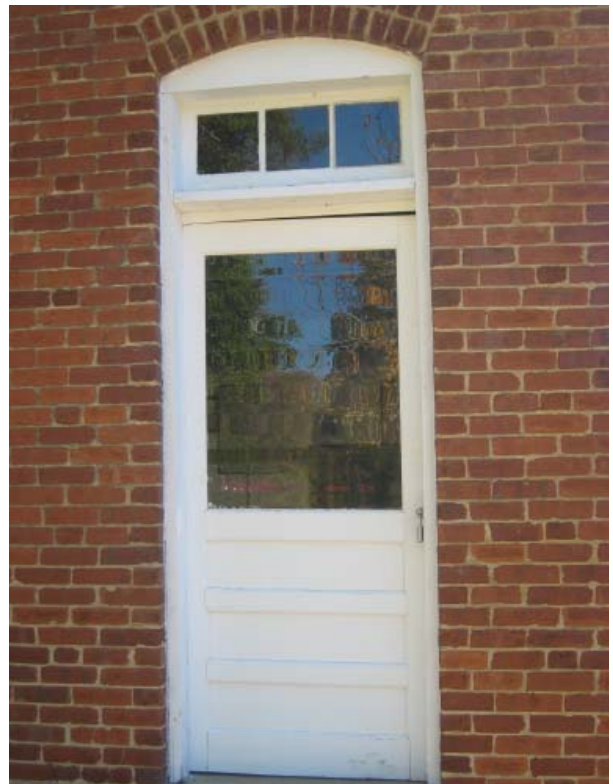
On the west elevation, the southernmost doorway is original. It retains its original framing, transom, three-inch tall cast-iron keeper for a rimlock, and sandstone threshold. The 2'-10" wide by 6'-5" tall door is a replacement; the transom frame has been modified to accommodate this shorter replacement door. The door is configured with a single-light over three horizontal panels. It has two modern barn-strap hinges and a five-inch pull handle.

Figure 66. Original south doorway of west elevation.

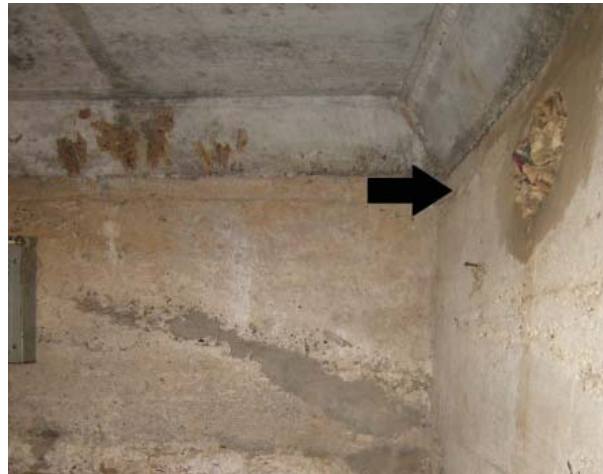
Figure 76. Opening for flue in south wall.

An 8” diameter flue opening is in the south wall, evidence of an earlier means of producing heat. This flue is high on the wall; the centerline of the flue is 5’-2” above floor grade in a room with a ceiling height of 6’-7”. Perhaps related, an 8” diameter opening is in the upper west wall supporting the raised concrete floor, close to the

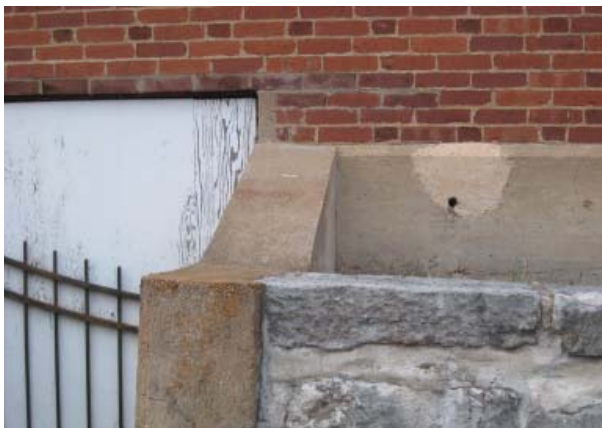
exterior south wall of the building. This opening may have allowed the unsightly flue on the exterior of the south wall to be moved to the interior of the building, existing in a less visible location on the roof.

Figure 77. Exterior patch over flue opening in south wall.

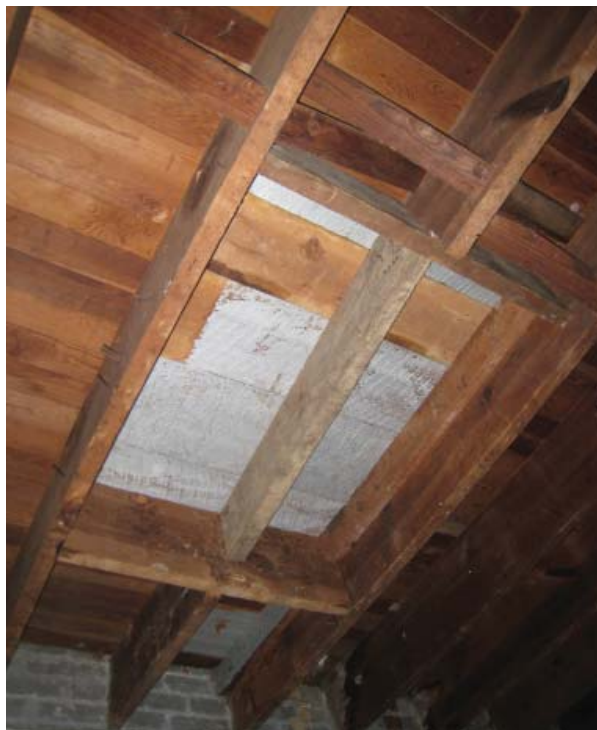
The largest patch measures approximately 2'-6" by 3'-2". It is close to the east wall of the building and slightly south of the east doorway at first-floor level. This patch probably covers a hatch with ladder stairs connecting loft and first floor noted in Section I.B. A section of loft floor joist was removed and two headers installed for this opening confirming that this was a change following initial construction. The patching material used to cover this opening consists of salvaged plank boards of random widths.

Figure 85. Hatch in ceiling was added.

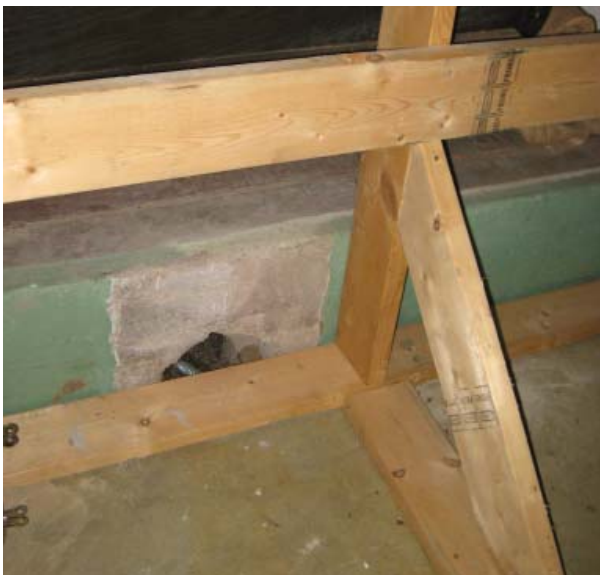
Figure 87. An 8" diameter hole at raised floor.

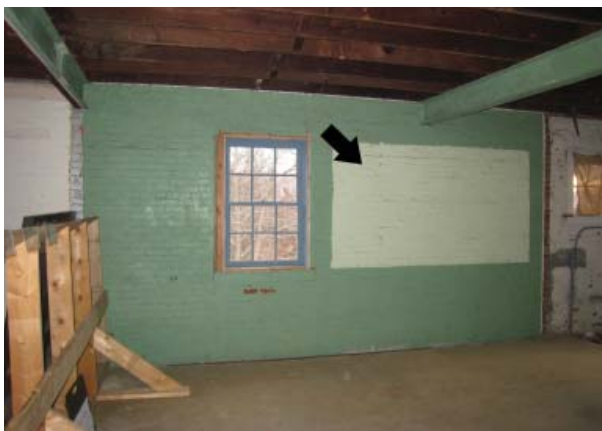
Figure 89. South wall of center section. Area of light colored paint was behind a display board when the room was repainted.

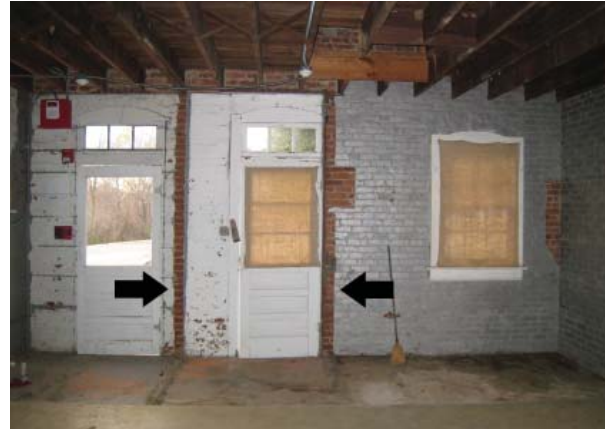
Figure 92. West wall of west section. Note imprints of partition walls added to enclose the restrooms.

- Develop in situ displays of the evidence of interior changes to the building, such as the added restrooms (Figure 92), as seen in the paint layers.
- Develop in situ displays of other evidence of building changes identified in this report such as the original ladder access to the loft (Figure 95 and Appendix A Sheet 4). Protect the evidence from disturbance.

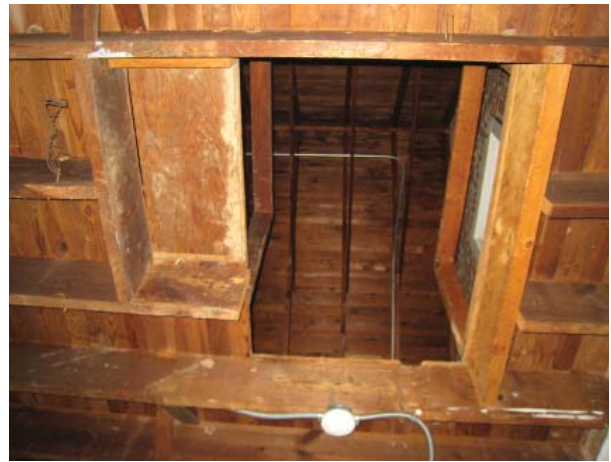
The framed opening for ladder access to the loft is near the center of Section 103 in its northwest quadrant. See *Appendix A - Sheet 3 for location*. The current configuration contains part of the original design for east-west ladder stair access and the 1970s modification when ladder access was reoriented to the north-south position to accommodate the expansion for the Cemetery Interpretive Center. See *Figures 94 and 95*. It was probably at this time of reorienting the axis of loft access that the original ladder stair was discarded.

Figure 95. Original opening for ladder access to loft with later modifications. Note patch partially enclosing original opening. (See Appendix A Sheet 4)

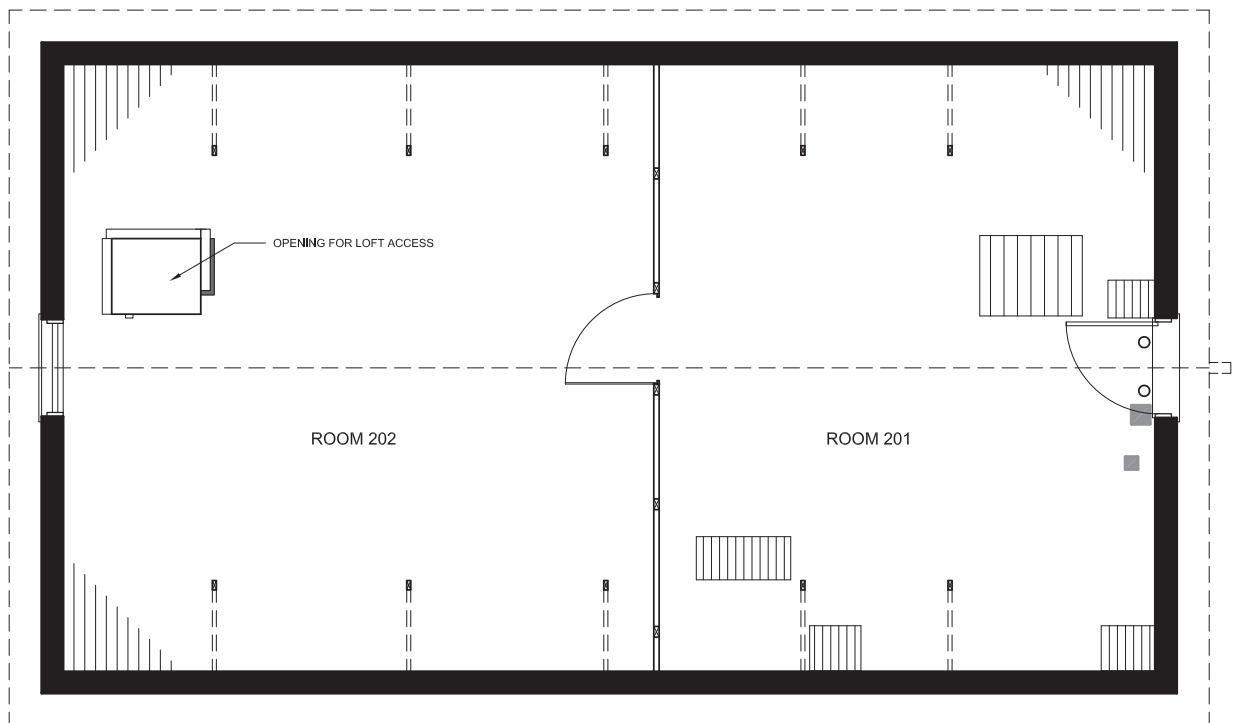
Figure 94. Loft plan.

There are numerous patches in the flooring of the loft. Most occur in the adjoining Room 201. The original opening for ladder access subsequently modified in the 1970s is near the west wall. During the 2010 demolition the associated fixed-ladder stair, probably dating to the 1970s modification, was removed. See *Figure 94 and Appendix A - Sheets 3, 4, and 5*.

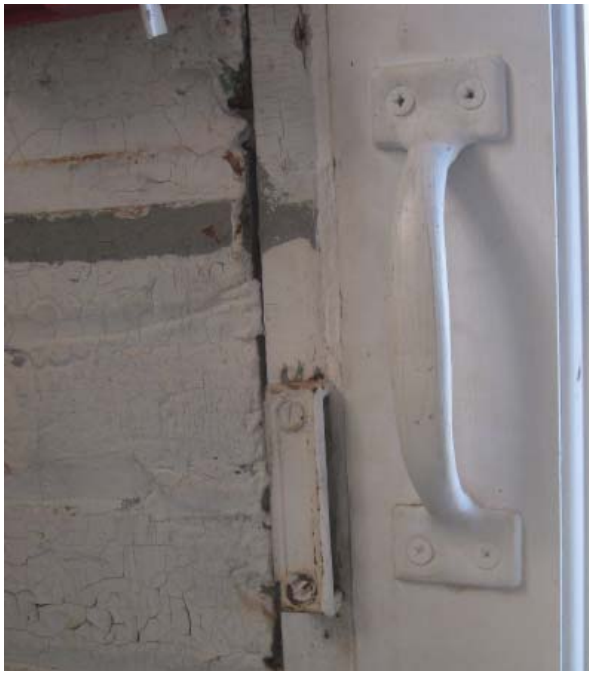
Figure 96. Original rimlock keeper and modern 5" handle of south door.

The southernmost doorway is original as is its three-light transom. On the south jamb the original door lock keeper remains. However, on this original door the rimlock and hinges are missing.

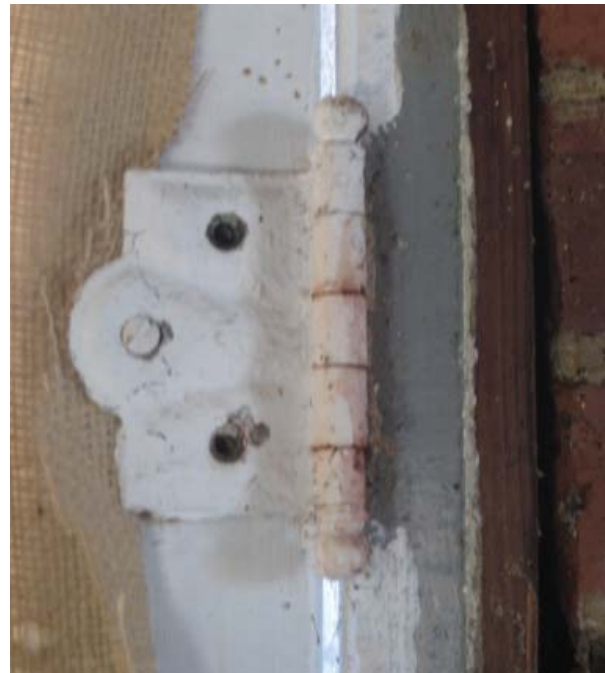
Figure 98. Clamshell door hinge on added center doorway.

The central doorway was installed in an original window opening when the restrooms were installed, probably in the 1930s. The door is probably later though the clamshell door hinges are appropriate for that period. The door is missing its lock.

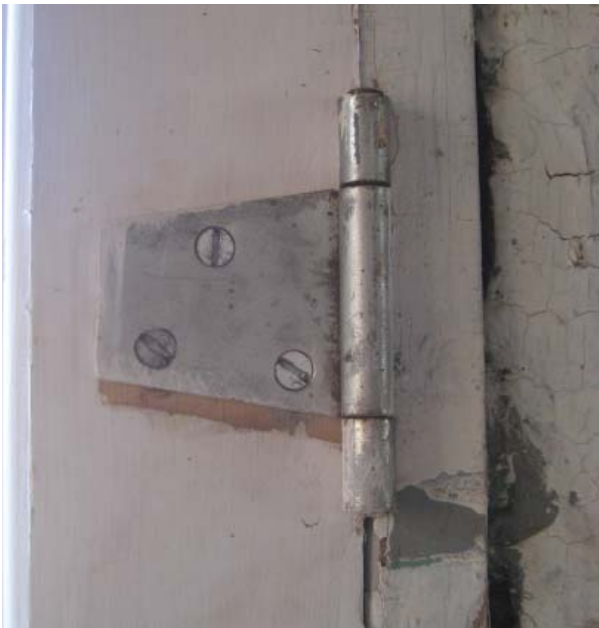
Figure 97. Modern barn-type strap hinge on south door.

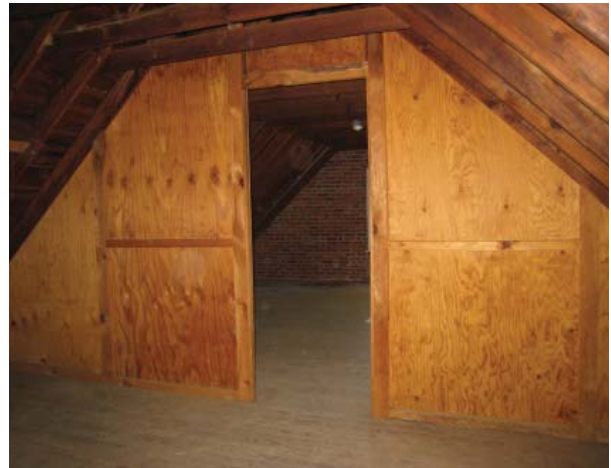
The hatch and ladder stair in the west part of the first floor, Section 103, allowed easy access to the loft. Therefore, the plywood and wood stud wall was constructed in the 1970s to divide the loft into two rooms; a door at the center of the wall allowed the east Room 201 to be locked. Thereupon, sale

Figure 99. Added partition wall (west wall of Room 201).

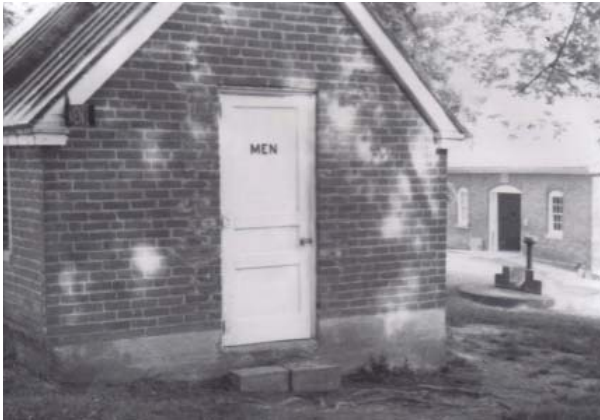
Figure 107. West gable end shown in 1964. Note the change in grade, awkward step, and absence of paved walkway. Roof hatch above the well is visible on north slope. Carriage House/Stable is in background. (FODO collection)

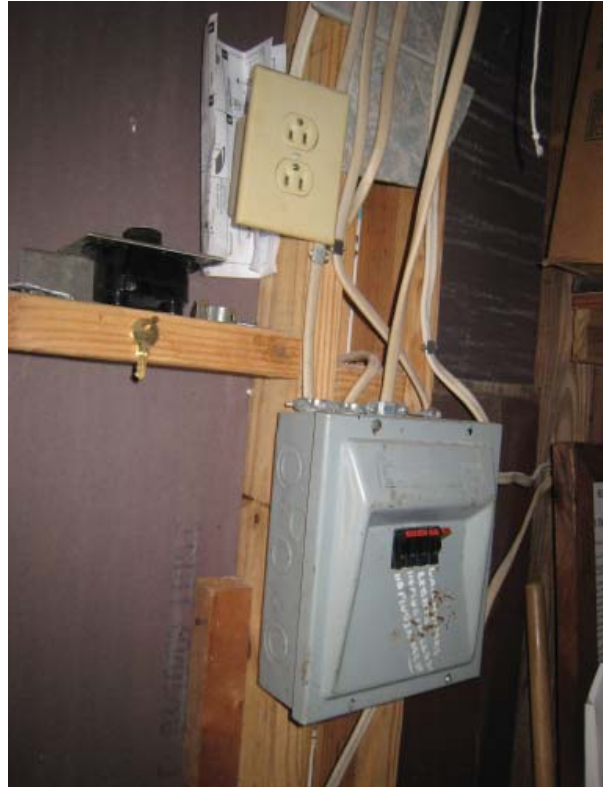
Figure 124. Electrical panel in Service Closet.

Although the date is not clear, the building apparently has been rewired within the last thirty years; exposed wiring is vinyl-wrapped. The electrical service panel with four 30-amp breakers is in the Service Closet.

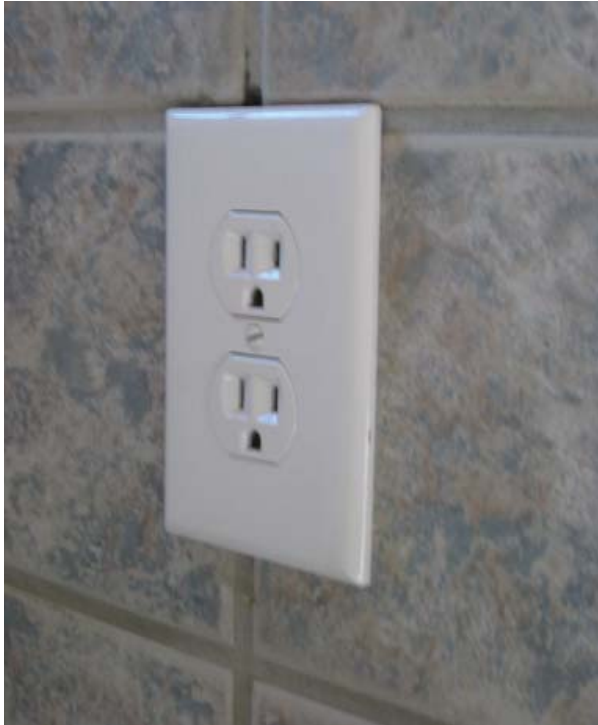
Figure 126. Typical outlet cover.

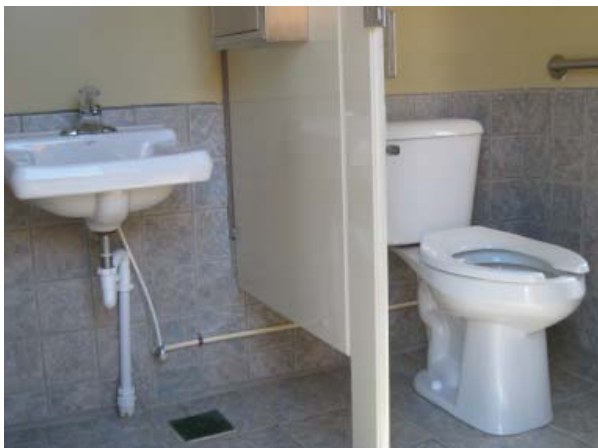
Figure 127. Typical lavatory and toilet.

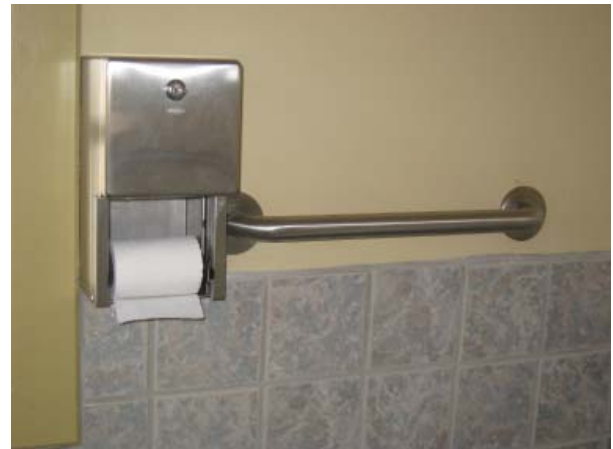
Figure 128. Typical grab bar and toilet paper dispenser.

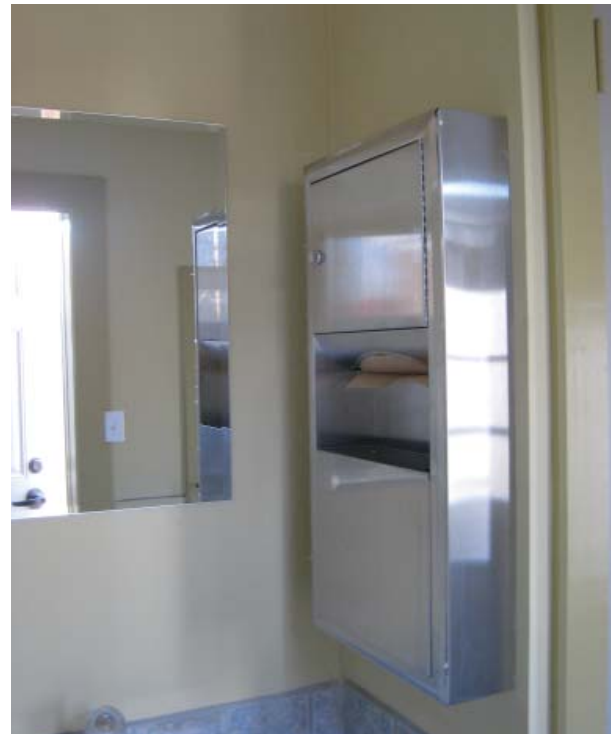
Figure 129. Typical paper towel dispenser.

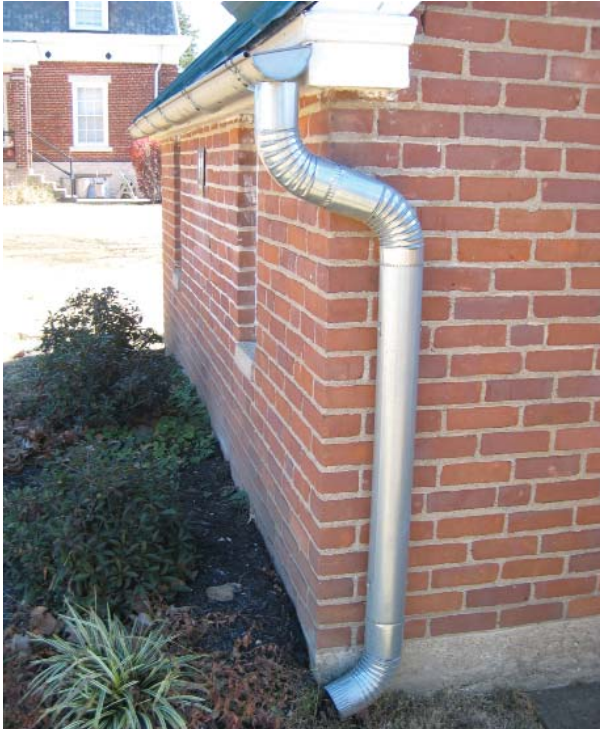
unpainted half-round gutters are on the north and south elevations with 4”-diameter round downspouts. The water disperses at grade with no additional provision for dispersal.

Figure 130. Round downspouts take rainwater to grade.

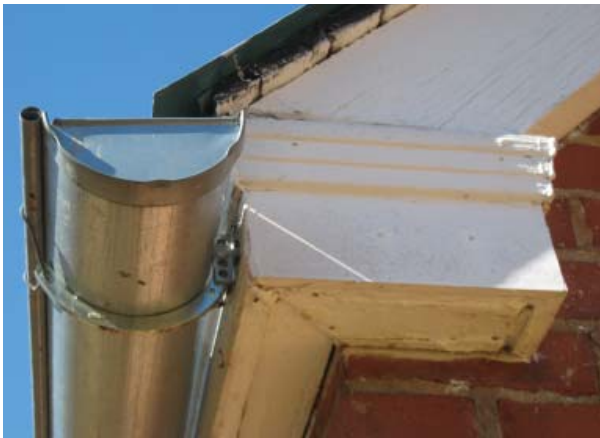
Figure 131. Box cornice.

The simple wood box cornice with recessed soffit and trim, apparently original, extends along the north and south elevations. At the east and west gable ends of the building are matching returns. See Figure 131.

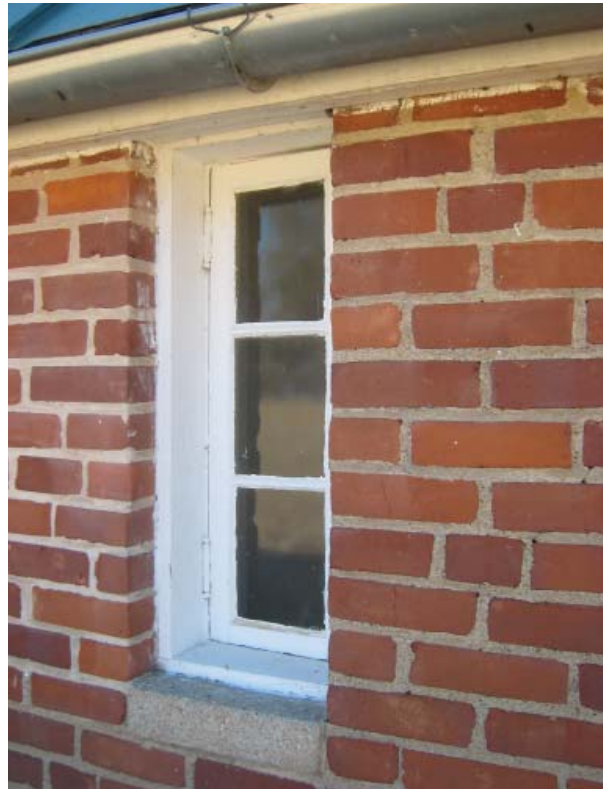
All window units appear to be original. All contain a three-light wood casement sash measuring 11”

wide by 2’-8” tall. The original hardware also remains: two steel three-inch-tall five-knuckle ball-pin hinges and brass control arm for adjusting sash opening.

Figure 132. Typical casement window.

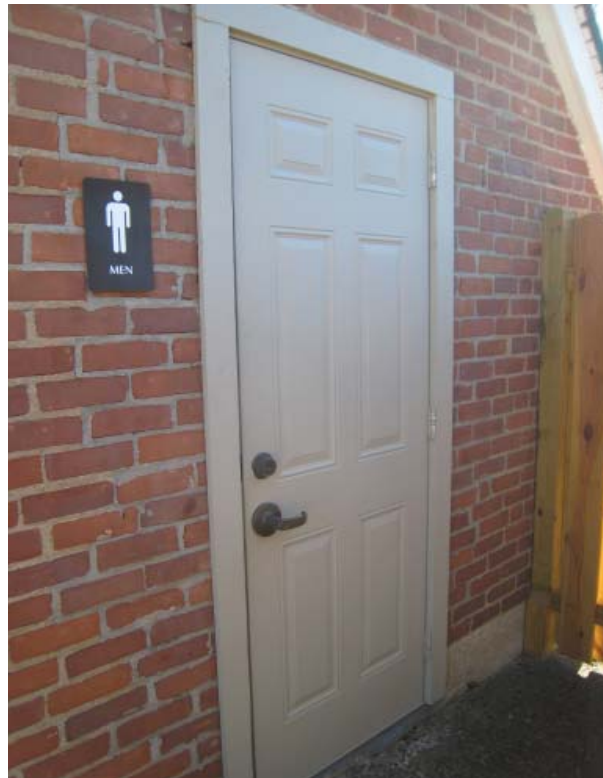
Figure 133. Typical metal six-panel entrance door.

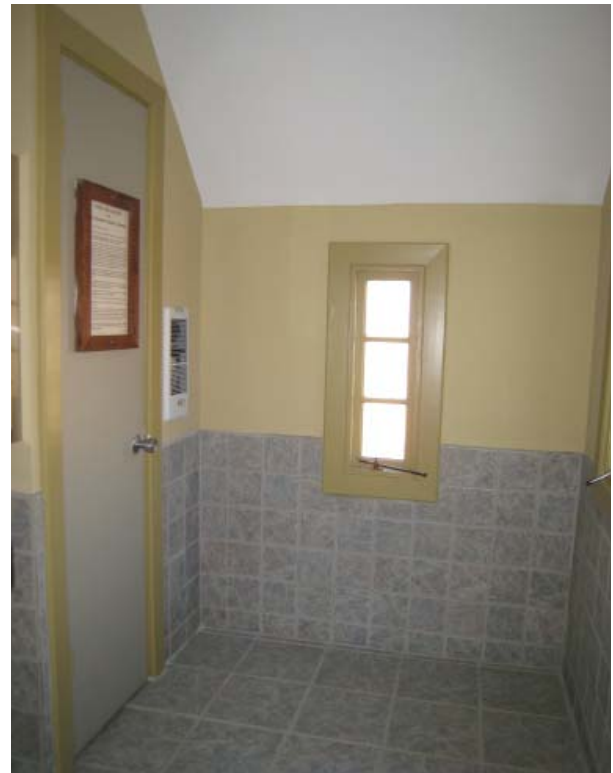
Figure 135. Alcove with doorway to Service Closet on north side of restroom.

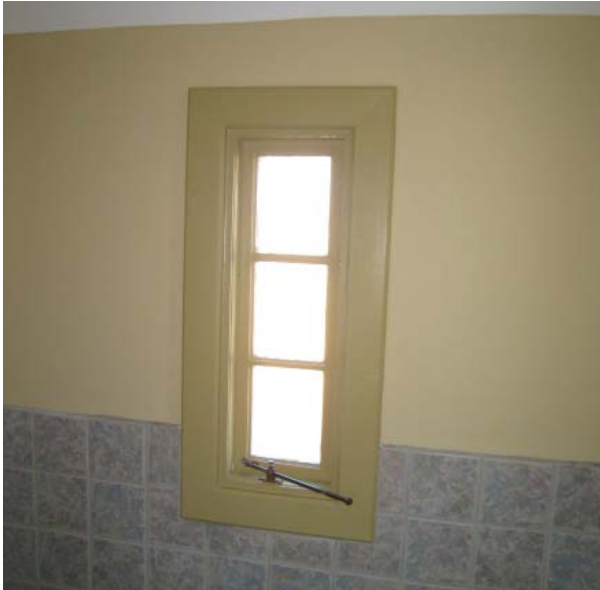
The four window units of this room are original features. Each window retains its original, three-light wood casement window sash measuring 11"

by 2'-8" and its original window hinges; each sash has two, three-inch-tall, five-knuckle ball-pin steel hinges. Each casement window also has a brass control arm, early if not original hardware, and is operable. There are no screens or clear evidence of earlier screens. The interior window casing is comprised of plank boards with beveled edge; the boards measure 3/4" by 4".

Figure 136. Typical casement window.

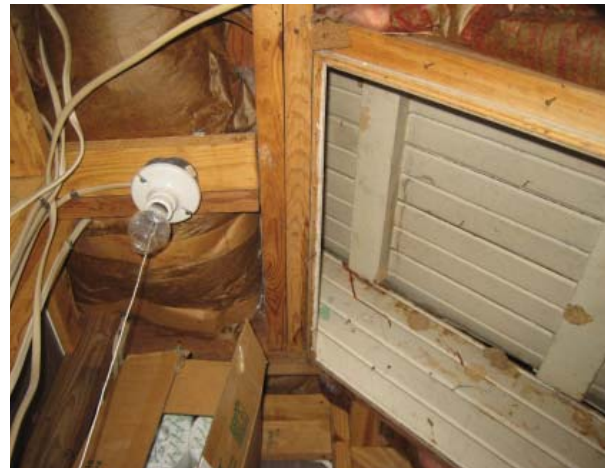
Figure 138. Access to roof hatch in Service Closet.

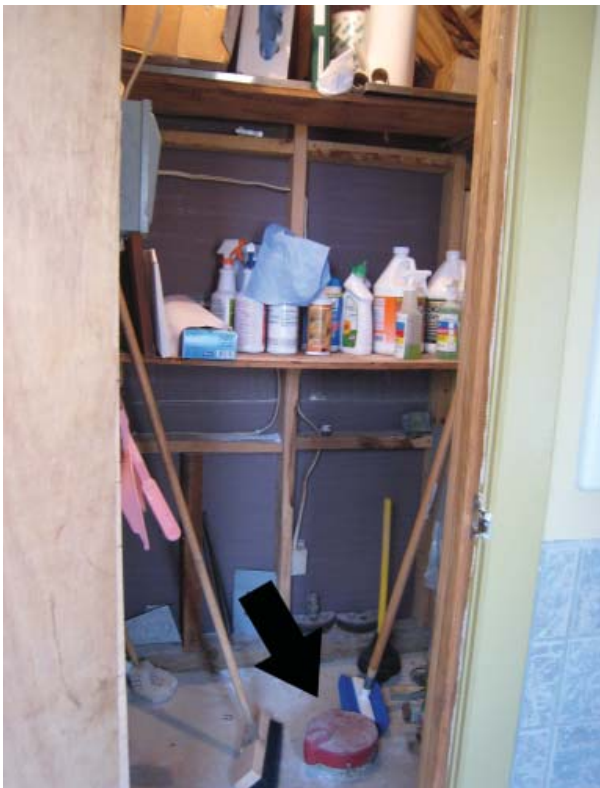
The wellhead is centrally located at floor level. A roof hatch, which was critical for installing or removing long sections of pipe associated with the well, is located immediately above the wellhead.

Figure 137. West wall of Service Closet and wellhead at floor.

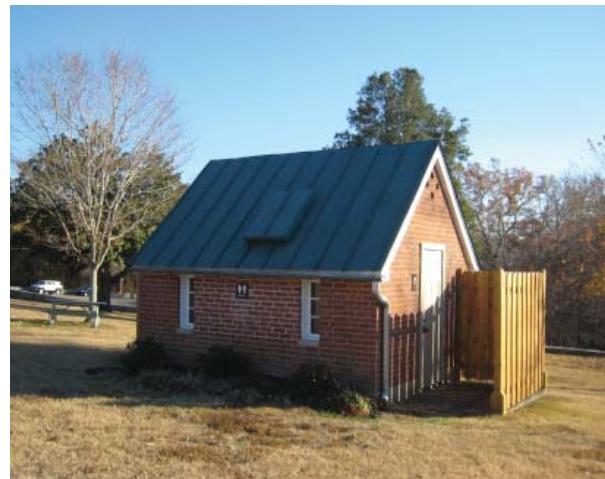
Figure 139. Roof hatch.

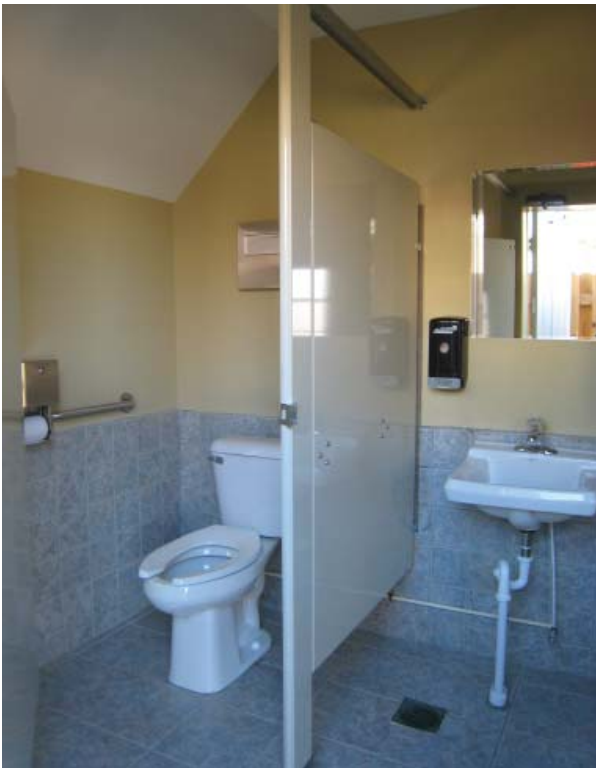
A steel toilet enclosure is on the south side of the room. This is a stock item and the paint coating is factory applied.

Figure 140. West wall with toilet enclosure in south section and lavatory in center section.

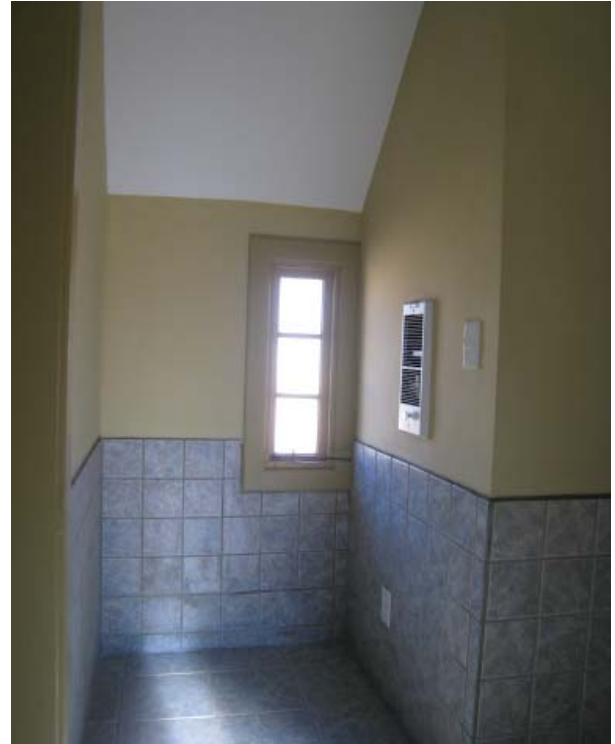
Figure 141. Alcove on north side of restroom.

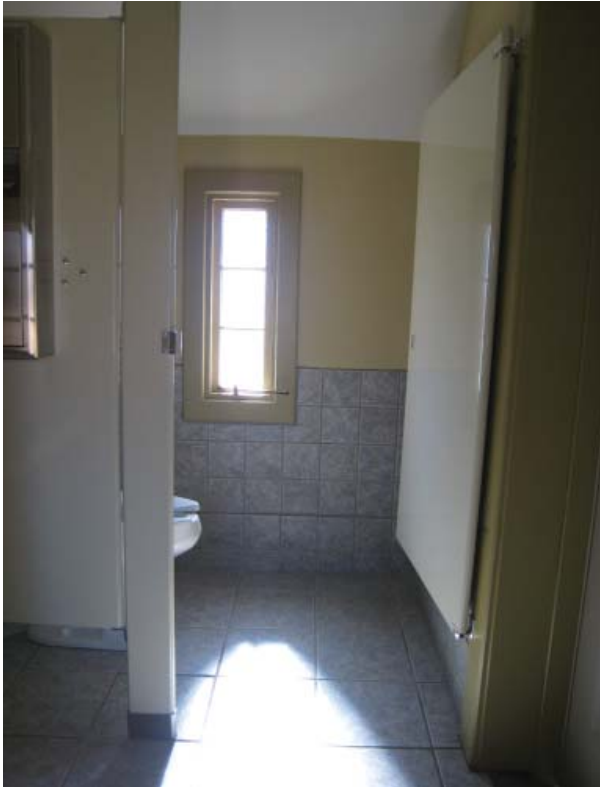
Figure 142. Toilet stall enclosure on south side of restroom.
