Inventory of Coastal Engineering Projects in Fort Matanzas National Monument

Natural Resource Technical Report NPS/NRSS/GRD/NRTR—2013/703

March 2013

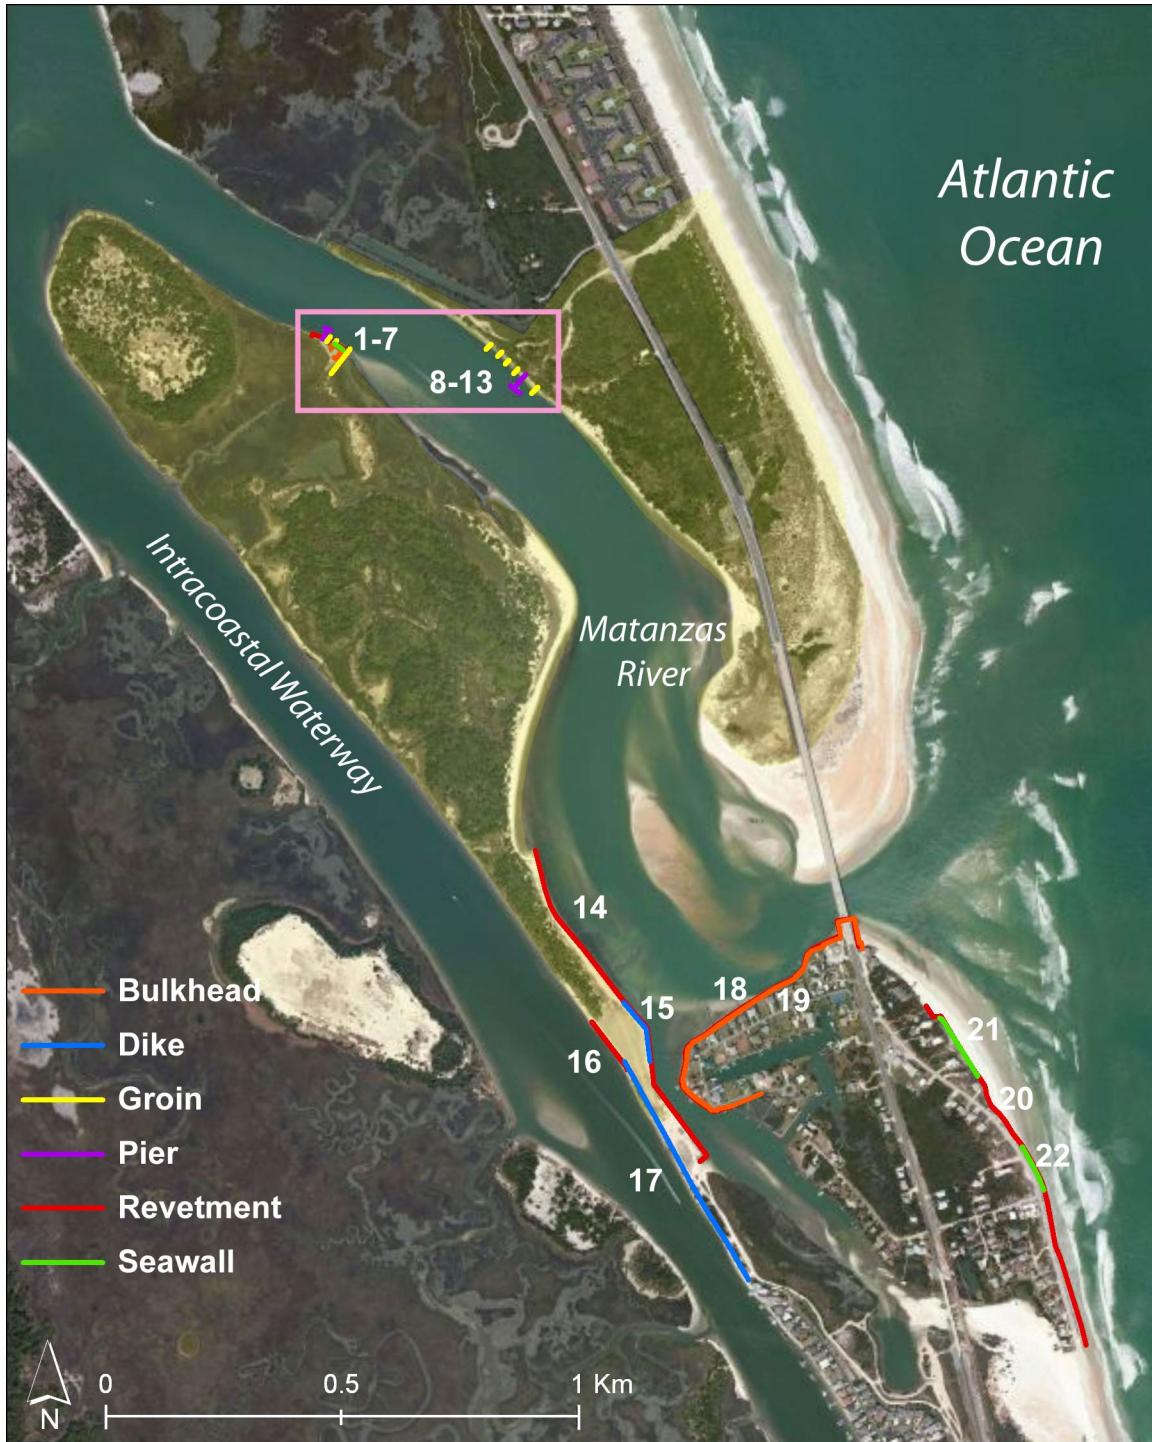
Figure 5. Structure map for the FOMA area. Yellow shading shows park property. Area in pink box is shown in Figure 9 (image from ESRI Bing Maps basemap layer 2012).

To separate the Matanzas River from the new ICW, the USACE built a sheet pile dike on the southwest shore of Rattlesnake Island in the latter part of 1936 at a cost of \$1,721.11 (Figure 4 & #17 Figure 5) (Freeland 1940, Mehta and Jones 1977). Original reports record the dike's length at 640 meters (2,100 ft). We report a length of 533 m (1,749 ft) based on field observations and examination of aerial imagery. The dike may extend further to the southeast, but it is not currently visible due to a revetment.

In 1964 Hurricane Dora breached the northern end of the dike, causing a decline in the percentage of tidal flow moving through the north arm of the river (Figure 6) (Mehta and Jones 1977). The USACE closed the breach in 1977, which had widened to 97 m (319 ft), with construction of a steel sheet pile dike (#15 Figure 5) at a contract cost of \$873,419 and revetment on both sides of the breach (#14, 16 Figure 5 & Figure 7) (Mehta and Jones 1977). The project

In 1957–1958, a 126-meter (415 ft) long concrete sheet pile seawall was built along the ocean shoreline in Summer Haven to protect the highway (#22 Figure 5) (Mehta and Jones 1977). The seawall was severely damaged during a nor'easter in November 1962 and by Hurricane Dora in 1964 (Mehta and Jones 1977).

Roughly 550 m (1,800 ft) of granite revetment was installed in 1963 (#20 Figure 5) (FDEP 2000). The revetment was extended in 1964 after Hurricane Dora and has been repaired many times (Mehta and Jones 1977, FDEP 2000). In 1976, 975 m (3,200 ft) of beach south of the bridge was nourished with an unknown volume of sand (NPS 1981). A 150-meter (490 ft) long seawall of unknown age also exists near the northern end of the revetment (#21 Figure 5).

The shoreline west of the bridge along the Matanzas River is armored with a bulkhead and rock revetment for approximately 880 m (2,890 ft) (#18–19 Figure 5). Roughly 325 m (1,070 ft) of the revetment, extending west from the bridge, was installed in 1964 (NPS 1981). The histories of the bulkhead and the remaining section of revetment are unknown.

During large storm events, Summer Haven has experienced wash-over of the beach. A nor'easter in March 1989 overwashed the dune immediately south of the revetment (#20 Figure 5) and established a short-lived inlet connecting to the Matanzas River (Taylor Eng. 1989). Since 1991 over 1,300,000 m³ (1,700,336 yd³) of sediment dredged from the ICW has been placed along Summer Haven's ocean beaches (Table 2) (David Roach, Executive Director Florida Inland Navigation District, email, 13 Sept 2012).

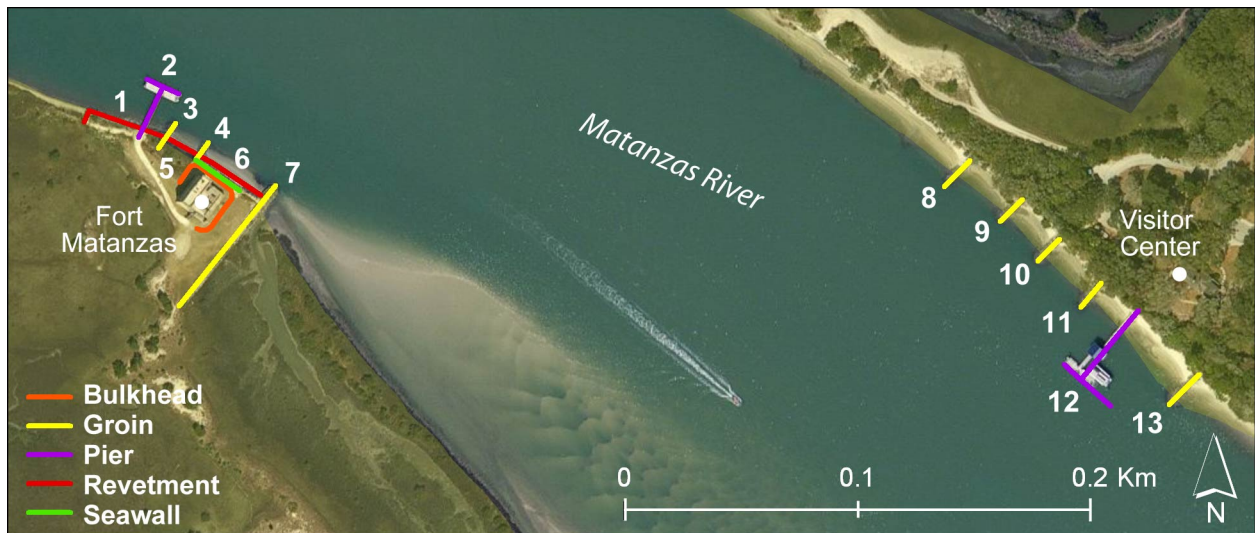
Figure 9. Structure map for the area around Fort Matanzas and the Visitor Center. Yellow shading shows park property (image from ESRI Bing Maps basemap layer 2012).

In 1940 a coquina seawall was constructed along the northeast side of the fort (#6 Figure 9) and two groins were built (#3, 4 Figure 9) on the shoreline (NPS 1980). The seawall is not currently visible because a coquina revetment covers it. The groin at the southeast corner of the fort was built in 1948–1949 (#7 Figure 9) (NPS 1980) and lengthened and reinforced with timber sheet

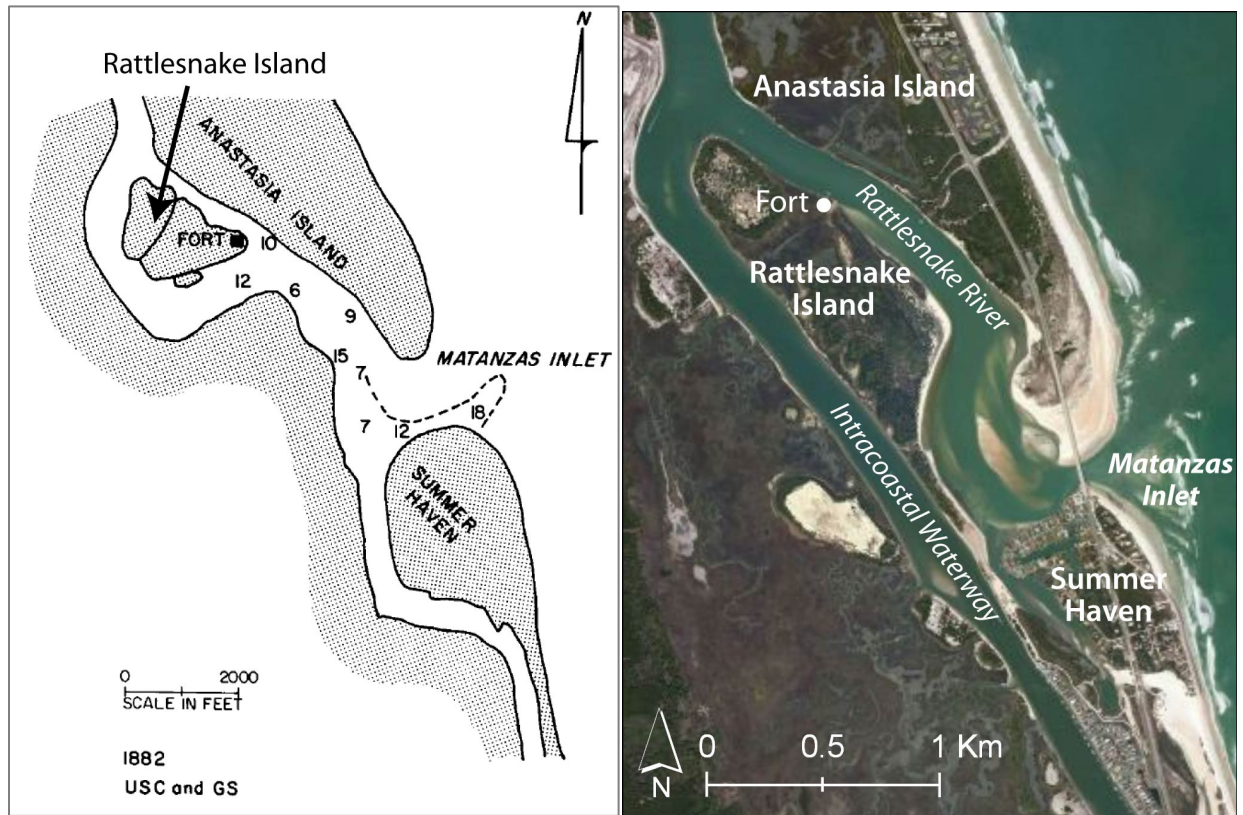
Figure 11. 1882 map (left) and 2011 image (right) of the Matanzas Inlet area (map adapted from Mehta and Jones 1977, image from ESRI Bing Maps basemap layer 2012).

The changes to the Matanzas Inlet system impacted the natural flow of sediment within the inlet and the surrounding region. The creation of the ICW led to a reduction in current velocity at the junction of the Matanzas River and the ICW north of Rattlesnake Island, which caused the development of a shoal (Frazel 2009). The USACE currently dredges 133,800 m³ (175,000 yd³)

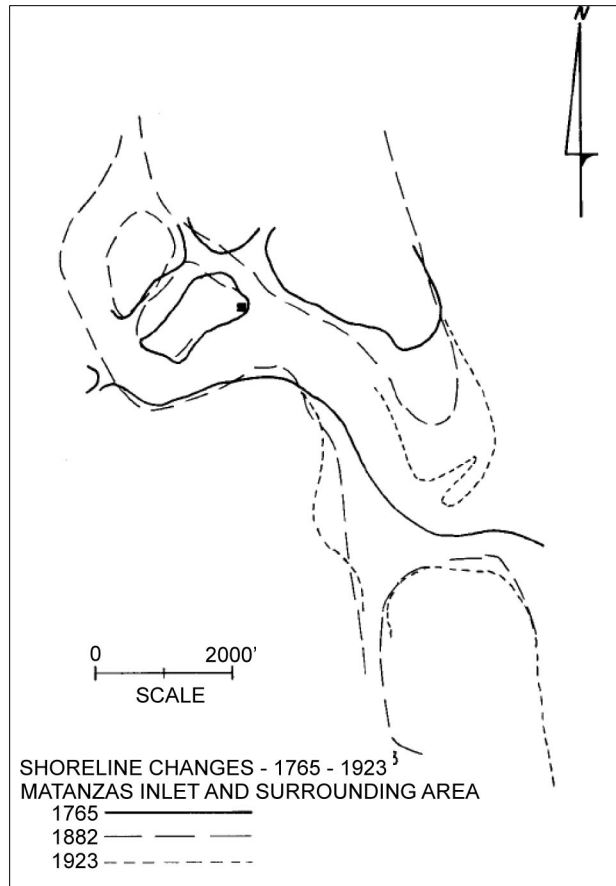
Impacts to natural sediment transport processes from the collection of structures near the fort likely began prior to the Matanzas Relocation Cut. Historic surveys suggest that the original Rattlesnake Island likely tended to migrate northwest (Mehta and Jones 1977) (Figure 14). The presence of tidally dominated upriver flows and limited sediment deposition from upriver sources, further support this notion (Gallivan and Davis 1981, Price 2005). The original shoreline stabilization measures (pre-1935) held the fort in place while minor erosion likely occurred in the surrounding areas. The erosive nature of the area remained unchanged following the ICW project with additional layers of fortification (seawall, revetment, bulkhead and groins) subsequently constructed.

Figure 14. Historic shoreline change in the Matanzas Inlet area (from Mehta and Jones 1977).
