HISTORIC STRUCTURES REPORT

ARCHITECTURAL DATA SECTION

RESTORATION OF BASEMENT KITCHEN

ENLISTED MENS' BARRACKS "E"

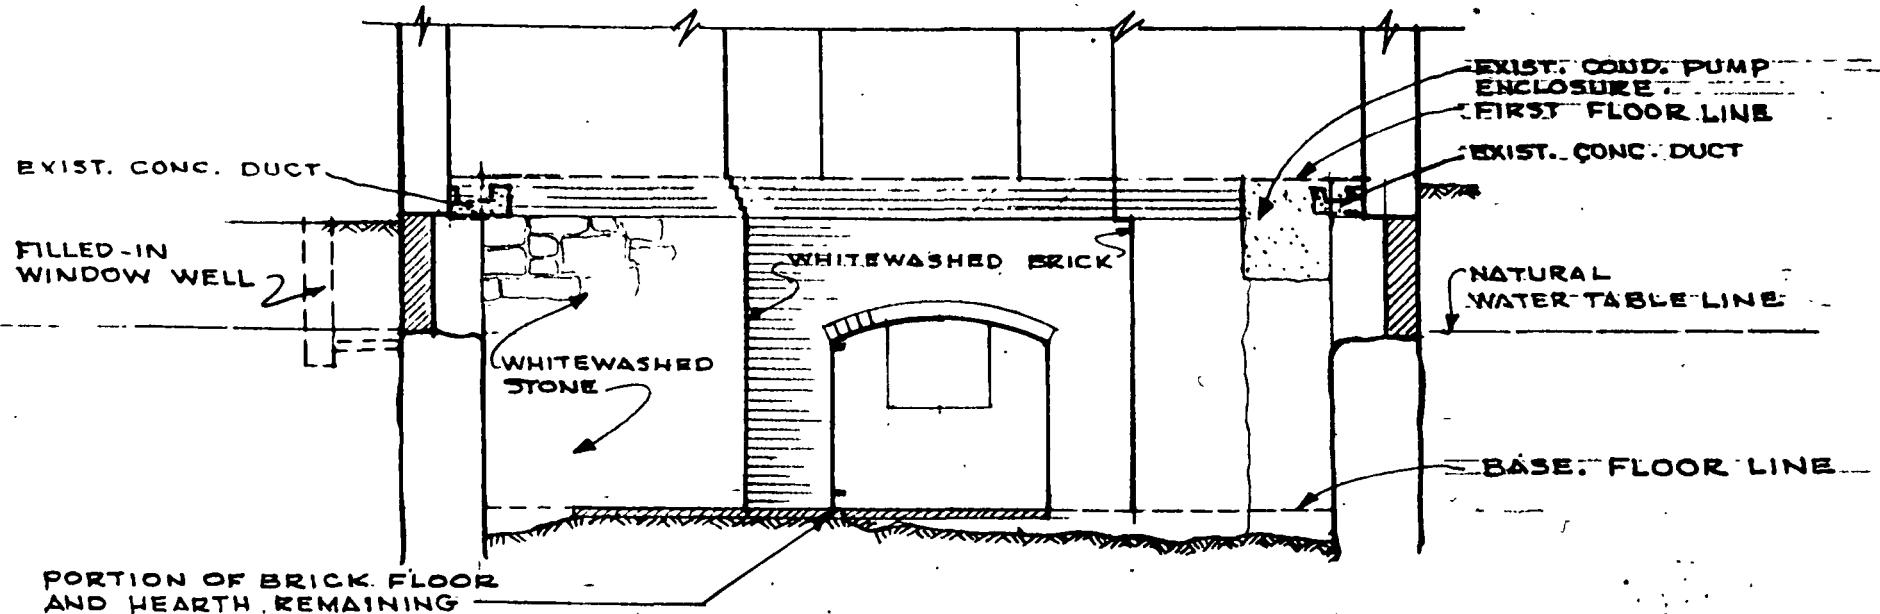
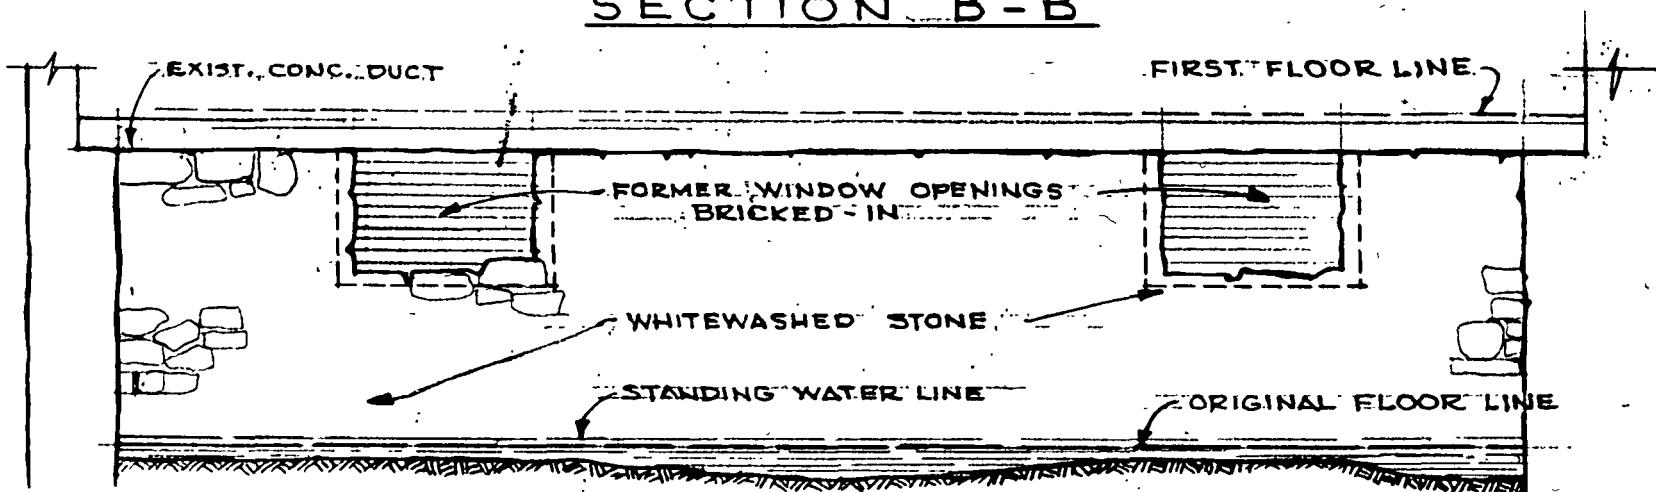
SECTIONS - EXISTING CONDITIONS

The walls are constructed of exposed rubble field stone and were whitewashed. There are three layers of whitewash indicating that the room was not used a great deal before it was filled-in. This is borne out by the small amount of burning evidence on the rear wall of the fireplace.

The masonry appears to be in good condition. A concrete channel is attached to the upper part of the two long walls for the piping to the first floor heating convectors. In addition to the pipe channels there is a 1'-6" x 3'-10" concrete enclosure in the west corner which houses the condensate pump. The concrete enclosures, which are in front of the window openings are late, dating from the installation of the present heating system, and in order to complete the architectural investigation and affect a restoration they will have to be removed.

The greater thickness of the stone foundation wall results in a ledge at the juncture of the brick walls of the building and the top of the stone masonry. The ledge at the side walls provided bearing for the first floor joists in the original building.
