Battery Horace Hambright

Fort Pulaski National Monument, Georgia

Historic Structure Report

February 2019

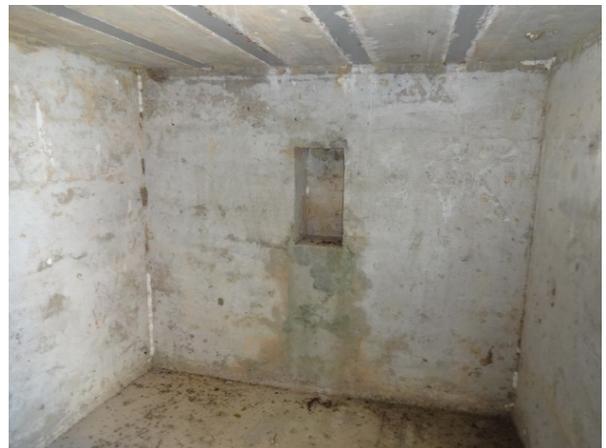
21 The magazine at the southeast corner of the
 22 battery is approximately 12 feet by 8 feet in plan
 23 (Figure 33). The walls, floors, and ceiling are all
 24 concrete. No parge coating was applied to the
 25 concrete surfaces of the east magazine. The
 26 bottom of the steel I-beams embedded in the
 27 ceiling are visible. On the south wall of the room is
 28 a small niche. The niche is approximately 3 feet 3
 29 inches above the floor, 1 foot wide, and 3 feet 6
 30 inches tall. The niche, which was likely used for
 31 ventilation, has an open pipe at the top that
 32 extends to the exterior of the building (Figure 34).
 33 The pipe extends out from the exterior wall
 34 (Figure 35).

35 **FIGURE 33.** The magazine. Note the niche in the far
 36 wall and the embedded steel beams in the ceiling.

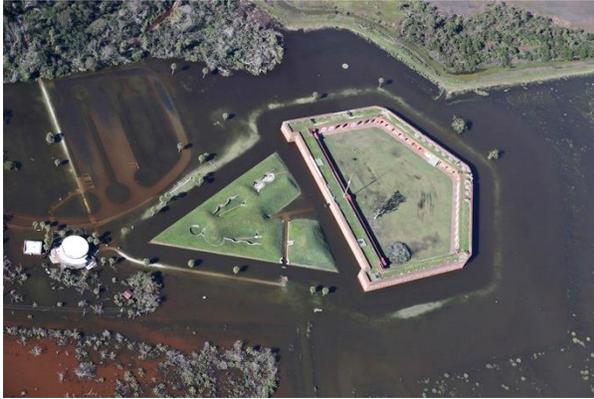
5 **FIGURE 73.** Aerial view of Fort Pulaski after Hurricane
 6 Irma, showing the dike system holding in floodwater.
 7 (Source: Fort Pulaski National Monument)

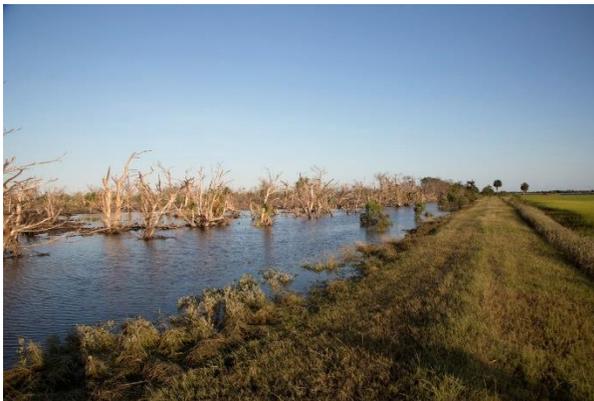
8 **FIGURE 74.** View of the dike south of the fort
 9 retaining floodwater after Hurricane Irma (channel is
 10 on right in photo). (Source: Fort Pulaski National
 11 Monument)

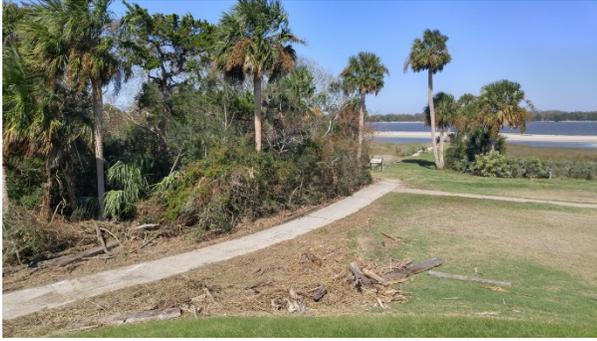
36 Although documentation and monitoring of
 37 existing conditions are important, more immediate
 38 and active measures are required at Fort Pulaski
 39 National Monument in response to climate
 40 change. Battery Hambright escaped severe damage
 41 during the hurricanes and tornado discussed
 42 above; however, the battery is not only
 43 threatened—it is also being impacted by climate
 44 change (Figure 75 and Figure 76).

7 **FIGURE 75.** View from top of Battery Hambright after
8 Hurricane Matthew, looking north. (Source: Fort
9 Pulaski National Monument)

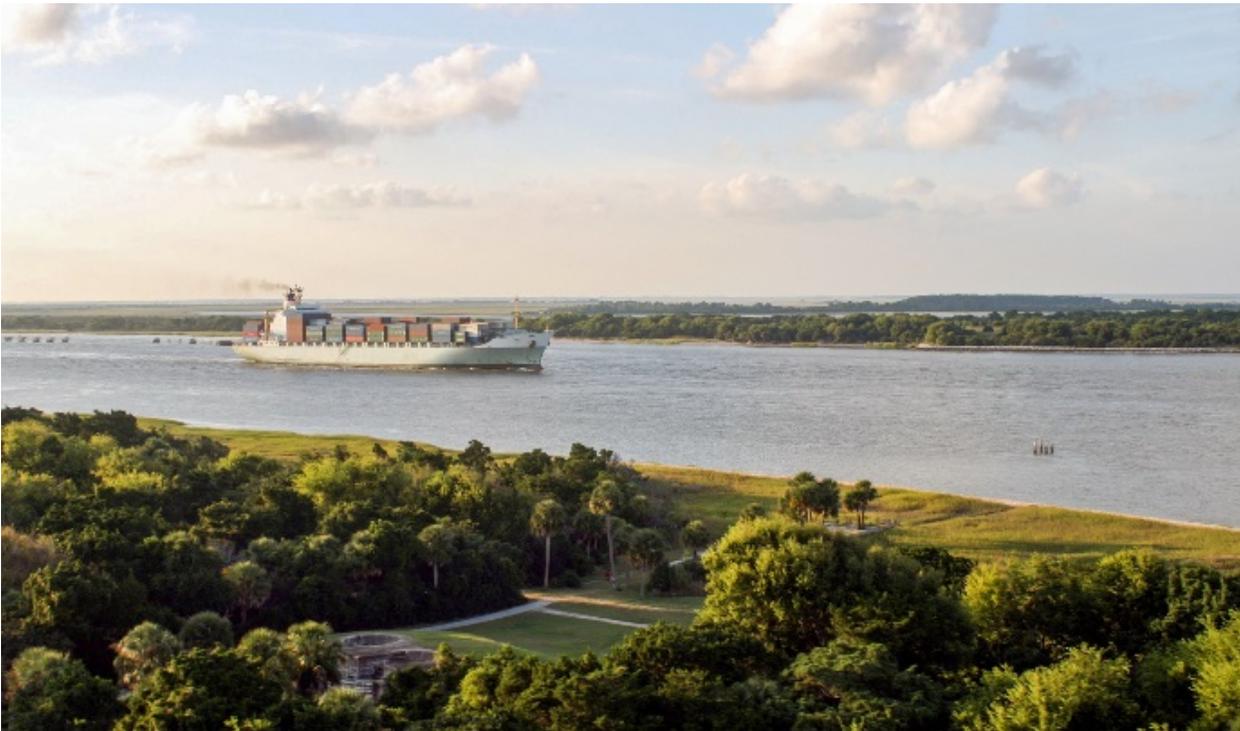
35 Erosion along the north shore of the channel has
36 significant potential to affect Battery Hambright
37 (Figure 77). The US Army Corps of Engineers
38 completed a beneficial dredge project of the
39 channel in October 2015. The spoils from the
40 dredging project were deposited near the
41 shoreline associated with the park rather than the
42 north side of the river as is usually done. This
43 effort was conducted in consultation with the
44 National Park Service Southeast Archeological
45 Center, which oversaw the protection of
46 significant historic features such as the north pier,
47 in order to create a “barrier island” that would
48 promote oyster colonization as a stabilization
49 technique. It is known that oyster bars were
50 historically found in this location, but had been
51 undercut and eroded as far as the dike located in
52 front Battery Hambright due to the wake caused
53 by large vessels, including container ships, passing

1 **FIGURE 77.** Container ship traveling along the North Channel near Fort Pulaski. (Source: Fort Pulaski National
2 Monument)

62 The placement of the dredge spoils offshore in the
63 North Channel is intended to restore the
64 underwater topography that helps to dissipate
65 wave action from passing ships. So far the effort
66 appears to be very successful. Before the beneficial
67 dredge placement, waves at high tide were lapping
68 over the dike adjacent to the north slope of the
69 battery. Today, plantings in the marsh area are
70 coming back behind the deposit, and the new
71 barrier island has retained about 40 percent of its
72 overall size despite continued passage of ships in
73 the channel. Even if erosion continues to occur,
74 spoils placement can be repeated every few years
75 when the Corps dredges the river. It is hoped that
