Visitor Center

Fort Pulaski National Monument, Georgia

Historic Structure Report

July 2019

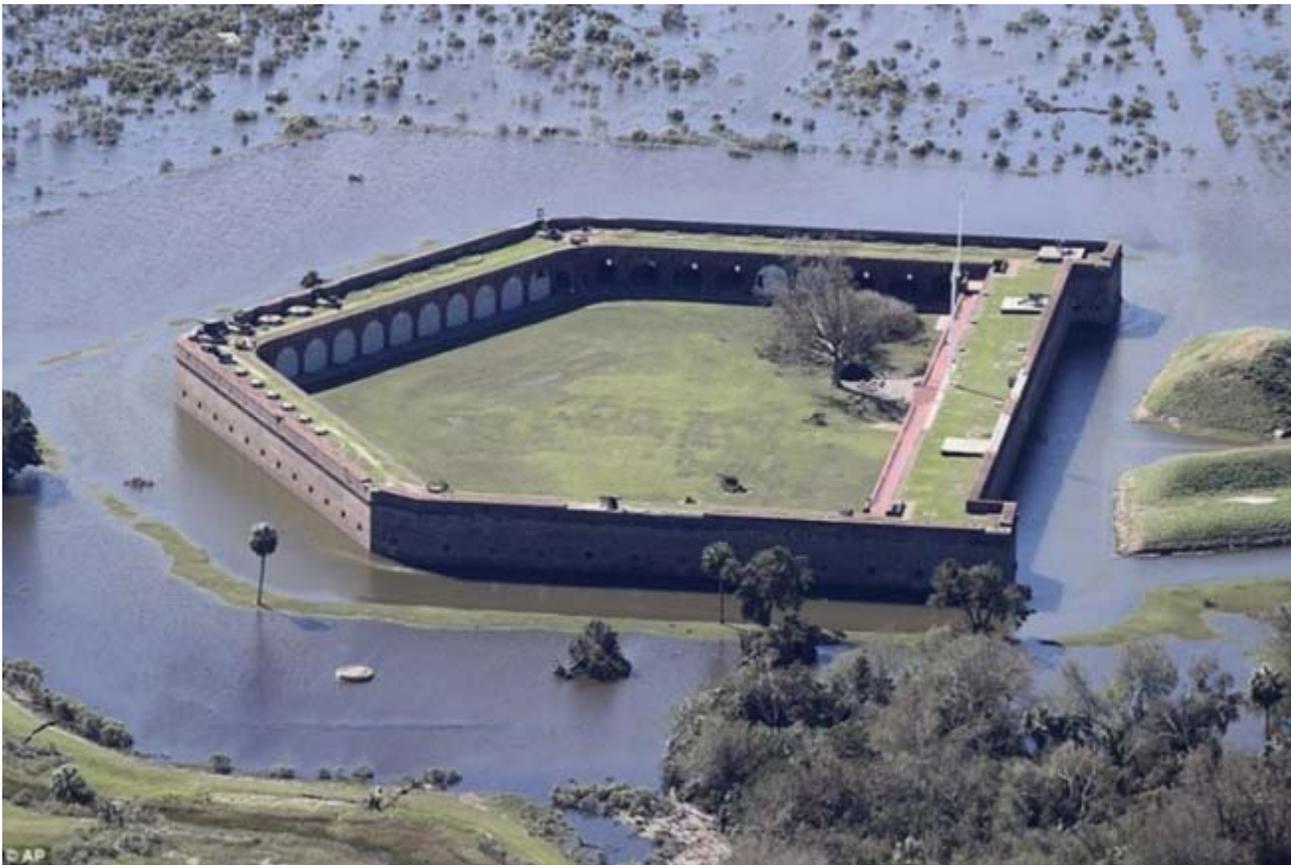
FIGURE 35. Flooding at Fort Pulaski after Hurricane Matthew, October 2016. (Source: Associated Press / Curtis Compton)

- 2016 – On October 8 and 9, after leaving a path of destruction throughout the Caribbean and along the Atlantic coast of the United States, Hurricane Matthew entered Georgia as a Category 3 hurricane. Peak wind gusts of 96 miles per hour were recorded at Tybee Island and 11 inches of rain fell at Hilton Head, South Carolina. According to NOAA / National Ocean Service data, a storm surge of 8 feet was recorded at Fort Pulaski and a new record for tide level of 12.57 feet MLLW (mean lower low water, above normal low tide), which occurred two hours after high tide, was set exceeding the old record that was established during Hurricane David in 1979.⁹⁹ The damage was severe; the park was extensively flooded, and water remained trapped within the fortification for days (Figure 35). More than 300 trees were

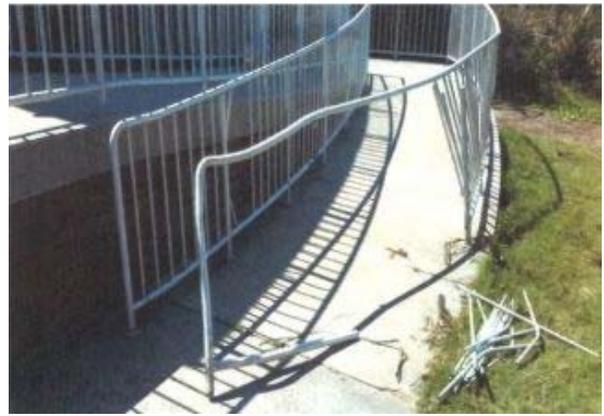
- 2016 – On May 23, an EF2 tornado caused extensive damage in the park (Figure 36). The tornado:

... touched down near the entrance of the park. The tornado then proceeded in an East / Northeast direction over the Historic District of the park. The visitor center, comfort station, fort, and surrounding landscape received damage from a direct strike. The Visitor Center sustained damages to the interior ceiling due to wind and pressure causing the suspended ceiling to break free from the hanger rods. The ceiling contains asbestos material, which must be completely removed and abated before further repairs begin. Additional Visitor Center damage corrective actions include replacing damaged walkway railing, replacing a damaged 10 ton heat pump and associated ductwork, and interior lighting, security camera and fire detection repairs sustained from ceiling damage. The Visitor Center Comfort Station roof surface was completely removed and the structure sustained a large amount of damage.⁹⁷

FIGURE 36. Railing damage at the visitor center from the tornado on May 23, 2016. (Source: *Fort Pulaski National Monument Tornado Assessment Damage Summary, May 25–26, 2017*)

A temporary visitor center was opened in the fort. It was determined that the comfort station roof structure needed to be rebuilt and a new roof added, the mini-split HVAC system needed to be replaced, the visitor center ceiling needed to be abated and repaired, and other minor damage repaired.⁹⁸

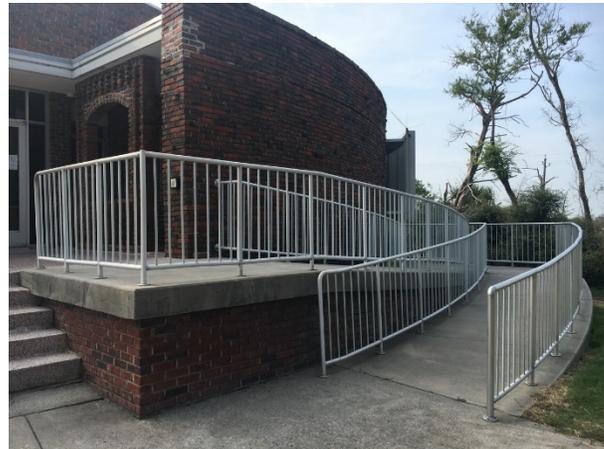
FIGURE 37. Railing at west entrance to visitor center after repairs, August 2018. (Source: Fort Pulaski National Monument)

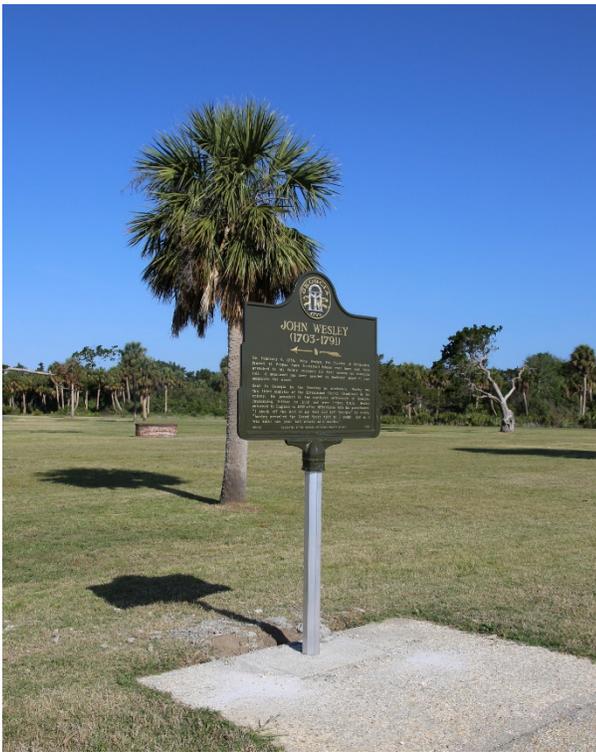
FIGURE 38. New historical marker, April 2018.
(Source: Fort Pulaski National Monument)

- 2018 – New historical markers were installed to replace those damaged by the tornado in 2016 (Figure 38). A new visitor center sign was also installed (Figure 39).
- 2018 – In November, the NPS issued a Determination of Eligibility and requested concurrence from the State Historic Preservation Office.
- 2018 – On December 4, the Georgia Department of Natural Resources Historic Preservation Division issued a letter concurring that the Fort Pulaski National Monument Visitor Center is eligible for listing in the National Register of Historic Places

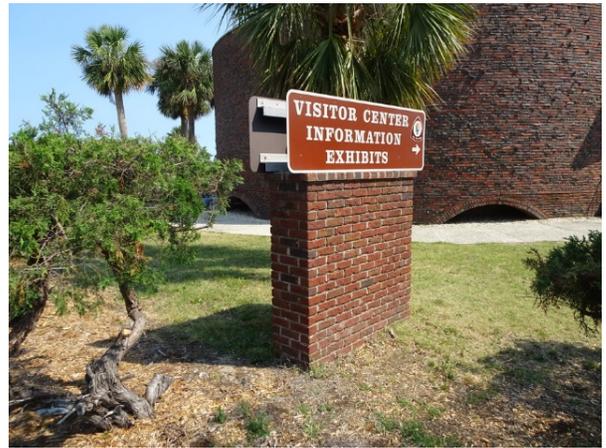
FIGURE 49. Painted steel sign (replaced in 2018).

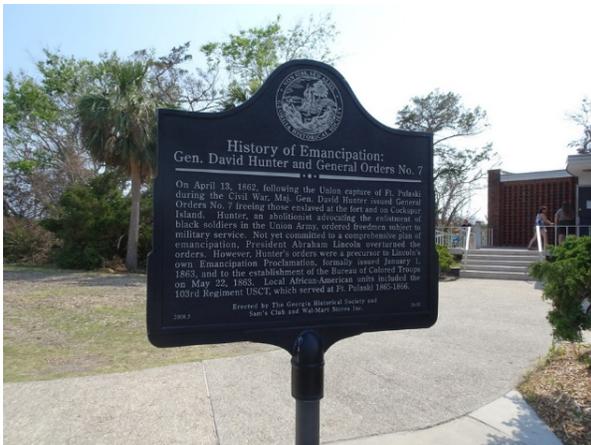
FIGURE 48. Cast aluminum informational sign. (Several of the historical markers were damaged during the 2016 tornado that struck the park, and replaced in 2018.)

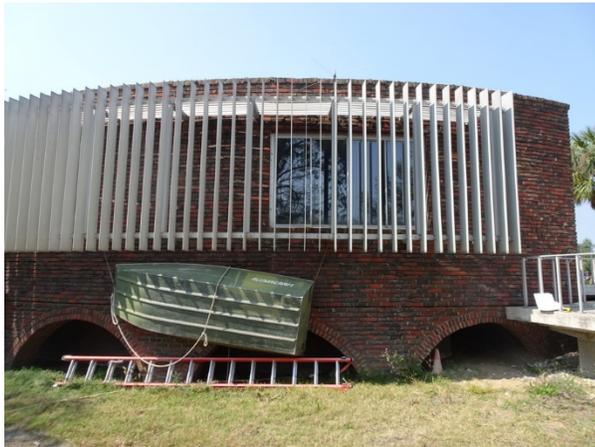
on center, and projects 24 inches from the face of the wall. Vertical slats, each measuring 8 inches wide by 8 feet long, are mounted to the tubular frame by a series of aluminum clips. The slats are spaced 8 inches apart. At the top of the sun shade and mounted to the horizontal portion of the tubular frame are a series of seven horizontal 3-inch aluminum slats. Several of the vertical louvers were displaced by the tornado that touched down in May 2017. The tubular frame that supports the louvers was also deformed, and both were repaired by the summer 2018.

FIGURE 58. Vertical louvers block direct sunlight.

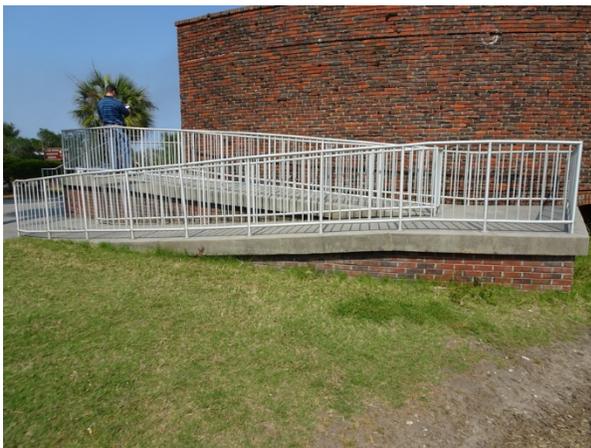
The round metal pipe railing along the entrance ramp on the west side of the visitor center was heavily damaged by the tornado. Because the vertical supports of the railing system were embedded in the concrete ramp, the ramp had to be partially demolished and reconstructed in 2017 to anchor and support a new guardrail.

FIGURE 63. West entrance U-shaped ramp. (This photograph was taken before the railing was damaged during the 2016 tornado. Photographs after the tornado, and following repairs, are provided in the preceding chapter of this report.)

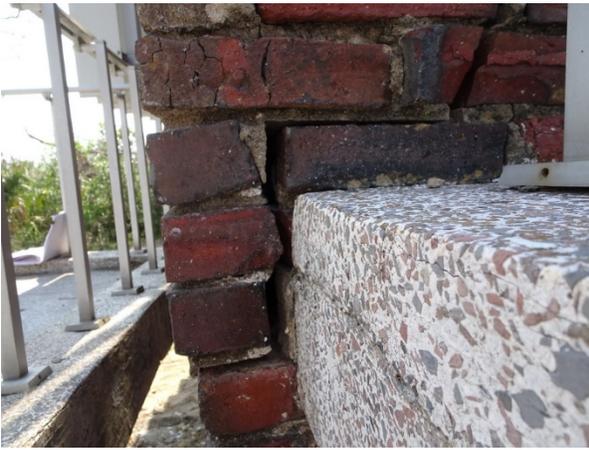
- Displacement and severe cracking were observed at the return end of the brick masonry adjacent to the east porch. The cracking was approximately 3/4 inch wide and extended vertically, approximately 24 inches through the brick masonry and joints (Figure 76 and Figure 77). The bottom of the crack extended to the terrazzo paving of the landing.
- Step cracking was observed at the brick masonry return end wall near the west entrance landing (Figure 78). The cracking extended approximately 8 feet, from a few courses above the connection with the concrete porch slab to the top of the wall. The crack extended through mortar joints as well as through several individual brick units.

FIGURE 76. Displacement of brick masonry at east entrance landing.

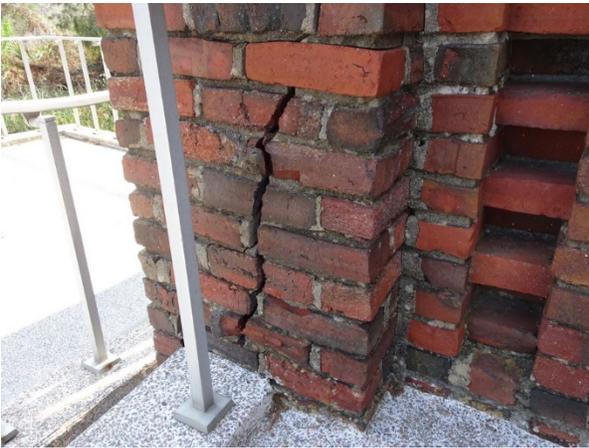
FIGURE 77. Severe cracking of brick masonry at east entrance landing.

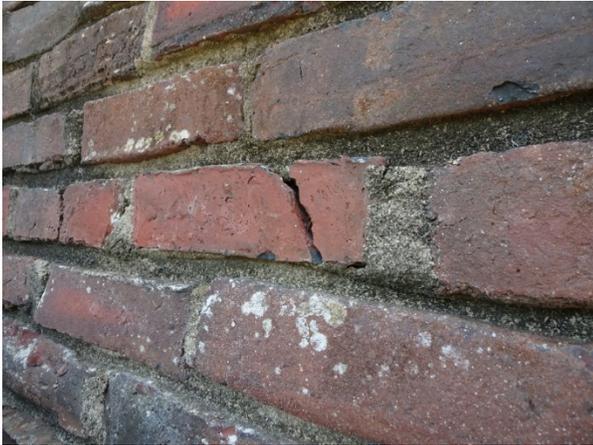
- Vertical cracking was observed at individual brick units in the field of the exterior wall (Figure 80). The cracking ranged in width from hairline to 1/4 inch in width and was typically aligned with the adjacent mortar joints above.

FIGURE 80. Vertical cracking at individual brick units.

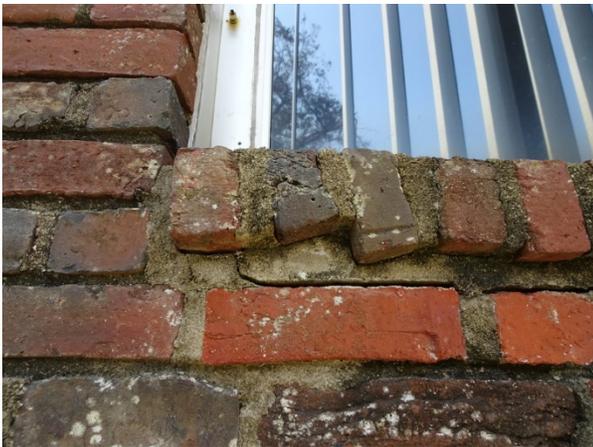
- Open and cracked joints were observed at the mortar bed joint below window sills and coping units (Figure 81 and Figure 82). The cracks were typically 1/8 inch wide. At some locations, the cracked mortar had been temporarily repaired with sealant, which was also observed to have failed.

FIGURE 81. Cracked joints at window sills.

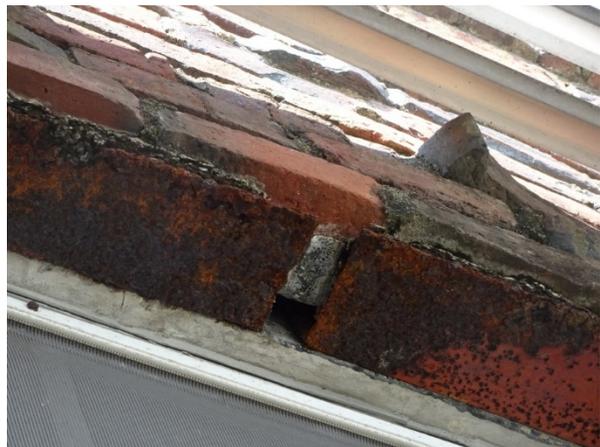
- Gaps were observed between steel shelf angles at window and door heads (Figure 83). Each shelf angle is approximately 20 feet in length and adjacent angles do not fully abut one another. The gap between adjacent shelf angles was as large as 1-1/4 inches at some locations.

FIGURE 83. Gaps at window and door heads.

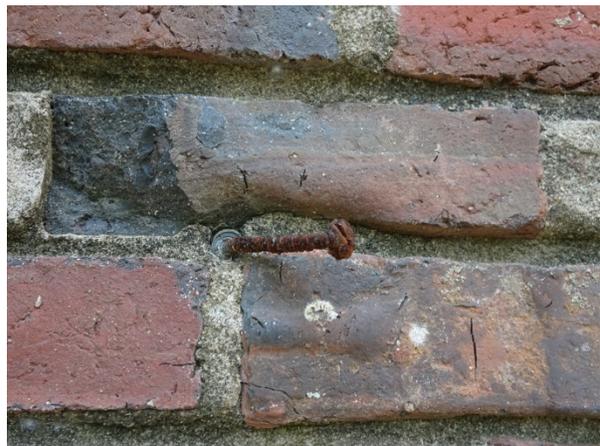
- Abandoned, ferrous expansion anchors were observed in the brick masonry (Figure 84). The anchors were set in the mortar joints and exhibited surface corrosion.

FIGURE 84. Embedded expansion anchor in brick masonry.

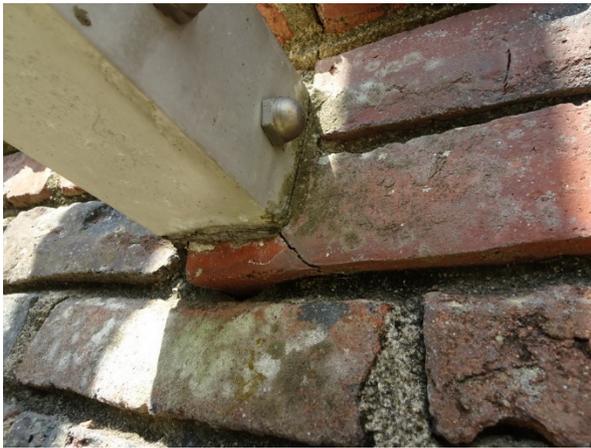
- Cracking was observed at brick masonry adjacent to the metal sun shade anchors (Figure 85). The cracks at these locations were typically 1/16 inch wide and extended outward from the location of the anchorage.
- Spalling was observed at some brick units, particularly brick units at corners and coping (Figure 86). The spalled brick was typically associated with other distress conditions such as cracked joints.

FIGURE 85. Cracking at masonry adjacent to sun shade anchors.

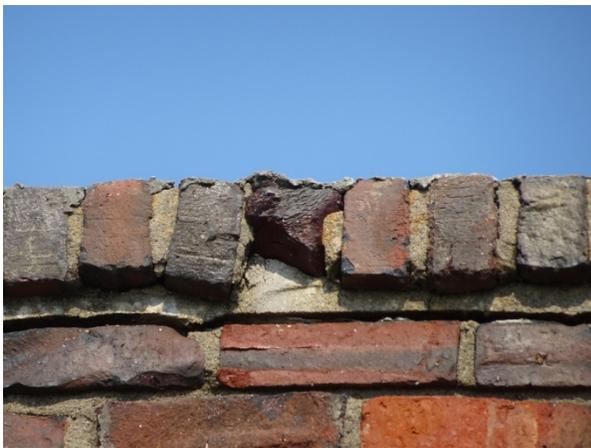
FIGURE 86. Spalling at brick units at coping.

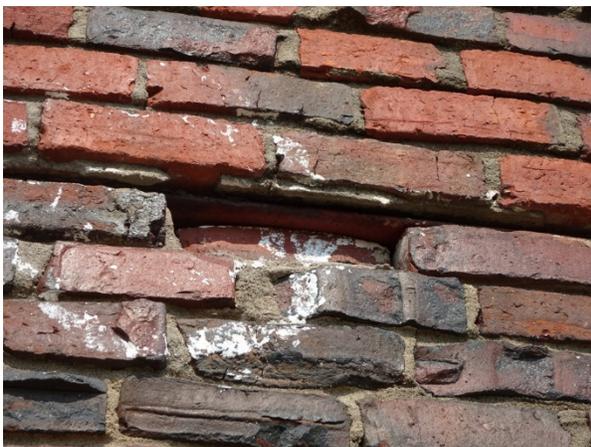
FIGURE 87. Missing brick unit below upper shelf angle.

- One brick unit below the upper shelf angle on the southwest portion of the building was observed to be missing (Figure 87). A white paint ring was observed on the masonry

adjacent to where the brick was missing. The reason for the missing brick is unknown.

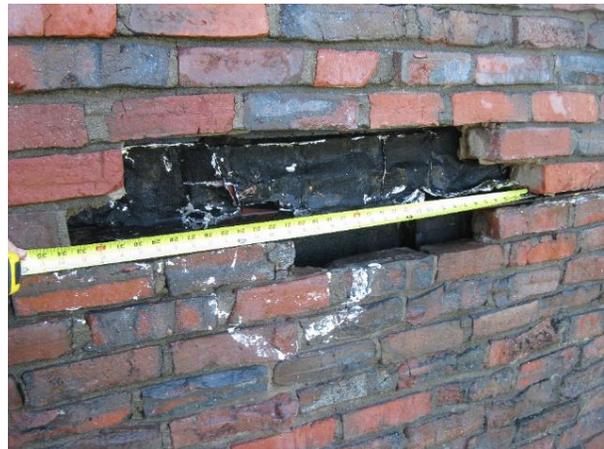
Inspection Opening No. 1. The first inspection opening was made at the upper shelf angle to the west of the aluminum sunscreen on the south facade. The opening was approximately 34 inches wide and incorporated two courses of brick above the shelf angle and one below the angle (Figure 89). The brick below the shelf angle tightly abutted the underside of the angle. Aluminum laminated flashing, consisting of a thin aluminum sheet and asphalt impregnated fabric, was observed on the angle (Figure 90). The flashing was placed in a reglet in the concrete beam approximately 5 inches above the angle and terminated approximately 1/2 inch short (inboard) of the toe of the angle. The flashing was torn and wrinkled, and it was not adhered to the steel angle. The angle measured approximately 3 inches vertically and 4 inches horizontally by 1/4 inch thick.

FIGURE 89. Overview of inspection opening no. 1.

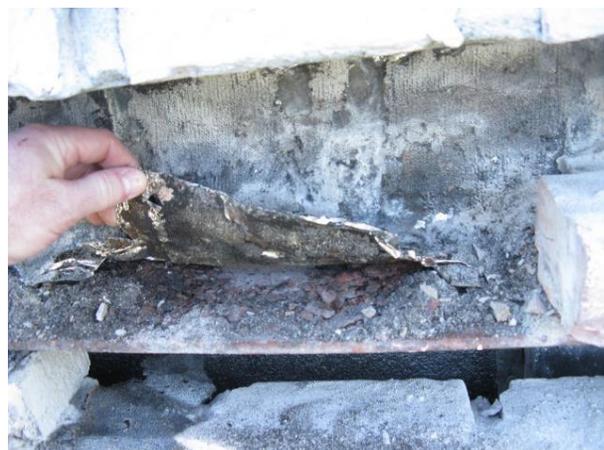
FIGURE 90. Aluminum laminated flashing at inspection opening no. 1.

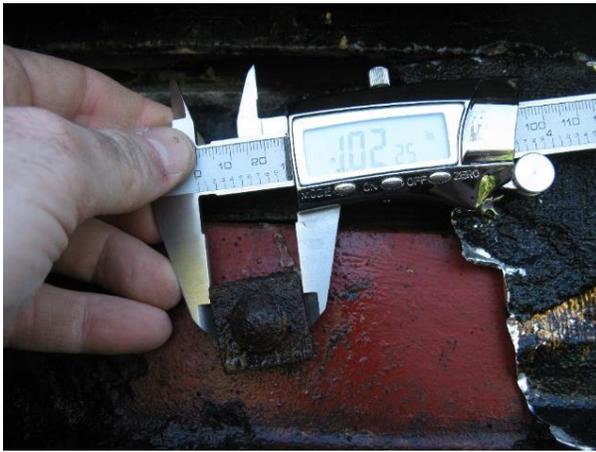
A 5/8-inch-diameter anchor bolt with 1-inch square nut, was exposed at the left end of the opening (Figure 91). The bolt was placed in a wedge insert embedded in the concrete beam. The exposed bolt exhibited moderate surface corrosion, but no section loss. A second wedge insert was noted approximately 17 inches from the first anchor; however, no slotted hole or bolt were present (Figure 92). Moderate surface corrosion was observed on the horizontal surface of the angle throughout much of the exposed length; however, significant corrosion with severe section loss was noted at the left (as viewed from the exterior) 9 inches of the exposed portion (Figure 93). Portions of the outer edge of the angle were completely missing at this location.

FIGURE 91. Close-up of anchor bolt at inspection opening no. 1.

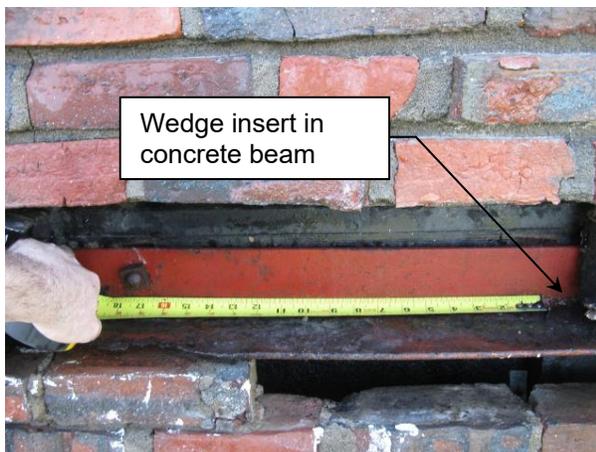
FIGURE 92. Wedge insert 17 inches from anchor bolt.

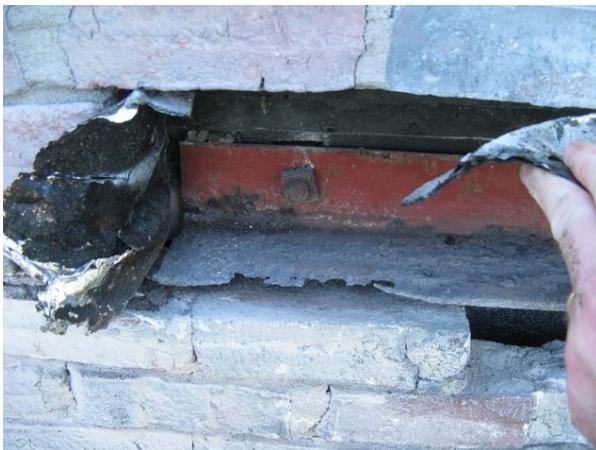
FIGURE 93. Severe section loss at left end of inspection opening no. 1.

of corrosion to defects in the flashing such as tears or wrinkles. In inspection opening No. 1, the flashing was not adhered to the angle and was wrinkled and torn near the left side of the opening, enabling corrosion of a portion of the angle. The flashings were terminated short of the end of the shelf angle at inspection opening no. 2, which has contributed to isolated deterioration of the unprotected portion of the angle.

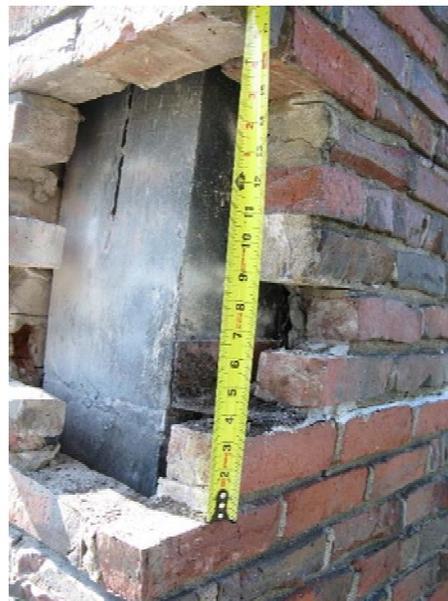
end of the wall (Figure 94). A shelf angle was observed in the south side of the opening; however, no angle was provided on the west face of the column or along the north face of the wall. The angle on the south wall matched the dimension of the angle exposed in inspection opening no. 1. A slotted hole and wedge insert were observed 4-1/2 inches from the edge of the angle; however, no bolt existed at this location (Figure 95). The aluminum laminate flashing terminated approximately 6-1/2 inches from the exposed end of the angle (Figure 96). Severe corrosion with significant section loss was noted at the exposed end of the angle (Figure 97). The angle thickness was reduced to 0.14 inches at this location. The brick below the angle generally tightly abutted the underside of the angle. A corrugated metal brick tie was observed in the cavity, in a slotted insert in the concrete column (Figure 98 and Figure 94). The tie appeared to be in good condition.

FIGURE 94. Overview of inspection opening no. 2.

Inspection opening no. 2 revealed that the shelf angle terminated on the south wall and that no intermediate supports were provided for the brick veneer on the west or north face of the wall. As a result of these varying support conditions, the cumulative expansion of the brick veneer on the west and north faces was greater than the expansion on the south facade, which contained an upper shelf angle, resulting in the cracks in the brick veneer that were noted during WJE's April site visit, as described above.

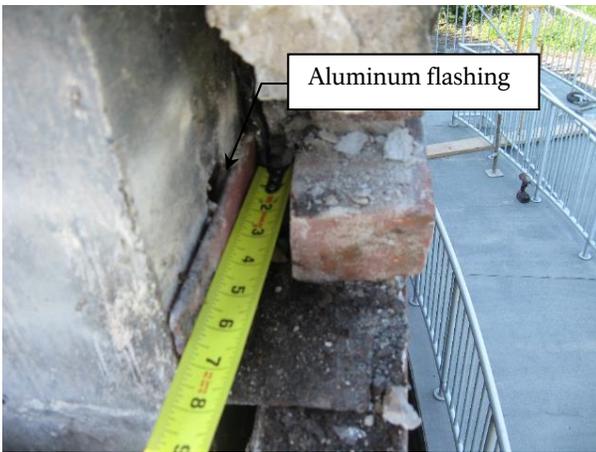
FIGURE 96. Termination of aluminum flashing.

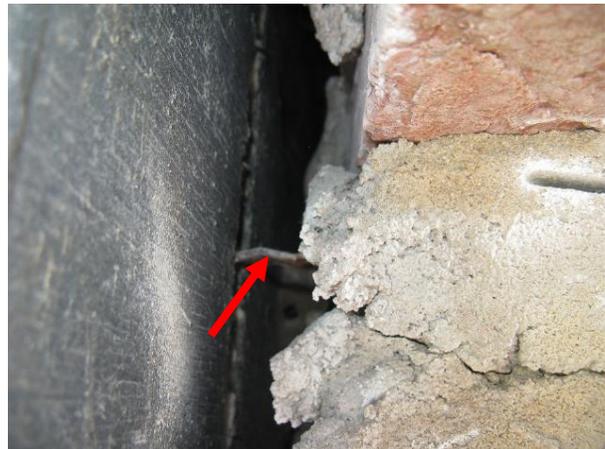
FIGURE 98. Corrugated metal brick tie in south wall.

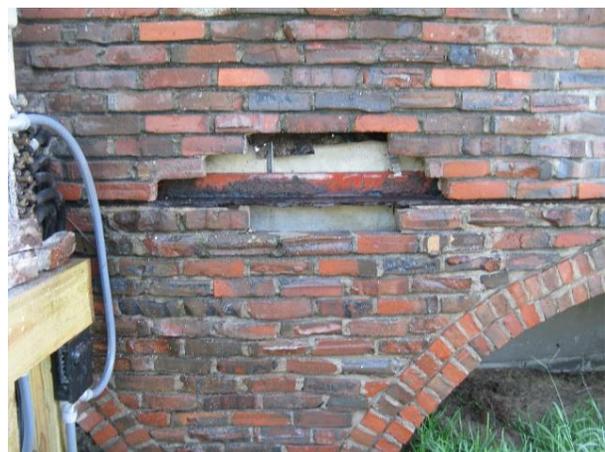
Inspection Opening No. 3. This inspection opening was made at the lower shelf angle near the center of the south wall. The opening was approximately 12 inches in height, incorporating three courses of brick above the angle and one below, and 36 inches in width (Figure 99). The angle exposed measured approximately 3-1/2 inches vertically by 4 inches horizontally by 5/16 inch thick. The aluminum laminate flashing terminated approximately 5 to 7 inches above the angle (Figure 100). Severe corrosion, including full thickness section loss, was observed on the horizontal leg of the angle throughout the entire exposed portion (Figure 101). Significant corrosion with pitting and section loss extended onto the vertical leg of the angle in some areas. No slotted holes or bolts were exposed in the opening and none could be detected in the near vicinity of the opening. Corrugated metal brick ties were noted in slotted inserts in the concrete beam at

FIGURE 99. Overview of inspection opening no. 3.

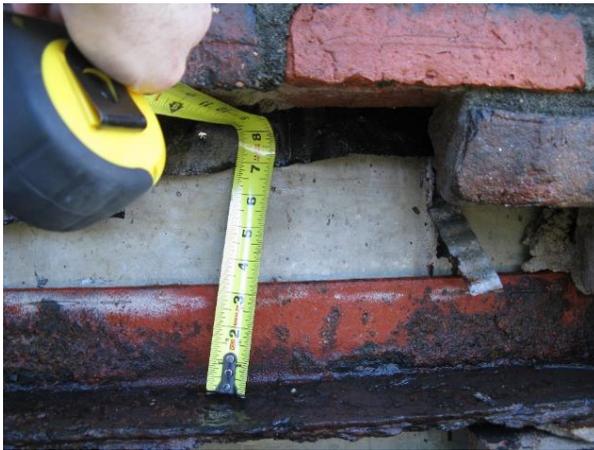
FIGURE 100. Flashing terminating above angle at inspection opening no. 3.

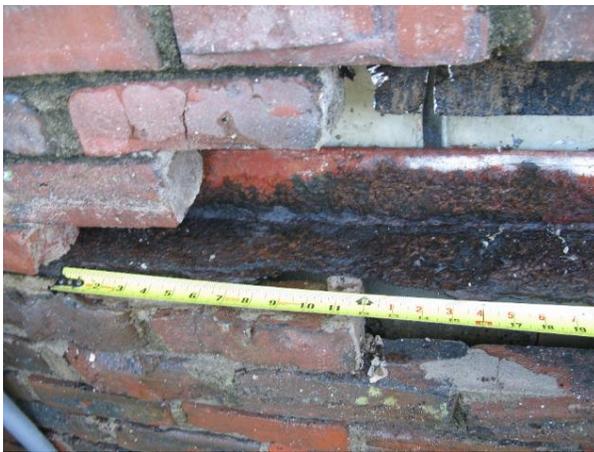
FIGURE 101. Complete section loss at horizontal leg of angle.

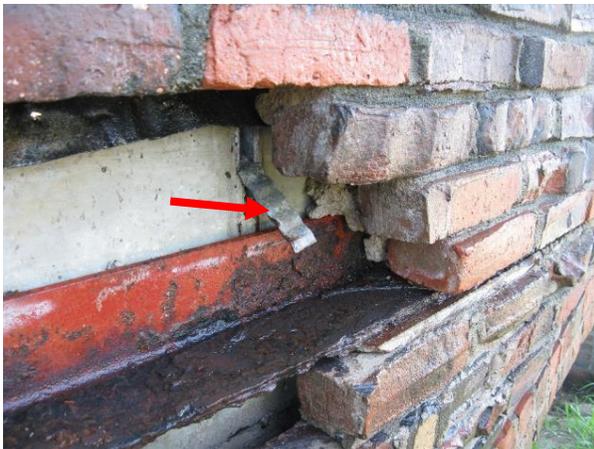
approximately 16 inches on center (Figure 102). The exposed ties were in good condition.

FIGURE 102. Exposed brick tie in insert in concrete beam.

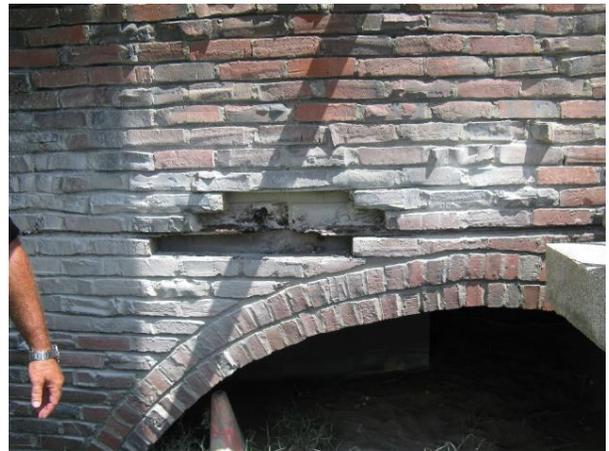
two courses of brick above the angle and one below (Figure 103). The angle dimensions matched those in inspection opening no. 3. The opening was made at the ends of adjacent shelf angle segments. The aluminum laminate flashing terminated approximately 9 inches above the angle and extended into the brick veneer. Bolts were observed near the end of each shelf angle segment. The bolt in the segment exposed at the left side of the opening was severely corroded (Figure 104). The bolt in the shelf angle segment exposed at the right side of the opening exhibited surface corrosion, but the nut had lost significant section (Figure 105). Both angles exhibited full section loss across the horizontal leg over a portion of the exposed area (Figure 106).

FIGURE 103. Overview of inspection opening no. 4.

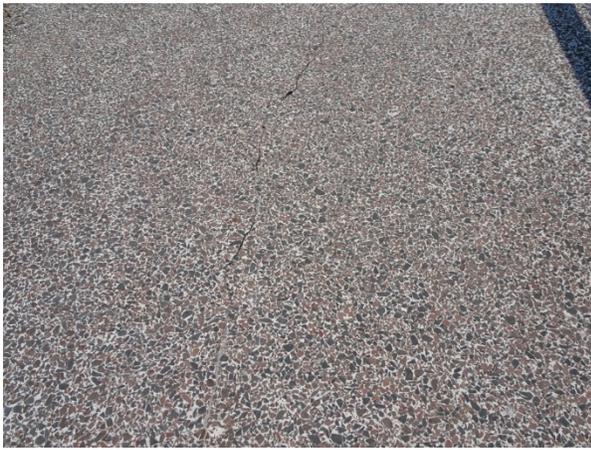
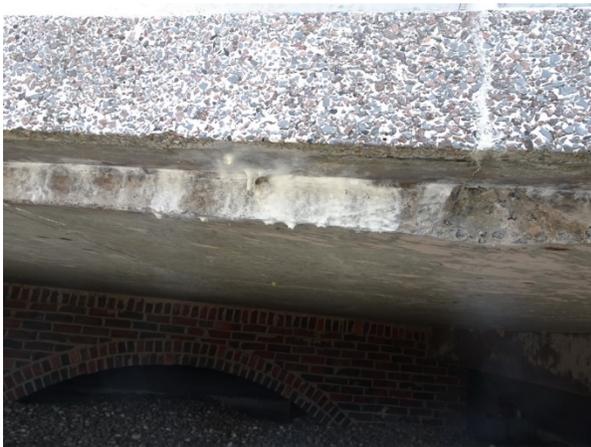
- Cracking was observed at the terrazzo deck at the entrance landings. The cracking consisted of hairline to 1/8-inch wide cracks in the concrete (Figure 107 and Figure 108). At some locations, specifically along the side and outer edge of the deck, the cracking appeared to be more widespread and was accompanied by efflorescence (Figure 109). At one location, a 1/8-inch-wide crack/incipient spall was observed. The crack/spall was positioned near the edge of the landing slab, where it abuts the concrete ramp (Figure 110). Typically, the wider areas of cracking appeared to be associated with loss of the exposed aggregate.

FIGURE 107. Cracking at terrazzo landing.

FIGURE 108. Cracking at terrazzo landing.

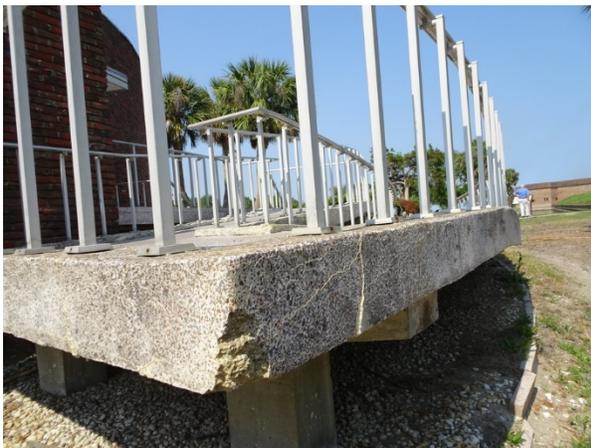
FIGURE 109. Cracking at outer edge of porch deck.

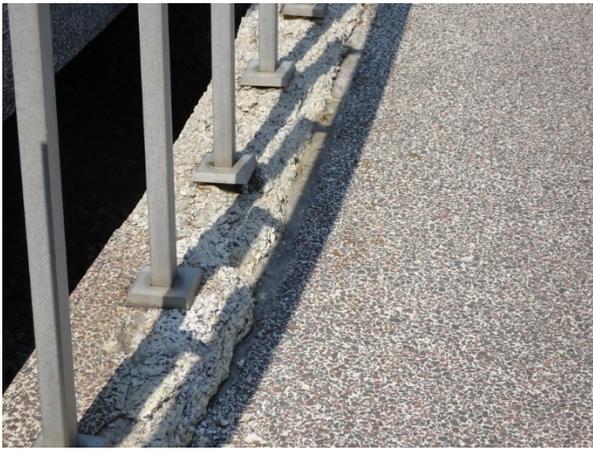
- Horizontal cracking and severe deterioration of the terrazzo were observed at the 2-inch-tall curb and the terrazzo landing at the east entrance (Figure 111 and Figure 112). The spalling was most pronounced at the edges of the curb.
- A large spall was observed at one location on the east entrance terrazzo landing (Figure 113). The spall was approximately 2 inches wide, 12 inches long, and 1/2 inches deep and was adjacent to a metal divider strip.
- Hairline cracking was observed at the concrete surface of the west ramp (Figure 114). The cracking was typically hairline and extended perpendicular across the ramp at regular intervals approximately 6 feet apart.

FIGURE 112. Deterioration of concrete at terrazzo porch.

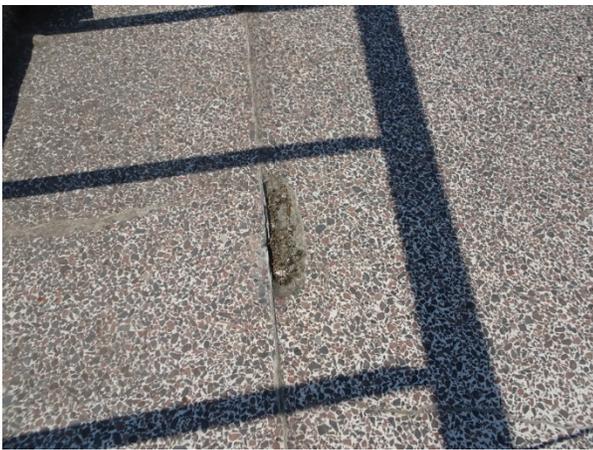
FIGURE 113. Spall at east porch terrazzo deck slab.

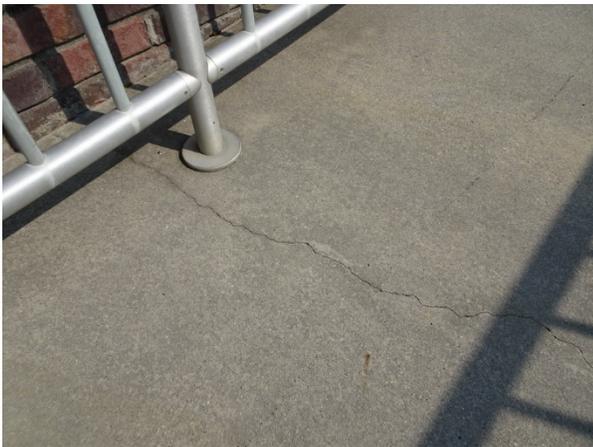
FIGURE 114. Hairline cracking at west ramp.

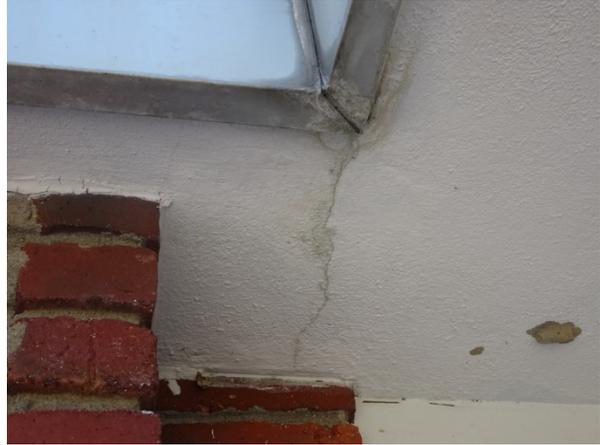
- Cracking was observed at the plaster ceiling at the exterior overhangs (Figure 115). The cracks were typically less than 1/16 inch in width and were located at interior corners.

FIGURE 115. Cracking observed at exterior canopies.

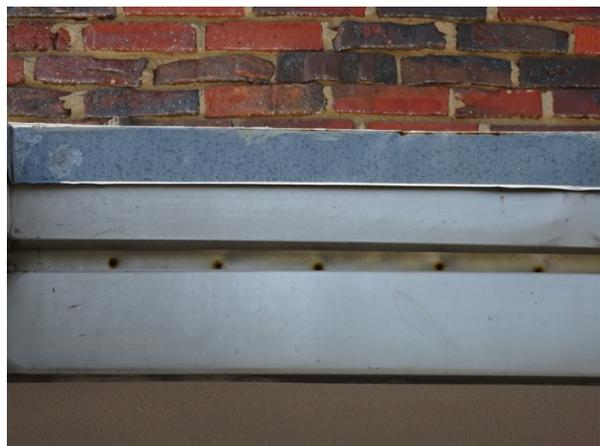
- Displaced vertical sun shades were observed at two locations. The displacement was observed following the May 2017 tornado event. Distress included a broken metal angle at the base of the vertical fins. The fins were displaced approximately 1/2 inch.
- Mild surface corrosion was observed at metal features including fasteners and metal-framed doors. The corrosion was most pronounced at roof termination bars, windows, and at the decorative fascia at the canopy roofs where the fasteners are more exposed to the elements (Figure 116).

FIGURE 116. Mild surface corrosion.

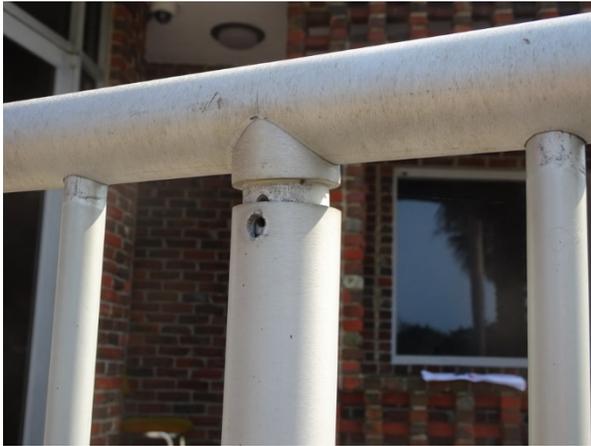
- Displaced handrails were observed at a few locations (Figure 117). The displacement included missing anchors and impact damage, both of which may result in components of the handrails becoming bent, loose, or damaged. Additional damage was documented following the May 2017 tornado event. It was reported that approximately 50 percent of the length of the non-original handrail at the west accessibility ramp had been damaged. The damage included broken and bent spindles and rails.
- Biological growth was observed on the face of the aluminum sun shades (Figure 118). The growth was most pronounced at the base of the shades as well as at the horizontal framing members.

FIGURE 117. Displaced handrails.

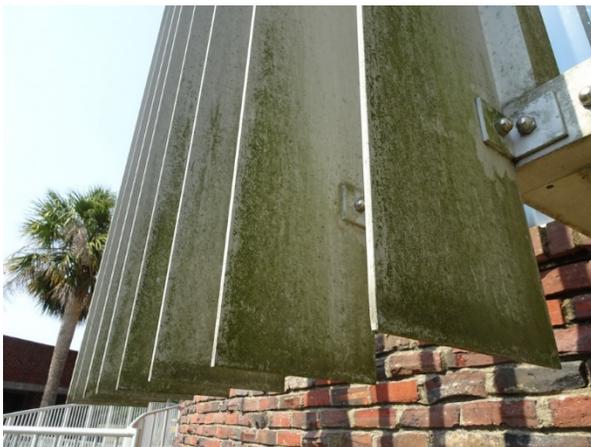
FIGURE 118. Biological growth on aluminum sun shades.

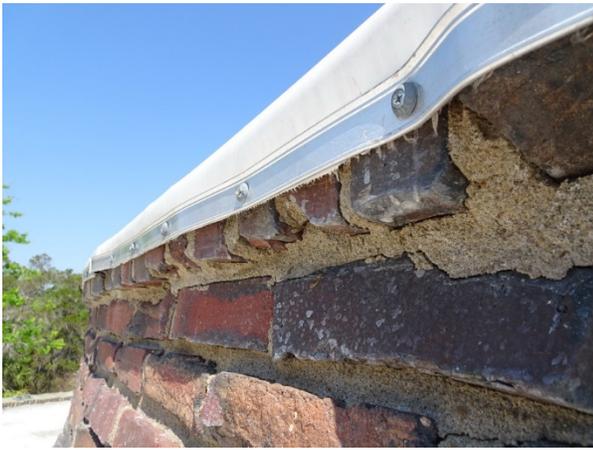
- The roof membrane and termination bar at the upper roof are anchored into the exterior face of the brick wall (Figure 120). This detail causes damage to the brick and has introduced unaccommodated stresses to the roof membrane. It has the potential to reduce the serviceable life of the roof membrane. In addition, the detail is aesthetically intrusive to the historic appearance of the building.
- Punctures were documented in the roof membrane following the May 2017 tornado. There were two punctures identified; each puncture appeared to have been caused by debris embedded in the roof.
- At a few locations, small voids and penetrations were observed at the adhered seams of the TPO roof system (Figure 121). The distress was typically located at flashing details, such as at scuppers and parapet walls.

FIGURE 120. Improper anchoring of roof membrane and termination bar.

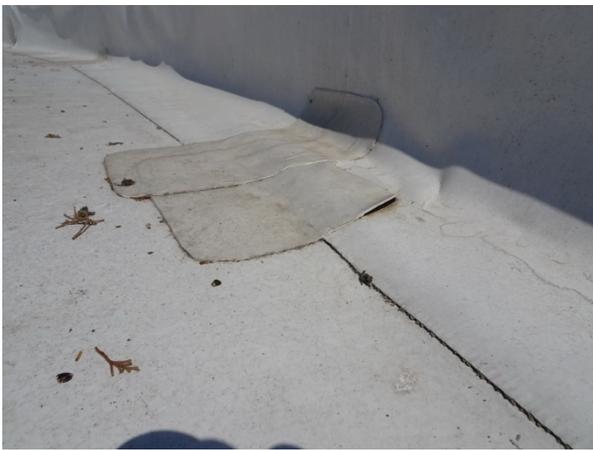
FIGURE 121. Voids at seams of TPO roof system.

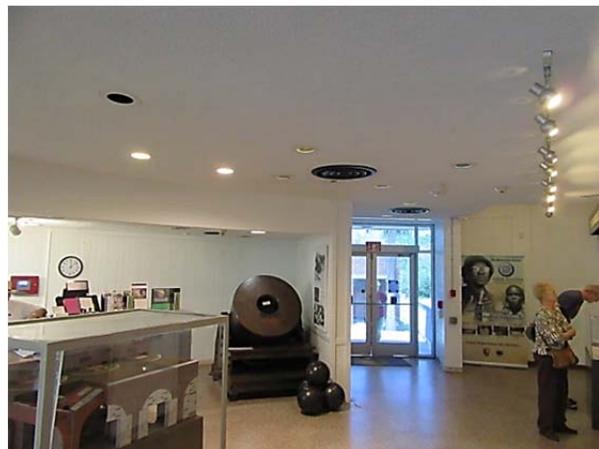
FIGURE 134. The 9-foot-tall plaster ceiling in the exhibits space

not damaged by the tornado and, consequently, were not abated along with the plaster ceilings in the rest of the building (refer to Figure 134). Abatement and replacement of all remaining asbestos-containing ceilings in the visitor center should remain a priority.

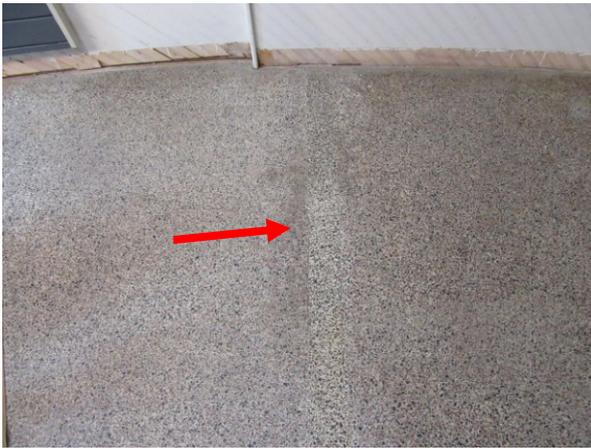
Presently, minor cracks are visible in the floor, and the position of previously demolished walls can be seen where the floor color changes slightly (Figure 137). Also, the terrazzo is chipped in places where former displays and exhibits were anchored to the floor (Figure 138).

FIGURE 137. Ghosting from original interior partition on terrazzo floor.

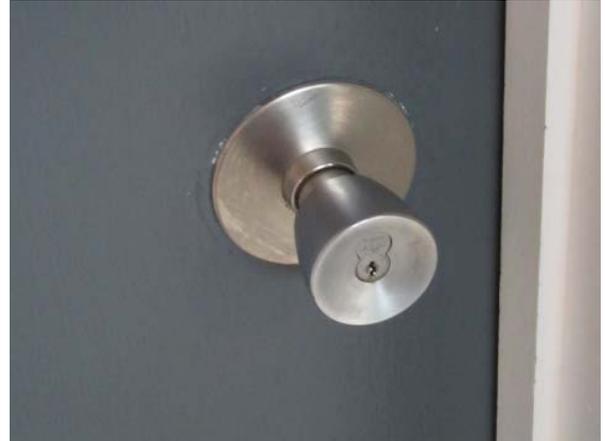
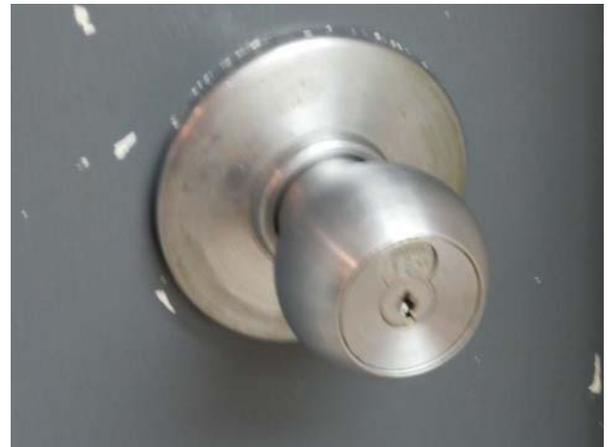
Generally, interior doors throughout the visitor center have a mixture of cylinder and mortise hardware with a variety of knobs, which are not compliant with the requirements of the Americans with Disabilities Act (ADA) (Figure 152 and Figure 153 and refer to Figure 149).

FIGURE 152. Knob door hardware.

FIGURE 153. Knob door hardware.

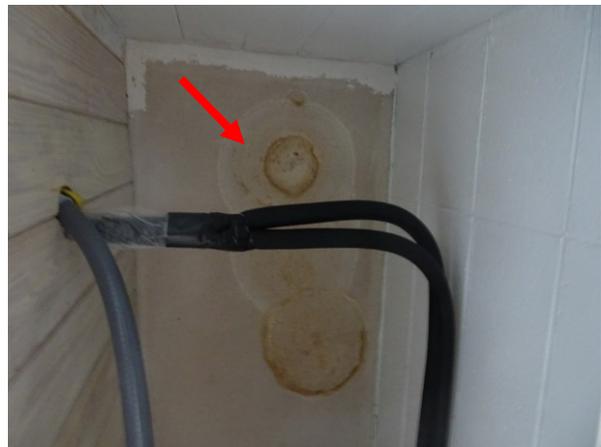
- Plaster degradation and water stains on ceilings from roof leaks and at roof drains are evident. According to park staff, a recently installed new roof has mitigated the leaks (Figure 156 and Figure 157).

FIGURE 156. Water stains on plaster ceiling.

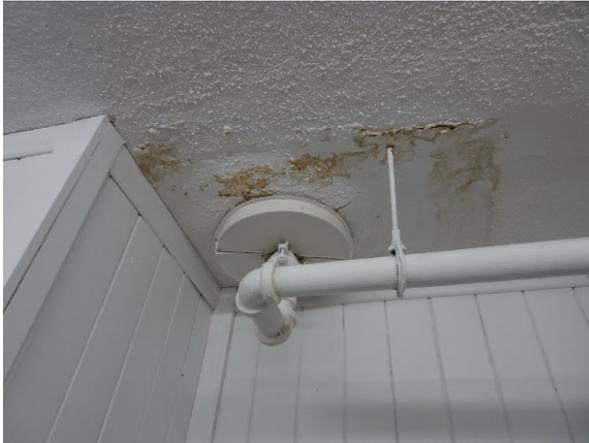
FIGURE 157. Plaster degradation and water stains on plaster ceiling at roof drain.

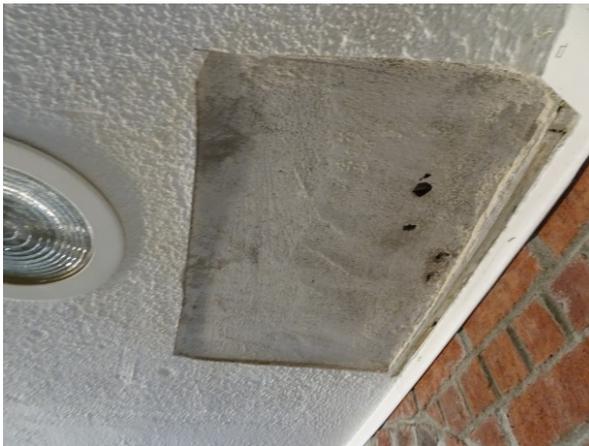
- A rectangular section of the plaster ceiling behind the information desk was removed in the past, leaving a thin layer of the brown coat still adhered to the wire mesh. A repair should

be a priority during the next maintenance cycle (Figure 158).

FIGURE 158. Rectangular cutout in plaster ceiling.

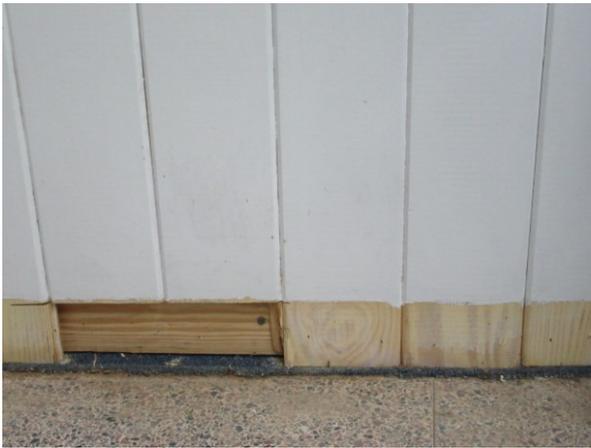
FIGURE 159. Non-original wood paneling over original CMU wall.

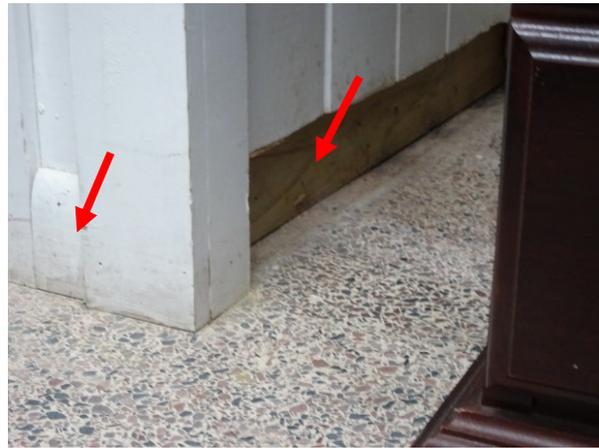
FIGURE 161. Tear-drop baseboard and missing baseboard below non-original wood paneling.

- After Hurricane Matthew in October 2016, the vinyl cove base at the bottom of walls was removed to aid mold remediation. Some of it is still missing resulting in an unsightly condition (refer to Figure 144 and Figure 157). Where new wood paneling was installed, common tear-drop wooden baseboards were applied; they are also missing in places (Figure 161). According to park staff, new vinyl and wooden base are scheduled for installation.

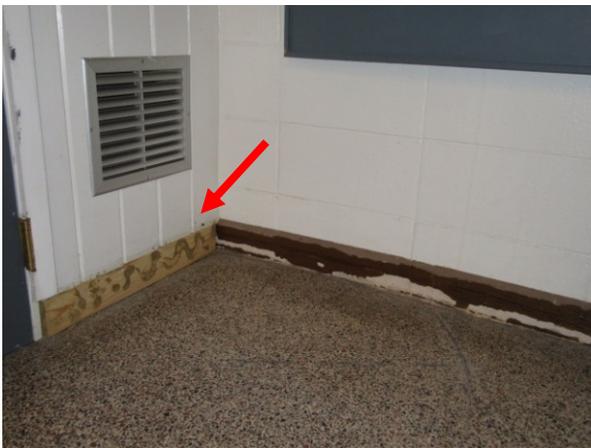
FIGURE 160. Wood paneling on wood stud wall adjacent to original CMU. Missing vinyl base on CMU wall.

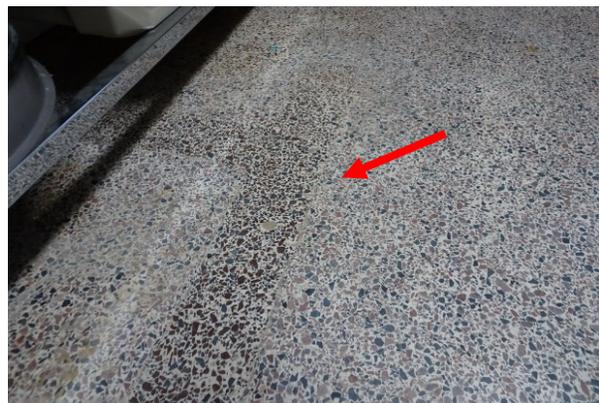
- The terrazzo floor in the visitor center is still in good condition after years of visitor and staff traffic. Cracks that appeared in 1964 after the building was completed did not adversely affect its serviceability or appearance. Slight ghosting is apparent where original interior partitions were removed (Figure 162), and there is some spalling where exhibits and displays were anchored to the floor.
- Rust stains are visible where water on the floor has caused metal file cabinets and furniture to corrode, particularly in office 2 (Figure 163). Although the staining is unsightly, the performance of the terrazzo is not compromised.

FIGURE 162. Ghosting from original interior partition on terrazzo floor.

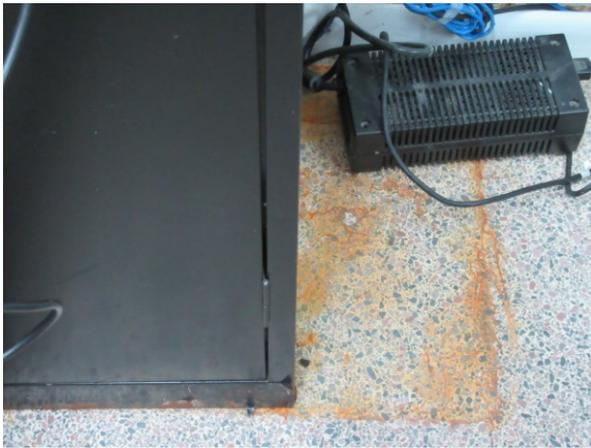
FIGURE 163. Rust stains on terrazzo floor.

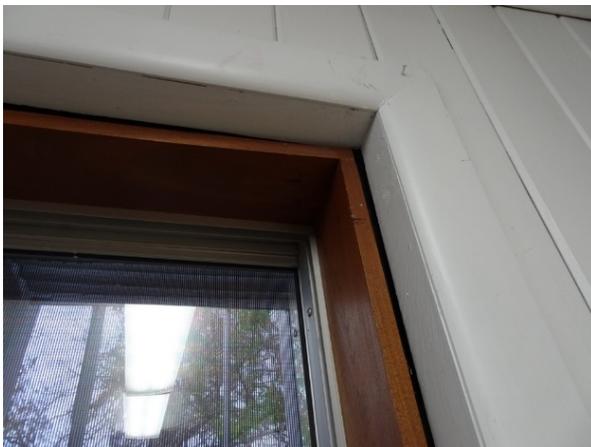
FIGURE 164. Original stained wood trim at windows is partially covered by painted trim.

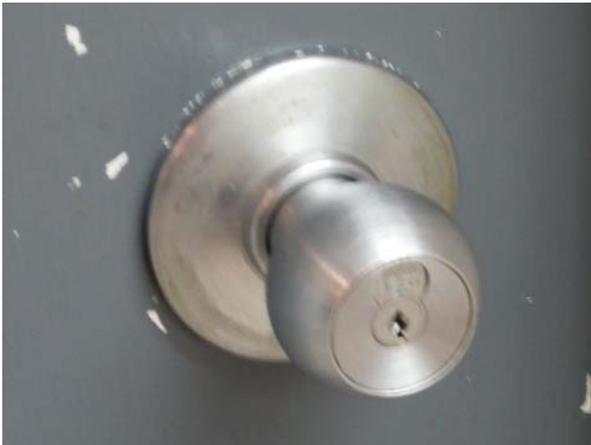
- Several interior doors were either painted or replaced the original stained, solid-core, flush wood doors. Two original stained wood doors are located in the mechanical room and the janitor's closet; the latter still retains its glass transom. Other transoms have been filled in with painted wood paneling.
- Two stile-and-rail doors with full glass lights are located at the entrance to the theater. Both are recent additions and are in good condition.
- Hardware throughout the visitor center is a combination of original and recent components. Most of it is in fair to good condition and appears to function properly. Finishes on the older hardware are worn. The variety of knobs is not consistent with the

original hardware, and knobs are not ADA compliant (Figure 167).

FIGURE 167. Knob door hardware is not ADA compliant.

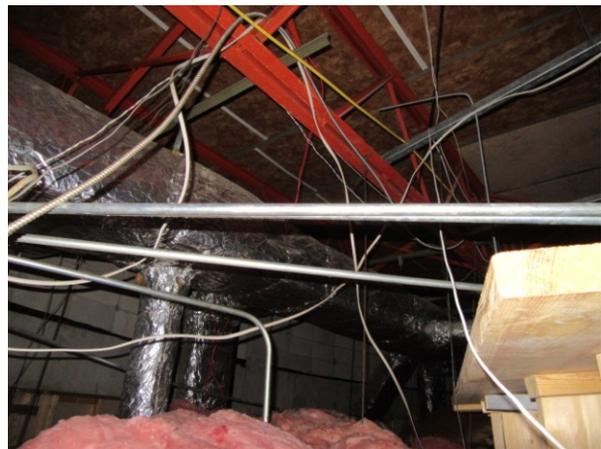
FIGURE 169. Tangle of wires above the suspended plaster ceiling.

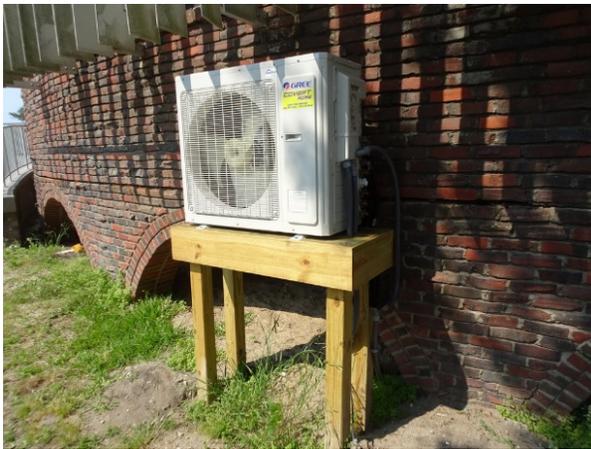
FIGURE 178. VRF system outdoor heat pump compressor that was replaced after it was damaged by the Hurricane Irma and the tornado in 2017.
