Visitor Center

Fort Pulaski National Monument, Georgia

Historic Structure Report

July 2019

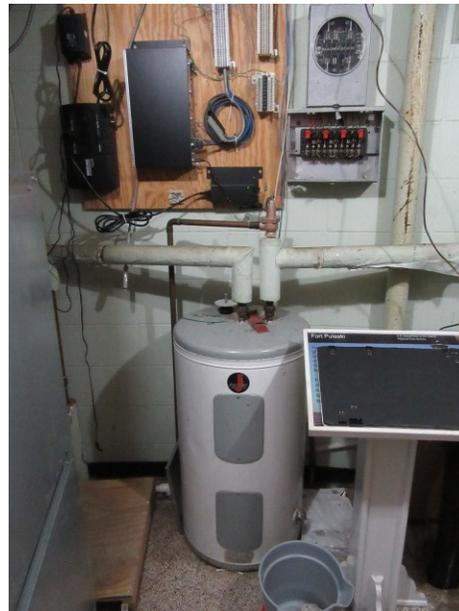
FIGURE 180. Electric water heater in mechanical room.

Plumbing. Potable water is supplied from a remote well house southeast of the visitor center to an electric water heater in the mechanical room (Figure 180). When the original men's and women's restrooms were removed during the early 1990s, domestic water lines and drain lines in the crawlspace to these two restrooms were abandoned and capped. Plumbing for the janitor sink and break room sink remain (Figure 181). A waste line runs to a subgrade septic system and drain field nearby.

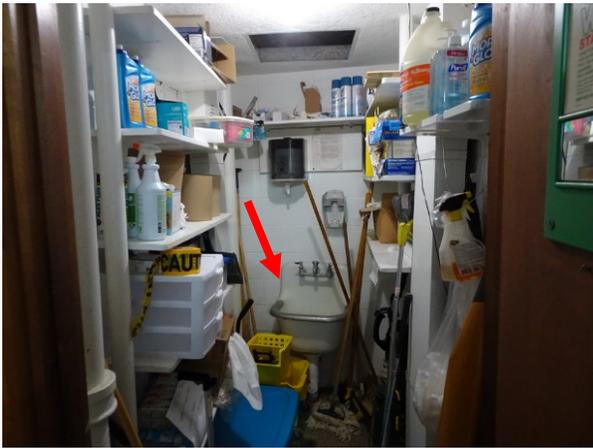
FIGURE 181. Janitor sink.

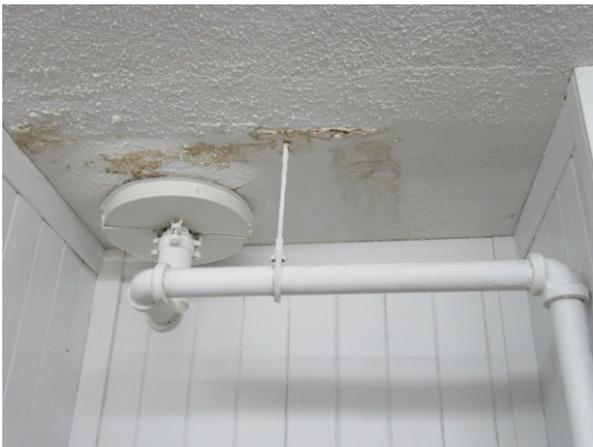
Cast iron roof drains and piping for the lower roof are exposed in the administration and staff spaces, and water stains and ceiling damage around the drains are an indication of past leaks (Figure 182). It was not possible to observe all the other drains, since drains for the higher roof are only accessible above the plaster ceiling at access hatches in the janitor's closet and mechanical rooms. Beyond those immediate locations, views are blocked by ductwork and insulation (Figure 183).

FIGURE 182. Water stains and plaster ceiling damage around roof drain in office 2.

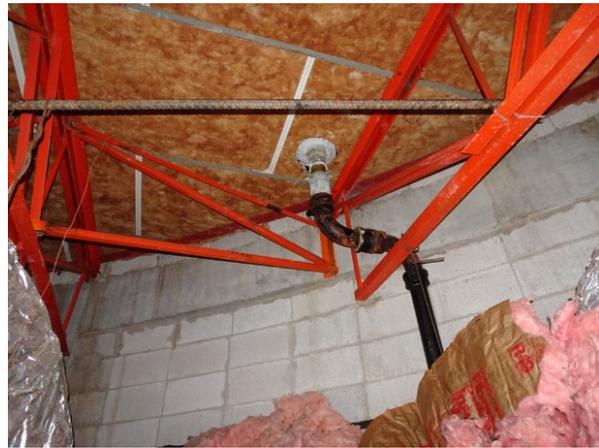
FIGURE 183. Roof drain from high roof above suspended plaster ceiling, as viewed from access hatch.

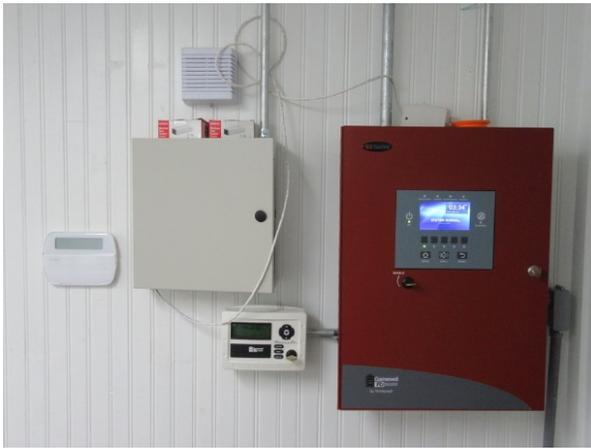
The current fire alarm control panel and annunciator control pad are in office 1 on the north wall (Figure 184) and an ancillary panel is mounted on the wall behind the information desk. Hard-wired and wireless smoke and heat detectors are distributed throughout the building. New devices replaced older ones, but many of the outdated and non-functional detectors remain, in some places next to the new ones (Figure 185). Manual fire alarm pull stations are at the main east and west entries and next to the exit door in office 2 (Figure 186). Besides fire extinguishers, there is no integrated fire suppression (sprinkler) system (Figure 187). Most likely this is because the visitor center was originally designed and constructed to be non-combustible, as that was defined by the applicable building code in the early 1960s, and because the park was and is not connected to a municipal water system.

FIGURE 184. Fire alarm panel (red), annunciator control pad, and security system panel.

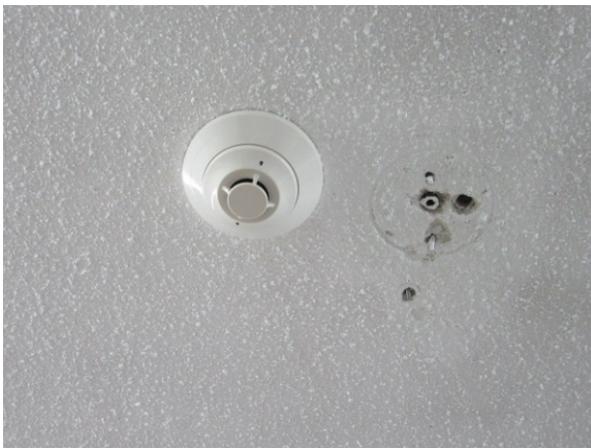
FIGURE 185. New smoke and fire sensor next to remnants of old sensor.

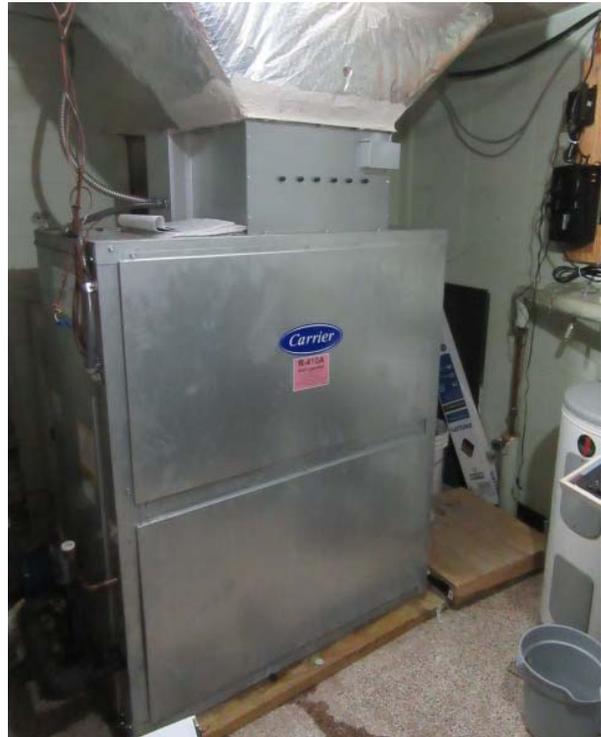
- The two HVAC systems are relatively new and energy efficient. An air handler for the ten-ton, split system, heat pump located in the mechanical room is connected to ducts above the suspended ceiling (Figure 191).
- Condensate from the indoor equipment was trickling along the floor from under the unit to a floor drain. Typically, a condensate line carries liquid from the equipment to a drain (Figure 192).

FIGURE 191. Ten ton air handler.

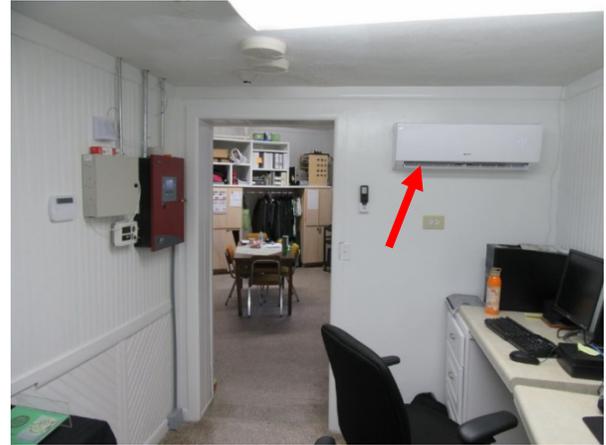
- A highly efficient, ductless, variable refrigerant flow (VRF) system was installed for the administration spaces on the south side of the building. It is also less than two years old and appeared to be working properly at the time of the site visit for this report (Figure 194). Since that time, the VRF units were damaged by Hurricane Irma and a tornado in 2017 and were inoperable. These units were replaced with new ones in July 2018.
- Some ducts and supply registers were abandoned when the VRF system was put in.

FIGURE 194. Wall-mounted indoor VRF fan unit.

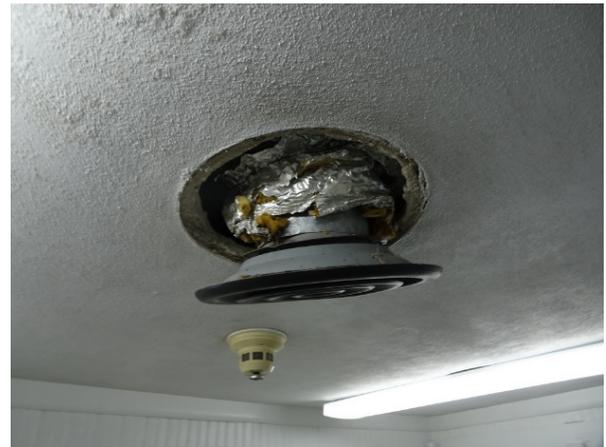
A ceiling mounted register in office 1 was hanging from the ceiling attached only to an insulated duct (Figure 195).

FIGURE 195. Abandoned HVAC supply register no longer secured to plaster ceiling.

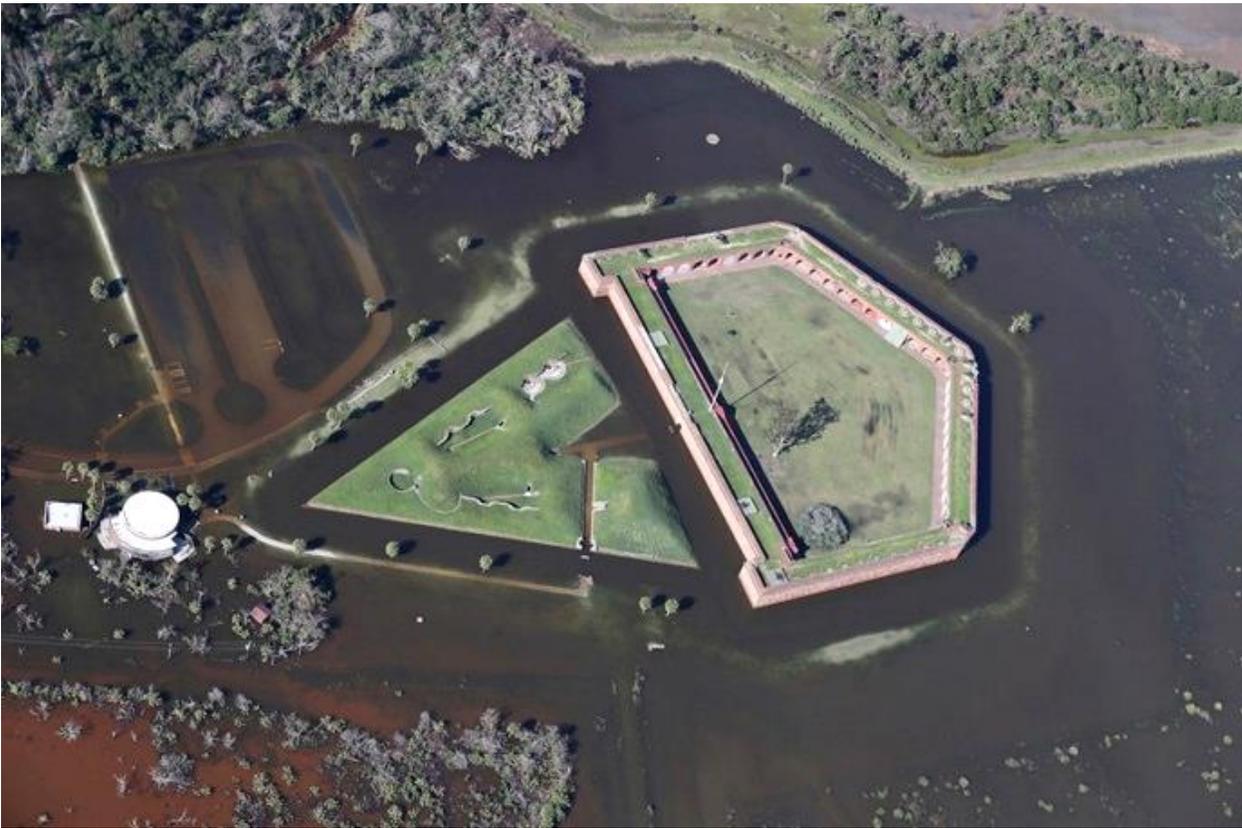
FIGURE 196. Aerial view of Fort Pulaski after Hurricane Irma, showing the dike system holding in floodwater. (Source: Fort Pulaski National Monument)
