**Fort Pulaski National Monument
Quarantine Attendants' Quarters**

**Historic
Structure
Report**

March 2004

National Park Service

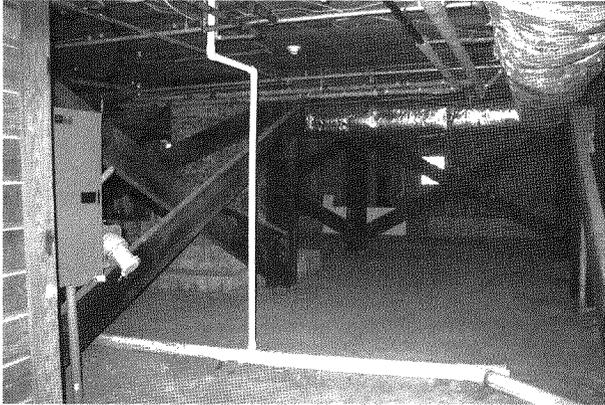
FIGURE 24. View west under north porch, showing typical piles and cross-bracing. (NPS-SERO-CR, 2003)

The house is set on a foundation created by sixteen, circular-sawn, creosoted, timber piles supporting a platform constructed of similar creosoted timbers. Twelve piles support the perimeter of the main body of the house and another four are arranged in a smaller, concentric square within the perimeter piles. Piles range from 11-1/2" by 11-1/2" to 12-3/4" by 12-3/4" but are generally 12" by 12". Piles are cross-braced with circular-sawn timbers 3" to 3-1/2" by 11-1/2" to 12" bolted to the piles. The piles elevate the building's wood frame approximately 8'-4" above grade. Cast-iron straps, 1/2" by 3" by 24", are used to bolt each pile to 12" by 12" beams on which the house's sills and joists rest. Beams run directly beneath the outside walls of the house on the north and south sides but are set back from the outer wall about 14" on the east and west sides.

There is no evidence that the piles and beams forming the foundation have ever been replaced, although there is at least one brace west of the chimney base which was probably added during World War II. Piles and beams are in relatively good condition. There has been some oxidation of the iron straps and bolts, and termite damage is visible on the pile at the southeast corner of the house and in isolated areas elsewhere.

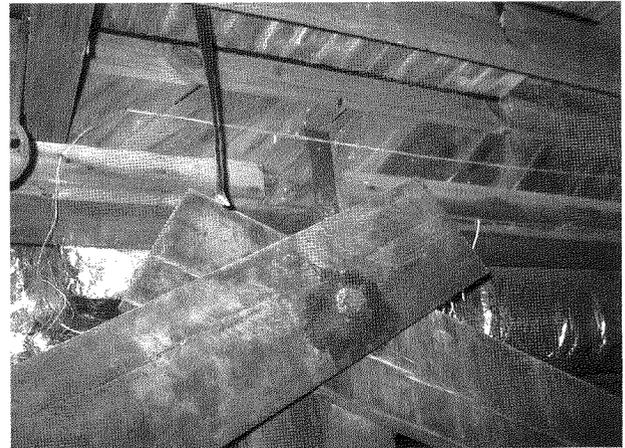
FIGURE 25. View of typical pile-beam-crossbrace

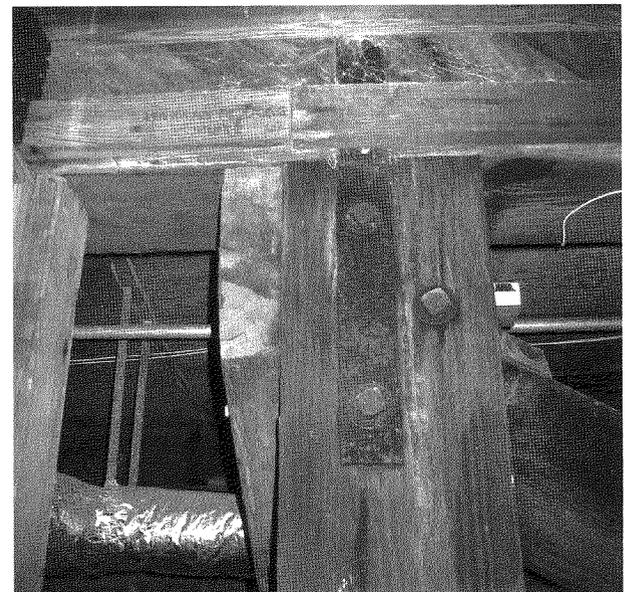
FIGURE 26. View of typical iron strap that secures house framing to pilings. (NPS-SERO-CR, 2003)

probably made with wire nails. Although none of the wall framing could be examined, the building appears to have been built with a conventional wood frame resting atop the wooden piles and beams that form its foundation. The building's frame appears to be in generally good condition, and although there is no visible evidence that framing is overloaded or inadequate, hidden termite damage and rusting fasteners may have reduced the building's capacity to withstand storm damage.

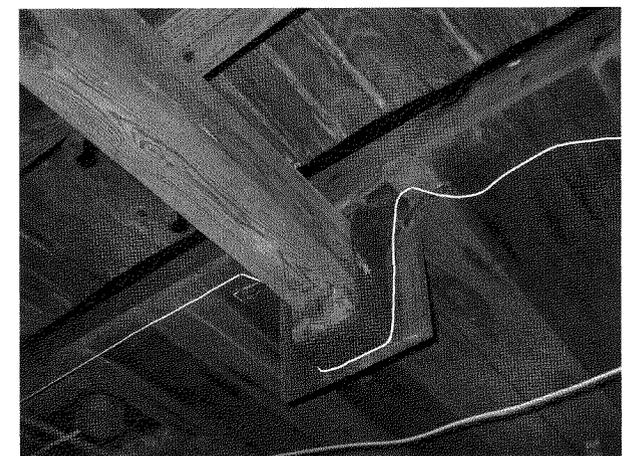
FIGURE 27. View of typical cast-iron U-shaped bracket used to hang beams for porch floor joists. (NPS-SERO-CR, 2003)

Porches. The porch floors are framed by joists set between beams that run perpendicular to the outside walls of the house. On the north, east, and now-enclosed west porches, these beams were hung from U-shaped, cast-iron brackets that are probably bolted to the sills. Only one of the original beams has not been replaced by modern material of slightly smaller dimension; it is located under Room 107, which was created by enclosing part of the west porch prior to World War II. On the south porch, which was added after original construction and then completely rebuilt in 1942, the iron brackets are not present.

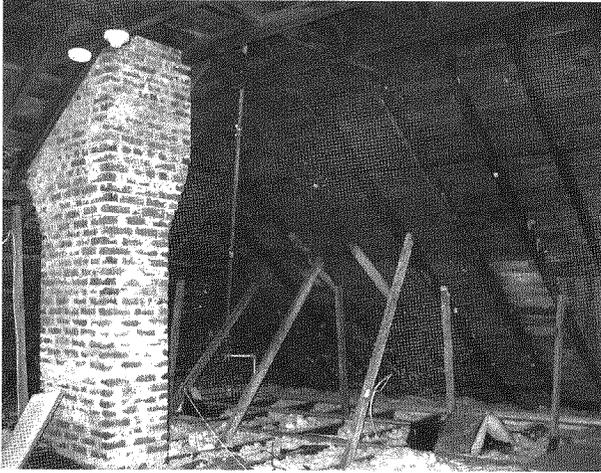
The chimney is corbeled out above the attic floor to a wider stack that runs through the roof. The reason for this corbeling is not clear, unless it was simply to create a larger, more visually appealing, chimney stack above the roof line. The top of the chimney

FIGURE 28. View northeast of chimney stack as it rises through the attic. (NPS-SERO-CR, 2003)

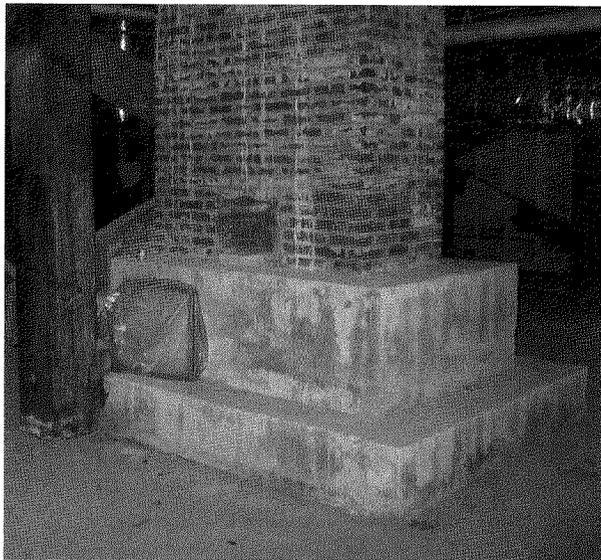
The existing chimney and fireplace were constructed by the Navy in 1942 and are in good condition. The foundation of the chimney is formed by a two-tier, concrete base poured in forms constructed with 6"-wide boards. The bottom tier of the base measures about 6'-6" by 9' and rises about 14" before stepping in to the second tier, which is about 4'-6" by 7'. It rises about 24" to the bottom of the brick chimney base, which itself is about 2'-6" by 5' in plan. Brick are standard, hard-fired, red brick set with a hard, grey, Portland mortar. There was apparently no cleaning of the masonry after construction, leading to its present stained appearance. A cast-iron door for an ash dump is located at the base of the brick shaft. Hinges in the frame are broken and the door is detached. All elements are rusting.

FIGURE 29. View southwest of chimney breast. (NPS-SERO-CR, 2003)

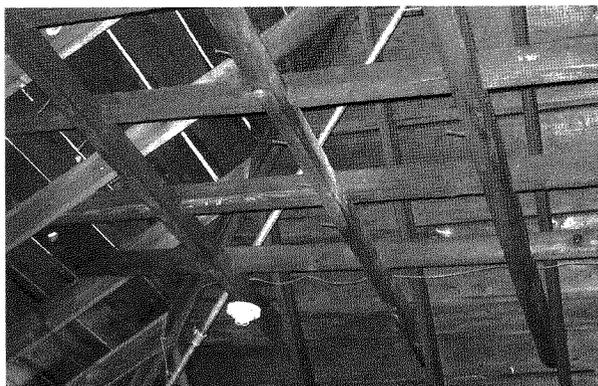
FIGURE 32. View northwest in attic showing cross-braced collar beams on main roof. (NPS-SERO-CR, 2003)

centers with 1" by 6" (nominal dimension) ridge-boards. The rafters are braced and cross-braced by two sets of collar beams (2" by 4", nominal dimension), with the set running east and west notched and set over the other set which runs north and south. Knee braces, 2" by 4" (nominal dimension), have been installed on all sides of the attic, probably after the house was constructed.

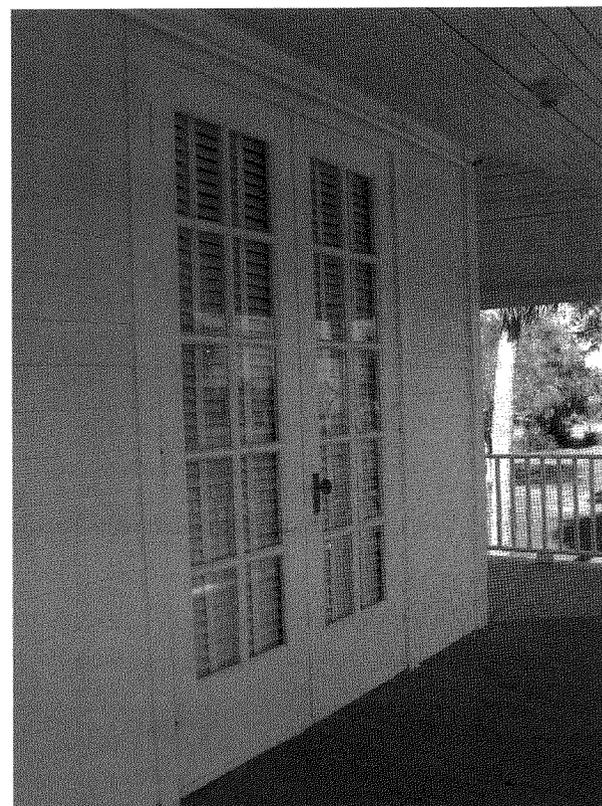
Pairs of double French doors are located on the north, east, and south sides of the house. All are about 5'-0" by 8'-0" with ten lights in each door. Doors are hung with 4", brass, butt hinges with movable, ball-end pins, and the entry door in each set is fitted with a mortise lock with oval brass knobs and a rectangular, brass, escutcheon plate. Sliding, brass, barrel bolts, originally fastened the other leaf of each pair of doors. Some of these have been recently replaced with cast-aluminum bolts, and most of those that remain have been painted.

FIGURE 38. View of typical double French doors, these located on the east side of Room 101. (NPS-SERO-CR, 2003)

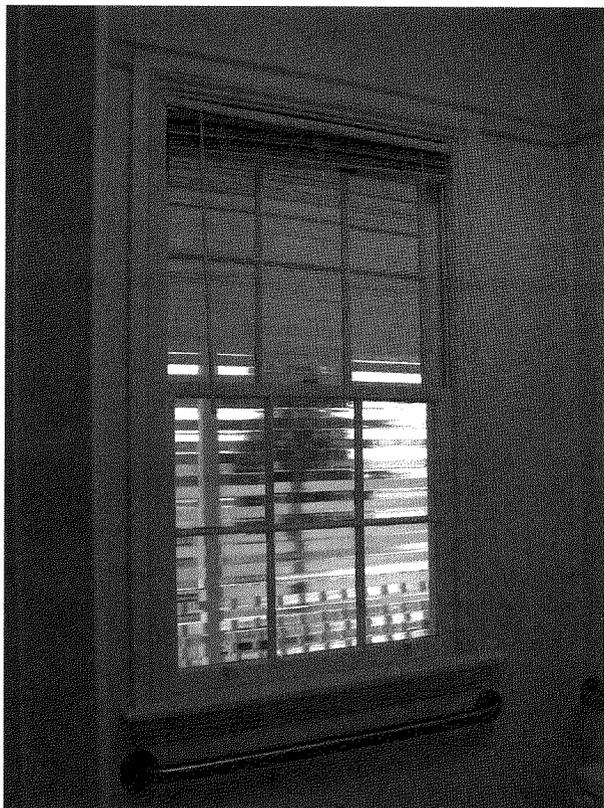
FIGURE 40. View of translucent, prismatic glass in bathroom. (NPS-SERO-CR, 2003)

In Room 106, a trio of double-hung, six-over-six windows date to 1942. They measure about 2'-6" by 5'-9". In the bathroom (Room 102), there is a single, double-hung, six-over-six window dating to 1942. Measuring 2'-6" by 4'-4", it is glazed with an unusual, broadly-ribbed, prismatic glass that renders the window translucent. A similar window was also present in the bathroom that was removed from the west end of Room 106 in the 1990s. The window at the west end of the kitchen (Room 108) is a similar size, but it is glazed with plain, clear glass. Double-hung windows were also once present in each of the dormers, but these were replaced by the present louvered vents in the 1990s. The eleven windows that enclose the west porch were installed in 1998. Windows there have one-over-one sash with insulated glass and measure 2'-7" by 5'-11".

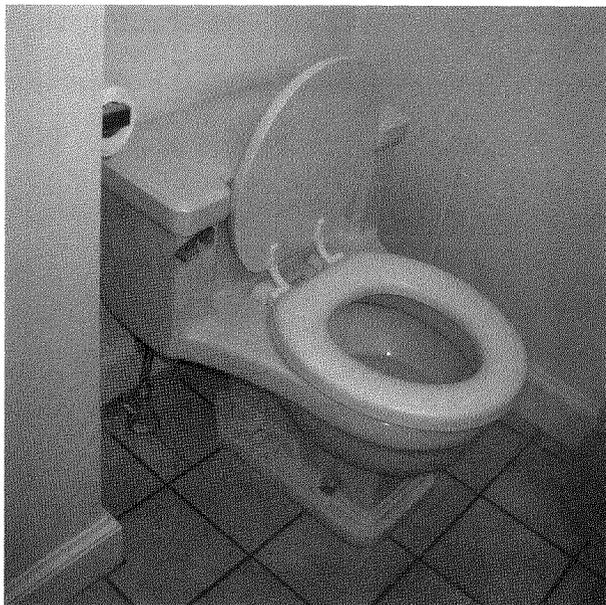
FIGURE 56. View of historic toilet in bathroom 104. (NPS-SERO-CR, 2003)

Fixtures. The historic lavatory was replaced, perhaps as early as the 1960s. At present a wooden cabinet with formica countertop spans the north side of the room. The toilet, a "Standard One-Piece," is dated October 3, 1941, and was installed during the remodeling in 1942. A similar toilet was present in Room 102 until replaced in 2002.

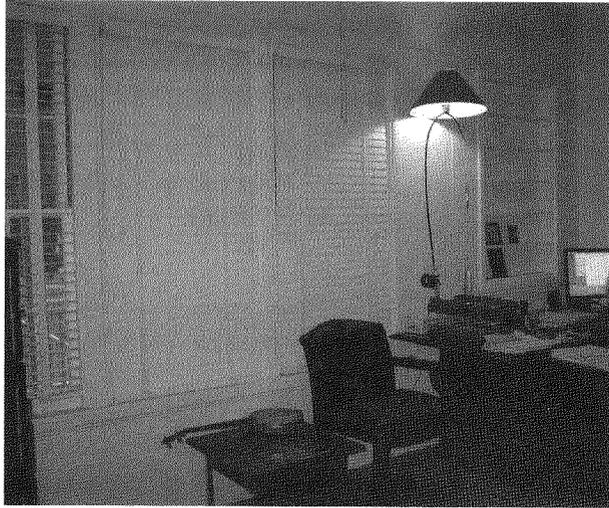
FIGURE 60. View southwest in Room 106. Bookcase at right marks location of old bathroom window. (NPS-SERO-CR, 2003)

Miscellaneous. At the western end of the south wall a window originally served the bathroom formerly in that location. It is reported to have been similar in size and configuration to the one that remains in bathroom 102 and had the same prismatic glass. The window was removed and replaced by the present built-in bookcase in 1998. The door in the west wall that connected the bath to Room 107 was also removed at the same time and a similar bookcase installed in the opening in Room 107.

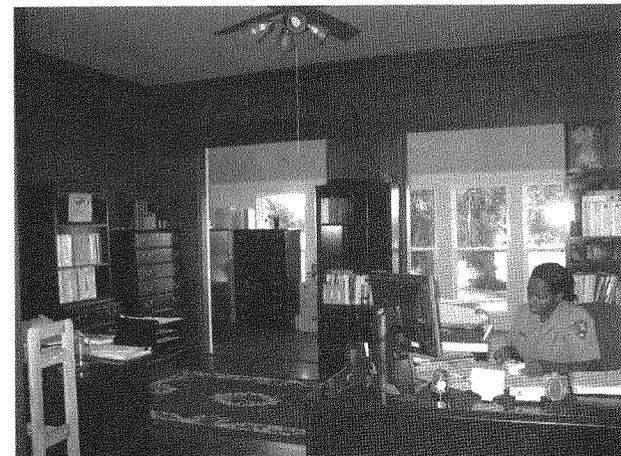
FIGURE 69. View southwest in Room 109. (NPS-SERO-CR, 2003)

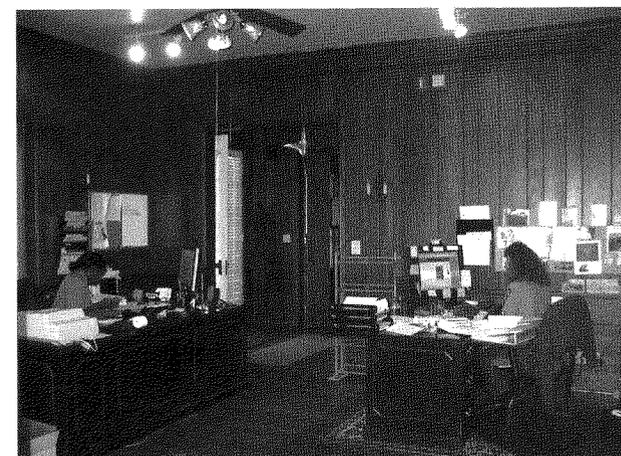
FIGURE 70. View northeast in Room 109. (NPS-SERO-CR, 2003)

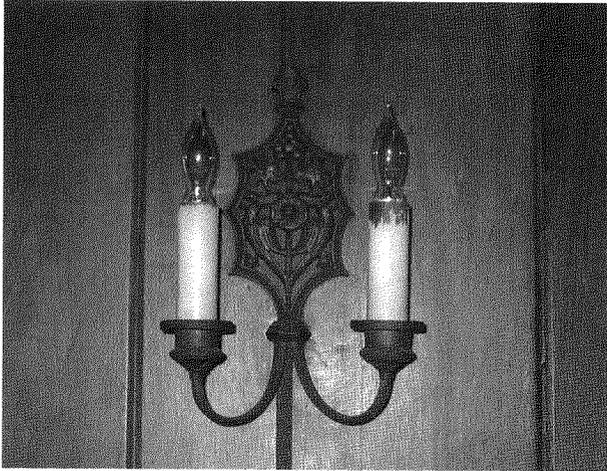
FIGURE 71. View of wall sconce, c. 1942, located in Room 109. (NPS-SERO-CR, 2003)

Electrical. The building's electrical system was rehabilitated in 1995, and presumably is in good condition, although loose wires and coverless junction boxes were noted in the attic. Only three light fixtures remain from the historic period, the overhead light in Room 100 and the two wall sconces in Room 109. The fixture in Room 100 is operative; the sconces are not.

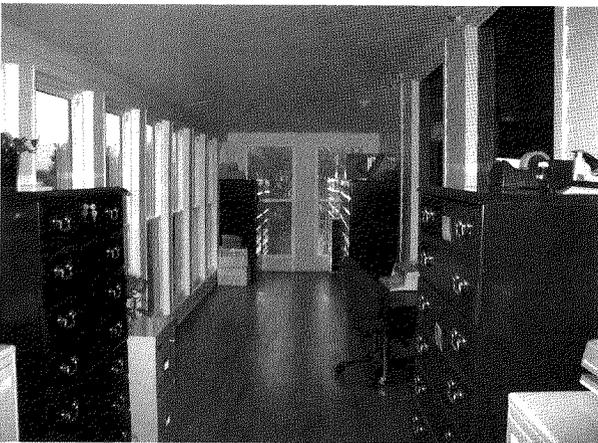
FIGURE 72. View north in Room 110. (NPS-SERO-CR, 2003)

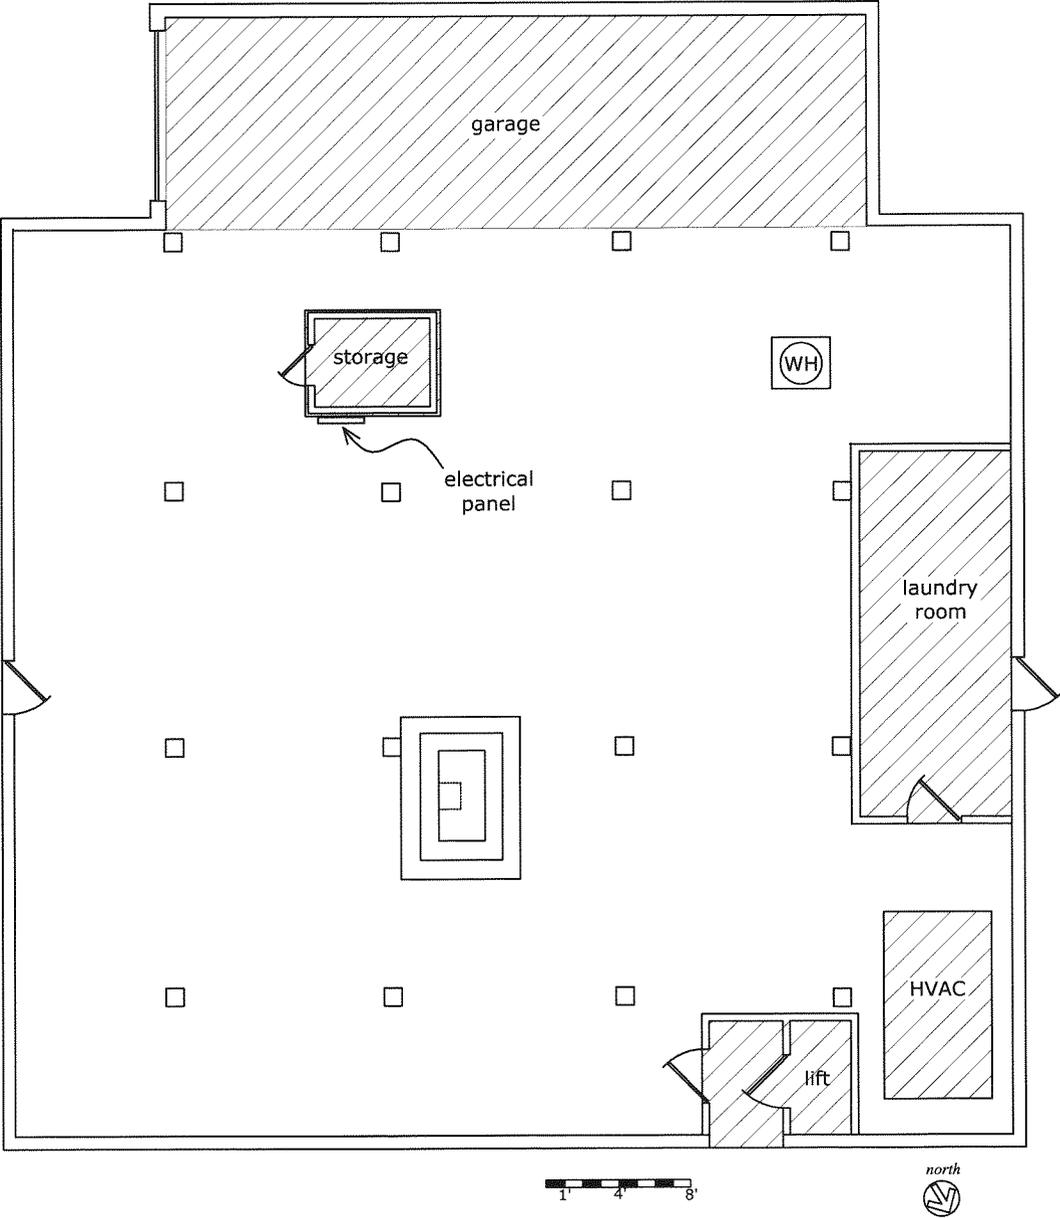
FIGURE 74. Plan of existing basement. Concrete slab-on-grade is indicated by hatching; remainder of floor is dirt. (T. Jones, NPS-SERO-CR, 2003)

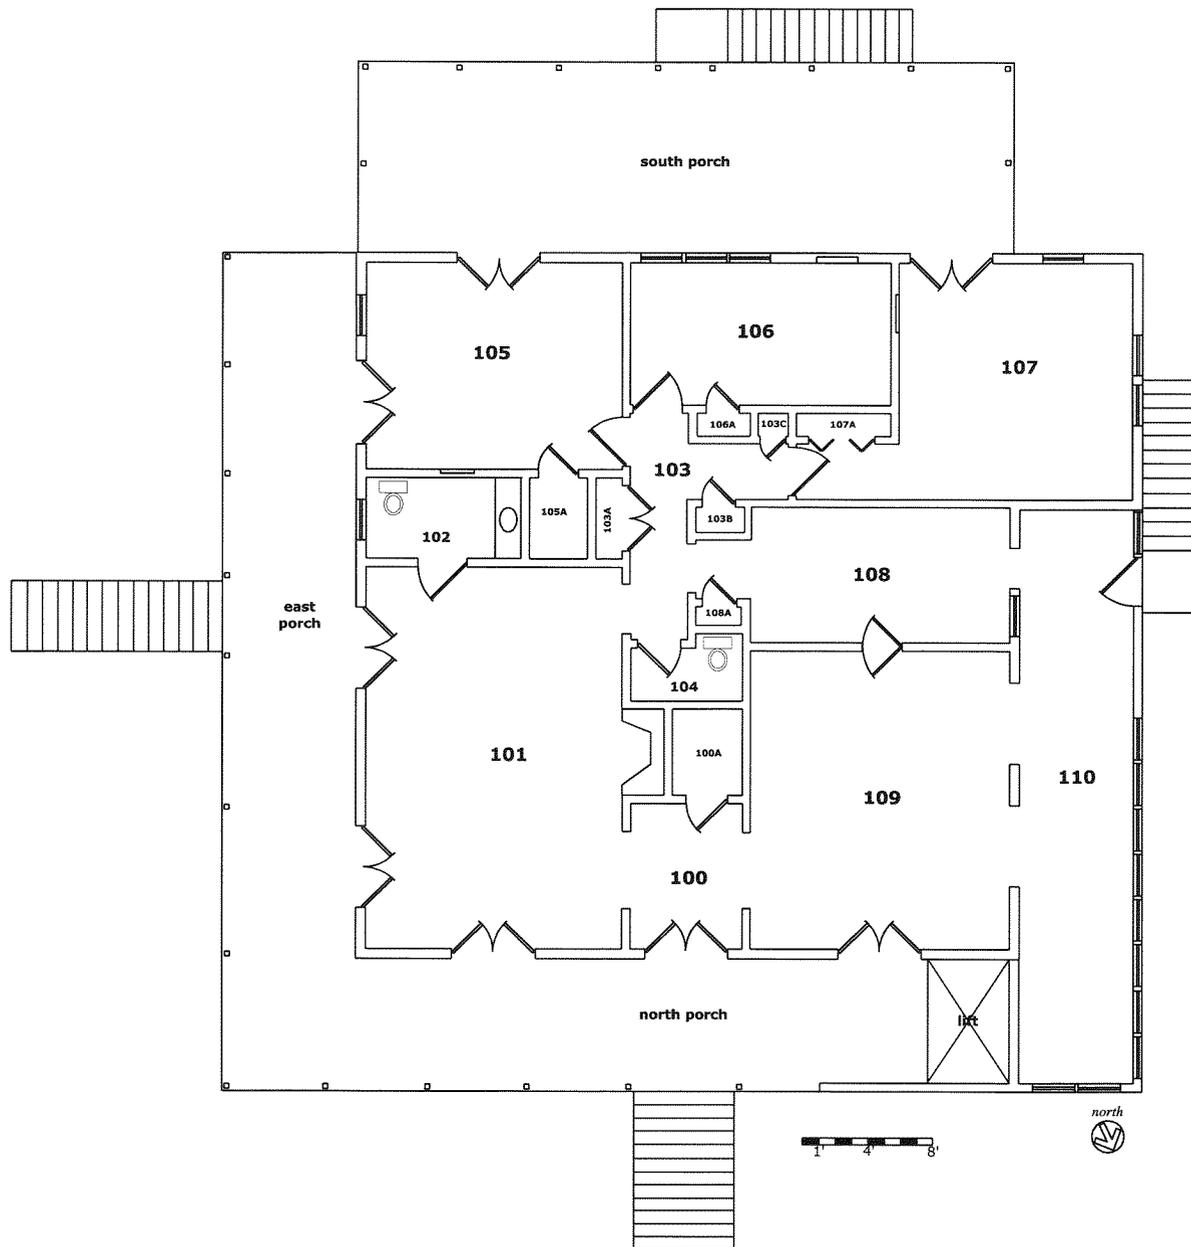
FIGURE 75. Plan of existing first floor. (T. Jones, NPS-SERO-CR, 2003)
