Fort Union National Monument

National Park Service
U.S. Department of the Interior

UNDERSTANDING THE DETERIORATION OF ADOBE WALLS

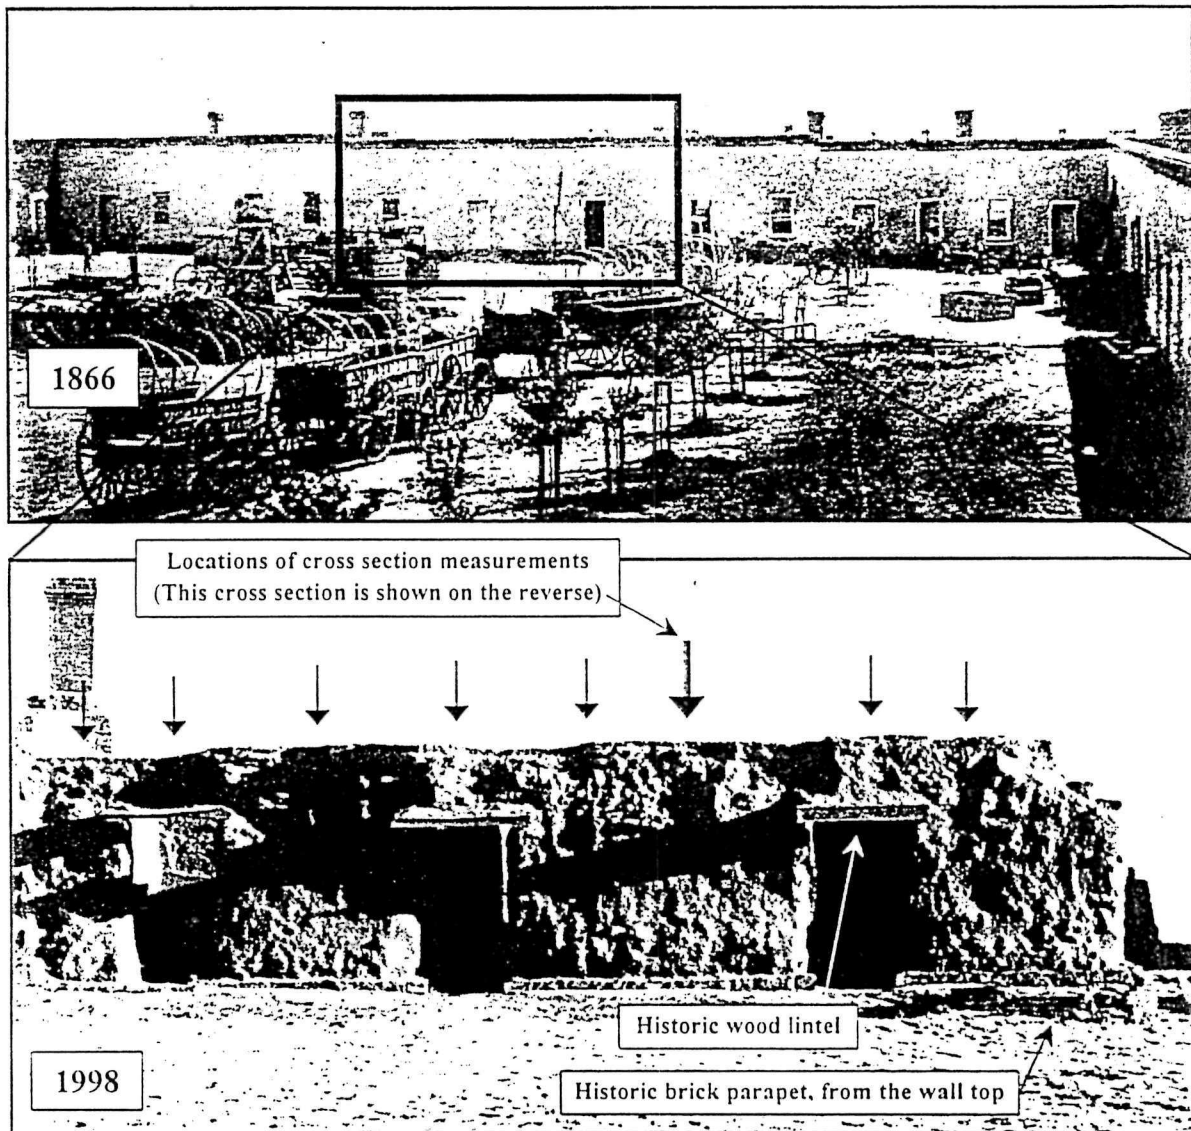
Mechanics' Corral

(Look for this wall directly in front of the audio wayside within the Mechanics' Corral.)

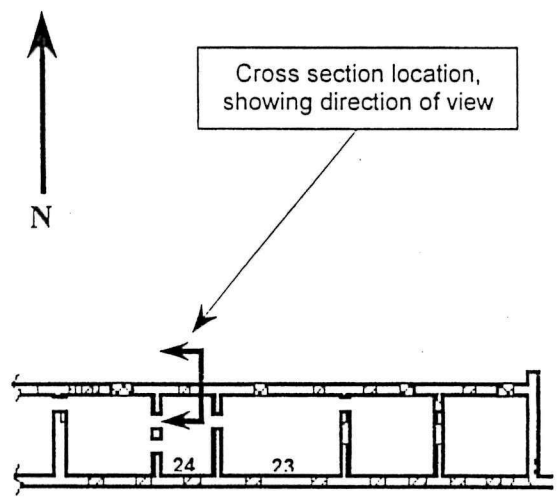
HS 36, Mechanics' Corral
North Elevation
(rooms 23 and 24, #6)

The heavy black line on the illustration at left shows the present cross section of the eroded adobe wall of HS 36 at the location shown on the photograph, above, and plan, below. It is overlaid on a shaded field illustrating a cross section of the original adobe wall.
