**Frederick Douglass
Home**

HISTORIC STRUCTURES REPORT

ARCHITECTURAL DATA

JUNE 1970

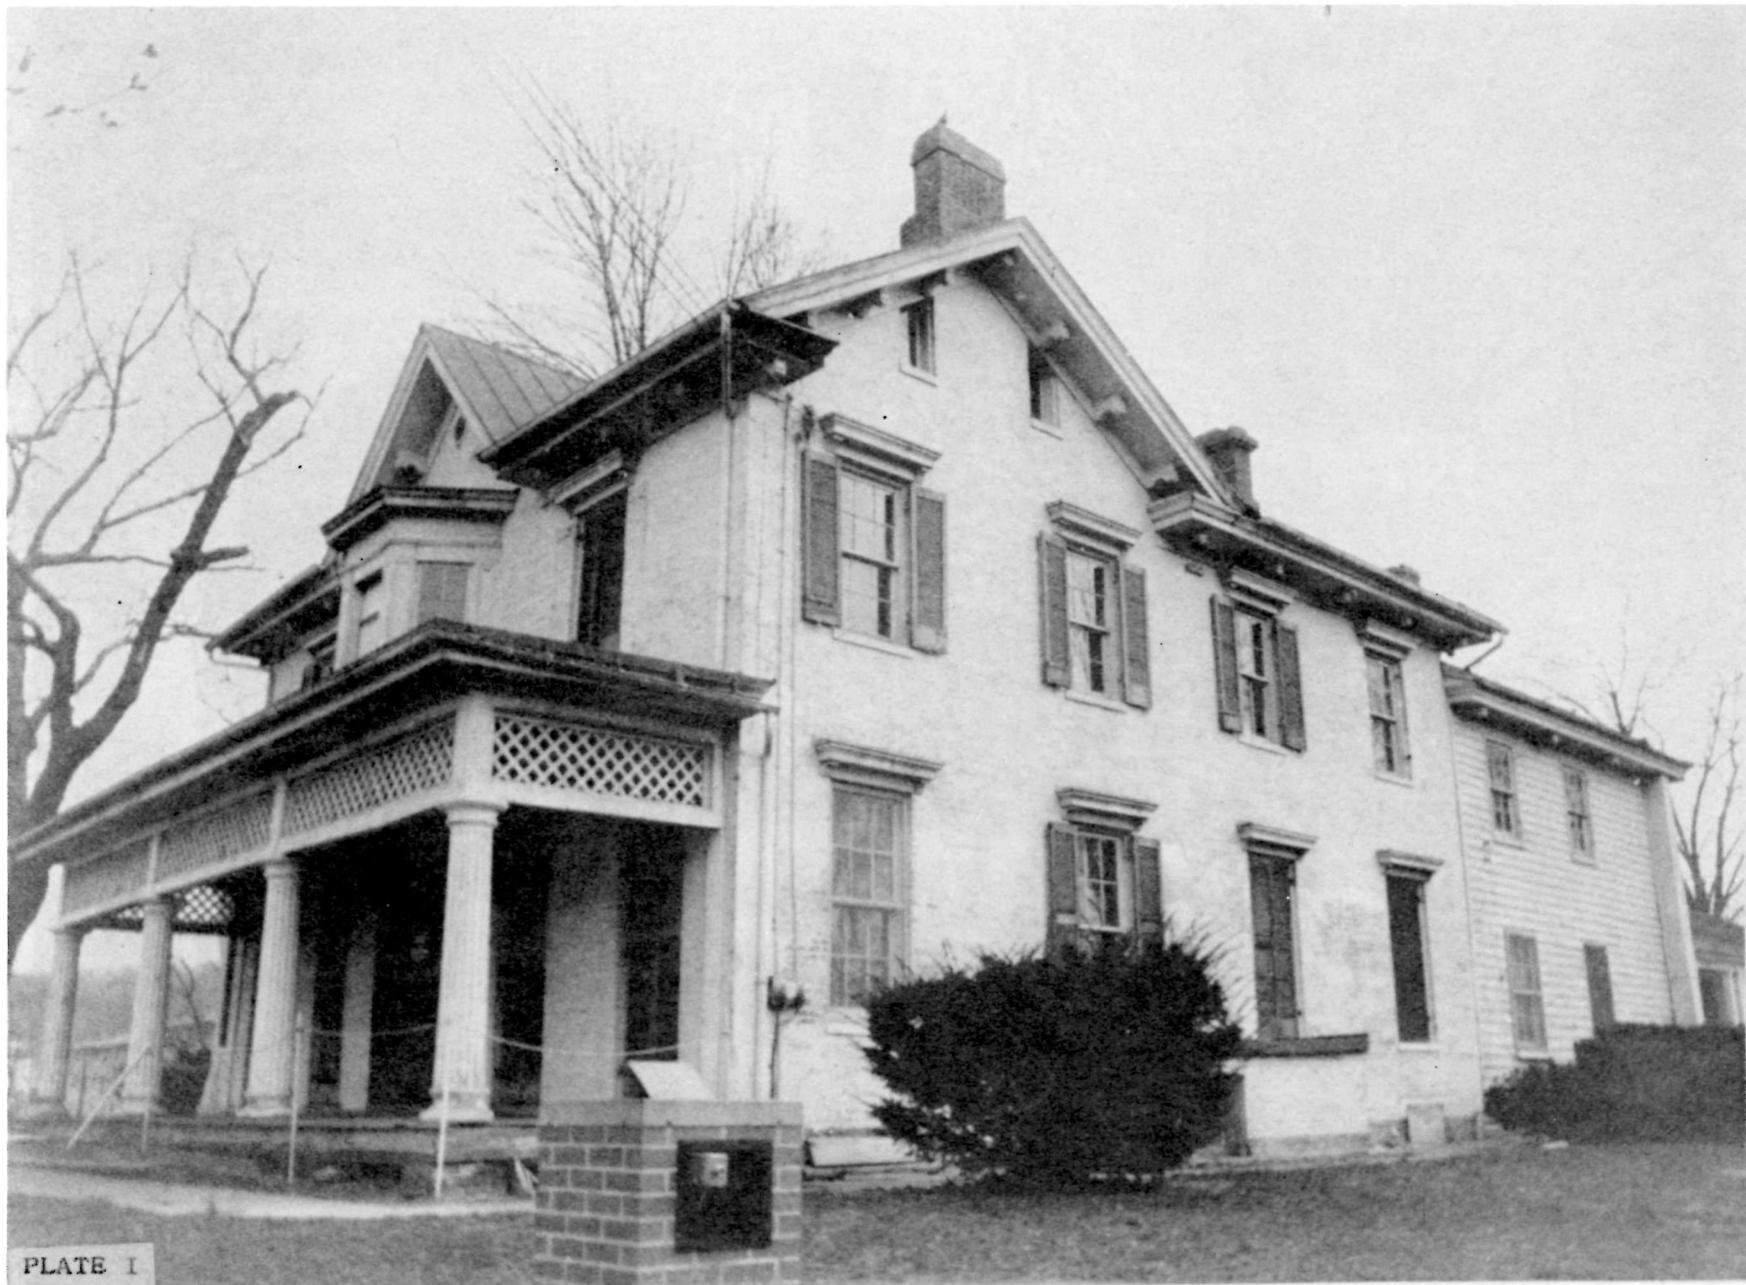
PLATE I

General view of Frederick Douglass Home from
the Northwest.

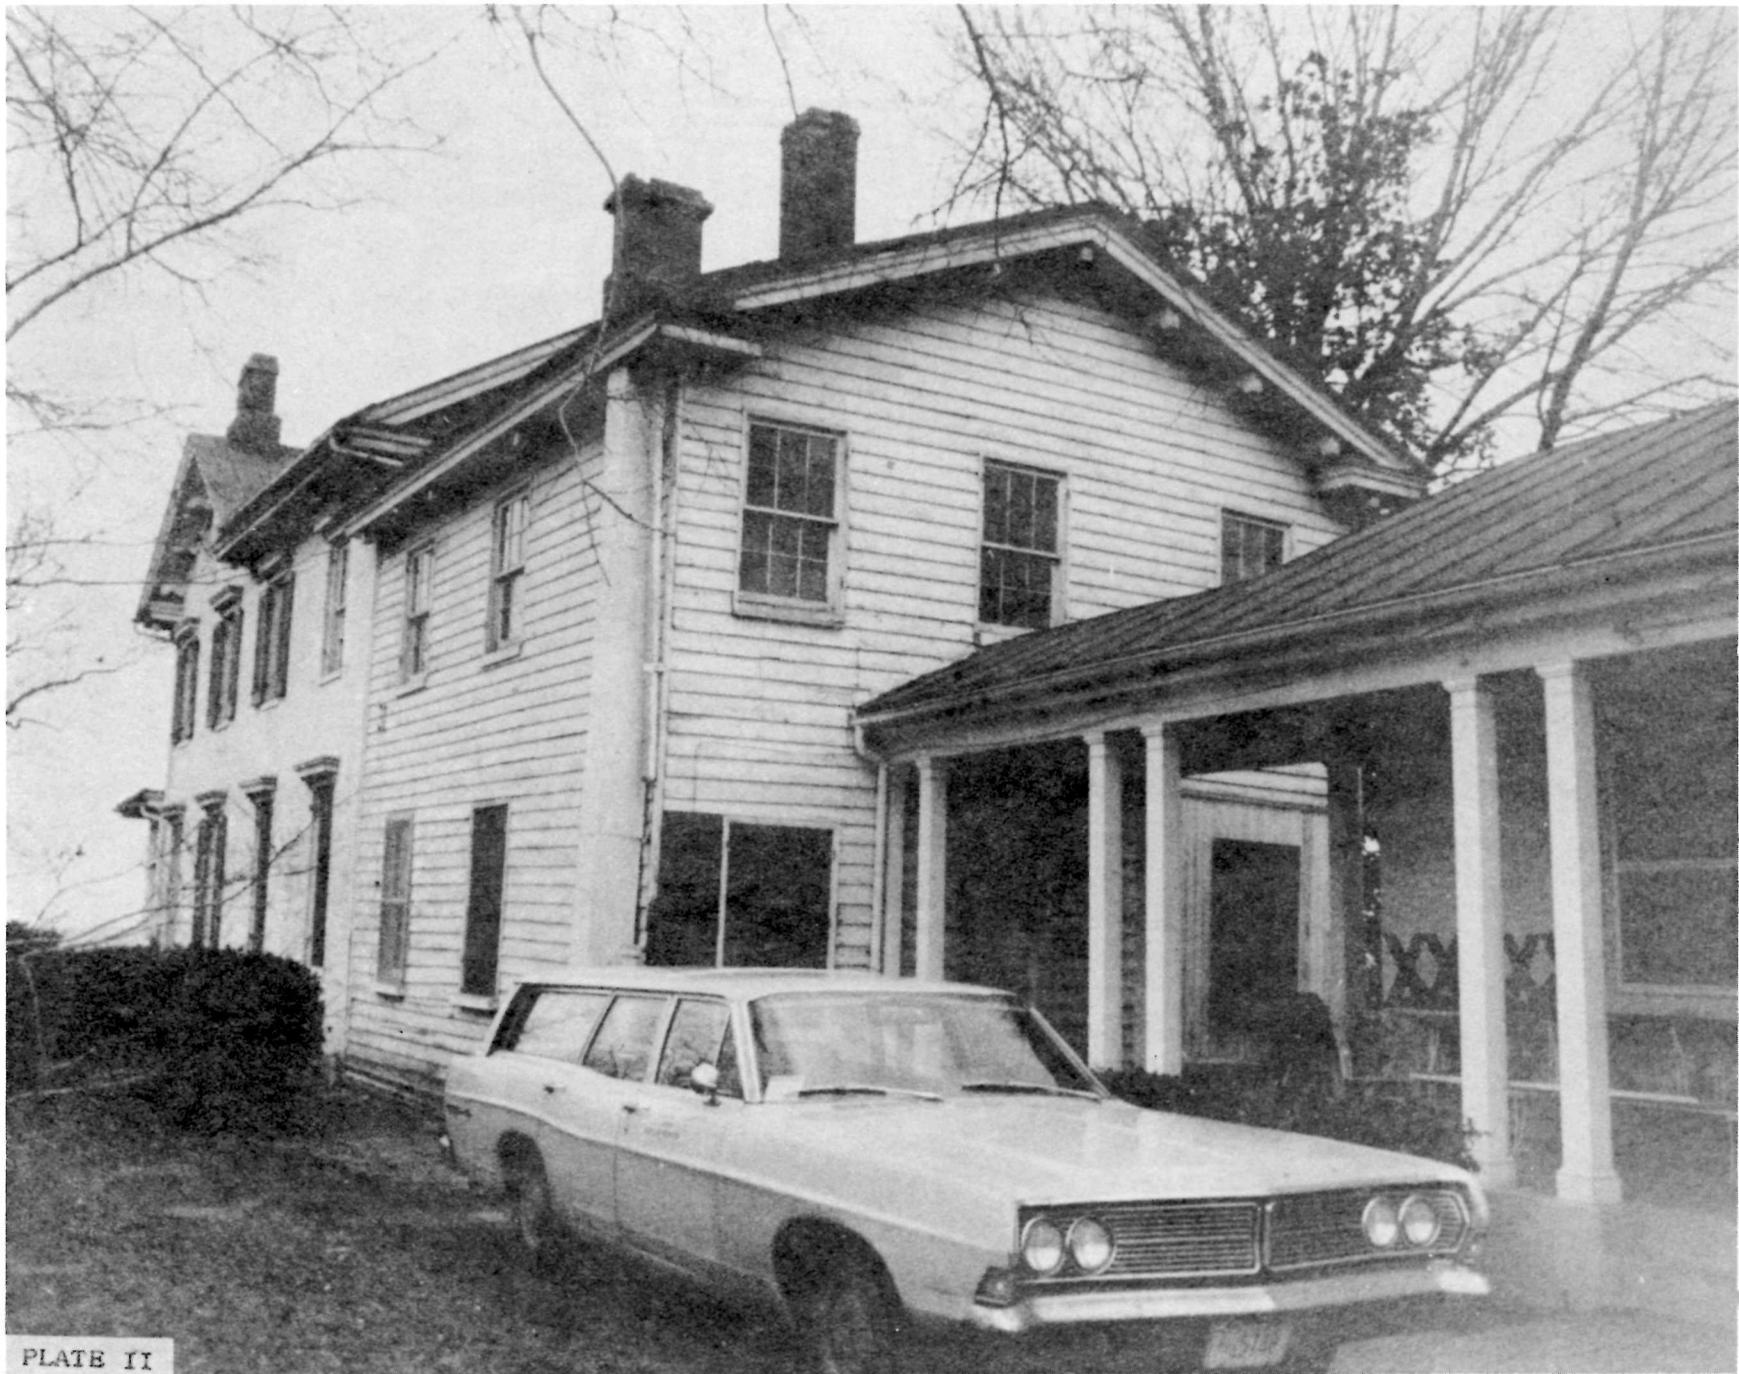
PLATE II

View from the Southwest showing the frame south wing and the modern breezway and caretakers quarters which will be removed.
