Geologic Analysis of Rock Deterioration
At Selected National Park Service
Archeological Sites :

ROCK MOTION HAZARD

ROCK DETERIORATION REPORT A

June, 1978

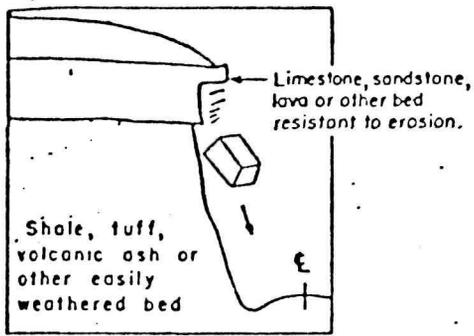
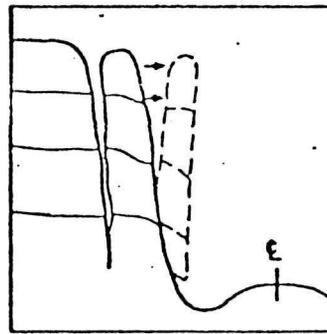
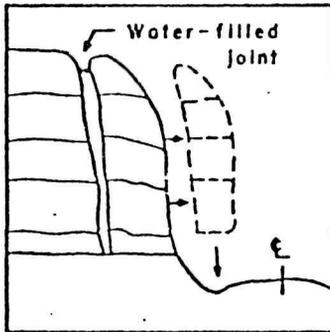
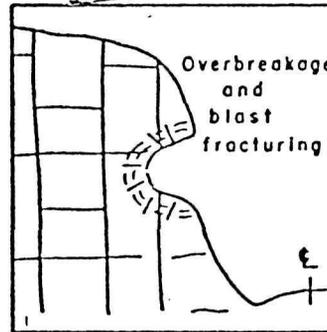
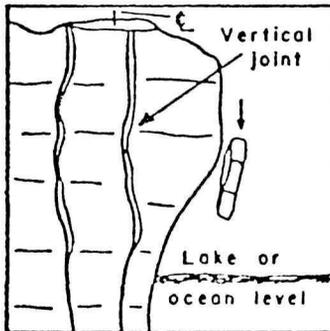
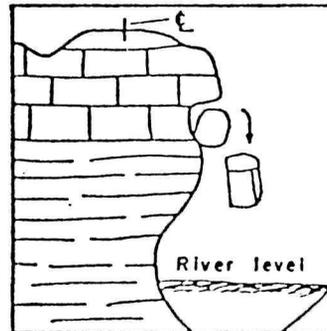
Figure 3. Rock fall.

A. Differential weathering

B. Frost wedging in jointed homogeneous rock

C. Jointed homogeneous rock. Hydrostatic pressure acting on loosened blocks.

D. Homogeneous jointed rock. Blocks left unsupported or loosened by overbreakage and blast fracture.

E. Either homogeneous jointed rock or resistant bed underlain by easily eroded rock. Wave cut cliff.

F. Either homogeneous jointed rock or resistant bed underlain by easily eroded rock. Stream cut cliff.

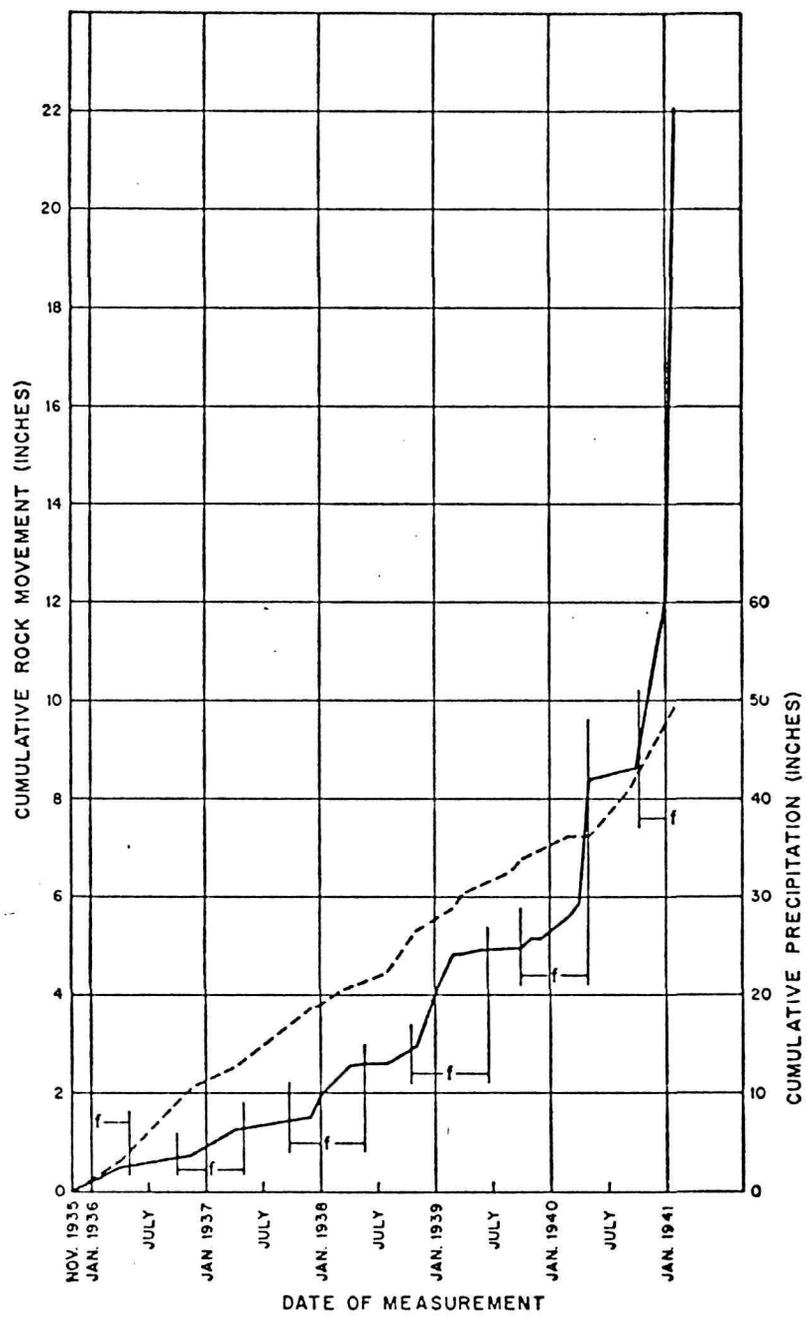
Figure 4. Time-Distance Plot Threatening Rock, 1935-41.

Cumulative movement of Threatening Rock (solid line) and cumulative precipitation (dashed line) plotted against date of measurement or time. Vertical lines, drawn at dates of first killing frost of the fall and the last killing frost of the spring for the years of record, indicate cumulative movement which occurred during periods of freeze and thaw. Freeze-thaw periods are designated f.

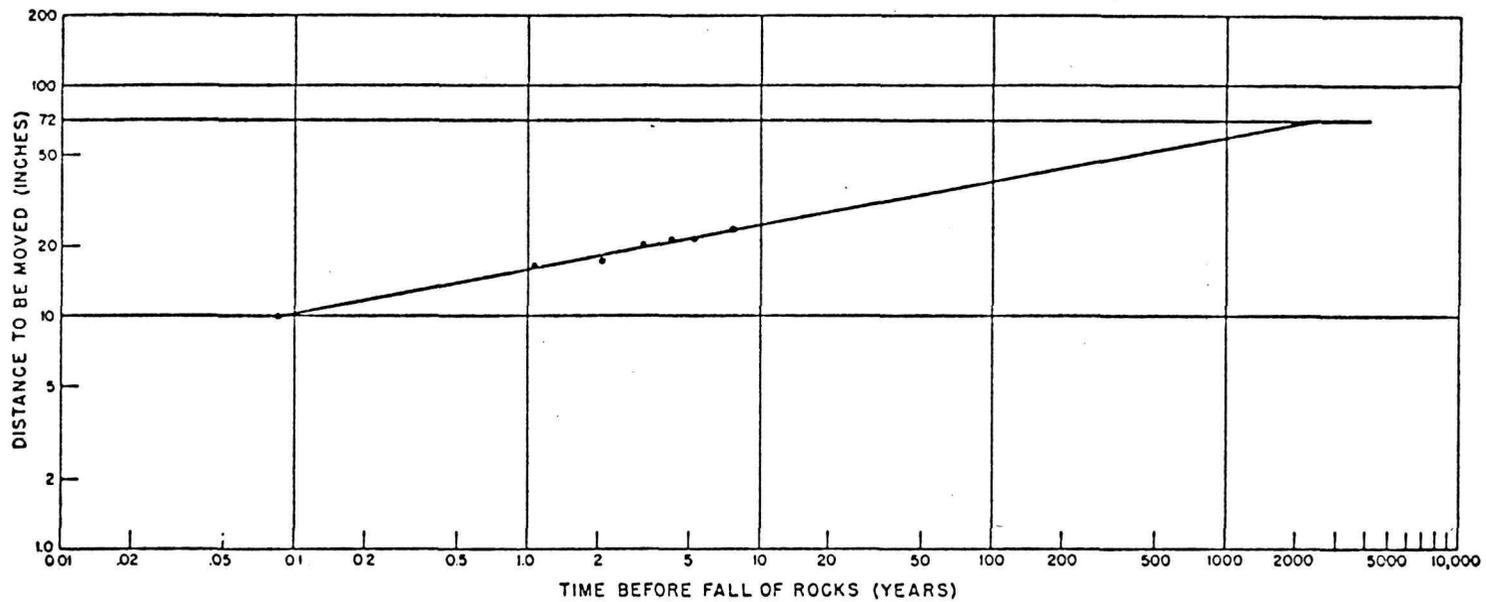
Figure 5. Logarithmic Plot Time-Distance, Threatening Rock.

Fig. 4. Relation between distance to be moved and time before fall of Threatening Rock. For example, one year before the fall of the rock an additional 16 inches of movement was required. Extending the regression line until it intersects the horizontal line representing total rock movement before fall, 72 inches, yields an estimate for the time required for this movement (about 2500 years).

Movement	Years required
1st foot	1600
2nd foot	650
3rd foot	200
4th foot	60
5th foot	8.0
6th foot	0.2

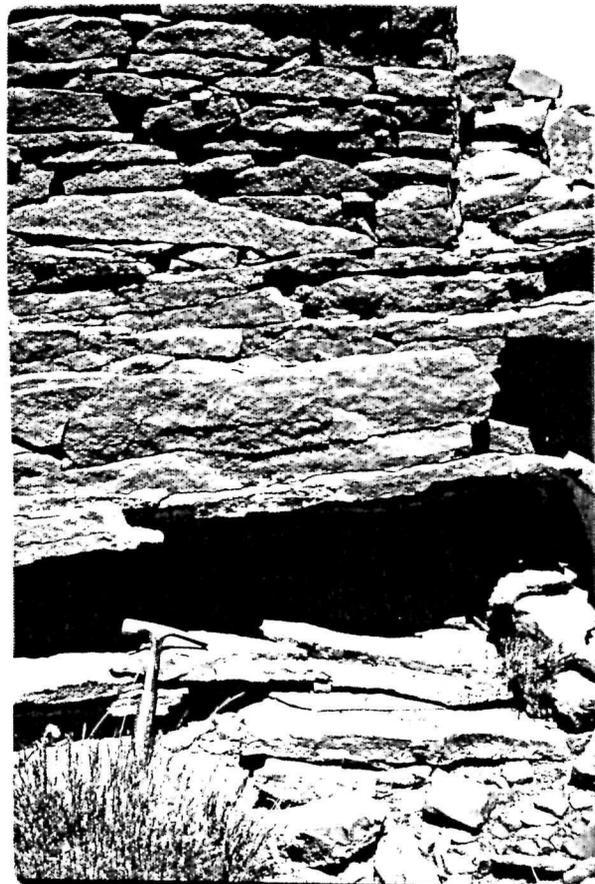
Figure 18. Ruin NA635, Wupatki. Small-scale slabbing of hard, layered Moenkopi Sandstone threatens section of ruin.

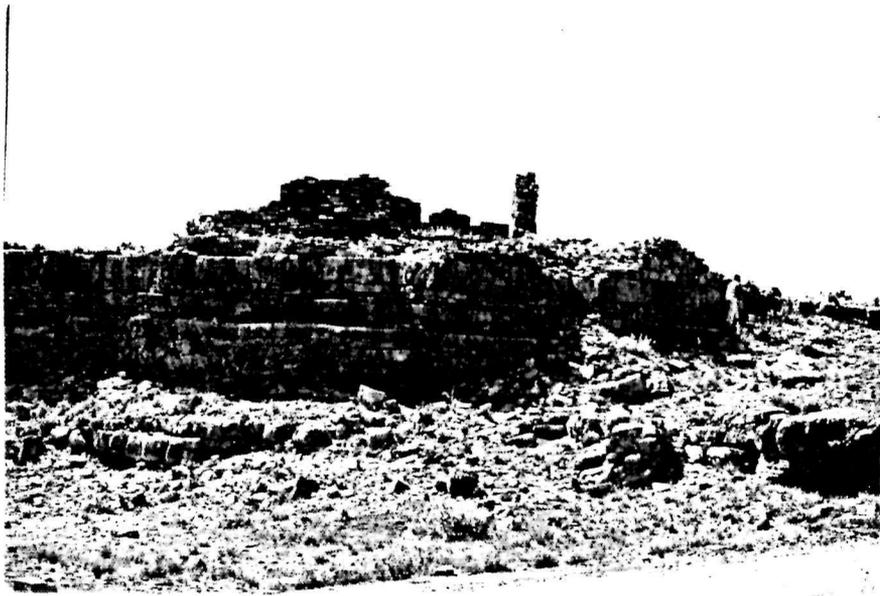
Figure 19. Blocky character of Kaibab Limestone in Lomaki area, Wupatki. Tendency to fall is accentuated by bedding, vertical jointing, and soft erodable interlayers.

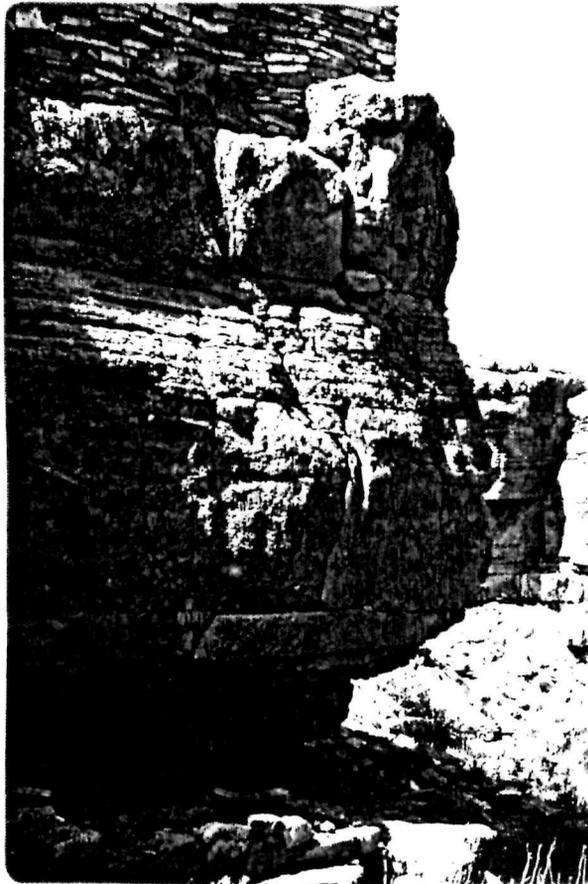
Figure 20. Horizontal slab apparently in motion below Lomaki Ruin, Wupatki. Vertical segments threaten visitor area and ruin above, but are not definitely in motion. Kaibab Limestone.

is likely to fall suddenly, but long-term motion with visual indication is expected for the vertical segments.

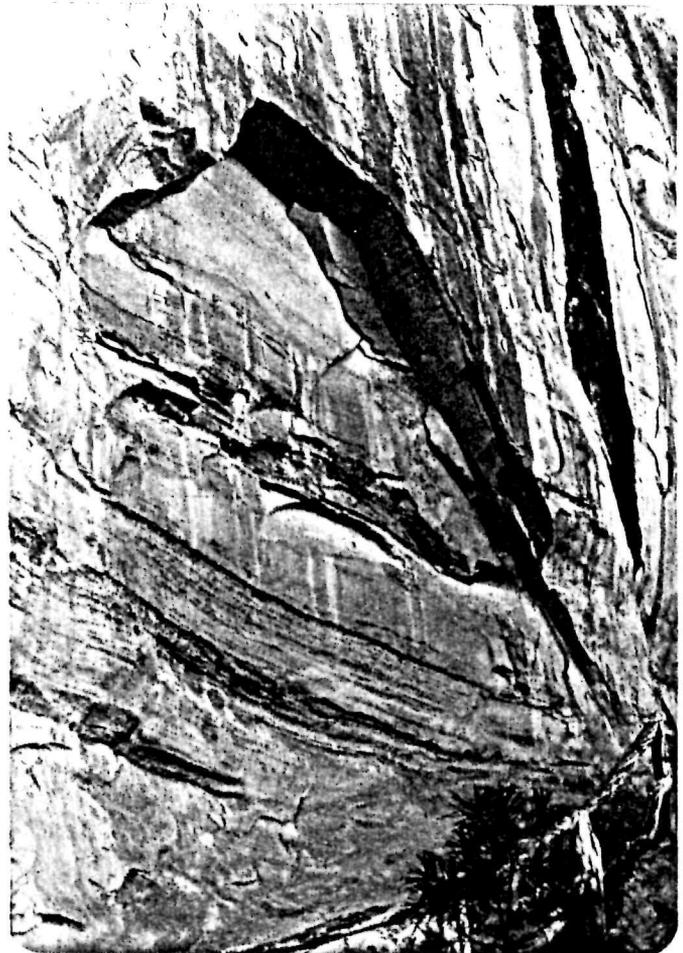
Figure 2A. Major instabilities exist along the north face of Inscription Rock on large scale as shown here and as random detaching flakes and blocks of 5 kg to 5 ton scale. El Morro.

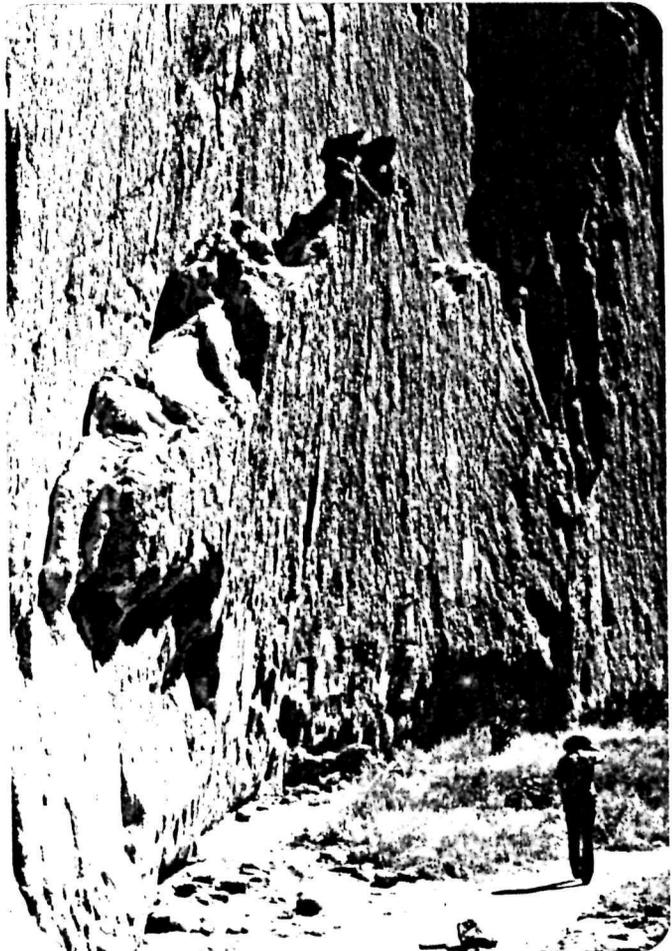
Figure 4A. Bandelier, Longhouse area. 30 m by 10 m massive sheet separating from face. Base coving and complex shattering add to a sense of imminent fall. The ranger walks on the visitor trail.

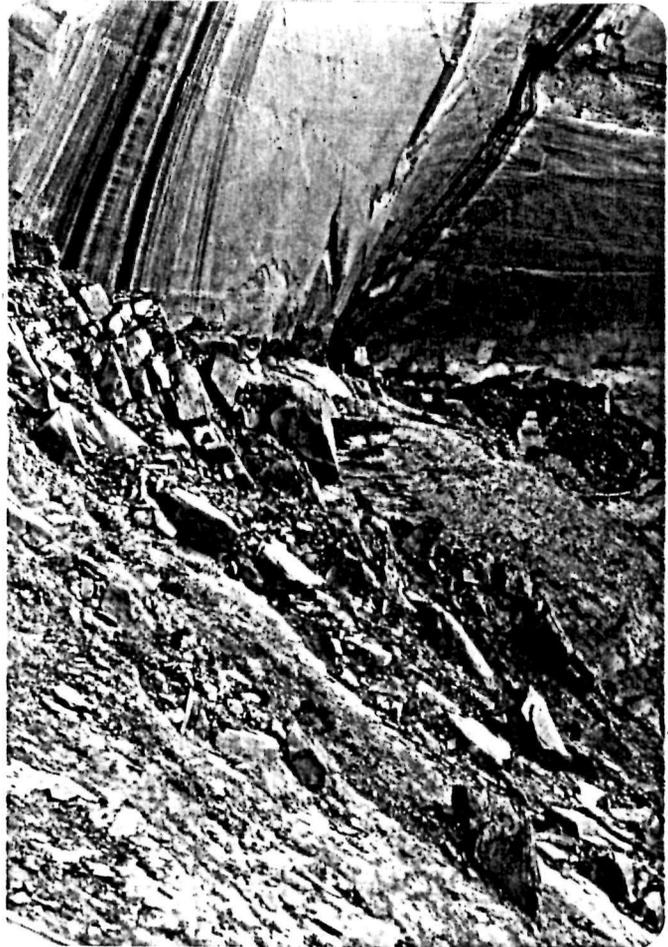
Figure 9. Southwest end of Sliding Rock Ruin. Another "unstable" talus mass again supporting masonry in original position.

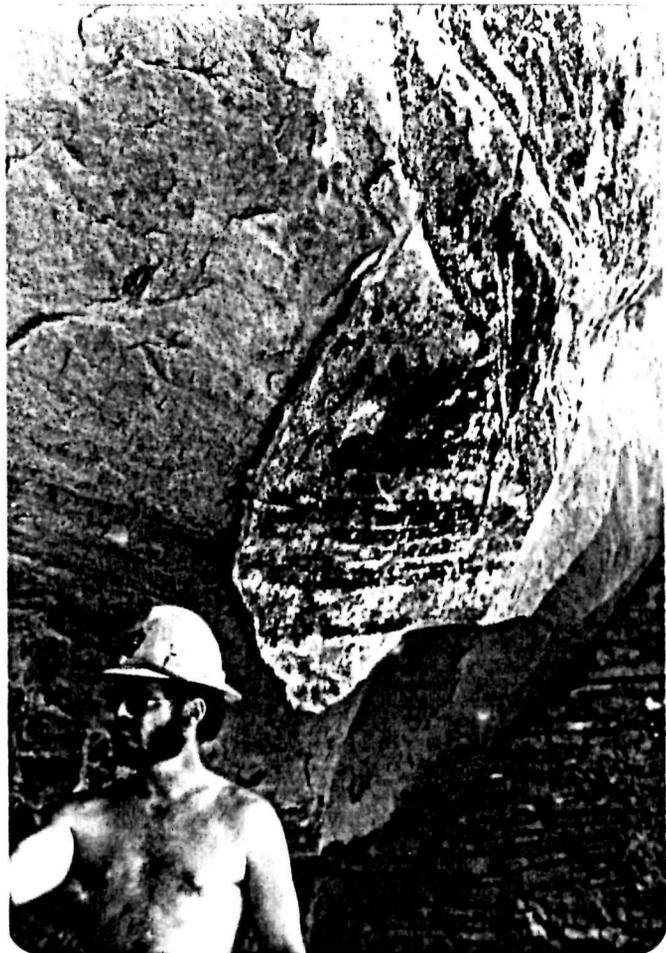
Figure 11. Post-habitation flaking and slabbing upward from alcove base. The slabbing may accelerate as the hardened weather-surface is undermined and soft rock exposed. Antelope House, Canyon de Chelly.

A major rock fall occurred in the grotto northeast and adjacent to Antelope House. The fall, 10-100 ton scale dropping a few meters from the horizontal root overhang, was witnessed in the 1920's.

Recommendations: Antelope House is visited regularly, so pry-bar slabbing of the alcove rear wall is suggested where the unstable section extends above pathways. The adjacent grotto (rock fall area) is fenced off from the visited area, but is easily accessible by determined visitors and is used for shelter and machinery storage by a Canyon resident. Monitoring of overhanging slabs is advisable--this would provide interesting data regarding the continuing instability vs. possible temporary stability following a major known fall event (Park Service jurisdiction?).

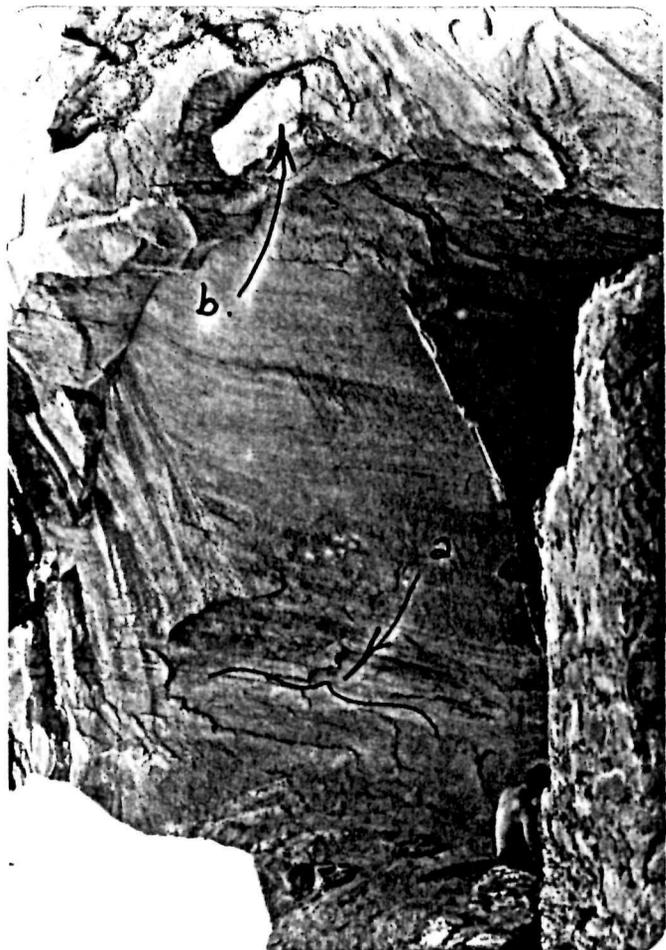
Figure 19. Adjacent to Figure 18. Base sapping (a) has promulgated upward. Overhead is now very unstable, the block at (b) hangs over the present visitor trail.

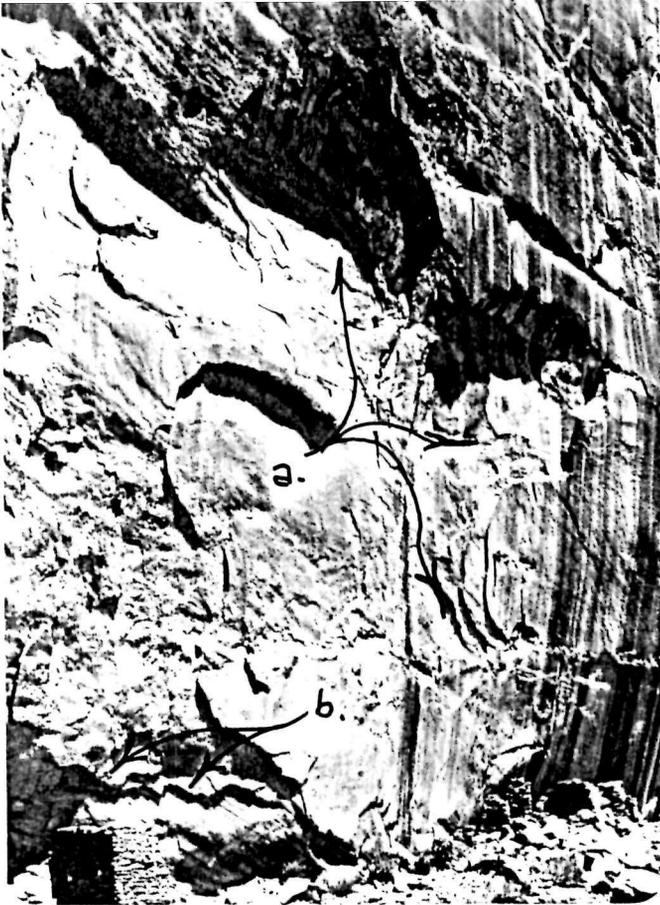
Figure 20. Snake House, Navajo.

- (a) Random instability on cliff face above ruin.
- (b) Active base sapping will accelerate instability.

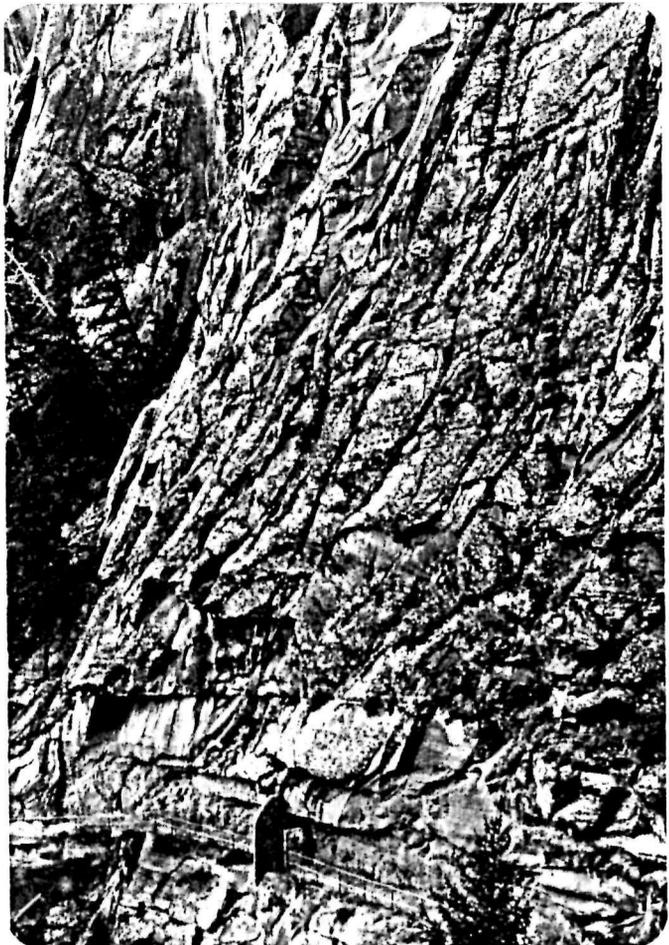
Figure 23. Natural slabbing promoted by vertical fractures crossed by bedding plane fractures. Note many "fresh" scars on the cliff face. The trail further undermines this unstable area. Betatakin Trail, Navajo.

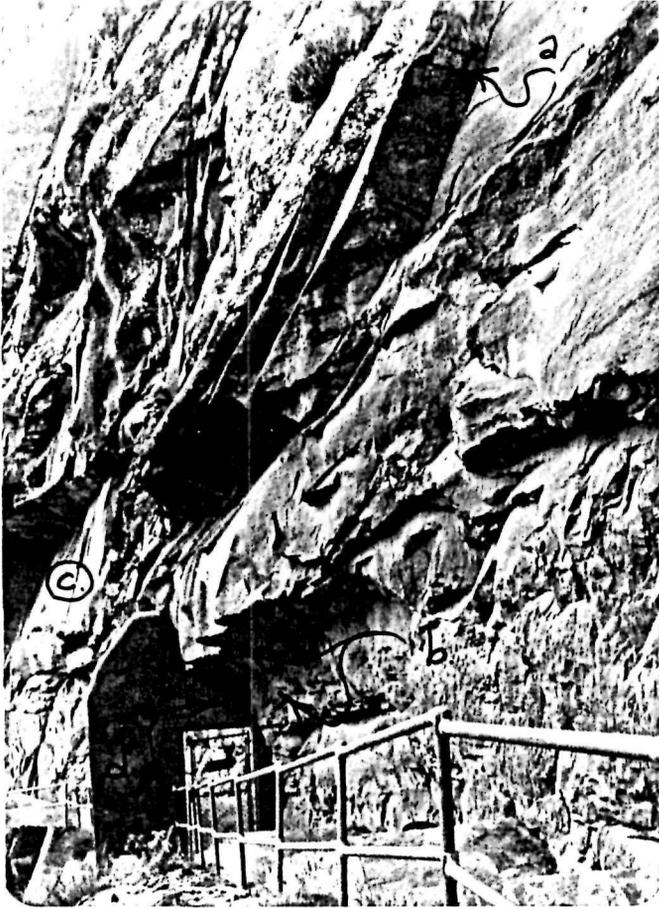
Figure 24. Betatakin Trail, Navajo. See text for explanation of points a-d.

- a. Loose cap rock.
- b. Rocks work loose from wall or cave on loose soil.
- c. Wall spreads as trail fill "works".

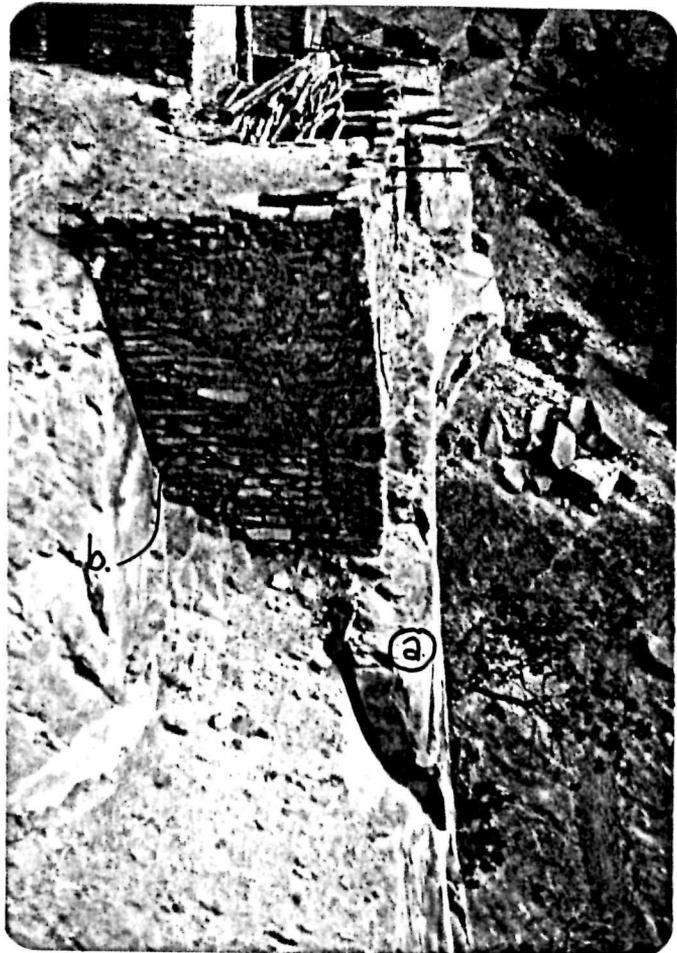
Figure 27. Motion of slab "a" detaching from the rock face causes cracking "b" in the masonry above. Betatakin. Note recent fall debris in background (right) which relates to instability shown in Figure 28.

Just to the right of view in Figure 26 a detaching slab shows its motion in the cracking masonry above (see Figure 27).

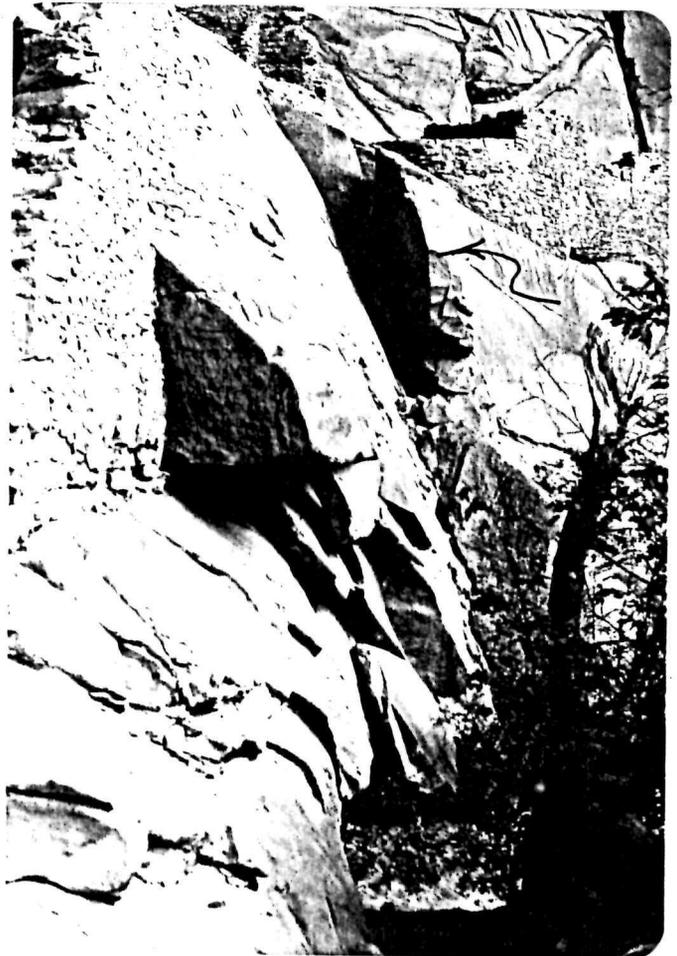
Figure 29. Apparently precarious 10 ton slab has half-meter wide crack out of view, behind. Blocks below the masonry (center) show motion and a fallen block behind the tree is cracking to threaten the trail.

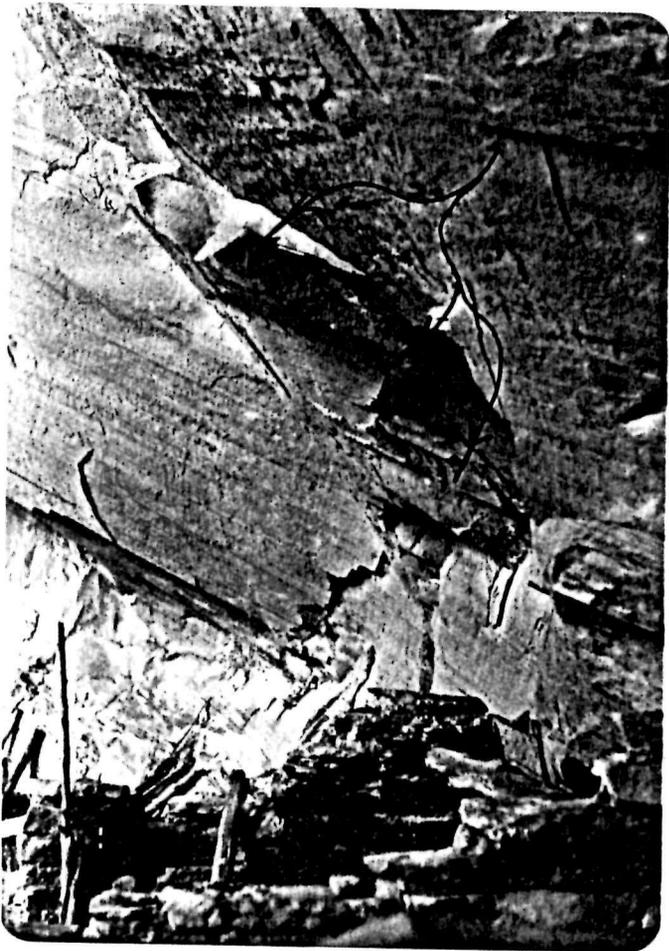
Figure 33. Active slabbing above room adjacent to and right of Figure 32.

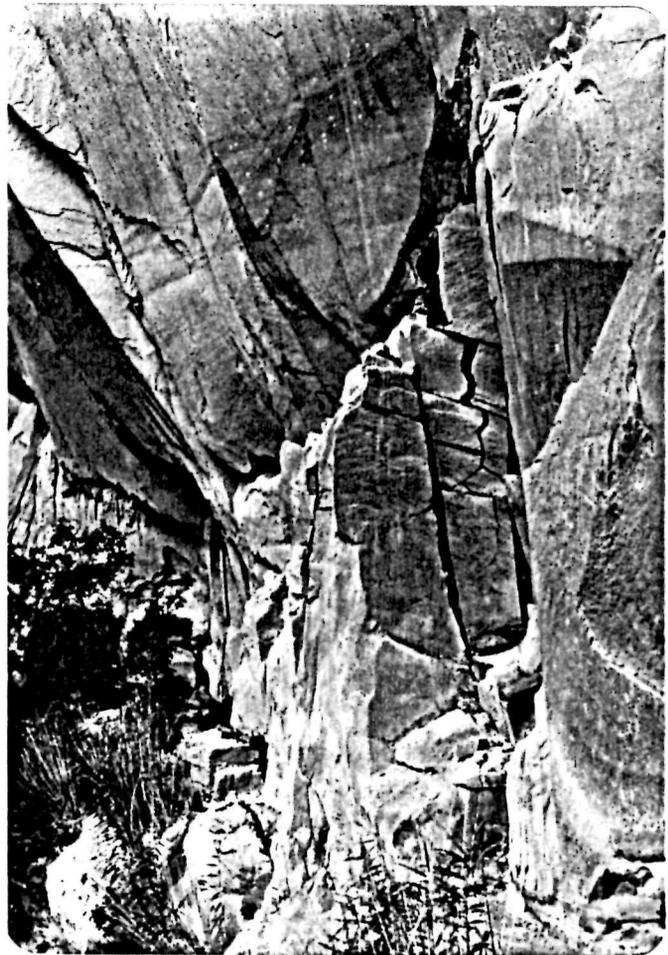
Figure 35. Shattered zone, looking west from Rock Art area. Also vertical cracks above show motion in this section of the cliff which buttresses the east end of Betatakin alcove.

Recommendations: Monitoring devices will be installed in most of the areas noted. Ends of cracks have been marked and documented in a few locations. This documentation will be sent to Navajo so crack propagation may be observed.

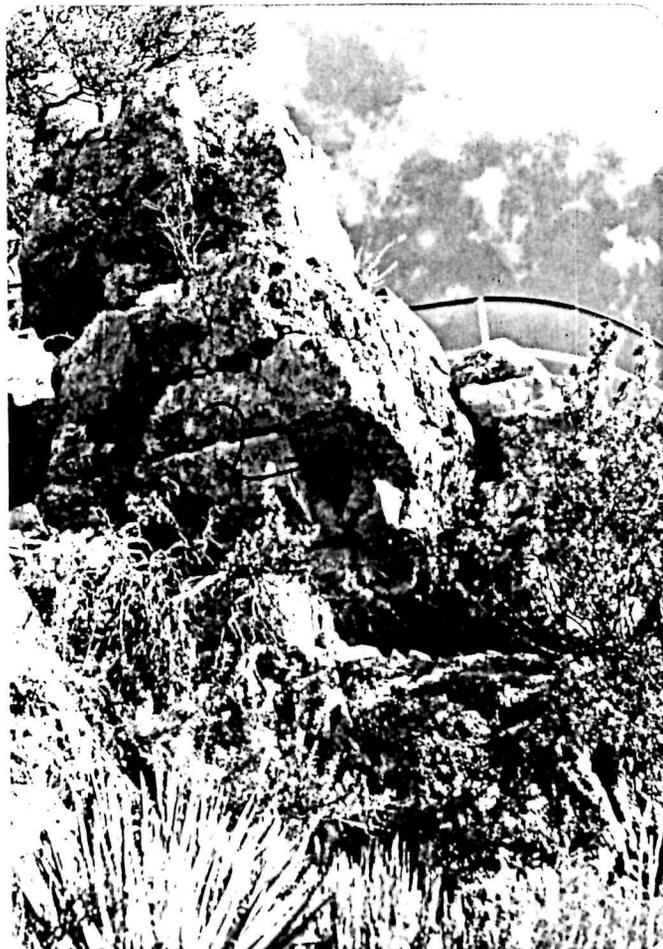
Figure 43. Random fall from otherwise stable faces and ledges. Walnut Canyon.

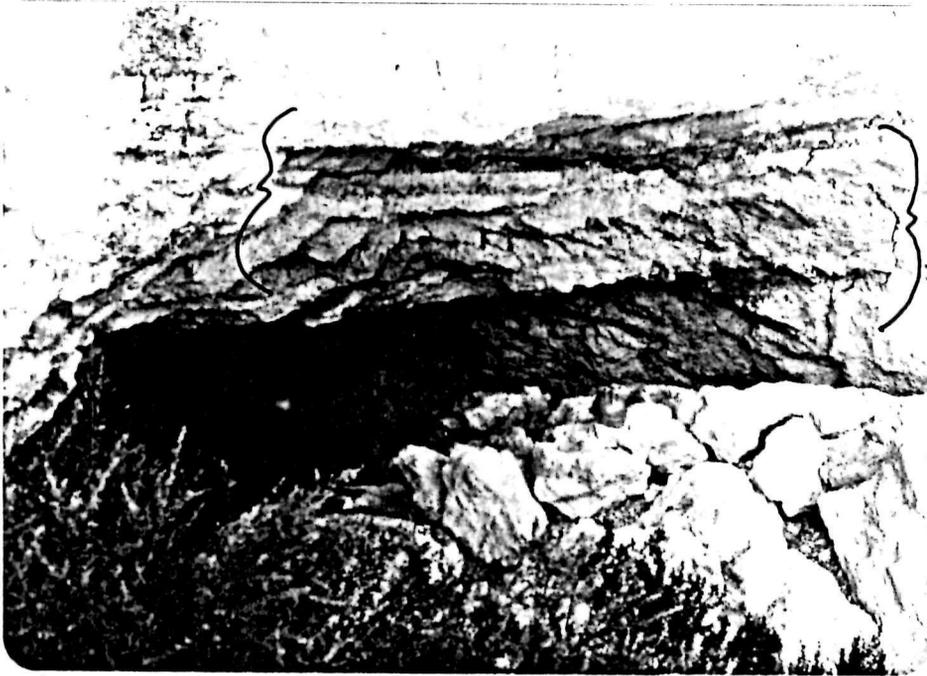
Figure 46. Grotto at ground level below Montezuma Castle. Fall has happened since 1890. Brackets show area of photo mosaic in Figure 47.

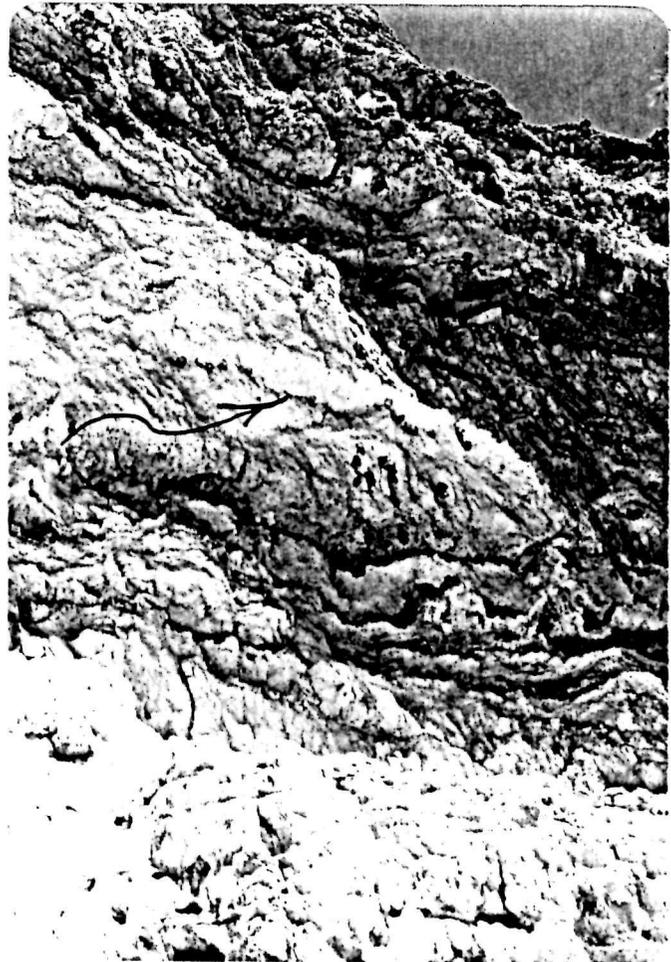
Figure 49. Zone "b" from Figure 48, showing loose slabs. All swallow's nests have fallen from the upper crack (motion?).

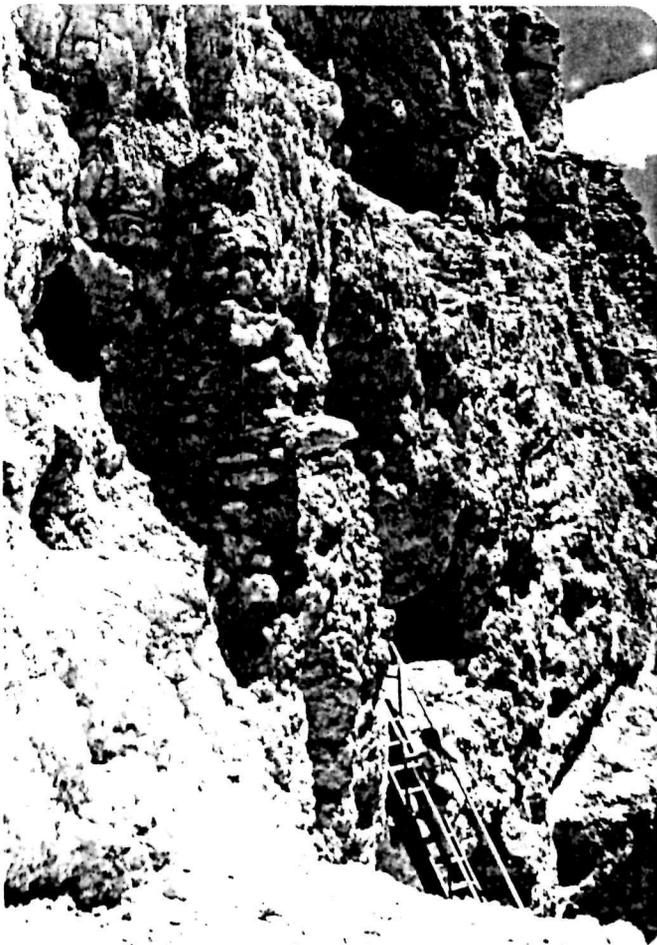
Some monitoring stations may be possible on specific crack systems. The central zones ("c" and "d" of Figure 48) are difficult to deal with due to complex motion, shattering, and discontinuous crack systems (Figures 50, 51). To the right and left (Figures 52, 53) old crack systems which may or may not be active can be instrumented. Fall does not appear as imminent in the areas of Figures 52 and 53 as elsewhere.

Figure 51. Precarious boulders in masonry remnant have been watched closely by Monument staff and remain firm. Much shattering is evident behind and above (including the mass to which the masonry is attached). Montezuma Castle.

Recommendations: Monitoring will be installed wherever possible, but the severe instabilities above walkways, stairs, and gathering points deserve immediate attention. The tallest (right hand) stairway to upper rooms is less threatened than lower walkways and stairs, though some danger exists there from the high cliff (section b, Figure 48). Of all sites visited this year, the central Castle "A" area most deserves detour of visitor traffic.
