HISTORIC STRUCTURE  
REPORT:

PHYSICAL FABRIC SECTION

LEISTER BARN

GETTYSBURG NATIONAL MILITARY  
PARK

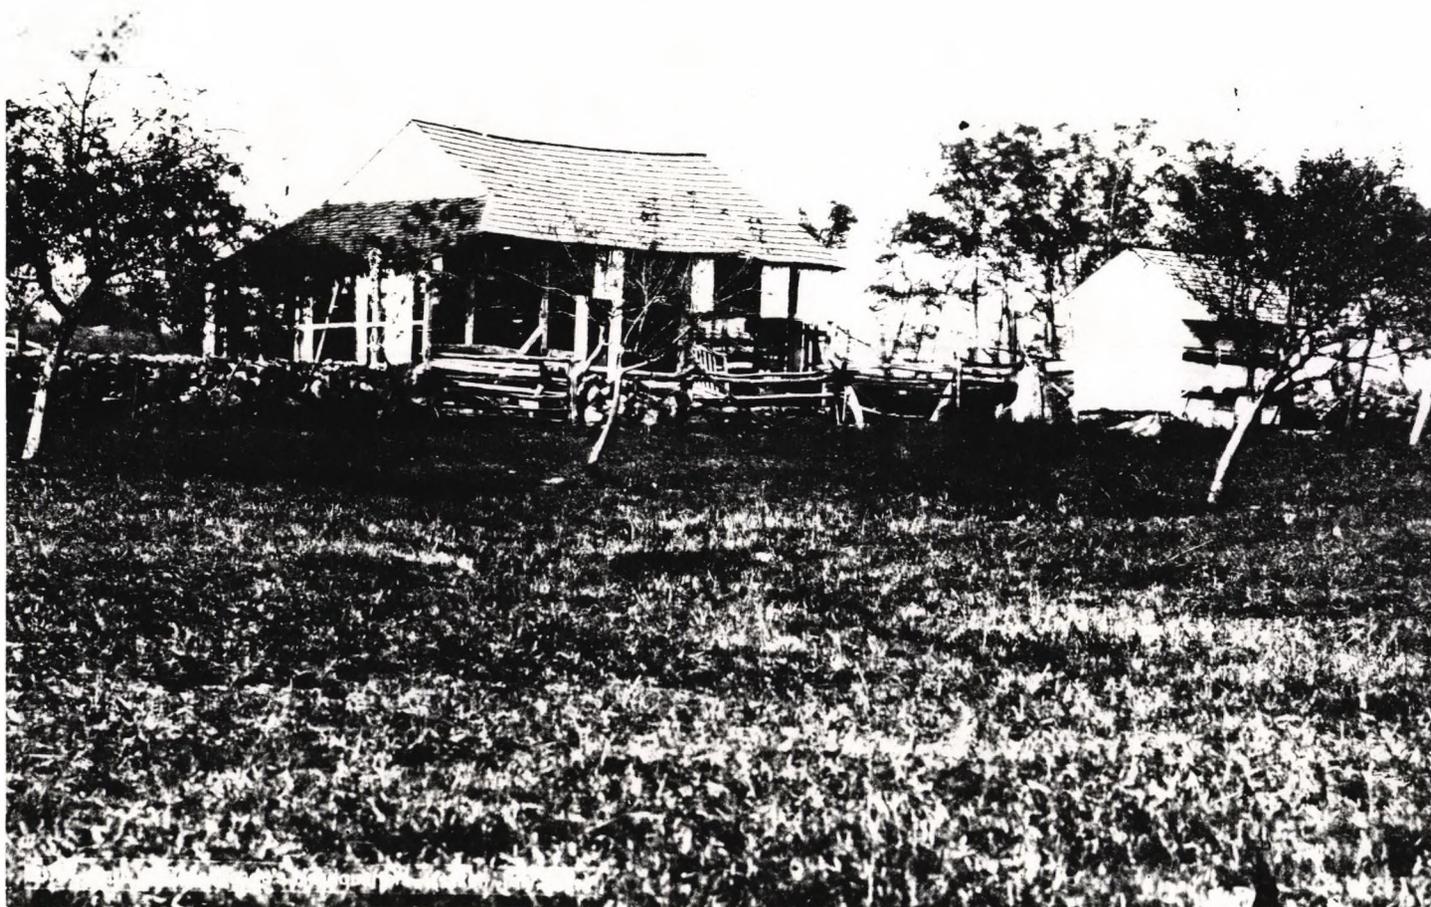
PHOTOGRAPH 3

The roofing on the higher barn bays is shown as drawn shakes, +12" exposure, lapped both vertically and horizontally across the course. (see Appendix D). The shed roof, however, appears to have been covered with drawn shakes laid in the "normal" manner -- i.e., side edges butted and with +12" vertical exposure. The ridge was combed toward the east, although the roofing adjacent to the hip rafter between the shed roof and main roof appears to have been combed toward the southwest. Photograph 3 also reveals that the roof pitch was flatter than that which exists today.

The visible exposed structural framing of the shed addition reveals that there was but a single exterior opening on the south and east elevations, a door at the southeast corner. The clearly visible continuous horizontal nailer on the south bent, as well as the five posts and two full-height diagonal braces, precluded openings to the south. The east wall of the shed had a framed door opening formed by the south corner post and a jamb post to the north which was let into the girt above. The door is missing in Gardner's view, but the upper drive pintle is possibly seen.

Leister Barn viewed from the south and east shortly after the Battle, July, 1863.  
Photographed by Alexander Gardner,

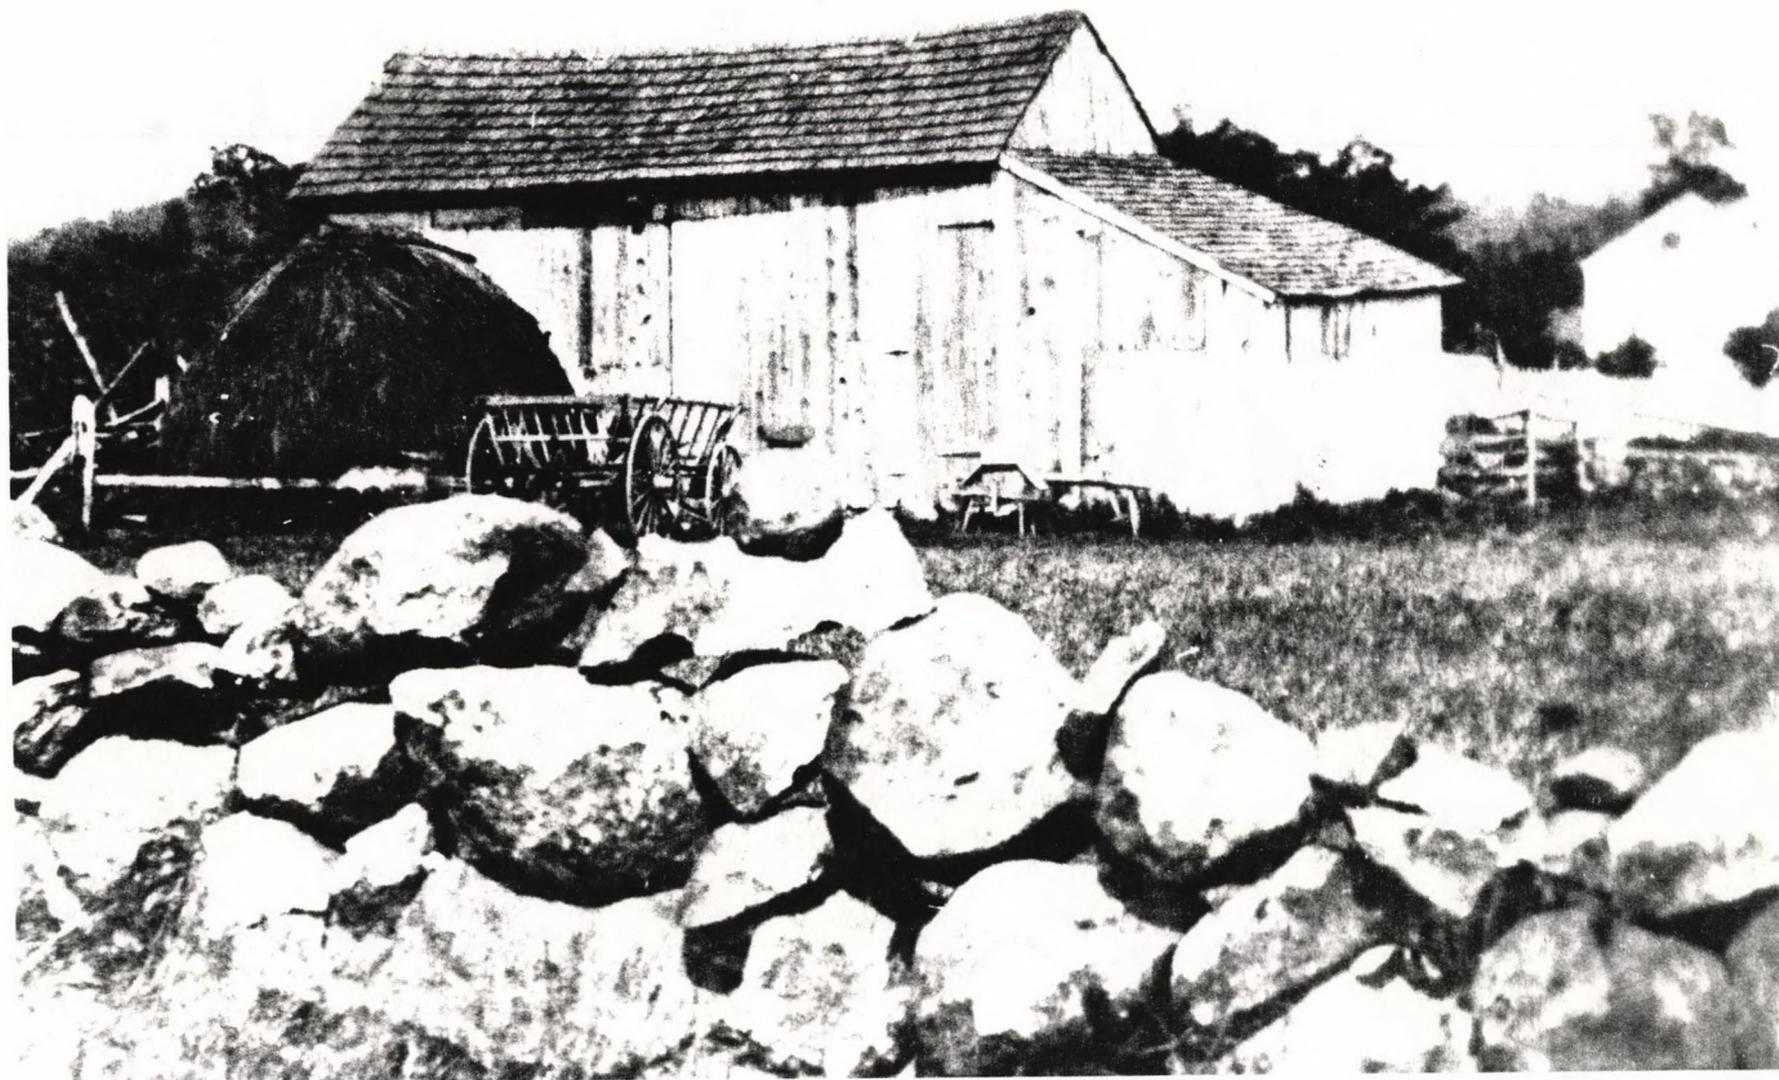
PHOTOGRAPH 4

Leister Barn, west and south elevations, taken shortly after the barn was re-clad, restoring the Battle damage. Photograph by Tyson c. 1866-68.

Although some of the original white-washed boards remain (particularly on the south gable, west elevation of the shed adjacent to the south leaf of the threshing floor doors, several on the west elevation of the shed, and on the threshing floor doors), the rest of the siding has been replaced. It is interesting to note that the new siding is tight, battenless, and unpainted, perhaps allowing for a season or two of

The visible continuous jointing of the south and west elevation siding on the shed, midway up the vertical face, is important because it locates the horizontal tie beam and girt serving as nailers. A nailer was seen in the south elevation framing in the Gardner View, and one of the bevelled mortises for the west elevation member still remains in the threshing floor corner post adjacent to the threshing floor doors, although the nailer was removed by 1882 along with the shed (Photograph 4). The presence of the unseen nailers in this view indicates that these elements and the adjacent posts of the shed framing were not changed after the war, but remained until the shed was removed c. 1880. Such was probably the case with the remainder of the frame.

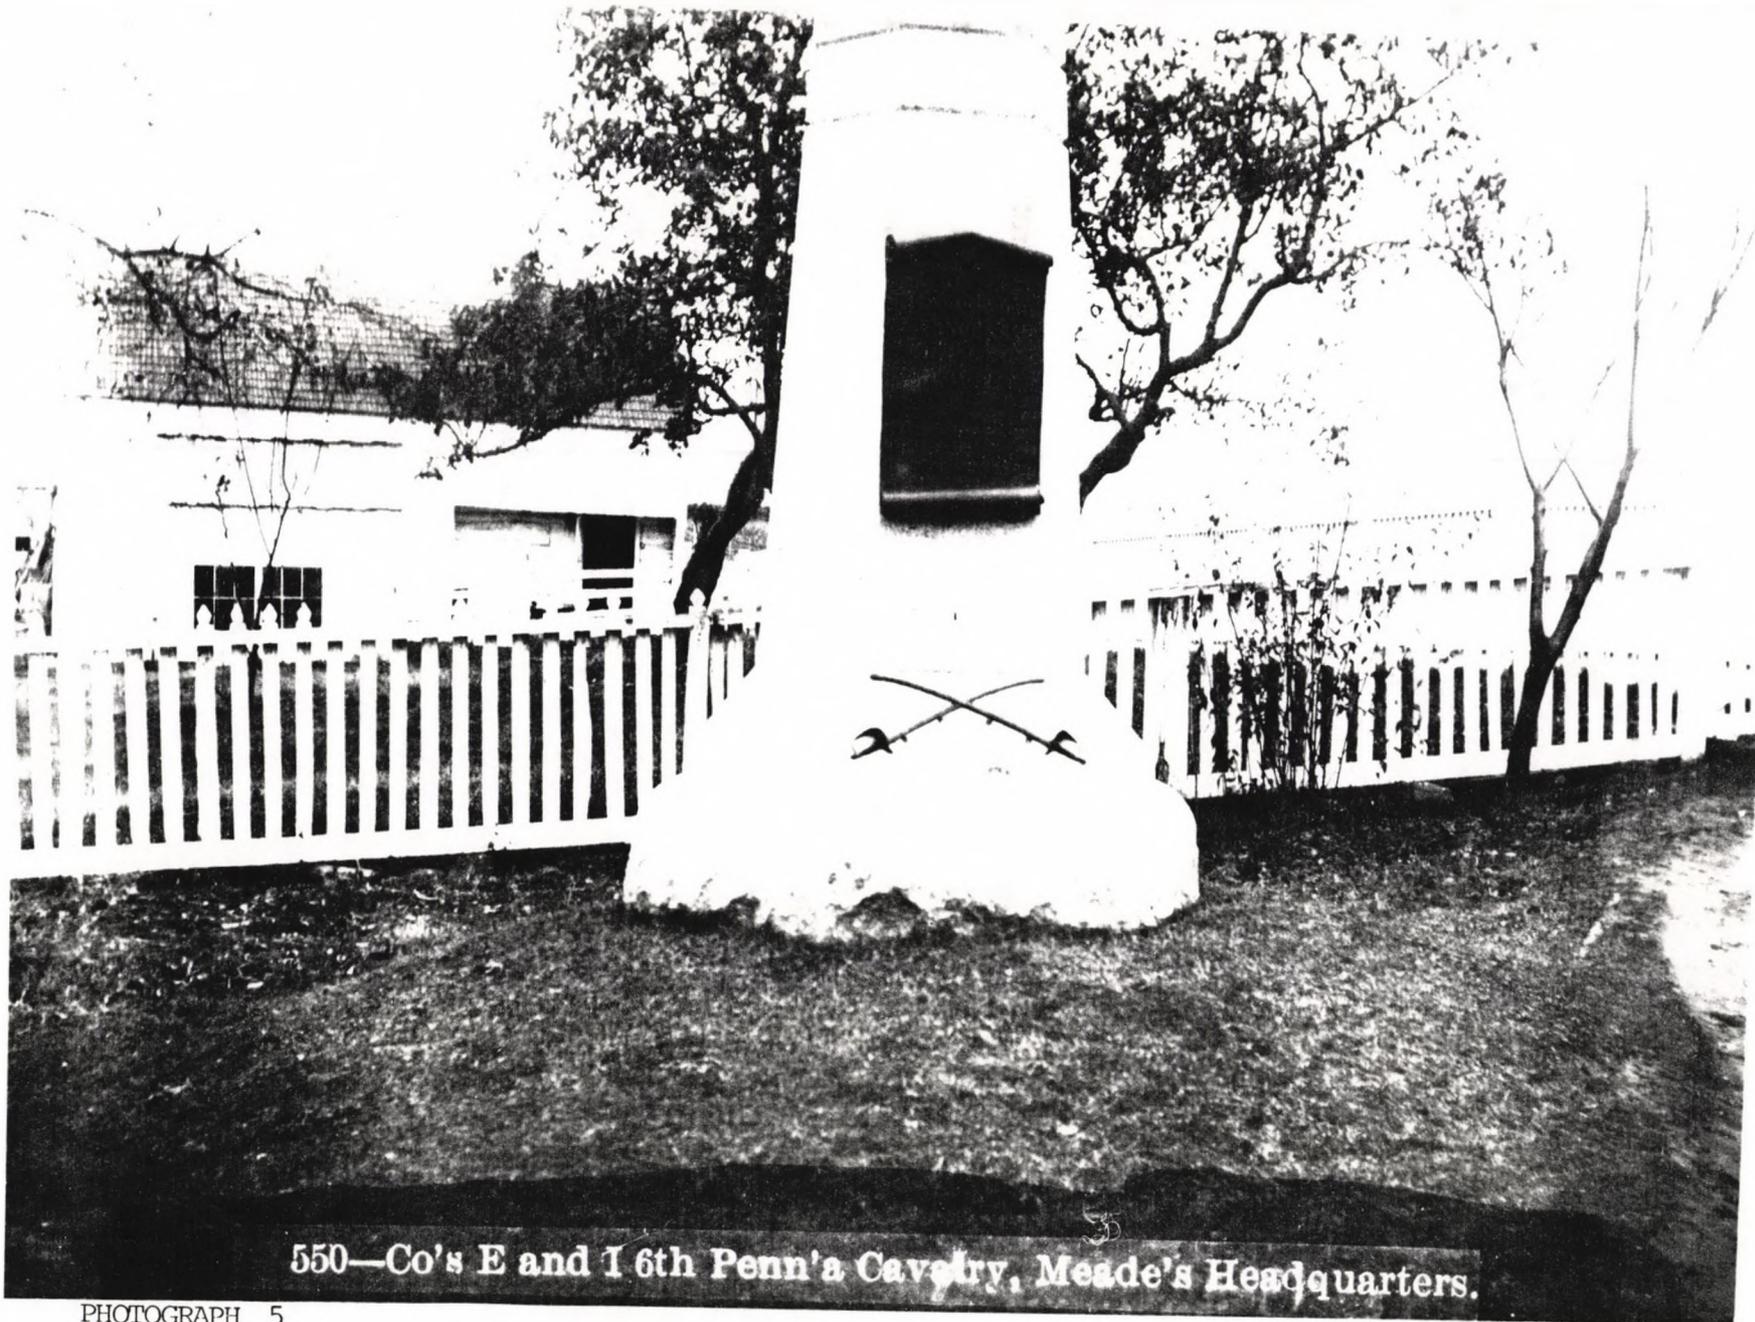
PHOTOGRAPH 5

Leister Barn ,East Elevation. Photograph by Tipton c. 1900.

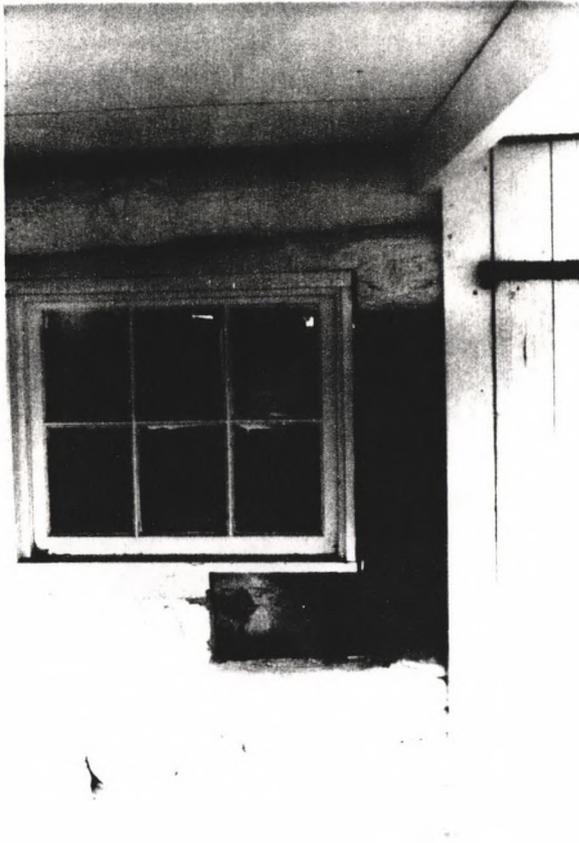
PHOTOGRAPH 10

LEISTER BARN, EAST ELEVATION, FOREBAY  
WINDOW AND DOOR TO STALLS.

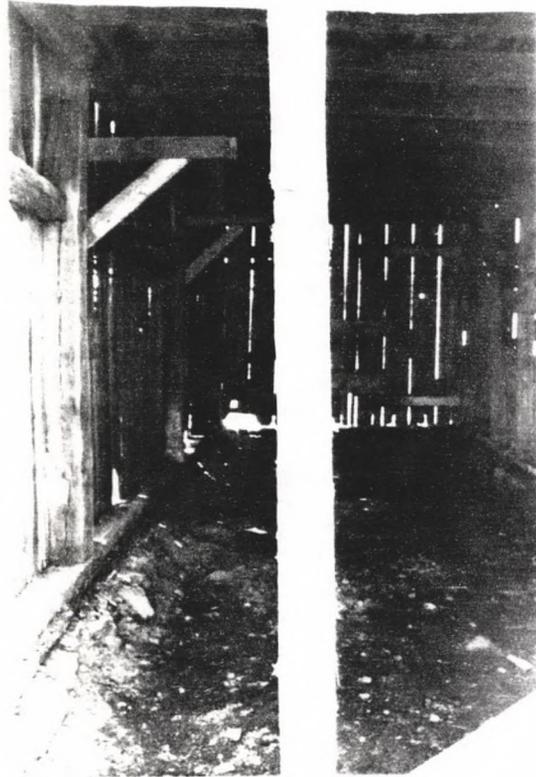
PHOTOGRAPH 13

EAST ELEVATION OF SOUTH BAY AFTER REMOVAL OF SIDING. THE CENTER STUD SUPPORTS THE GIRT ABOVE AND HAS THREE VESTIGIAL RABBETS. THE UPPER IS AT THE SAME HEIGHT AS ONE ON THE THRESHING FLOOR BENT, EAST POST, EXTERIOR AND APPEARS TO HAVE HELD A NAILER FOR ORIGINAL SIDING. THE TWO LOWER CUTS ON THE EAST APPEAR TO HAVE BEEN TO HOUSE DOOR BATTENS, BUT WERE NEVER USED AS THE DOOR WAS MOUNTED ON THE POST TO THE SOUTH.

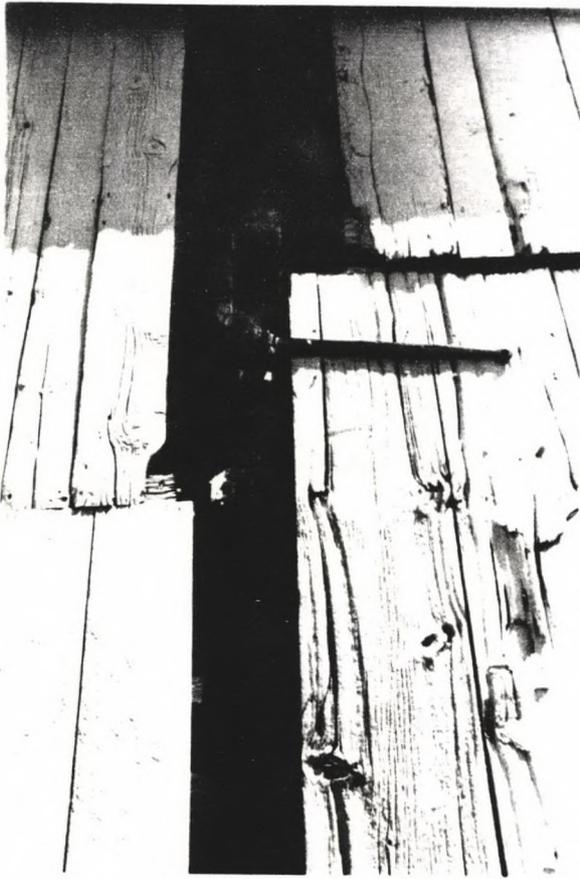
PHOTOGRAPH 19

Leister Barn, West Elevation: Detail  
of west jamb of threshing floor doors

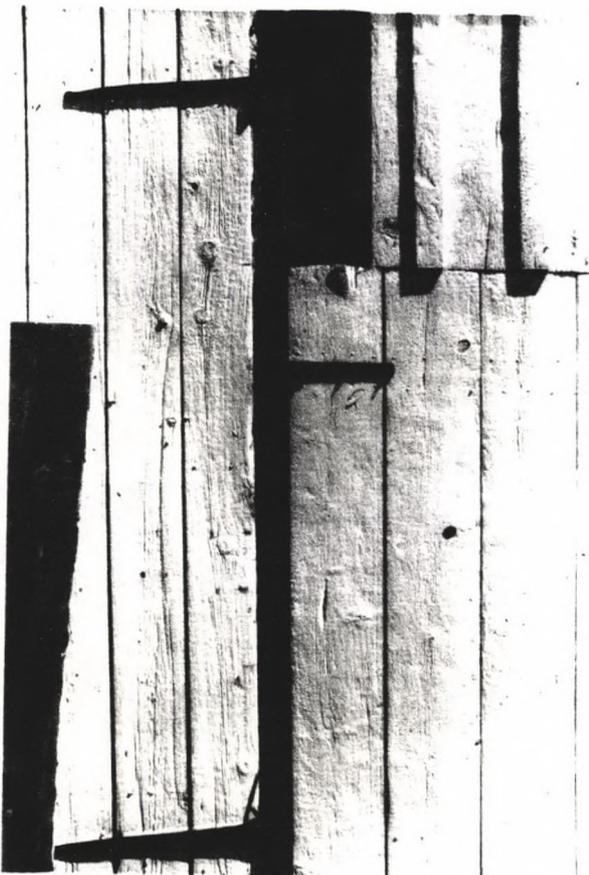
PHOTOGRAPH 20

Leister Barn, West Elevation: Detail of  
East Jamb of threshing floor doors and  
west jamb of carriage shed doors.

smaller wagon doors (7'7 1/2" high by 9'1" wide). The central doors show evidence of long use: wrought strap hinges hung from wrought drive pintles; vertically sawn boards deeply eroded by exposure to the elements; and a lack of battens. Without question, these doors predate or were part of the rehabilitation of the barn shortly after the Battle and are those seen in the 1866-68 Tyson Stereoview (Photograph 4). They probably replicate and incorporate part of the originals. The hinges and pintles appear to be in their original locations; only one earlier pintle hole adjacent to the upper north hinge exists in the framing. The one alteration to the doors appears in the quichet, or human-scale, door. Let into the larger right-hand leaf, it has been rebuilt, widened, and the wrought strap hinges seen in the Tyson view eliminated.

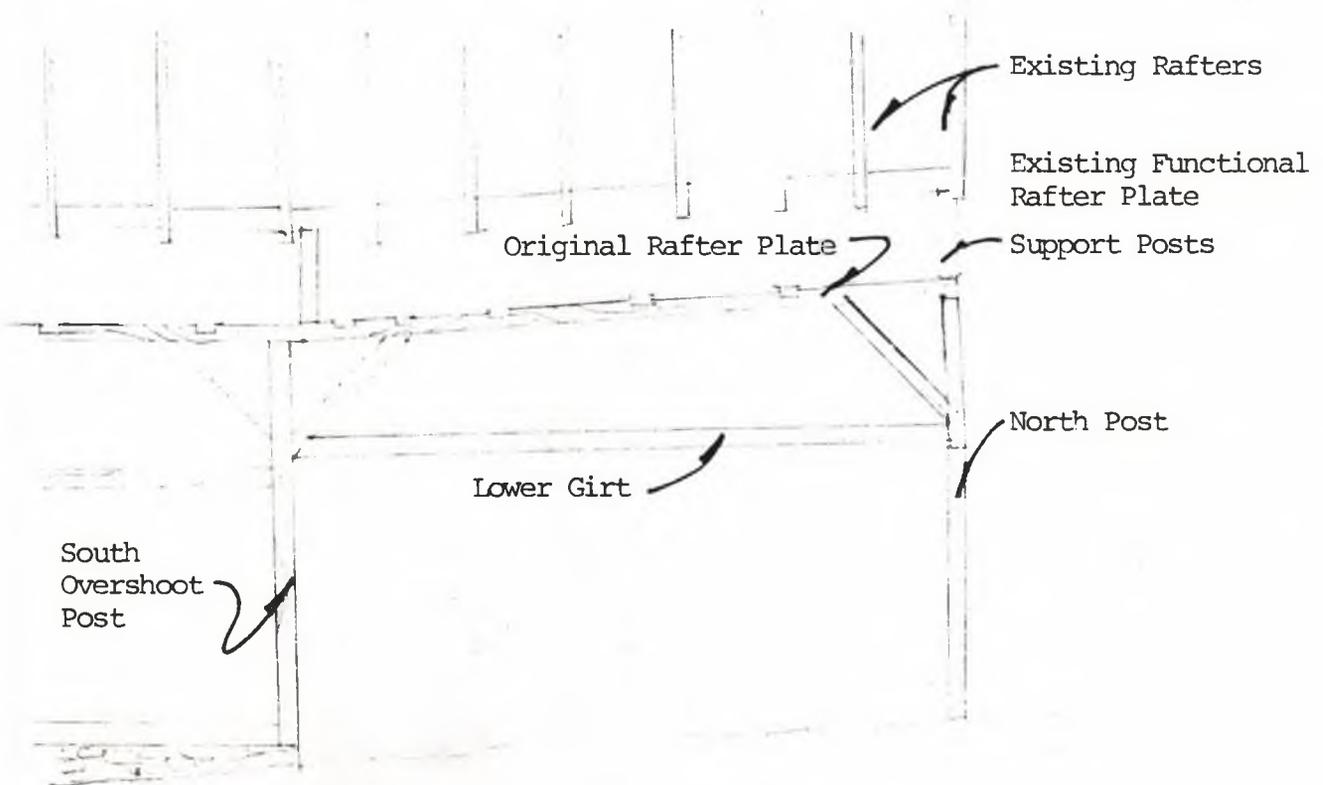
ILLUSTRATION 3

As seen in Photograph 26, and Illustration 3, the original units of the east elevation forebay frame consist of the upper section of the north post, the central girt, the southern post, the diagonal braces, and the lower girt. The central girt is, in fact, the original rafter plate as indicated by the bird's mouth mortises on its upper and outer faces. The posts supporting the existing functional rafter plate are toe-nailed to the earlier rafter plate and to the plate they support; these posts and upper plate were added c.1880 when the roof was raised to its present height. Both the original and 1880 members are hewn oak.

SKETCH ELEVATION OF EXISTING FOREBAY FRAMING. ORIGINAL FABRIC IS SHADED.

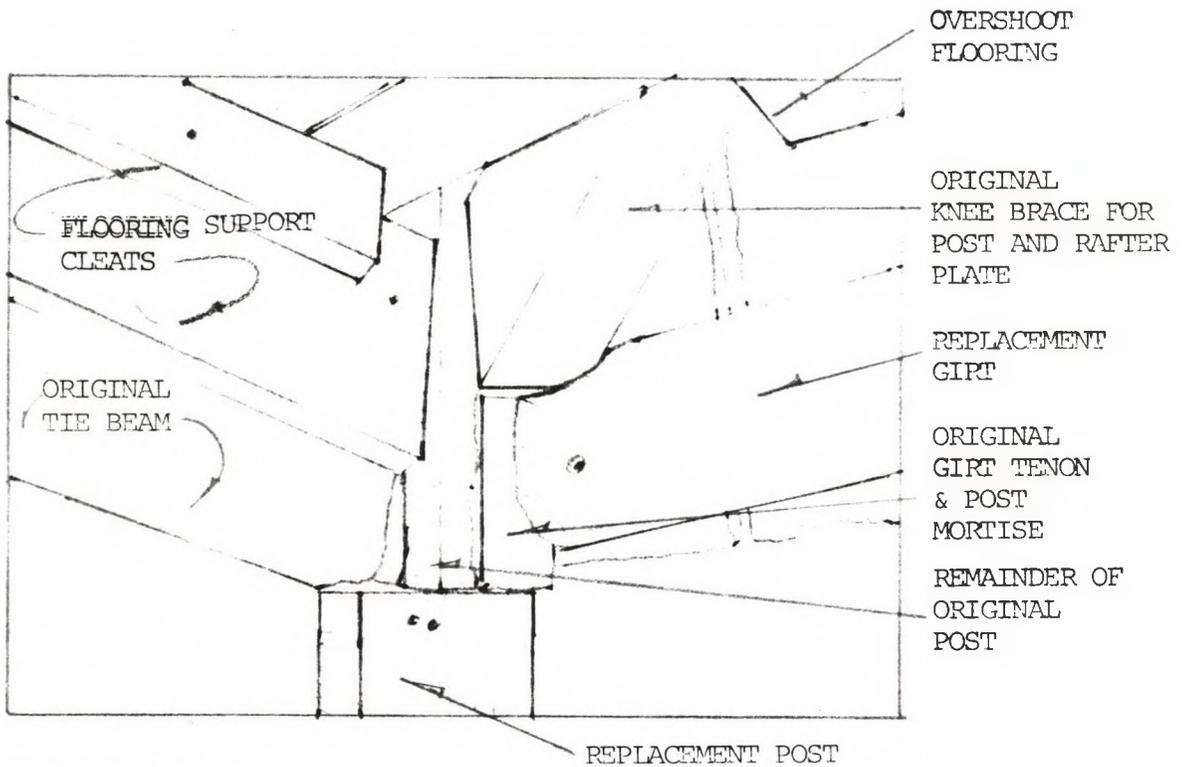
ILLUSTRATION 5

DETAIL SKETCH OF PHOTOGRAPH OF NORTH FOREBAY SUPPORT POST  
(NON-ORIGINAL MEMBERS ARE SHADED)

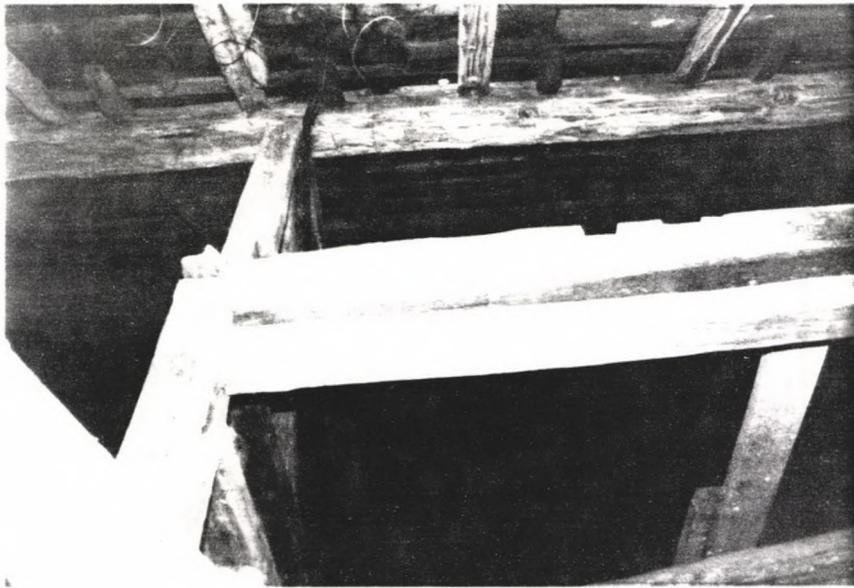
PHOTOGRAPH 31

LEISTER BARN INTERIOR. EAST ELEVATION OF THRESHING FLOOR BENT, EAST PRIMARY POST, AND PAIRED GIRTS CONNECTING THE THRESHING FLOOR BENT TO THE SOUTHEAST CORNER OF THE LOG BAY.

NOTE THE BIRD'S MOUTH MORTISES ON THE UPPER GIRT. ONE ORIGINALLY SEATED A PRIMARY RAFTER, THE OTHER AN EXTENSION RAFTER.

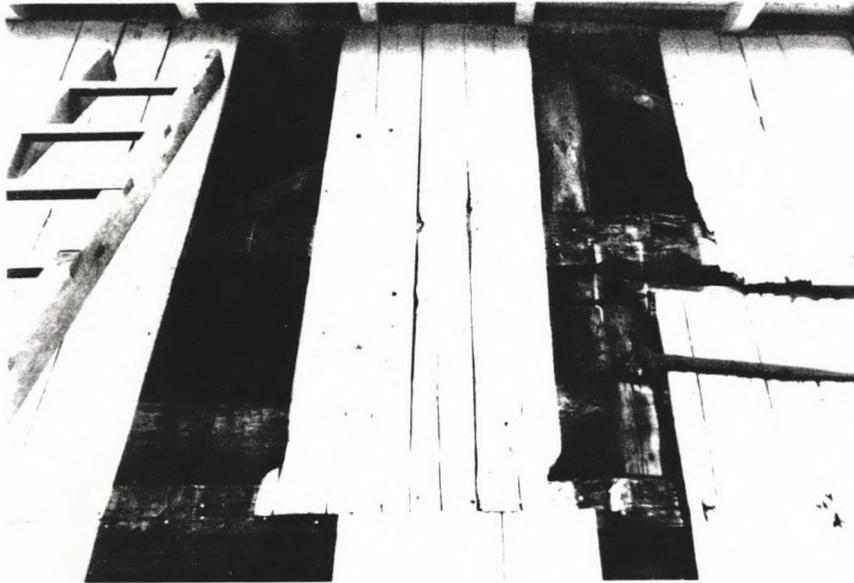
PHOTOGRAPH 32

WEST ELEVATION OF THE BARN, LOG BAY ADJACENT TO THE THRESHING FLOOR DOORS. WHERE SIDING HAS BEEN REMOVED ADJACENT AND ABOVE THE DOORS, AN ORIGINAL RAFTER PLATE WITH A BIRD'S MOUTH MORTISE STILL HOLDING A RAFTER END IS VISIBLE.

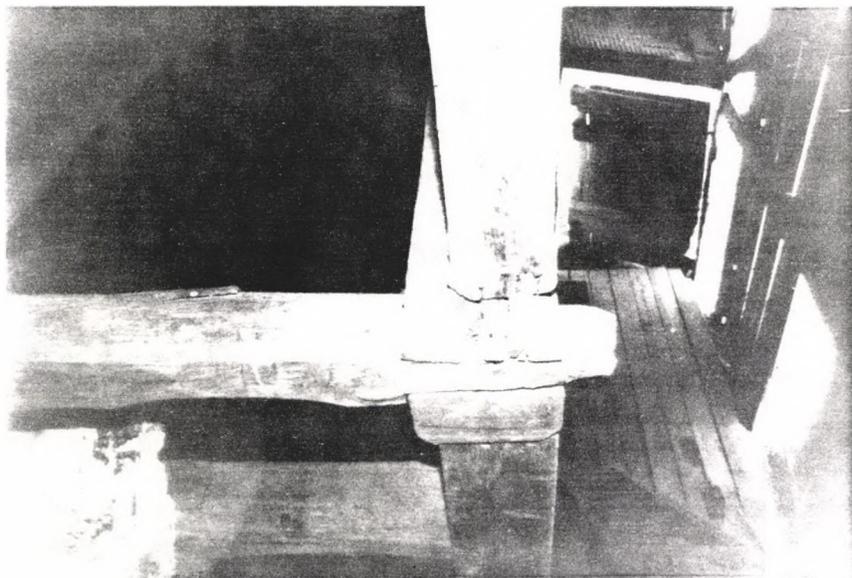
PHOTOGRAPH 34

The alteration of the roof pitch after the 1863 Gardner photograph, but before the 1882 Tipton view is substantiated by the existing framing. The roof alteration was accomplished by the installation of new + 6"x6" rafter plates above the older plates and supported by 5"x5"-6"x6" posts seated on, and toenailed to, the original plate. The posts were given lateral stability by the addition of 3"x4" knee braces which were also not let into the new or original frame, but spiked to both. Although it will be discussed in more detail below, all of these braces and posts appear to have been made from original rafters or south shed structural frame members. The added posts changed the pitch of the roof because those above the original west and primary east plate were 33" high, those mounted on the eastern plate carrying the overshoot and extension roof were only 26" high. The result of this height differential was that the eastern rafters were canted upward at a higher angle, raising the ridge more than it would have been if all three plates were raised by an equal value. Photograph 33 shows the south face of the west post of the threshing floor bent at the level of the original west rafter plate. Photograph 34 shows the main frame east rafter plate and bird's mouth mortises

LEISTER BARN THRESHING FLOOR BENT, EAST PRIMARY POST AT LEVEL OF ORIGINAL RAFTER PLATE. NOTE THAT THIS RAFTER PLATE CONNECTION IS SIMILAR TO THAT SEEN ABOVE, BUT THAT IT ALSO INCLUDES AN EXTENSION OF THE TIE BEAM WHICH ORIGINALLY WAS A SEAT FOR THE EASTERN HIP RAFTER.

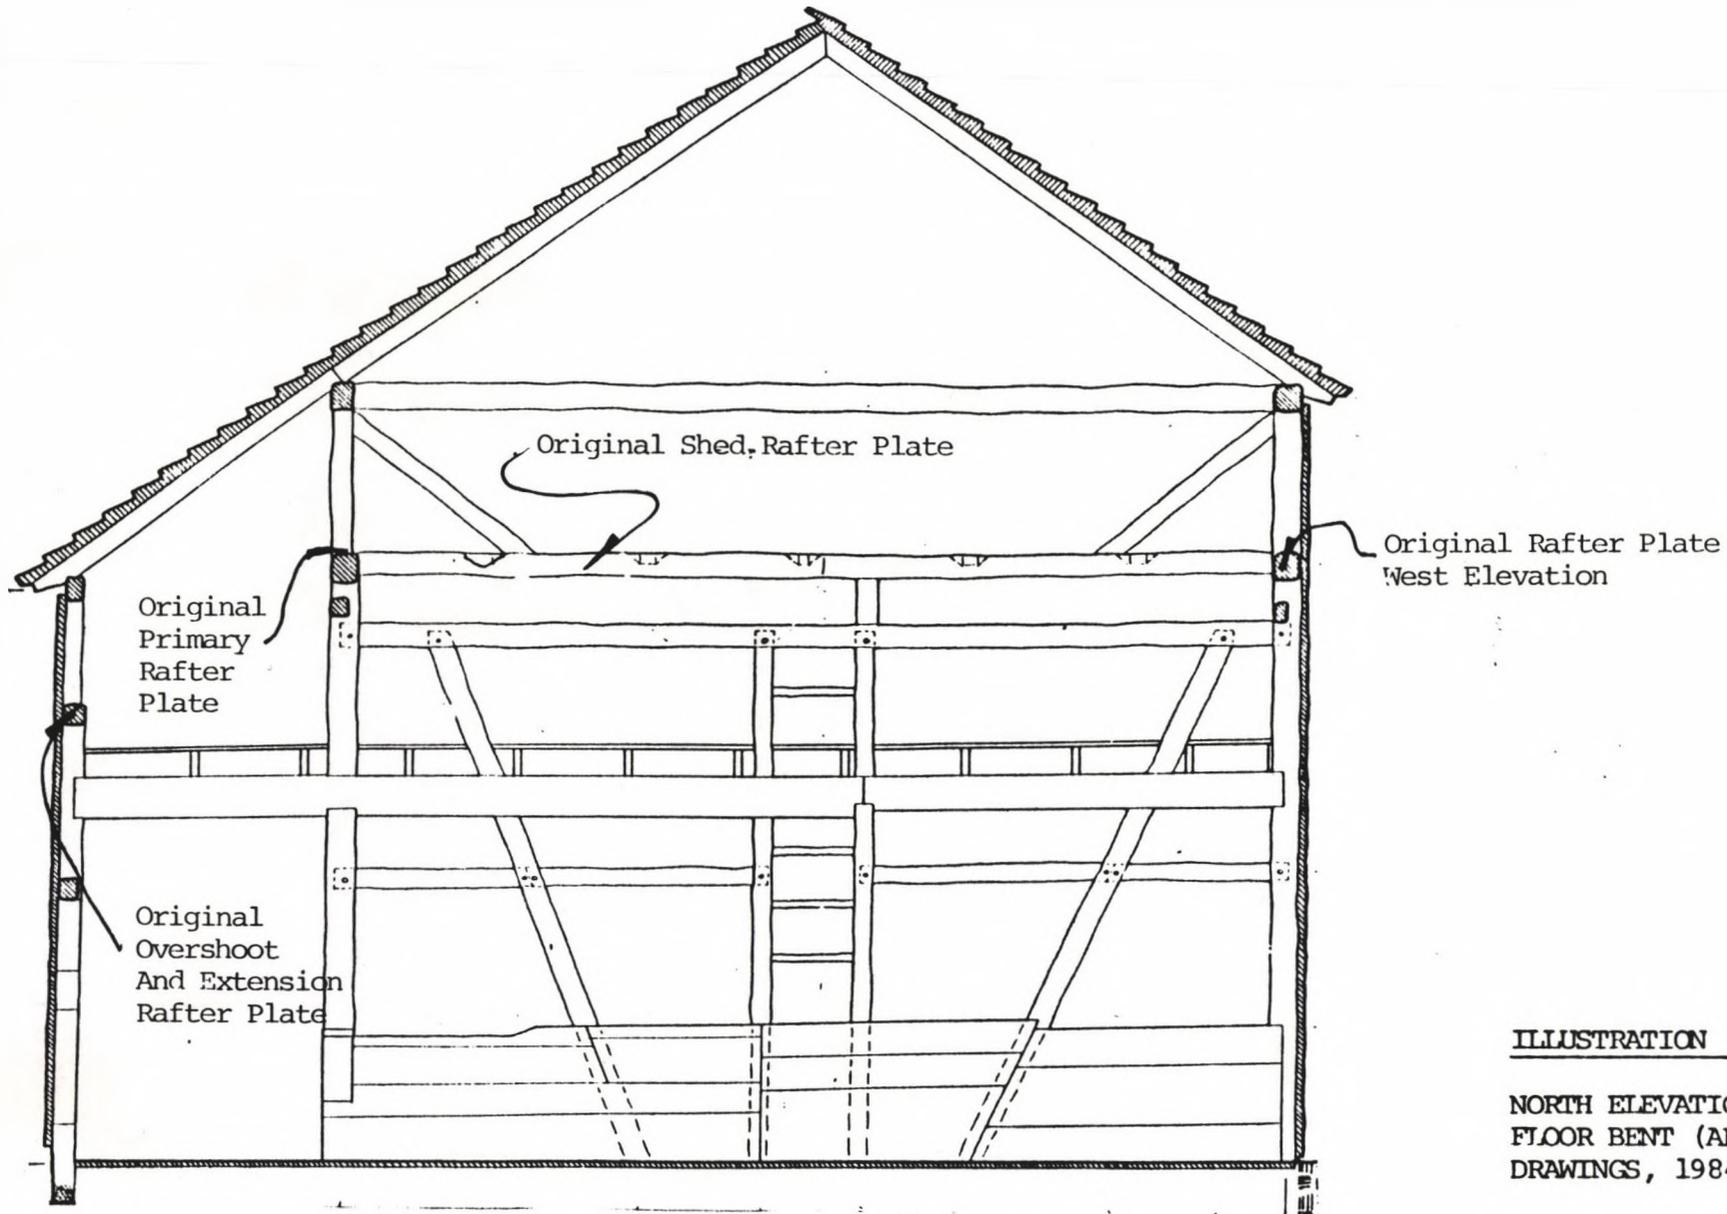
ILLUSTRATION 6

Of interest are the large diagonal members in the south threshing floor bent. Extending from the sill plate to the lower of the two transverse tie beams between the principal posts (Illustration 6), they are somewhat of a structural enigma. Hewn from oak, these 5"x5" members are tenoned to the sill plate and tie beams and additionally mortised to receive 4 1/2"x4" hewn ties tenoned into the principal posts and ladder studs. Similar construction has been noted in the McClean, Brian, Culp, and Codori Barns at Gettysburg, suggesting a common builder or a local vernacular tradition. They are of interest because they serve structurally as neither post nor brace, not being vertical and yet too close to vertical to act as effective bracing. The Gardner photograph reveals that the end (south) frame

NORTH ELEVATION OF THRESHING  
FLOOR BENT (AFTER HABS/HAER  
DRAWINGS, 1984)

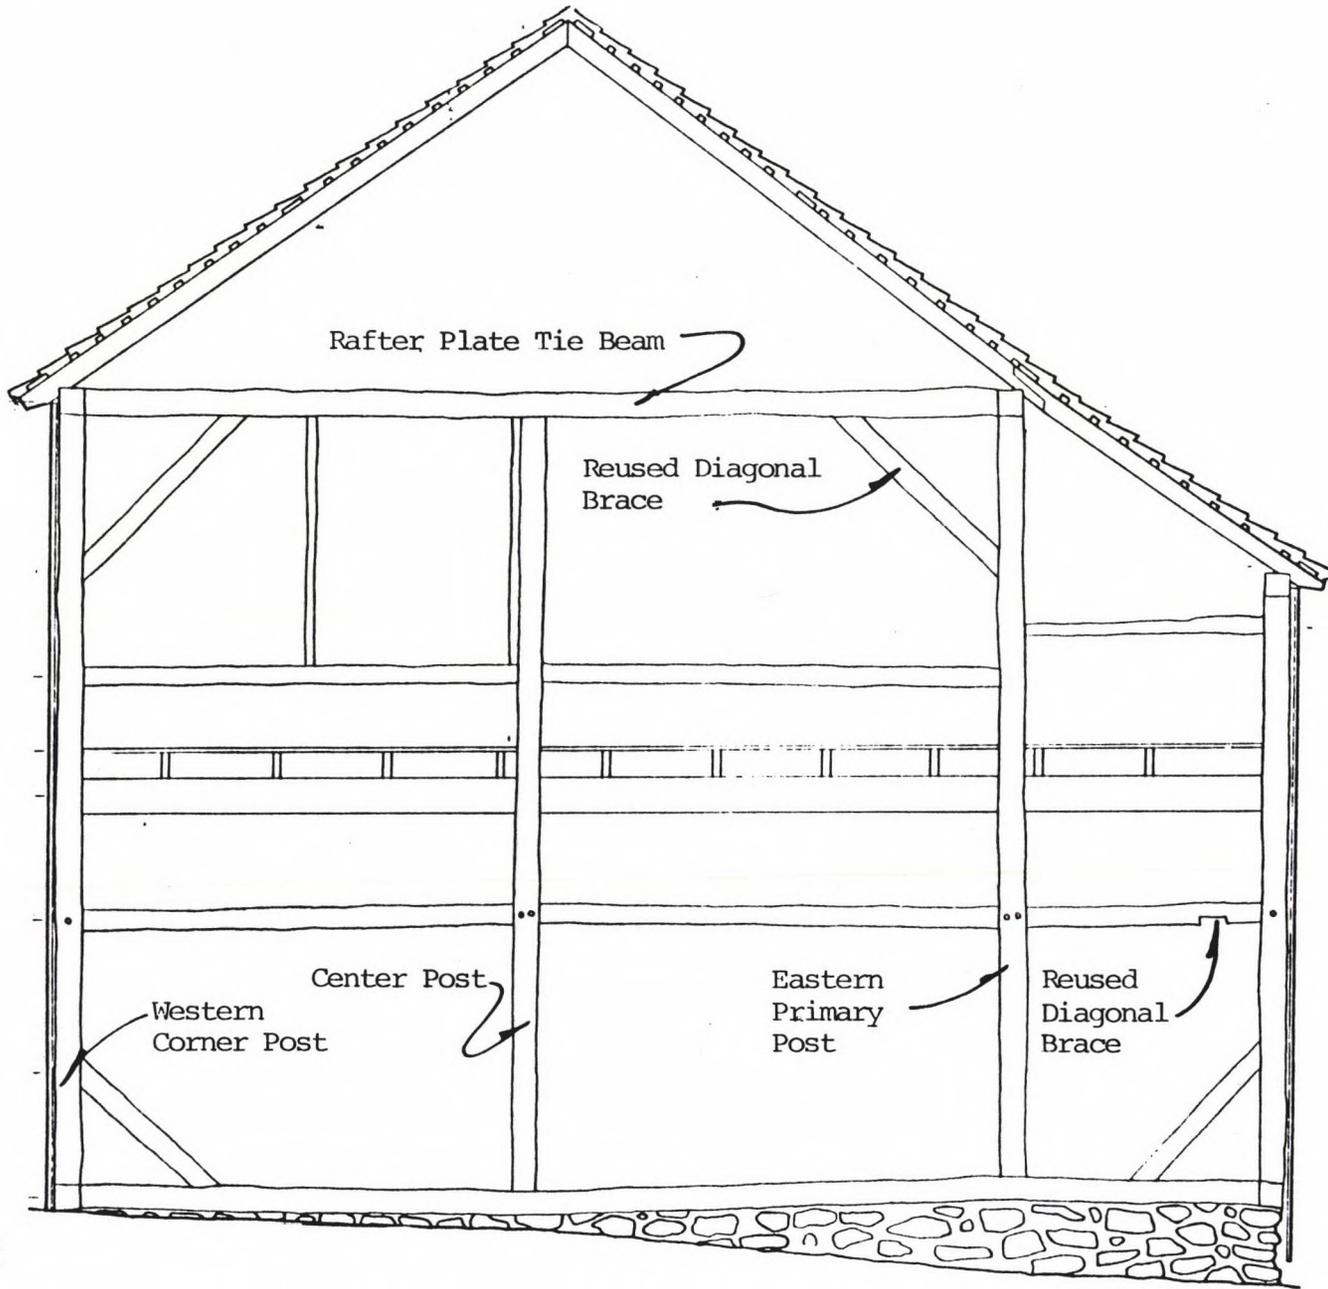
The existing south bent (Illustration 7) has four hewn oak posts. The three western ones are 6"x6" and extend from the sill plate (5 1/2"x5 1/2" and circular sawn) into which they are nailed up to the level of the existing functional 6"x6" east and west elevation rafter plates. The outer posts are let into the rafter plates, the center post let into a 6"x6" hewn tie beam that, in turn, is half-lapped onto the rafter plates. The easternmost post supports the functional rafter plate for the extension and is therefore shorter and lighter (5 1/2"x5 1/2"). The tie beams and knee braces in the bent are either machine planed or hewn; the hewn members are not joined to the frame, but nailed, and all show clear evidence of being reused.

ILLUSTRATION 7  
 SOUTH ELEVATION OF SOUTH  
 BENT DRAWN WITH SIDING  
 REMOVED (AFTER HABS/HAER  
 DRAWINGS, 1984)

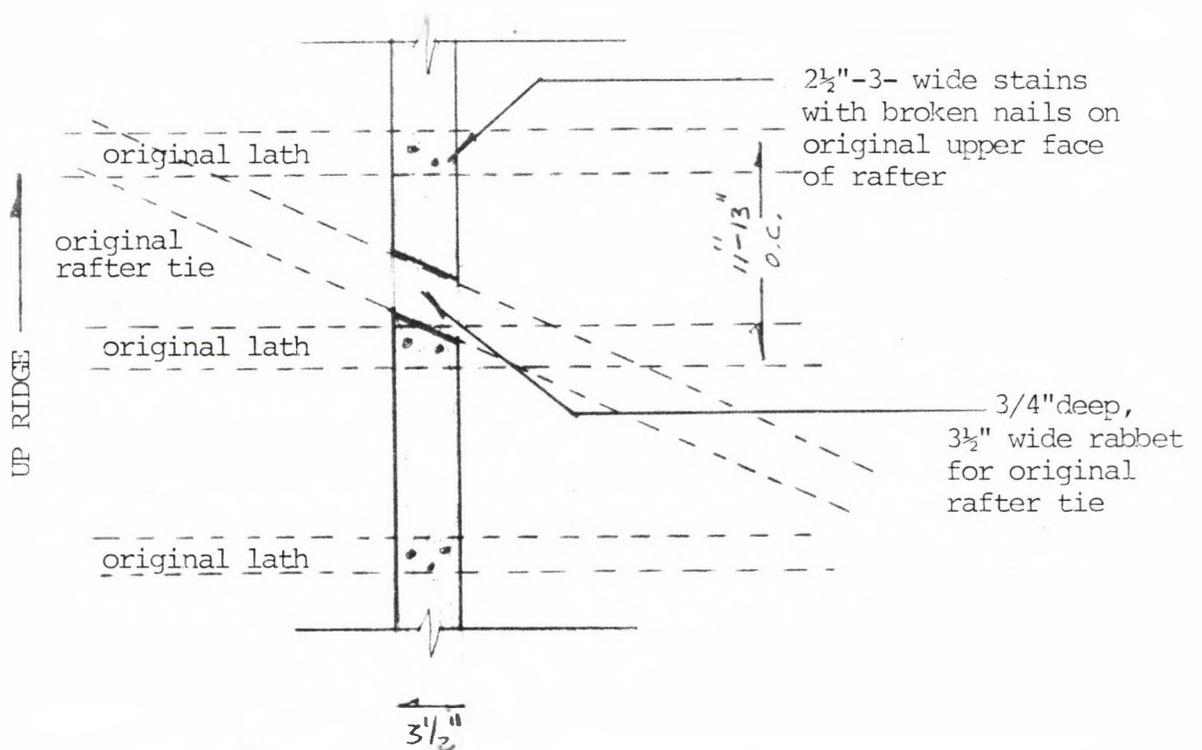
PHOTOGRAPH 37

The braces toenailed to the top of the original threshing floor bent shed rafter plate support the newer rafter plate posts. They were both made from reused earlier rafters. The western one (seen in Photograph 37) reveals broken wrought nails 12"-13" on center situated in discolored rectangular areas presumably formed by the original shingle

DETAIL OF UPPER BRACE FOR WEST NON-ORIGINAL RAFTER PLATE SUPPORT POST MOUNTED ON THRESHING FLOOR BENT. POST IS TOENAILLED TO ORIGINAL RAFTER PLATE AND THRESHING FLOOR BENT UPPER TIE BEAM.

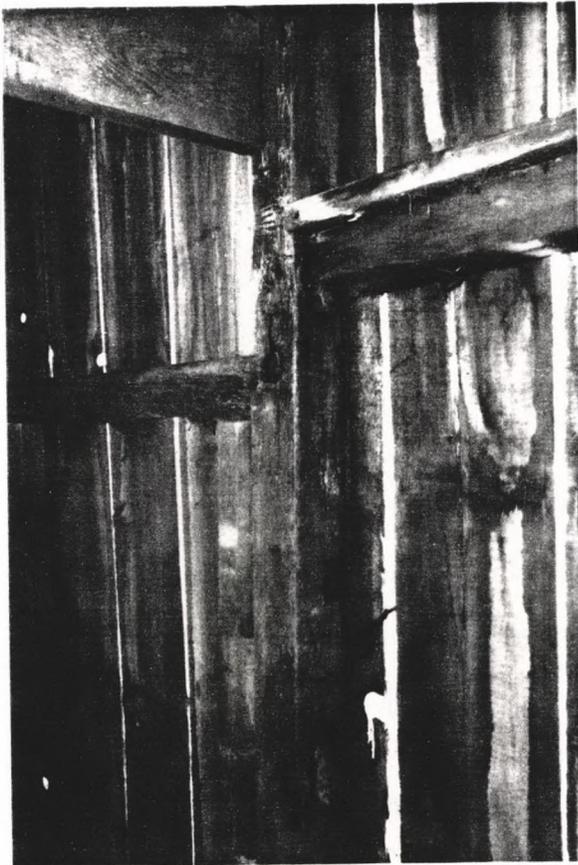
PHOTOGRAPH 38 (ABOVE)

EAST ELEVATION OF SOUTH BAY ABOVE HAY LOFT FLOOR. NOTE THAT THE EXISTING HORIZONTAL GIRT IS HALF-LAPPED; THAT TO THE LEFT (NORTH) IS PART OF THE ORIGINAL SOUTH SHED FRAME.

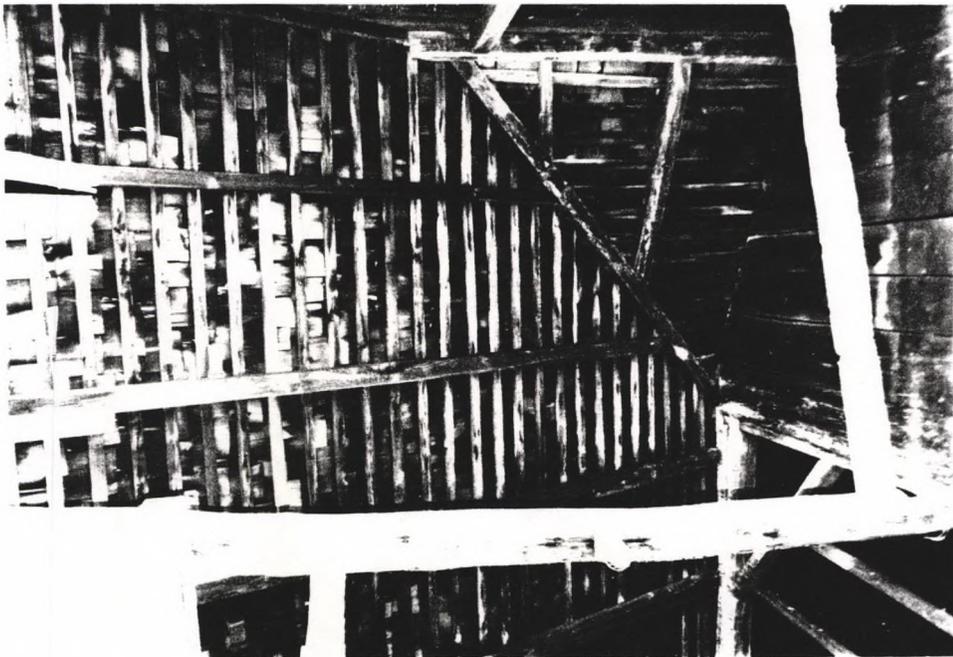
PHOTOGRAPH 40

Although the jointing of the plate and hip rafter is unknown because the plate was cut and spliced c.1880, the upper hip rafter seat remains (Photograph 40). The Culp Barn roof, dating to the same period, has a similar joining of shed roof to gable; its hip rafter detail is shown in Photograph 41.

LOWER SURFACE OF ORIGINAL PRIMARY (EASTERN) RAFTER PLATE AND THRESHING FLOOR BENT CORNER POST SHOWING DETAIL OF ORIGINAL HIP RAFTER SEAT.

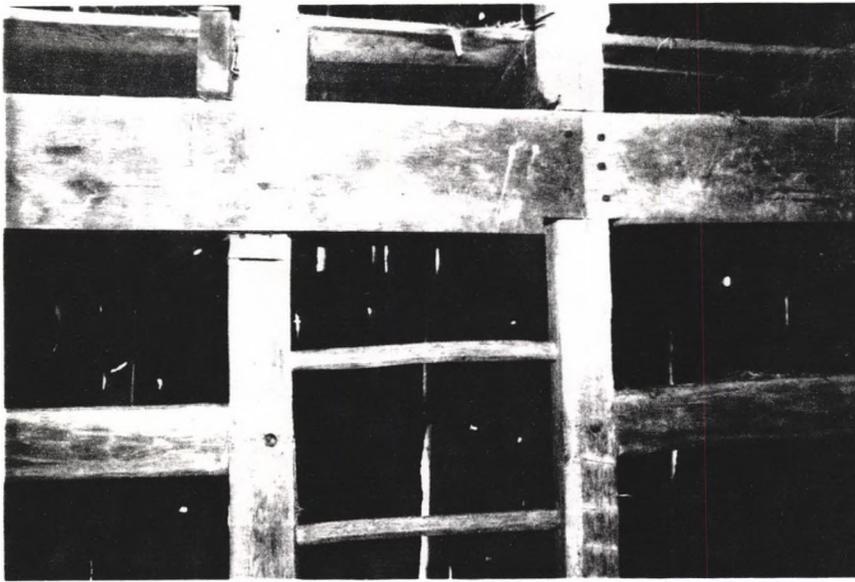
PHOTOGRAPH 41

CULP BARN (GETTYSBURG N.M.P.) HIP RAFTER FRAMING.

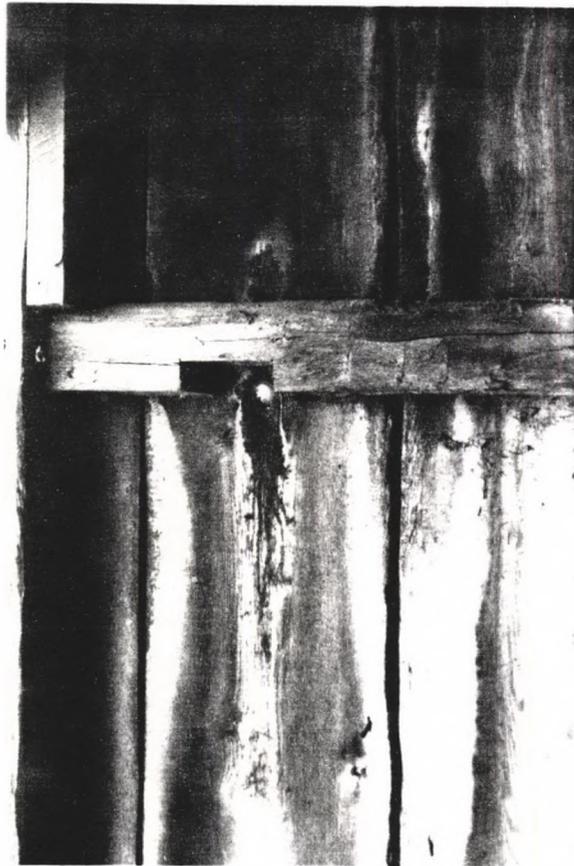
SOUTH BENT OF SOUTH BAY AT THE LEVEL OF THE EXISTING FUNCTIONAL  
RAFTER PLATE.

THE HORIZONTAL TIE BEAM IS PARTIALLY SUPPORTED BY THE KNEE BRACE  
SEEN IN THE CENTER OF THE PHOTOGRAPH. THE RABBET IN THE UPPER  
FACE OF THE BEAM, AND THE MANY BROKEN NAILS, INDICATE THAT THE  
MEMBER IS A REUSED PORTION OF AN ORIGINAL SOUTH SHED DIAGONAL  
BRACE.

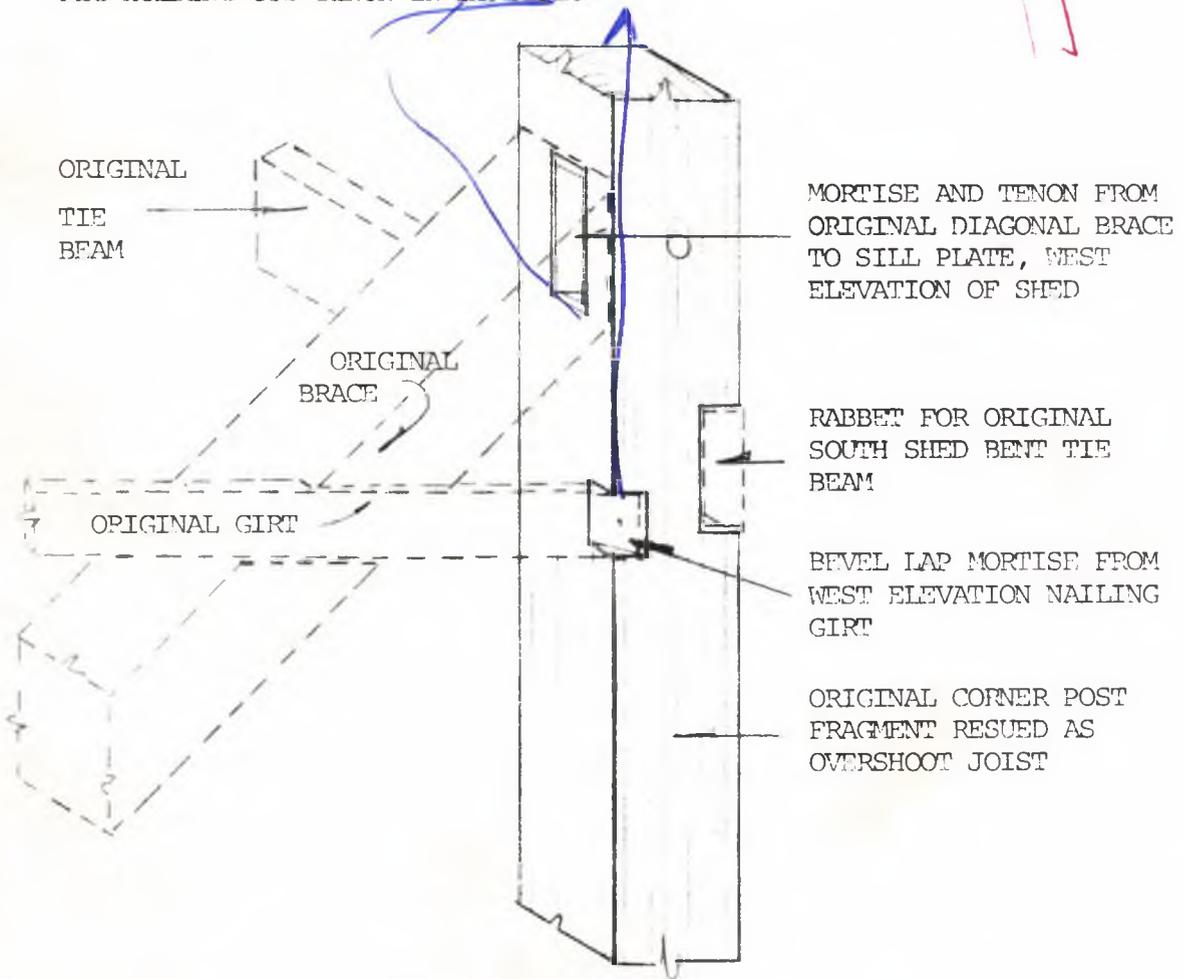
PHOTOGRAPH 45

the overshoot flooring (Photograph 45 and Illustration 9). Hewn from oak, the 4 1/2"x5" beam has a 2"x6" mortise. That on the south face of the existing west post of the threshing floor bent is 2"x6 1/4" and that on the east post, 2 1/4"x6 1/4". One of the mortised faces also has a rabbet, 5" wide and 1 1/2" deep, containing five broken nails.

The rabbeted side and the adjacent face reveal a number of broken and bent nails. The second nailed face has a beveled lap mortise, 2 1/4" high and 1 1/4" deep. The locations of the mortise, beveled lap, and rabbet pinpoint the location of the original south and west elevation ties and brace.

BOTTOM AND SOUTH ELEVATION OF CENTRAL OVERSHOOT FLOOR JOIST. BEVEL LAP MORTISE AND RABBET ARE VISIBLE AS IS PEG HOLDING CUT TENON IN MORTISE.
