HISTORIC STRUCTURE  
REPORT:

PHYSICAL FABRIC SECTION

LEISTER BARN

GETTYSBURG NATIONAL MILITARY  
PARK

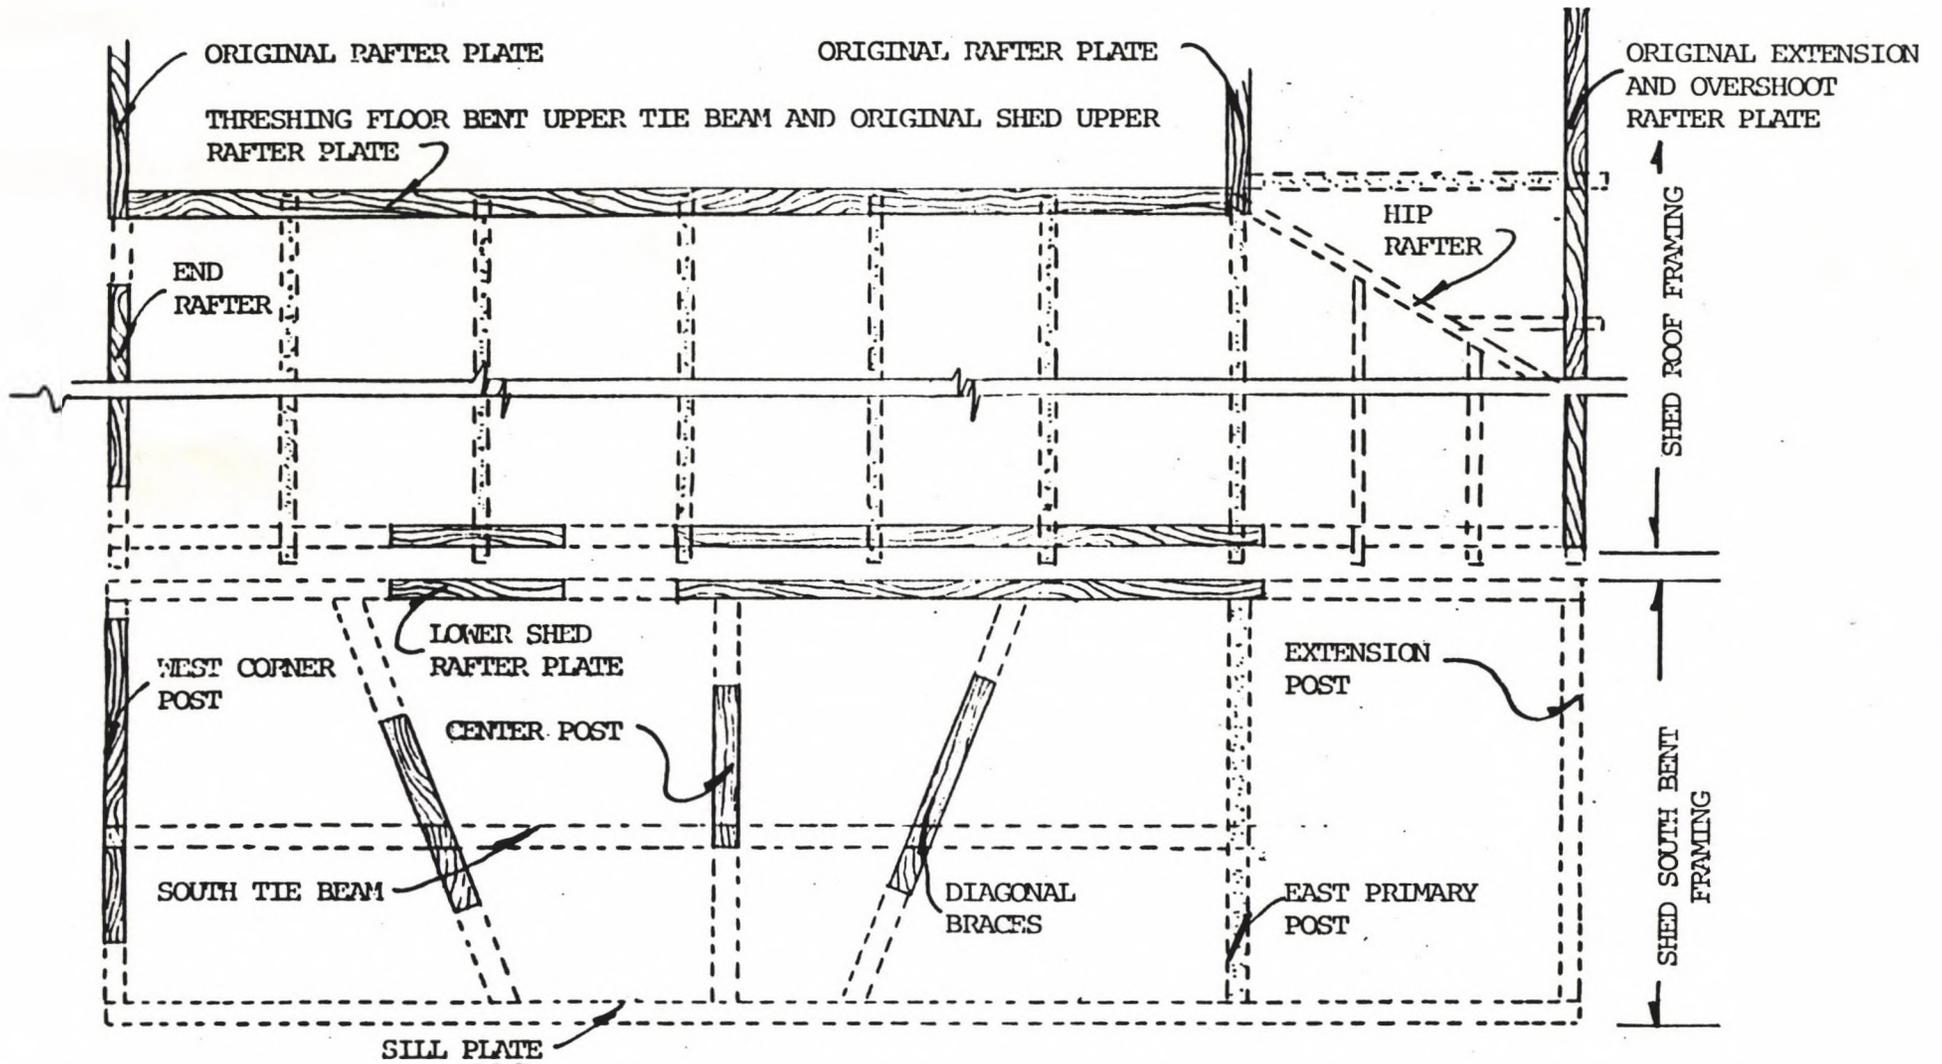
ILLUSTRATION 10

As previously noted, a portion of the threshing floor ladder and the entire south bay west elevation tie beam have nonfunctional bird's mouth mortises and/or blind mortises. As shown in illustration 10, these joints correspond with both the rafter seats remaining on the threshing floor bent and with the Gardner photograph. Furthermore, the dimensions of the blind mortises agree with the sizes of the reused members herein identified as having been part of the original shed south bent.

SKETCH PLAN AND ELEVATION OF SHED BAY ROOF PLAN AND SOUTH ELEVATION FRAMING. IN SITU OR IDENTIFIED REUSED FABRIC IS SHADED; REUSED FABRIC OF UNKNOWN SPECIFIC LOCATION IS STIPPLED.
