## **Tennessee Valley Stables (Cunha/Rapozo Ranch, Ranch A/B)**

### **Cultural Resource Reports and Site Treatment: Cultural Landscape Report Historic Structure Reports Archeological Assessment and Treatment Report**

June 10, 2013  
United States National Park Service,  
Golden Gate National Recreation Area  
Division of Cultural Resources

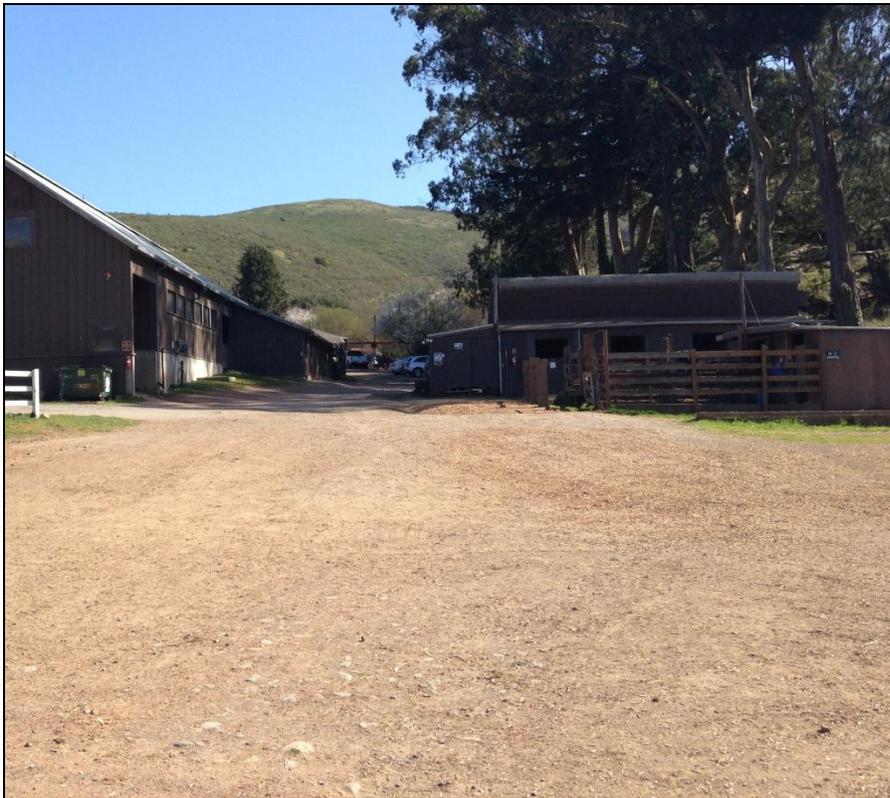
The rustic, understated circulation features are a character defining feature within Ranch A/B and should be preserved.

- Maintain the historic circulation features in their rustic, understated character including specifically the alignment, width, paving, and absence of asphalt and striping.

- As feasible, restrict use of concrete to the historic limits which include remnant foundations and ramps and the concrete alley north of the main barn complex.
  - Any modifications to the historic concrete must be performed in consultation with the park’s historical landscape architect.
- If a hardened surface is required, consider use of road base with a binding agent, such as Perma-Zyme®, TerraHold or a triple shot of chip seal, as has been proposed for Satterlee Road at Fort Baker.
- Do not attempt to define parking spaces with stripes, wooden curb stops, or any other manufactured features. The use of stones or logs may be appropriate.
- New circulation features should be located outside of the historic building core, where feasible.
- The use of historic building foundations for parking is discouraged.

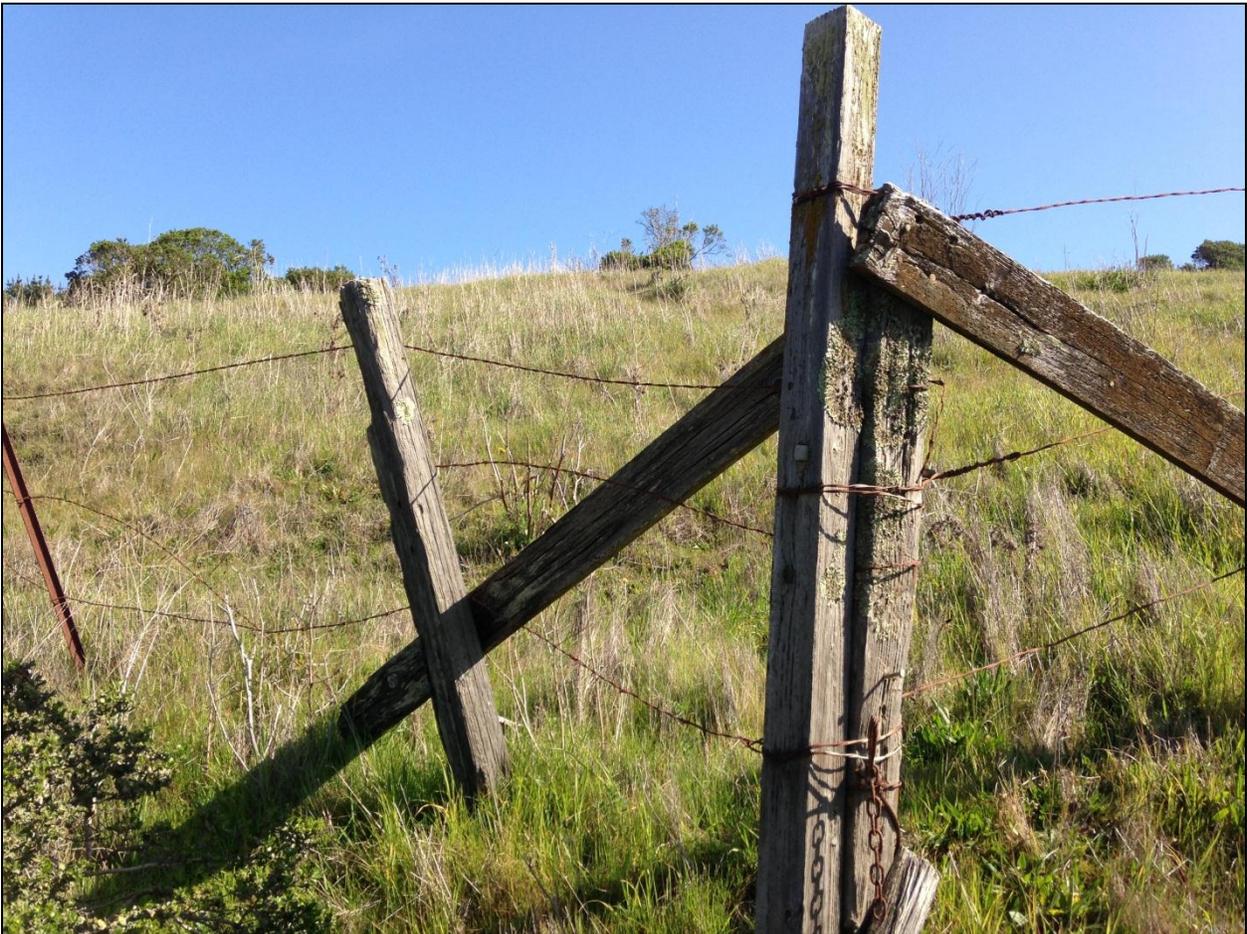
Fence posts should be maintained as a contributing resource.

- Maintain and preserve the fence posts as contributing resources.
- Maintain historic utilities, as feasible.
  - Introduction of contemporary utilities and facilities associated with operations should be visually compatible with historic structures within the core.
- Conduct historical archeological investigations to document remnant historic small scale features throughout the historic district such as dump sites, fence lines, utilities and infrastructure, the location of non-extant structures and foundation ruins.
- Limit the addition of new small scale site features for contemporary use. If new small scale features are required, the following guidelines apply:

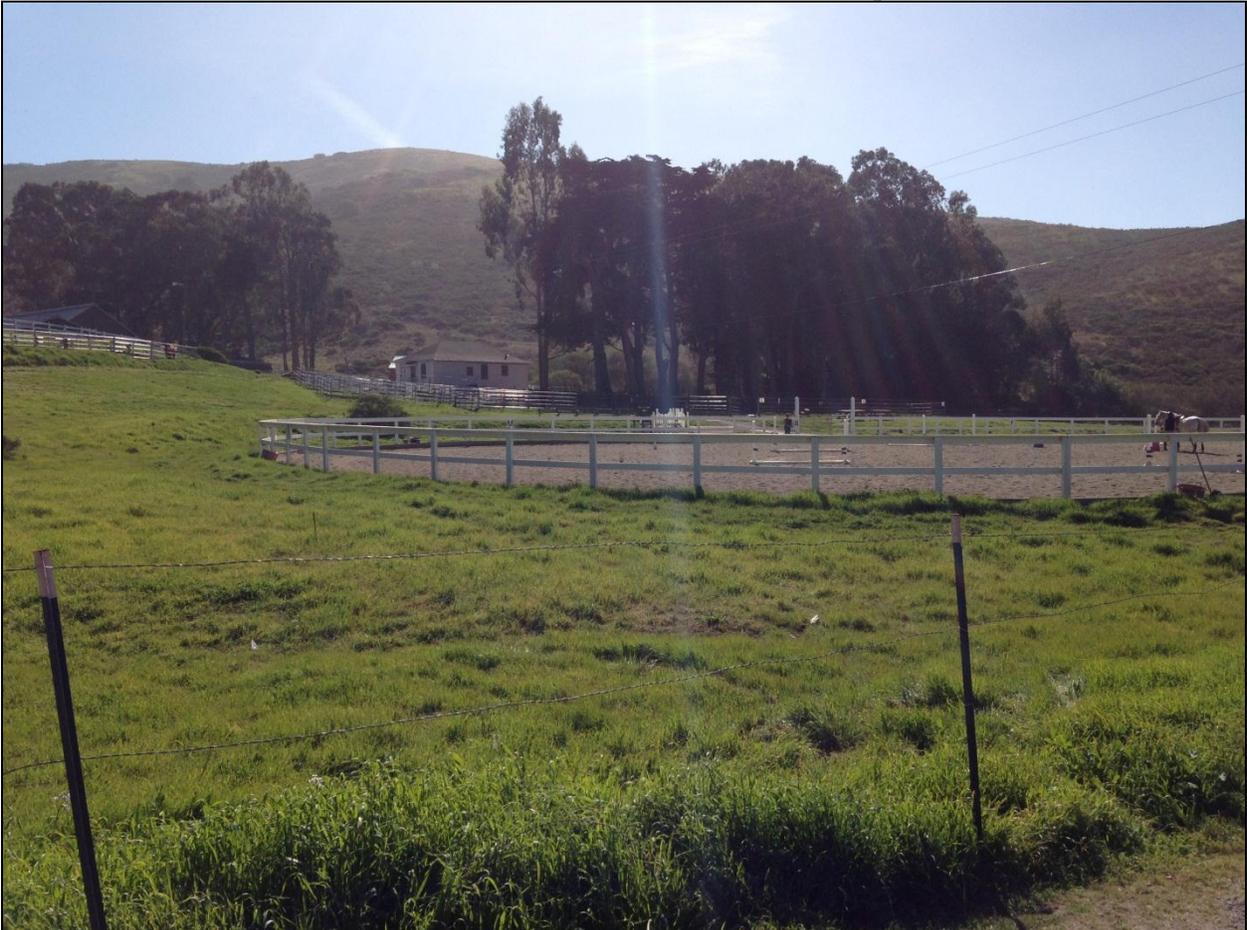
The two historic windbreaks and grasslands are remnants of the historic vegetation.

- Preserve and maintain the historic vegetation, which includes 2 windbreaks and the open grasslands.
- In consultation with an arborist, preserve and maintain the historic windbreaks by pruning the trees for long term health.

- Maintain the footprint and continuous canopy of the windbreaks as a primary character feature.
  - Windbreaks should be assessed by a certified arborist to ensure that there are no immediate threats to life/safety, buildings and structures, and the trees themselves.
- When it is no longer safe to maintain existing windbreaks, trees should be removed and replanted en masse in order to achieve an even aged stand.
  - Replacements should match in species and spacing, as possible.
  - Removal of any historic, or possibly historic trees, should be done in a manner that adequately documents the species and location through both photography and GIS information (coordinate with Park GIS specialist).

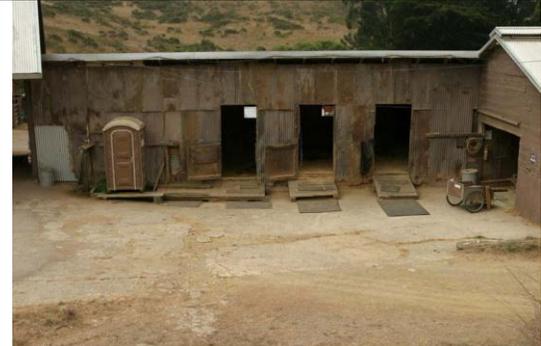
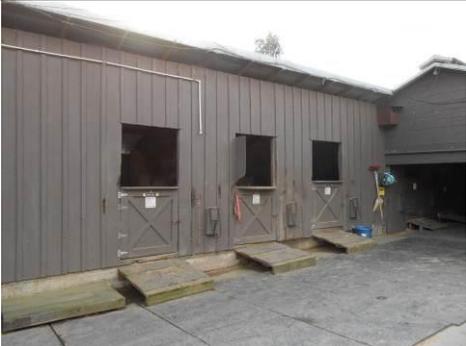
A comparison of the photos submitted in the *National Register Determination of Eligibility (2008)* with existing conditions today show that little has changed at the Bunkhouse (Auxiliary Residence/TV-102) except for painting and rodent proofing, minor changes have occurred at the Milk House Shed Addition (Stables Annex/TV-104) where the galvanized corrugated steel vertically oriented sheet siding on the north wall was replaced with wood board and batten siding and the House Barn (Garage/Red Barn/TV-106) was saved from loss by a Rehabilitation stabilization treatment. Though perhaps more uniform in appearance due to their being painted brown, the dairy ranch barn buildings still possess a large degree of integrity to the period of significance for the Cunha/Rapozo Ranch (Ranch A/B) site.

<p>North wall of Milk House Shed Addition (Stables Annex) (NPS Photo, 2008)</p>	<p>North wall of Milk House Shed Addition (Stables Annex) (NPS Photo, 2012)</p>

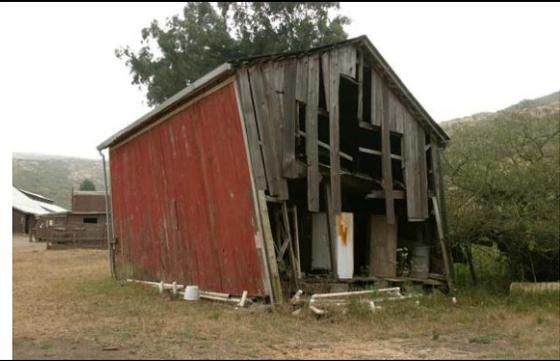
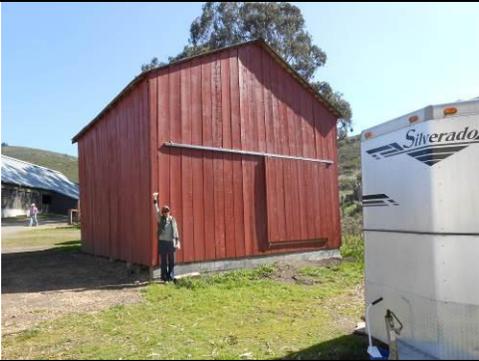
<p>House Barn (Garage/Red Barn) (NPS Photo, 2008)</p>	<p>House Barn (Garage/Red Barn) (NPS Photo, 2013)</p>

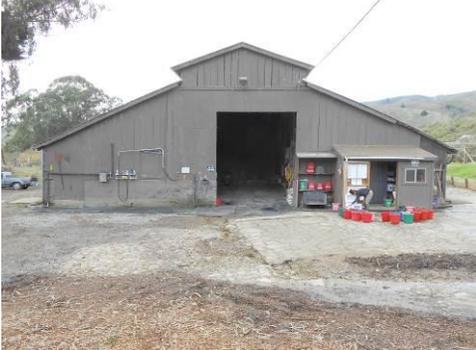
<p>East wall entry to Milking Barn (Hay Barn) (NPS Photo, 2012)</p>	<p>Looking east from northeast corner of Milking Barn (Hay Barn) roof with louvers extant (NPS Photo, 2012)</p>

*Overall in fair condition*

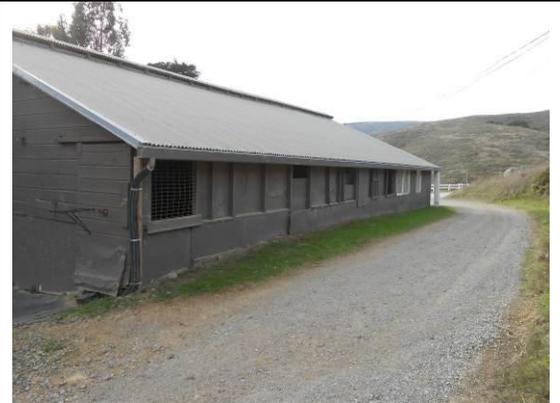
<p>Milk house north wall detail (NPS Photo, 2012)</p>	<p>Looking west at shed addition stables and milk house (NPS Photo, 2012)</p>

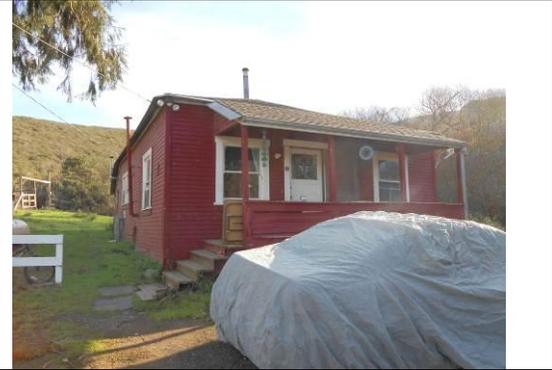
*Overall in fair condition*

<p><b>Bunkhouse (Auxiliary Residence) looking east (NPS Photo, 2012)</b></p>	<p><b>East Wall of Bunkhouse (NPS Photo, 2013)</b></p>

4. Create a Rehabilitation concept for the Bunkhouse (Auxiliary Residence/TV-102) that will address the deterioration of the building exterior envelope and structural deficiencies of the foundation and rear shed addition, including repairs and conservation of the horizontal lap siding, repairs and replacements to the deteriorated rear shed addition, front porch, front stairs and rails, and repairs, replacements and rehabilitation of the windows and doors.

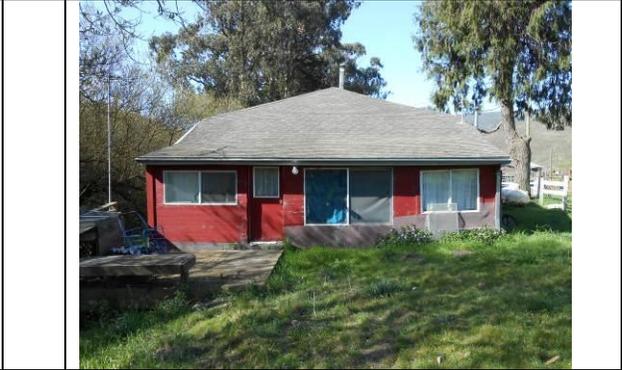
- The east wall of the building is the shed addition bearing wall and condition of the structural support for this addition could not be assessed and is presumed fair to poor (several of the post supports for the building appear to be relatively modern additions that perhaps replaced the historic support structure). and has 1x4 tongue and groove horizontal board siding in poor condition.
- One 4'-8"x 2'-3" sliding metal sash window (white) in fair condition.
- One 6'-0"x 4'-0" sliding window (white) in poor condition.
- One 4'-0"x 3'-0" sliding window (white) that is severely racked and is in poor condition.
- One 2'-6" wood entry door with single lite in fair condition.

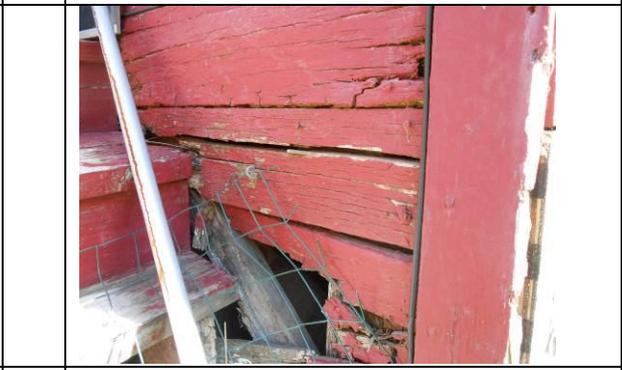
<p><b>Bunkhouse looking northeast (NPS Photo, 2012)</b></p>	<p><b>Bunkhouse west wall southwest corner (NPS Photo, 2013)</b></p>

- Concrete pier footings with wood posts in fair to poor condition (several of the post supports for the building appear to be relatively modern additions that perhaps replaced an historic support structure); frame walls and 4" wide wood horizontal lap board siding painted red in fair condition; wall has 1x4 end boards painted red in fair condition.
- Covered entry porch in fair condition; wood stairs in poor condition
- One 2'-6" wood 3 panel entry door with single lite in fair condition.
- Two 3'-0" square one over one double hung wood sash windows painted white in fair condition. Upper sash (exterior) has simple sash horns.

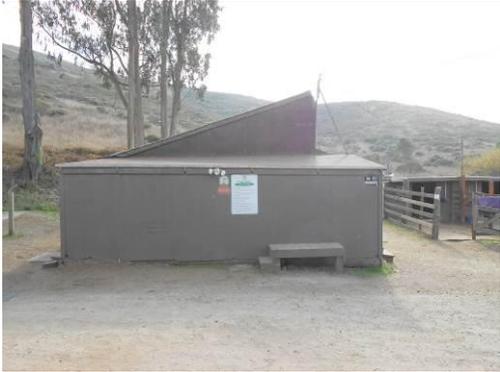
- Wood framed east half of the original barn gabled wall is extant, is covered in asphalt sheet roofing and is in fair condition. A large portion of the framing does not appear to be original and includes pressure treated lumber. The west half of the gable wall is no longer extant. The north wall has a wood shed addition used as tack room.

<p>Calf Barn (Auxiliary Stables) looking southeast (NPS Photo, 2012)</p>	<p>Calf Barn (Auxiliary Stables) north façade (NPS Photo, 2013)</p>

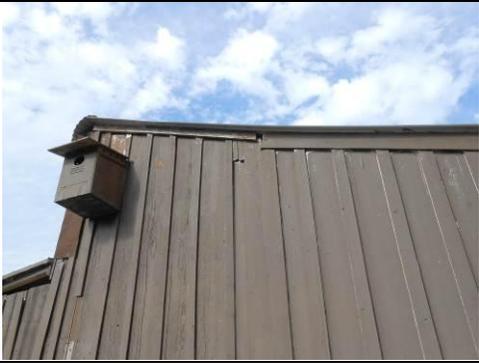
<p>Calf Barn (Auxiliary Stables) looking west (NPS Photo, 2012)</p>	<p>Calf Barn (Auxiliary Stables) south wall siding detail (NPS Photo, 2013)</p>

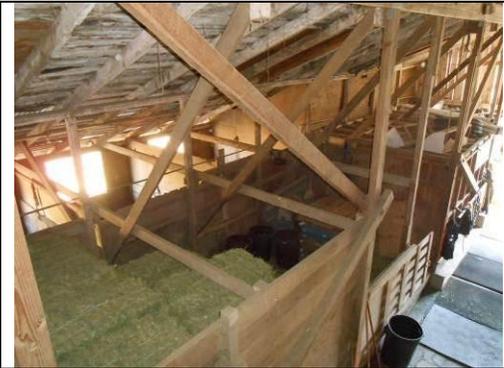
<p>Milking Barn (Hay Barn) concrete manger and raised feed alley (NPS Photo, 2013)</p>		<p>Milking barn (Hay Barn) interior structural detail (NPS Photo, 2013)</p>

In the Main Barn Complex the structural system is light wood framing. In the oldest portion of the building, the Milking Barn (Hay Barn & Stables), the structural framing system consists of four parallel post and beam lines running east to west comprised of slender 4x4 posts on 6'-0" centers, with 2x4 top plates. Column lines are braced with 2x6 horizontal bracing at roughly 8'-0" above the floor, and 2x6 rafters at 3'-0" centers with 1x6 skip sheathing support a shed roof of wood shingles under corrugated galvanized steel sheets. In the central high bay space, a modern arrangement of 4x6 beams supporting a glulam beam with 2x6 diagonal braces has been added in parallel to the 20'-0" tall posts of the central

bay, covering the louvered ventilation features that support the gabled roof. The diagonal braces appear to be older than the recent work yet not as old as the original construction and brace the column lines together in two directions. Bracing at the lower column line, between the column and the outer walls is mostly missing, and the few extant braces are discontinuous. This creates a unique and somewhat unorthodox structural system of unknown evolution.

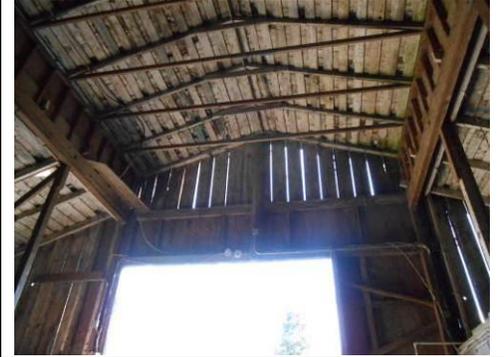
<p>Milking Barn (Hay Barn) north side structural and roof details (NPS Photo, 2013)</p>		<p>Milking Barn (Hay Barn) east entry wall detail (NPS Photo, 2013)</p>

7. Create a Rehabilitation concept for the Milking Barn (Hay Barn/TV-103) portion of the Main Barn Complex that will address the needed maintenance of the building exterior envelope and any structural deficiencies of the building, including documentation of the floor drains and concrete dairy features, replacements of insect damaged, rotted and missing structural members (including rafter tails) where needed, replacements of rotted or damaged wall siding with matching materials, and repair and replacement of missing louvered vents. Any Rehabilitation concept should address the missing structural elements, loss of ventilation and visual compatibility issues created by the ca. 1992 structural stabilization work, detail an appropriate and compatible design concept for the northeast corner of the building and replace the siding on the east wall (around and above the entry way).

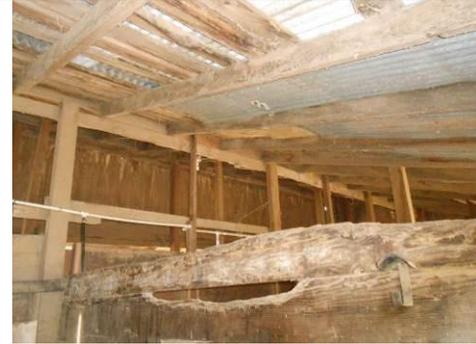
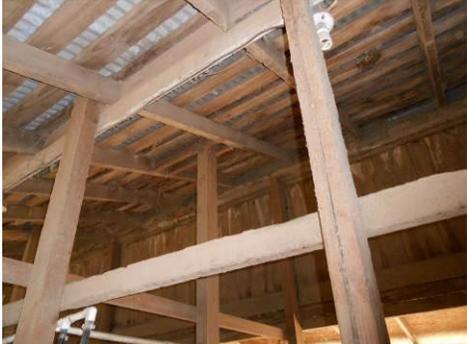
- The majority of the wood frame roof framing appears to be original 2x6s at 2'-6" on center with 1x6 skip sheathing. The roof framing has generally not been repaired, and there are missing and damaged sections of skip sheathing in some places. The light gauge corrugated galvanized steel roof has been partly replaced, though the age of the older sheet roofing is unknown, it is possibly a late 1940s replacement of a wood shingle roof.

The Calf Barn appears in a ca. 1940 photo in its present location as a gabled structure such that is possible the west gabled half of the building was at one time removed to create the shed form that is extant. Three main lines of parallel structural supports consisting of 4x4 posts and 2x beams, which run north to south, support this notion and are similar to the structural systems seen in the Milking Barn (Hay Barn & Stables). The posts, beams, wood frame walls, skip sheathing and siding of the calf barn are a mixture of modern replacements, older perhaps salvaged lumber and originals, including some unusual (if not unorthodox) structural conditions. The pitch of the roof and the volume of the space however appears to have been preserved.

<p>Calf Barn (Auxiliary Stables) interior (NPS Photo, 2013)</p>			<p>Looking up into ridge of Calf Barn (Auxiliary Stables) (NPS Photo, 2013)</p>

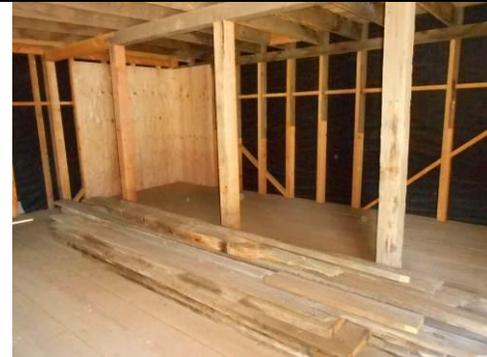
<p>House Barn interior shear wall at northwest corner (NPS Photo, 2013)</p>	<p>House Barn interior (NPS Photo, 2013)</p>

The House Barn has rough sawn dimensional 2x4 balloon framed stud walls with diagonal blocking. During the rehabilitation of the building, a new wood floor was installed to replace the existing and it was discovered that the existing floor was itself a replacement (built on top of one that had rotted out – the bearing walls were cut to accept the floor and no bottom plate was installed – this detail was retained as a record of the evolution of the structure. A new wood loft at 8’-8” was installed.

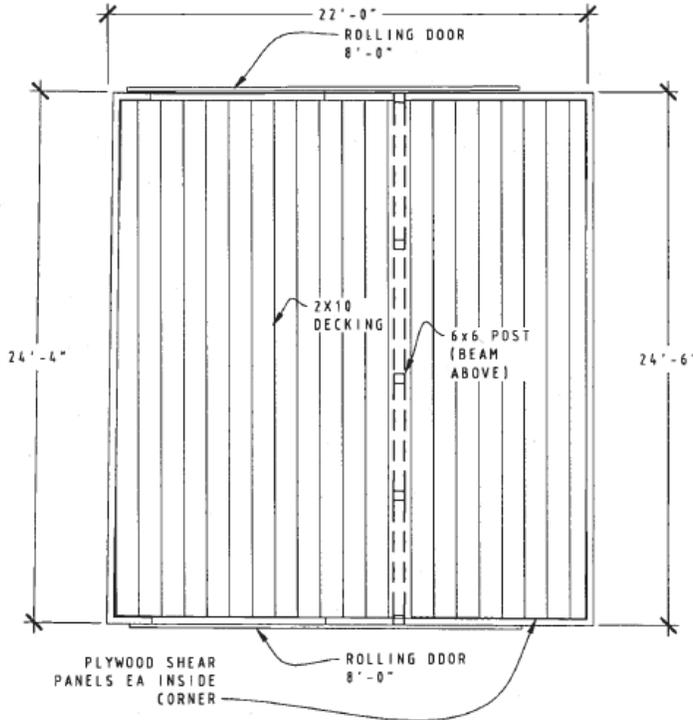
**FIRST FLOOR PLAN**  
SCALE: 1/4" = 1'-0"

NOTE: THE BUILDING WAS STRUCTURALLY STABILIZED IN 2011. LACK OF BOTTOM PLATE ON THE STUD WALLS AND EVIDENCE OF A WOOD FLOOR BENEATH THE EXISTING INDICATED THE FLOOR WAS REPLACED/BUILT-UP. THIS UNORTHODOX STRUCTURAL DETAIL WAS PRESERVED. CHARACTER FEATURES INCLUDING THE FOLLOWING SHOULD IDEALLY BE RETAINED/RESTORED IN ANY REUSE SCHEME:

- 8'-0" FLOOR TO CEILING HEIGHT
- 1'-0" WIDE ROUGH SAWN VERTICAL SIDING
- FIRST FLOOR 2x8 ROUGH SAWN DECKING
- VISIBLE BALLOON FRAME FULL DIMENSION 2x4 STUD WALLS @ 24" O.C. W/ DIA. BRACING
- LOFT 2x8 @ 24" O.C. W/ 1x8 T&G FLOORING
- ROOF 2x4 RAFTERS W/ VISIBLE WOOD SHINGLES AND 1x DIA. BRACING

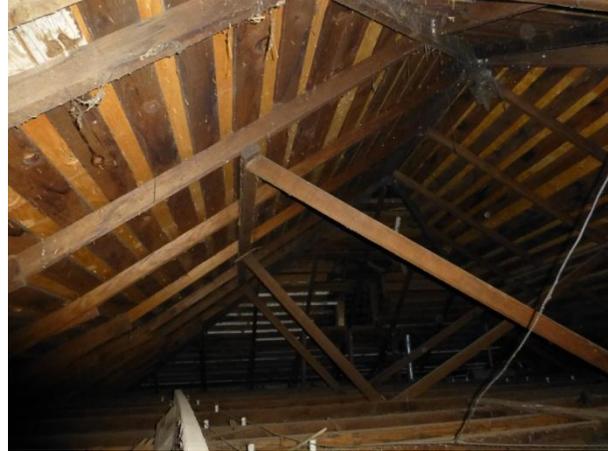
Attic framing conditions

Recommendation: It is recommended that a structural engineer review the deficiencies in the structural system in the storage area beneath the main floor of the house and throughout. It is likely that the east facade will need a new stem wall foundation. An alternate treatment would be to install new piers and new wall framing to support the listing facade. Missing portions of the wood framing at the south facade will require new wood framing material. A structural engineer should suggest the final treatment for the building (See Concrete Foundations under Exterior Recommendations).

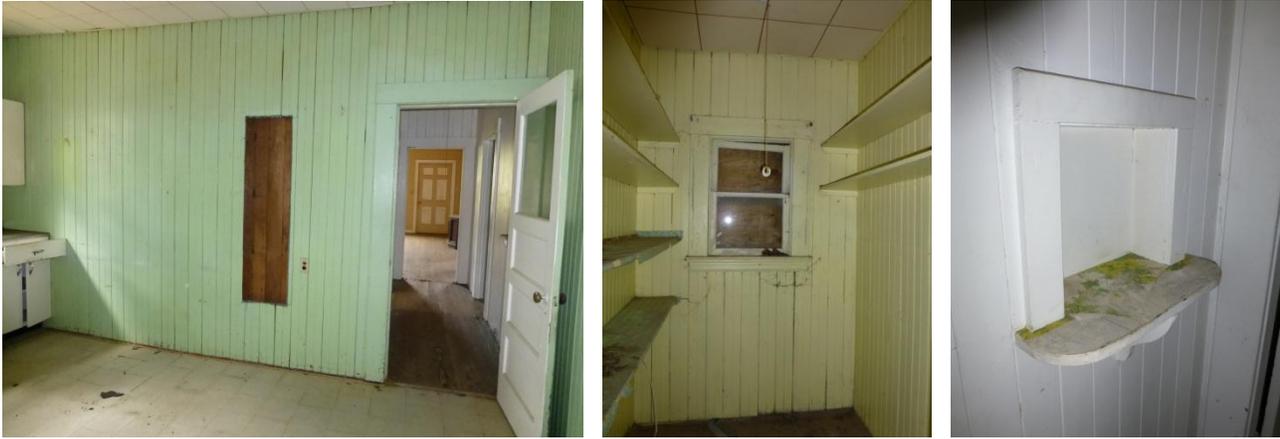
Condition: Many of the interior rooms are finished with a painted wood wall paneling. There are vertical and horizontal installations and V-groove and beadboard versions of this finish at the wall and ceiling. These finishes are highly sensitive to alteration and should be restored and repaired to the greatest extent possible to maintain the historic integrity of the former farm house interior. A section of panel is missing in the kitchen (possible location of a previous shelf or closet), but the majority of the wood paneling is in fair condition with some areas in good condition requiring some prep and paint. Other architectural features including wood shelves in the pantry and the small shelf in the hallway should be maintained and restored. Less sensitive to alteration of course, are the acoustic ceiling tiles found in most rooms and wallboard finished spaces at the front north part of the building.

Beadboard wood panel (Room 210), pantry shelving (room 209), hallway shelf (Room 211) (NPS Photos 2013)

Recommendation: Restore or repair wood beadboard and V-groove wall finishes. Remove all acoustic ceiling tiles to reveal the remaining wood panel ceiling finishes and restore. Wallboard wall finishes may remain and should not be given new wood panel finishes to match the rest of the house. Surfaces may be painted a new color to suit the new use of the building.
