# Fort Barry Balloon Hangar and Motor Vehicle Sheds

## *Abbreviated Historic Structures Report*

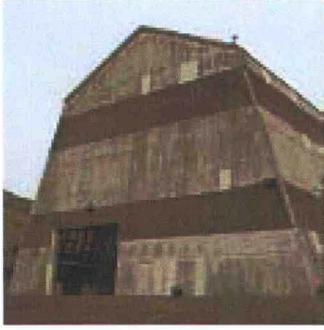
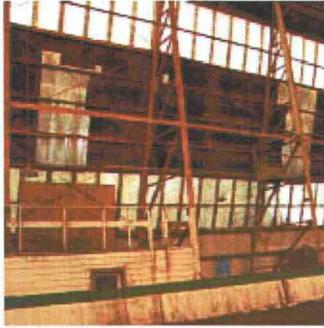
The north elevation of the Balloon Hangar showing the existing 15' x 20' opening and the two tiers of corrugated glass fiber sheets. (Jane Lehman, 2002)

The vertical trusses form bays along the sides of the Balloon Hangar and the glass fiber sheets let in an ample amount of natural light. (John Martini, 2004)

Two rows of translucent, colored corrugated glass fiber sheets exist in place of the original windows. When the sheathing on the first tier was replaced, the window heights were doubled to approximately 9' tall. These sheets are in fair condition.

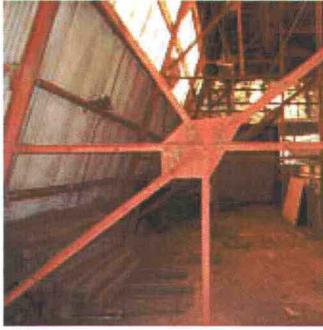
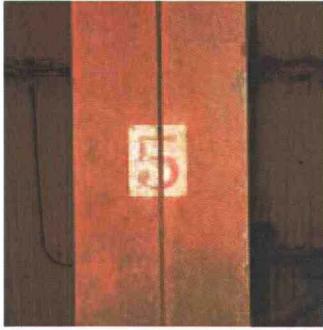
The structure's original field-assembled trusses are clearly visible. (John Martini, 2004)

Stenciled number on Bay 5 remaining from the Balloon Hangar's use as a maintenance garage during World War II. (John Martini, 2004)

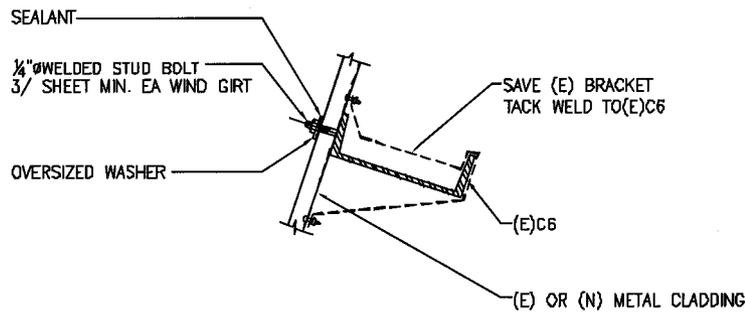
**TYPICAL CLADDING CONNECTION** 9

NOTE: THIS DETAIL APPLIES AT ALL (E) BRACKETS AND BROKEN CONNECTORS,

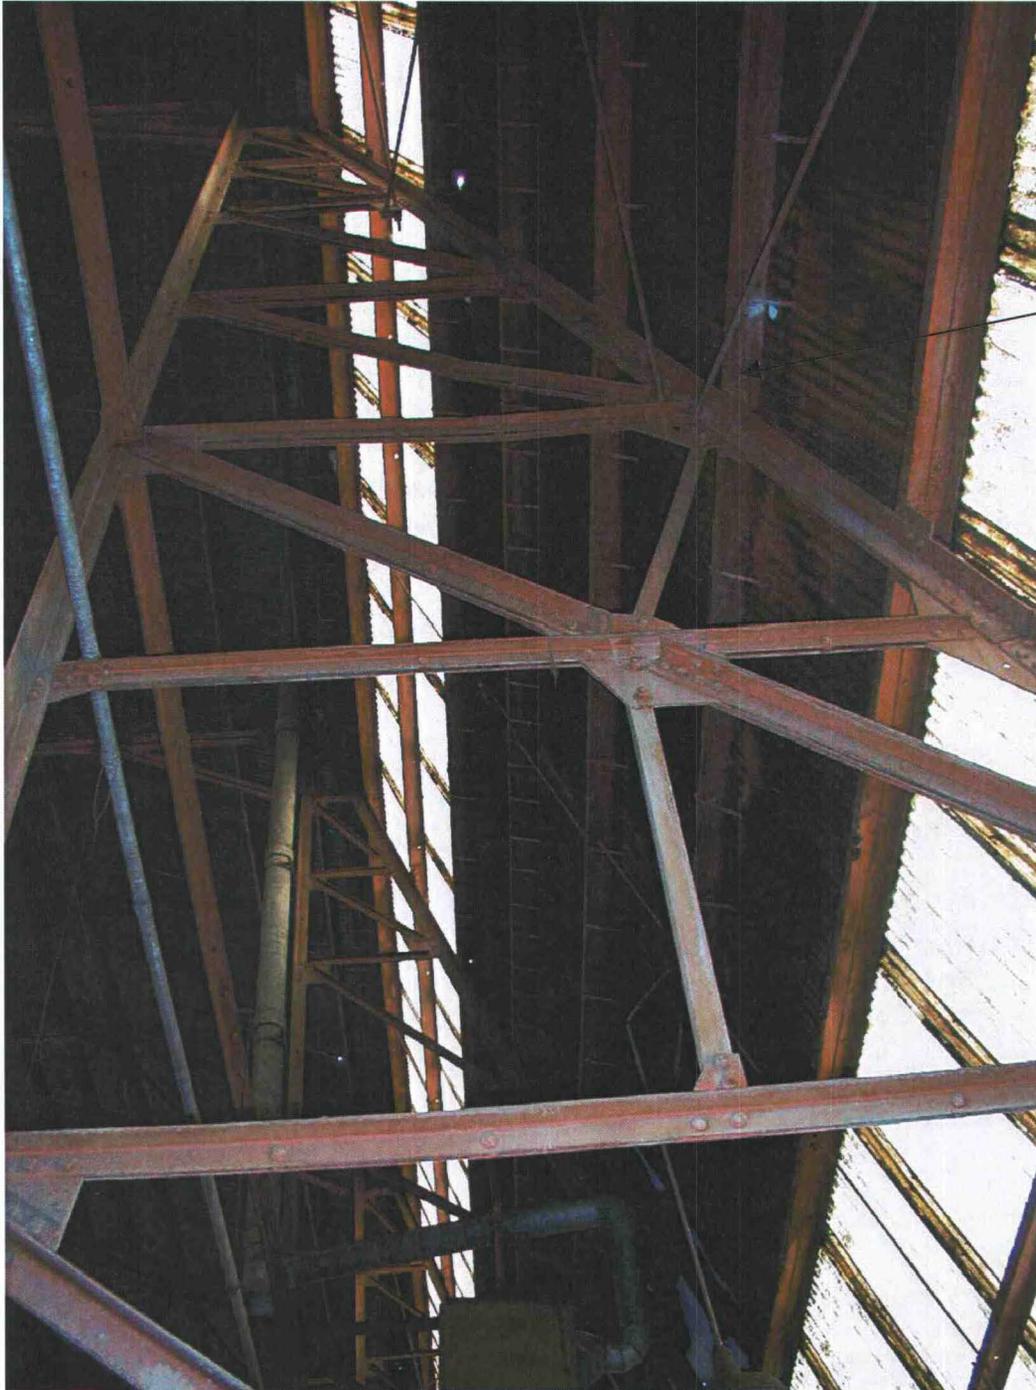
Typical Vertical Truss

1. Many rods in the braces resisting forces in the north-south direction are missing, greatly weakening the building.
2. Large eccentricities exist between the horizontal elements and the diagonal rod braces in the north-south resisting lateral braces. These can lead to severe damage.

Note:  
Eccentricity  
between rods  
and horizontal  
member

1. All missing rod bracings should be replaced. In addition, the eccentricity between the diagonals and horizontal elements in the north-south direction can be remedied by the addition of added horizontal pipe elements and new connectors for the rod bracing.
2. Added sag rods can be replaced on the south wall and members can be added to support these sag rods.
3. All damaged or missing cladding should be replaced. Refer to following report on architectural elements.
4. All sheet metal brackets should be replaced with welded stud bolts.
5. Heater supports should be strapped.
6. Cladding should be cut away from ground slab at corners.

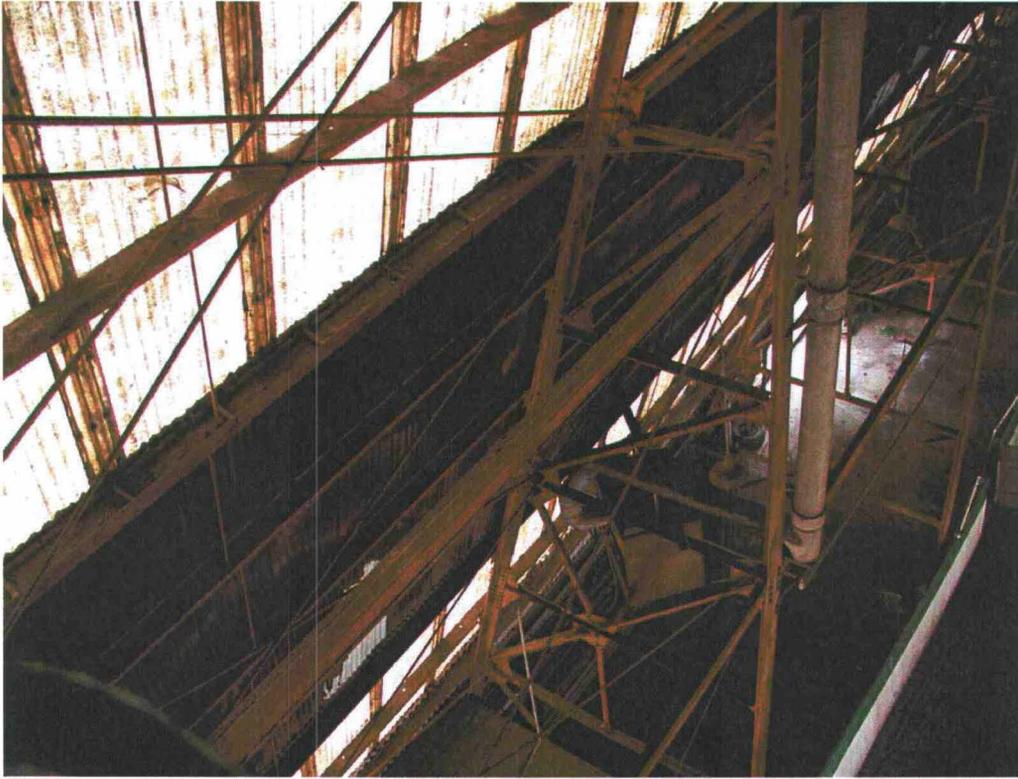
Vertical Truss and Diagonal Rod Bracing

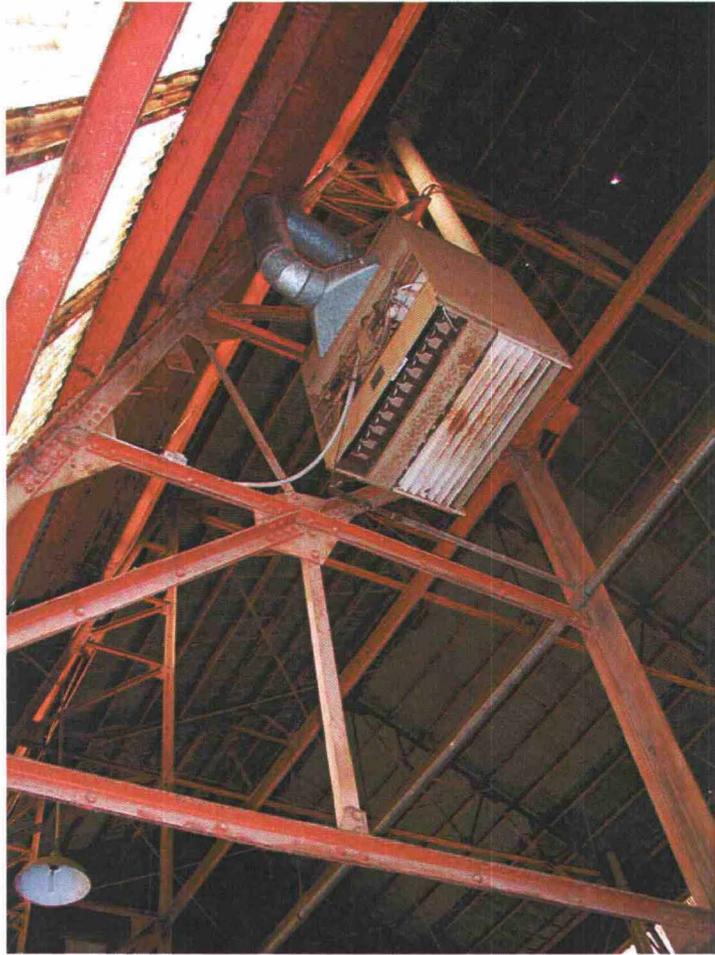
6. Attachment of suspended heaters is inadequate and is a falling hazard in the event of an earthquake.
7. Cladding bears on slab on grade, which causes damage if the building moves in wind or earthquake. This can be seen from the damage at the north-east corner.

Suspended Heater

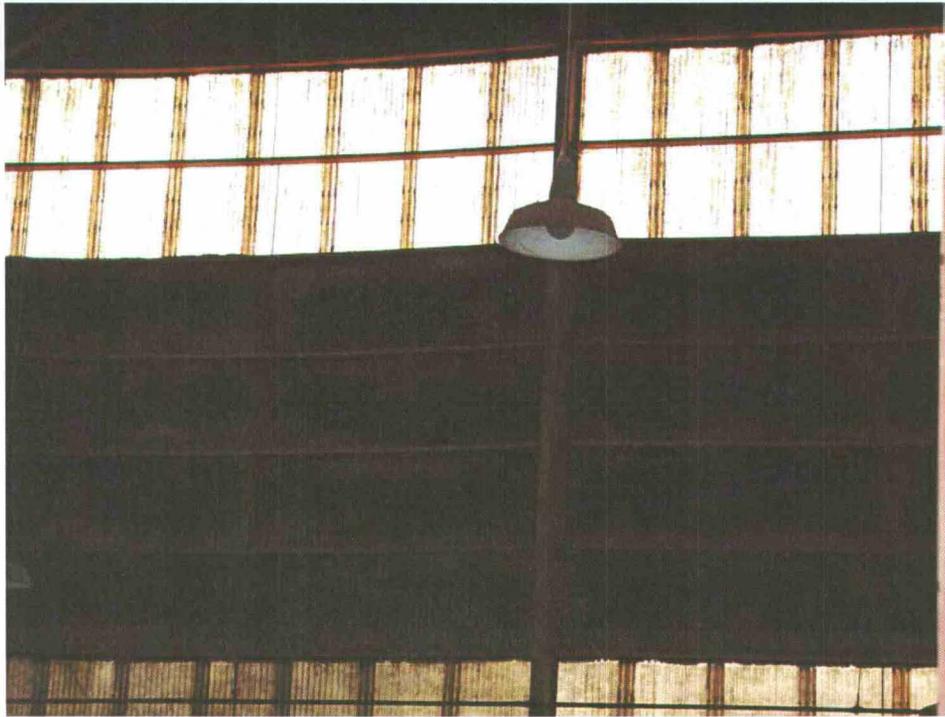
3. Sag rods and sag rod supports at the south wall are overstressed. This can lead to excessive damage to the south wall cladding, although the south face is the most sheltered.

Sagging Wind Girts at South Wall

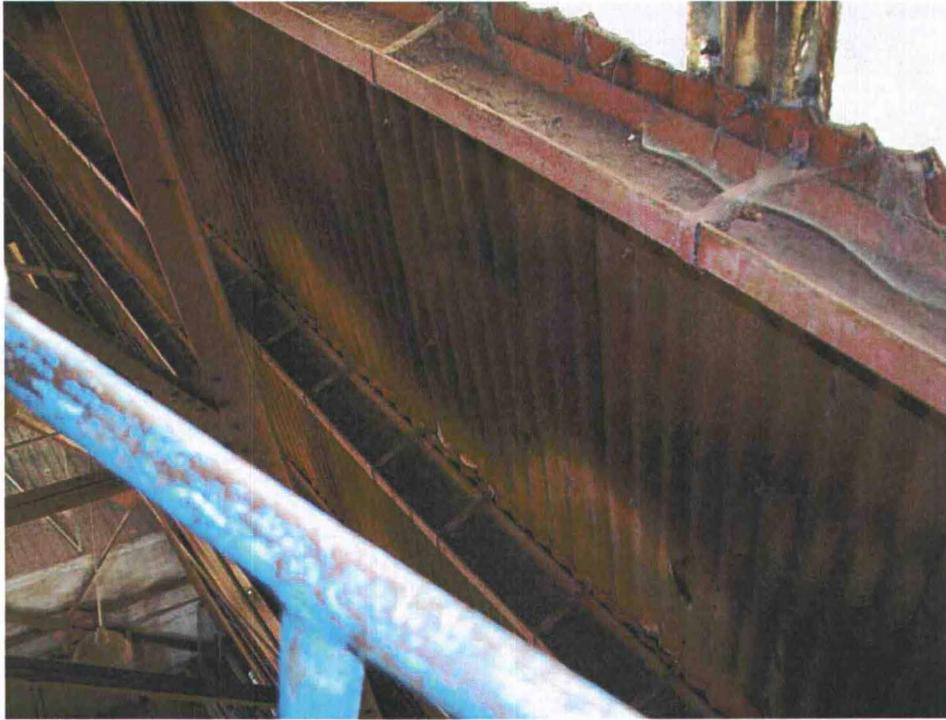
4. Large areas of missing cladding can greatly increase wind loading leading to more damage.
5. The sheet metal bracket cladding attachment is too flexible and leads to damage.

Wall Cladding Bracket Supports

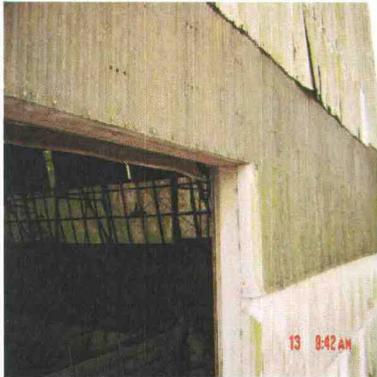
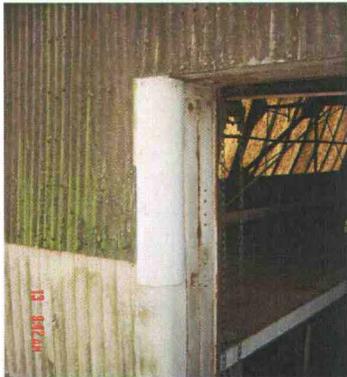
A few sheets at Level 3 became detached from structural brackets and buckled. The most extensive damage occurs at the bottom corners.

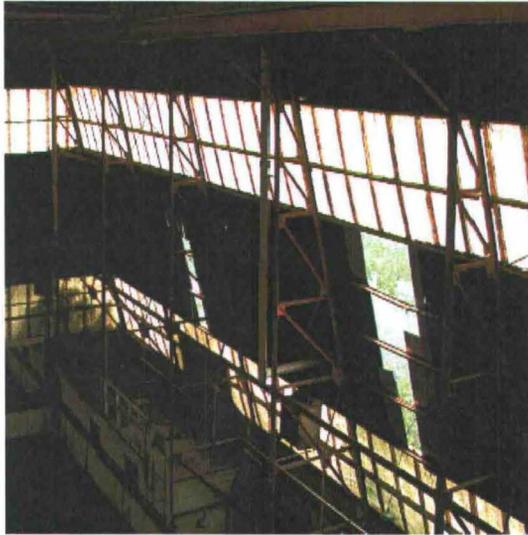
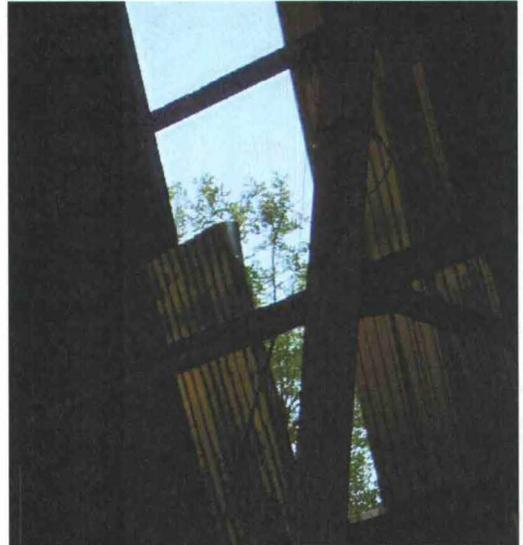
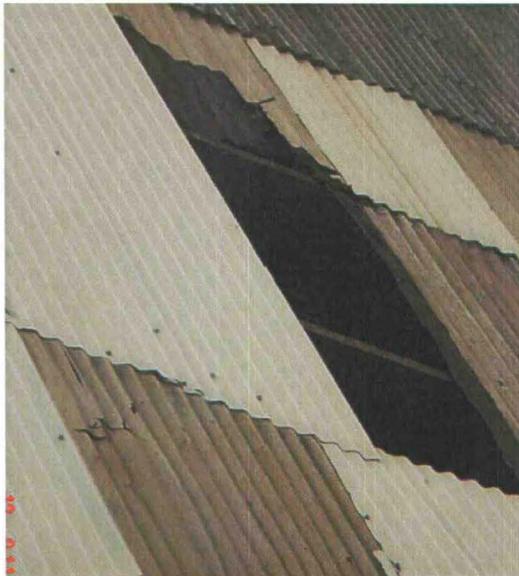
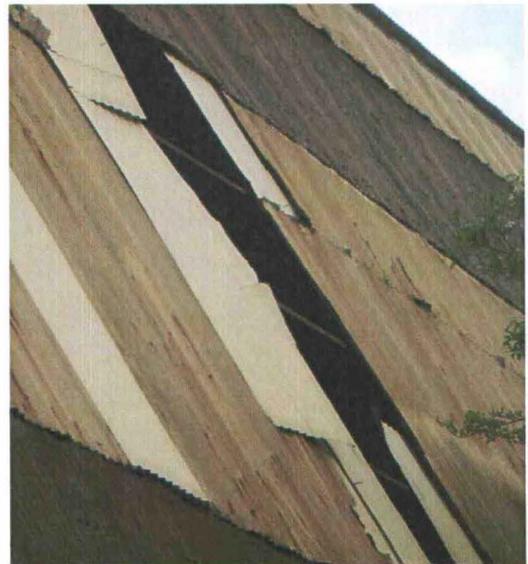
As illustrated by the photos above, the West Elevation presents the most damage. Even though there has been relatively recent extensive repairs at level 5 and 3, where painted corrugated sheet metal replaced some corrugated asbestos coated iron sheets, the inadequate detailing and installation made them temporary only; currently the replacement sheets have been ripped off and this side of the building is open to the environment in numerous places.

The “window rows” (corrugated glass fiber sheets) at level 2 and 4 appear to be in good condition, with less than 2 percent distress. Most of the distress occurs at the bolthole attachment to structure.

Presently, some remaining replacement panels are unstable and only partially attached to structure, thus constituting a hazardous condition, as they may fall down at any moment.

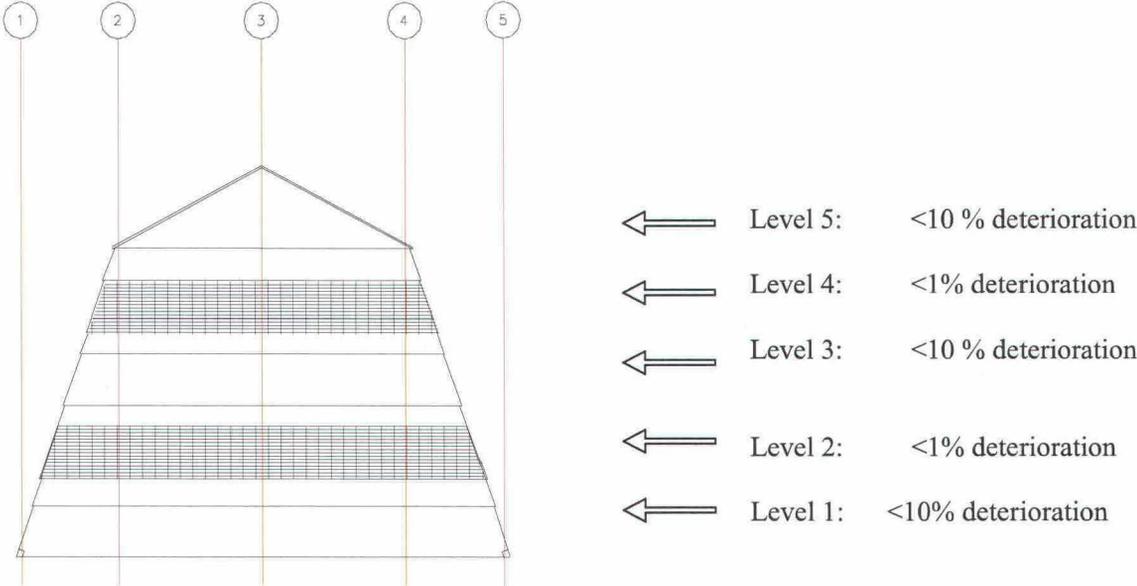
**South Elevation**

As illustrated by the photos above and insofar as the outgrown vegetation permitted full visual observation, the South Elevation presents the least damage.

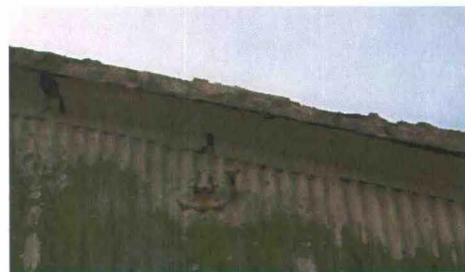
As illustrated by the photo above and insofar as visual observation was possible from the distance, the roof does not present substantial deterioration, despite being over 50 years old. A thorough cleaning of the roof is needed, as moss is present, especially toward the eaves. In addition, rust is present at seams.

The fascias on both South and North Elevation are severely rusted and should be replaced. There are no fascias or gutters on the East and West Elevations, and those should be installed to prevent water penetration. (Historic Photos shows gutters and 3 downspouts on each side).

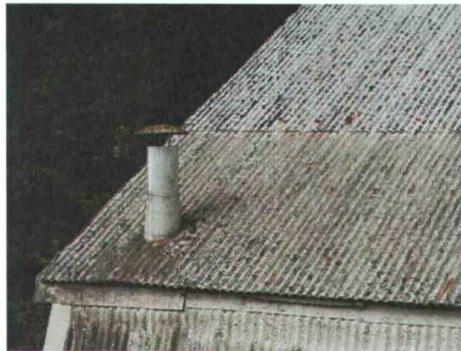
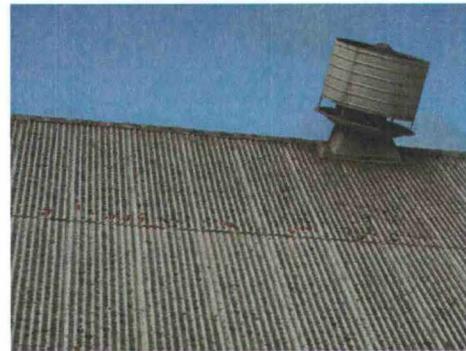
Visual observation from inside out was instrumental in assessing the roof's extent of deterioration: when looked at from inside, various size openings are visible, occurring mostly at seams, allowing water inside the structure. A larger amount of rust is present on the underside, primarily at seams. Past roof repairs are also noticeable.

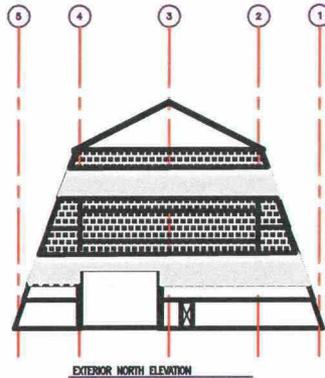
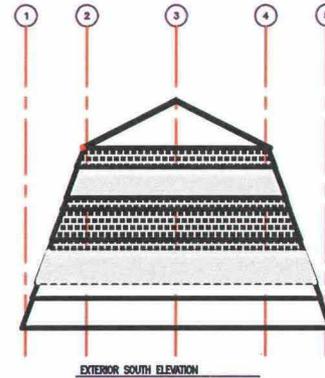
- ROOF: CLEAN AND REPAIR
- Level 5: 10 % deterioration  
REPLACE
- Level 4: <1% deterioration  
CLEAN AND REPAIR
- Level 3: 20 % deterioration  
REPLACE
- Level 2: <1% deterioration  
CLEAN AND REPAIR
- Level 1: 25% deterioration  
CLEAN AND REPAIR

- ROOF: CLEAN AND REPAIR
- Level 5: <10 % deterioration  
REPLACE
- Level 4: <1% deterioration  
CLEAN AND REPAIR
- Level 3: <10 % deterioration  
REPLACE
- Level 2: <1% deterioration  
CLEAN AND REPAIR
- Level 1: <10% deterioration  
CLEAN AND REPAIR

NOTE: See NPS Hazardous Material Consultants for cleaning and repairs of asbestos containing materials

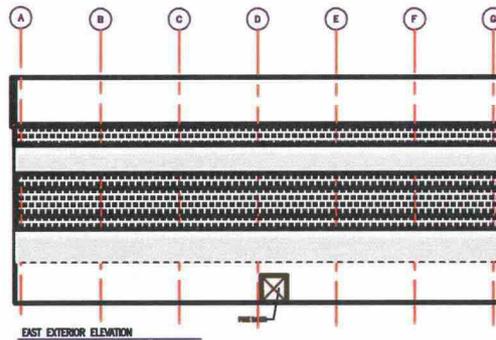
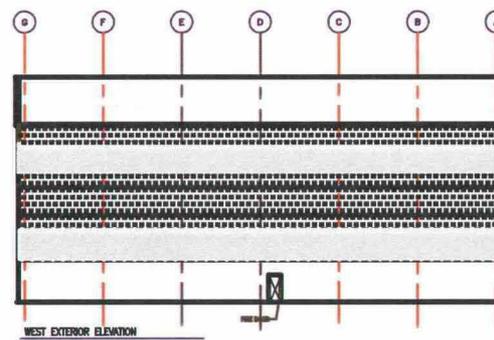
- ROOF: CLEAN AND REPAIR
- Level 5: 30 % deterioration  
REPLACE
- Level 4: <2% deterioration  
CLEAN AND REPAIR
- Level 3: 80 % deterioration  
REPLACE
- Level 2: <2% deterioration  
CLEAN AND REPAIR
- Level 1: 15% deterioration  
CLEAN AND REPAIR

- ROOF: CLEAN AND REPAIR
- Level 5: 40 % deterioration  
REPLACE
- Level 4: <2% deterioration  
CLEAN AND REPAIR
- Level 3: 70 % deterioration  
REPLACE
- Level 2: <2% deterioration  
CLEAN AND REPAIR
- Level 1: 15% deterioration  
CLEAN AND REPAIR

REPLACE AS SHOWN

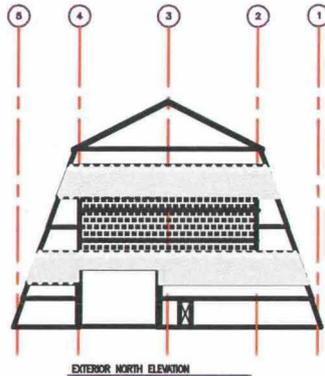
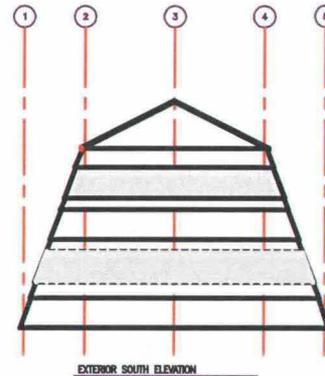
- ROOF: CLEAN AND REPAIR
- Level 5: 10 % deterioration  
CLEAN AND REPAIR
- Level 4: <1% deterioration  
CLEAN AND REPAIR
- Level 3: 20 % deterioration  
REPLACE AS SHOWN
- Level 2: <1% deterioration  
CLEAN AND REPAIR
- Level 1: 25% deterioration  
CLEAN AND REPAIR

- ROOF: CLEAN AND REPAIR
- Level 5: <10 % deterioration  
CLEAN AND REPAIR
- Level 4: <1% deterioration  
CLEAN AND REPAIR
- Level 3: <10 % deterioration  
CLEAN AND REPAIR
- Level 2: <1% deterioration  
CLEAN AND REPAIR
- Level 1: <10% deterioration  
CLEAN AND REPAIR

NOTE: See NPS Hazardous Material Consultants for cleaning and repairs of asbestos containing materials

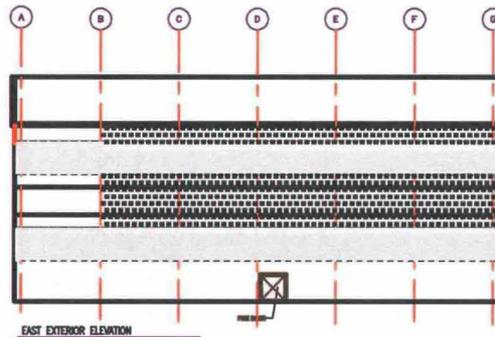
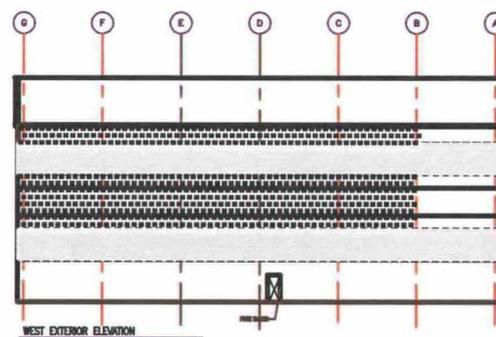
- ROOF: CLEAN AND REPAIR
- Level 5: 30 % deterioration  
REPLACE AS SHOWN
- Level 4: <2% deterioration  
CLEAN AND REPAIR
- Level 3: 80 % deterioration  
REPLACE AS SHOWN
- Level 2: <2% deterioration  
CLEAN AND REPAIR
- Level 1: 15 % deterioration  
CLEAN AND REPAIR

- ROOF: CLEAN AND REPAIR
- Level 5: 40 % deterioration  
REPLACE AS SHOWN
- Level 4: <2% deterioration  
CLEAN AND REPAIR
- Level 3: 70 % deterioration  
REPLACE AS SHOWN
- Level 2: <2% deterioration  
CLEAN AND REPAIR
- Level 1: 15% deterioration  
CLEAN AND REPAIR

REPLACE AS SHOWN
