**Fiscal Year 2003
Archaeological Site Monitoring and Management
Activities Along the Colorado River in Grand Canyon
National Park.**

2003

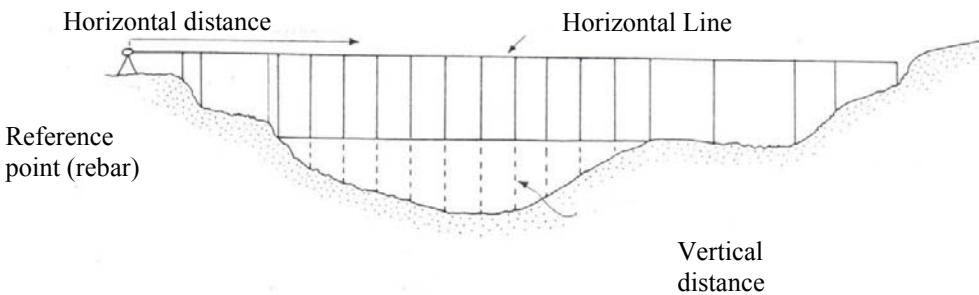
Figure 10. Diagram of a cross section across a drainage. Adapted from Harrelson et al. (Harrelson 1994).

B:11:281 – Since FY98, the gully southwest of Feature 1 (roasting feature) has been actively migrating upslope. This year RCMP monitors established three cross sections beginning several meters above the current headcut (Profile 1) and continuing downslope approximately one-meter apart (profiles 2 and 3). Cross section measurements will be taken next year, providing a Time 1 to Time 2 comparison of how each profile changes.

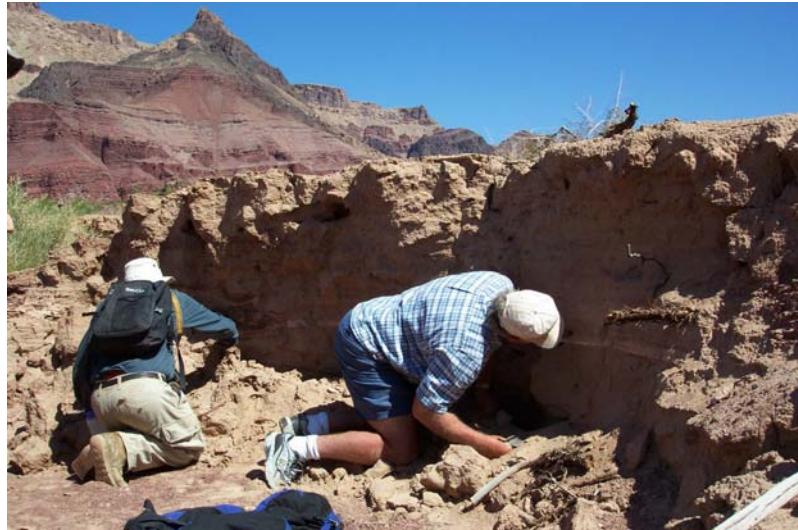
Figure 13. Dave Rubin, USGS sedimentologist and Fred Nials, geoarchaeologist prepare to collect samples for the eolian transport research (May 2003).

An ash-like, non-cultural sample was collected at C:13:273 on the eolian transport trip. This sample came from an extensive lens located near Feature 3 and extending toward the river's edge. Sedimentologists thought this lens could be volcanic. See Figure 13 for the location of the exposed white ash. USGS will analyze the sample. Table 9 lists the sites where samples were taken in FY03.
