HISTORIC STRUCTURE REPORT

HERMIT'S REST

GRAND CANYON NATIONAL PARK

December 2007

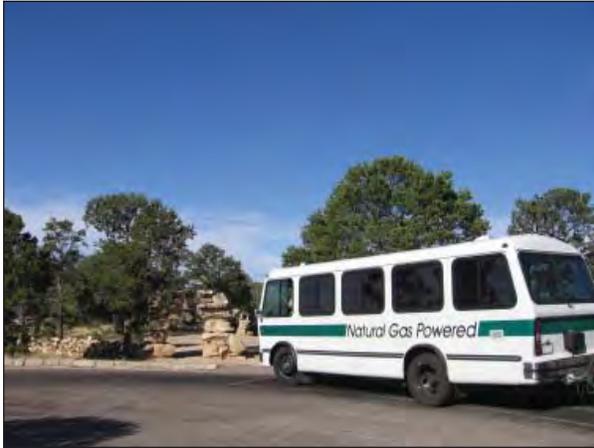
Shuttle sign missing.	Replace shuttle sign.	Low
* Note: See the <i>Ultimate Treatment & Use</i> section of this report for additional information on each recommendation.

FIG. S1: Free shuttle bus at the Hermit Rest's stop. Note corbel arch at left, 2007.

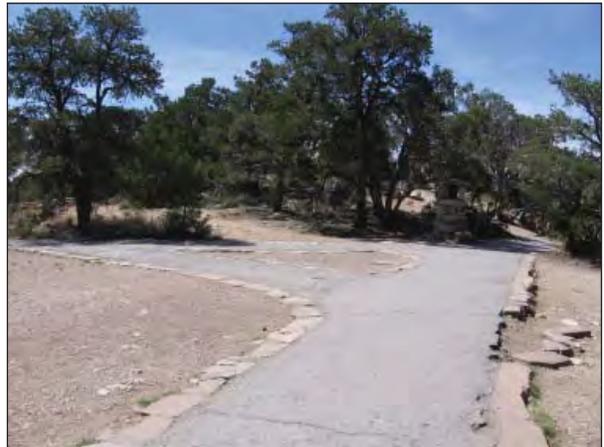
FIG. S4: View of the asphalt path and stone lamppost facing east from the shuttle bus stop and parking lot. Note displaced stones bordering asphalt path, 2007.

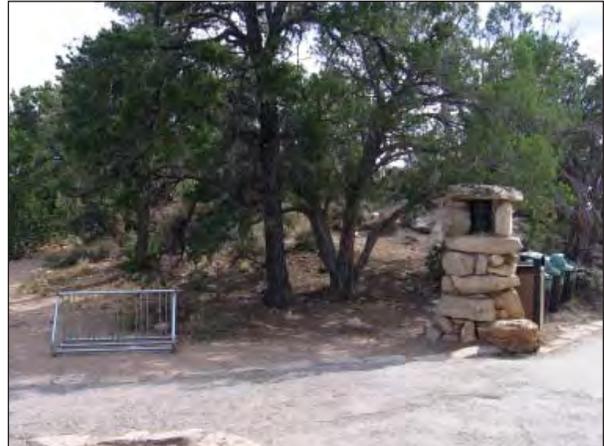
FIG. S6: Inappropriately located bike rack, 2007.

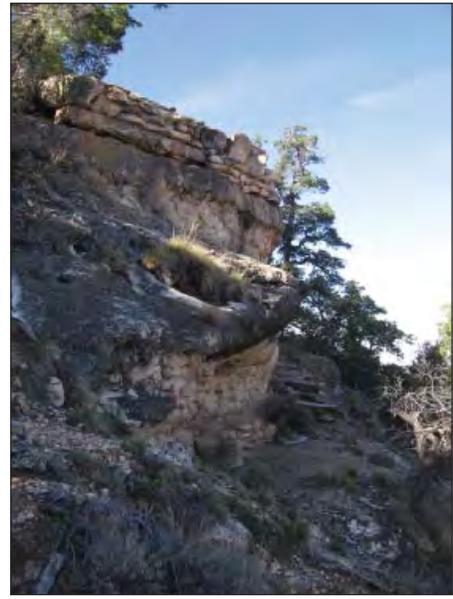
FIG. S10: Hidden overlook below the Hermit's Rest. Note the short stone masonry wall at the top, and the stone masonry bench in the more enclosed area at the bottom, 2007.

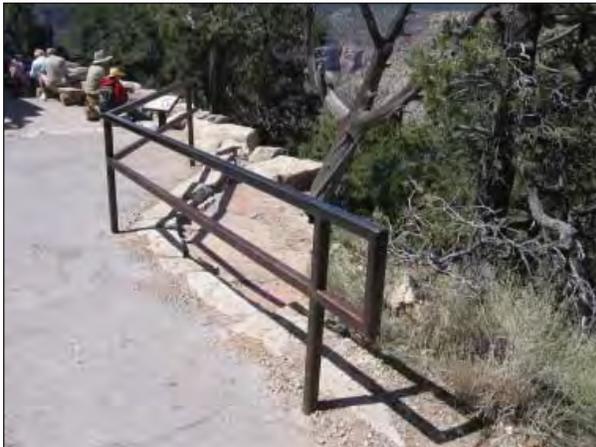
FIG. S11: Guardrail at the location of removed stairs to the hidden overlook, 2007.

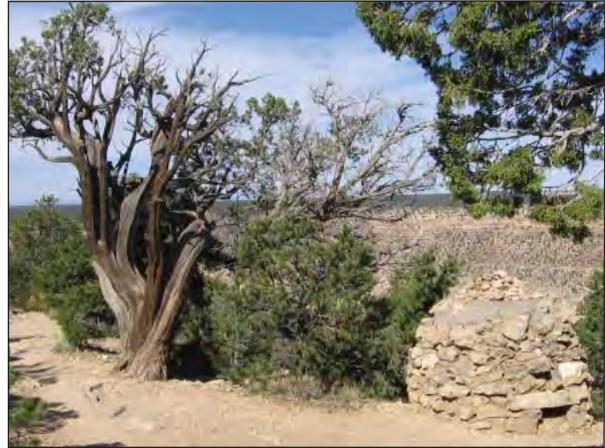
FIG. S14: View facing northwest showing the unpaved path to Hermit Trailhead at left and the historic stone oven with excessive mortar at right, 2007.

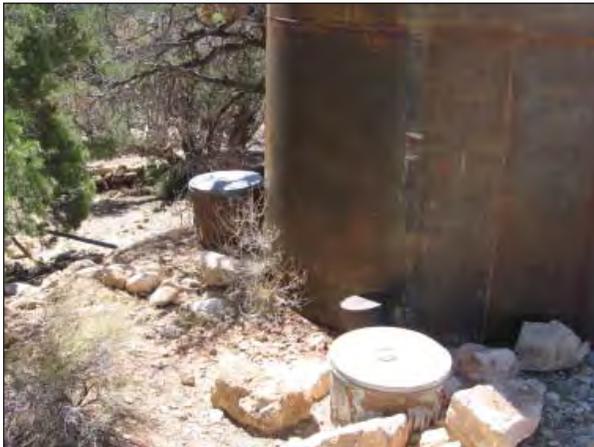
FIG. S19: Detail of the water tank with meters inside trash cans. Note "Fred" etched onto the tank, 2007.

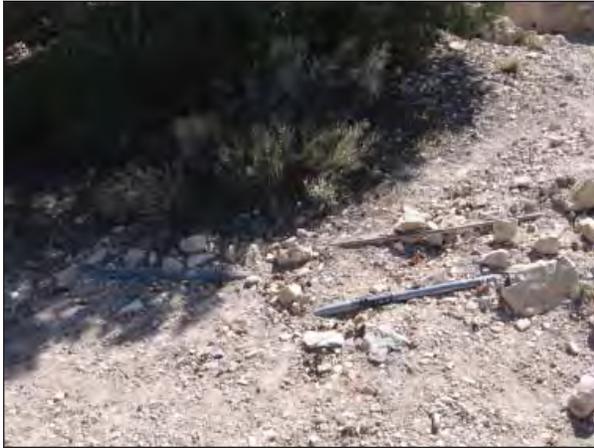
FIG. S21: Exposed water pipes, 2007.

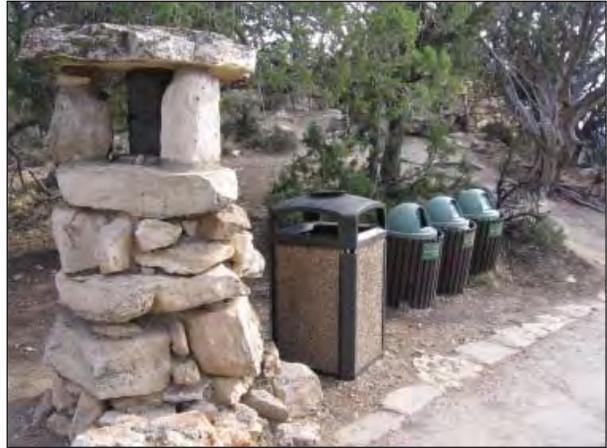
FIG. S26: Historic lantern impinged upon by trash receptacles, 2007.

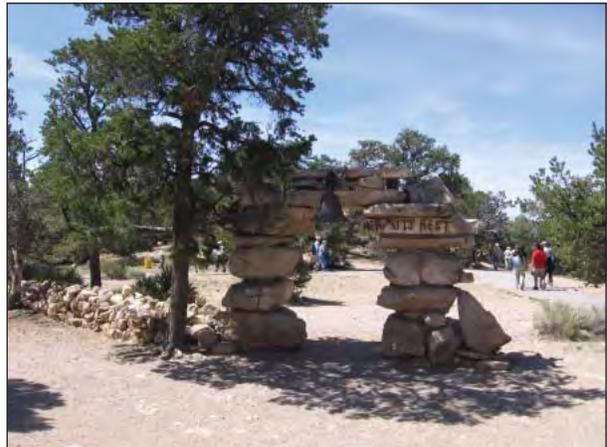
FIG. S28: Stone corbel arch with drystacked stone wall at left and asphalt path at right, 2007.

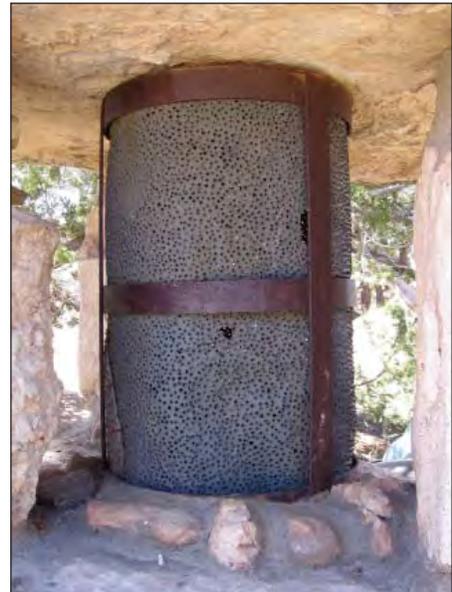
FIG. S33: Close up of punched zinc lantern. Note flap wired shut at bottom left, 2007.

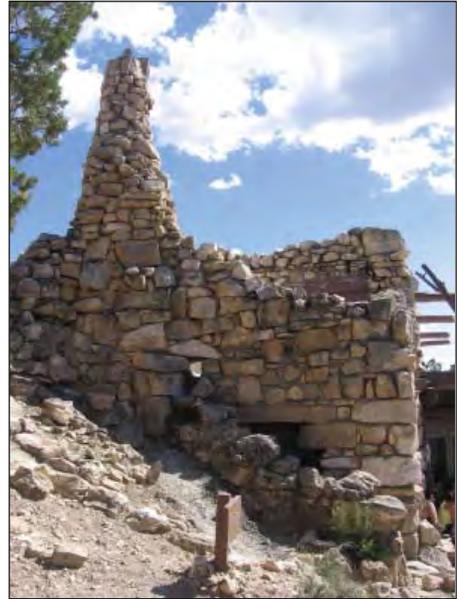
FIG. E6: East elevation, 2007.

Damaged 2 x 4 attached to Office window trim. See FIG. E58.	Remove 2 x 4. If required, paint lintel in the area of removed 2 x 4.	Moderate
Lichen present on stone. See FIG. E6.	Lichen may be result of water pooling near stone. Evaluate site in consultation with landscape architect. Regrade as required in consultation with landscape architect to effectively move water away from the building.	Low
Historic bark beetle damage to fascia on porch roof. See FIGS. E23.	No treatment required.	Low
Elastomeric roofing material unnecessarily applied over single concrete block situated on roof. See FIG. E33.	Remove roof and concrete block. Replace roof.	Low
Paint on stone wall between main entrance and Kitchen. See FIG. E42.	Remove paint using gentlest means possible.	Low
Excessive putty between mullion and glass on east window. See FIG. E51.	No treatment required.	Low

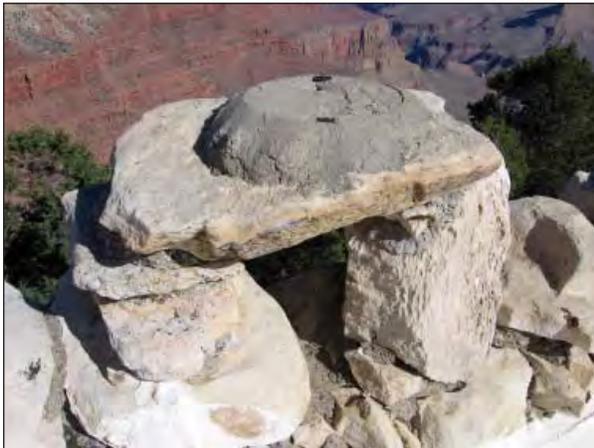
FIG. E13: Mortar applied on top of the roof lookout, 2007.

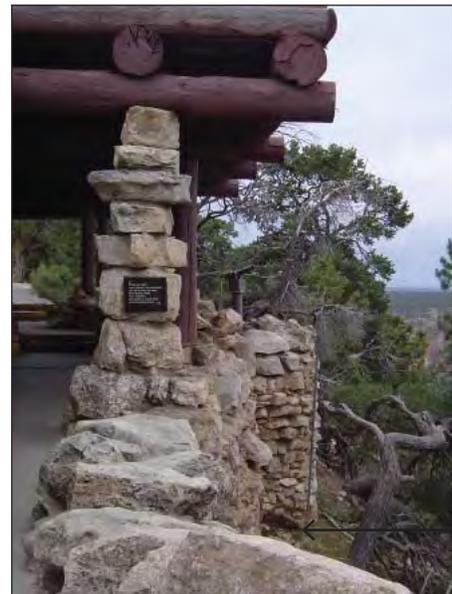
Stones are displaced at grade beneath the porch's north retaining wall. This stone wall provides support to the porch and acts as a retaining wall between the building and the canyon's edge. At its north edge, the ground has eroded away from the wall causing stones to become displaced. In some areas, modern mortar has been applied for stability and in other areas, the stones are missing.

FIG. E16: View of the Hermit's Rest porch facing west. Note displaced stones at arrow, 2006.

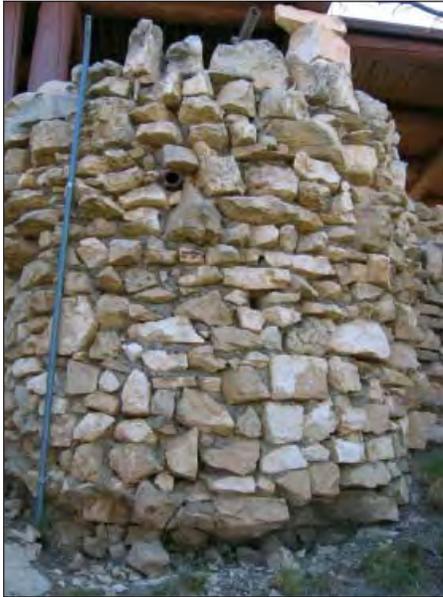
FIG. E17: Erosion at the base of the north retaining wall. Note pipe in wall. This rounded wall is presumed to cover a cistern, 2007.

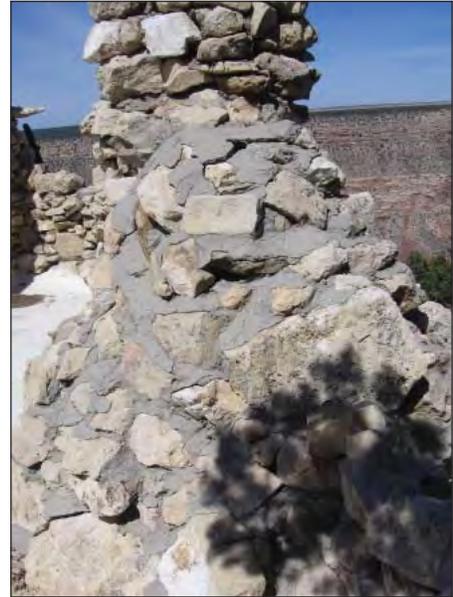
Excessive and/or incompatible mortar applied to stone. See FIGS. E10, E18, E19, E32.	No treatment required. If stones become further displaced, secure with compatible mortar. Compatible mortar should match the historic mortar in texture, color and placement within the joints.	Moderate
Secondary Room chimney missing stones/mortar creating holes. See FIG. E10.	Install stone in-kind where missing. Secure new and loose stone with compatible mortar. Compatible mortar should match the historic mortar in texture, color and placement within the joints.	Moderate
Unsecured wire mesh over Secondary Room chimney. See FIG. E10.	Remove wire mesh from the chimney. Install animal-proof screen on the inside of the chimney, out of view.	Moderate
Lack of animal-proof screen on Great Room chimney (unless present inside chimney). See FIG. E11.	Install animal-proof screen on the inside of the chimney, out of view.	Moderate

FIG. E18: Excessive and incompatible mortar applied to the Secondary Room chimney, 2007.

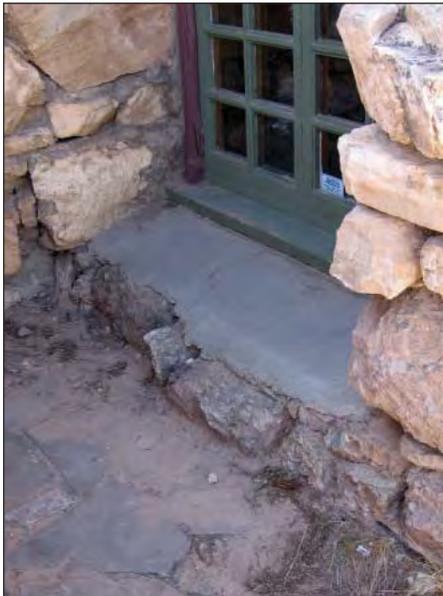
FIG. E19: Mortar applied on the stone outside of the east Secondary Room window, 2007.

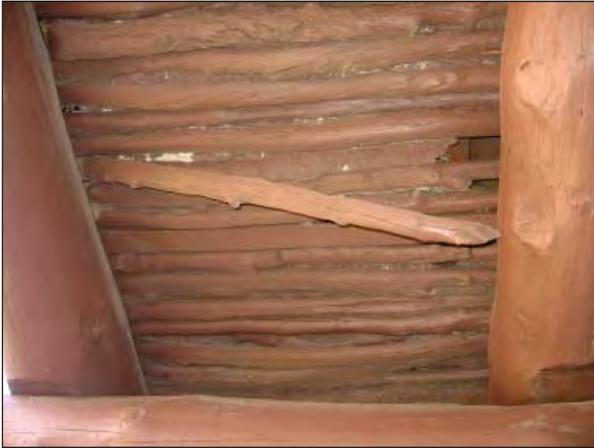
FIG. E21: Displaced latilla revealing boards on the underside of the historic porch roof, 2007.

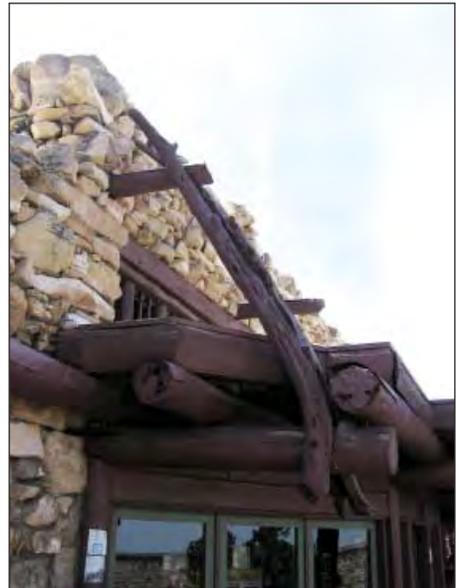
Unlike the other projecting north-south running log porch beams, the eastern-most beam is not supported by a wood post or stone base. Instead, it is seemingly supported from above by two irregularly shaped logs attached to the viga above. These irregularly shaped logs rest at an approximately 50° angle from the roof and sandwich the viga and the north-south running beam below. They suffer decay from moisture penetration. Although this arrangement may be designed to appear structural, it is most likely cosmetic. The north-south running beam is connected to the east-west running beam above by a large bolt. The north-south beam is sagging and displaced approximately 4" at its north end.

Displaced/sagging porch roof beam. See FIGS. E24, E25.	Restore porch. See <i>Alternatives for Treatment</i> for more information.	Severe
Unsecured water pipe and/or electrical conduit, propane supply. See FIGS. E33, E56.	Secure water pipe, electrical conduit and propane supply to roof.	Severe
Porch addition roof damaged with age. See FIG. E35.	Restore porch. See <i>Alternatives for Treatment</i> for more information.	Severe

FIG. E24: Faux-structural detail at the east side of the porch roof, 2007.

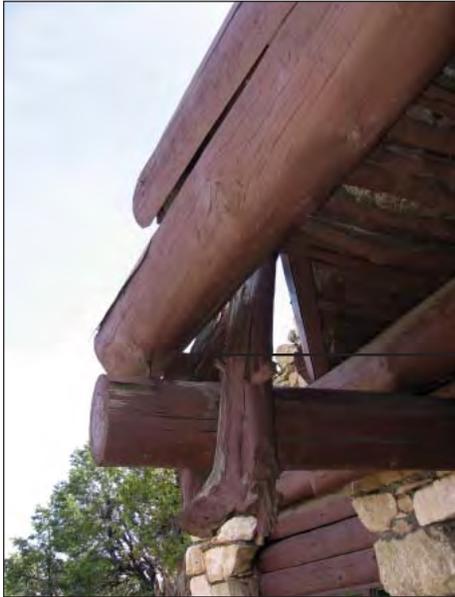
FIG. E25: Displaced porch beam at arrow, 2007.

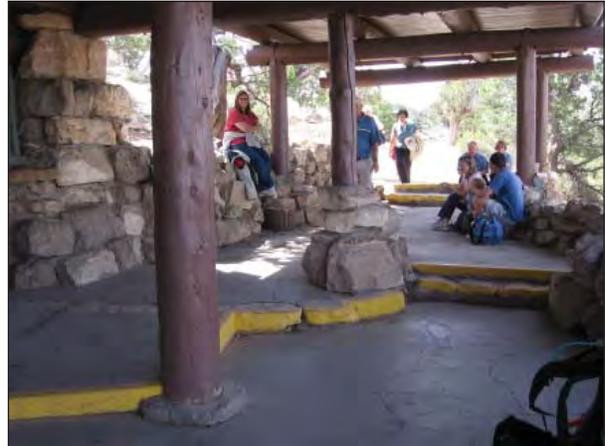
Exterior Deficiency/Modification	Recommended Treatment*	Impact
Modern alterations:		
Yellow painted stripes at level changes visually distracting. See FIGS. E26, E28.	Cease painting the floor level changes yellow upon completion of porch restoration. See <i>Alternatives for Treatment</i> for more information.	Moderate
Modern shelf installed on Kitchen Dutch door. See FIG. E40.	No treatment required.	Moderate
Porch floor raised one step on east side. See FIGS. E5, E26, E29 and CD3 in the <i>Chronology of Development & Use</i> section (page 25).	Restore porch floor to original configuration. See <i>Alternatives for Treatment</i> for more information.	Low
Some exhaust holes in Great Room chimney blocked to direct smoke. See FIG. E11.	No treatment required. Holes presumably blocked to prevent smoke from blowing to the path behind the Hermit's Rest, which was a historic route of travel around the site.	Low

FIG. E26: Porch floor facing west, 2007.

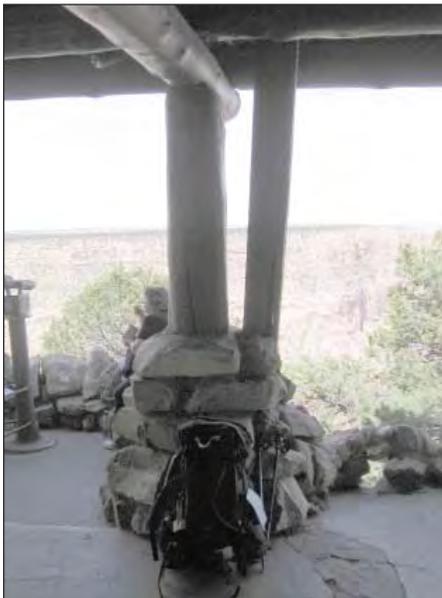
FIG. E27: Downspout (right of log post) encased in a wood box which is presumed to lead to a cistern beneath the porch floor at left, 2007.

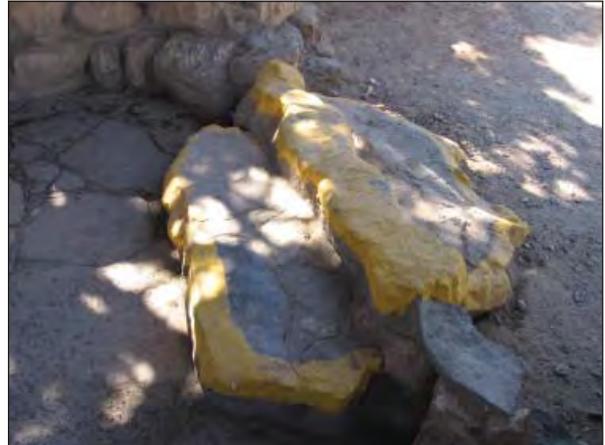
FIG. E28: Seemingly unnecessary steps at the west end of porch, painted yellow which detracts from the character of the site, 2007.

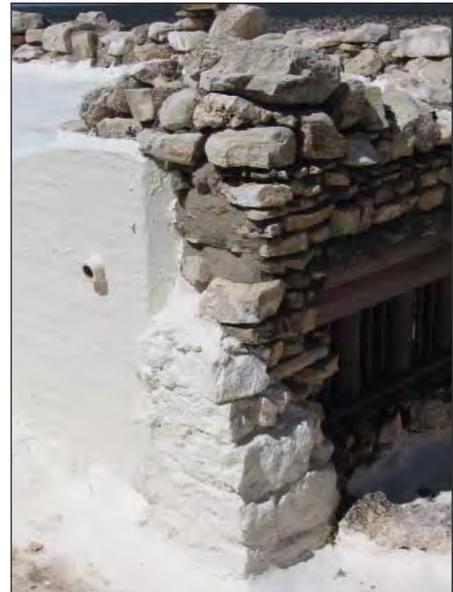
FIG. E32: Roofing material and excessive mortar applied to the stone at southeast corner of the building, 2007.

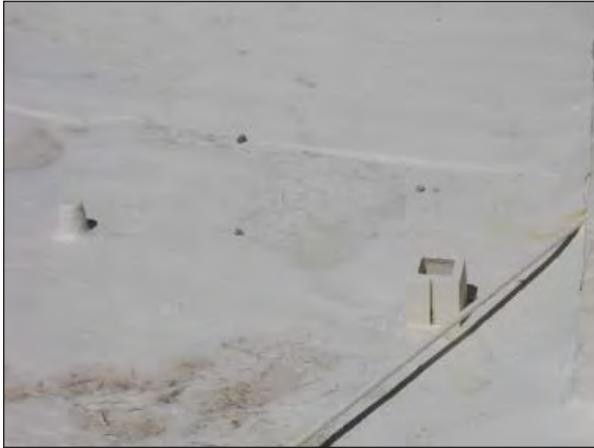
FIG. E33: View of the roof showing the concrete block and unsecured propane pipe, 2007.

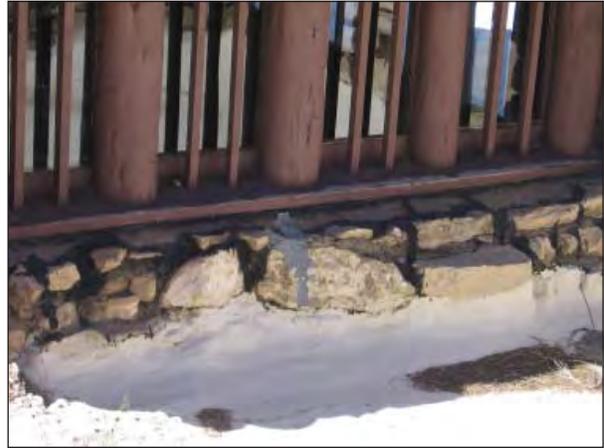
FIG. E34: Roof tar applied as mortar between the stones under the clerestory windows, 2007.

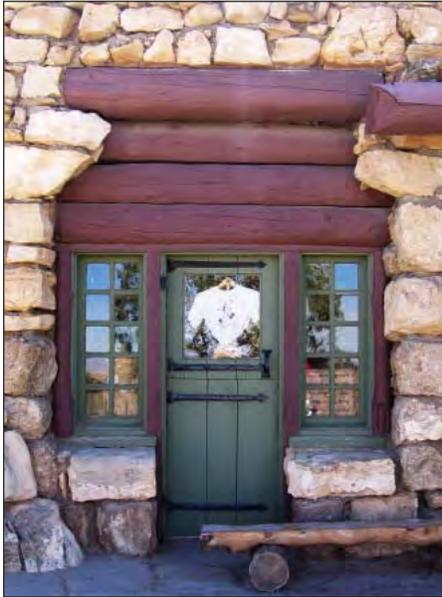
FIG. E38: Decayed door jamb and trim on the Secondary Room entrance, 2007.

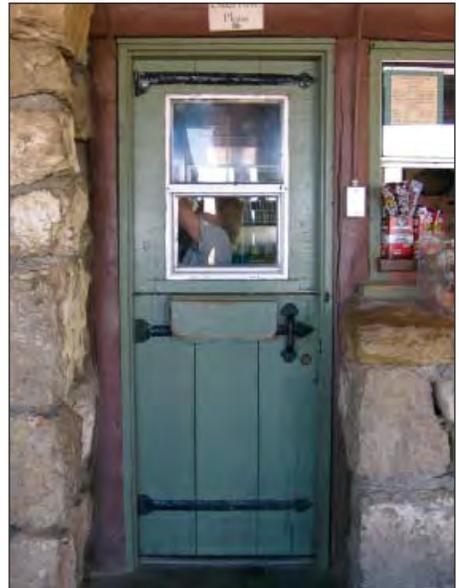
FIG. E40: Kitchen Dutch door with modern alterations including double-hung aluminum frame window and fold down shelf, 2007.

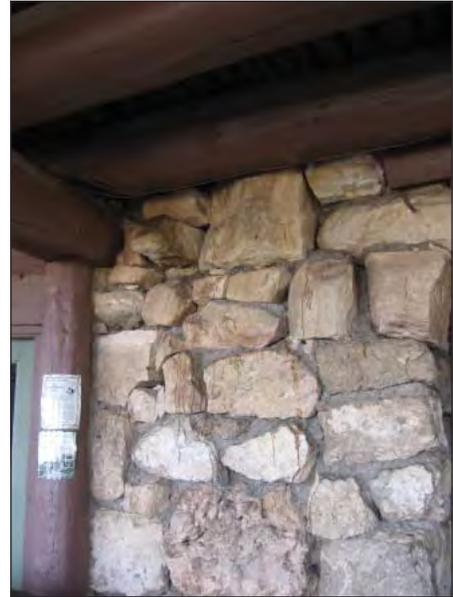
FIG. E42: Paint drip on the north elevation stone wall between the Great Room and Kitchen, 2007.

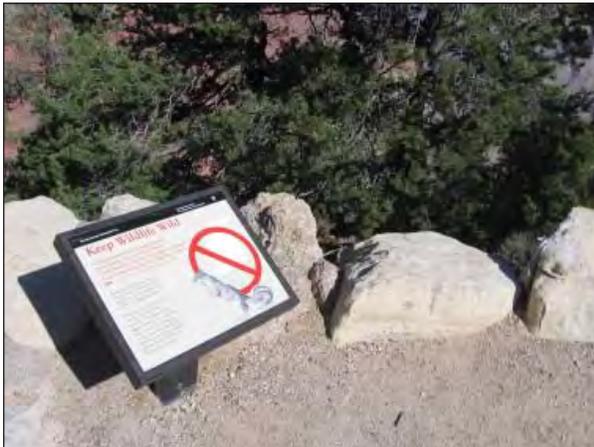
Modern signage to discourage feeding of wildlife mounted on ground at porch impairs view of the Hermit's Rest. See FIG. E47.	Remove signage. Install in a location that is both affective at discouraging the feeding of wildlife and does not impair the view of the Hermit's Rest.	Low
Telescopes mounted on porch floor. See FIG. E45.	No treatment required. Telescopes provide entertainment for visitors and are in keeping with the character of the Hermit's Rest.	Low
Kitchen window replacements on west elevation. See FIG. E55.	No treatment required. When windows require replacement, install replicas of original windows.	Low

FIG. E47: Modern signage to discourage feeding of wildlife, 2007.

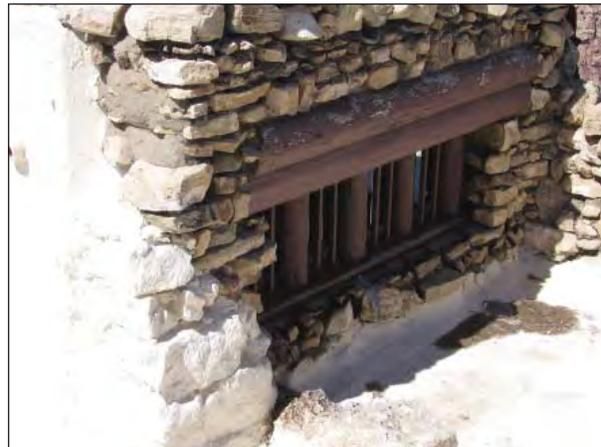
FIG. E48: East clerestory. Note the elastomeric roofing material on the stones and the peeling paint on lintels, 2007.

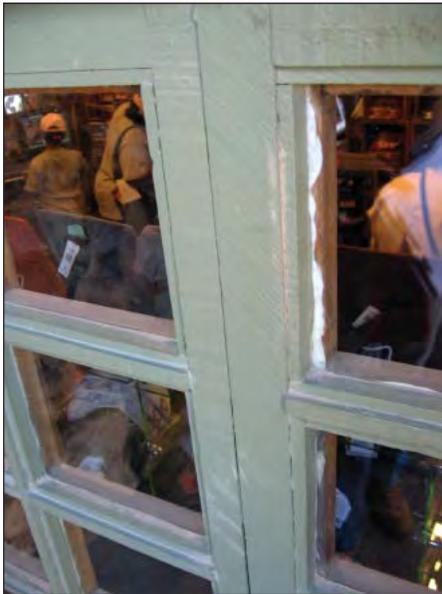
FIG. E51: White putty between the mullion and glass on the east elevation Secondary Room window, 2007.

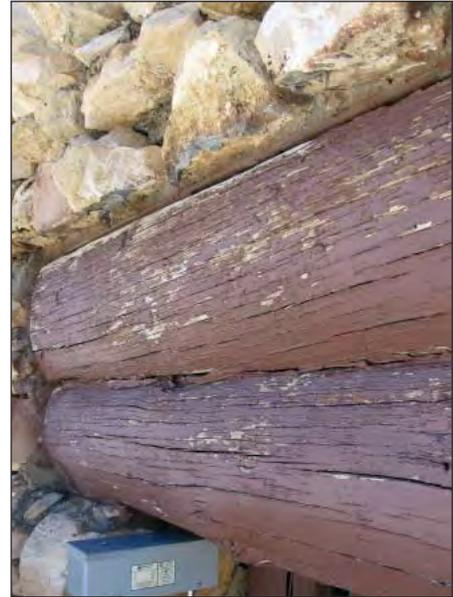
FIG. E54: Peeled paint on the lintels above the west elevation clerestory window, 2007.

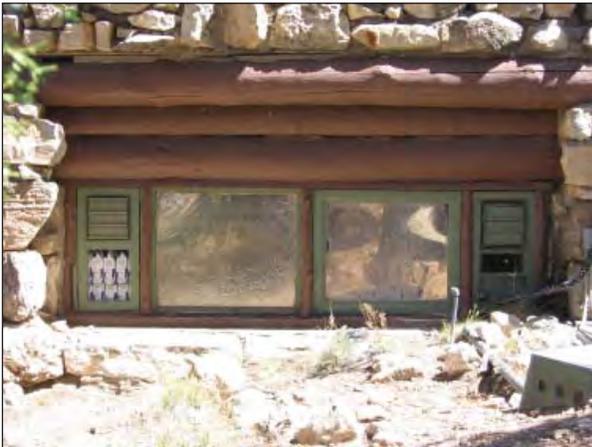
FIG. E55: Kitchen windows on the west elevation showing reflective film on center windows and vents on flanking windows. Note grey water line entering the building through the window at right, 2007.

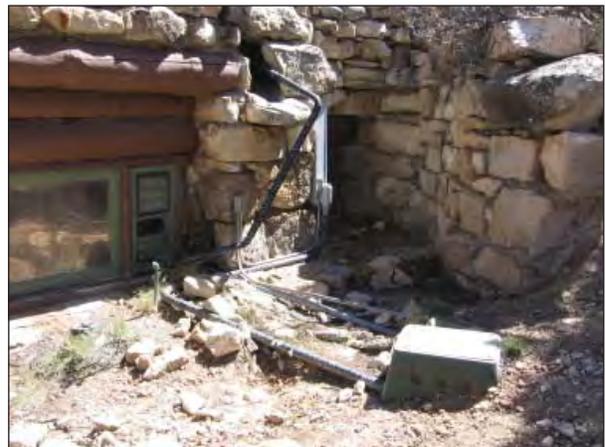
FIG. E56: Unburied water pipes and electrical conduit in front of the west elevation. Note grey water pumps upward in pipe situated on the drainage, 2007.

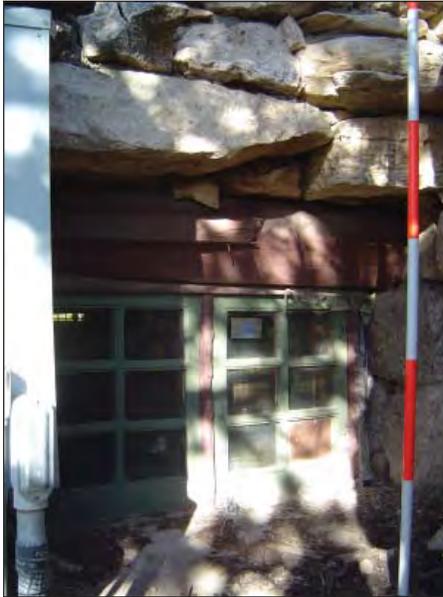
FIG. E57: Office window on west elevation. Note the duct tape and plastic applied around the window and masonite boarding in the bottom right glass pane, 2007.

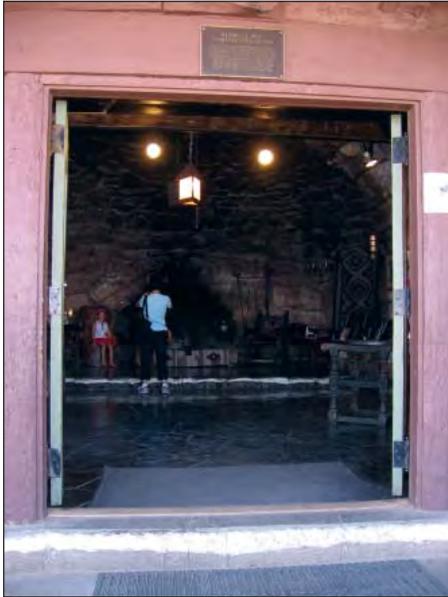
White painted stripe at fireplace area level change visually distracting. See FIGS. GR1, GR2.	Cease painting the floor level change white. The Hermit's Rest staff have never observed anyone trip at this level change, even when the white paint becomes worn.	Moderate
Floor regularly waxed giving it a shiny appearance. See FIGS. GR1-GR4.	Evaluate other surface finishes that do not appear shiny but still protect the floor from increased visitor traffic.	Moderate
Incompatible mortar applied on built-in stone bench. See FIG. GR11.	If stones become further displaced, secure with compatible mortar. Compatible mortar should match the historic mortar in texture, color and placement with the joints.	Moderate
Table/chair missing seat. See FIG. GR19.	Restore seat in-kind.	Moderate
Electrical conduit and propane pipe installed through window frame. See FIG. E53 in the <i>Exterior</i> section (page 78).	Remove conduit and patch window trim. Install conduit through existing mortar joint.	Moderate

FIG. GR1: Level changes from the exterior into the Great Room and from the main floor level to the fireplace area, 2007.

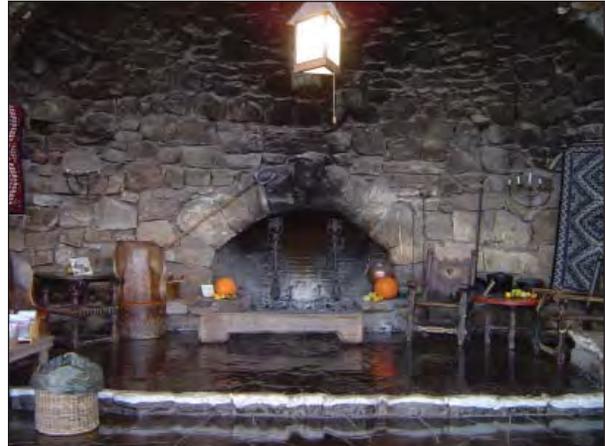
FIG. GR2: Great Room fireplace showing domed stone ceiling, historic furniture, white-painted step and waxed flagstone floor, 2006.

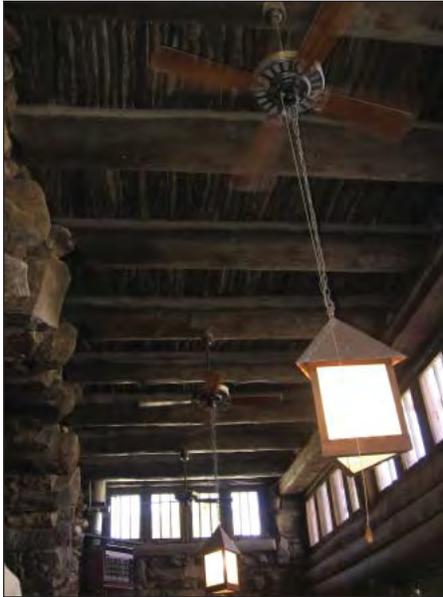
Modern ceiling fans with hanging light fixtures. See FIG. GR5.	No treatment required.	Low
Modern conduit on north, east and west walls See FIG. GR7.	Obscure conduit by painting to match log members.	Low
Historic lamp fixtures electrified. See FIG. GR24.	No treatment required.	Low
Modern electrical outlets at fireplace. See FIGS. GR24, GR25.	Remove exposed conduit and outlet on the west side of the fireplace that is unused. Retain electrical outlet on the east side.	Low
Modern propane heater mounted on steel C-channel. See FIG. GR27.	No treatment required.	Low
Modern shelves below west windows and between west windows and Kitchen archway. See FIG. GR28.	Remove shelves.	Low

FIG. GR5: Great Room ceiling showing log beams, latilla, clerestory windows, propane heater, modern ceiling fans and modern light fixtures, 2007.

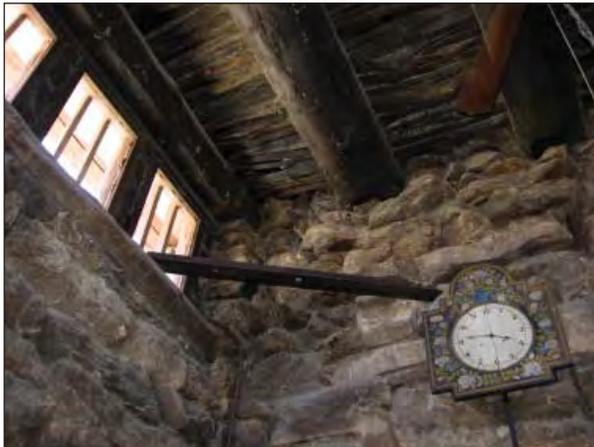
Great Room Deficiency/Modification	Recommended Treatment*	Impact
Missing features:		
Rodent access at location of removed propane heater. See FIG. GR7.	Seal gaps between building materials in consultation with park Historical Architect.	Severe
Doors to Secondary Room missing. See FIG. GR4.	No treatment required.	Low
Three iron firewood holders missing. See FIG. GR11.	Restore missing firewood holders in-kind.	Low
Historic light fixture missing shade covering. See FIG. GR26.	Restore missing covering in-kind.	Low
Modern alterations:		
Modern merchandise displays obscure character-defining features. See FIGS. GR3, GR4, GR13.	Consult with merchandise display specialist. Replace large sales displays with compact units that do not obscure windows, doors and circulation routes.	Moderate
Archway blocked with non-original safe and burlap. See FIGS. GR3, GR16.	Remove burlap and install on stretcher to be placed behind arch. Burlap should have the appearance of being taut and to the dimensions of the archway.	Moderate

FIG. GR7: View of the southeast corner of the Great Room showing the stone walls, wood ceiling and windows, painted clock and steel c-channel for the removed propane heater. Note conduit in corner, 2007.

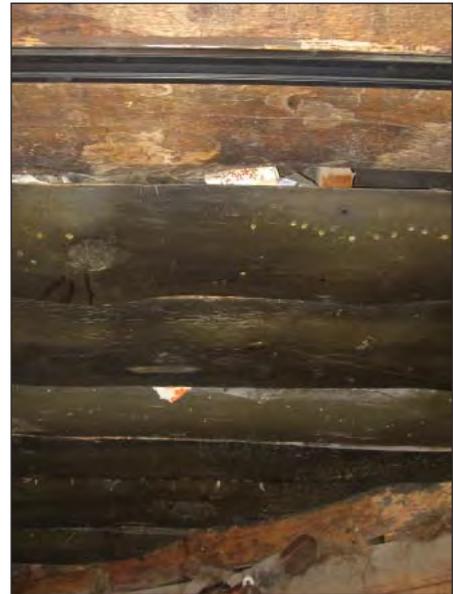
The ceiling in the entrance area is composed of non-original log slabs oriented east-west. Rodent damage is visible on this ceiling. Rodents have carried trash through the ceiling and in some locations trash is visible between the log slabs. Originally, this ceiling consisted of east-west log beams with latilla running perpendicular between them, similar to the existing clerestory ceiling. The original ceiling configuration is likely still present above the log slab ceiling.

Great Room Deficiency/Modification	Recommended Treatment*	Impact
Damaged features:		
Log slab ceiling at entrance damaged by rodents. See FIGS. GR8, GR9.	Remove modern log slabs. Restore latilla and log beams above modern log slabs. Seal gaps between building materials in consultation with park Historical Architect.	Severe
Trash left by rodents visible in ceiling. See FIGS. GR8, GR9.	Remove modern log slabs. Restore latilla and log beams above modern log slabs. Seal gaps between building materials in consultation with park Historical Architect.	Severe
Loose stone on integrated bench. See FIG. GR12.	Secure stone using compatible mortar. Compatible mortar should match the historic mortar in texture, color and placement with the joints.	Severe
Level change from exterior. See FIG. GR1.	No treatment required. A wheelchair ramp is available when needed. See the <i>Alternatives for Treatment</i> section for more information.	Moderate

FIG. GR8: Modern log slab ceiling at the entrance showing the debris collected by rodents, 2007.

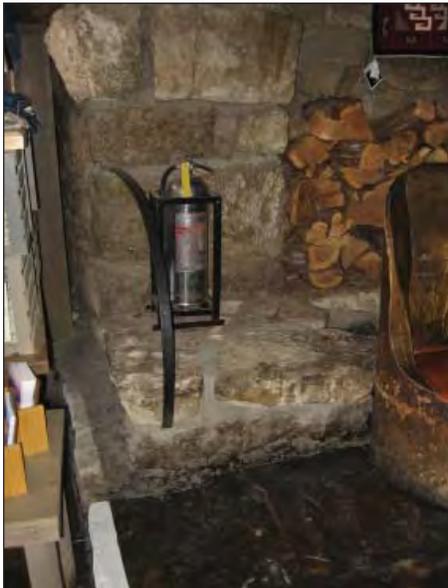
An integrated stone bench flanks the fireplace in the fireplace area. A stone is loose on the bench just east of the fireplace. The bench's depth projects near the step to accommodate firewood storage. Iron straps were originally located on both sides of these projections to contain the firewood. Only one iron strap remains and is located on the north side of the east bench. Modern mortar has been applied on the stone bench in this location.

FIG. GR11: Built-in bench showing the iron firewood holder and incompatible mortar, 2007.

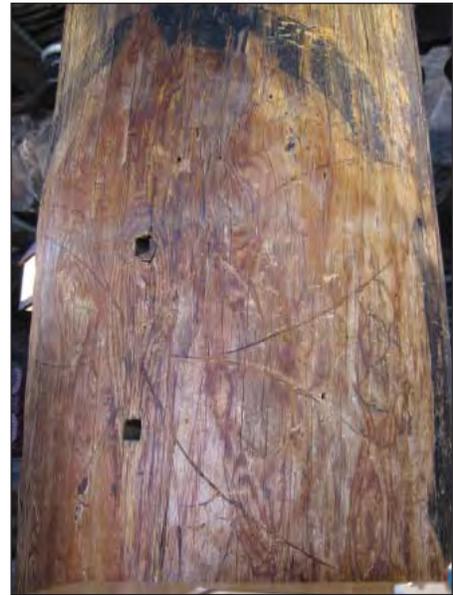
FIG. GR14: Post showing etched lines, faded paint and holes where candelabra was once mounted, 2007.

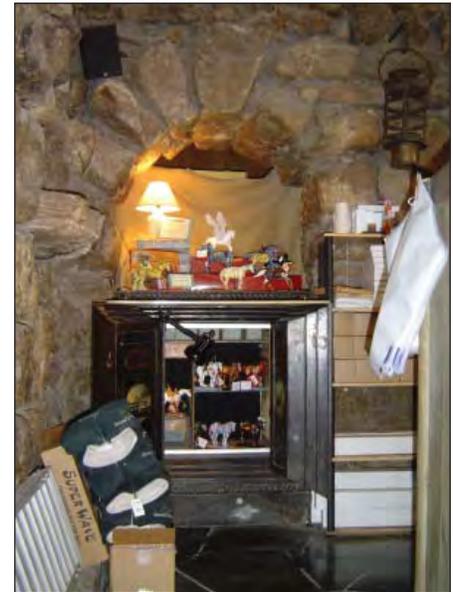
FIG. GR16: View of the south arch on the west wall, blocked by non-original safe and covered with burlap. Note stone niche and modern speaker at left, 2007.

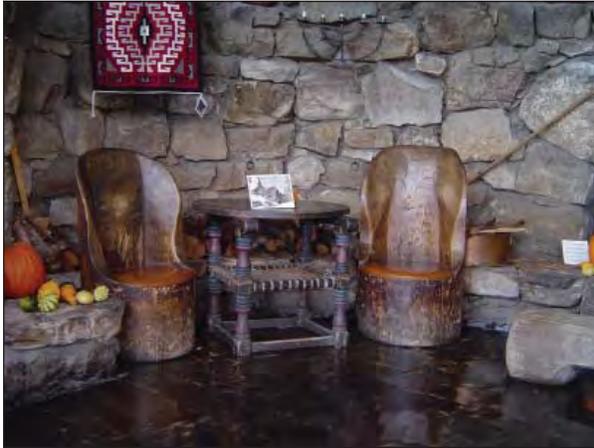
FIG. GR17: Log barrel chairs with vinyl seat covering and painted wood table that converts into chair in front of the built-in stone bench, 2006.

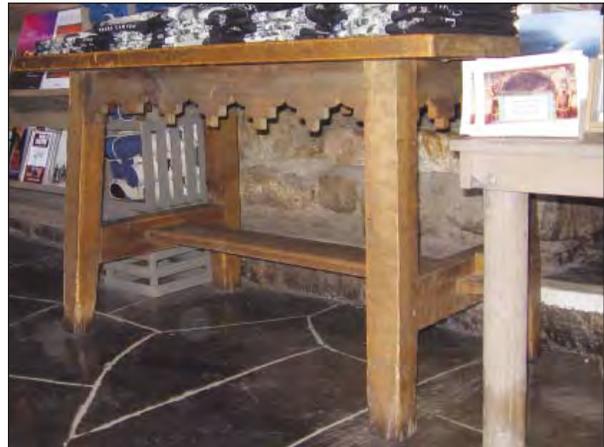
FIG. GR20: Historic wood table, 2007.

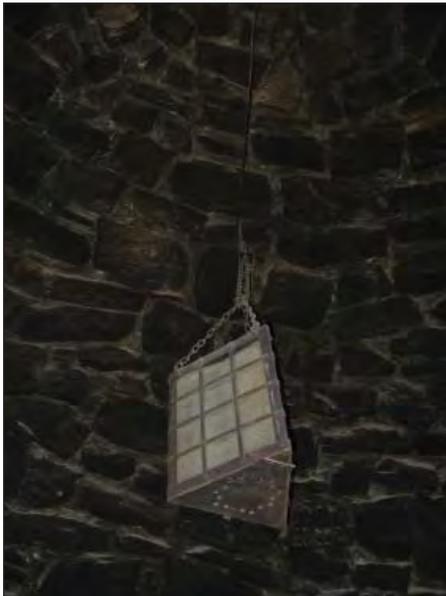
FIG. GR23: Light fixture suspended from the domed ceiling. Note this light fixture was originally hung from the corbel arch to the east of the Hermit's Rest, 2007.

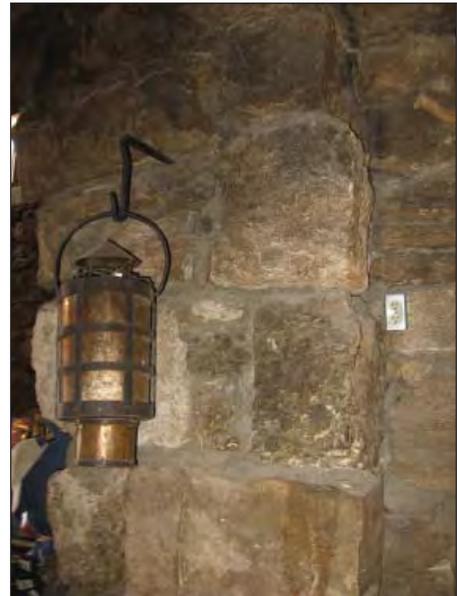
FIG. GR24: Electrified lamp fixture on an iron hanger and modern electrical outlet, 2007.

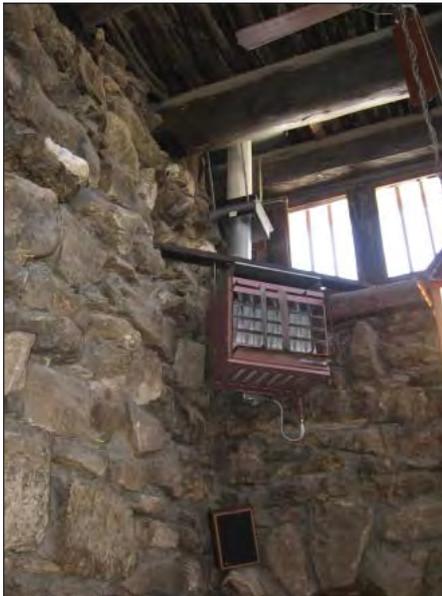
FIG. GR27: Propane heater and modern speaker in the southwest corner of the Great Room, 2007.

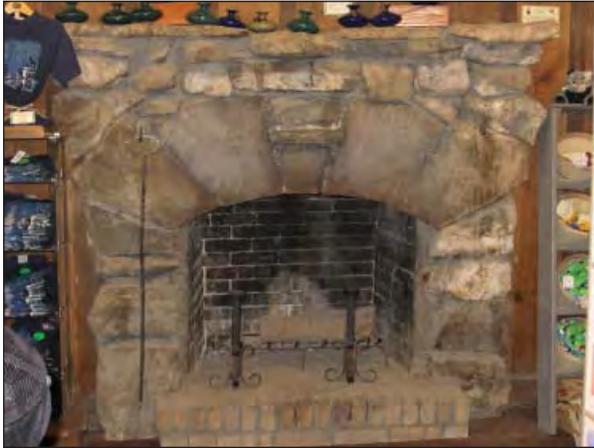
The east wall has a stone fireplace which has been partially replaced. The reason for the alteration, which was executed sometime before 1994, is unknown. The lower stones as well as the brick at its base are original. Originally, the fireplace featured an iron spherical-lune shaped hood, which is no longer present. The fireplace is approximately 6' wide x 4 ½' tall. A small stone shelf projects above the opening. The fireplace is no longer operable.

FIG. SR1: Stone fireplace on the east wall of the Secondary Room, 2007.

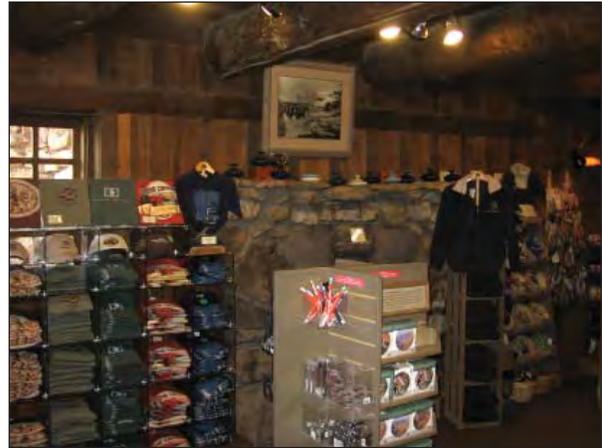
Secondary Room Deficiency/Modification	Recommended Treatment*	Impact
Fireplace plugged.	No treatment required.	Low
Modern track light fixtures installed. See FIGS. SR2, SR17.	No treatment required. Modern track lighting is not visually intrusive and does not appear falsely historic.	Low
Reversed door to west wall closet. See FIG. SR7.	Re-orient door so that iron strap hinges face the Secondary Room.	Low
Modern trim over north arch on west wall See FIG. SR10.	Remove modern trim and install trim to match historic trim over the other arch.	Low
Modern battens where original battens missing. See FIG. SR15.	Remove modern battens and install battens to match historic.	Low
Security camera installed in northwest corner with cord draped across north wall See FIG. SR16.	If security camera required, mount cord to corner and run cord down the wall at the corner.	Low
Modern Dutch door. See FIG. SR19.	No treatment required. See <i>Alternatives for Treatment</i> for more information on exterior access into this room.	Low

FIG. SR2: East wall of the Secondary Room showing the fireplace, merchandise display over wood window, board and batten wall, and ceiling-mounted track lighting, 2007.

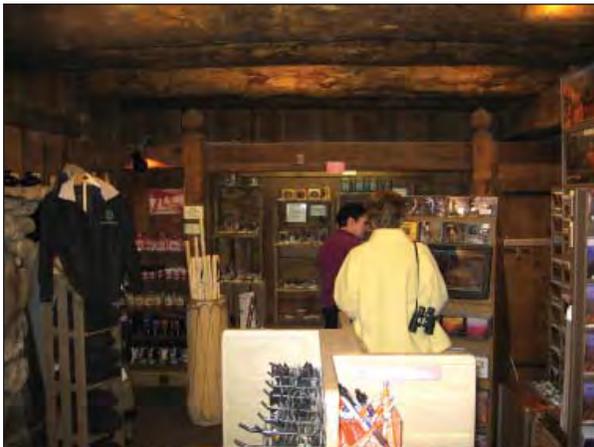
FIG. SR3: South wall of the Secondary Room showing the original partition wall with a modern false wall at center, 2007.

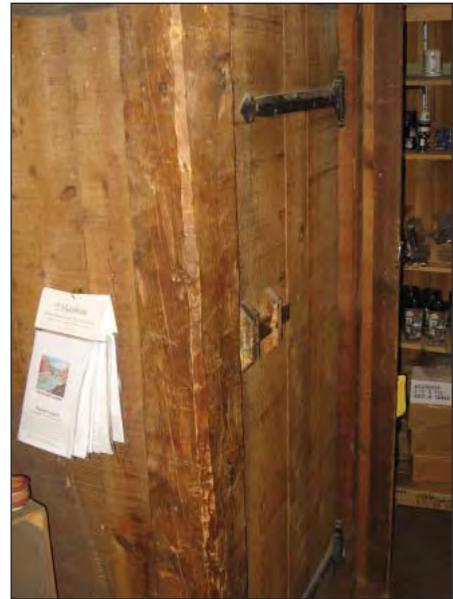
FIG. SR6: Wood closet door, hardware and iron hinges on the west side of the south wall, 2007.

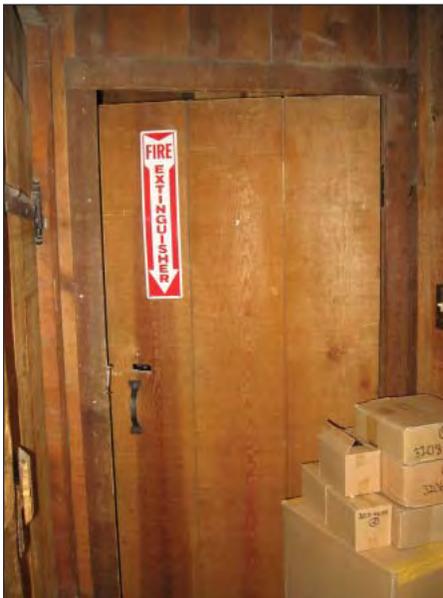
FIG. SR7: Closet door on the south side of the west wall currently oriented with the iron strap hinges facing the closet interior, 2007.

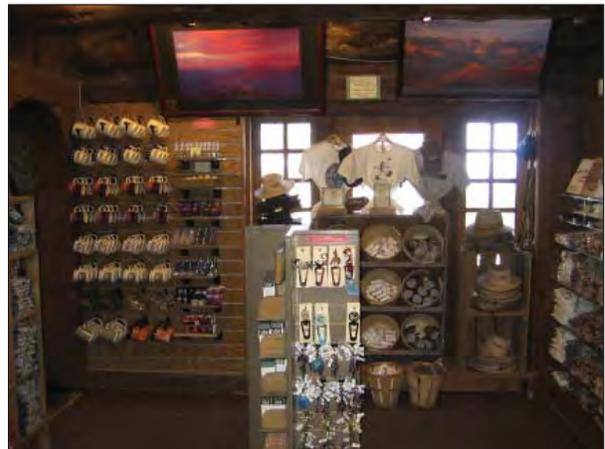
On the north wall, a wood Dutch door to the exterior is flanked by fixed ten-lite wood windows. The unfinished quality of the interior side of the door suggests that the Dutch door is a modern replacement. It is unknown when the door was replaced.

Secondary Room Deficiency/Modification	Recommended Treatment*	Impact
Damaged features:		
Exterior door blocked by merchandise. See FIG. SR8.	Remove merchandise display from the area in front of the door. See <i>Alternatives for Treatment</i> for more information.	Severe
Water damage on closet ceiling. See FIG. SR13.	See <i>Site</i> and <i>Exterior</i> sections for recommended treatments to prevent moisture penetration to the interior.	Severe
Rodent access gained through gaps between wall boards, ceiling boards, and connections between wall and ceiling. See FIGS. SR13, SR14.	Seal gaps between building materials in consultation with park Historical Architect.	Severe
Rodent footprints on ceiling logs. See FIG. SR17.	Clean footprints from ceiling logs. Seal gaps between building materials in consultation with park Historical Architect.	Severe
Daylight blocked by display in windows. See FIGS. SR2, SR8.	Consult with merchandise display specialist. Replace large sales displays with compact units that do not obscure windows, doors and circulation routes.	Moderate

FIG. SR8: North wall of the Secondary Room showing the merchandise display blocking the exterior Dutch door and windows. Note the modern slat wall at left, 2007.

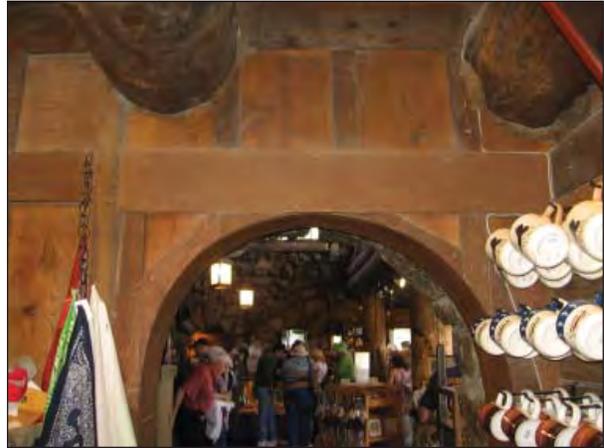
FIG. SR10: North arch on the west wall showing modern trim, 2007.

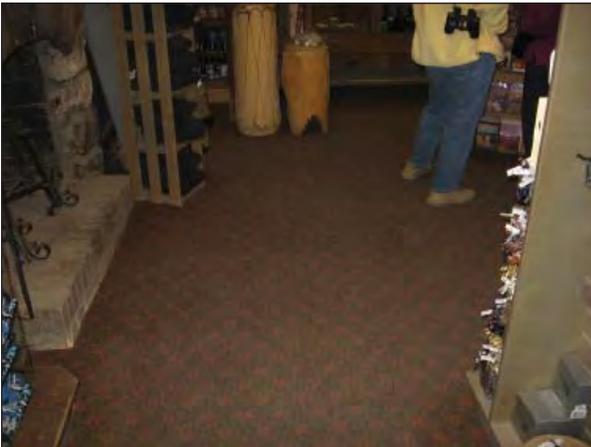
FIG. SR11: Modern carpet, 2007.

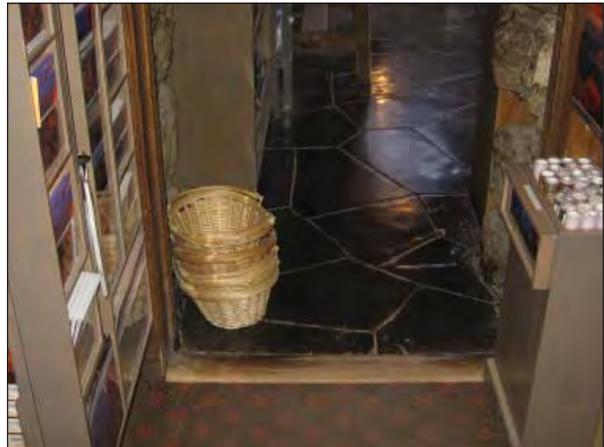
FIG. SR12: Threshold between the Secondary Room and Great Room, 2007.

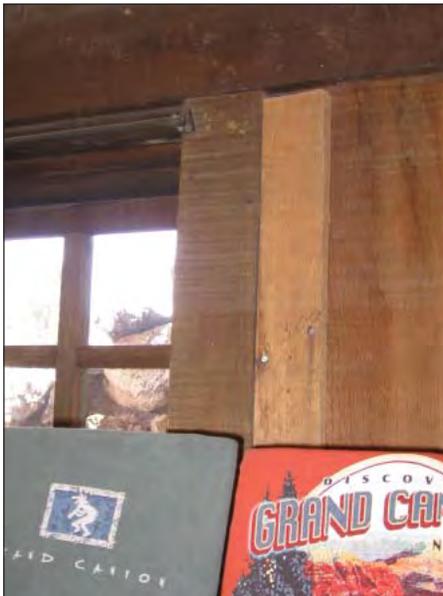
All of the Secondary Room walls are composed of vertical wood board-and-batten. Vertical wood battens, approximately 1' wide, are spaced approximately 3" apart. Battens are darker in color than the boards. The battens span the height of the room between the wood ceiling and baseboard trim. A presumably missing batten has been replaced with a modern batten on the south side of the east window.

FIG. SR15: Modern batten to the right of the window on the east wall, 2007.

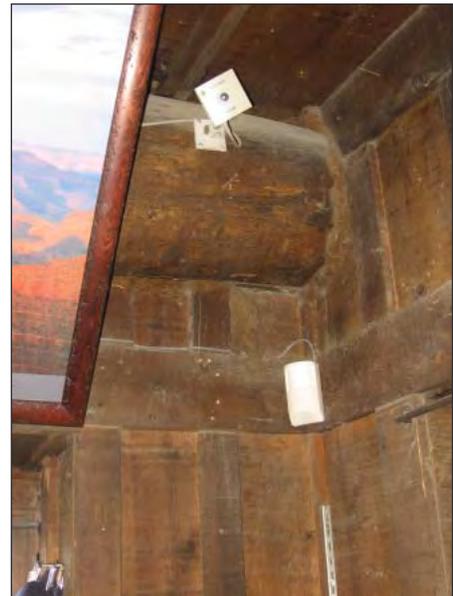
FIG. SR16: Northeast corner of the Secondary Room showing a security camera, 2007.

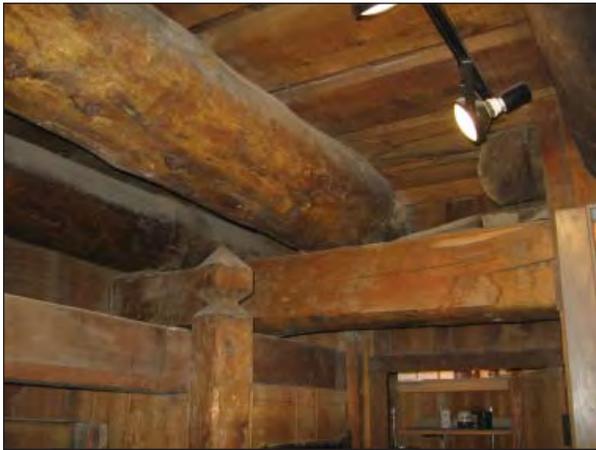
FIG. SR17: Southwest corner of the Secondary Room showing the closet wall configuration, ceiling treatment and animal footprints at right, 2007.

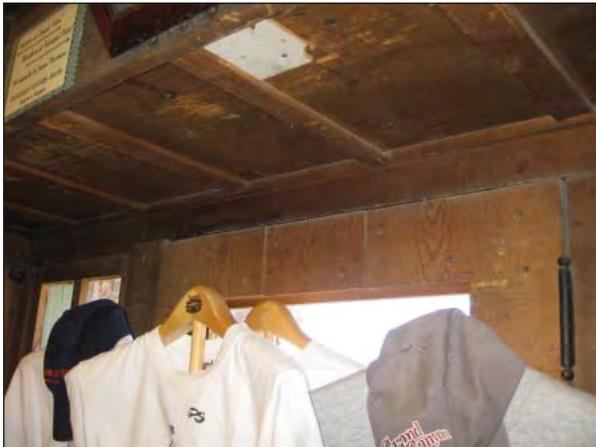
The ceiling and baseboard trim are approximately 6" wide, as are wood door and window trim. The trim is dark in color. Wood trim is missing around the north door. An additional wood trim piece runs the length of each wall at the height of the top window trim. It has the same dimension and color as other battens and trim. A modern white trim board is mounted on the ceiling near the north door.

Missing battens in closet. See FIG. SR18.	Install battens in-kind to prevent rodent access into the room.	Moderate
White board on ceiling near north door. See FIG. SR19.	Remove white board.	Moderate
Stone fireplace reconfigured. See FIGS. SR1 and CD13 in the <i>Chronology of Development & Use</i> section (page 31).	No treatment required.	Low

FIG. SR19: White board near the exterior Dutch door. Note the unfinished quality of door, 2007.

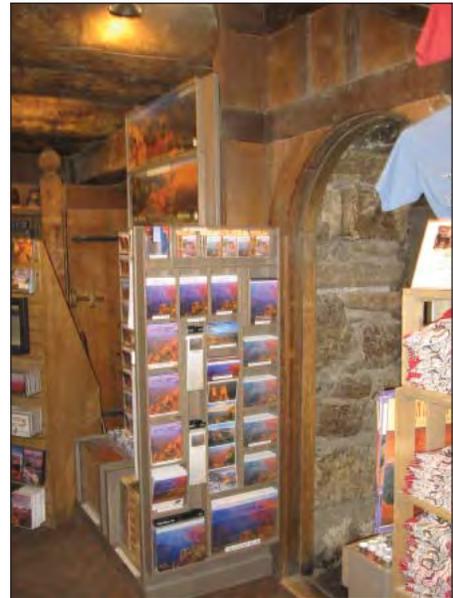
FIG. SR20: Protruding area of the west wall, 2007.
