HISTORIC STRUCTURE REPORT

HERMIT'S REST

GRAND CANYON NATIONAL PARK

December 2007

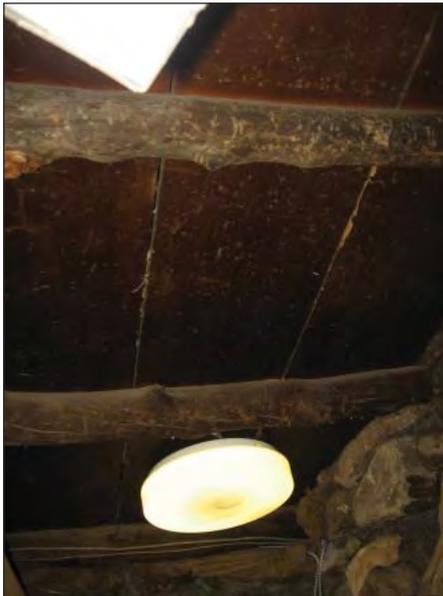
Hall Deficiency/Modification	Recommended Treatment*	Impact
Damaged features:		
Water damage on ceiling. See FIG. H4.	See <i>Site and Exterior</i> section for recommended treatments to prevent moisture penetration to the interior.	Severe
Modern alterations:		
Archway to Great Room blocked with safe and burlap. See FIG. GR16 in the <i>Great Room</i> section (page 90).	Remove burlap and install on a stretcher to be placed behind arch. Burlap should have the appearance of being taut and to the dimensions of the archway.	Moderate
Partition wall removed. See FIG. H1.	No treatment required.	Moderate
Exposed wiring haphazardly mounted. See FIGS. H2, H4, H6, H7.	Bundle wiring and mount to ceiling and walls in straight lines along the corners.	Moderate
Modern fluorescent ceiling fixtures. See FIGS. H3, H4.	No treatment required.	Low

FIG. H3: Ceiling treatment on the north side of the Hall, 2007.

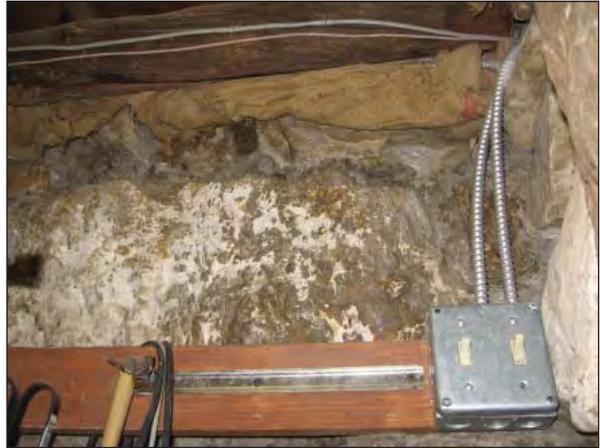
FIG. H6: North wall showing conduit. Note burlap in-fill between wall and ceiling, 2007.

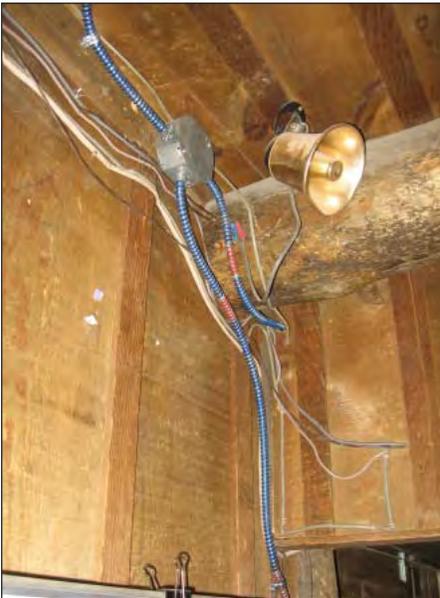
FIG. H7: View facing northwest showing conduit, 2007.

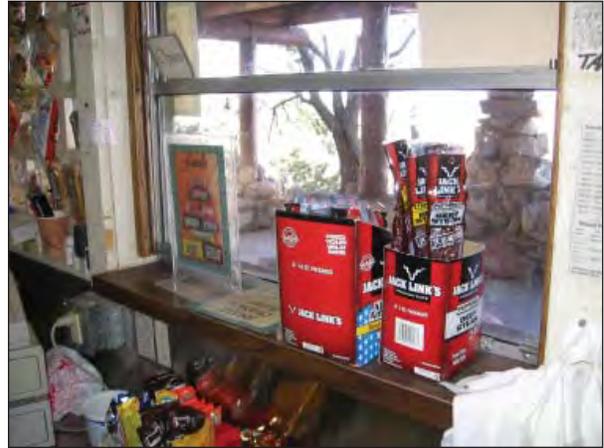
FIG. K2: Aluminum window on the north wall with modern shelf, 2007.

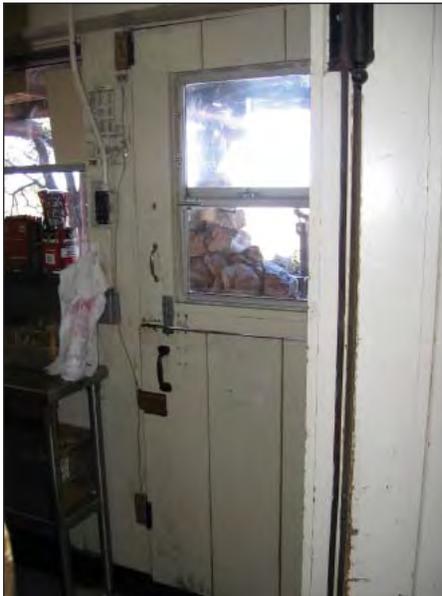
FIG. K3: Dutch door on the north wall showing the modern aluminum window, 2007.

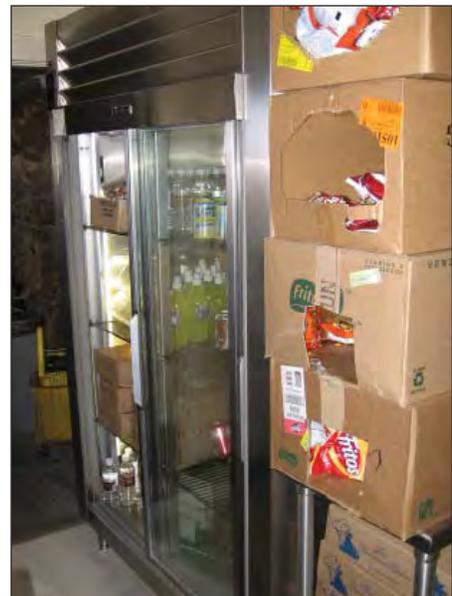
FIG. K4: Refrigerator facing north. Note vinyl tile floor, 2007.

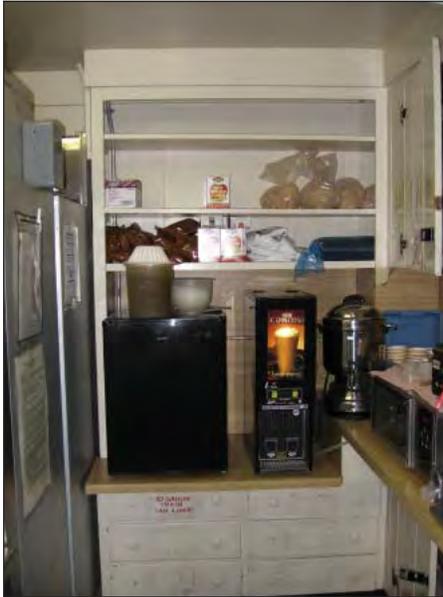
Modern cabinets, counters and backsplashes. See FIGS. K5, K6.	No treatment required.	Moderate
Exhaust fans and louvered vents installed in side windows on west wall. See FIGS. K10, K12.	Vents provide needed ventilation for the Kitchen interior. Evaluate alternatives to window vents with commercial kitchen specialist. Ventilation alternatives must respect the character and significance of the building.	Moderate
Window covered with improperly adhered reflective film. See FIG. K12.	Remove reflective film. If sun protection is required, then properly install new tinted window film.	Moderate

FIG. K5: East wall showing modern cabinets and the back of the refrigerator at right, 2007.

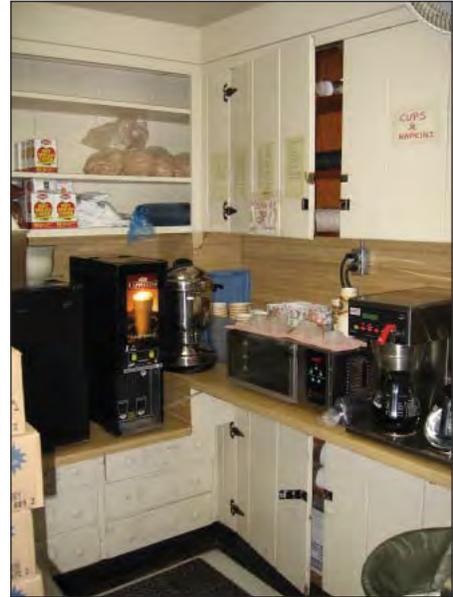
FIG. K6: Southeast corner of the Kitchen showing wood cabinets and drawers, 2007.

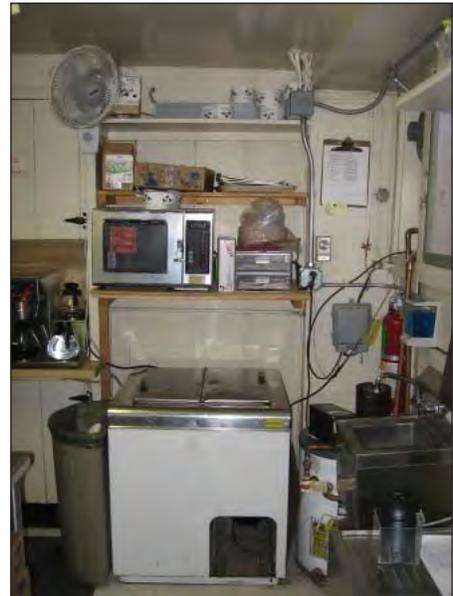
FIG. K8: West side of the south wall showing conduit, freezer and modern shelves, 2007.

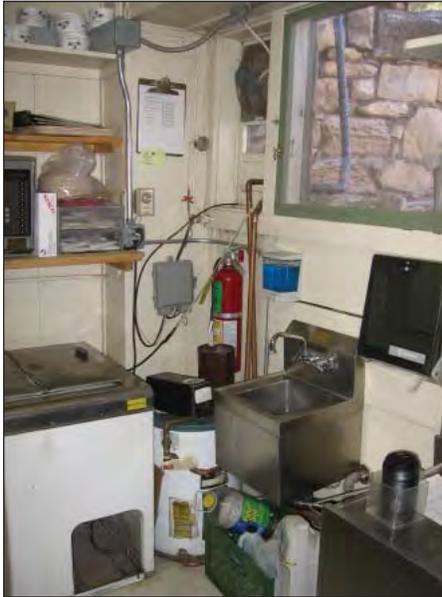
FIG. K9: Southwest corner of the Kitchen showing the freezer at left, hot water heater at center, and sink at right. Note the exhaust fan in the window in the corner and wiring over the fire extinguisher, 2007.

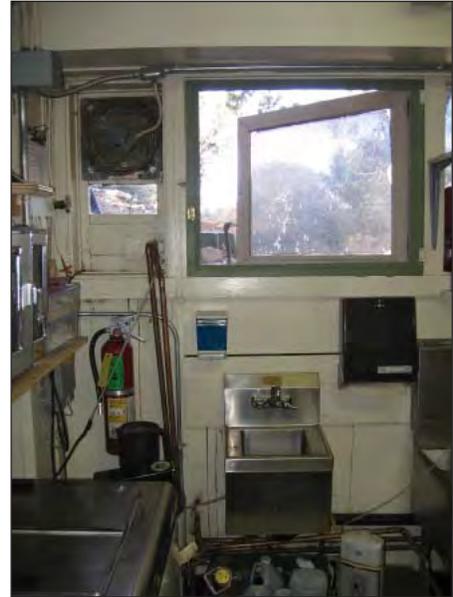
FIG. K10: South side of the west wall, 2007.

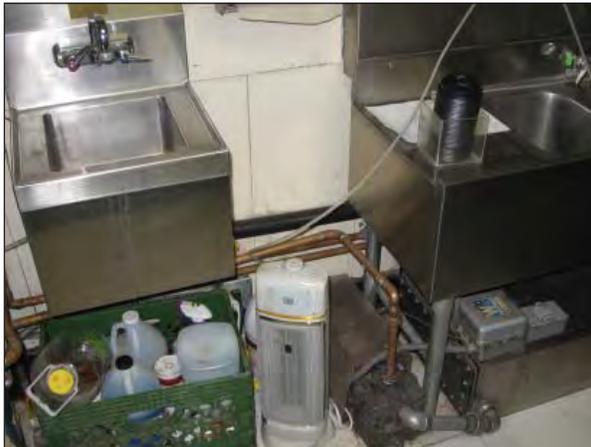
FIG. K11: West wall showing sinks, Jabsco pump and storage, 2007.

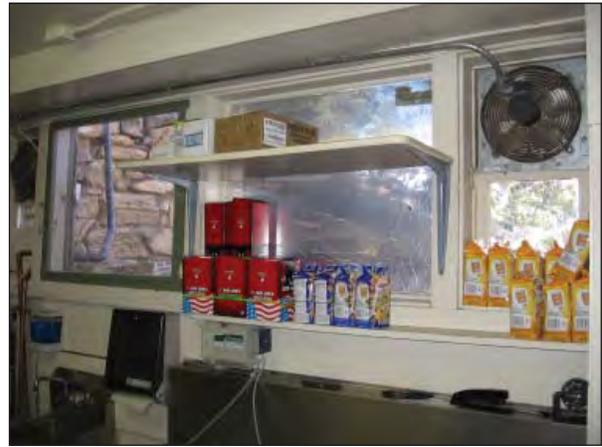
FIG. K12: West windows showing window film, exhaust fan, storage shelf and blocked daylight, 2007.

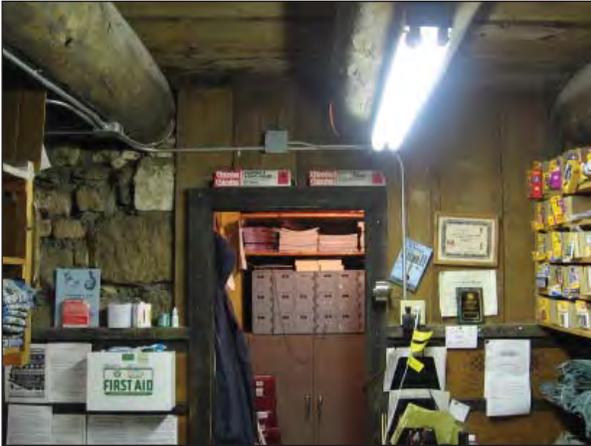
The closet door is missing.

FIG. O1: View facing east showing the wainscoting over the stone wall at left and over board and batten at right. Note the missing closet door and fluorescent lighting, 2007.

Modern fluorescent lighting installed on ceiling. See FIG. O1.	No treatment required.	Low
Baseboard heater installed on west wall. See FIG. O2.	No treatment required.	Low
Modern shelving installed in office and closet for merchandise storage. See FIGS. O2-O5.	No treatment required. Original wainscoting and cabinets should not be damaged by the addition of any modern shelving. Nothing should be attached to the original wainscoting and cabinets.	Low
Partition wall removed and original toilet room and storage area combined into single closet. See FIG. O10.	No treatment required.	Low

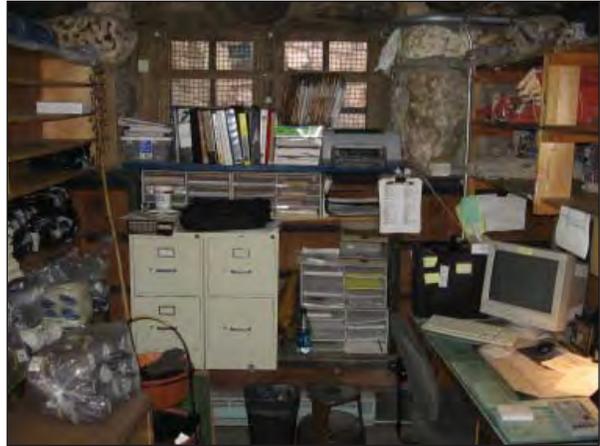
Office Deficiency/Modification	Recommended Treatment*	Impact
Damaged features:		
Water damage on ceiling. See FIG. O8.	See <i>Site</i> and <i>Exterior</i> section for recommended treatments to prevent moisture penetration to the interior.	Severe
Rodent access gained through gaps between wall boards. See FIG. O9.	Seal gaps between building materials in consultation with park Historical Architect.	Severe
Electrical conduit installed through window frame. See FIG. O2.	Remove conduit and patch window trim. Install conduit through existing mortar joint.	Moderate
Lead-based paint present in Office closet. See FIG. O10.	No immediate treatment required. Follow abatement process as required.	Moderate
Missing features:		
Closet door missing. See FIG. O1.	No treatment required.	Low
Office door missing part of wood latch. See FIG. O6.	No treatment required.	Low
Modern alterations:		
Security wire installed over window. See FIG. O2.	Remove wire. The Hermit's Rest now has a drop safe.	Moderate

FIG. O2: View facing west showing wainscoting, storage and wire over windows, 2007.

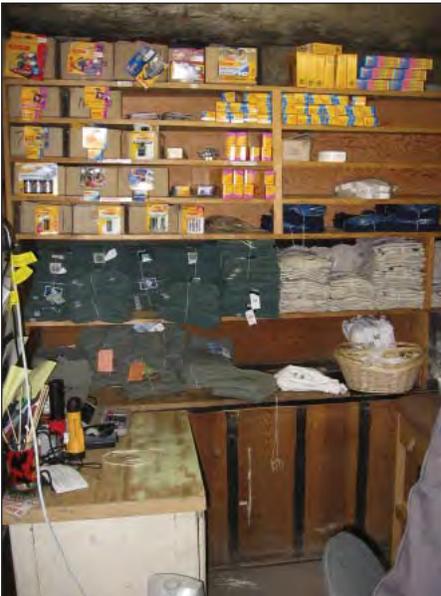
FIG. O3: East side of the south wall showing historic cabinets and modern shelves for merchandise storage, 2007.

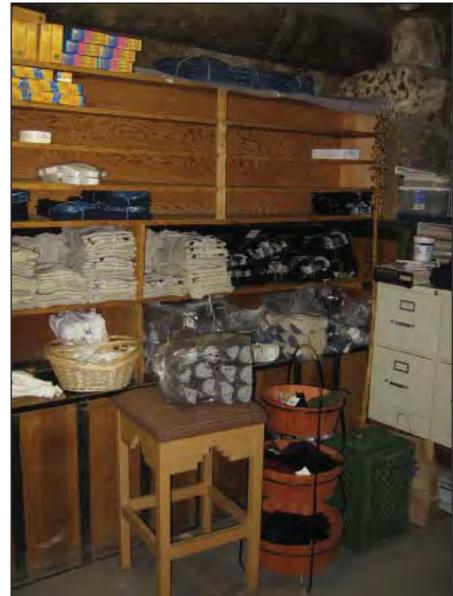
FIG. O4: West side of the south wall showing historic cabinets and modern shelves for merchandise storage, 2007.

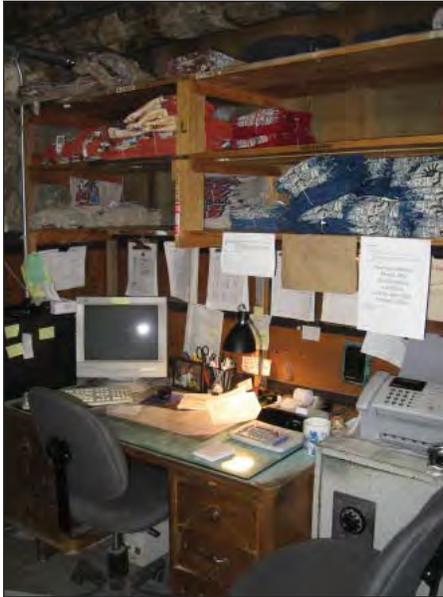
FIG. O5: West side of the north wall showing wainscoting and modern shelves for merchandise display, 2007.

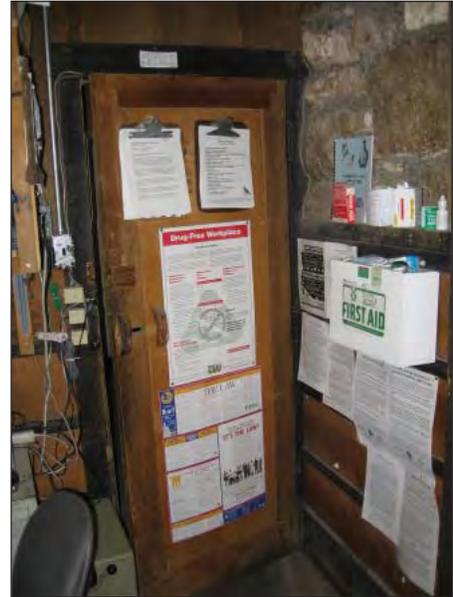
The back of the wood door from the Hall into the Office has wood-burnt paintings that match those on the wainscoting. It has wood hardware but is missing a horizontal latching member.

FIG. O6: Wood door with wood hardware on the east side of the north wall. Note wainscoting on the east wall at right, 2007.

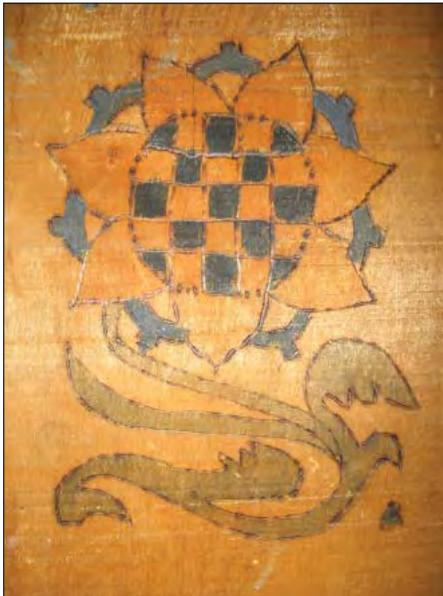
FIG. O7: Detail of a painted image with wood-burnt lines on the wainscoting, 2007.

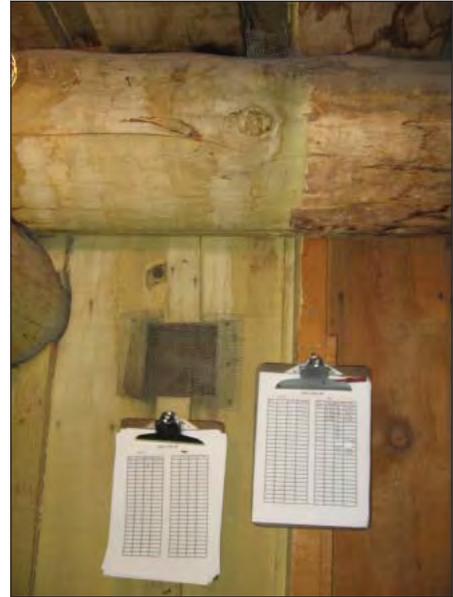
FIG. O10: Office closet showing yellow paint in the historic toilet area and unfinished wall. Note the screen over a hole in the wall, 2007.

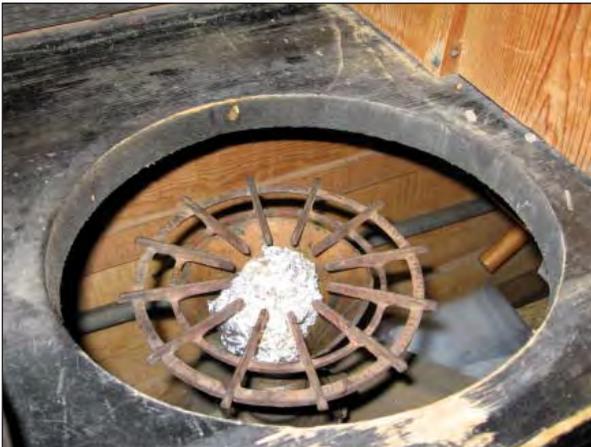
FIG. O11: One of three gas stove elements located within the cabinets on the south wall, 2007.

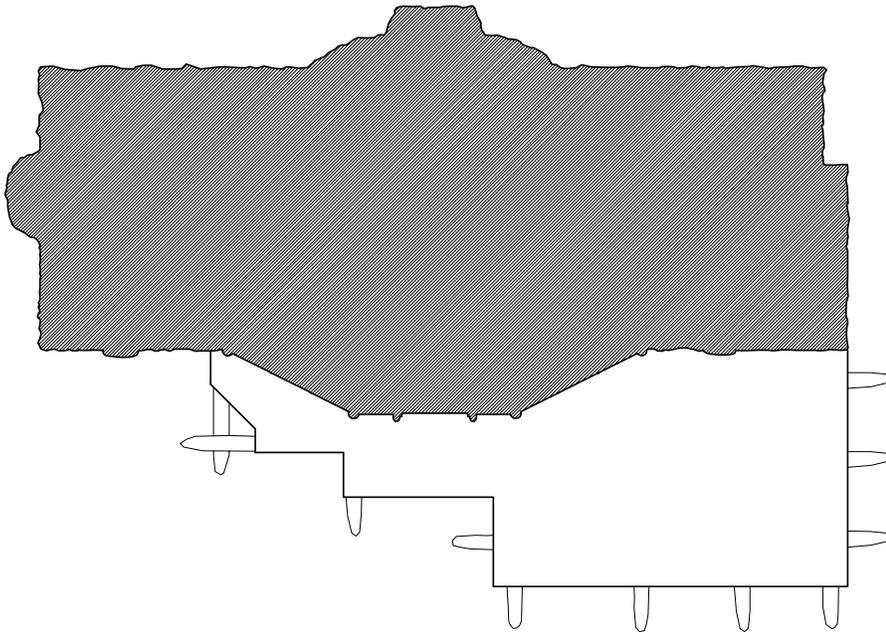
FIG. AT1: *Option A* for Porch Restoration. The west porch addition would be removed and the historic porch restored.

Remove the entire porch structure and restore to its historic roof and floor configuration. Preserve all original porch stonework and retain all intact wood members for re-use. Repair deteriorated wood members where possible and replace in-kind where necessary. Install posts on footings. Install beams to extend beyond the porch roof line. Remove the lower area of concrete floor infill, the inappropriate concrete work near the Kitchen area and the modern steps at the west side of the porch. Restore the porch floor to its original stepped configuration with poured concrete scored in a flagstone pattern. Sufficient documentation, including original drawings, historic photographs and extant members exist to ensure that restoration efforts can be executed with accuracy in regards to original intent. See the *Alternatives for Treatment* section for further discussion of the porch restoration.

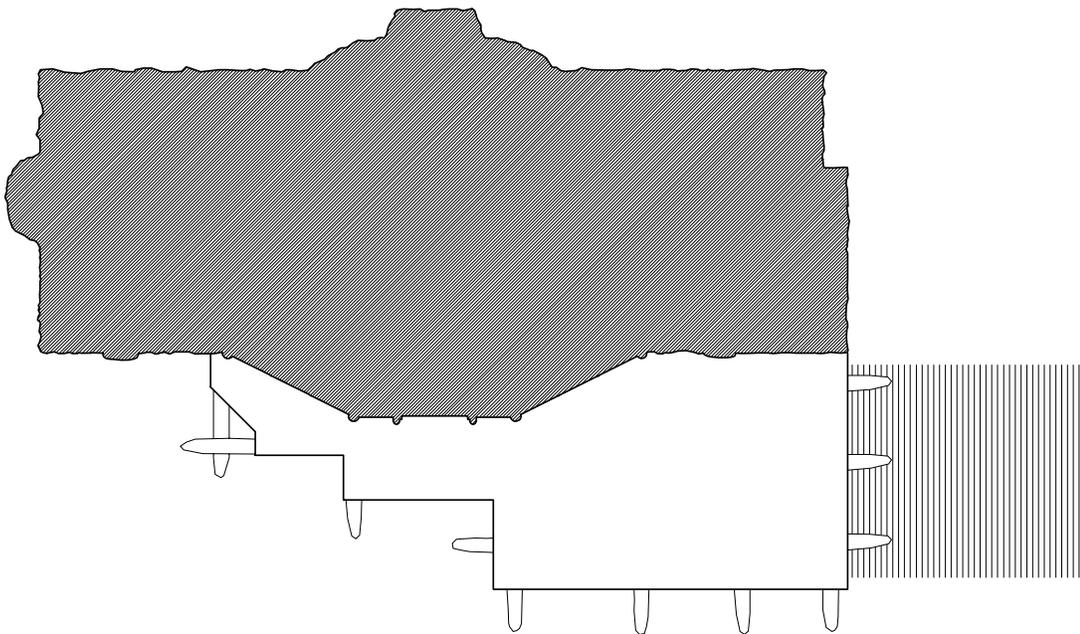
FIG. AT2: *Option B* for Porch Restoration. The historic porch roof would be restored. The west porch addition would be replaced by a porch roof constructed with compatible materials that are differentiated from the historic roof.

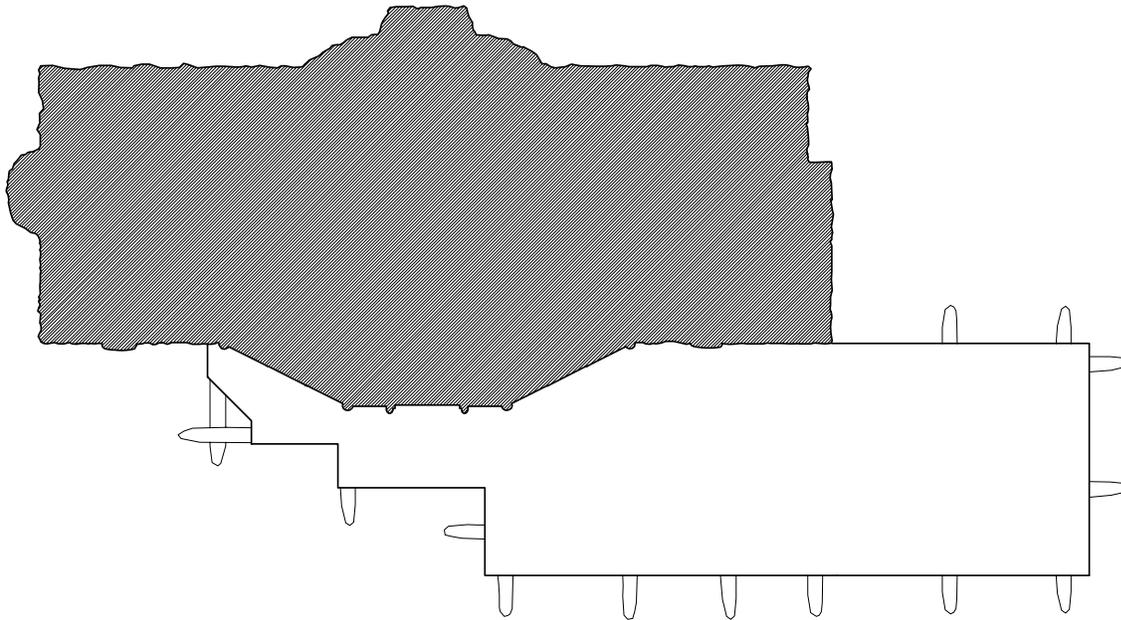
FIG. AT3: *Option C* for Porch Restoration. The entire roof porch would be reconstructed in the style of the original porch roof with protruding horizontal porch beams.

In *Option C*, the historic porch roof would be restored and the west porch addition integrated. This alternative would provide a unified design for the entire porch, but may blur the line between the historic and non-historic porch areas.

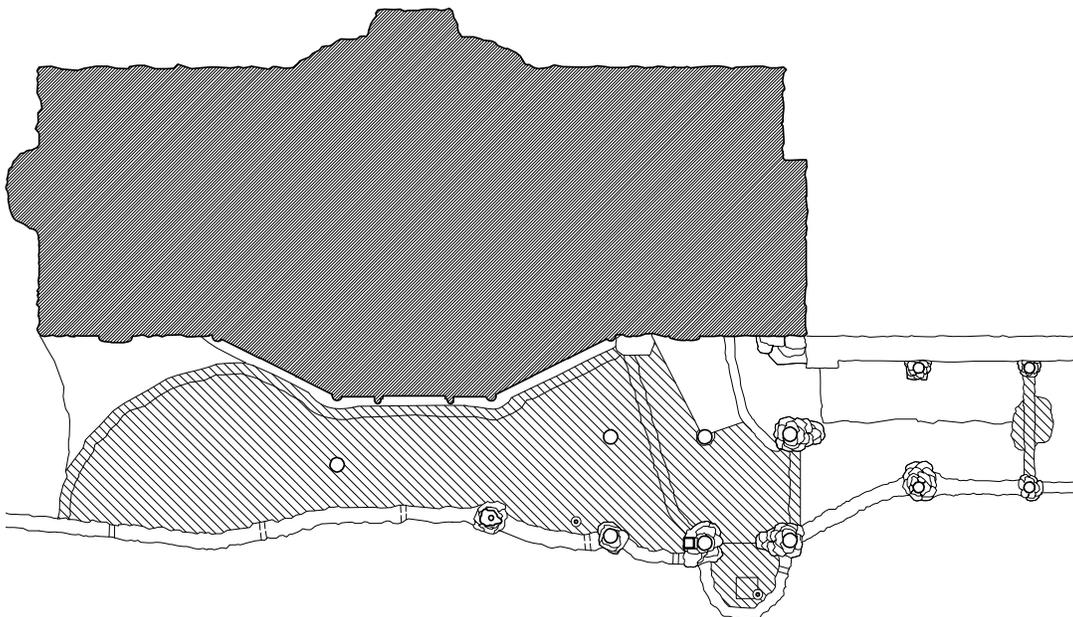
This alternative would further alter the original depressed condition of the porch area and would lessen the height of the north wall to a greater degree. This alternative is NOT recommended.

FIG. AT5: Accessibility Alternative Two. In order to create a level surface in front of the Hermit's Rest and provide compliant access through the Great Room entrance, concrete would be poured where hatched, except in the area of the west steps where the concrete steps would be removed.
