# North Rim Entrance Station

Historic Structure Report

North Rim Entrance Station  
Historic Structure Report

*prepared by*  
Architectural Resources Group  
Architects, Planners & Conservators, Inc.  
San Francisco

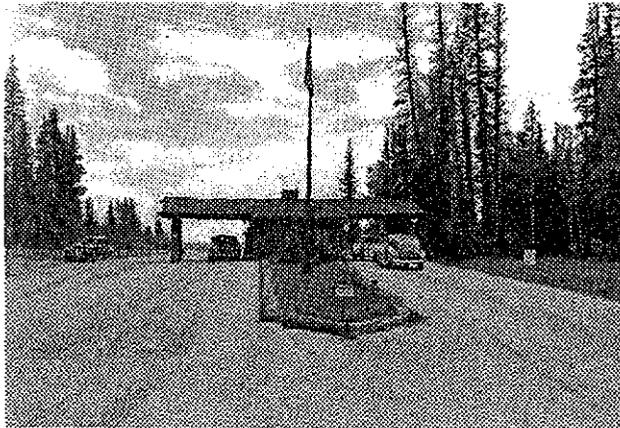
*Figure 13. The image illustrates the North Rim Entrance Station as seen from the north. Note the change in road surface, log curbing, increased traffic and ever-present flag-pole. Photo is dated circa 1948. Unnumbered image from the Grand Canyon National Park Archives and Maintenance Records.*

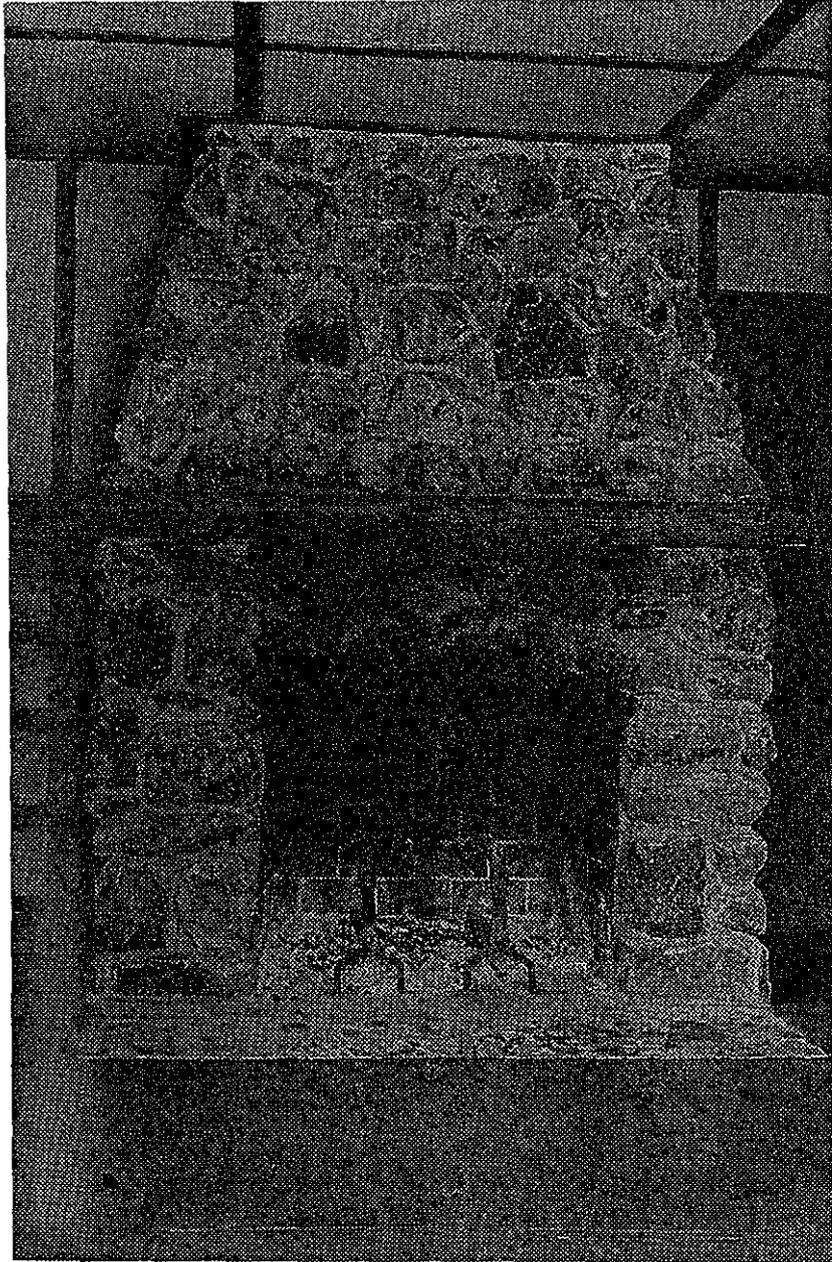
A key feature is the wood-burning stove located in the center of the room. It replaced a rustic stone fireplace, of rough hewn masonry, that stood in the same position. (See Appendix E, Figure 15 and Appendix F, Figure 10.) The stove sits on a 4 inch concrete base.

*Figure 15. The image illustrates the original fireplace on the interior of the North Rim Entrance Station. The original interior finishes appear to be celotex panels with varnished or dark painted batens. The stone fireplace was removed during the rehabilitation campaign of 1954-55. Other works at that time included the removal of the interior partition wall, masonry chimney, and wood floor. The works significantly altered the character of the building's interior. Photo is undated. GCNPA Number 8048.*

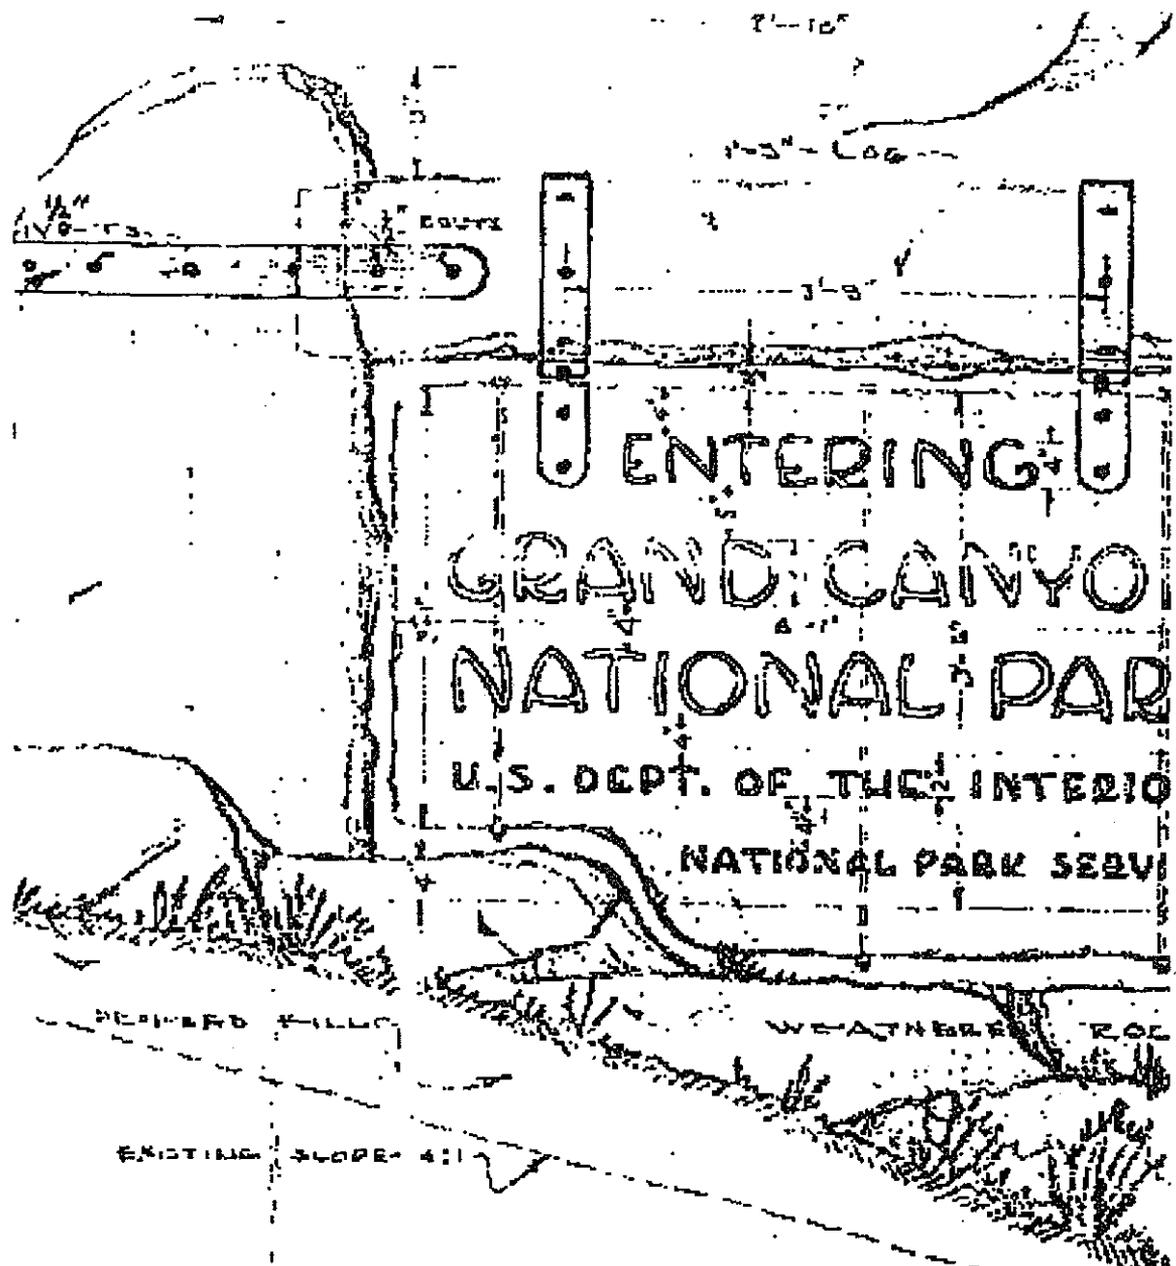
Designed and installed in 1939, the original sign introducing the Grand Canyon National Park is extant but has been recently altered. The sign sits at the actual boundary of the park, a short distance to the north of the checking station. The original 1939 panel has been retained and reused; it now hangs from a new horizontal beam resting on massive peeled whole log posts and is held with heavy metal straps with oversized rivets. The panel is painted brown (though was probably stained natural wood originally) with white painted lettering, and a scalloped edge around the perimeter. The lower left corner of the panel is cut back, contoured to follow the line of the masonry base below which, though extant, is partially obscured by the grade. Altered in the 1990s, the new design retains the original carved hanging sign but clunky new posts and unsympathetic landscaping make it less successful than the original. (See Appendix E, Figure 16.)

Figure 16. The image is a drawing of the North Rim Entrance sign, 1938. Note that the panel is cut back at the lower left hand corner to follow the contour of the rocks and landscaping. The hanging sign has been refurbished and reused but the landscaping no longer retains the original configuration.

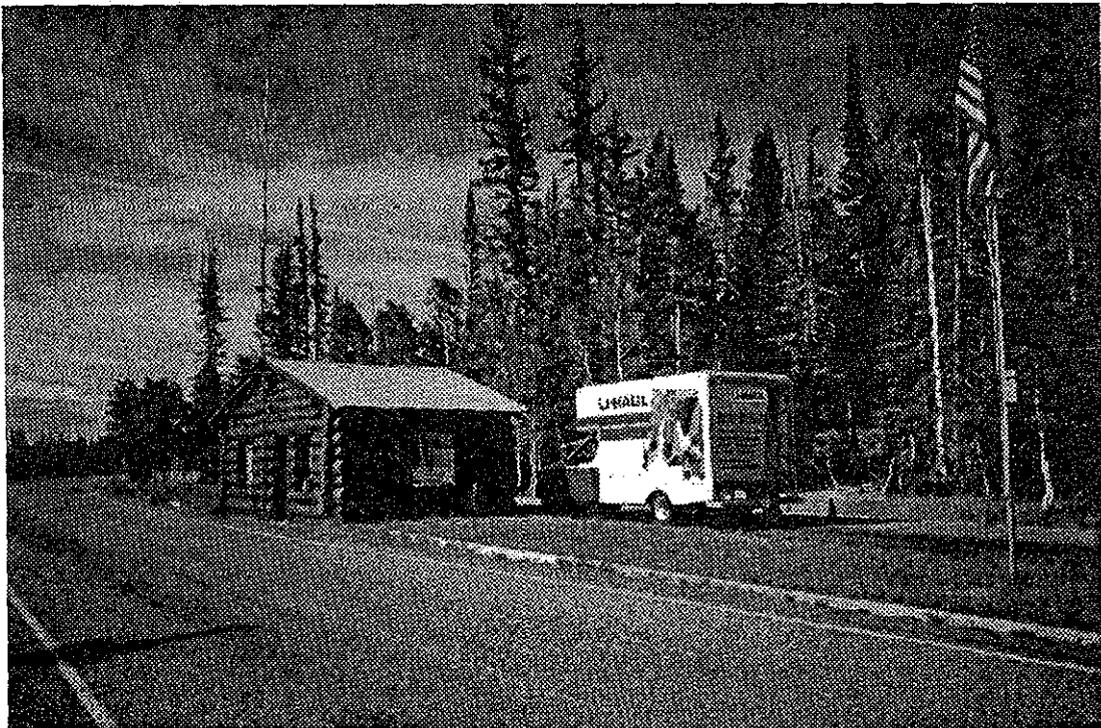
*Figure 4. The image illustrates the relationship between the North Rim Entrance Station and the type of larger vehicles that could not access the North Rim when the canopies were extant. Removal of the canopies allowed passage into the park of the recreational vehicles and trucks which gained popularity in the decades after WWII. The exact date of the removal of the canopies is unknown, but probably dates to the late 1950s or 60s. ARG Photo dated June, 2000.*

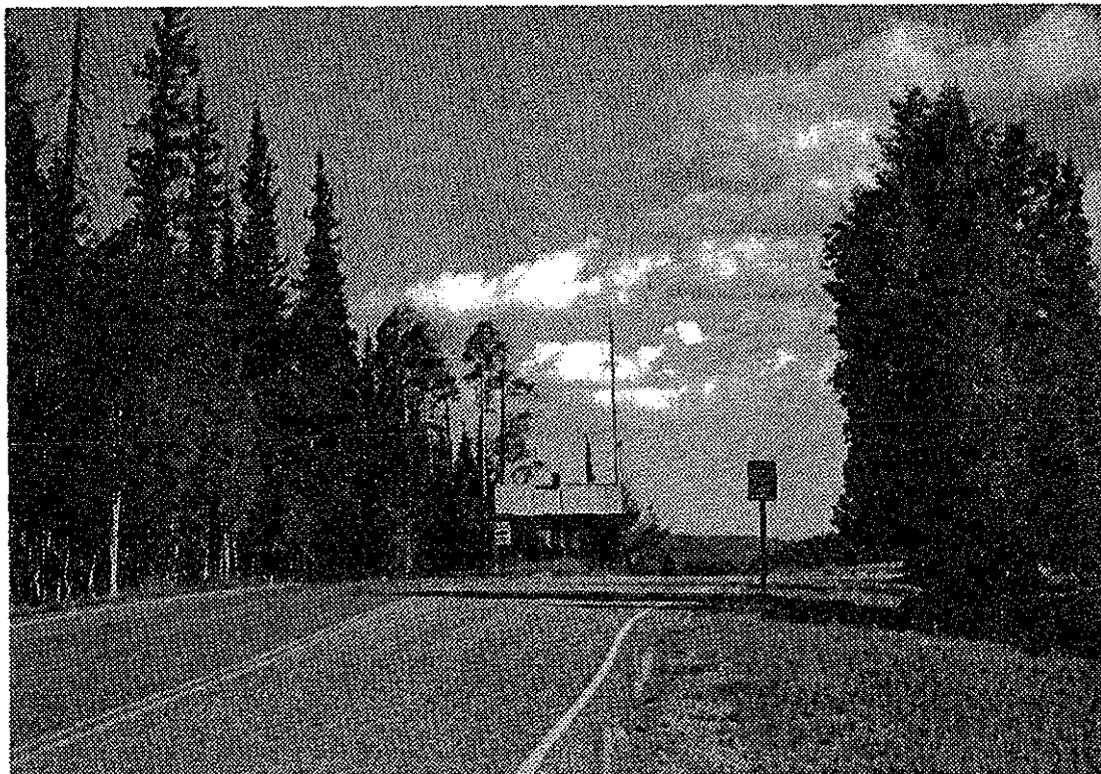
The North Rim Entrance Station sits just inside the Grand Canyon National Park boundary on the North Entrance Road thirteen miles north of the edge of the North Rim, Bright Angel Point and the Grand Canyon Lodge. The building is sited intentionally atop the slight, wooded saddle separating Demotte Park from Little Park. The approach road from Jacob Lake to the entrance station and on to the North Rim covers long, undulating stretches and steep slopes with corresponding grades and curves over 40 miles. Several miles north of the entrance station, the road opens to a wide grassy meadow with a thick forest of trees along both edges. As the traveler crosses the meadow nearing the park, the length of road dips and rises, revealing the distant entrance station to the viewer in stages. Approaching the park boundary, the trees again close in upon the station to create a narrow portal to the park. Traffic is funneled through the entrance passage toward the south to another wide meadow, almost a mirror image of the meadow to the north. The building's elevated position on the crown of a knoll provides commanding views north and south across both meadows, allowing the ranger to see oncoming traffic. (See Appendix F, Figures 5 and 6.) From a distance the building's transparency is apparent as it is possible to see blue sky beckoning through the station's windows on the north and south sides. The transparency lends an interesting detail, but is not an original feature as the old stone fireplace stood in the center of the structure, blocking the view through the building. (See Appendix F, Figure 7.)

*Figure 7. The image illustrates the south approach to the site. ARG Photo dated June, 2000.*

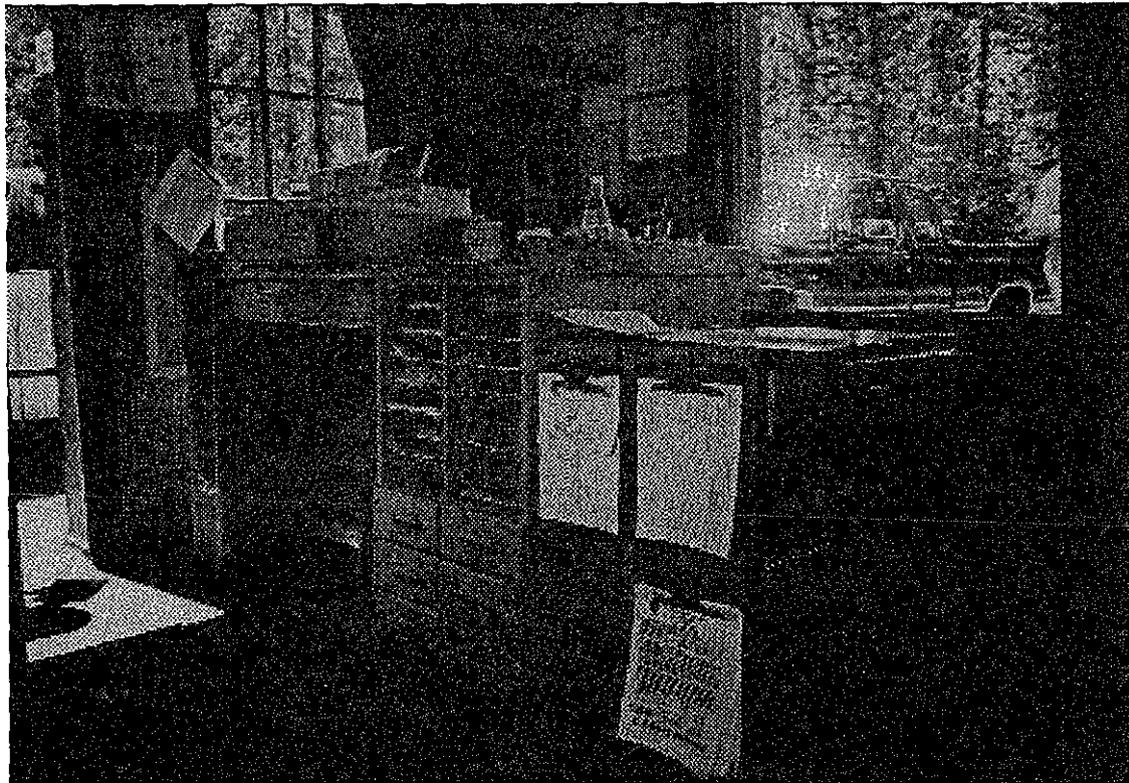
*Figure 9. This image shows the northwest interior corner of the building with the ranger's desk in the foreground. The images also illustrates the relationship between the arriving vehicles and their proximity to the ranger's principal workspace. ARG Photo dated June, 2000.*

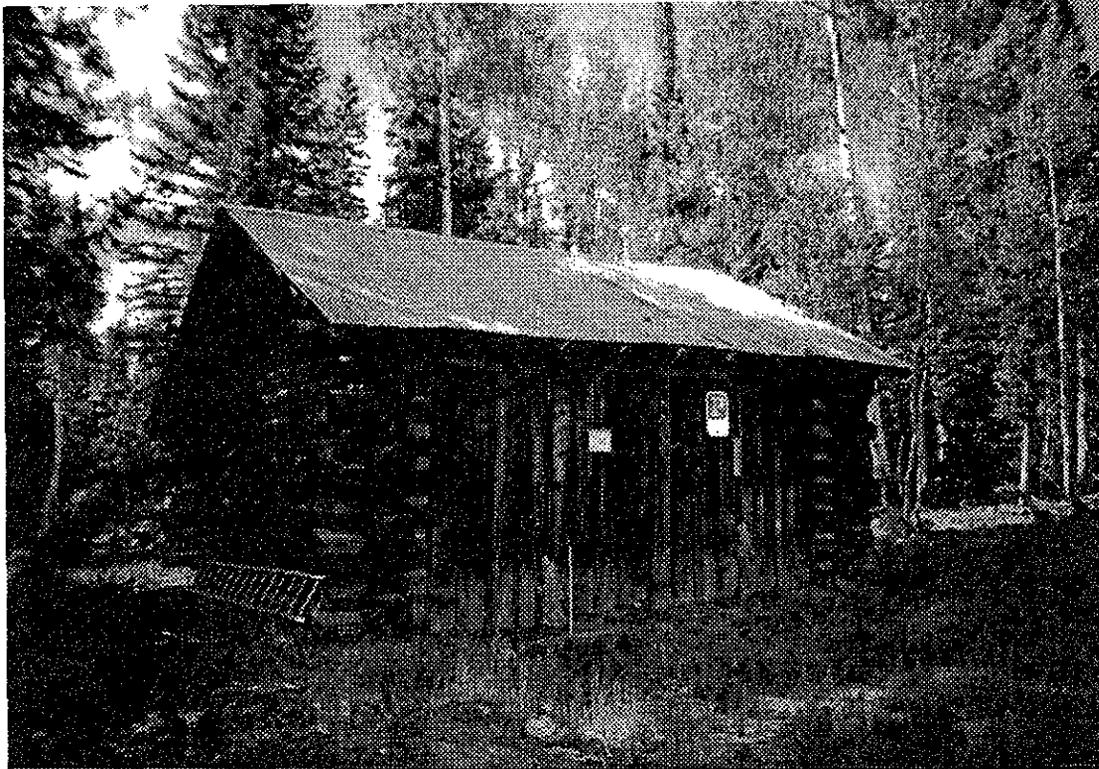
*Figure 16. The structure in this image is Building 122A, a garage ancillary to the employee residence near the park entrance. This underutilized structure is located approximately 400 feet from the North Rim Entrance Station. Though in need of rehabilitation and waterproofing, the shed could provide additional storage space for the entrance station. See the Treatment and Use Section of the HSR for further discussion of this structure. ARG Photo dated June, 2000.*

Another option for providing additional storage space for the entrance station is to move excess materials off site and out of the building. Building 122A, a garage ancillary to the employee residence (Building 122) is located approximately 440 feet to the east of the entrance station. While the building appears to be used by the employees who reside nearby, it does seem somewhat underutilized. Though in need of rehabilitation and water-proofing, the building could provide additional storage space for printed materials, pallets, etc. (See Appendix F, Figure 16).
