South Rim Ranger Operations Building  
Historic Structure Report

Grand Canyon National Park, Arizona

## I. EXECUTIVE SUMMARY

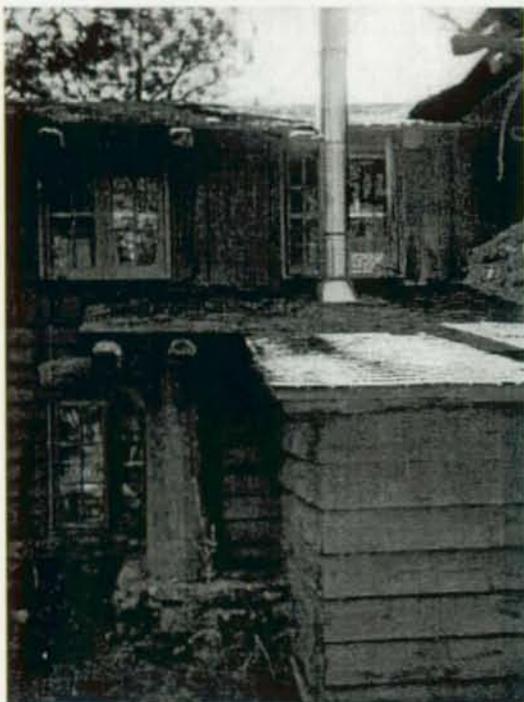
While the exterior has been altered, these changes, such as the installation of the metal awning, have been generally sympathetic. The exceptions are the recently installed flue at the rear (**Figure 18**), the vault added to east side of building, the removal of the exterior door at the east elevation, the electrical service at the south elevation, the replacement front door, and the reconfiguration of the south facade by eliminating a first floor window and inserting a door. The interior design has been compromised by the addition of interior walls, removal of historic finishes, relocation of doors, and the addition of an office into the lobby space. While some materials, such as the log rafter ends and decorative log work, have been

Figure 18: Flue at east elevation, added Spring, 2000.

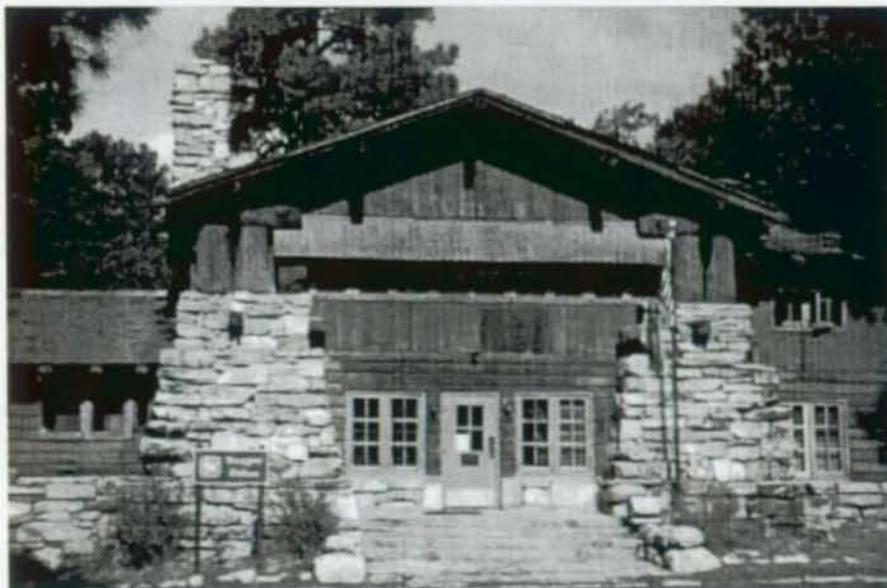
Figure 20: Principal facade, May, 2000. Dark patch above the main door and window on right indicates the previous position of non-historic building sign.

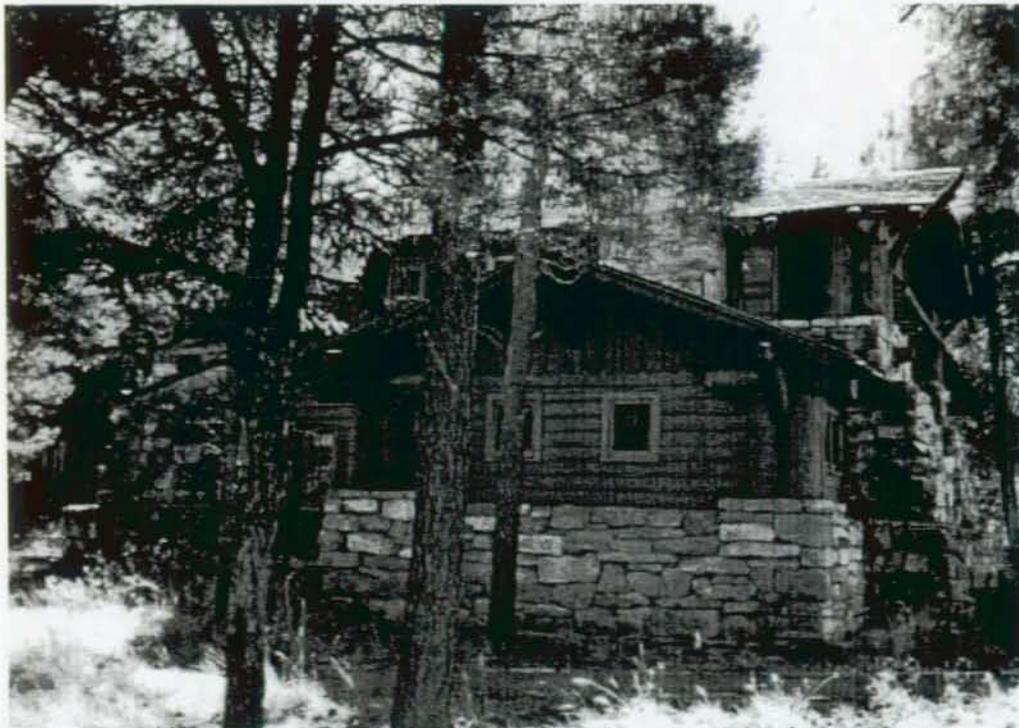
Figure 22: North elevation.

General exterior conditions are the same as at the west elevation. Deviation from the standard conditions at this elevation include new hardware at the three second-story windows. The western window at room 104 is damaged and needs to be reattached to the frame. Additionally, the western-most crawl space (vault), at the time of our site May 2000 site visit, contained approximately two feet of standing water.

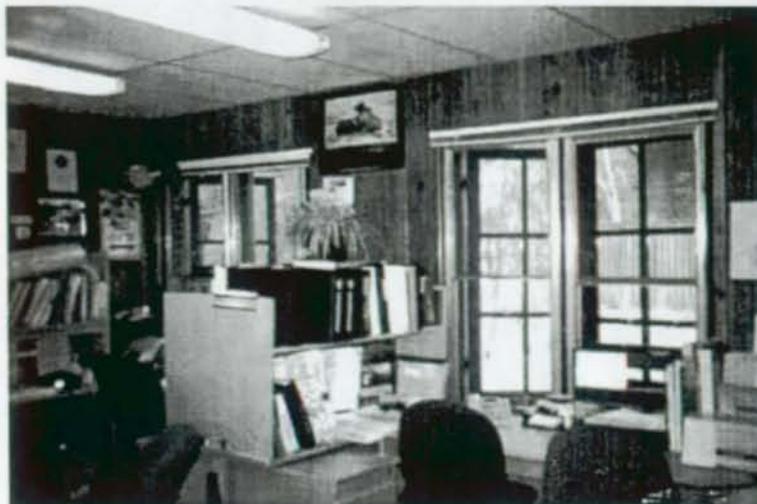
Figure 25: Typical first floor office interior.

The first floor spaces are in fair to good condition. The boiler pipes broke in 1976 and all of the interior finishes (celotex and batten), except in the toilet rooms and lobby, were replaced. The newer finishes in the structure are in good condition though not appropriate for the historic character of the structure.

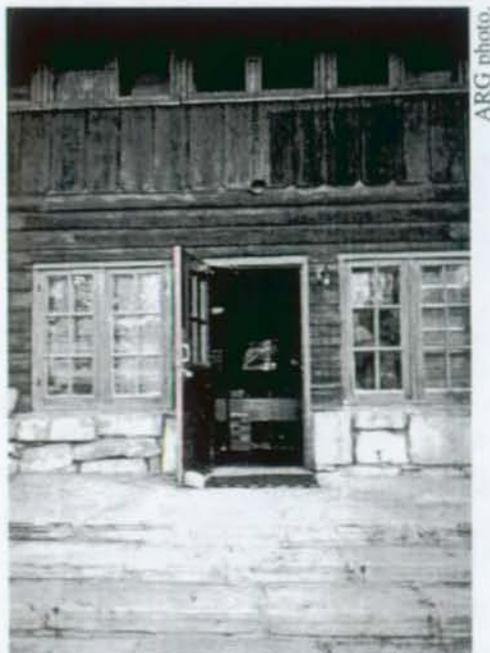
Figure 26: Principal entrance, 10 July 2000.

In the recent past, the building has not been open to the public; the front door (at the west facade) has been locked and the south entrance has become the primary entrance for the rangers who occupy the building. However, as of June 2000, the front door has been re-opened and a staff person has been assigned to the lobby area to answer the questions of any visitors. **(Figure 26)** The public use of the

primary lobby space is in keeping with the building's design. It would be awkward to insert desks and workspaces into this area, which should continue to serve a public function. The re-instatement of public access to the lobby does, however, raise issues for handicapped accessibility, as this primary entrance is accessed by exterior stairs. This issue is discussed in the "requirements for treatment" section of this document.

Public access further compounds the issue of security. Park security experts recommend the addition of security cameras and keyless entry systems at both exterior doors. Given the configuration of the lobby and stairway, it would be difficult to block public access to the second floor from the lobby. It may be possible to establish a completely secured area in the south wing of the building by adding doors to the south hallways at both the first and second floors.

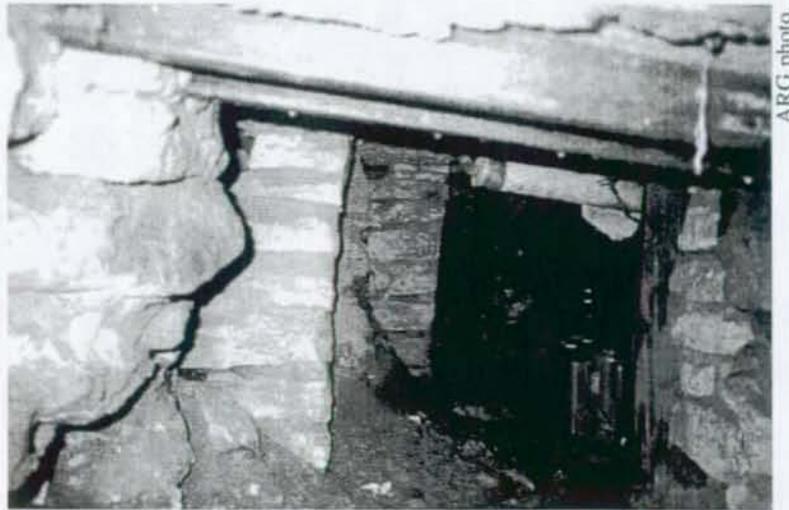
Lastly, the utility tunnels underneath the north end of the building are subject to seeping groundwater. (Figure 29) At times, water in the tunnels has risen to a depth of 24 inches. A drain should be installed at the low end of the tunnels to allow the water that enters between the surrounding rock strata and top soil to drain back out to the surrounding soil.

Figure 29: Utility tunnel. Standing ground water was measured to a depth of 24" in May, 2000.
