113/D-SS3
Grand Canyon

Yavapai Observation Station

Historic Structure Report

Yavapai Observation Station
Historic Structure Report

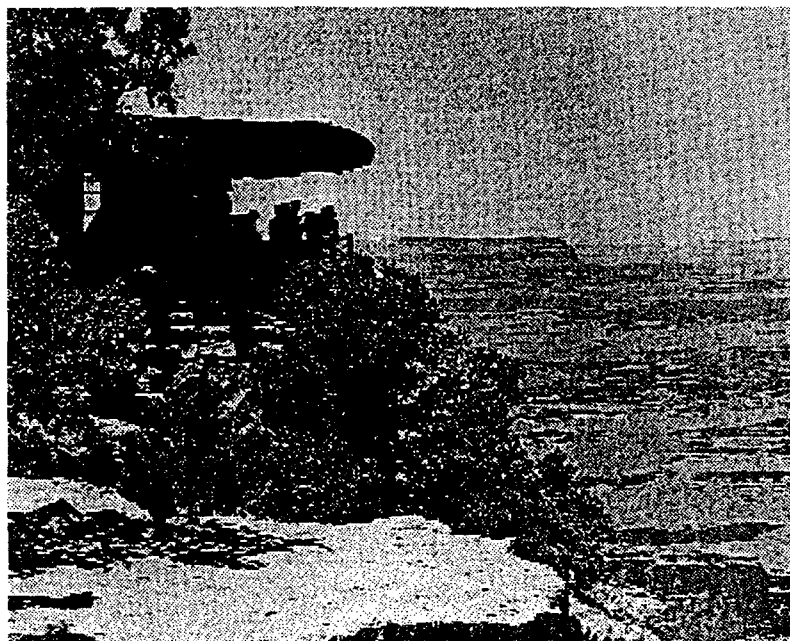
Figure 6. - The image shows figures on the open air deck of the Yavapai Observation Station. View is of the eastern side of the building. Note roof overhang at north side of the building in its original configuration before being cut back. GCNPA Photo Number 9765. Photo dated June 16, 1929.

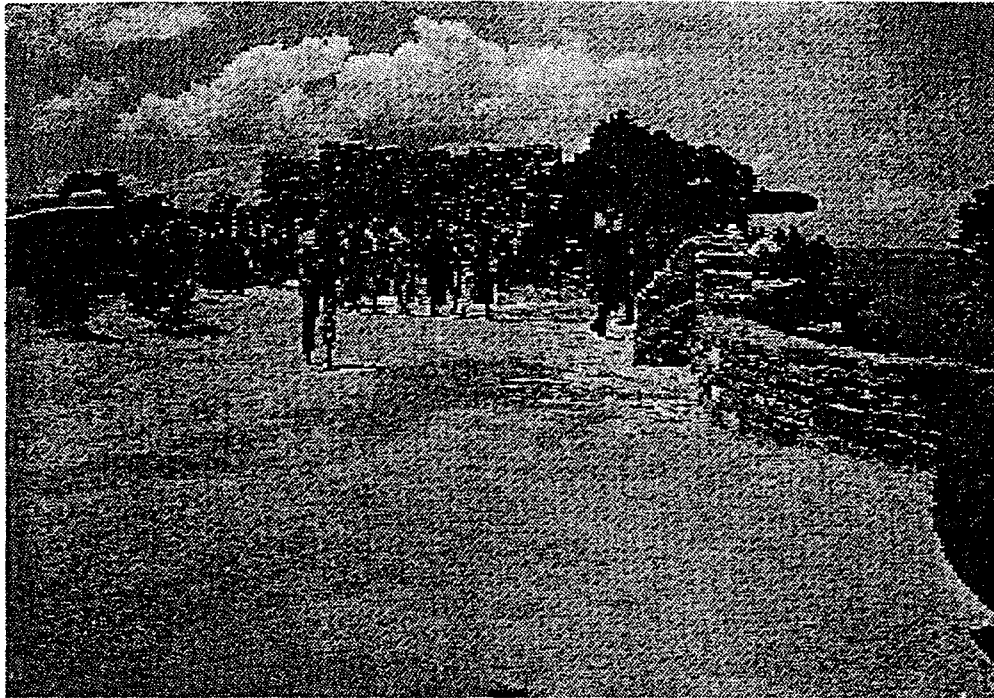
Figure 22. - The image shows park naturalist Eddie McKee in the foreground and the eastern side of the Yavapai Observation Station in the background. Note roof overhang at north side of the building in its original configuration before cropping. Note rough wall constructed to follow the rim. GCNPA Photo Number 9371. Photo dated September, 1932.

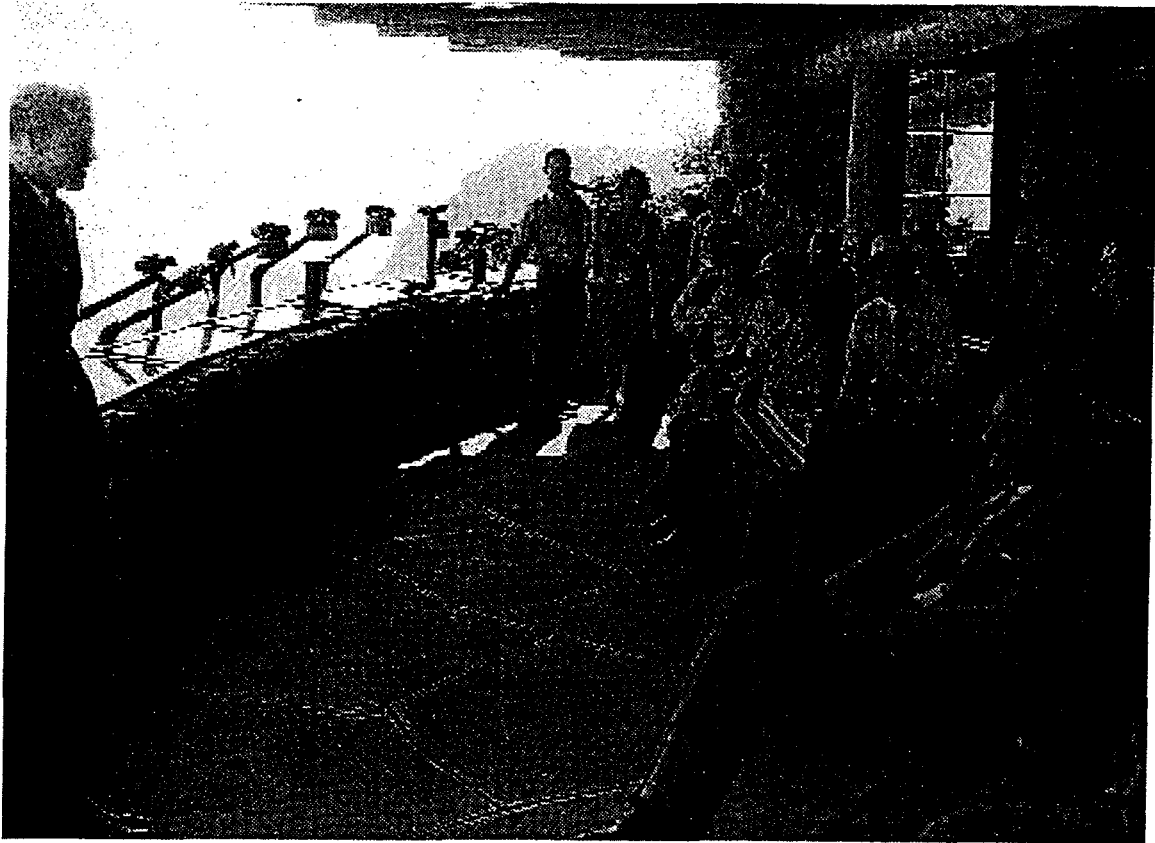
Figure 23. This photo shows Ranger Ralph Redburn addressing visitors on the open terrace of the Yavapai Observation Station. As seated visitors peer out into the canyon, it is evident why the parapet was originally kept so low. Photo dated September, 1932. GCNPA Photo Number 5825.

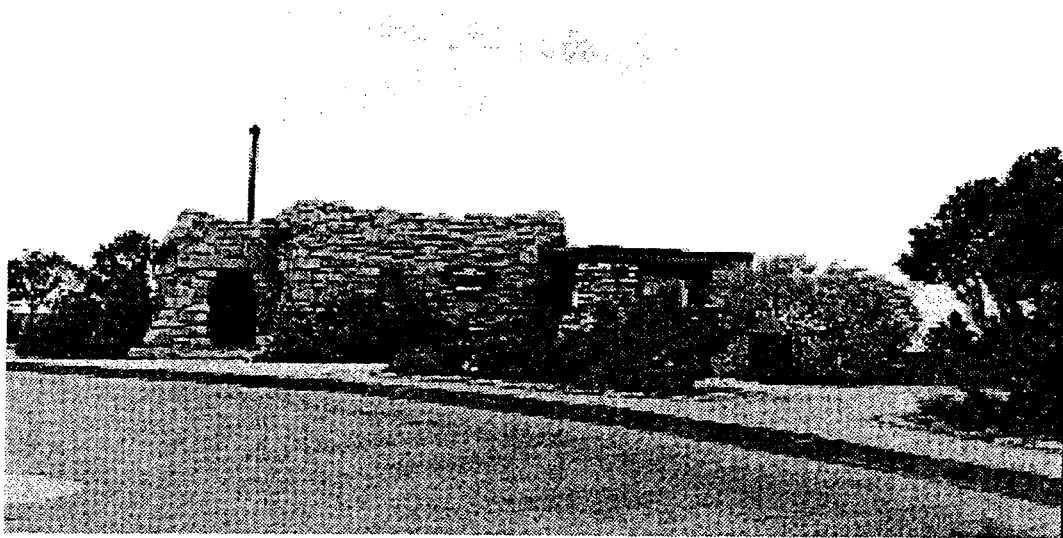
Figure 29. - The image shows a view of the eastern side of the building. Note curbing. Note flue which is no longer extant. GCNPA Photo Number 1753. Photo by J. M. Eden dated 1949.

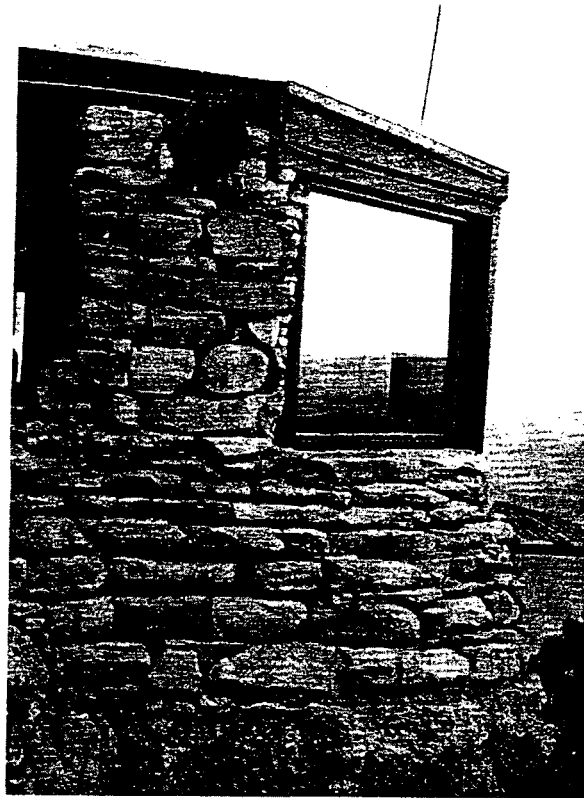
Figure 57. - The image shows the exterior of the east window of the observation room of the Yavapai Observation Station. Note the addition of rock chinking. Photo dated February, 1989 by Jacilee Wray.

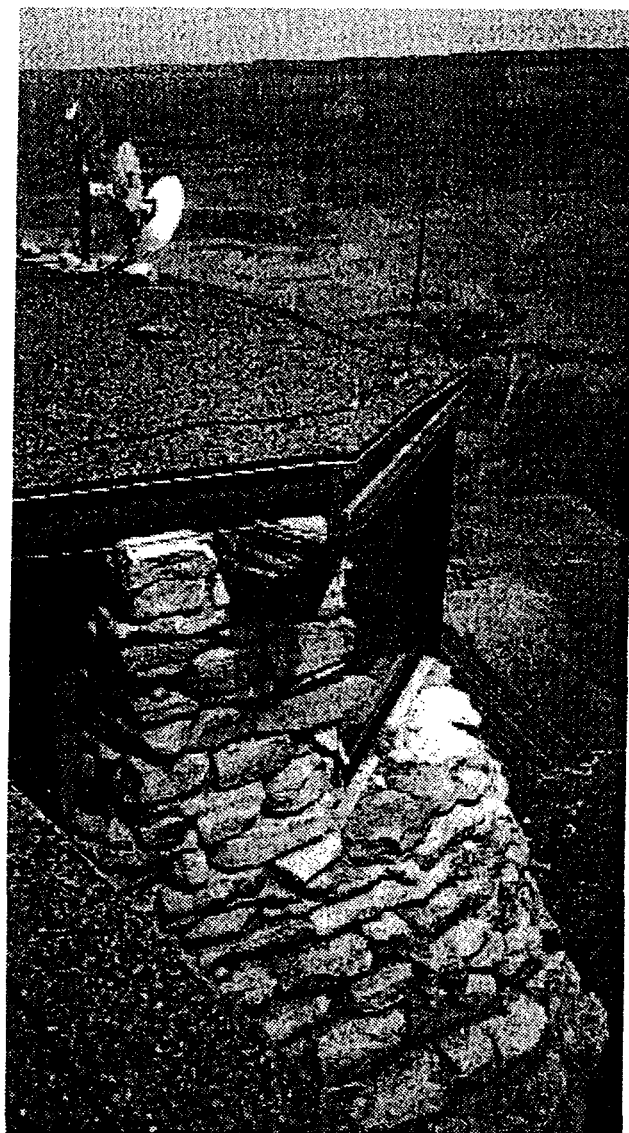
Figure 1. This image illustrates the unique relationship between the Yavapai building and the canyon below. Antennas and dishes on the roof were installed as part of Y2K compliance but are temporary and will be moved when the building is rehabilitated. View is looking down at the eastern corner of the north elevation. Photo dated May, 2000.

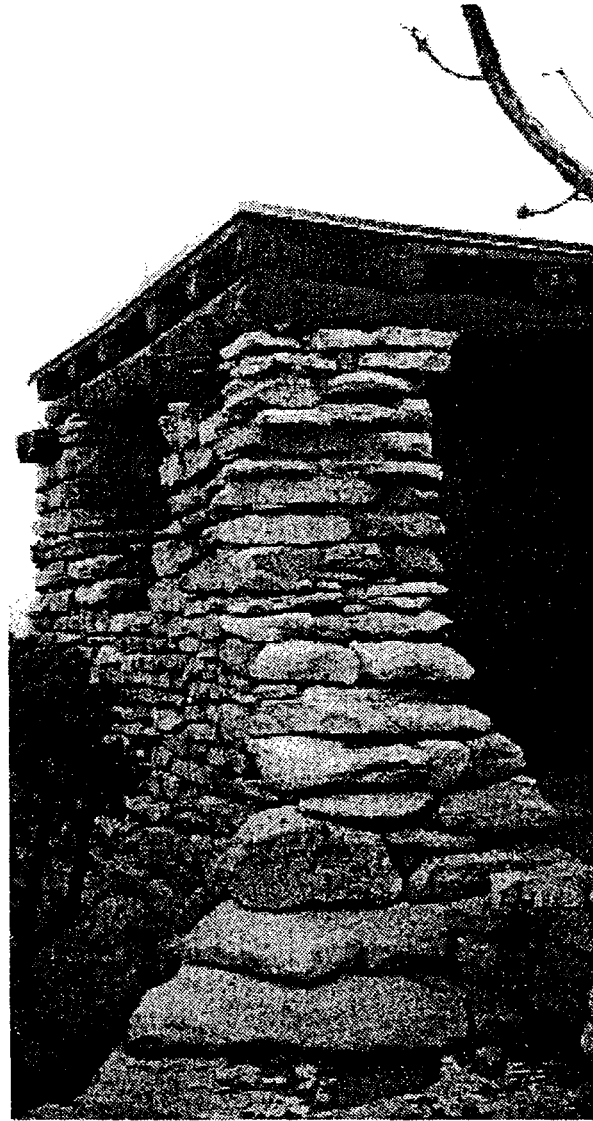
Figure 6. This image illustrates the native Kaibab stone at the corner pier and west elevation near the west entrance. Mortar was set so as to be invisible between the joints and stones were laid to look as if the pier was constructed without mortar. View is looking toward the north. Photo dated May, 2000.

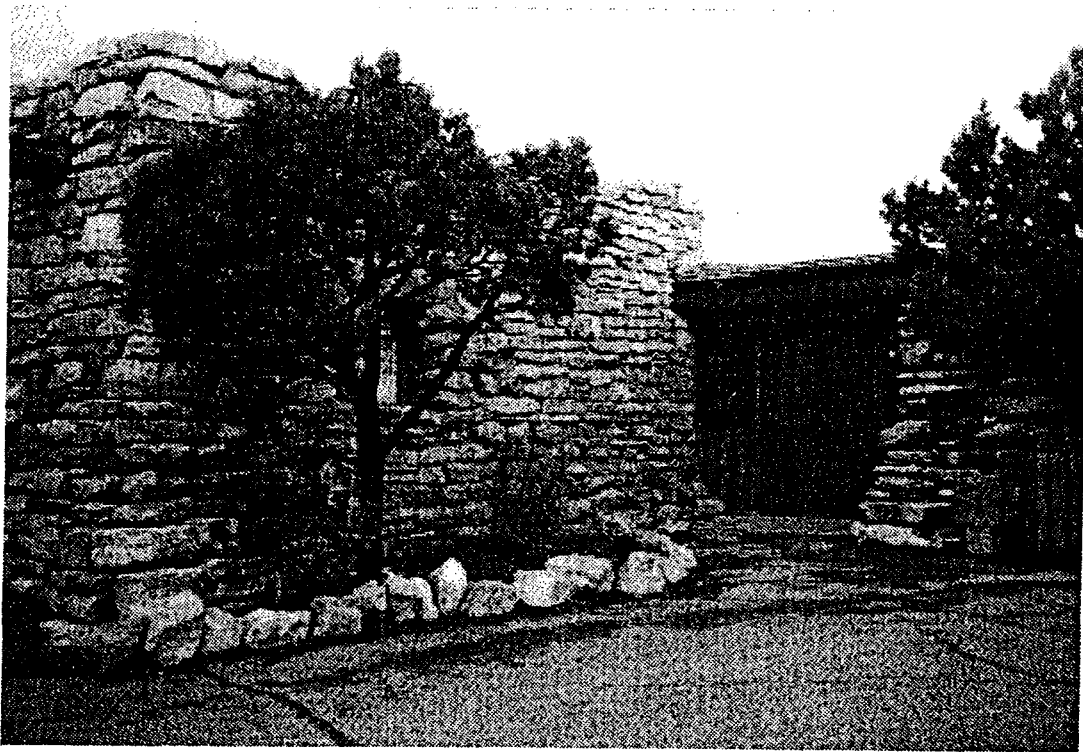
one small opening, now closed with a wood louver, toward the southern side of the building and three larger expanses of glass toward the canyon side. More pronounced at the east elevation are flared out lower courses of the stone walls; this corner treatment serves to mediate any sharp corners and soften the building's profiles (see **Appendix F, Figure 7**).

Figure 7. This image illustrates the east elevation of the Yavapai Observation Station. View is looking the northwest. Photo dated May, 2000.

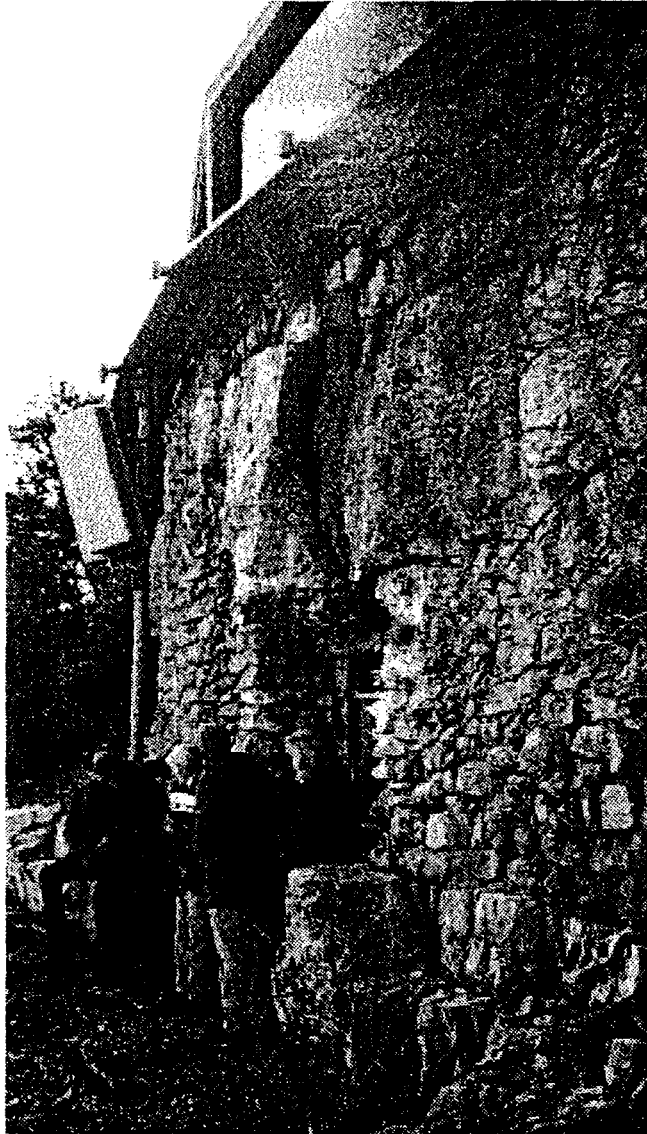
The north elevation dramatically rises straight up from the line of the sheer canyon wall below it (see **Appendix F, Figure 8**). The defining feature of this elevation are the five large picture windows which form the northern facade.

*Figure 8. This image illustrates the lower northern side of the Yavapai exterior.
Photo dated March, 2000.*

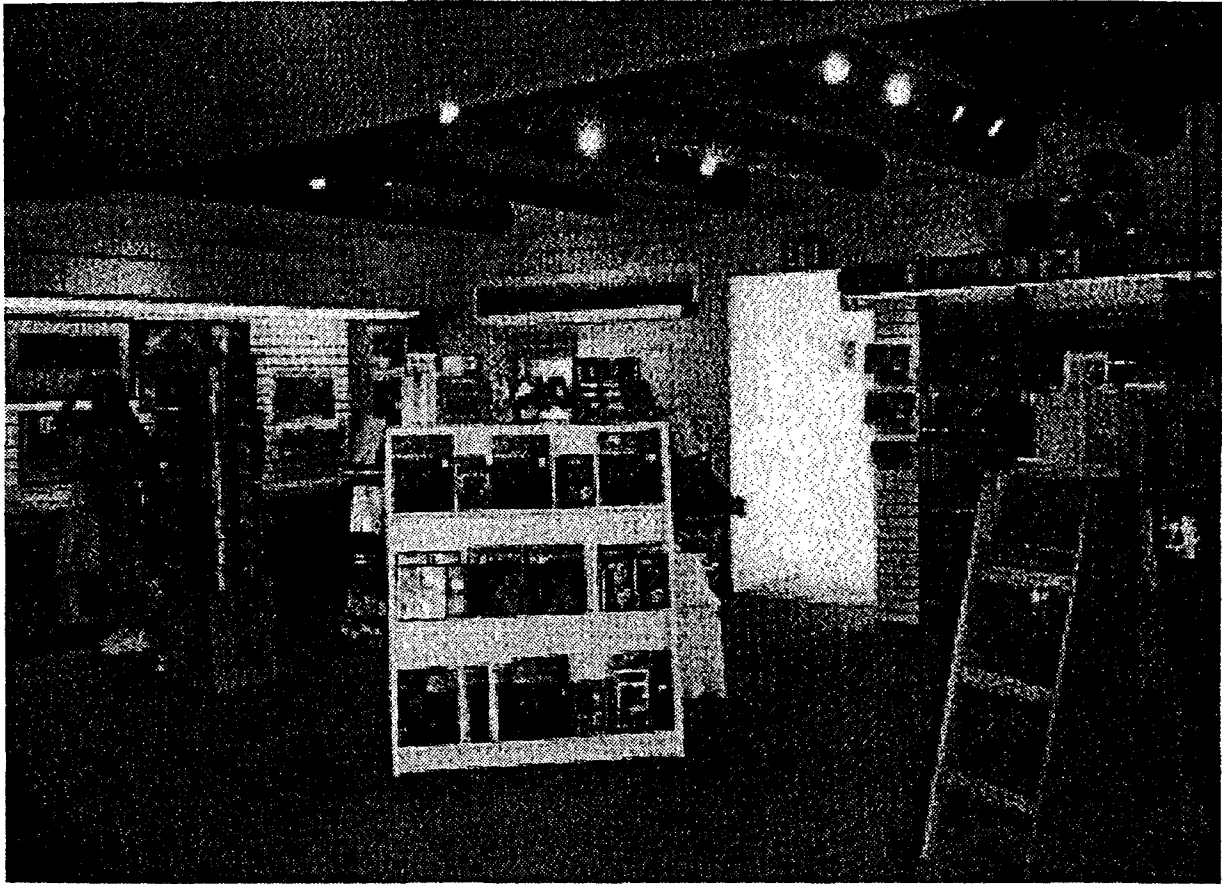
Figure 10. This image illustrates the interior toward the back of the Yavapai Observation Station. Much of the floor space is given over to the bookstore function: a cash register, check-out desk, free-standing laminated blonde wood book racks, plastic laminate display and shelving system, and fluorescent uplighters and under-soffit strips. Articles for sale are books, framed photographs, videos, postcards and calendars. With the exception of the ceiling rafters, very few original finishes or features are visible. Photo dated May, 2000.

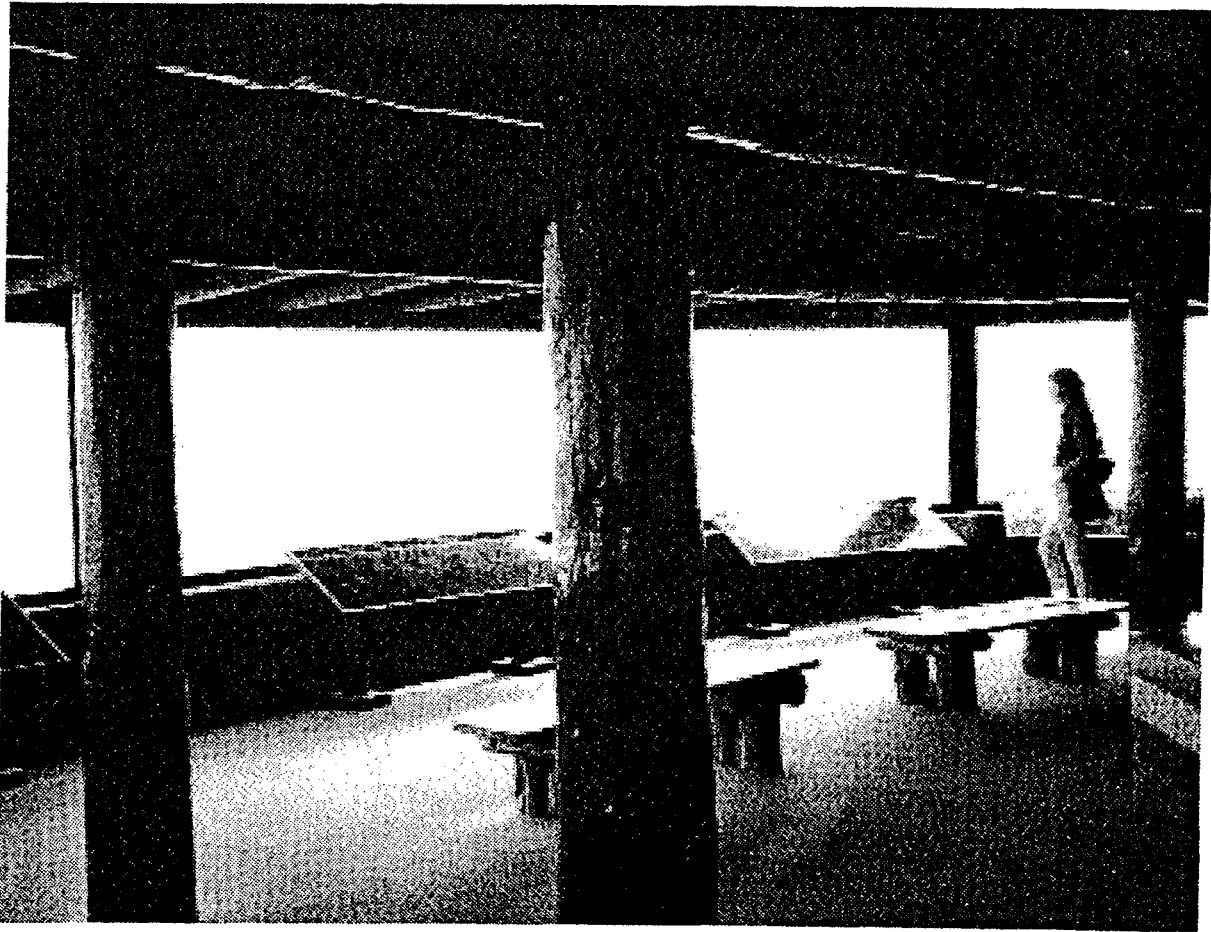
Figure 11. This image illustrates the northern side of the Yavapai interior. As opposed to the bookstore function of the back half of the interior, the north side of the interior provides space for viewing the canyon. The timber columns on the interior are original. Photo dated May, 2000.

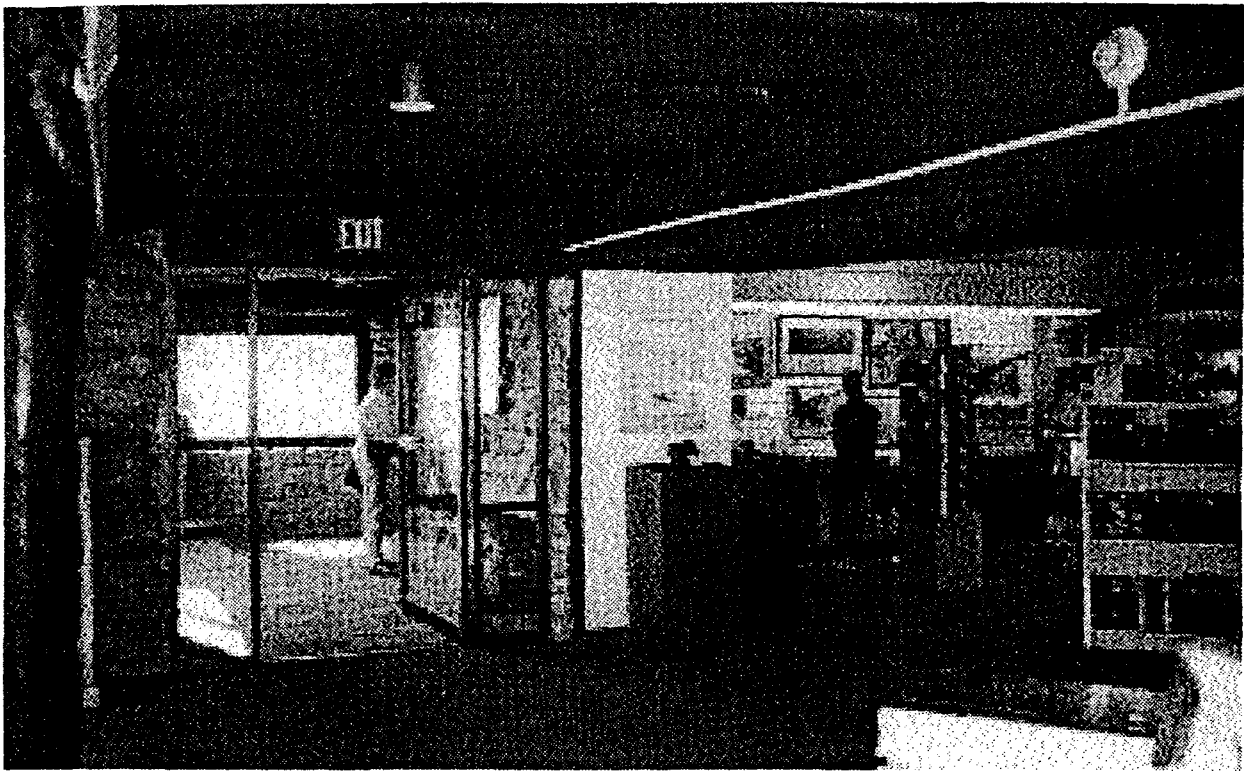
Figure 12. This image illustrates the eastern side of the Yavapai interior and the eastern entrance where glass doors have been installed. Photo dated May, 2000.

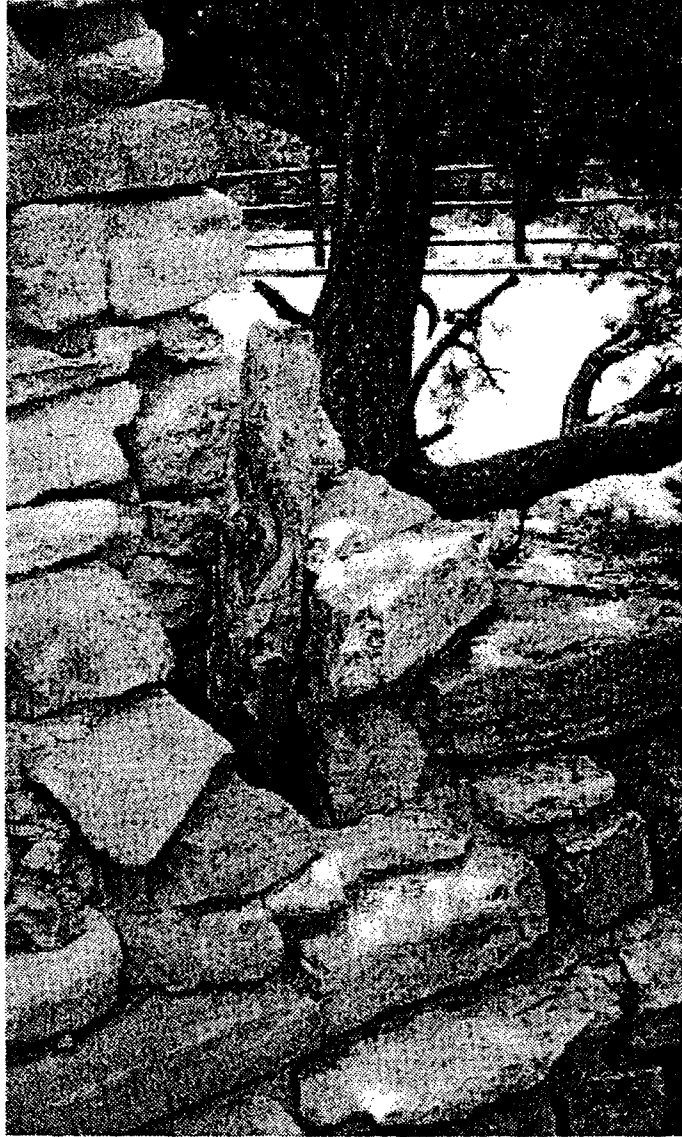
Figure 14. This image illustrates the tree well on the west side of the building, though the tree is no longer extant. Maier, ever sensitive to the surrounding landscape, incorporated this unplanned feature into the building during construction to accommodate an existing tree rather than cut it down. Photo dated May, 2000.

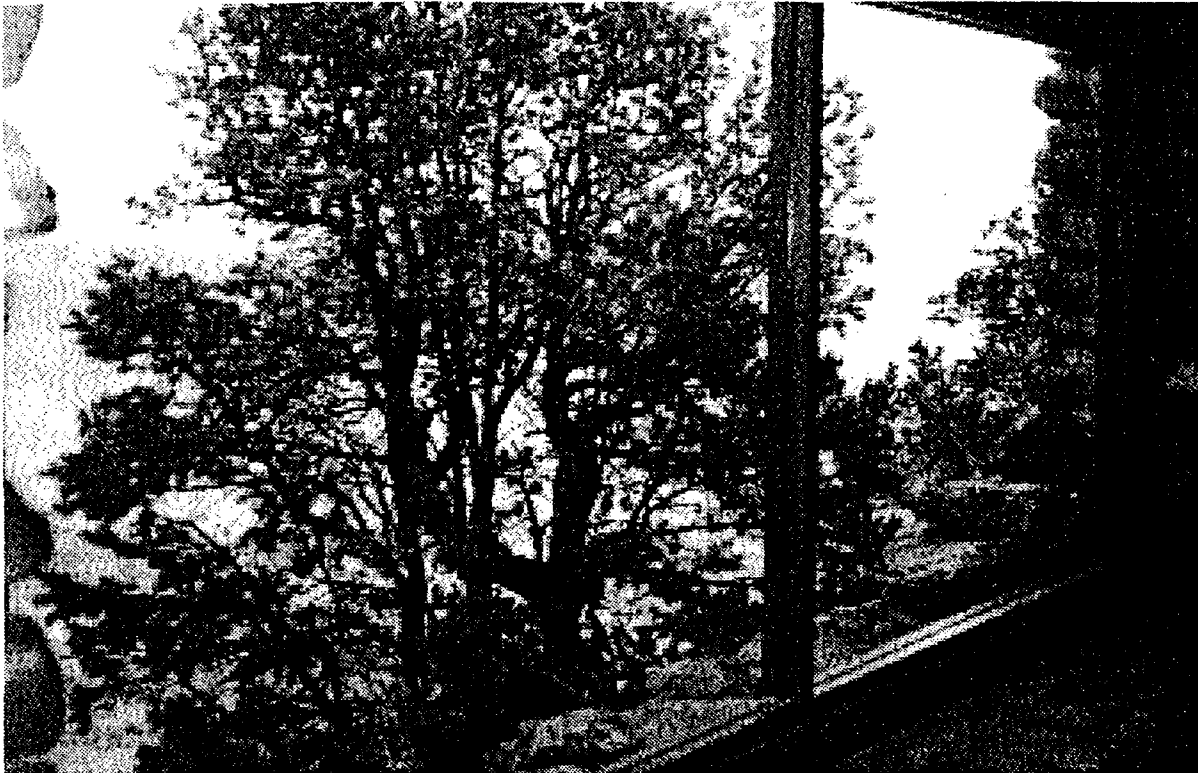
As described above, the interior has been altered from its original condition and interior finishes are largely replacements. The condition of the original, scored concrete floor (designed to imitate flagstone paving) and extent to which original material remains after renovations undertaken in 1978 is not known. The existing wall shelving and sales desk in the exhibit room area obscure any remaining original finishes. Window openings have been altered and in-filled (see Appendix F, Figure 18).

Figure 18. This image illustrates the windows on the east side of the Yavapai interior, inside the foyer entrance. The windows were installed in 1979, replacing the 1953 glazing. The windows look to the north. Photo dated May, 2000.

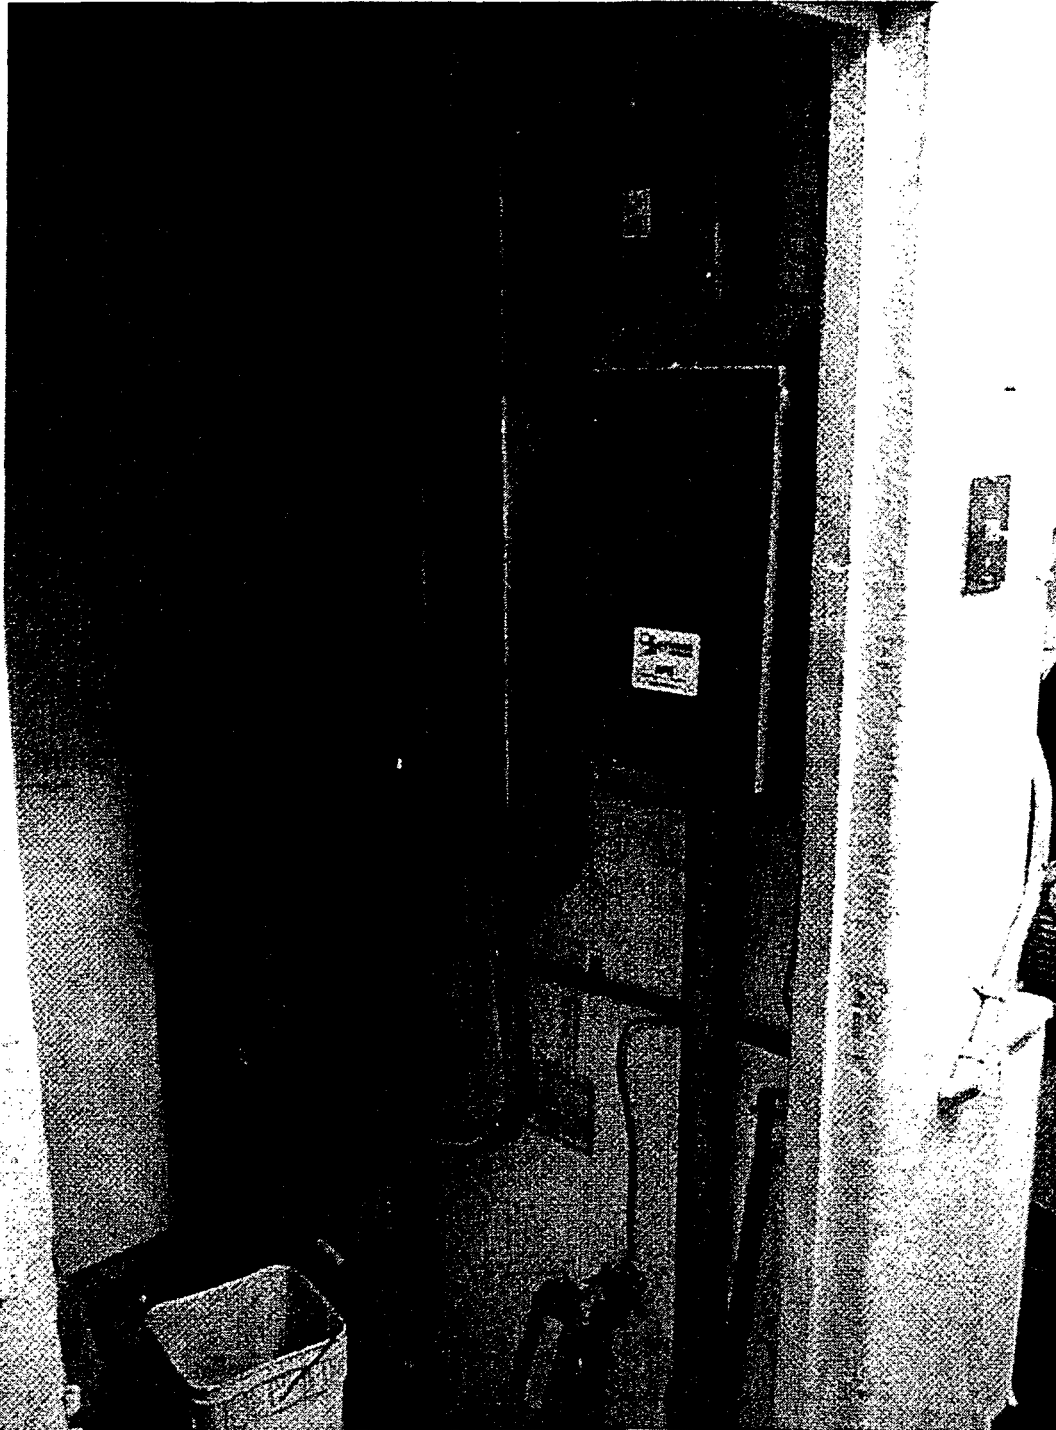
2: Electrical Panels

The existing service equipment appears to be in fair condition but is a candidate for replacement due to its age. Recommend replacement.

All existing panelboards should be replaced with new panels during the renovation phase.

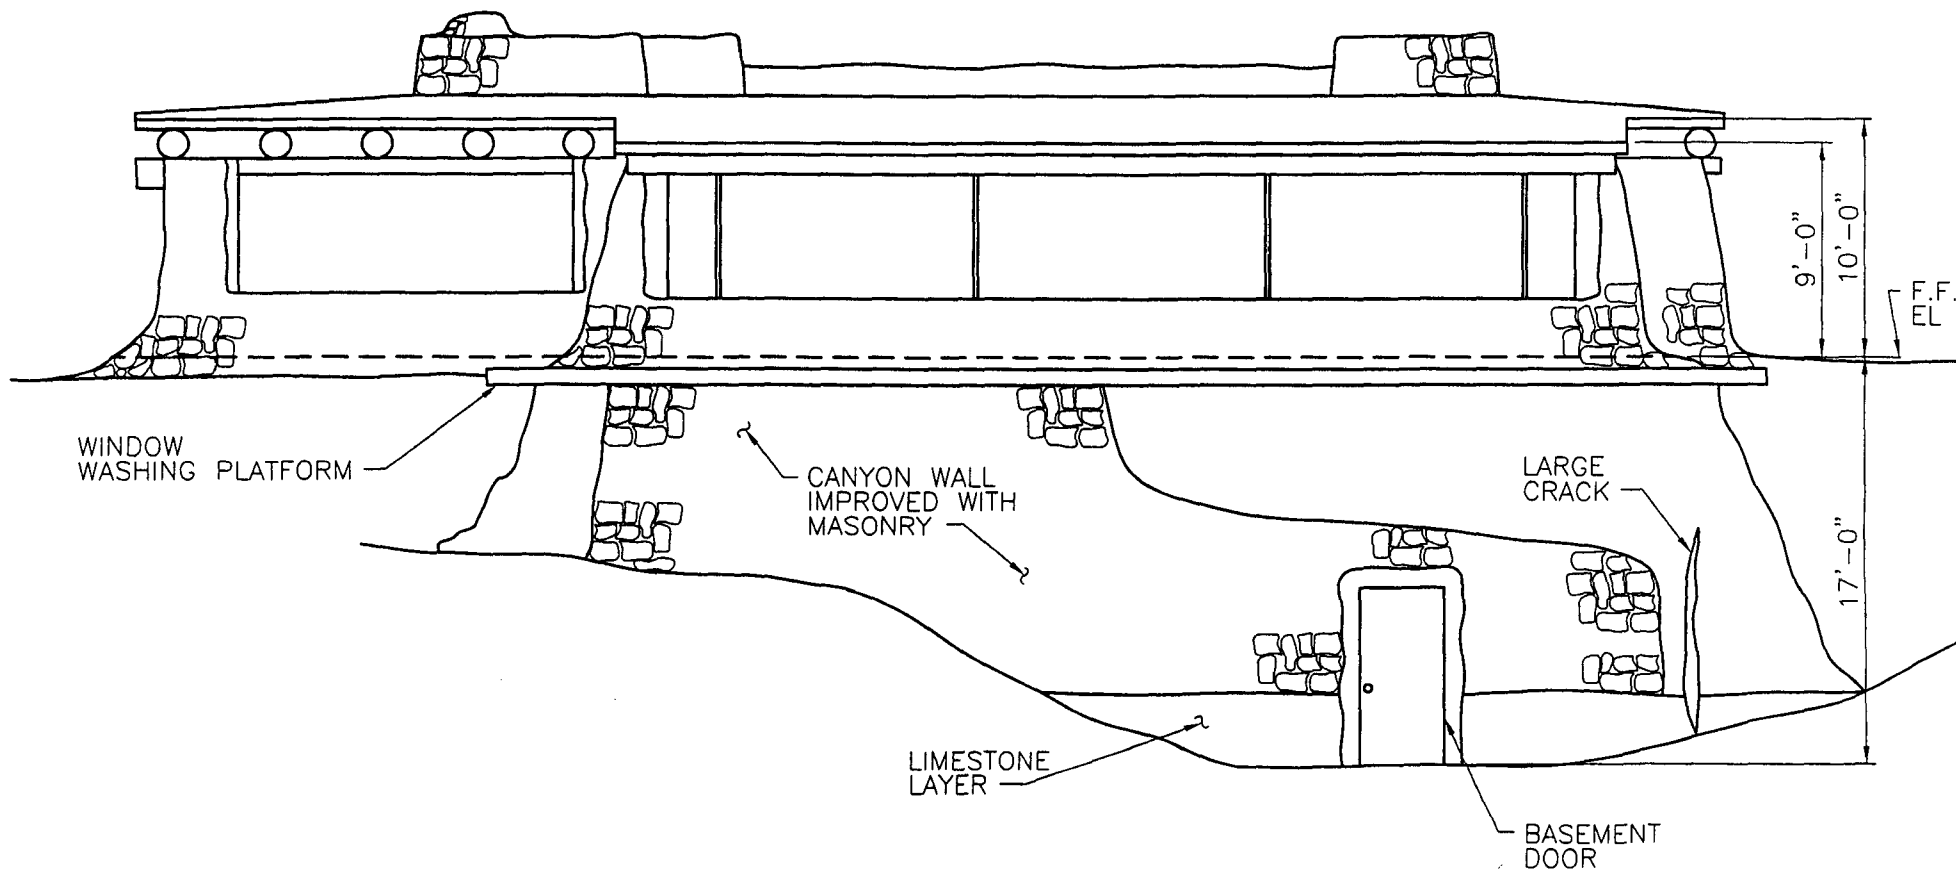
FIG. 4 YAVAPAI POINT MUSEUM

Aligned with the north wall of the building, is the canyon edge. In areas it has been patched or improved with stone masonry to support the curved north side of the building. A portion of this masonry work encloses the "Basement," which has a single door opening on the north side, see Figure 4.

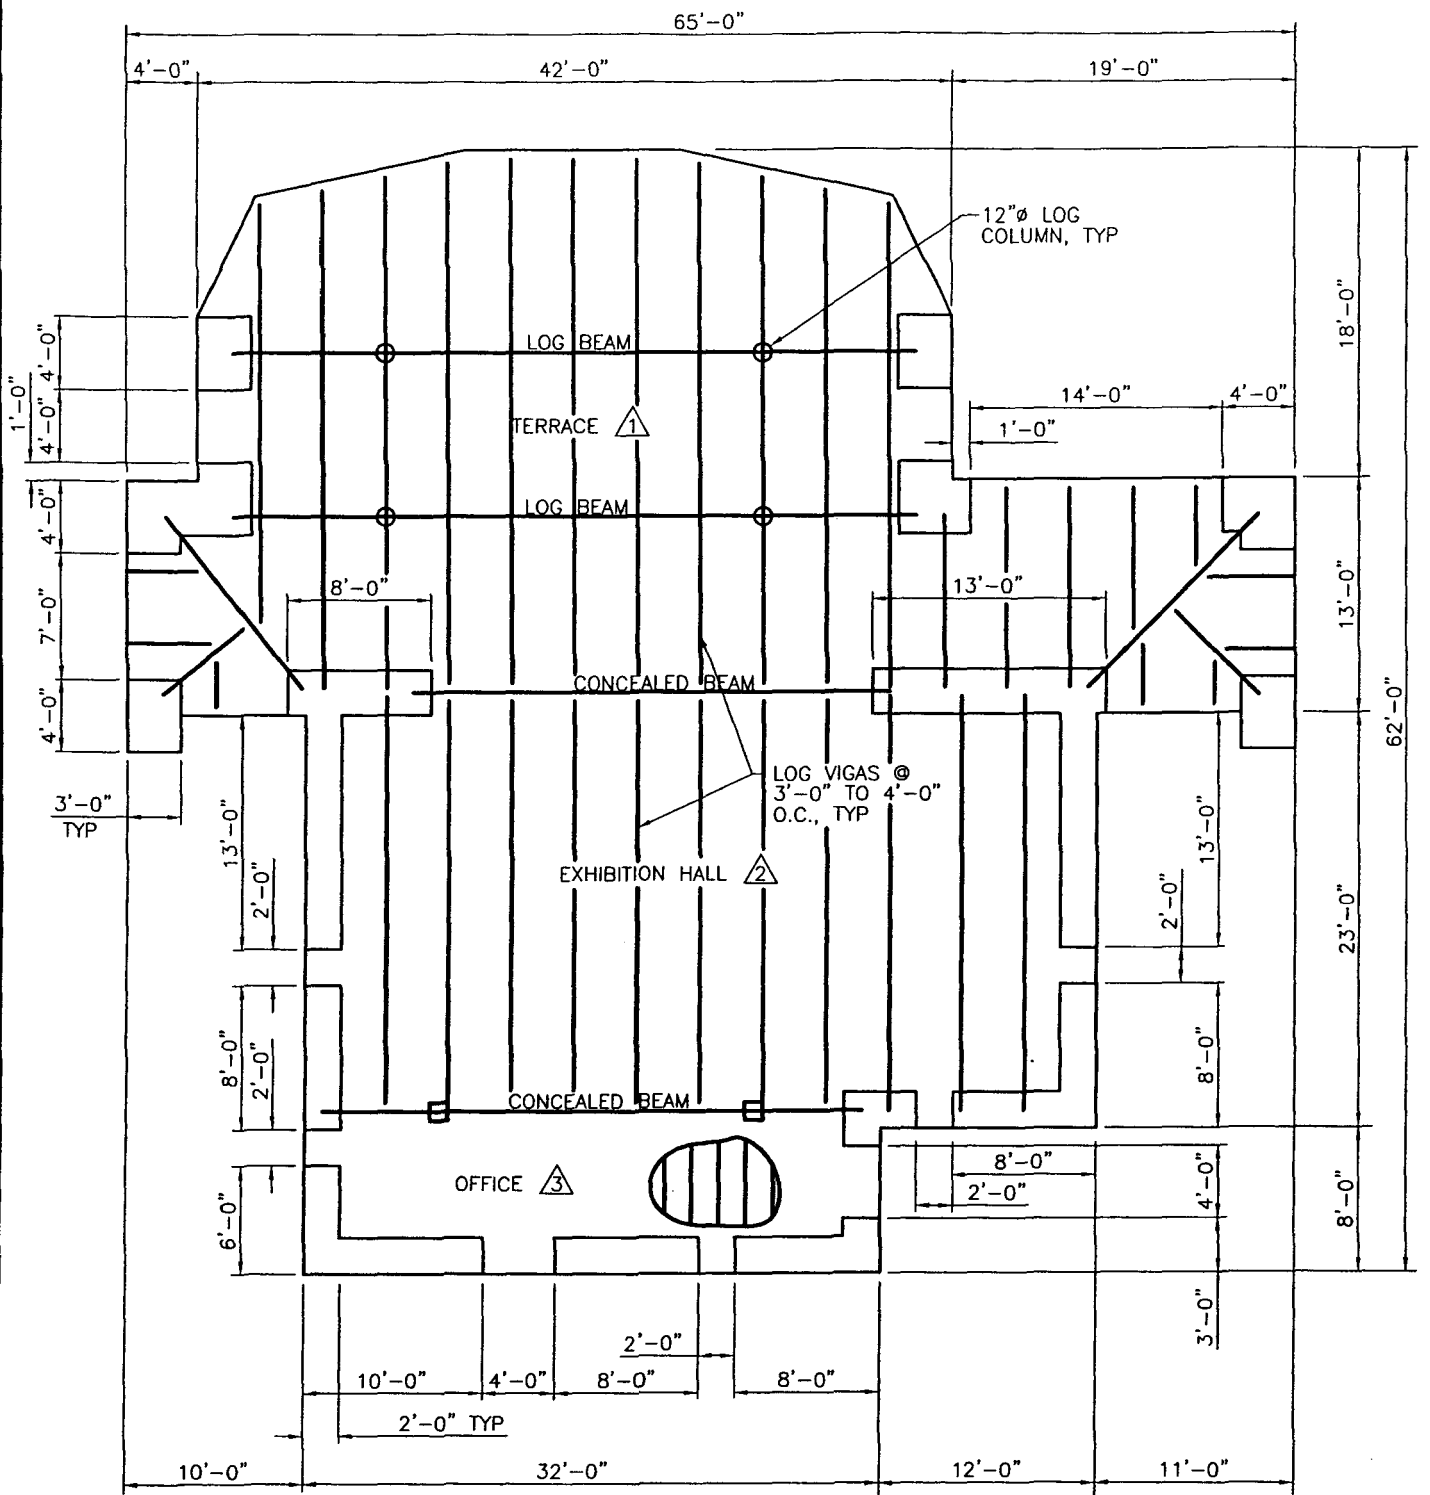
FIG. 5 YAVAPAI POINT MUSEUM

The roof of the Terrace consists of built up tar and gravel roofing over 3/8" plywood over 1 x 10 straight sheathing. The sheathing is supported by vigas spanning from the beam between the Exhibition Hall and Terrace, over two column supported log beams, and cantilevering out to the curved north wall. In the original configuration, there was no north wall, so it is reasonable to assume the vigas still act as cantilevers, and are not supported by the more recently installed window framing. See Roof Framing Plan, Figure 5.

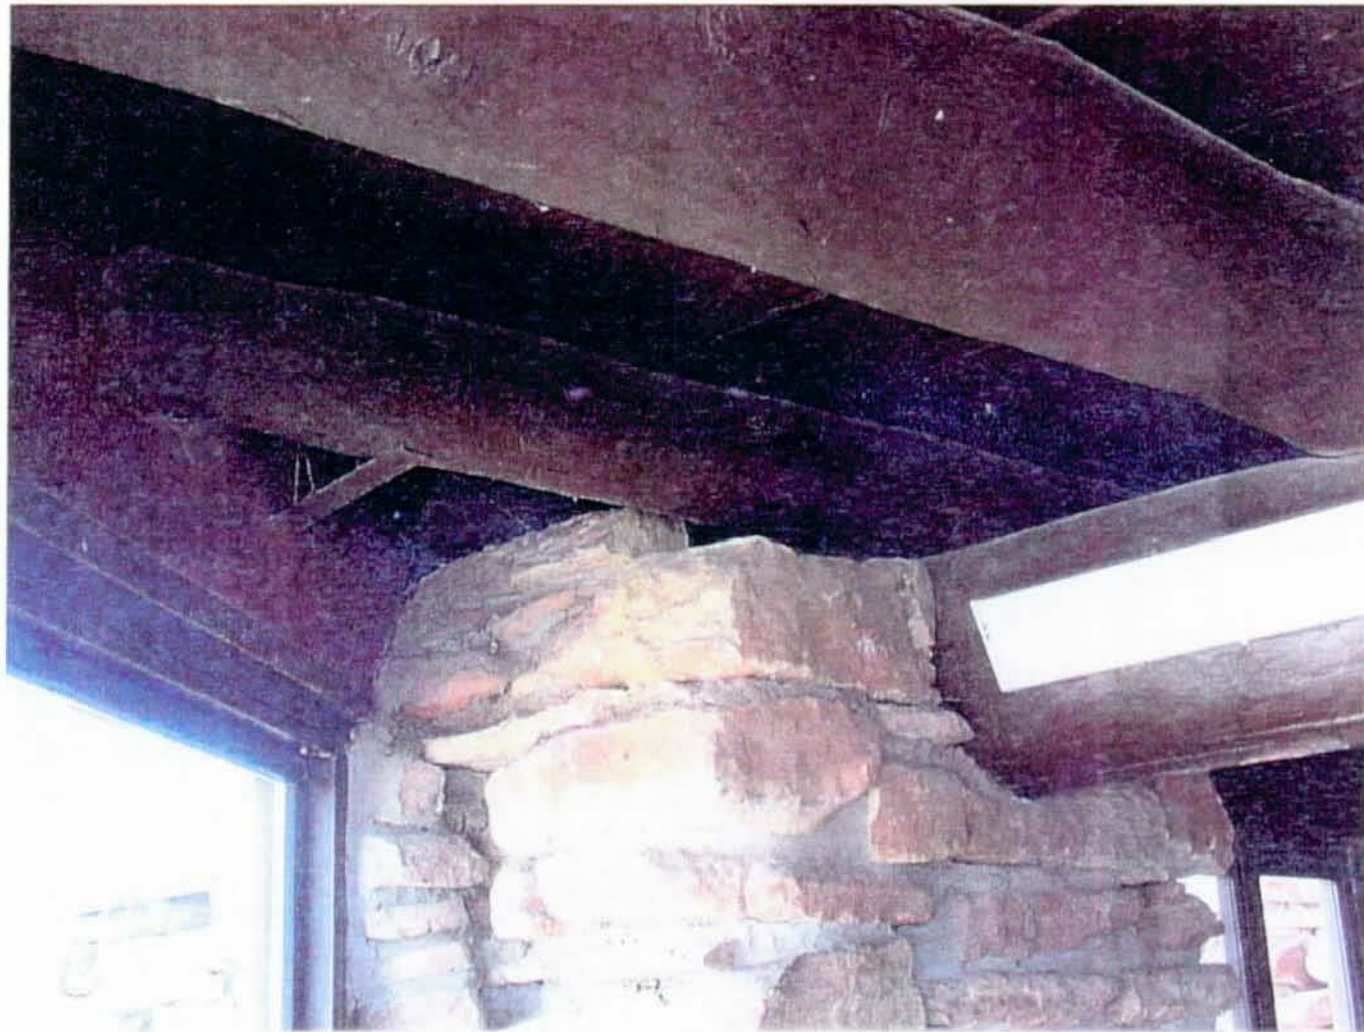
FIG. 12 YAVAPAI POINT MUSEUM

CRITICAL CONNECTION FROM EXTERIOR

Figures 12 and 13 show the connection at the northeast column from the outside and inside of the building, respectively.

Movement of the roof relative to the column in the north-south direction would require the main beam to shear through the top of the column. The area of the failure surface would be approximately $12" \times 36" = 432$ sq. in. At a shear strength of 10 psi, this would equate to a load of 4,320 lbs, far in excess of the applied reaction of $2,454 / 2 = 1,227$ lbs (see Figure 11).

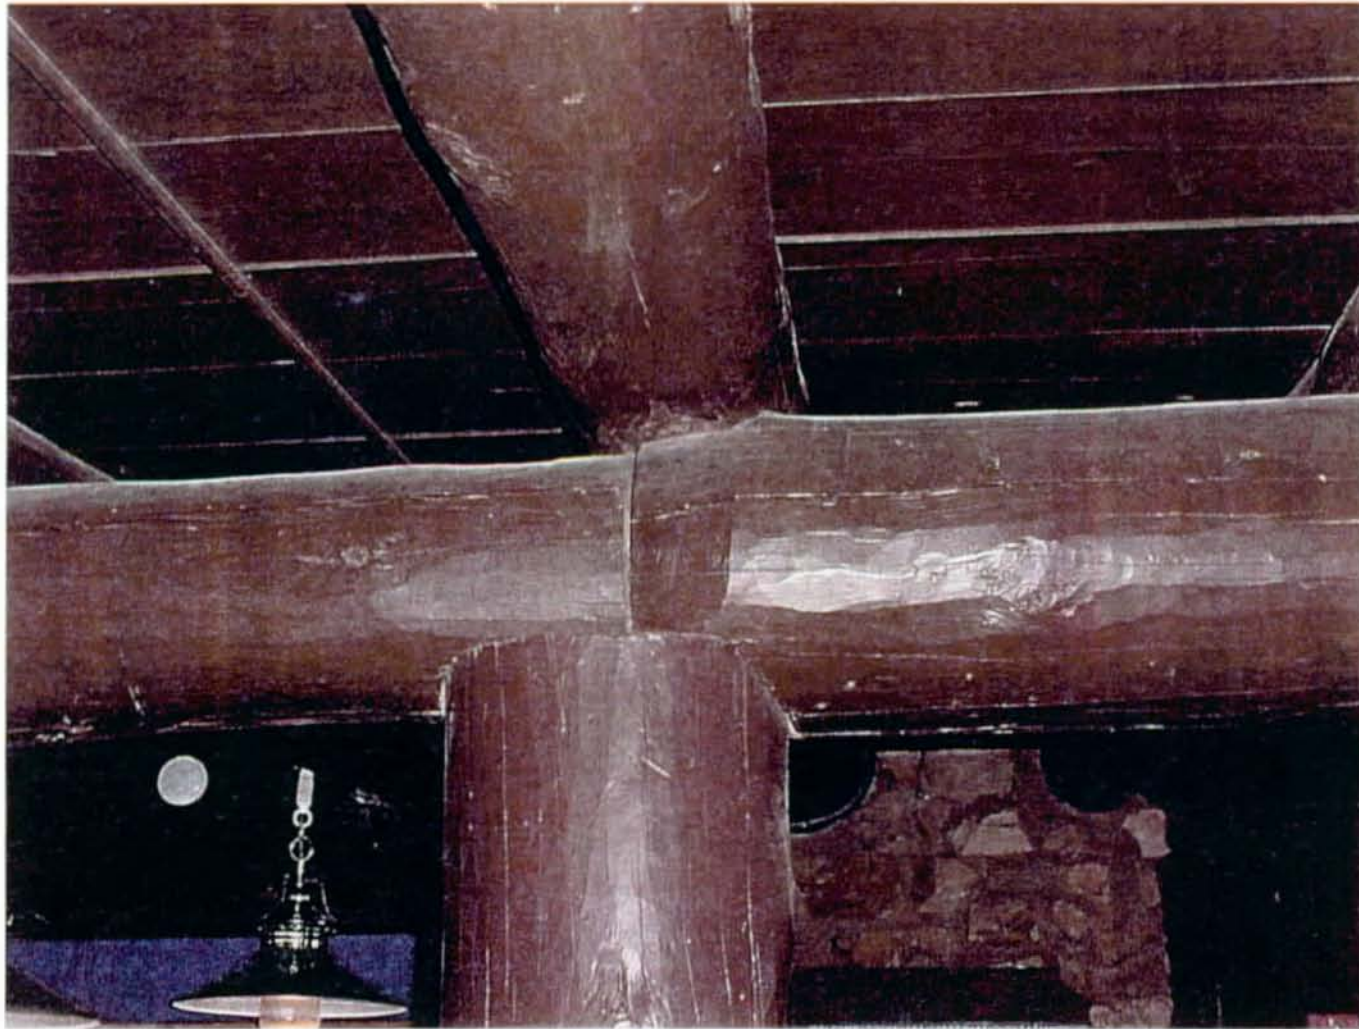
FIG. 13 YAVAPAI POINT MUSEUM

CRITICAL CONNECTION FROM INTERIOR

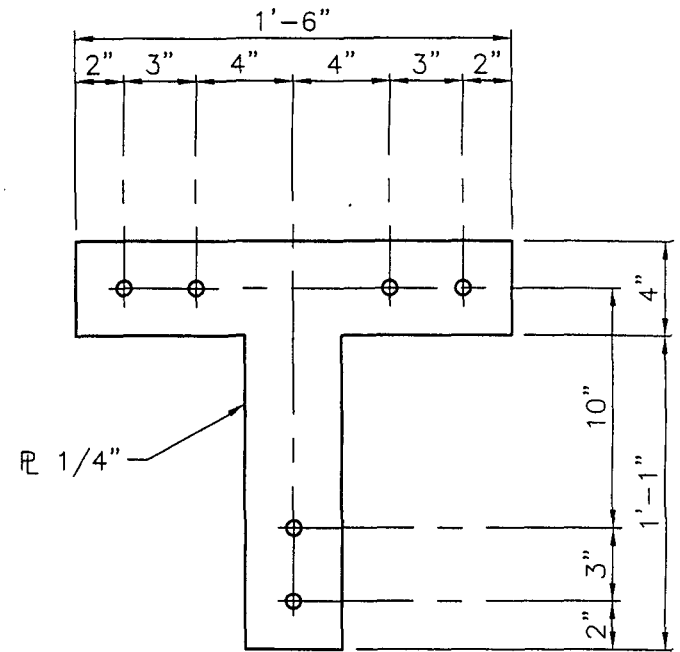
COLUMN CONNECTION RETROFIT

Although they may exist, positive connections between the log columns and the foundation, and between the columns and the beams, could not be verified with the limited investigation permitted. This condition occurs at four log columns in the Terrace area of the building. Unlike the roof to wall connections, the bearing length at the column to beam connections is very short (see Figure 14), and without positive connection, the possibility exists of the roof beams moving off the column and losing support.

NOTE:
TO MINIMIZE VISUAL IMPACT, A SINGLE
"T" PLATE MAY BE INSTALLED
IN A SLOT CUT IN THE COLUMN
AND BEAMS.
