APPALACHIAN CLUBHOUSE

Great Smoky Mountains National Park
Elkmont Historic District
Sevier County, TN

HISTORIC STRUCTURE REPORT

February 17, 2009

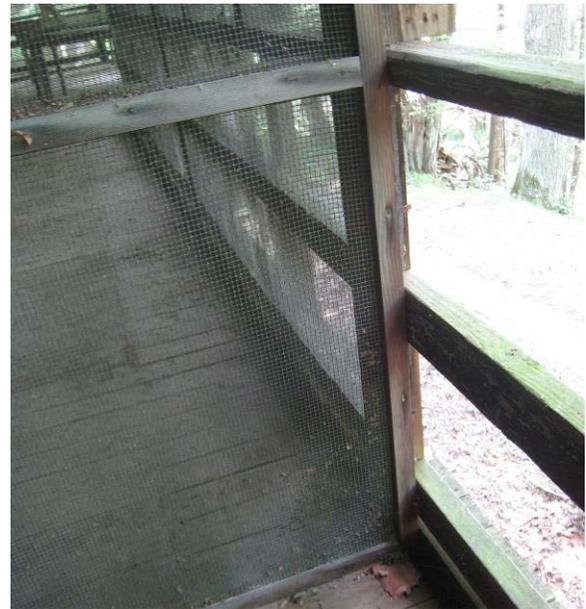
Exterior changes have been made at the East porch. The north half of the porch was screened at an unknown date. In addition to screening the north half, many of the deck

Figure B- 3. North half of screened porch.

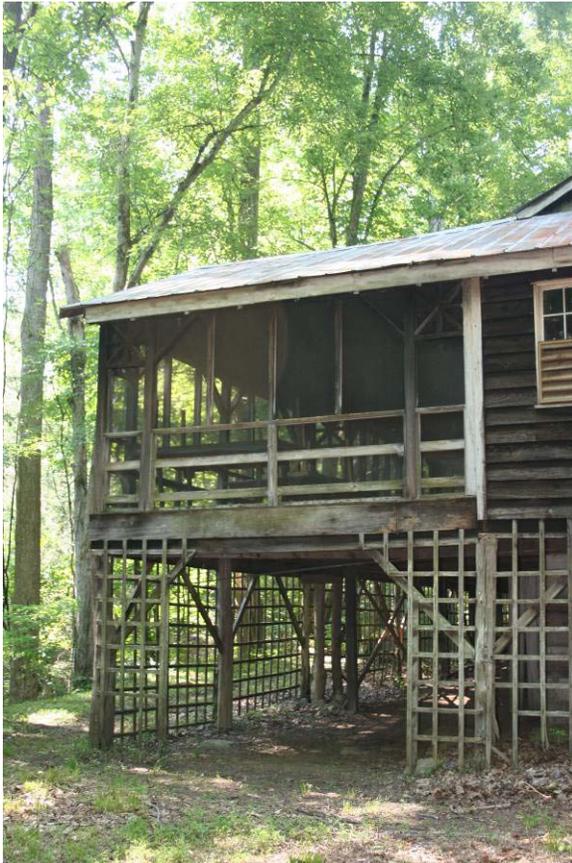
The east porch rafters measure 2" x 6" and are set 24" o.c. The deck boards measure 1" x 8". There is a section of replacement 1" x 5½" stained decking at approximately the middle, exterior side, of the porch. Most elements are early, if not original, and appear sound.

Figure C- 7. North elevation of east porch.

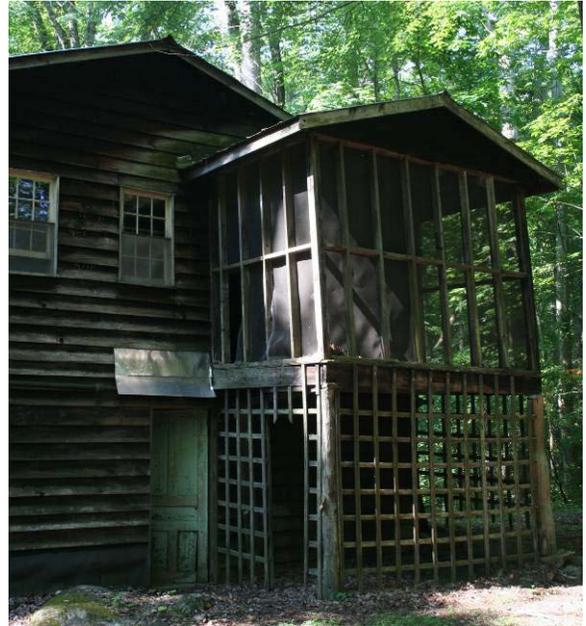
The north porch rafters measure 2" x 2¾" and are set 28" o.c. Deck boards measure 1" x 8". Most components are early, if not original, and appear sound.

Figure C- 8. North porch.

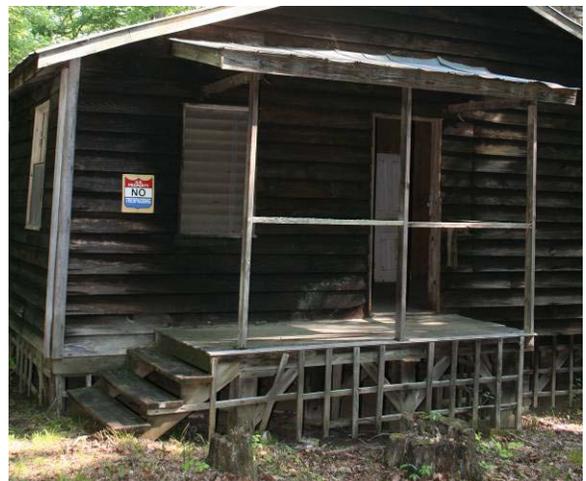
At the south porch, 2" x 6" rafters are set at 24" o.c. and rest on a 2" x 6" header. Deck boards measure 1" x 8", except for some replacement boards which measure 7/8" x 5½". Except for minor repairs, the framing and decking appear original and in good condition.

Figure C- 9. South porch.

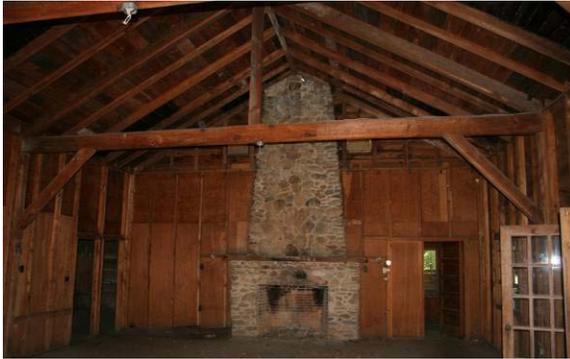
Figure C- 10. King-post truss.

At the tall, central Meeting Room, four, original, wood, king-post trusses span east-west to support the gable-end roof. Each bottom cord measures 6" wide by 10" deep. Each king post, its two flanking diagonals, and the top chord measure 6" x 6". Although not accessible for close inspection, all elements appear to be original and in good condition.

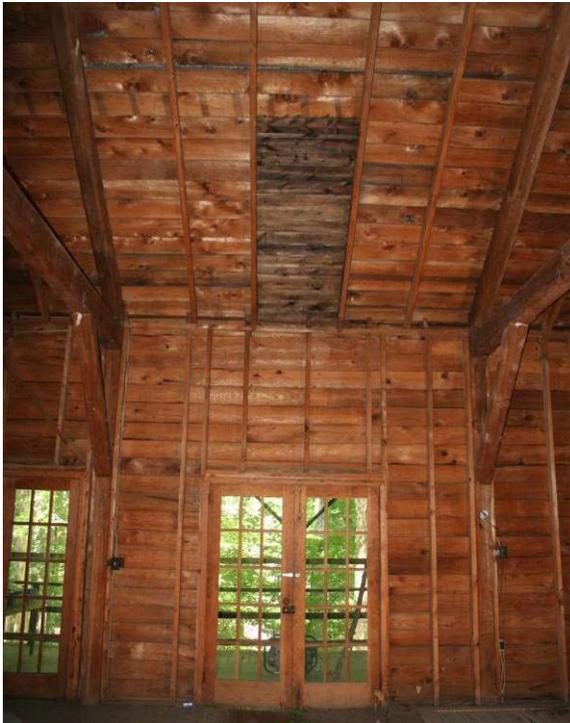
Figure C- 11. Rafters of Meeting Room.

two middle rafters are 2" x 6s" and are set approximately 34" apart. The two outer rafters are 2" x 4s" and are at about 26" o.c. Between the middle rafters, the deck boards measure 1" x 4" and are stained; all other deck boards measure 1" x 6" and are without stain, though they are dark from age. The difference in deck board size suggests difference construction periods; that the boards between the middle rafters are stained for a darker appearance suggest that they are a recent addition. The larger size rafters in the middle suggest they were intended to support a heavier weight above, probably dormer windows. These elements, too, could not be closely inspected but appear to be in generally sound condition.

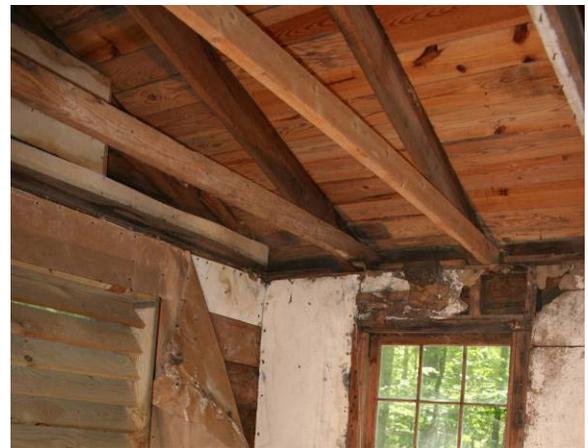
Figure C- 12. Original 2" x 6" rafters at south gable roof.

The framing system for the small gable and shed roofs that flank the hall on three sides, where visible, consist of 2" x 6" rafters set 24" o.c. with 1" x 8" deck boards. This appears to be the original with some localized repairs. The small gable roof on the south side and portions of the shed roof on the west side have had long-term roof leaks, causing damage to roof framing and room features. See *Interior Features: Rooms* for description of the damages and evidence of previous repairs.

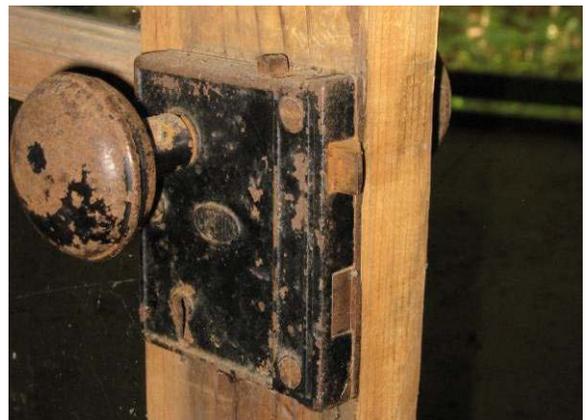
Figure C-15. Corbin rim-lock on door type D-1.

The remaining hardware for door type D-1 typically consists of a Corbin rim lock, two steel knobs and two butt-hinges. The rim lock measures approximately 3¼" x 3¾" while the hinges are five-knuckle and 3½" high.

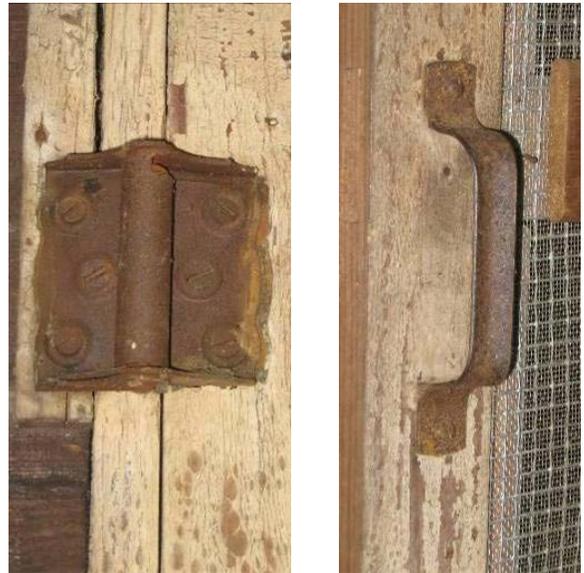
Door type D-2 hardware typically consists of two 3" high, spring hinges and a 4½" high pull. The only remaining pull however, is on the right leaf screen door in the central entry to Room 101.

Figure C- 18. Hardware on door type D-2.

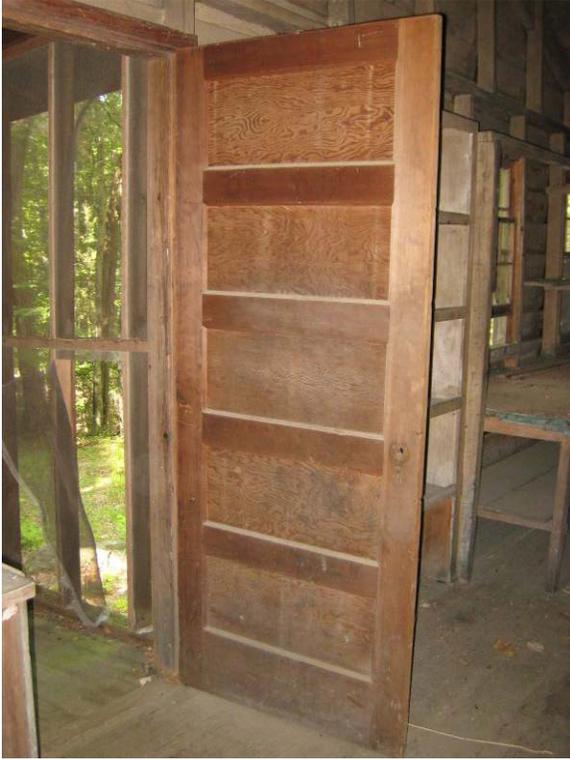
Figure C-19. Door type D-3.

The door hardware consists of two five-knuckle, 3½" high, metal, butt-hinges. Originally the door had a rim lock, keeper

and knob which are now all missing. Based on the ghost marks, the rim lock measured 3" x 3¾". Above the missing rim lock is a barrel bolt.

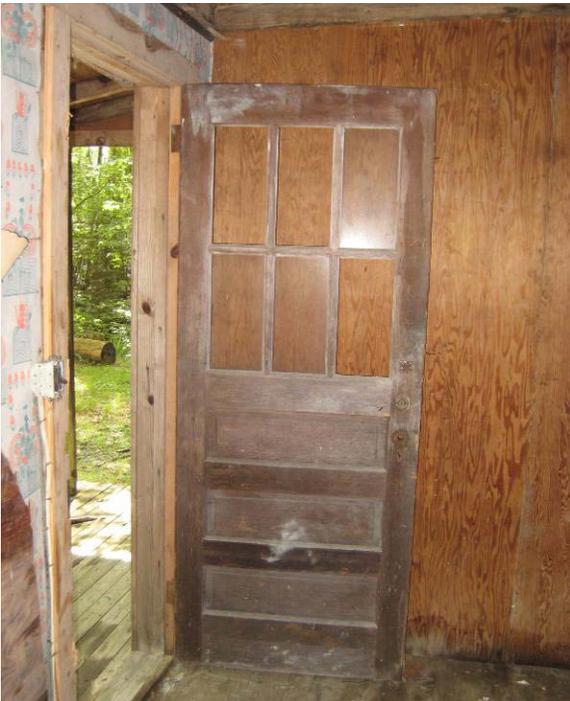
Figure C-20. Door type D-4.

The door hardware consists of two, five-knuckle 3½" high, metal, butt-hinges. Originally the door had two knobs and a key plate but they are missing. A "Yale" deadbolt is located above the knob.

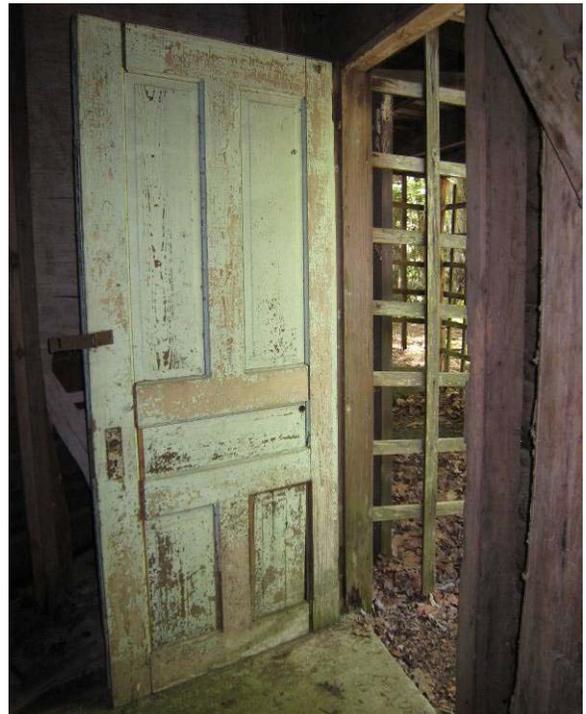
Figure C-21. Door type D-5.

The door hardware consists of two five-knuckle, 3½" high, metal, butt-hinges and a metal padlock. A knob with escutcheon plate were located at both interior and exterior face but they are now missing.

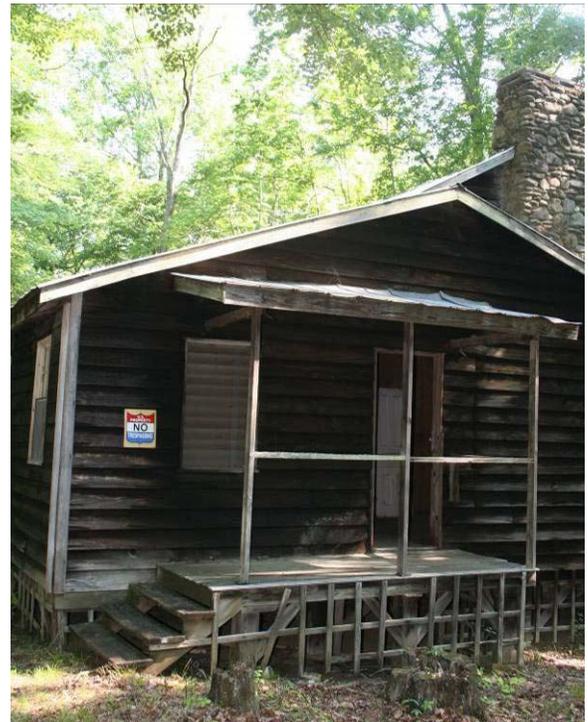
Figure C- 28. South porch.

Replacement 1 $\frac{1}{2}$ " x 5 $\frac{1}{2}$ " joists, $\frac{3}{4}$ " x 3 $\frac{1}{2}$ " floor deck boards and $\frac{7}{8}$ " x 5 $\frac{1}{2}$ " roof deck boards have been selectively added.

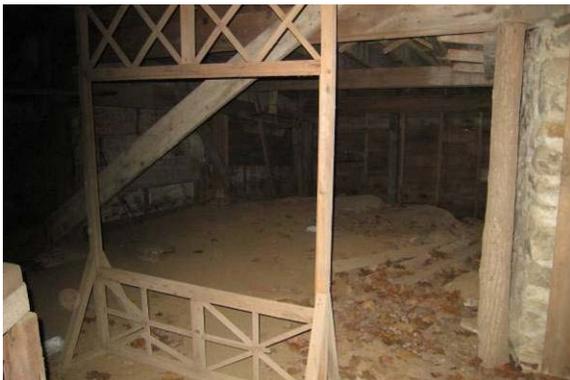
Figure C- 30. Interior of Room 001, looking southwest.

Along the north section of the west elevation, at the rooms enclosed at grade, there is a low, one-wythe deep, stuccoed-brick wall, apparently original, that supports the wall posts. This area of the building has suffered from long- term water damage. Perhaps slow evaporation of rainwater runoff along the shady exterior, or the dampness of the interior baths, or both contributed to the damage. Whatever the reasons, both the brick wall and the adjoining wood elements have extensive deterioration. See *Figure C- 30*.

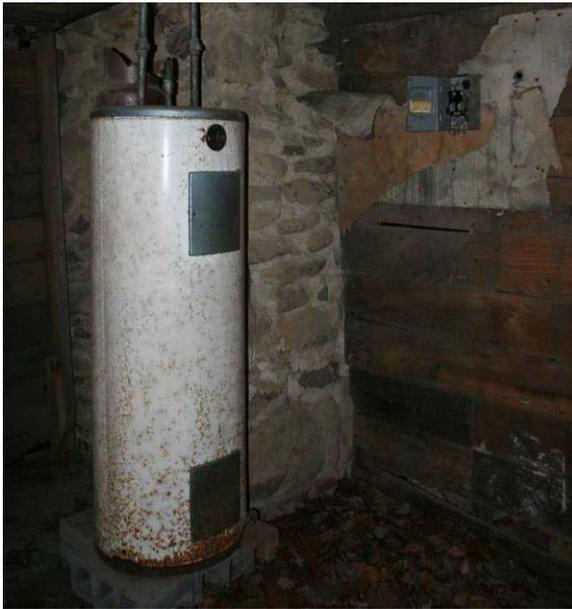
Mechanical Systems: Along the south wall of Room 002A there is a 58 gallon electric water heater by Row Con Company of Nashville, TN (model # B0090-XC, serial # 65-64029). The water heater is on concrete blocks.

Figure C- 35. Water heater and fuse box along south wall in Room 002A.

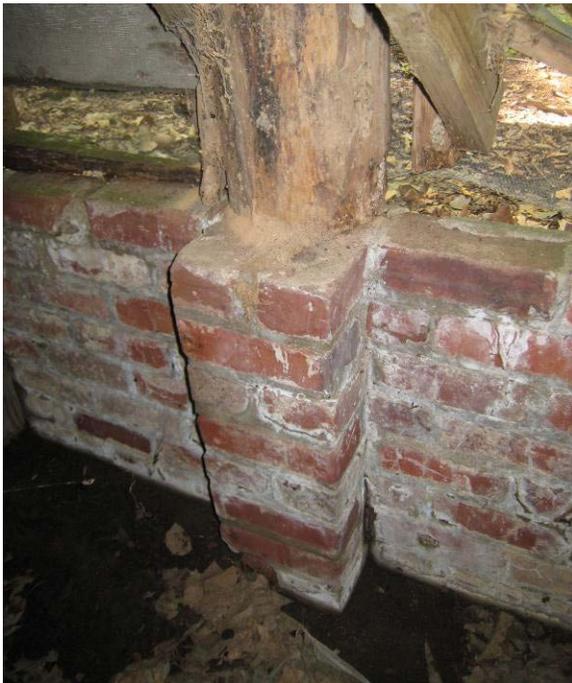
The west wall of Room 002B consists of a masonry foundation wall below and the backside of the exterior lap-board siding on the vertical 2" x 3⁵/₈" studs above. In addition to the studs, 6" diameter wood posts sit on projecting sections of the masonry foundation wall. Intermixed with the wood framed wall are double-hung windows.

Figure C- 38. Masonry foundation-wall and wood post at west wall of Room 002B.

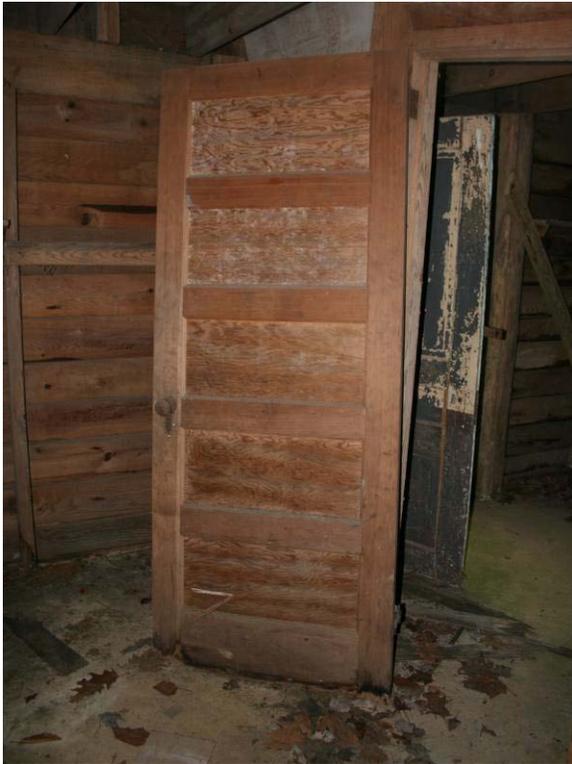
Doors: A doorway with a five-paneled door, similar to exterior door type D-3, is attached to the stud framing at the northeast corner of the room. The door measures 2'-8" x 6'-8" x 1¹/₄" and is probably original to the Clubhouse.

Figure C- 39. Interior five-paneled door in Room 002B.

The door hardware consists of two, five-knuckle, 3½" high, metal, butt-hinges. It also has a decorative metal knob with escutcheon plate on one face and a metal knob and rim lock on the other. The rim lock measures approximately 3¼" w. x 3¾" h. The keeper is 4" high. The knob, escutcheon, and rim lock appear to be early, if not original to the construction of the Clubhouse.

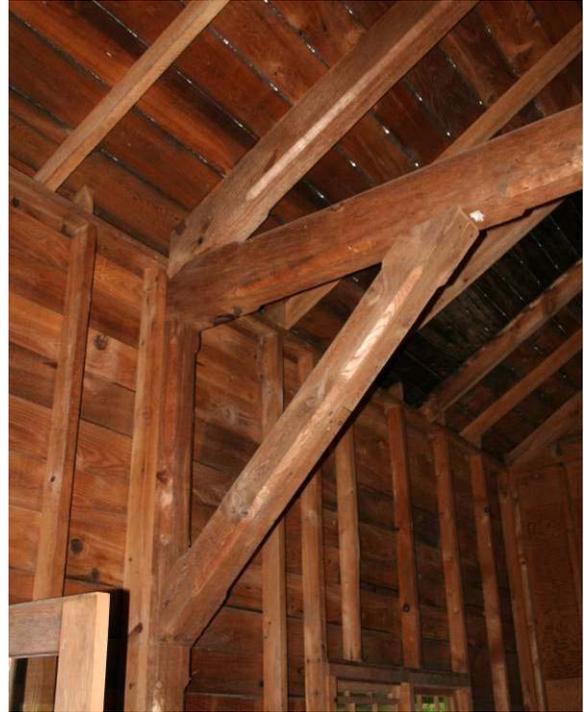
The majority of the roof deck consists of 1" x 6" plank-boards. The deck boards vary between the two middle rafters in each truss bay. At the bottom half, the decking

consists of varnished 1" x 4" plank-boards. These boards are not original and, together with the larger sized middle rafters, suggest dormer windows were probably originally installed.

Figure C- 46. Corner of king-post truss and underside of gable roof framing in Room 101.

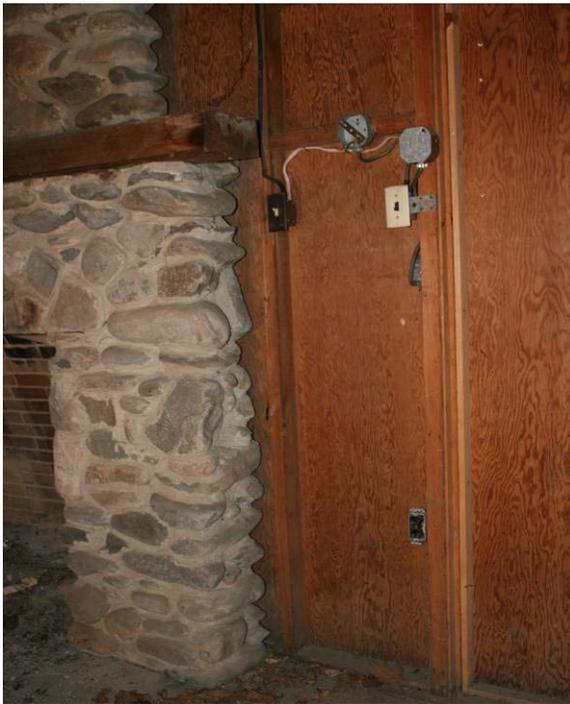
Four light fixtures appear to have been mounted to the underside of each of the four trusses. The fixtures are now missing with only the junction box and exposed wiring remaining.

The electrical wiring is all surface mounted and insulated either with fabric or plastic insulation.

Figure C- 47. Toggle light switches, junction boxes, and exposed wiring at north wall of Room 101.

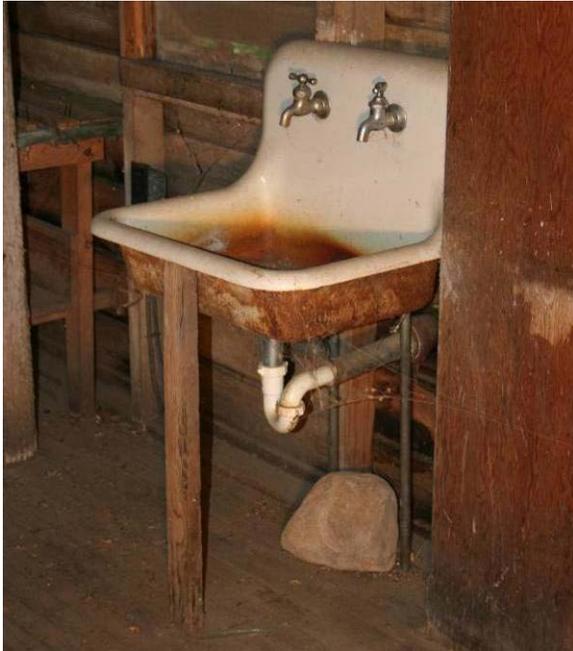
Plumbing Systems: An early, if not original, porcelain wall mounted sink with integral backsplash and faucet is located at the north wall. The front of this sink has since been propped up by a board.

Figure C- 53. Wall-mounted sink at north wall.

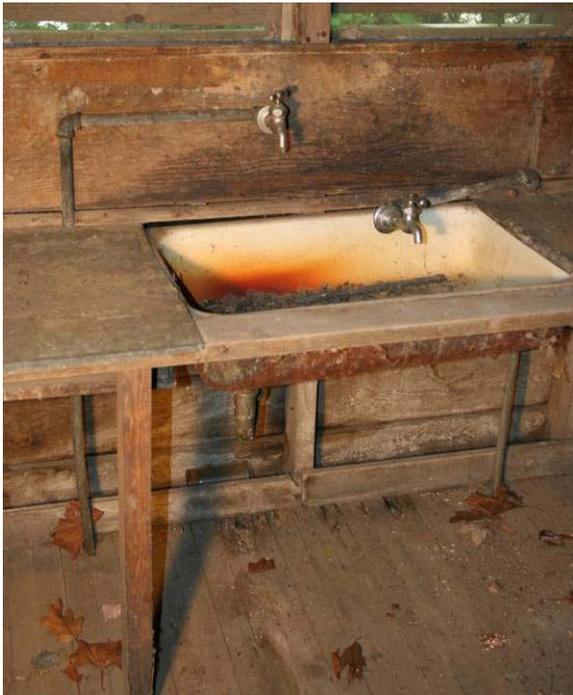
A single bowl under-mount sink is located in the countertop along the west wall. The sink, faucet, and piping all appear to be early, if not original.

Figure C- 54. Under-mount kitchen sink in U-shaped countertop at west wall.

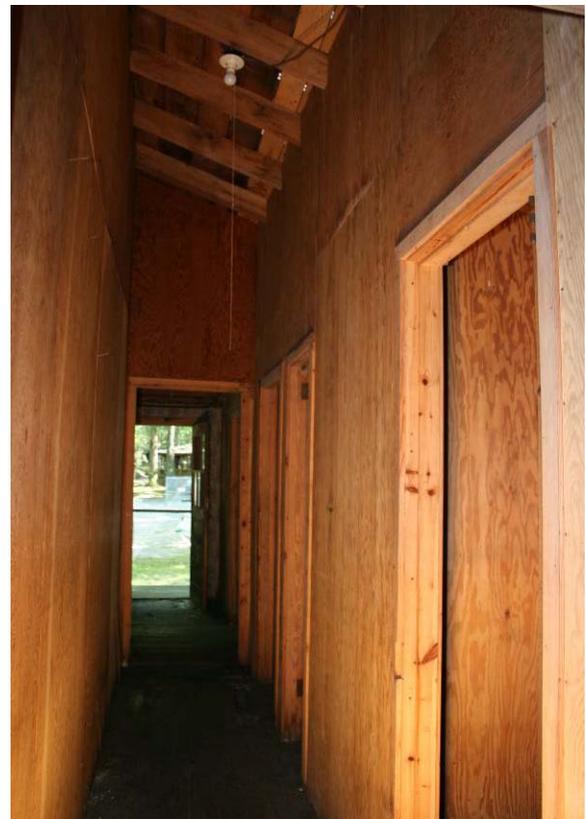
Figure C- 65. Corridor/Room 104D, looking south.

The plywood has buckled at the north, south, and west walls due to water infiltration.

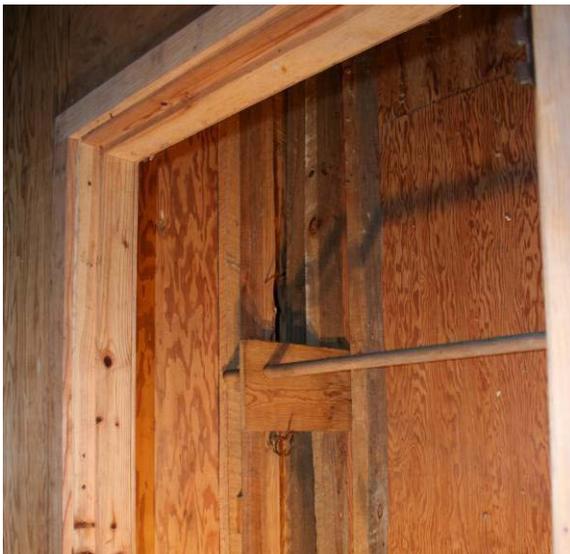
Figure C- 67. Looking southwest into closet along Room 104D's west wall.

The closet walls consist of the exposed studs and backside of ¼" plywood sheathing. Water stains are evident at the top, south end of the west wall.

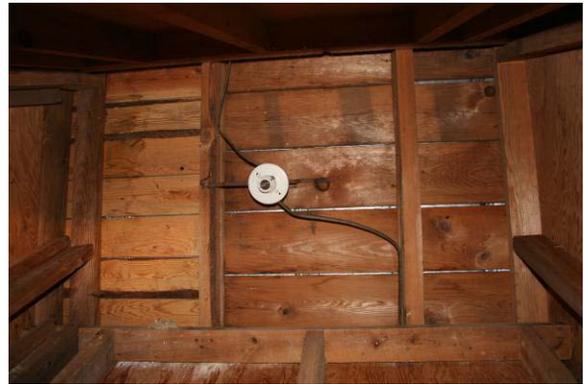
The rafters in the closet measure approximately 2" x 4". The roof deck boards appear to be 1" x 8" except at the south end where they were replaced by 1" x 6" boards.

Figure C- 69. Exposed roof framing in closet off Room 104D's west wall of.

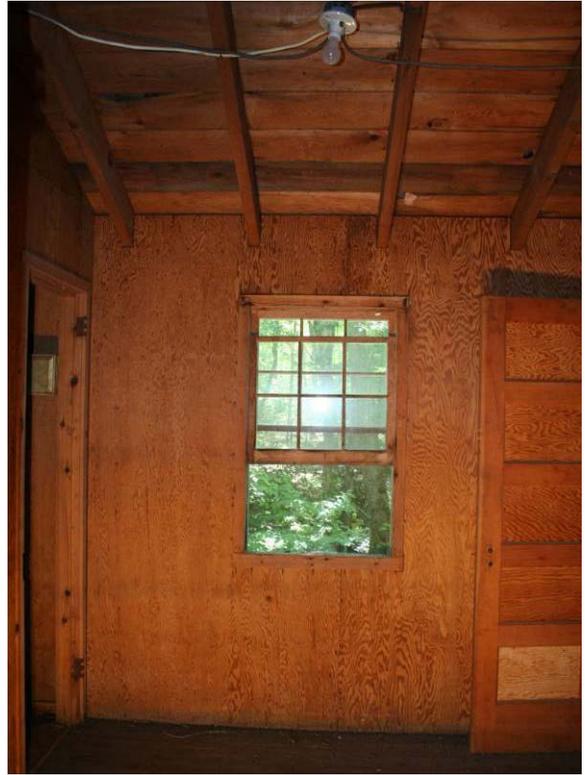
At the east and west walls, the plywood is buckling.

Figure C- 77. Room 108, looking west.

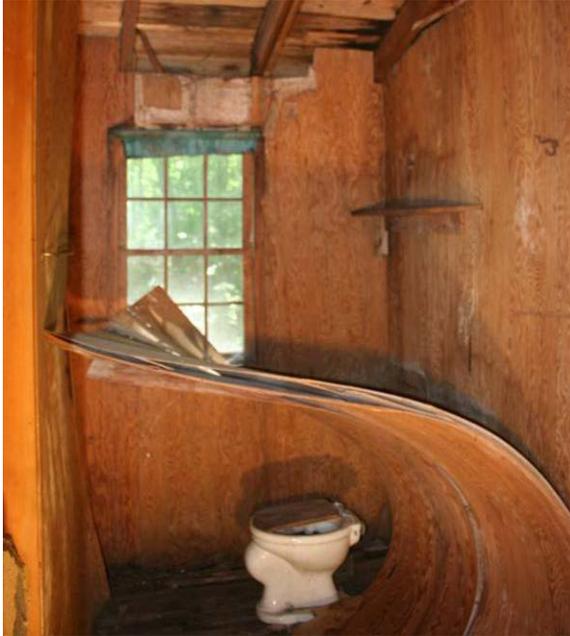
Figure C- 81. Room 110, looking west.

The plywood is in very poor condition with all walls showing signs of buckling and panels at the south wall have fallen off. Water infiltration appears to be the reason for the damage.

The deck boards in the northwest corner show signs of rot due to water infiltration.

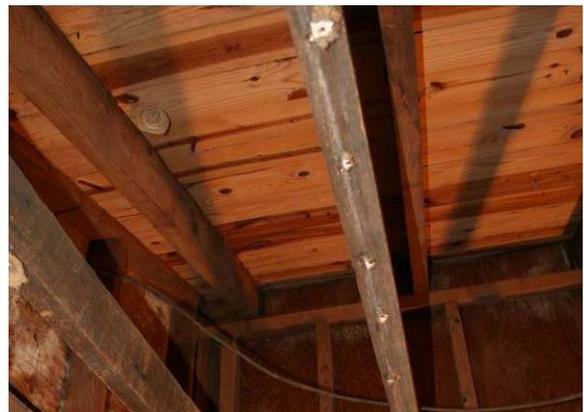
Figure C- 86. Ceiling framing and remnants of particle board.

Ceiling: A particle board ceiling was installed over wood framing but almost all

of the particle board is now missing. The particle board ceiling was 7'-6" above the finished floor.

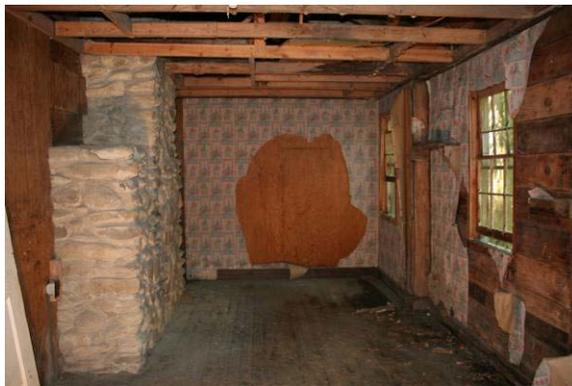
Figure C- 87. Room 112, looking east.

Some of the floorboards appear to be wet and are discolored due to water infiltration. There are also some boards with minor cupping.

At the north wall, the backside of the stone chimney projects into the room. Cracks are noticeable at the west end of the chimney and a patch has been placed over an old flue opening.

The bottom of the west wall has some water staining and minor buckling.

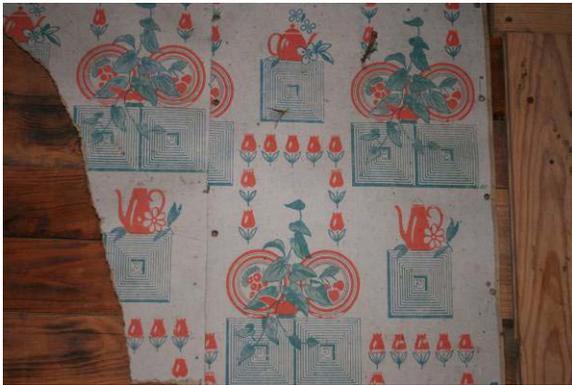
wallpaper. Much of the wallpaper at the west end of the wall is missing.

Figure C- 89. Wallpaper at south wall.

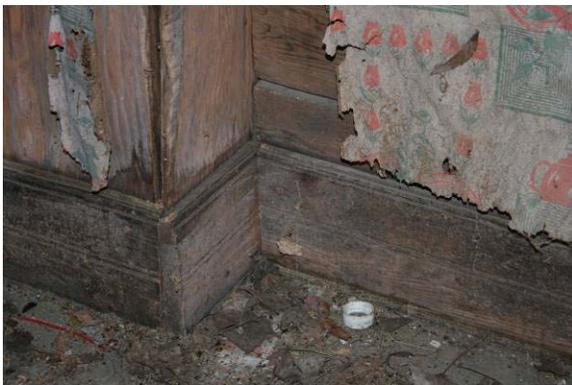
Figure C- 90. Base molding at south wall.

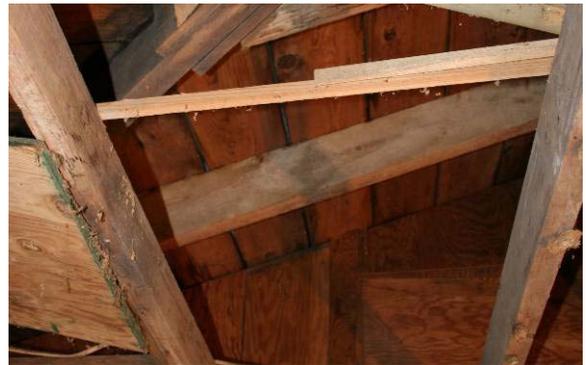
Ceiling: A particle board ceiling was installed over wood framing but almost all of the particle board is now missing. The particle board ceiling was 7'-6" above the finished floor. Some of the wood framing appears to be re-used pieces from elsewhere.

Figure C- 91. Miscellaneous wood framing at ceiling.

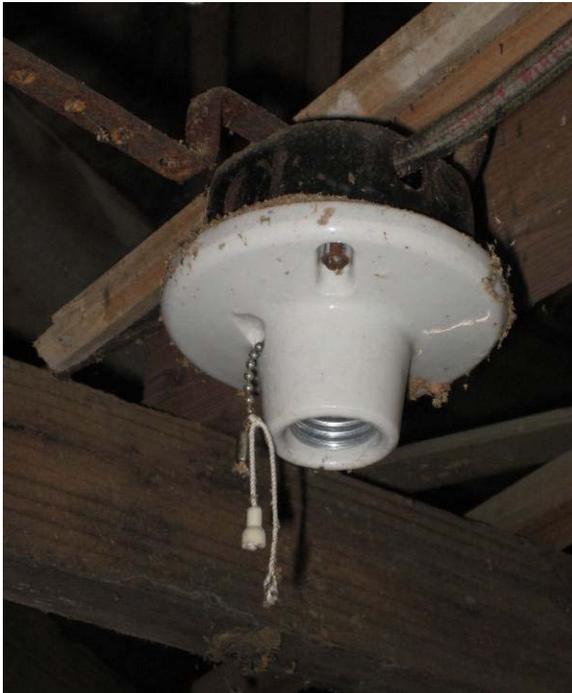
Figure C- 92. Ceramic light socket base in Room 112.

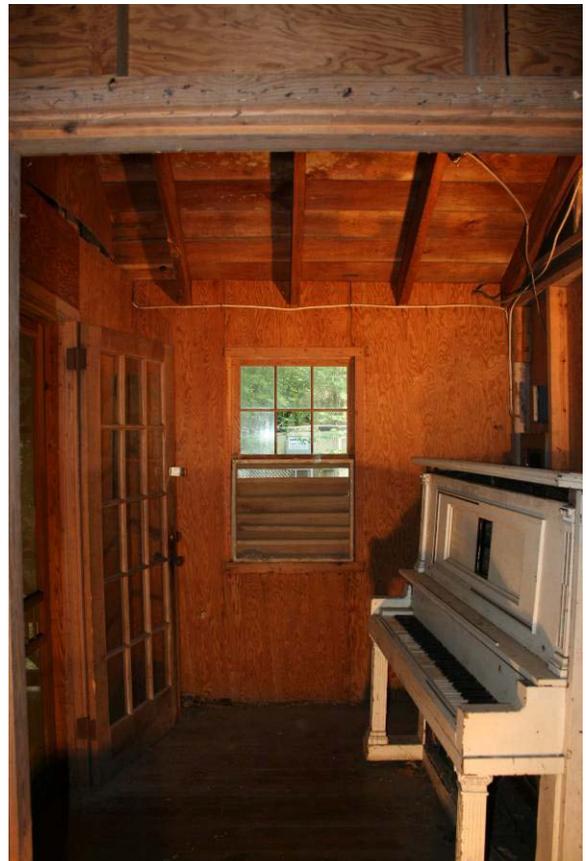
Figure C- 93. Room 113, looking south.

The bottom sash has been replaced by wood louvers.

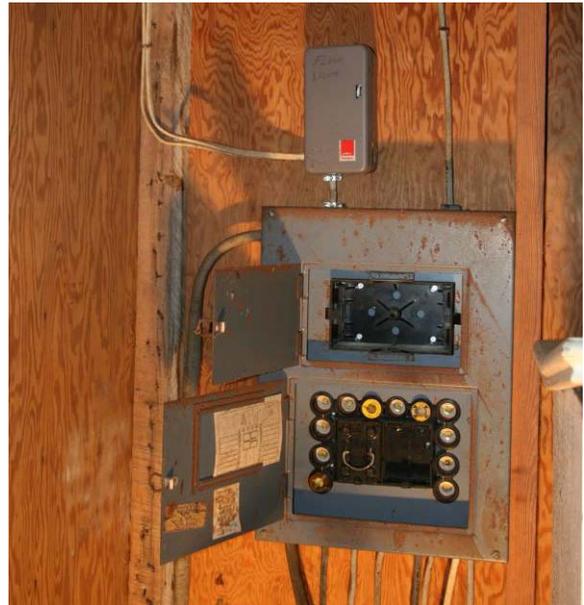
Electrical Service: Overhead electrical supply lines connected at the south side of the building. The fuse panel box for the disconnected electrical system is located on the west wall of Room 113. A subpanel is located on the south wall of the room at grade containing the hot water heater.

Figure C- 94. Electrical panel.

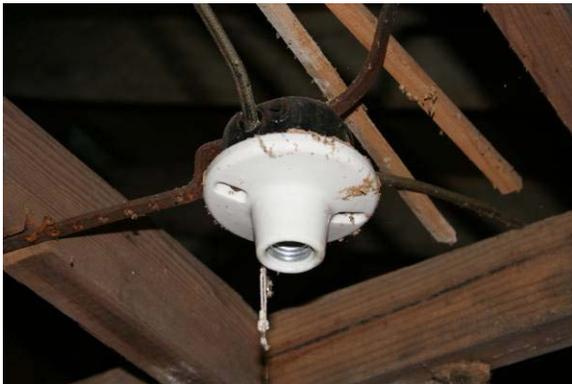
Figure C- 96. One variety of early ceramic light sockets.

The electrical system with all its components is important for interpretation. However, the potential for reactivation is not promising, except for some lighting fixtures once repaired.

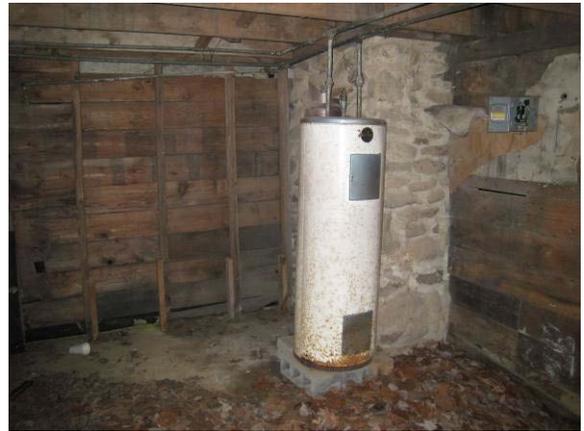
Figure C- 97. Electric water heater.

The plumbing lines and fixtures are important interpretive features but the usability of any portion is suspect.
